Concrete Dams Case Histories of Failures and Nonfailures with Back Calculations

DSO-98-05

**U.S. Department of Interior
Bureau of Reclamation
Dam Safety Office**

December 1998

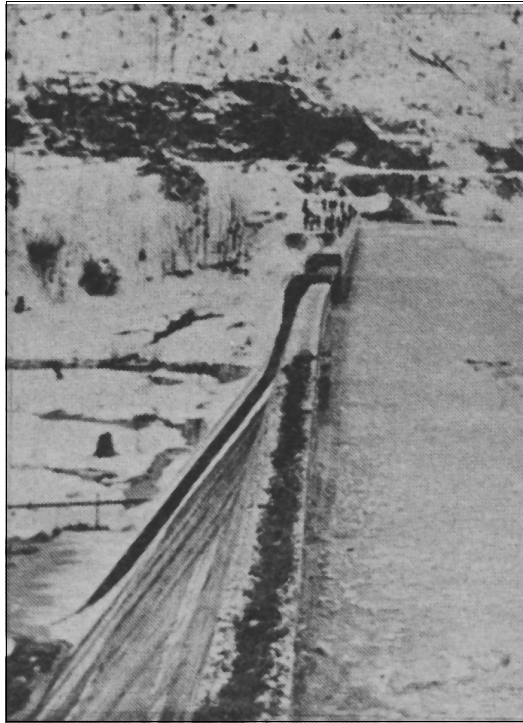
Behavior under loading: Rain and rapidly melting snow during a brief warm period the week of January 17, 1910, following a very cold and snowy December, filled the reservoir and caused a significant spillway flow. An undetermined thickness of ice still covered the reservoir. On January 22nd, a landslide dropped about 8 feet (2.4 m) on the eastern bank downstream of the dam, and water leaking from beneath the slide was evidently from the reservoir. Water in large quantities began coming up through the ground from 15 to 50 feet (4.6 to 15.2 m) downstream from the toe of the dam. On January 23, 1910, the center portion of the dam slid horizontally downstream as much as 18 inches (0.46 m) at the base, with a corresponding crest displacement of as much as 31 inches (0.79 m). A photo, taken from the eastern abutment and aligned with axis of the dam, shows a distinct bend along the length of the dam (figure AP-1). Five or six

large vertical cracks through the dam formed at this time. Two 8 to 10-foot (2.4 to 3.1 m) gaps were blasted in the crest of the dam, one near the spillway and one near the right abutment to lower the reservoir and reduce the loading. After a review of the structure, engineering consultants analyzed the situation (see figure AP-2) and advised strengthening the dam. The recommendations went unheeded and the dam was put back into service without the recommended repairs. Subsequent photos show significant leakage spilling through the large vertical cracks in the dam.

Discussion: The failure of the owners to strengthen the dam after the initial movement was the subject of much discussion in the articles written. Based on a photograph taken in January 1910, showing rather dramatic bending along the dam axis and tipping downstream at the center, it is amazing that no corrective action was taken and the dam was allowed to be put back in service.

It is likely that the initial movement in January of 1910, in which the top-center portion of the dam moved 31 inches (0.79 m) downstream and the bottom-center moved 18 inches (0.46 m), started as tipping and subsequent sliding due to large lateral forces at the crest due to high reservoir and ice loading. With water flowing from springs below the dam and unstable wet areas on the abutment, it was apparent that reservoir water had entered the foundation. The resulting bending along its length left the dam broken at several places but amazingly, the pieces remained in place while the reservoir was drained and the dam inspected. The anchor bars were perhaps the only thing holding the dam in place.

Figure AP-1. Photo showing bulge in crest during initial filling (after Potter County Leader, 9-24-1986)

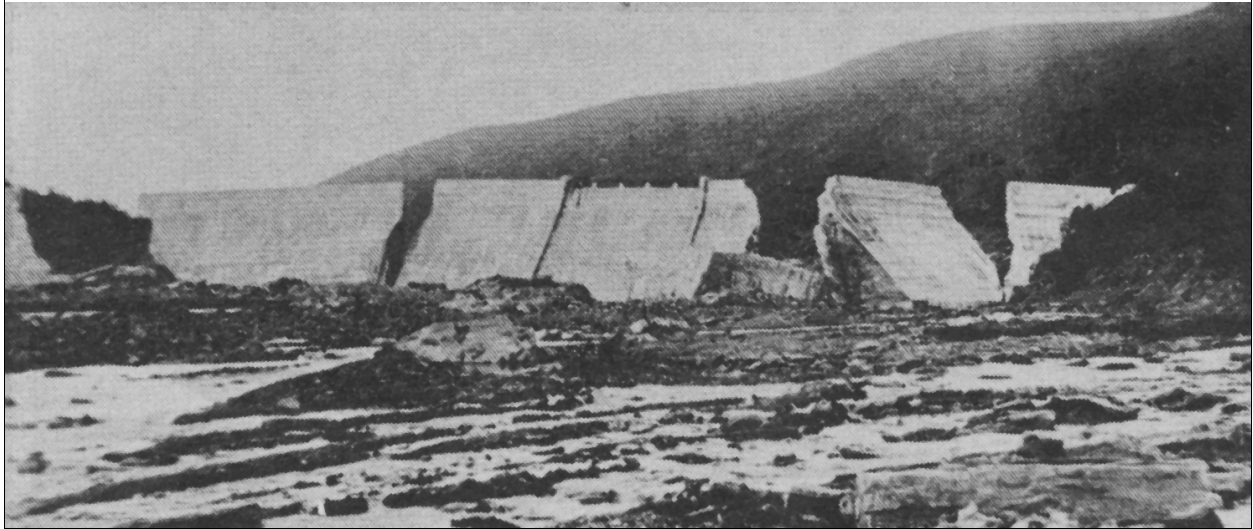
Figure AP-3. Photo showing downstream area after dam failure (after Potter County Leader 9-24-1986)

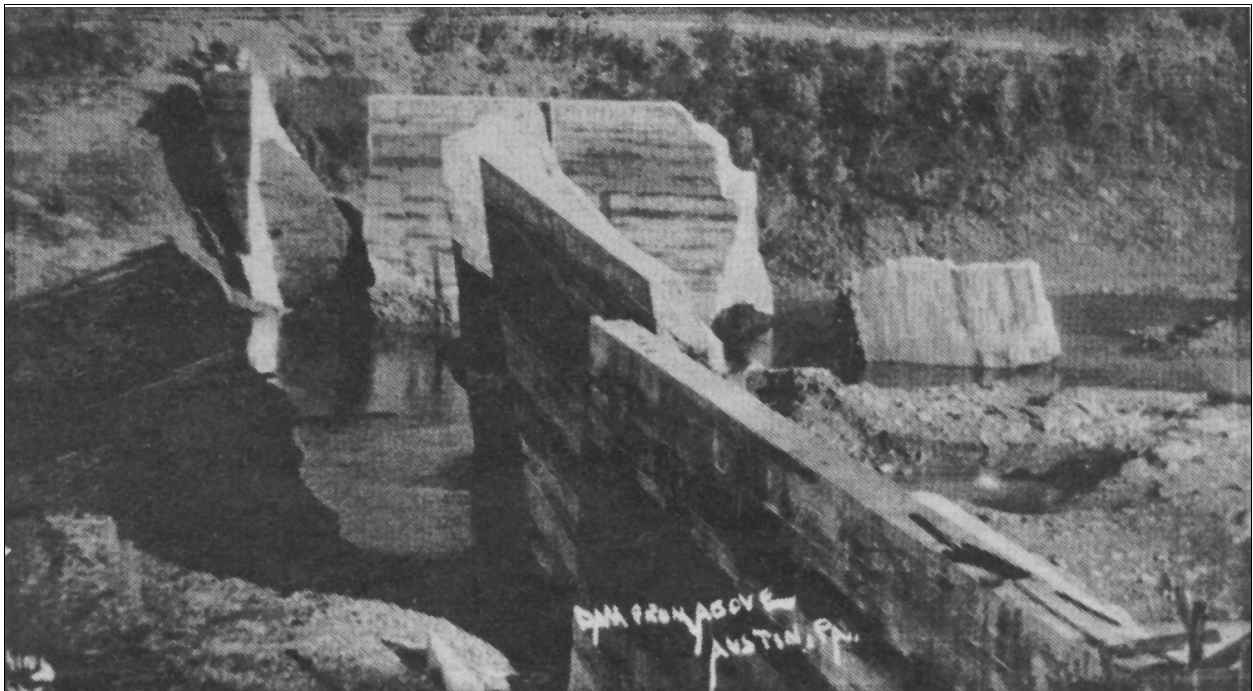
When the dam was returned to service, without performing the strengthening recommended by a consultant, it was only a matter of time before critical loads returned to destroy the weakened dam. That finally happened on September 30, 1911, when rain brought the reservoir level 7-inches (0.18m) above the spillway crest. According to Harry Davis's eyewitness account, a huge plug, 4 or 5 feet (1.2 or 1.5 m) above the base and west of the center segment, burst forth from the dam. The portions of the dam above and beside the plug then tumbled into the ensuing flood. East of the spillway one huge segment slid forward at a slight angle and another pivoted like a hinged gate opening to nearly 45-degrees. The description of this sequence of events leads one to recall the excessive fines that formed a "cream" at the surface of some placements in the same area as the blown out "plug". The compressive strength of some samples taken from this area were as low as 49 to 98 psi (0.34 to 0.68 MPa), so low that they had to be handled with great care to keep them from crumbling. A combination of weak horizontal planes in the dam and foundation, and the vertical cracks from bending could have produced a block which was susceptible to being blown out. Once the pieces of the dam began breaking loose, each moved independently according to the flood forces and foundation resistance present. Many of these huge segments stand nearly in place and upright to this day.

Figure AP-4. Photo of dam ruins after failure (after Potter County Leader 9-24-1986)

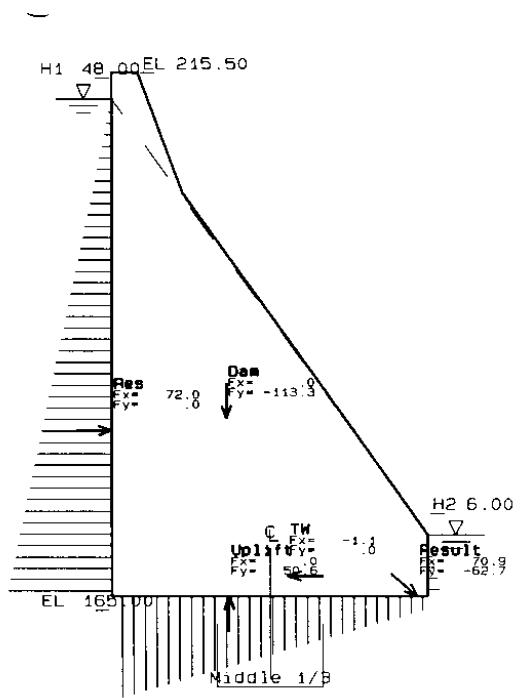
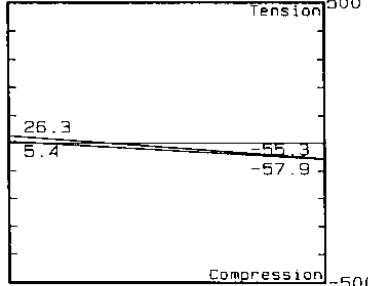
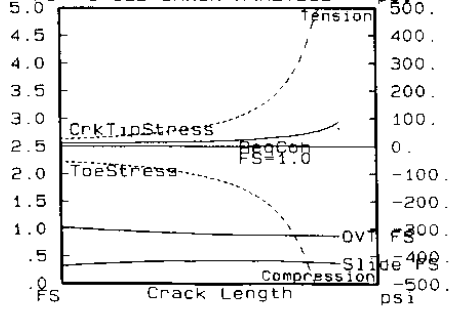
Figure AP-7. Calculations simulating conditions at time of failure

Back Calculations: Stability calculations were performed for the dam simulating conditions at the time of failure as shown on figure AP-7. Since the dam had no foundation drains, an uplift distribution varying linearly from reservoir head at the heel to tailwater head at the toe was assumed to occur near the base of the structure. The 4 feet by 4 feet (1.2 by 1.2 m) shear key at the upstream heel is not shown. With a water surface at the crest elevation of the spillway, stability calculations show that tensile stresses occurred at the heel of the dam. With uplift, the maximum tensile stress is about 26 lb/in² (0.18 MPa), with the linear stress distribution going to compression at a distance of about 9.7 ft (2.96 m) from the upstream face. If it is assumed that full uplift penetrates to the crack tip and that any tensile stress would cause cracking, the calculations show the crack would continue to propagate all the way through the dam. This may not be entirely realistic since the materials would have some tensile strength, and uplift would likely dissipate through joints in the foundation rock. The dam was built with horizontal construction joints, with little attention given to joint preparation between lifts, but there is

FORCED CRACK RESULT
 Heel initially in tension
 Crack extends entire width of base

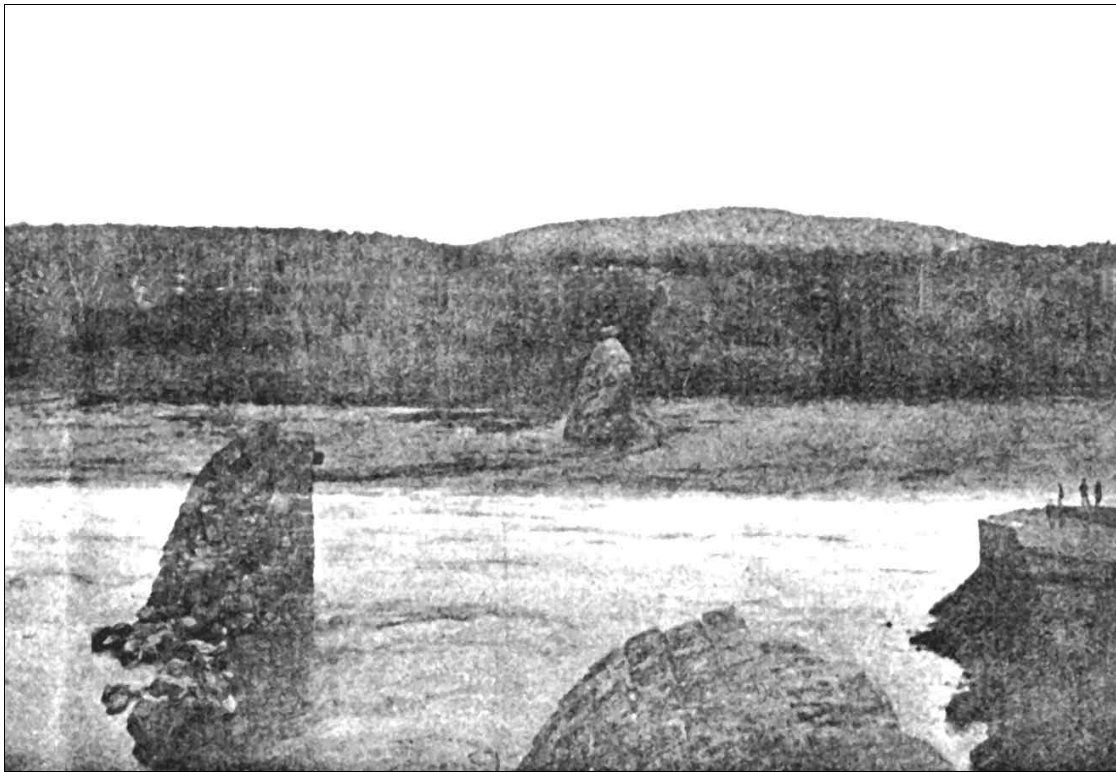
Behavior under loading: Shortly after completion in 1894, problems were encountered at the powerplant headgate structure due to water flow along a fault beneath the structure. The structure was badly damaged (exact failure mode unknown), necessitating costly repairs. On April 7, 1900, a heavy rainstorm resulted in 11 feet (3.4 m) of water going over the crest of the dam. At that time, about 440 feet (134.1 m) of the left side of the dam slid downstream about 40 or 50 feet (12.2 or 15.2 m) (see figures AT-1 and AT-2). This section of the dam maintained its line and vertical position. It then broke into two pieces, which remained intact for about 1 hour before breaking up and washing away. The water flowing over the structure had eroded the toe and exposed daylighting bedding planes. The strength of these planes was insufficient to resist the loading.

Figure AT-2. Failure of Austin Dam, TX (after Scientific American, 4-28-1900)

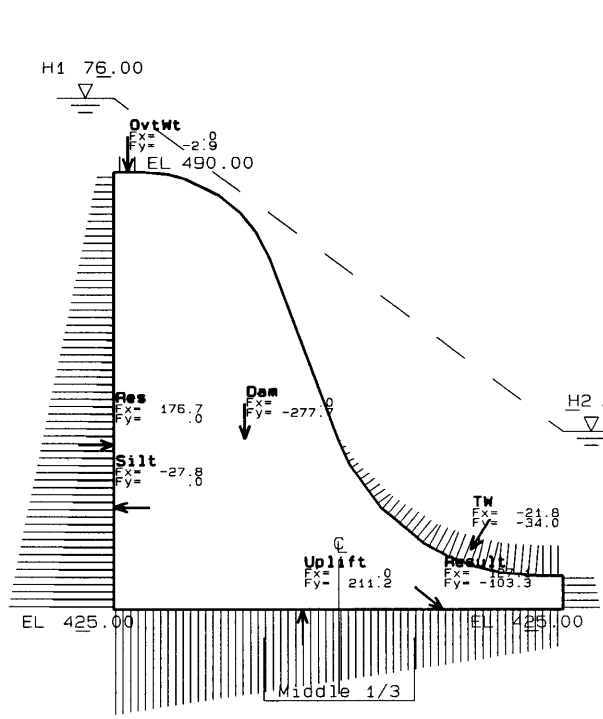
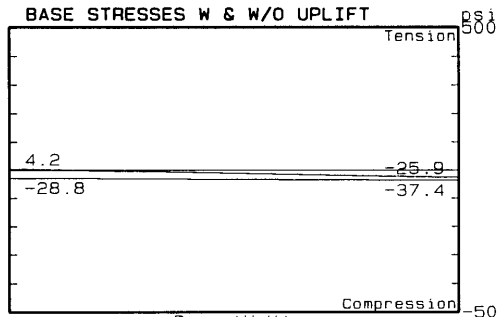
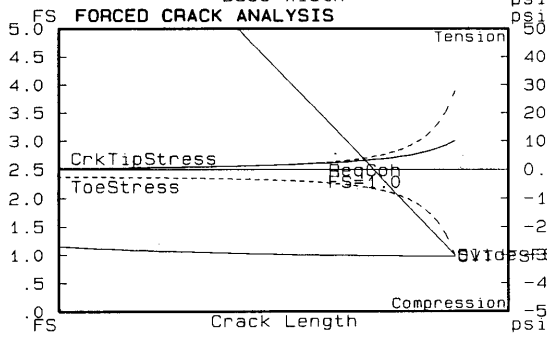
Figure AT-3. Calculations for Austin Dam, TX for conditions at failure

Back Calculations: The foundation of the original dam was virtually on the surface of the river bed rock. The foundation here consists of nearly horizontal layers of Edwards limestone, which is extensively fractured and contains many open or clay-filled seams. Stability calculations for the overtopping conditions which were occurring at failure of the original dam (see figure AT-3) show that tension existed at the heel of the dam when a linear uplift distribution is assumed from reservoir head at the toe to tailwater at the heel. However, the tensile stress is very small (4 lb/in² (0.03 MPa)). If zero tensile strength is assumed, and full uplift is assumed to penetrate to the crack tip, the calculations show that the crack would continue to propagate through the dam thickness. However, the dam was probably bonded to the foundation at least somewhat, and the foundation jointing probably interconnected enough that full uplift at a crack tip would not occur. It is unlikely that such a small tensile stress would result in complete instability. The more likely scenario stems from the fact that the design did not account for the potential riverbed erosion and undercutting of the dam toe during flood flows of the magnitude experienced (11 feet (3.4 m) over the spillway crest). The weak bedding planes would daylight into the eroded hole with the loss of any keying effect from downstream rock layers. Assuming resistance only from the portion of the dam base in compression, a friction angle less than 50 degrees would lead to sliding. It is likely that the friction angle of the weak bedding layers was considerably less than this, but there probably was some downstream passive rock, roughness, cohesion, and/or interlocking rock that prevented sliding until the reservoir reached the height at which failure occurred.

FORCED CRACK RESULTS
 Heel initially in tension
 Crack extends entire width of base

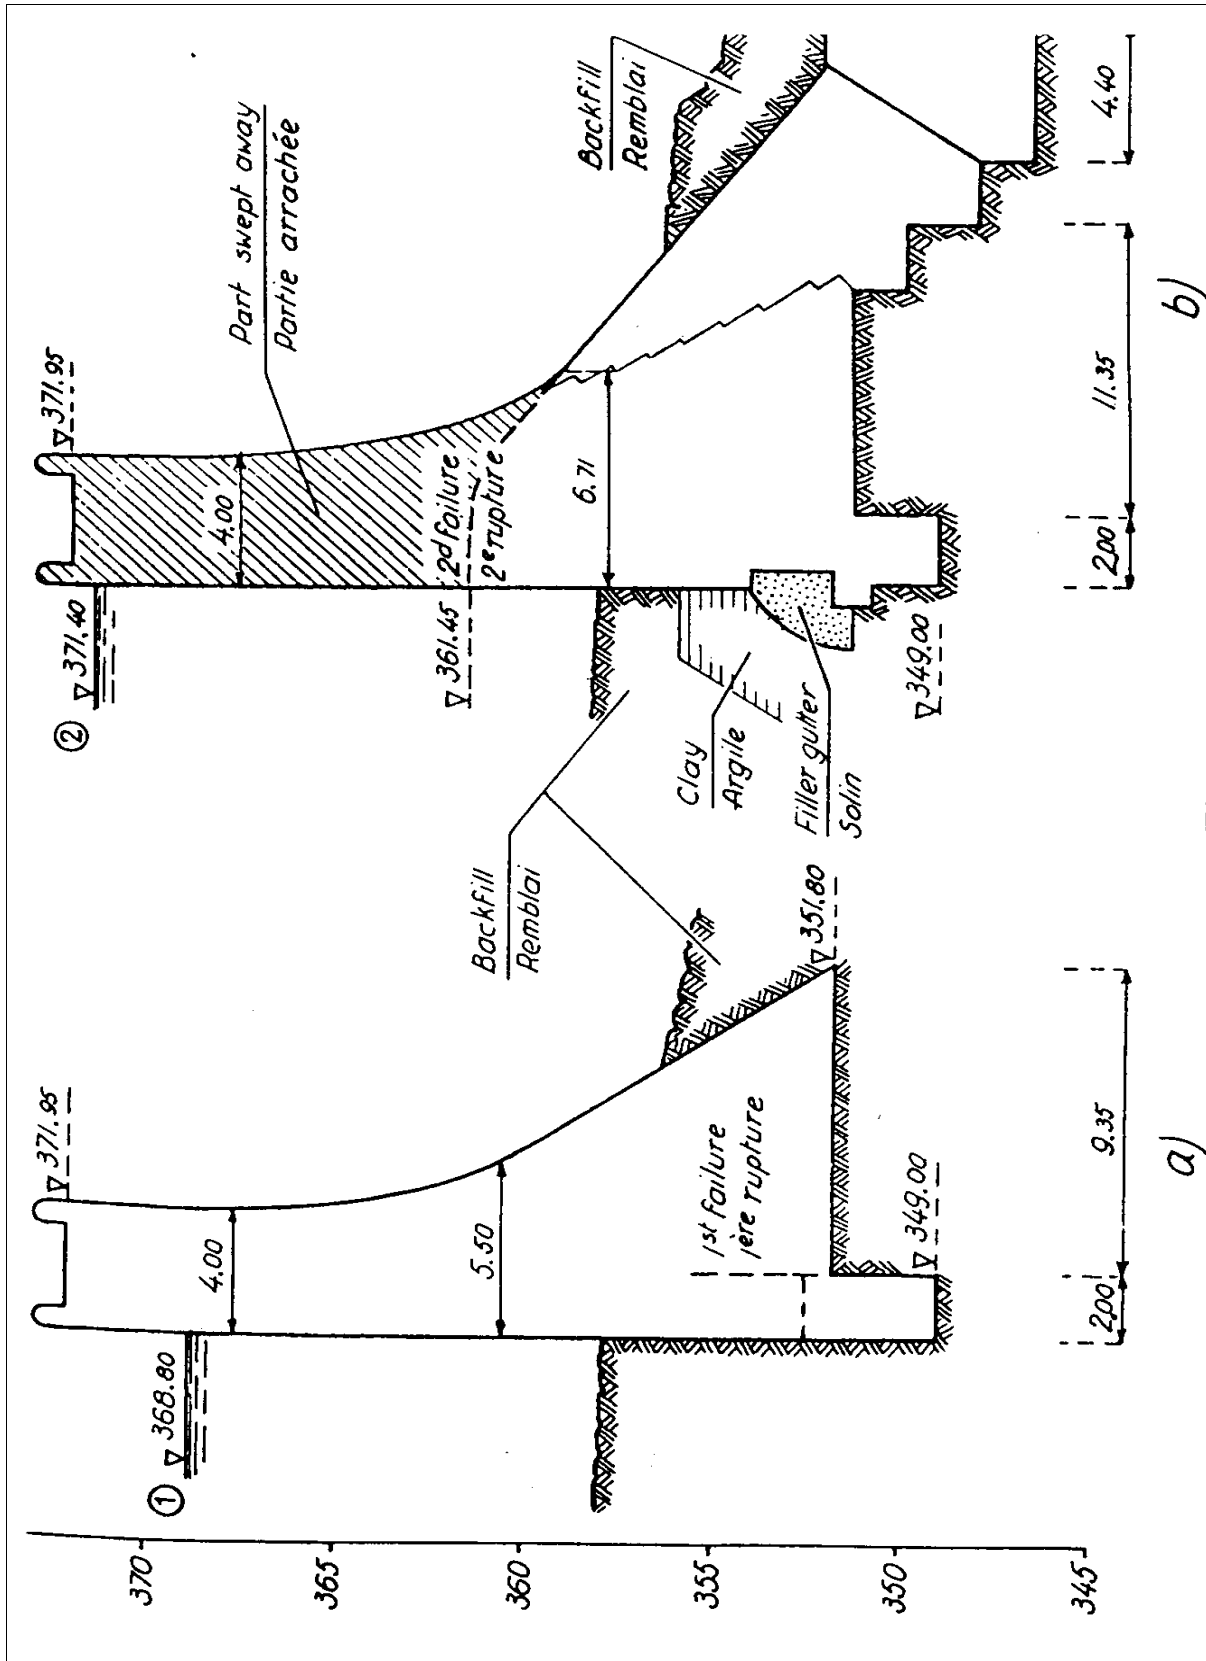
After serious performance problems, bordering on failure and uncorrected for an extended period of time (described below), the dam was finally modified by adding a longitudinal masonry course to cover a cracked and dislocated heel cutoff wall. The new masonry was covered with a clay layer to provide additional protection against leakage. The downstream side was thickened over the bottom third of the dam height and keyed deeper into the foundation, but the narrow top two thirds was not changed, and the dam eventually failed catastrophically (see figure BF-1).

From 1888 to 1889 the dam was strengthened by the addition of a downstream buttress and the upstream crack was sealed. During the subsequent reservoir filling the dam failed suddenly on April 27, 1895 when the reservoir reached elevation 371.4 m (1218.5 ft). The upper central portion of the dam, about 10.5 m (34.4 ft) high and 170 m (558 ft) long was swept away. A

nearly horizontal failure surface occurred at the upstream face and through the masonry for a distance of about 3.5 m downstream, where it dipped suddenly downstream. Numerous crush marks and shears were noted near the downstream face. This time the foundation did not move.

Figure BF-1. a. First failure of Bouzey Dam, b. Second failure of Bouzey Dam (after ICOLD 1974)

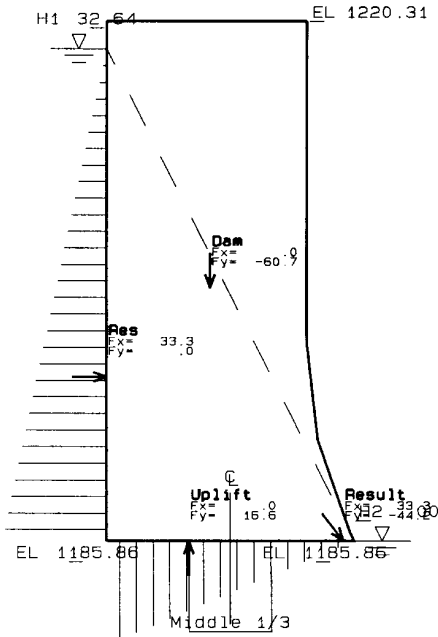
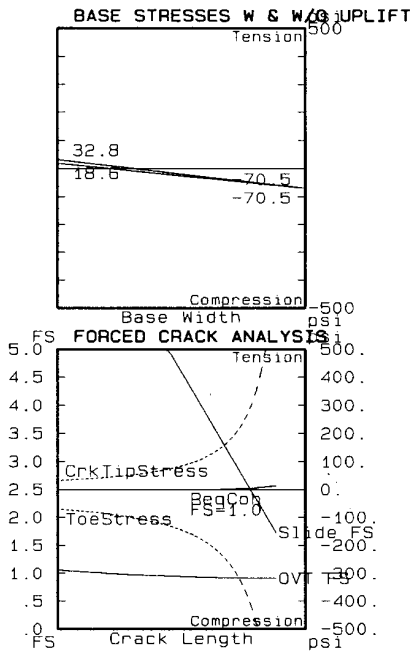
Figure BF-4. Analysis of Bouzey Dam, second failure

2) Second failure at mid-height: Stability calculations performed for the second failure scenario (see figure BF-4) with a linear uplift distribution show that tension (up to about 0.23 MPa (33 lb/in²)) existed at the upstream face of the dam at the level of the mid-height failure plane. Assuming zero tensile strength and full reservoir head up to the crack tip, the analyses show that the crack would continue to propagate until the top part of the dam broke away. The amount of tensile strength that may have existed in the masonry mortar is unknown, but based on descriptions, the mortar was probably weak. If the masonry was relatively water tight and cracked, full reservoir head could have been transmitted to the crack tip. Thus, cracking completely through seems to be a real possibility. At that point failure by overturning or sliding could occur. The crushing observed indicated that large compressive stresses existed at the toe of the dam. The downstream dip of the sliding surface near the downstream face could have followed the path of lowest strength, and was not modeled in the analyses. If it is assumed that a linear uplift distribution existed at the time of failure, then a friction angle less than about 37 degrees would be sufficient to cause sliding.

FORCED CRACK RESULTS
 Heel initially in tension
 Crack extends entire width of base

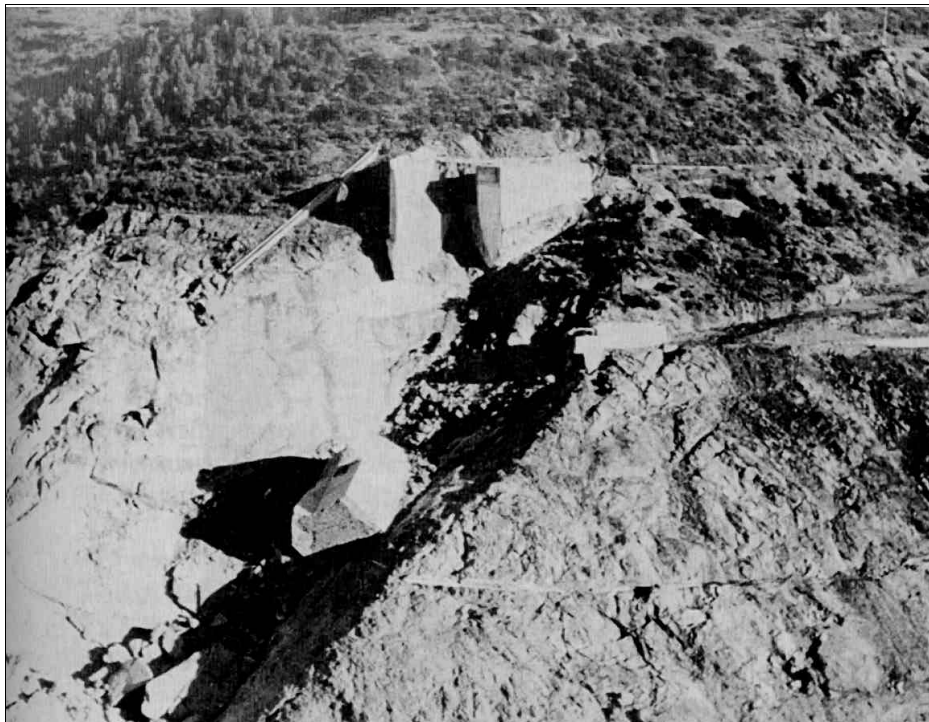
Figure MF-4. Left abutment after failure. Note upstream dipping fault and downstream dipping foliation shear (after Post and Bonazzi, 1987)

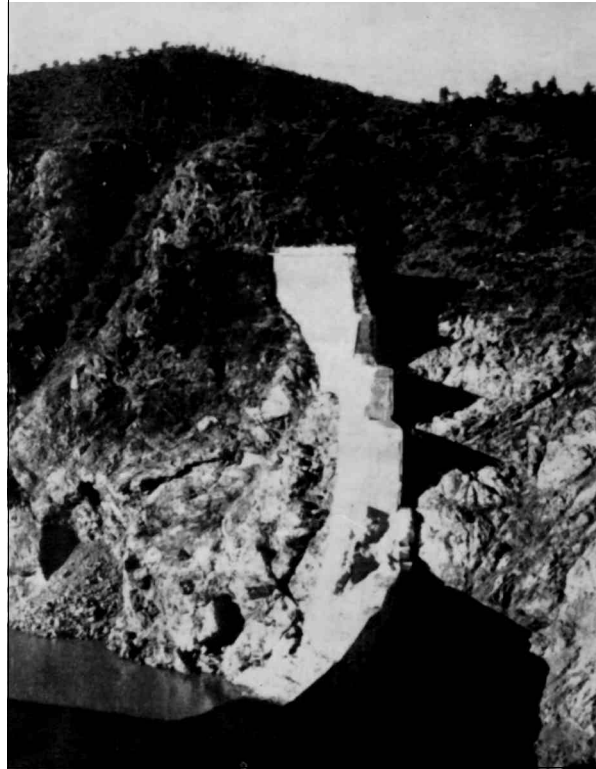
Figure MP-5. Right abutment after failure
(after Bellier, 1967)

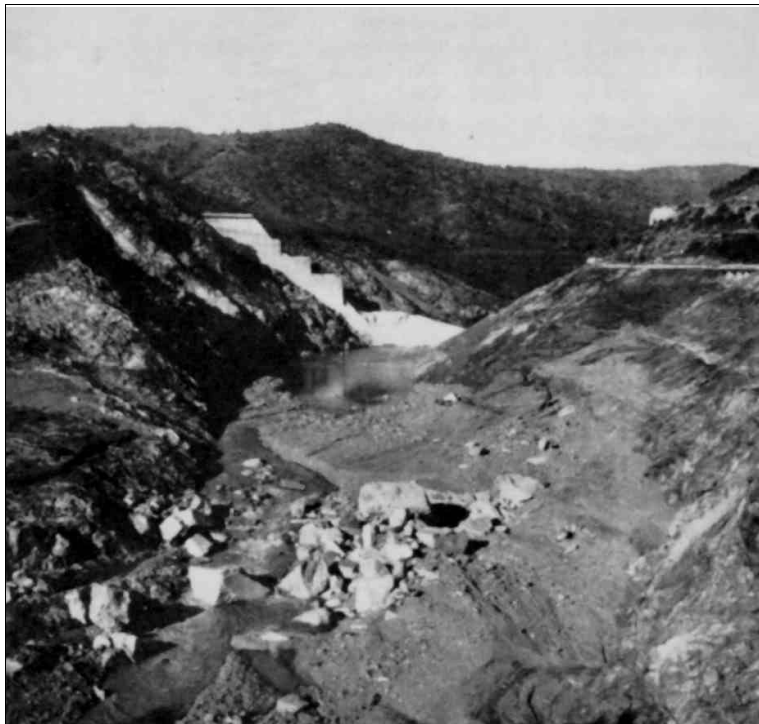
Figure MP-6. Looking from downstream after failure
(after Bellier, 1967)

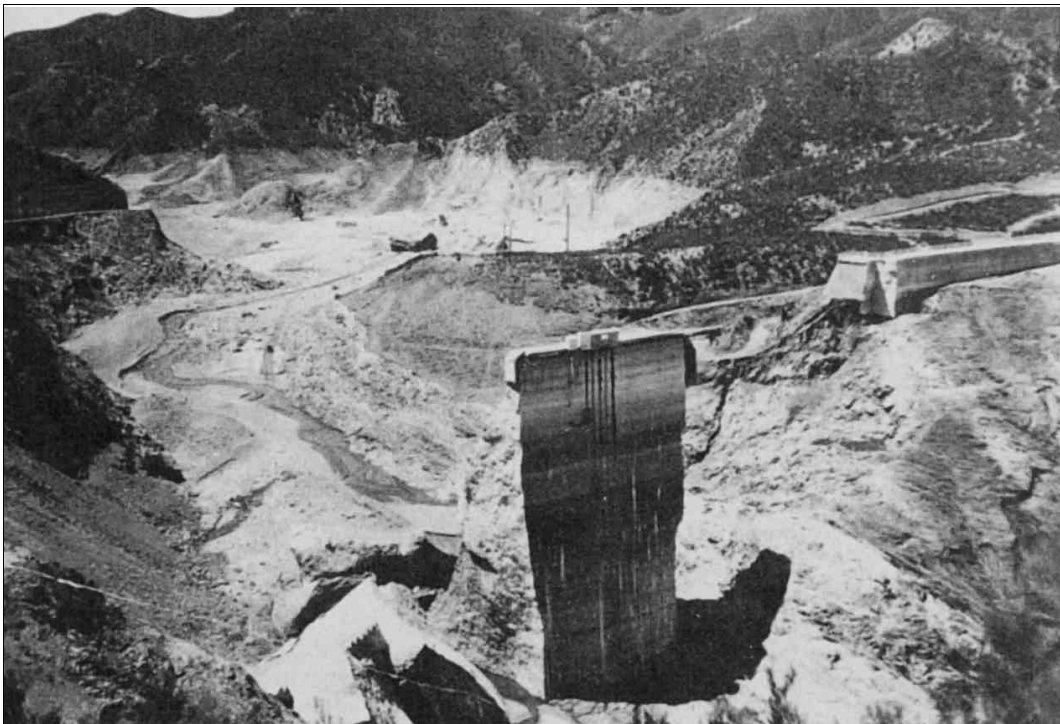
Figure SC-3. St. Francis Dam after the failure (Huber Collection, U of Cal Water Res Center Archives)

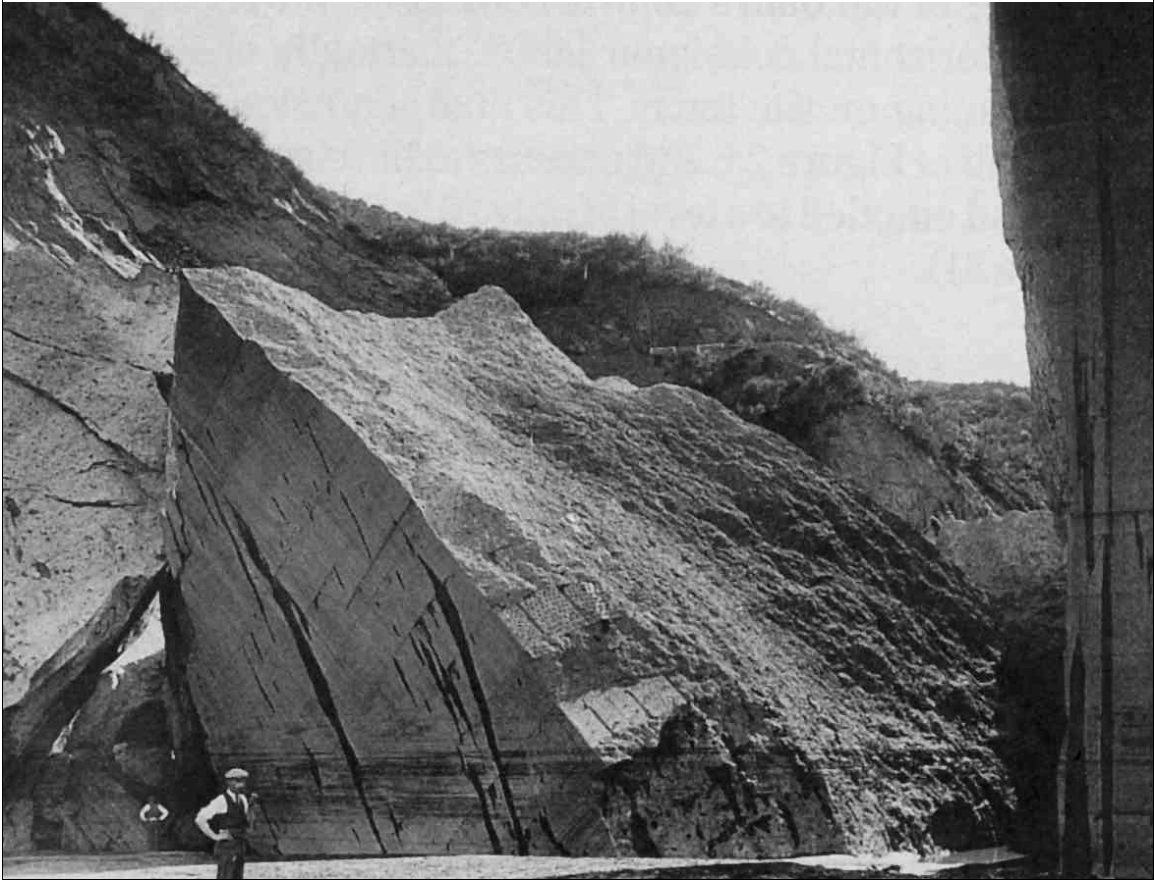
Figure SC-4. Blocks of concrete after failure, note size of men for scale (Huber Collection, U of Cal Water Res Center Archives)

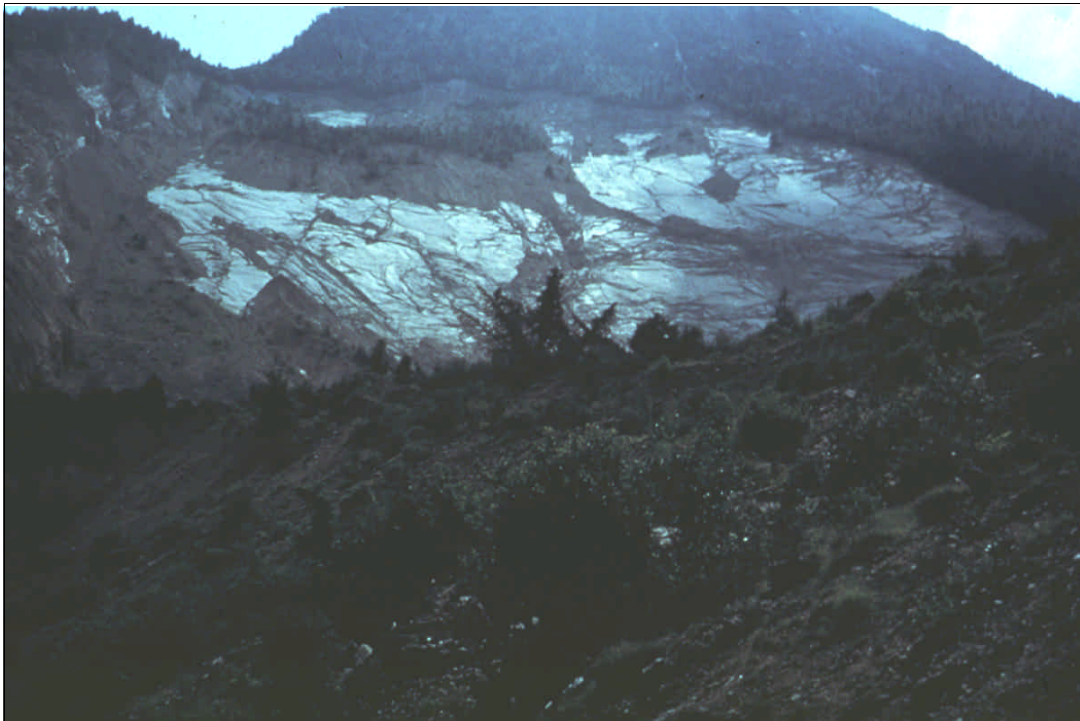
Figure VI-2. View of left reservoir bank following failure

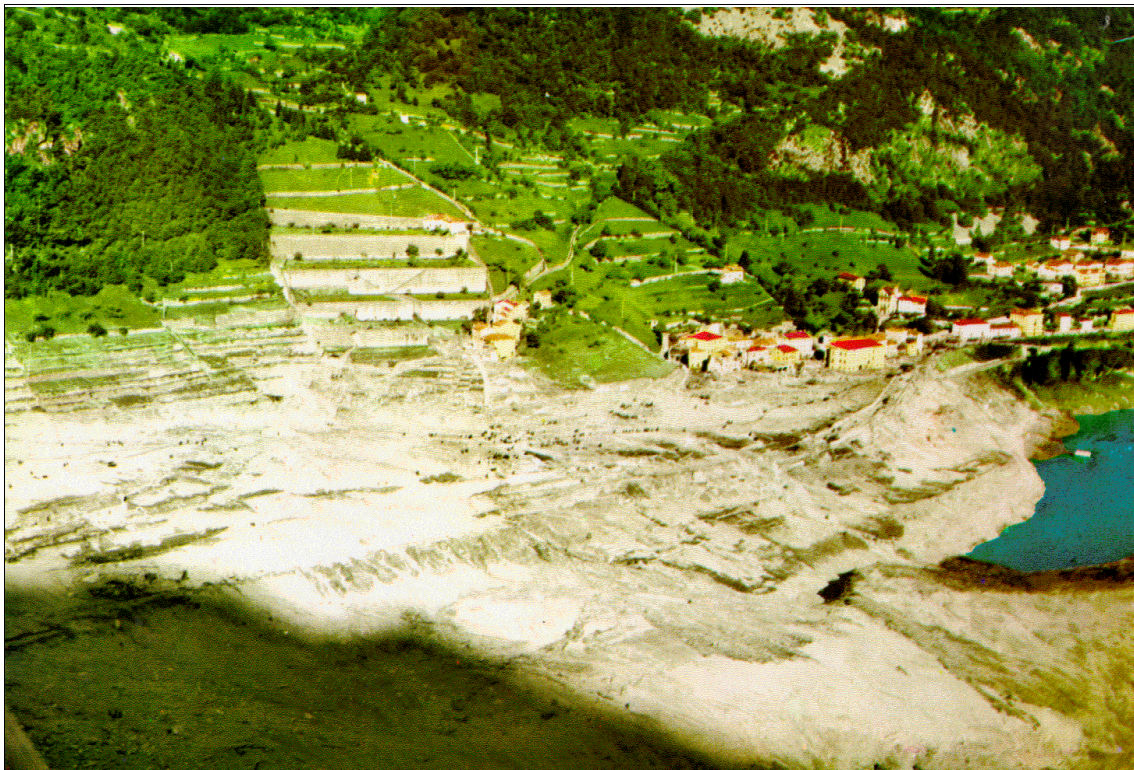
Figure VI-6. Village of Longarone after the failure

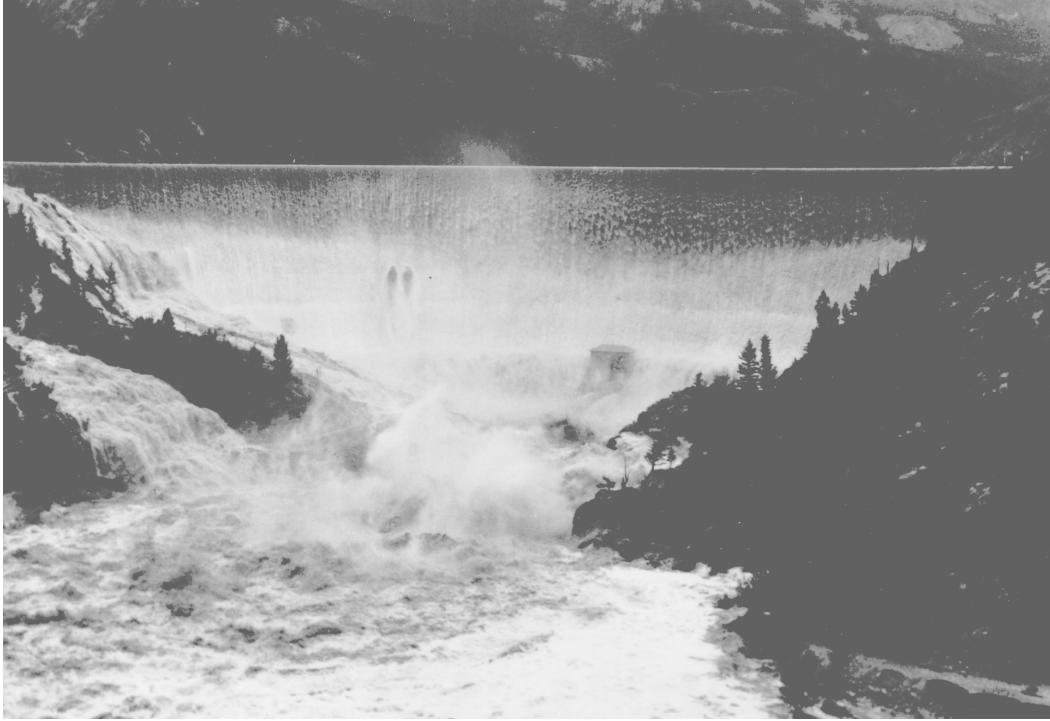
Figure GM-2. Overtopping of Gibson Dam in 1964
