UNDERWATER INSPECTION OF RED BLUFF
DIVERSION DAM

FISHWAY ATTRACTION STUDY

AUGUST 13 THROUGH 17, 2001

Subject: **UNDERWATER INSPECTION OF RED BLUFF DIVERSION DAM
STILLING BASIN -- AUGUST 13 THROUGH 17, 2001
FISHWAY ATTRACTION STUDY**

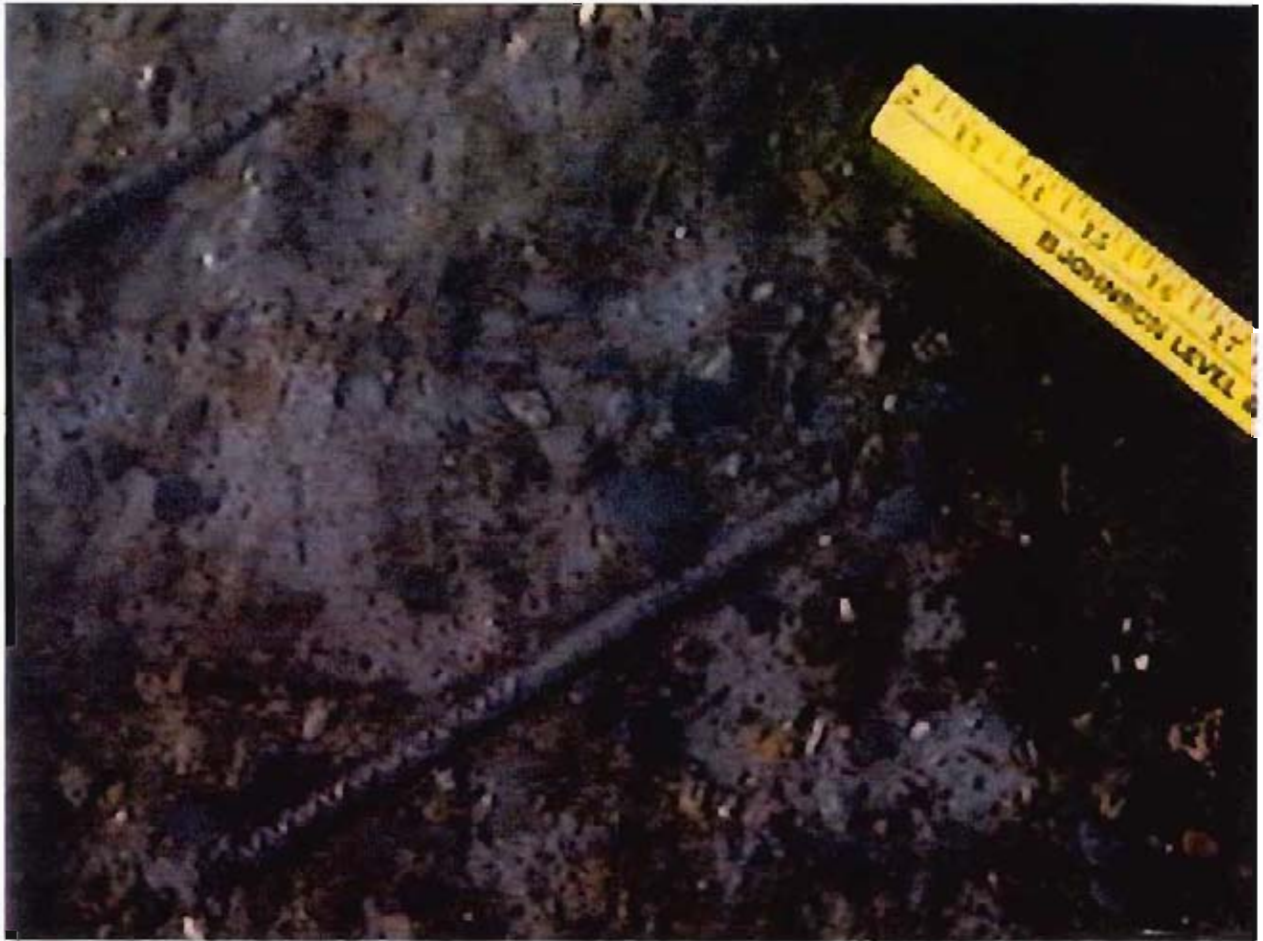
Photo 1

EXPOSED REBAR – GATE 1

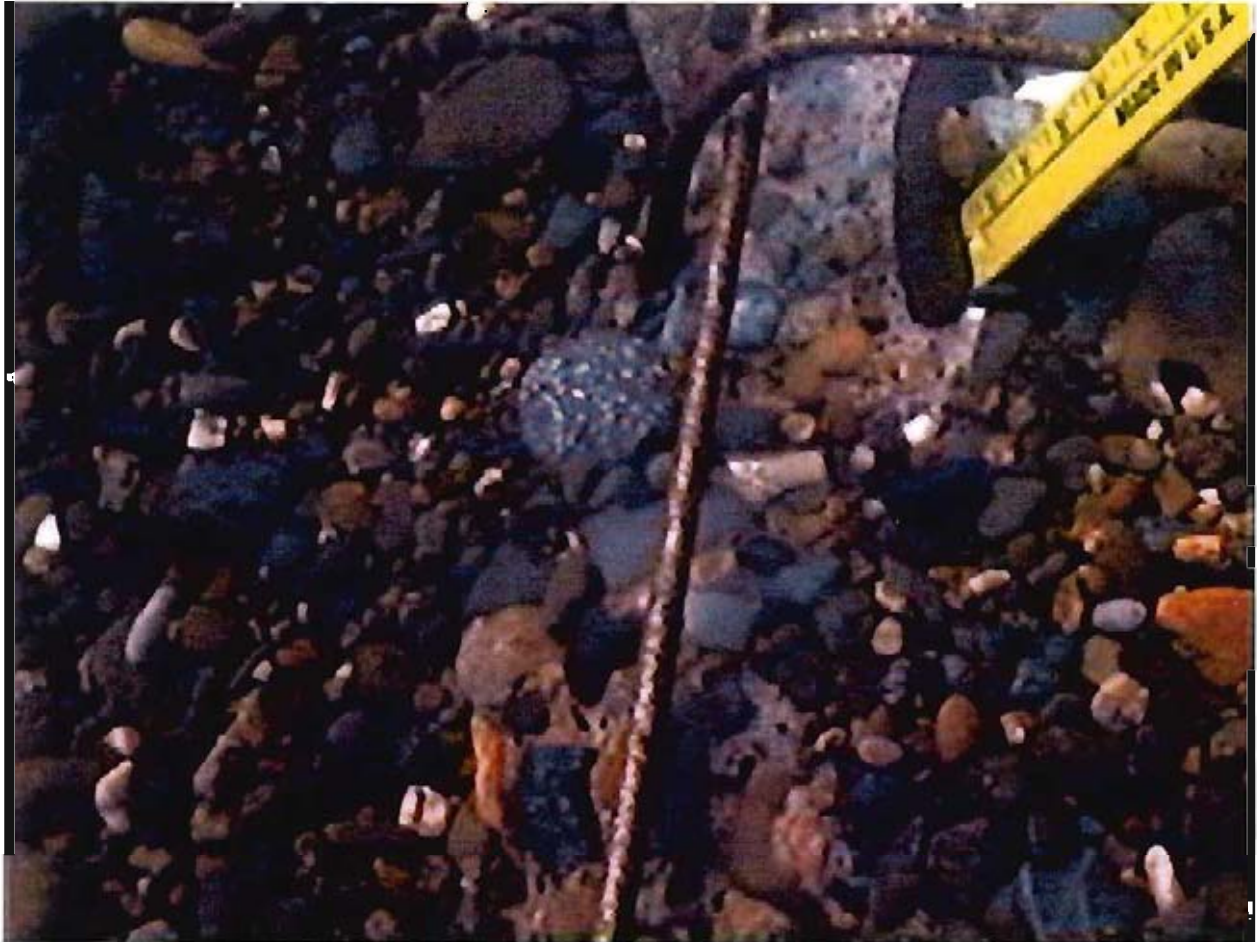
Photo 4

Severely Undercut Rebar (SU) on top of endsill downstream of Gate 2. The ruler shows 3 to 4 inches of undercutting. Loose fine and coarse gravel covers much of the endsill.

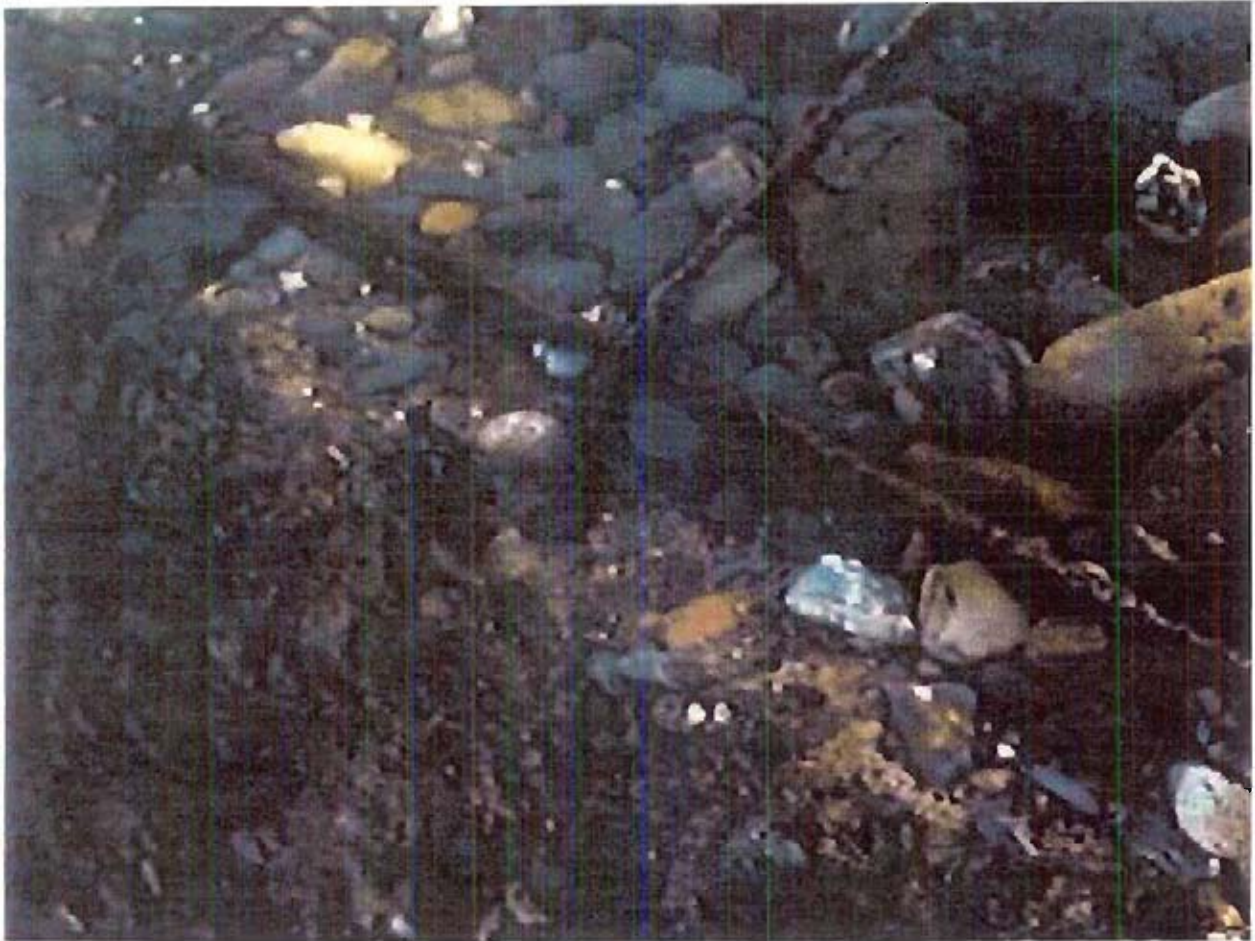
Photo 16

Severely Undercut Rebar (SU) and loose gravel and cobbles on top of endsill downstream of Gate 9.

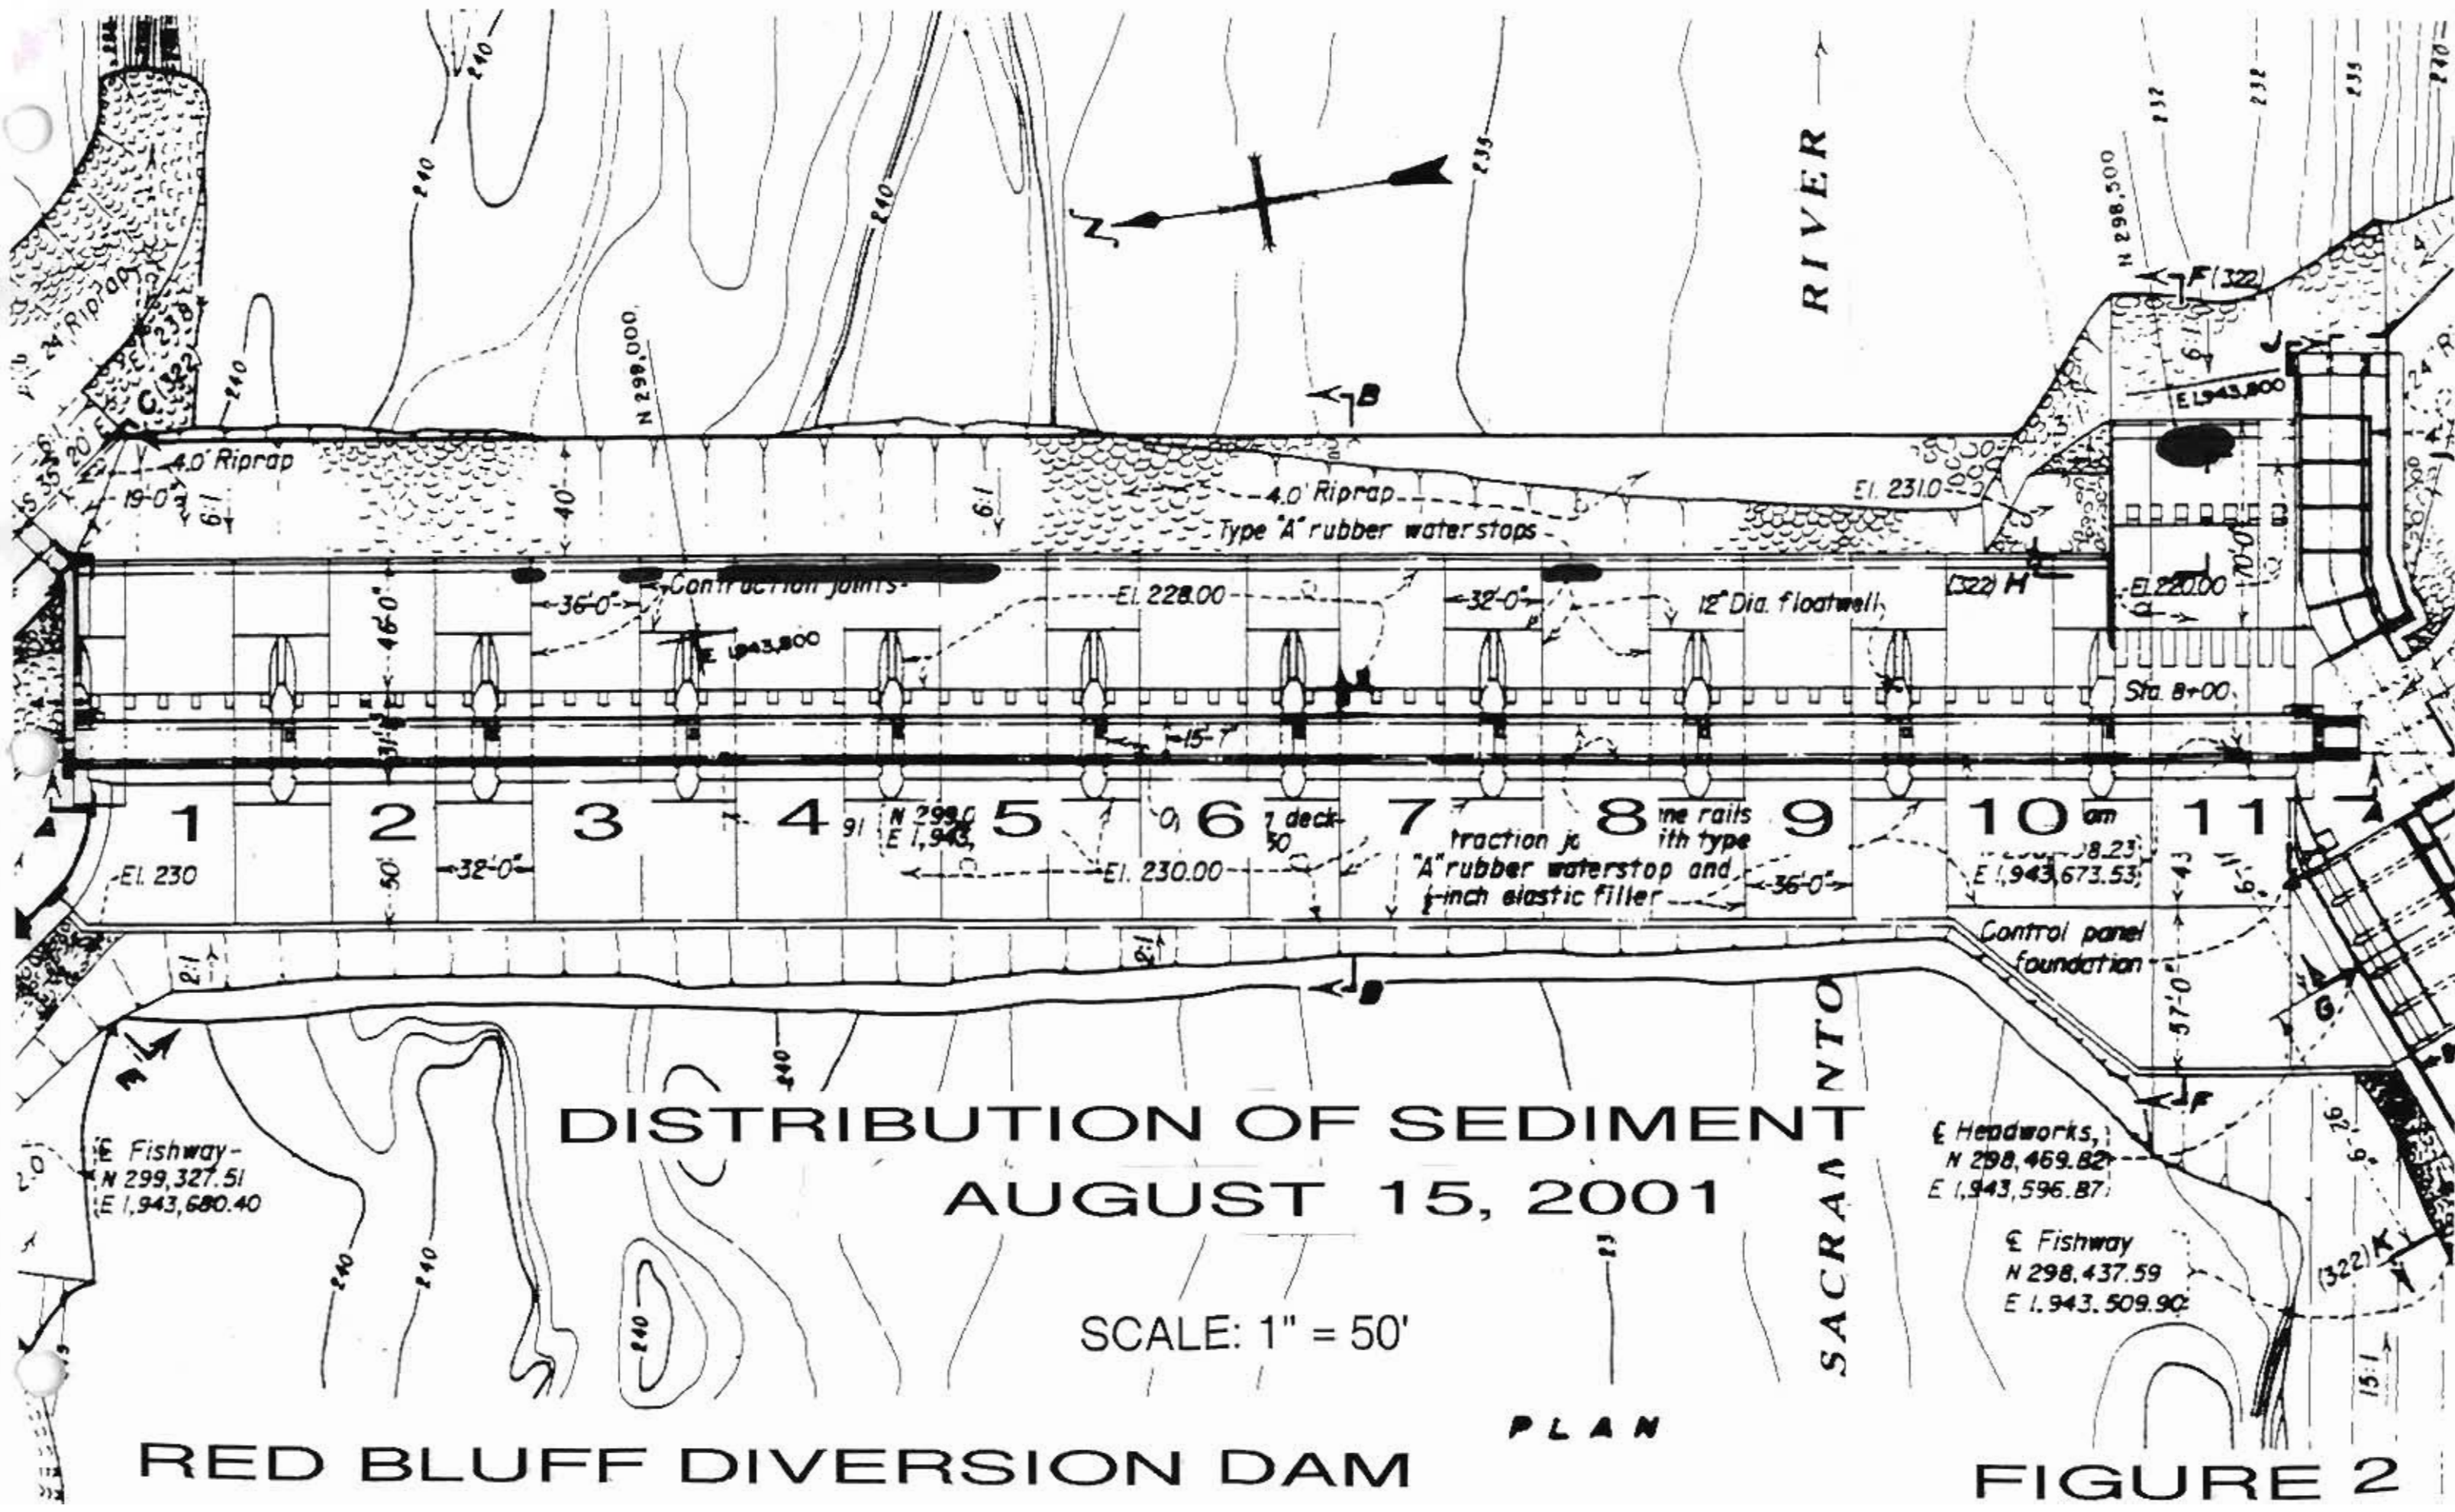
FIGURE 2

2) Following the week-long *center channel dominant* gate tests, much of this sediment was removed from the stilling basin and transported downstream to form a gravel bar that extended several hundred feet below the dam. Only a small amount of sediment remained in the cove area downstream of Gates 5, 6 and 7 (volume estimated at 3 cubic yards). An estimated 26 cubic yards of sediment were present downstream of Gates 8 and 10 (right side) and Gate 4 (left side) as follows:

**DISTRIBUTION OF SEDIMENT
AUGUST 15, 2001**

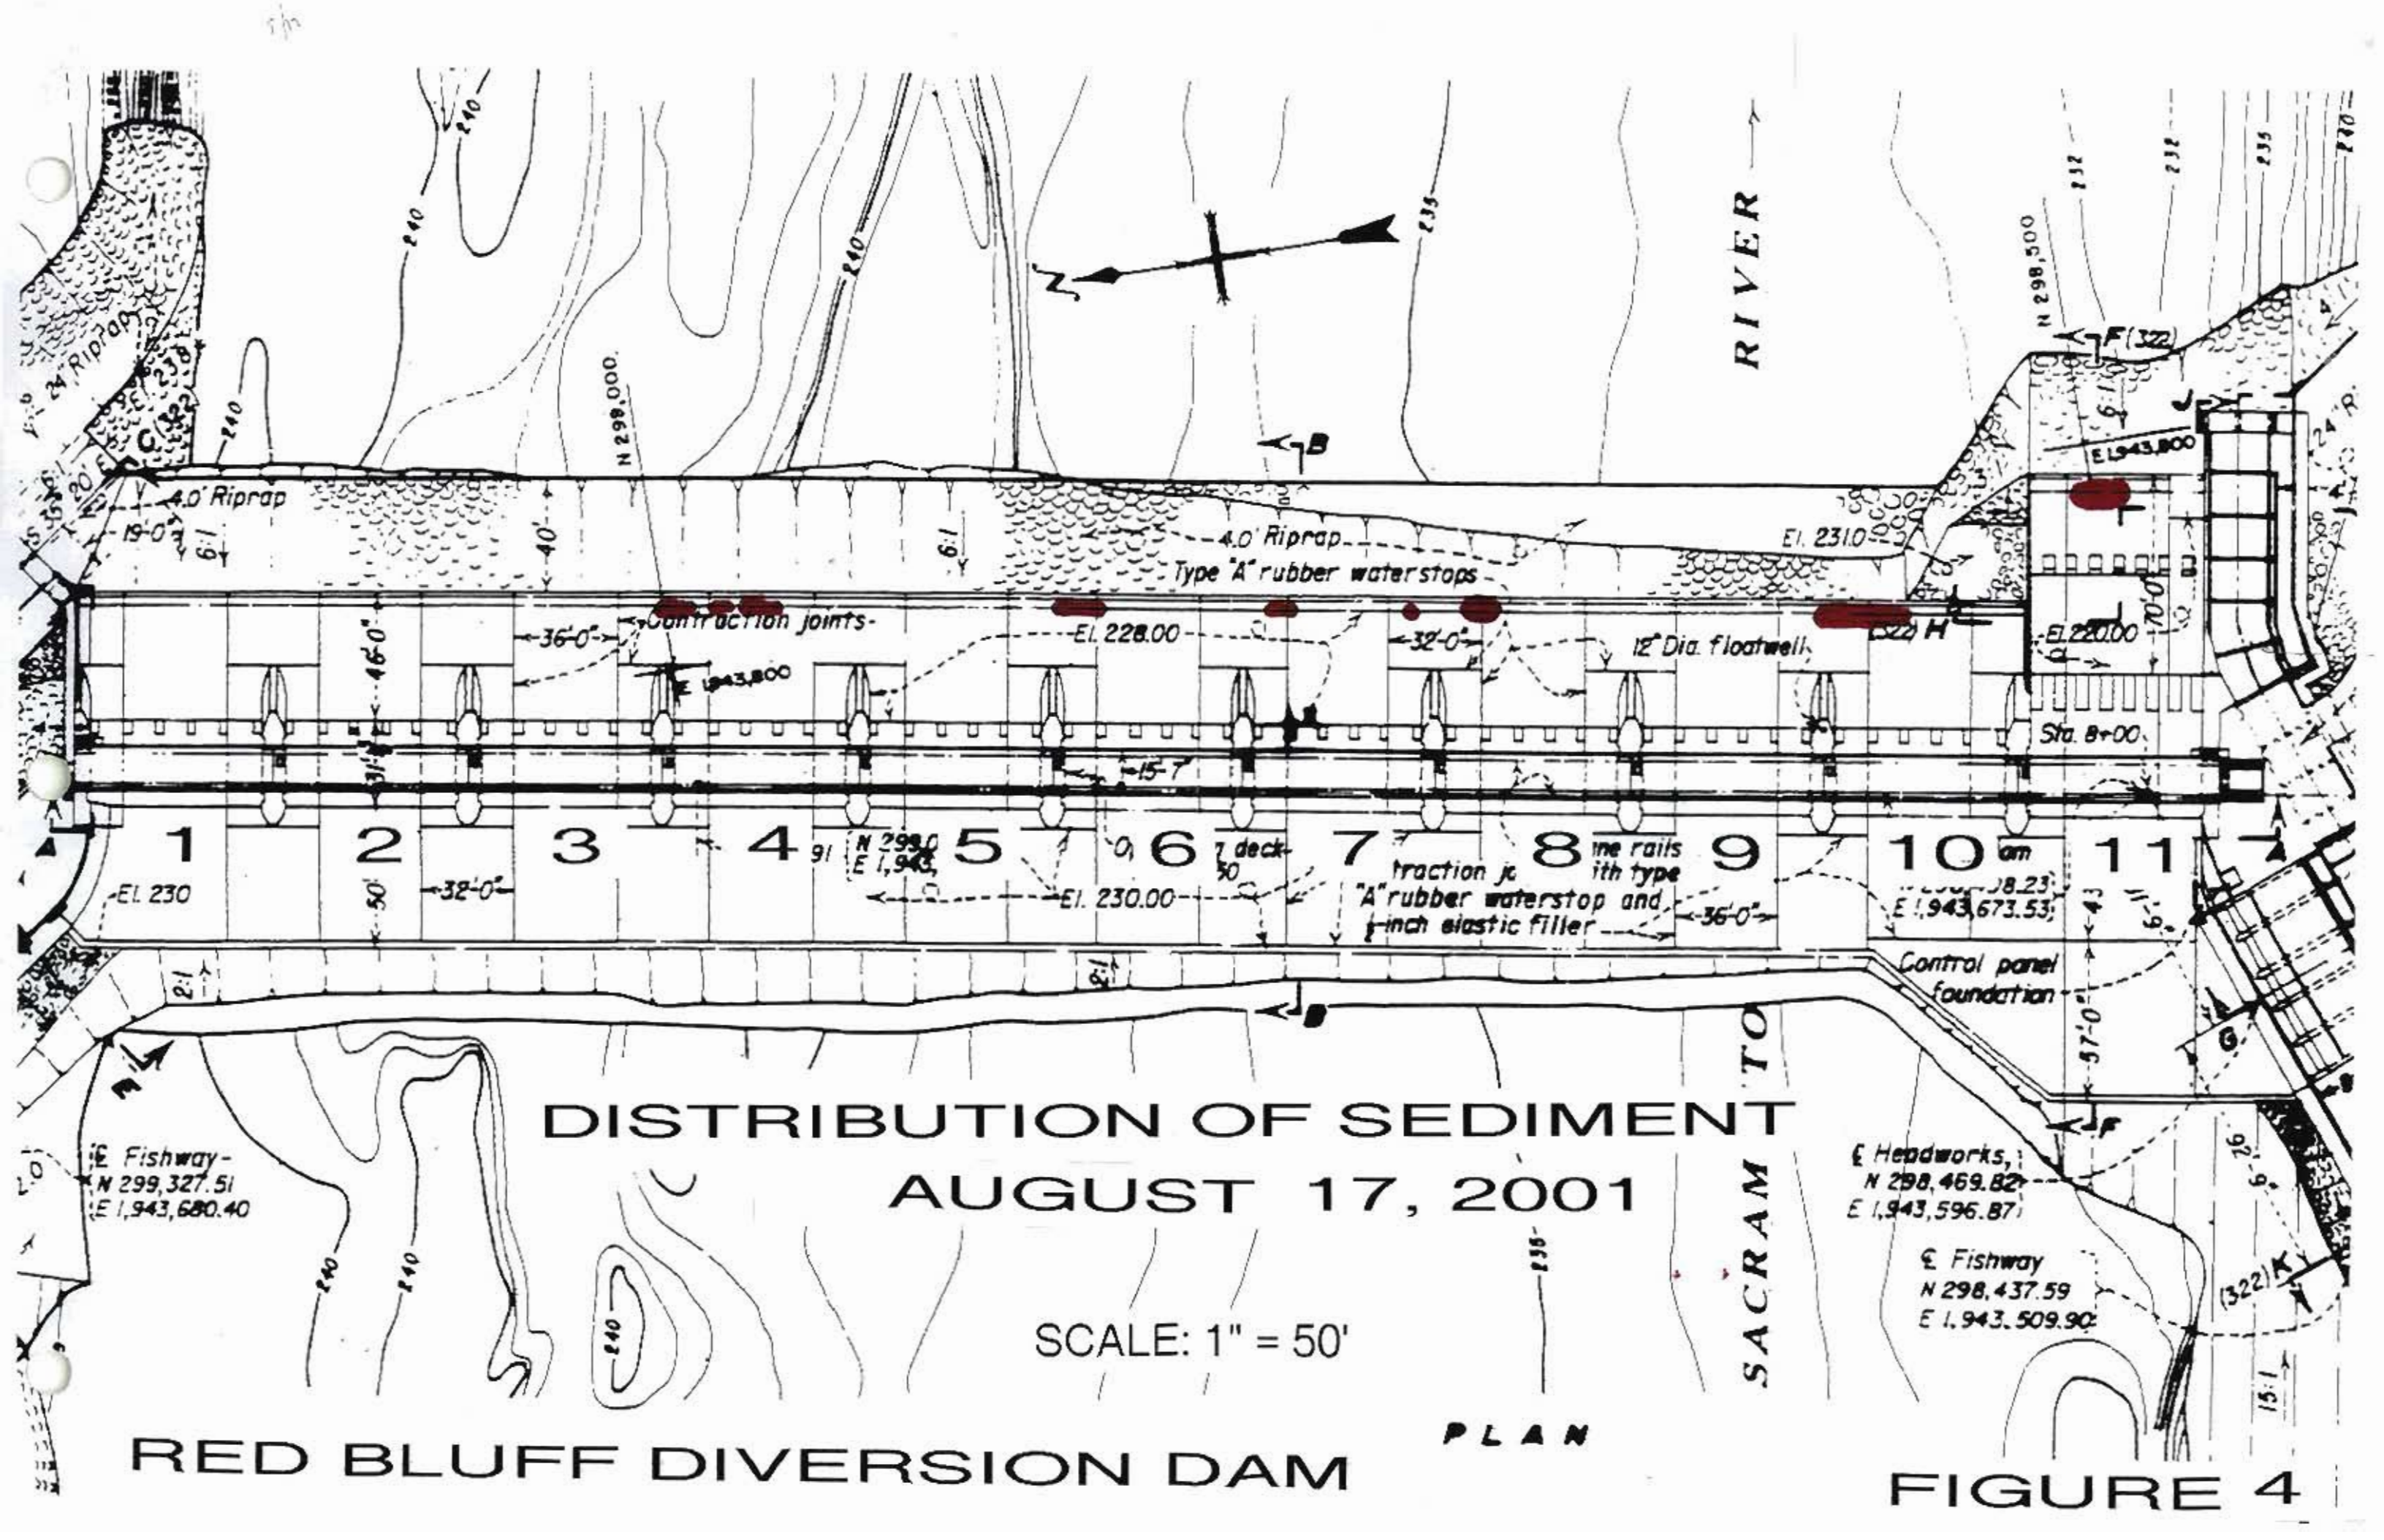
FIGURE 4

DISTRIBUTION OF SEDIMENT
AUGUST 17, 2001
