# Teton Dam

## Failure timeline

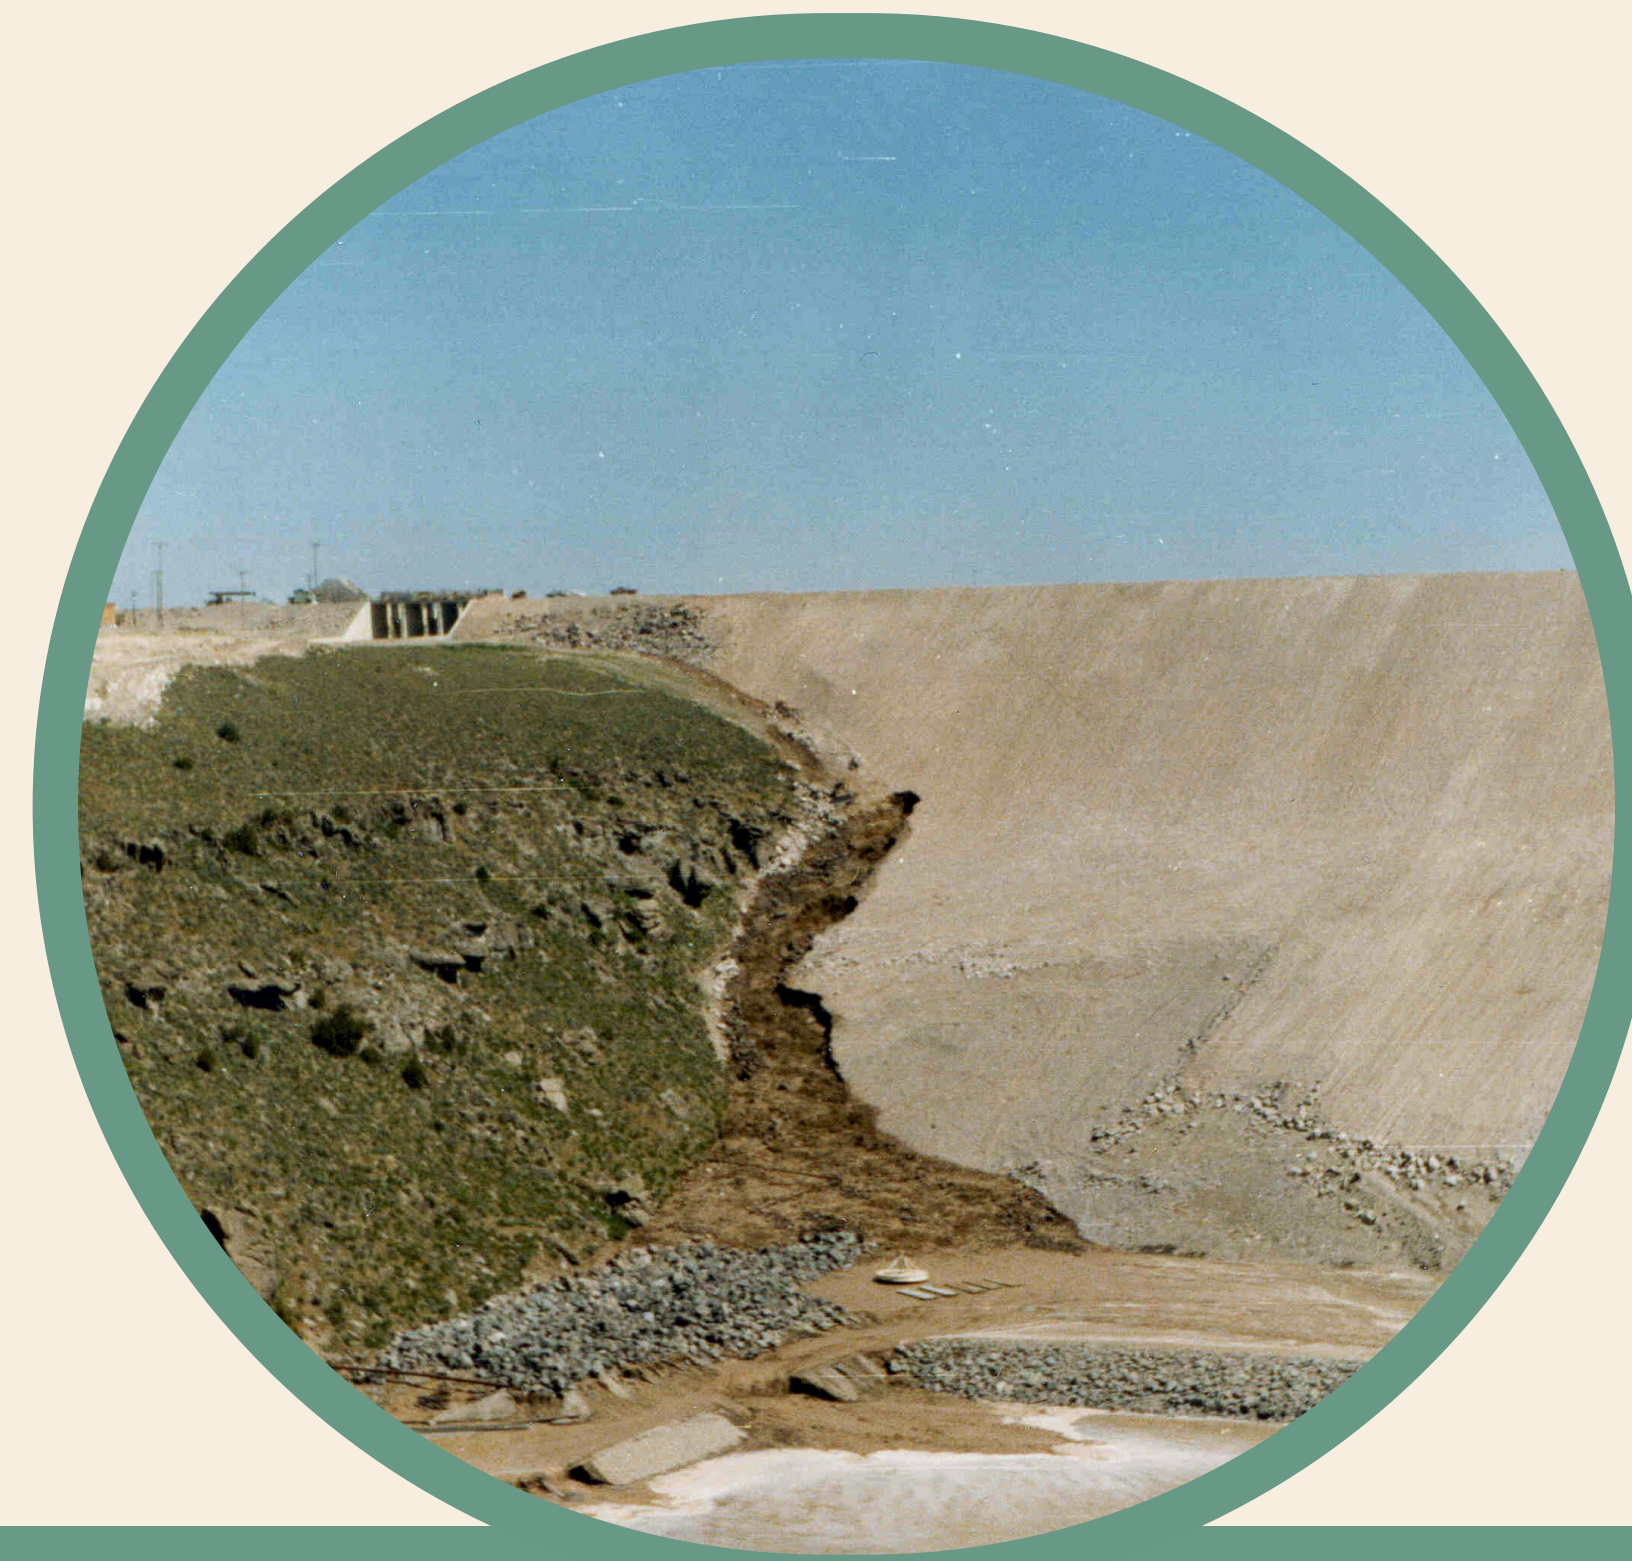
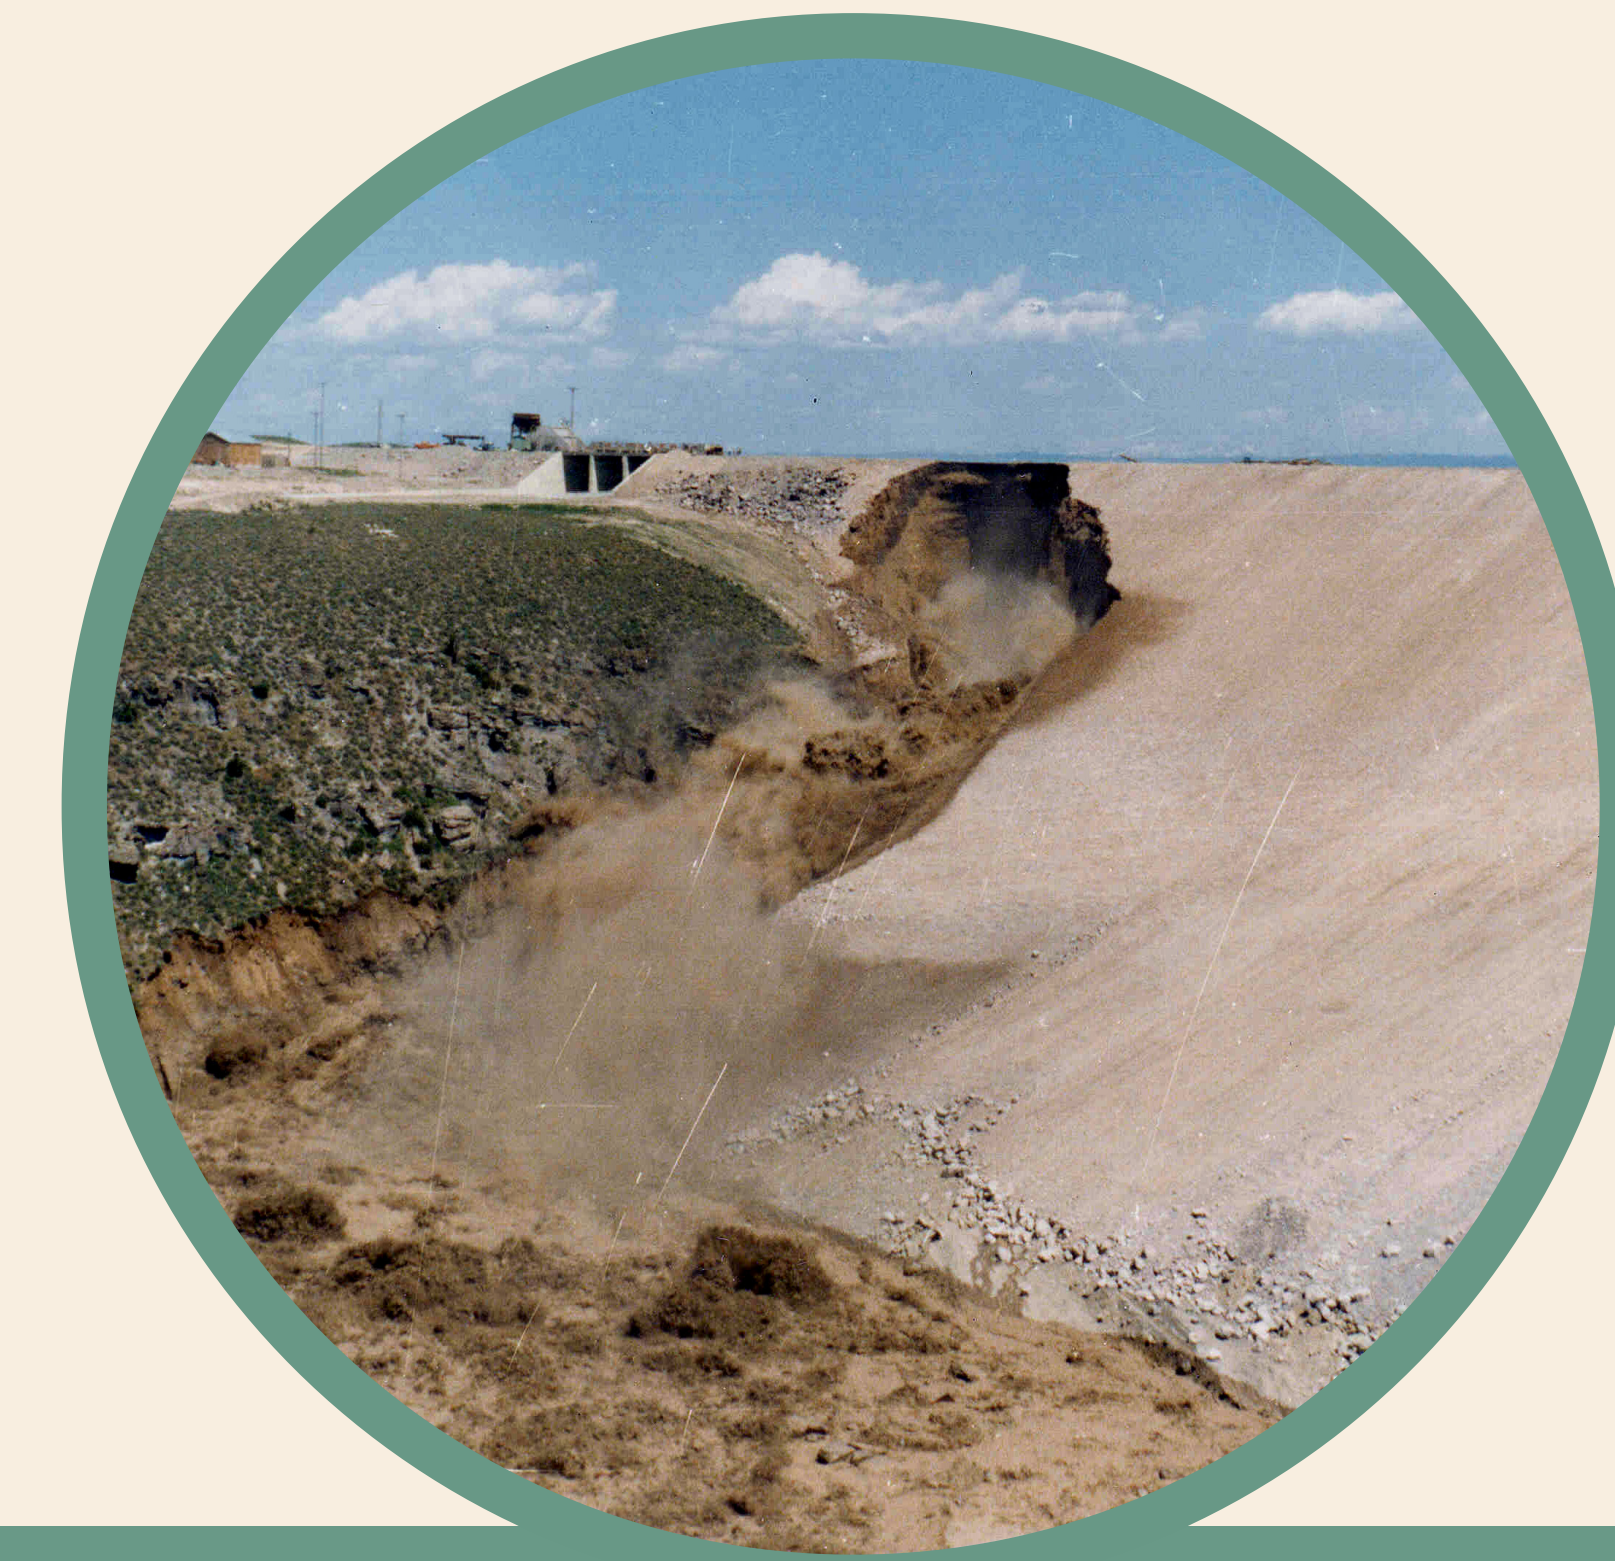
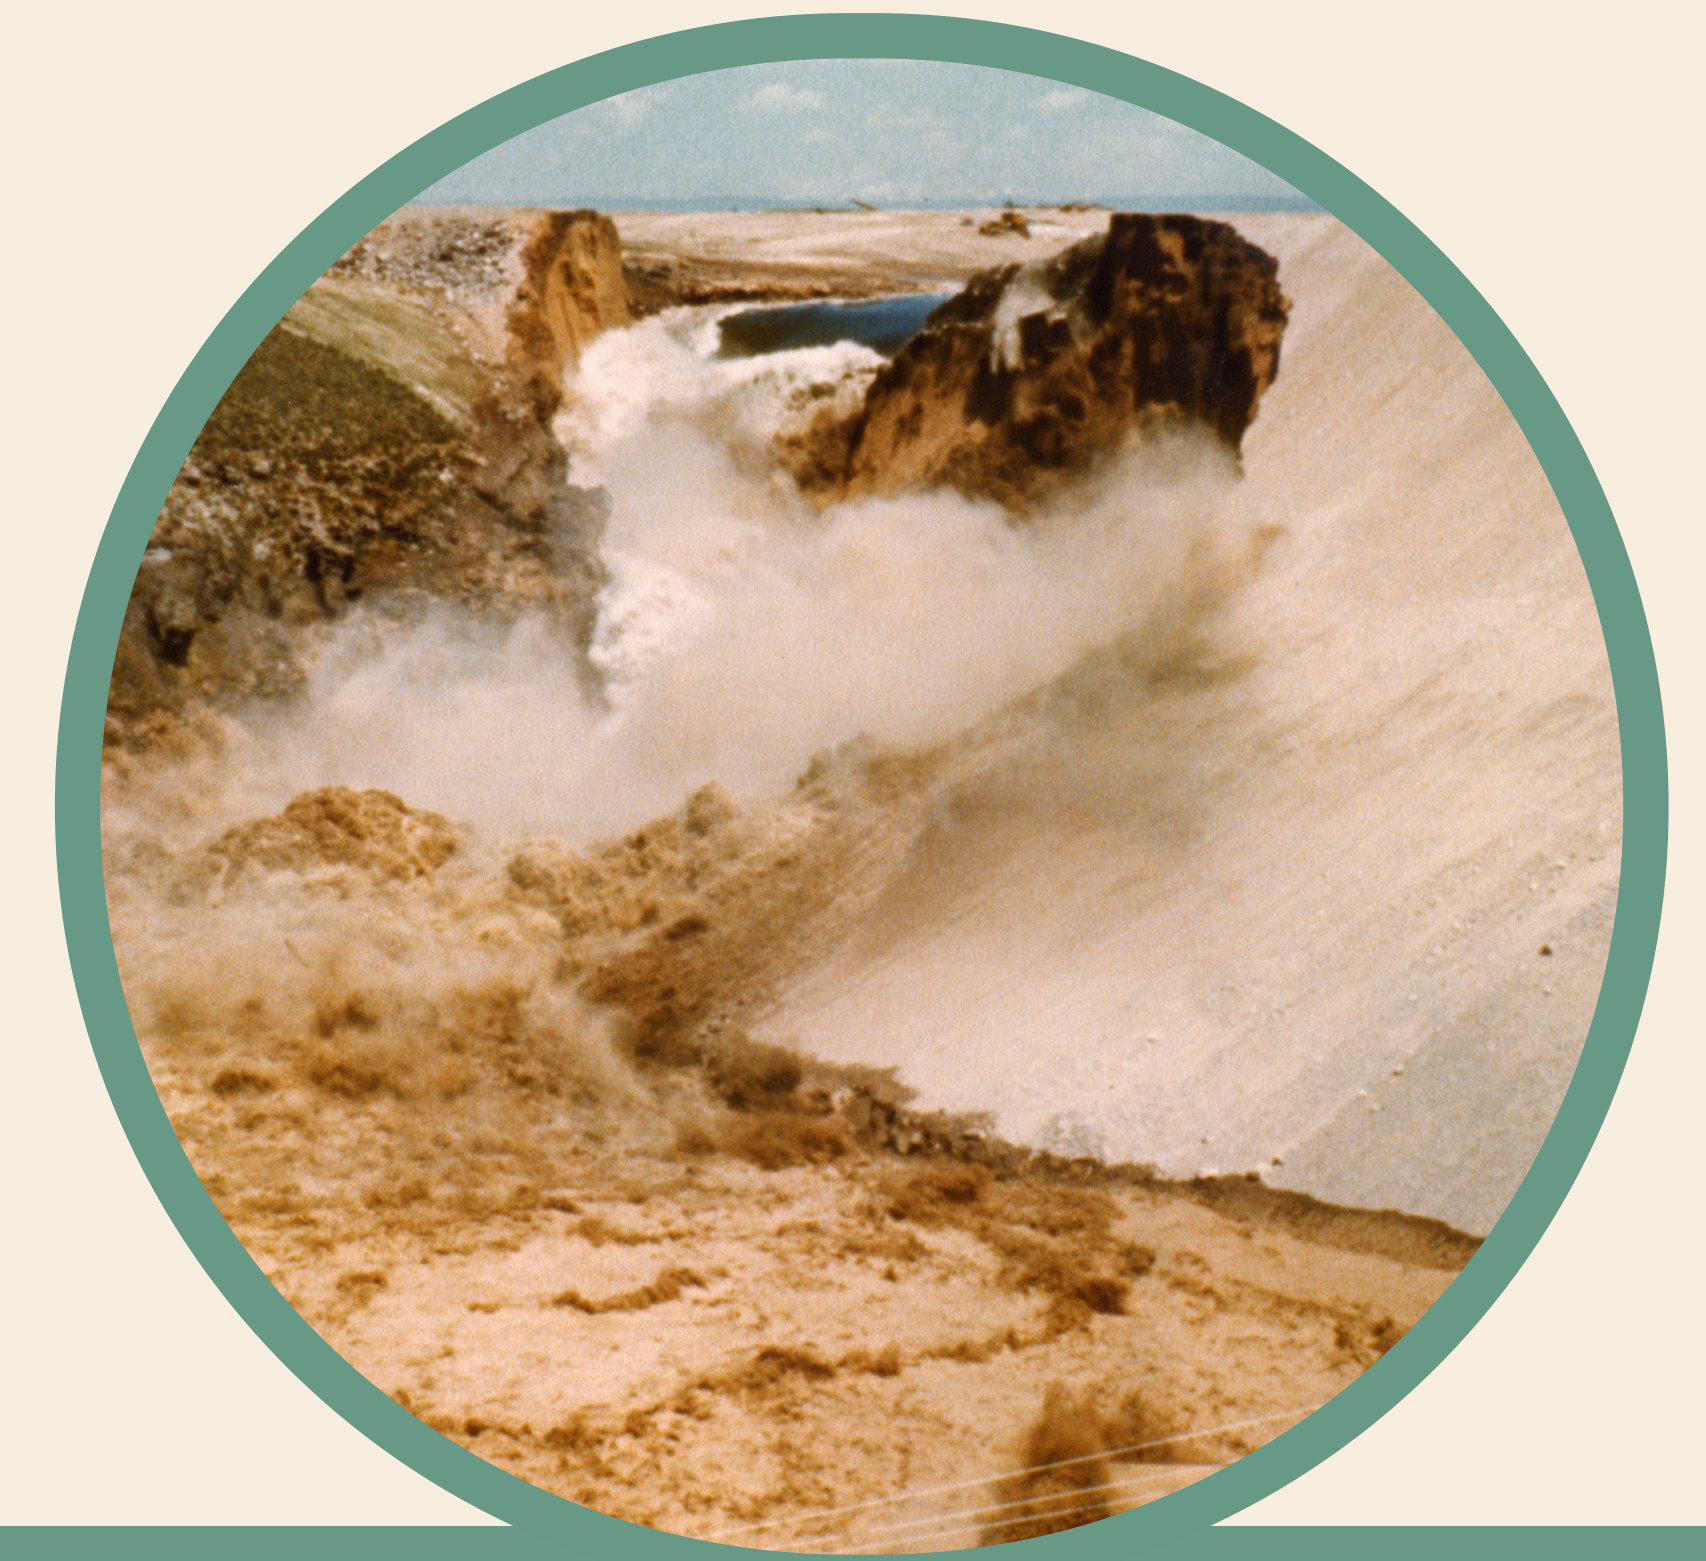
*“I proceeded on the north abutment side and started to push excess rock into the cavity to keep it from eroding into the dam abutment. In the process of doing this, the dozer settled about a couple of feet and sunk out from under me.”*

- Large leak develops 15 feet from the right abutment at elevation 5200
- Bulldozers attempt to fill hole
- A whirlpool appears on the reservoir side of the dam

- Two bulldozers lost to enlarging hole
- Operators escape, one machine never recovered
