FIELD TESTS TO STUDY THE PRESSURE
VARIATION INDUCED BY WAVE ACTION ON THE
MITER GATE LEAVES OF THE BUCKET CAISSON
DRYDOCK AT GRAND COULEE DAM--
COLUMBIA BASIN PROJECT

Hydraulic Laboratory Report No. Hyd.-282

JULY 6, 1950

Laboratory Report No. 282
Hydraulic Laboratory
Written by: F. C. Lowe
 J. C. Schuster
Reviewed by: J. W. Ball

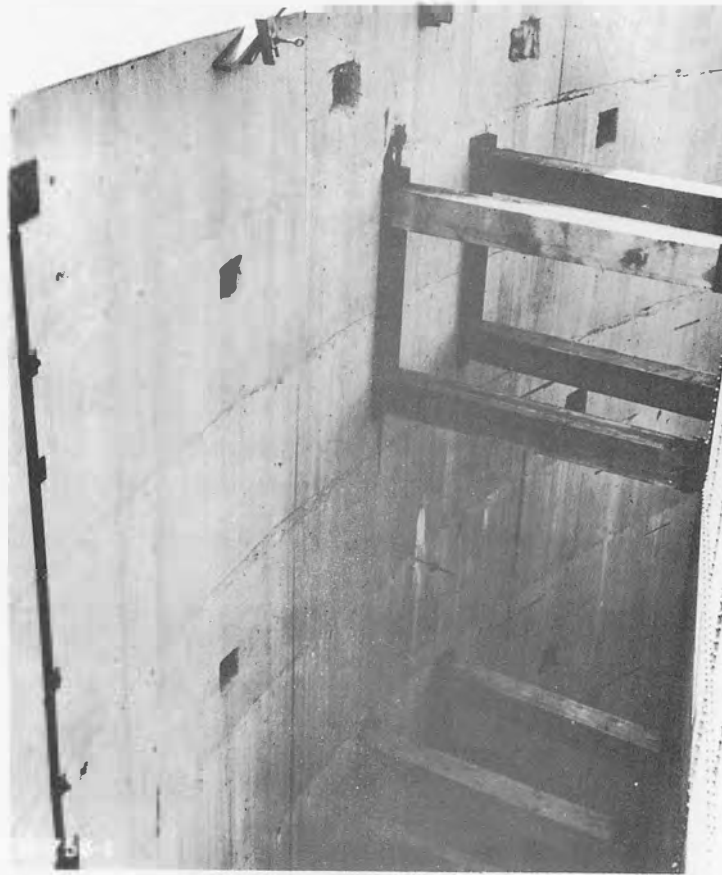
A. TIMBER WEDGE STRUTS BETWEEN TIPPING SECTION AND MITER GATE LEAVES.

cables holding the gate leaves could have broken with a static unbalanced pressure of 4.5 feet of water, but that failure was probably caused by a dynamic rather than a static condition; (2) failure of the anchor bars holding the hinge of the No. 2 leaf at the top of the miter gate was probably caused by bending moments induced by the water forces moving the gate against the friction of the gudgeon pin and hinge; and (3) the rivets in the gate loosened because of a torsional deflection of the leaves during the swinging motion. The memorandum and report recommended that information concerning the wave pressures on the miter gate be obtained before the design of a permanent device to hold the gate shut was completed and that the gate be wedged shut by timber struts placed between the gate and tipping section for the 1947 flood season. The wedges used during the 1947 season when pressure-cell measurements were made are shown on Figure 3A. No trouble was experienced with this arrangement.

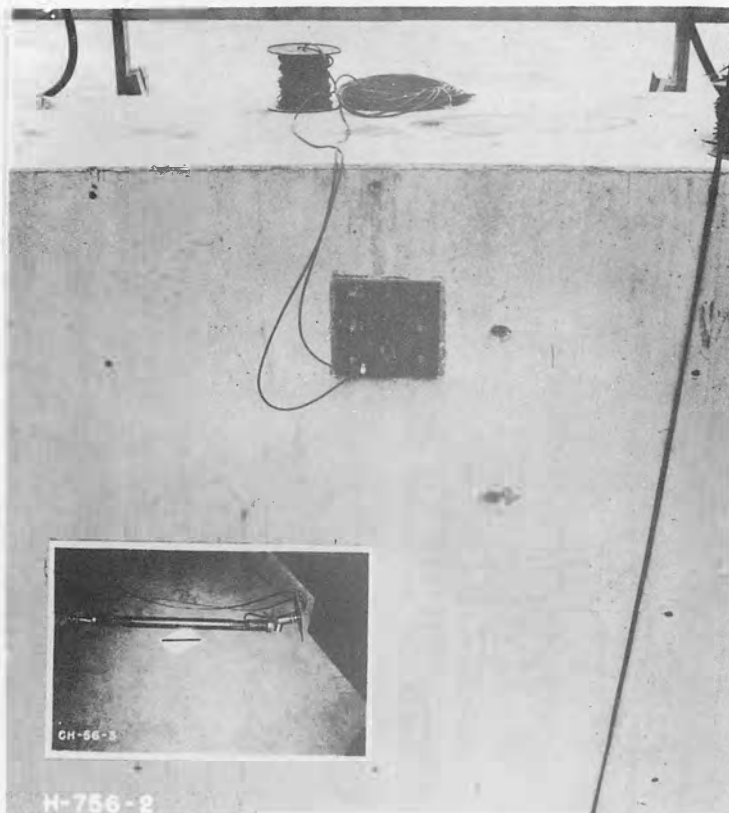
B. PRESSURE CELL INSTALLATION IN TIPPING SECTION.

the drydock. Pairs of these cells were mounted in the concrete tipping section by drilling a hole through it and inserting a short section of 3-inch pipe containing a cell at each end. The pressure ends of the cells were flush with the surfaces of the tipping section (Figures 3B and 4B). The pressure-cells on the miter gate were located in a similar position, three on the outside and three on the inside, but were mounted as shown in Figures 4B and 5. Seven cells were mounted on the No. 4 access shaft of the caisson to record pressures on the inside and outside of this shaft. Three were placed at elevation 955 and three at elevation 970. The cells of each group were set 120° apart (Figure 4B). The seventh cell was placed on the inside of this shaft at elevation 955. The cells were designated by numbers, 1 to 6 on the tipping section, 7 to 12 on the miter gate, and 13 to 19 on the access shaft.

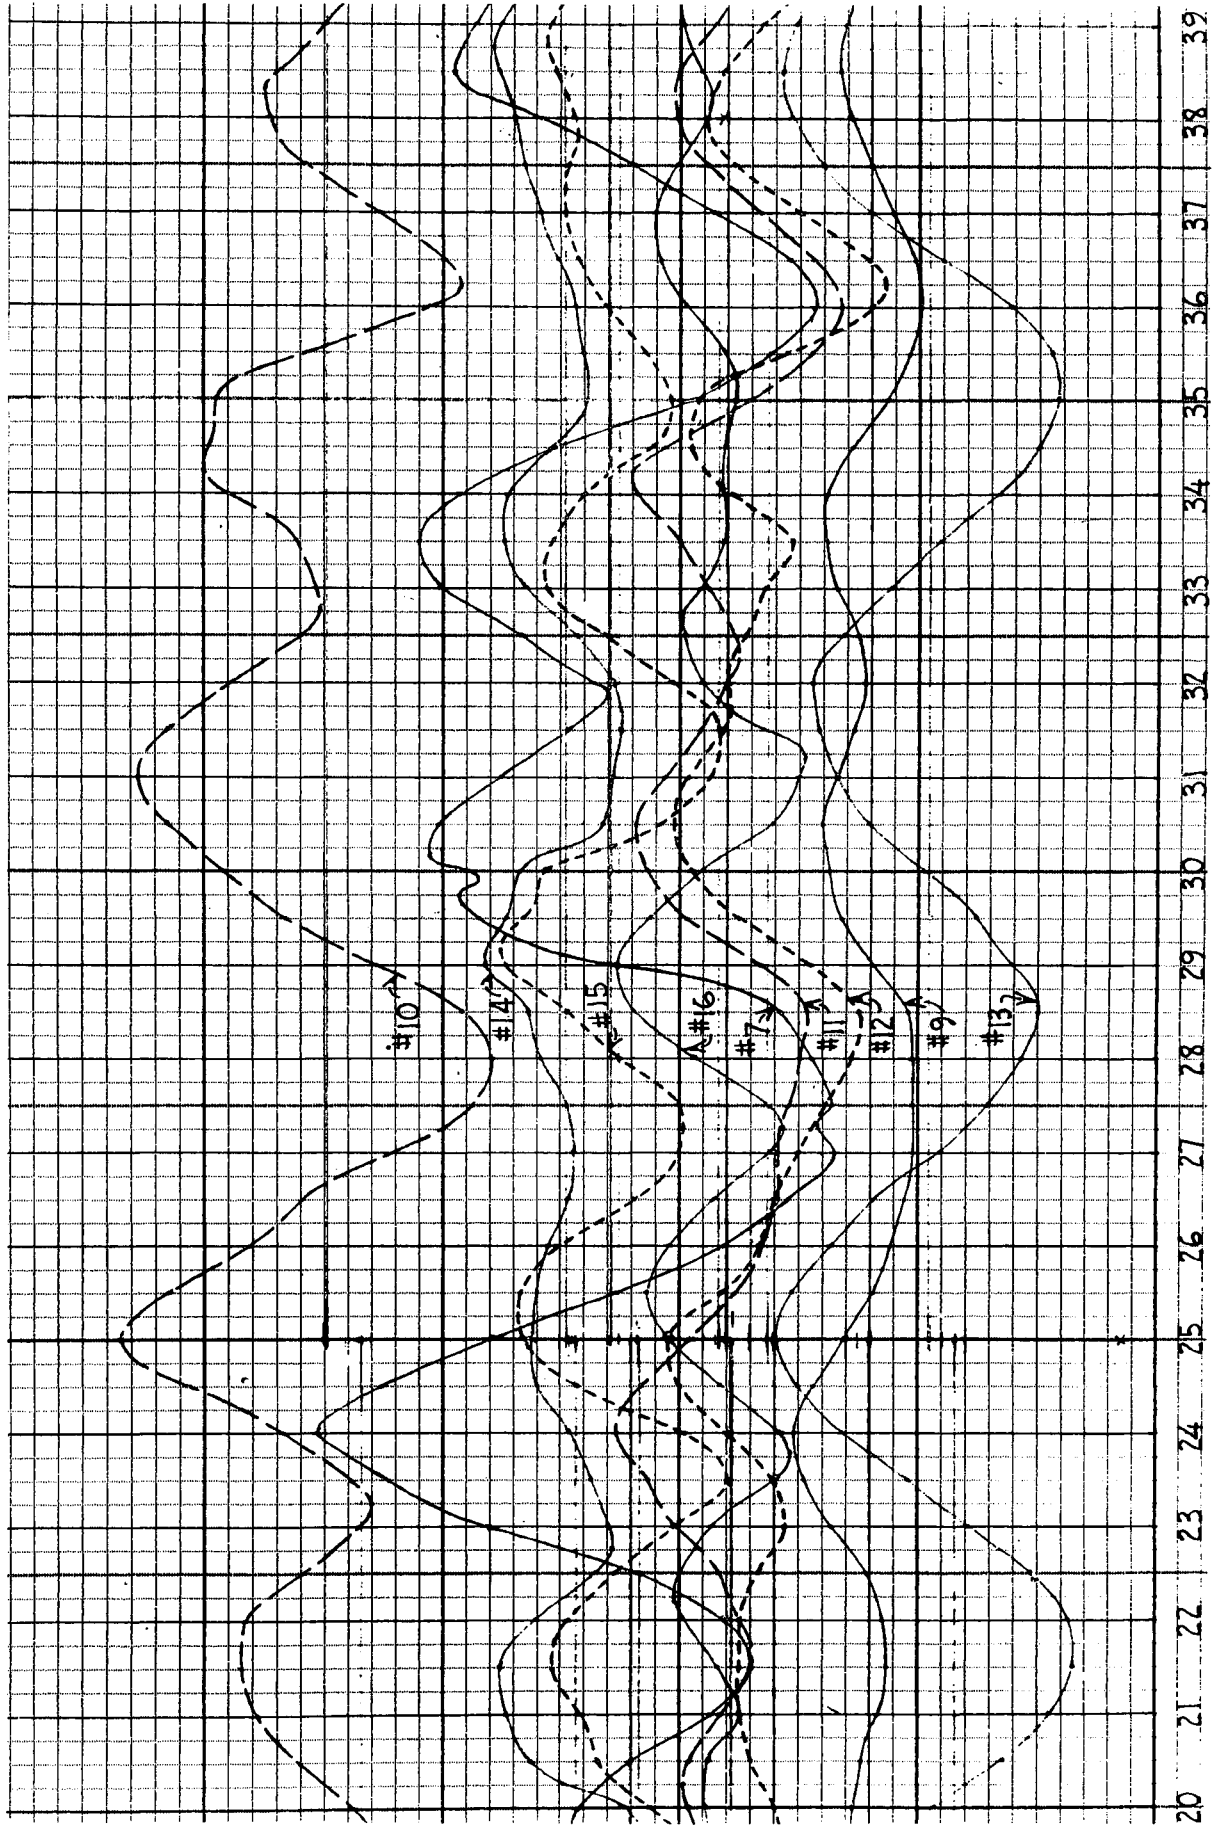
FIGURE 9

The irregular variation of pressure with respect to time at the several cells (Figure 9) was attributed to wave action since waves were described as being of a choppy irregular nature. It was noted that the amplitude of the pressure variations for a single cell was about 1 foot of water at the smaller discharges and about 1-1/2 feet of water at the larger discharges. The wave heights (from crest to trough) for the corresponding discharges as indicated by the suspended pile driver weight, about 30 feet away from the drydock, were about 1.7 feet for the smaller discharges and about 3.3 feet for the larger discharges; thus, the pressure variations as shown by the cells do not indicate the full height of the waves. A further study of pressure variation with respect to depth was made by comparison of records from the cell groups 1 and 5; 7, 9, and 11; and 10 and 12; but no consistent variation with depth was found.

The curves of Figure 9 show not only the magnitude of the varying pressure acting upon the cells, but also the phase differences between the cells on the different sides of the tipping section and the miter gate. These phase differences show how the pressures on the miter gate become unbalanced. At a given instant the pressure may be of a certain magnitude on the inside of the gate while it may be greater or less on the outside of the gate. In a study of these curves it was noted that two distinct types of wave action occurred, depending upon the depth of water over the drydock tipping section. When this depth was less than 2.5 feet (Tests No. 4 to 10), the waves apparently broke over the tipping section and miter gate in such a manner that the pressure variations on the opposite sides were very irregular. This was especially true of pressure variations of small magnitude, whereas the larger pressure variations, evidently caused by larger waves, retained their identity as the waves passed over the tipping section and gate. With this type of action, the maximum pressure difference was found to be about 1 foot of water. At the larger discharges and with greater depths over the gate (Tests No. 12 and 16) the wave patterns appeared to be more regular, especially at the peak discharge of 334,000 second-feet (Test No. 16). At this discharge the magnitude of the pressure variation increased to nearly 2 feet of water; however, the phase relationship of the variations at cells on each side of the gate was such that the maximum pressure difference on the gate was approximately 0.87 foot of water, less than that observed at smaller discharges. The manner in which these pressure variations occurred, with a somewhat regular phase difference, suggested that the unbalanced pressures on the opposite sides of the gate could be related to the slope of the waves, and that the assumptions using the Navy results to estimate the pressure differences was applicable, although conservative. In the light of these data, it was concluded that the design value of 2 feet of water for the unbalanced pressure would not be exceeded even with discharges in excess of those at which the tests were made.

1. Use an unbalanced pressure of 2 feet of water for designing the permanent gate-holding device on the miter gate.
