COACHELLA CANAL

UNDERWATER CONCRETE LINING STUDY

SUBJECT: Coachella Canal Underwater Concrete Lining Study - Request for Assistance
(Canal Lining)

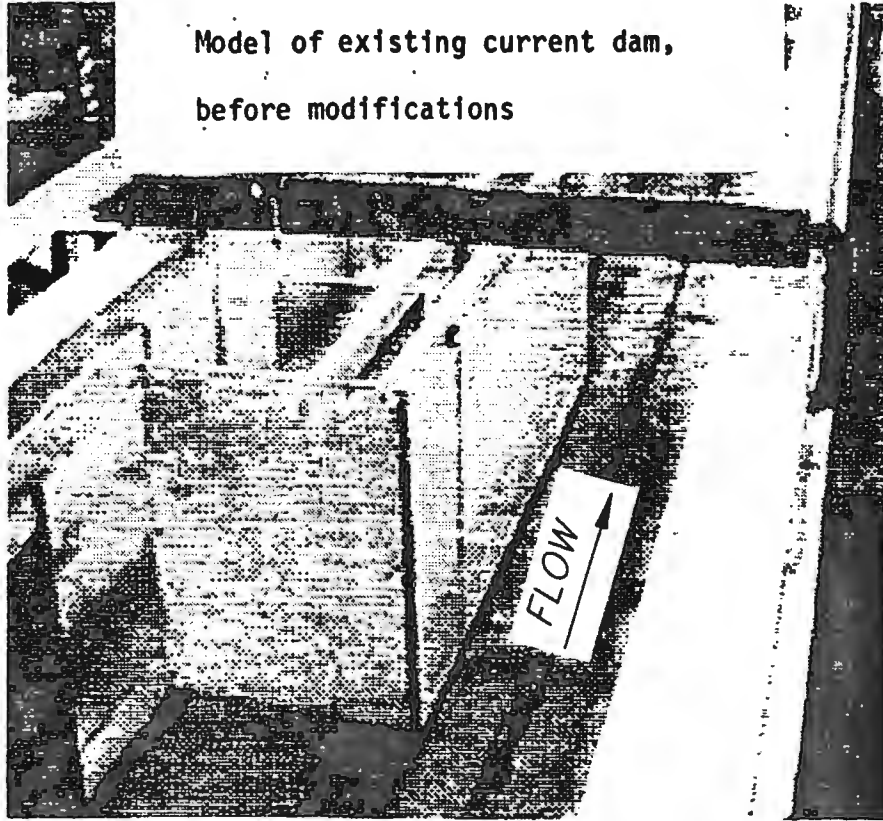
Figure 1

Model of existing current dam,
before modifications

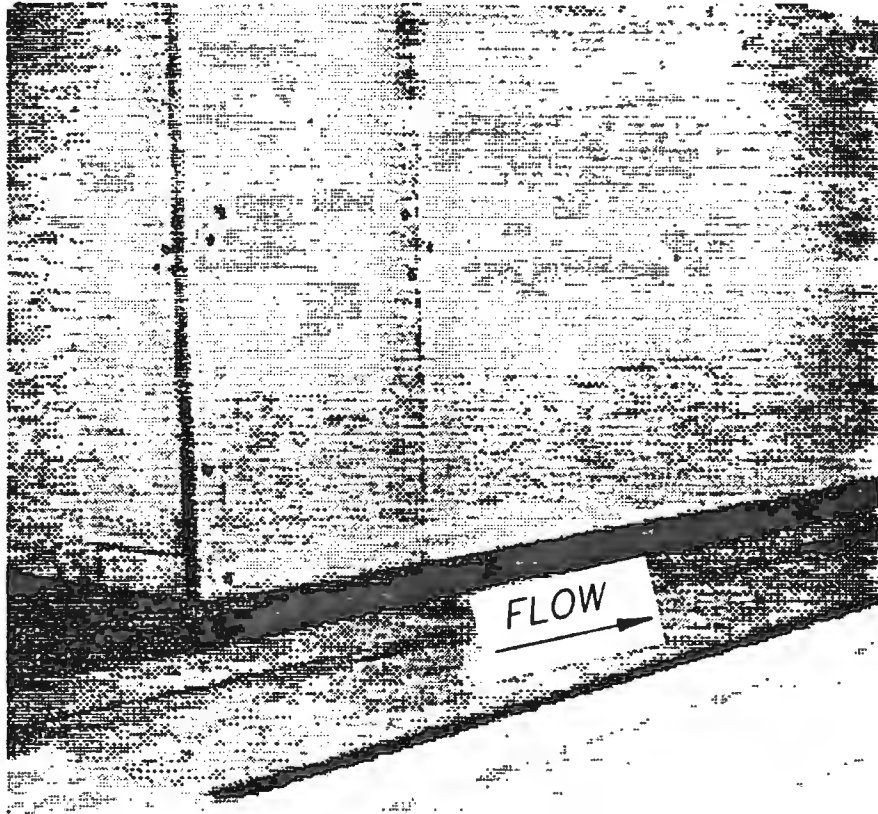
Figure 2

Paving in upstream and downstream direction

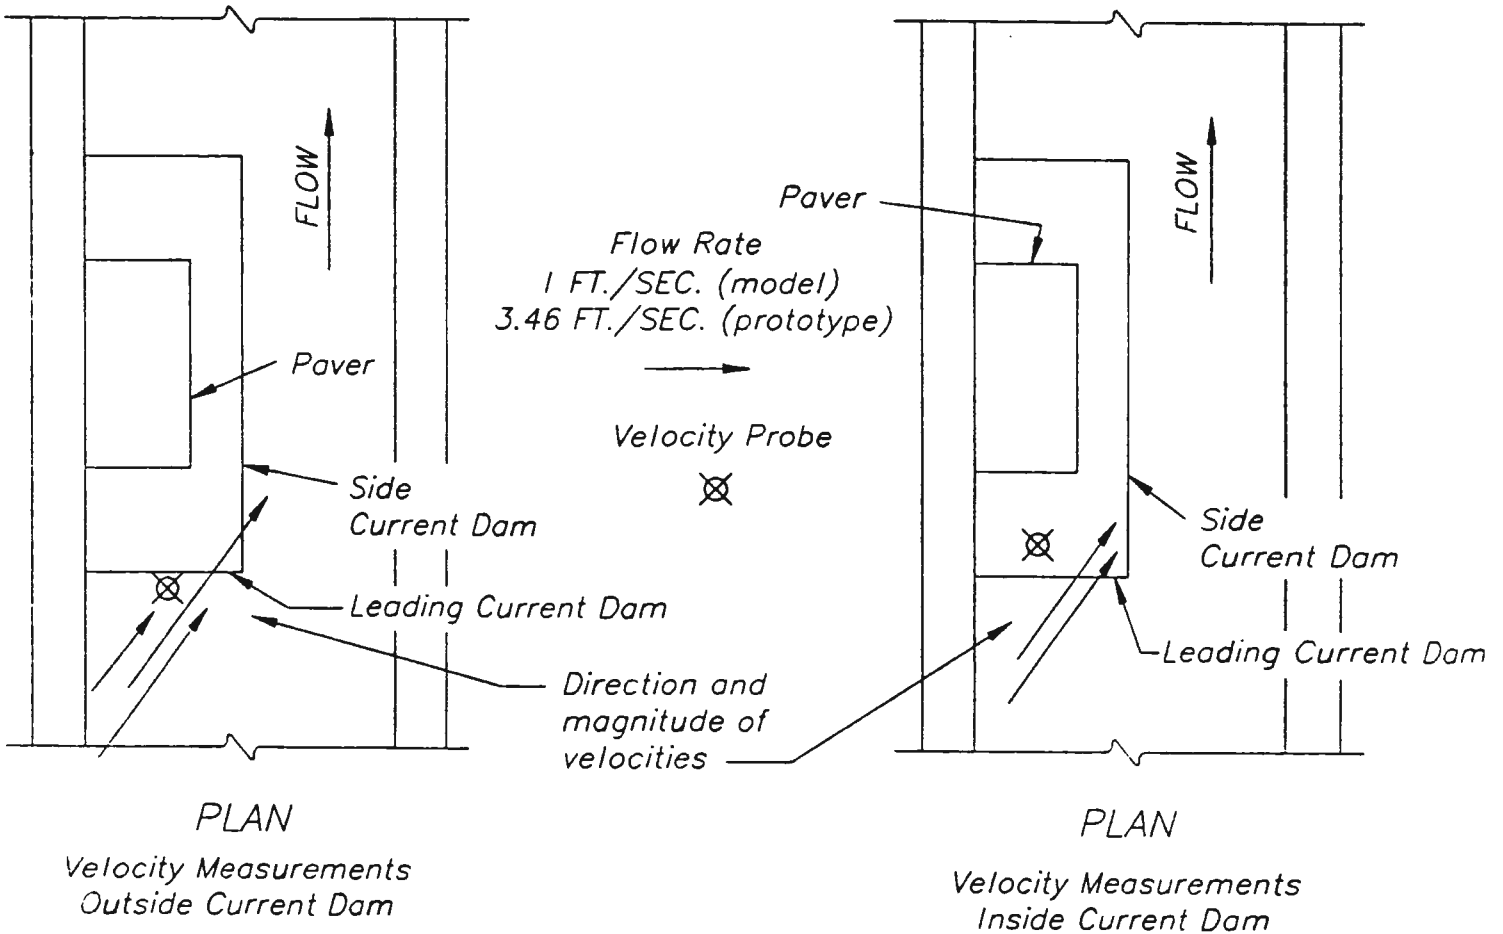
Originally, it was thought that the pressure differential between the canal water surface elevation and the water surface elevation inside the current dam caused the erosion. Model velocity measurements were taken near the upstream corners of the current dam (see fig. 3). The data show that the highest velocities occur diagonally across the leading corner, underneath the current dam. Various combinations of open area to the side current dam were tried to lower the velocities. This approach was not effective in decreasing the flow velocities. A 5-foot radius bull nose, open half cylinder, was installed on the leading current dam. This helped the flows considerably (see fig. 4) and lowered the velocities under the current dam by about 20 percent. A 10-foot-wide (10-inch model) section on the side current dam was then lowered to within 3 inches (prototype) of the bottom of the canal (see fig. 5). From the measured velocities, it was determined that only a 6-foot-long section of the side current dam was necessary and that it should be as thin as structurally possible to prevent the blunt nose effect, as witnessed before. This extension acts like a current guide vane.

*FIGURE 3 Relative Velocities Past Current Dam
Canal discharge = 700 cfs*
