Hydraulic Laboratory Technical Memorandum PAP-1145

Buffalo Bill Power Plant Tailrace Barrier Fence

As-Built Sonar Inspection

Pick-Sloan Missouri Basin Program

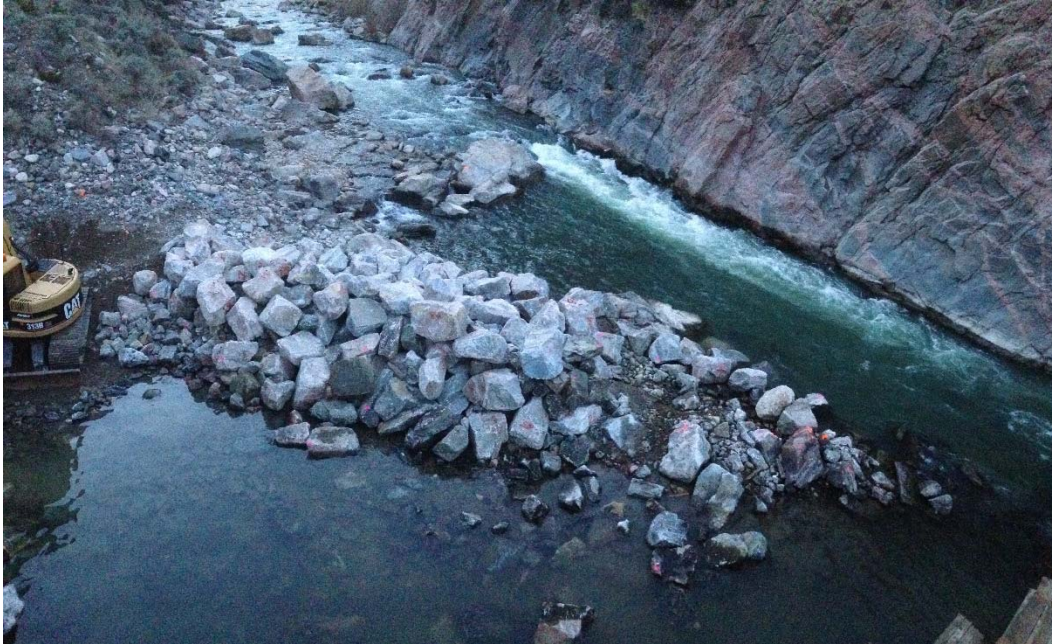
The Buffalo Bill Power Plant tailrace repair project was completed in March 2015. The contractor worked with the project staff to perform repairs on the tailrace apron which involved the installation of stainless steel plates to prevent future concrete erosion damage. The design called for installing anchored stainless steel plating and barrier fence sections along the length of the tailrace apron. The tailrace repair project also called for adding riprap to an existing tailrace protection dike located immediately upstream from the power plant. Boulders weighing up to two tons were used to reinforce the dike (see figure 2). As-built sonar images were collected on October 20, 2015.

Figure 2. Photograph of tailrace protection dike repairs in 2015.

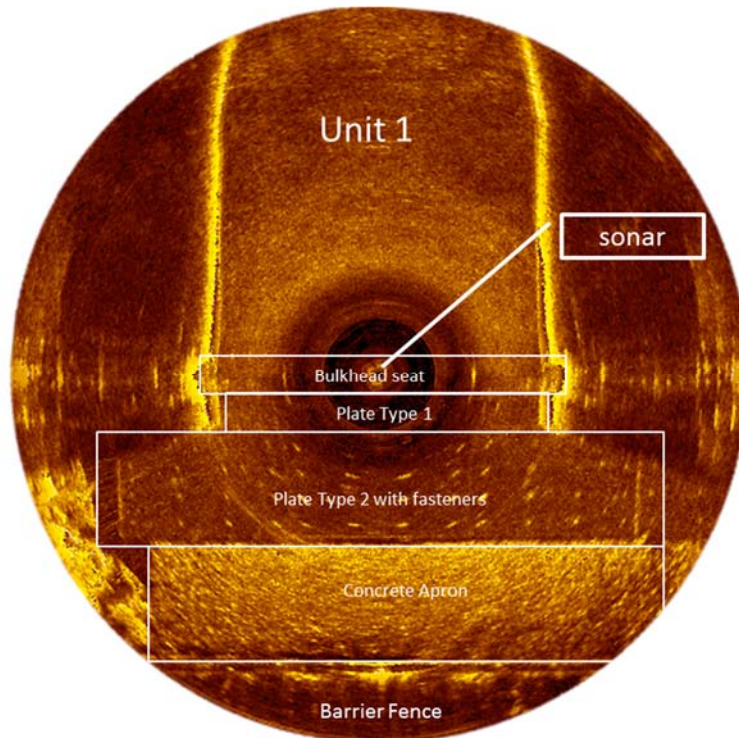
Figure 4 is a plan view acoustic image of Unit 1 tailrace collected using a 12 ft acoustic range. Various pertinent repair components in the image are annotated. This image shows the joints (2) of the plate type 2 near the edges of the annotation box and the fastener layout. There are two other plate type 2 joints in front of Unit 1, but their orientation with respect to the sonar beam (with a shallow beam incident angle) prevented the joints from showing up clearly in the image. A careful review of the sonar records did not indicate any rocks had passed through the barrier fence. The Unit 1 tailrace and concrete apron appears to be clear of large rocks and debris. Note: Components of the barrier fence were not imaged clearly from this sonar position. To obtain detailed sonar images of the barrier fence a tripod-mounted sonar would have to be deployed closer to the fence using a boat or boom truck. These images would provide some indication if rocks were accumulating against the fence. If over time rocks build up against the fence and form a rock ramp, this could allow river rocks to pass over the fence and accumulate in the tailrace.

Figure 4. Plan view image of Unit 1 tailrace collected with a 12 ft acoustic range. Various pertinent features in the images are annotated. Note: Components of the barrier fence were not clearly imaged from this sonar position.

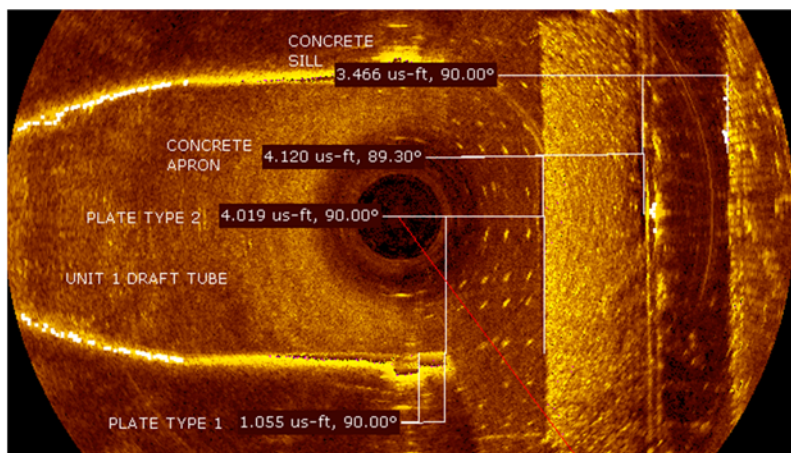
Figure 5 is a plan view acoustic image of Unit 1 tailrace collected using a 15 ft acoustic range with as-built dimensions on the various components. This image was rotated 90 degrees to facilitate dimensioning.

Figure 5. Rotated plan view image of Unit 1 tailrace collected with a 15 ft acoustic range. Various pertinent features in the images are annotated with dimensions in an as-built condition.

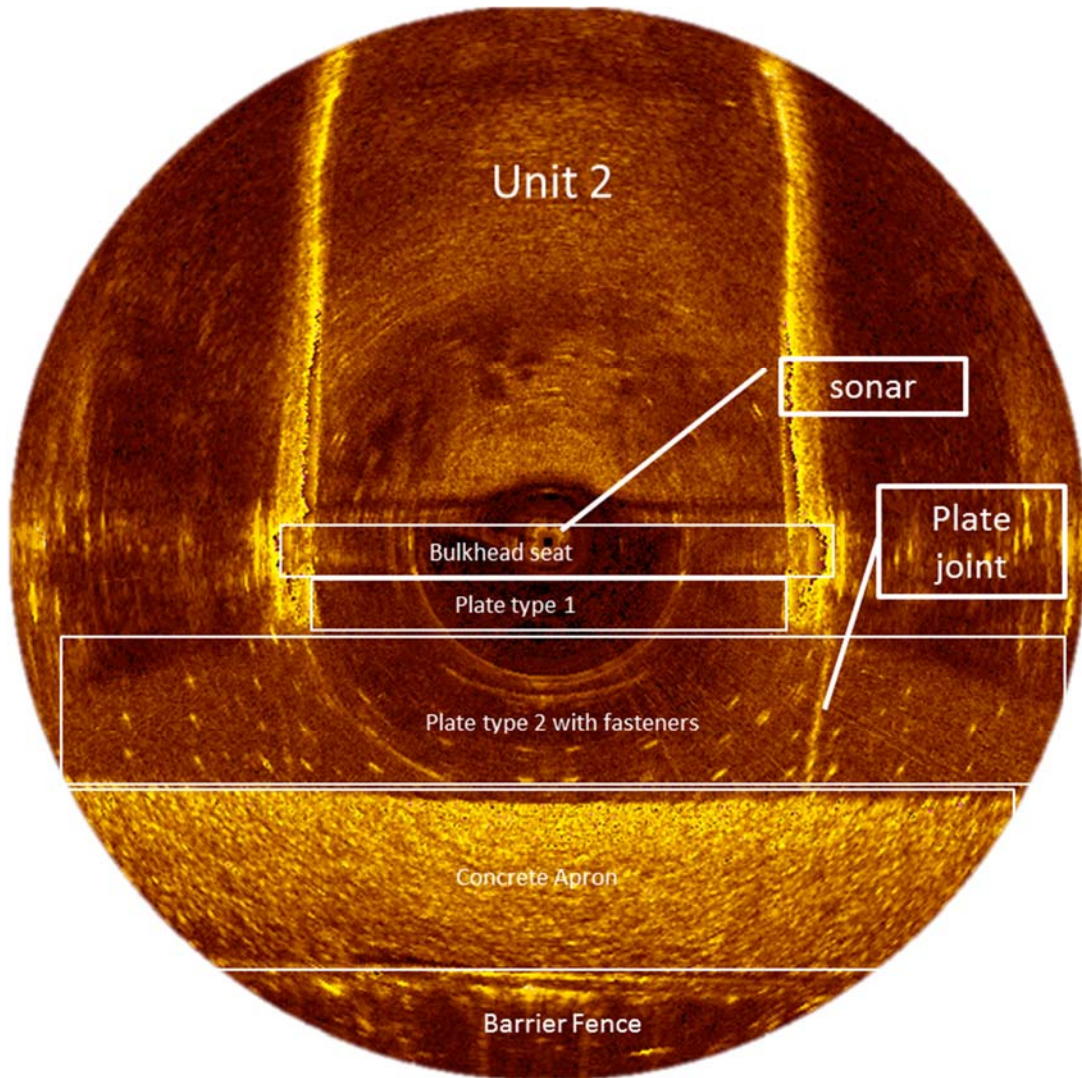
Figure 6 is a plan view acoustic image of Unit 2 tailrace collected using a 12 ft acoustic range. Pertinent features in the image are annotated. This image shows a single joint of the plate type 2, near the right side of Unit 2. The joint is slanted 9 degrees with respect to the bulkhead seat. The other joint is partially visible near

the left side of Unit 2, and it appears to be slanted. The slanted joints could be a distortion in the acoustic image because the rows of fasteners are also slanted at a similar angle. There is a plate type 2 joint on the centerline of Unit 2, but its orientation with respect to the sonar (at a very shallow beam incident angle) prevented this joint from showing up in the image.

Figure 6. Plan view image of Unit 2 tailrace collected with a 12 ft acoustic range. Various pertinent features in the images are annotated. Note: Structural components of the barrier fence were not clearly imaged from this sonar position.

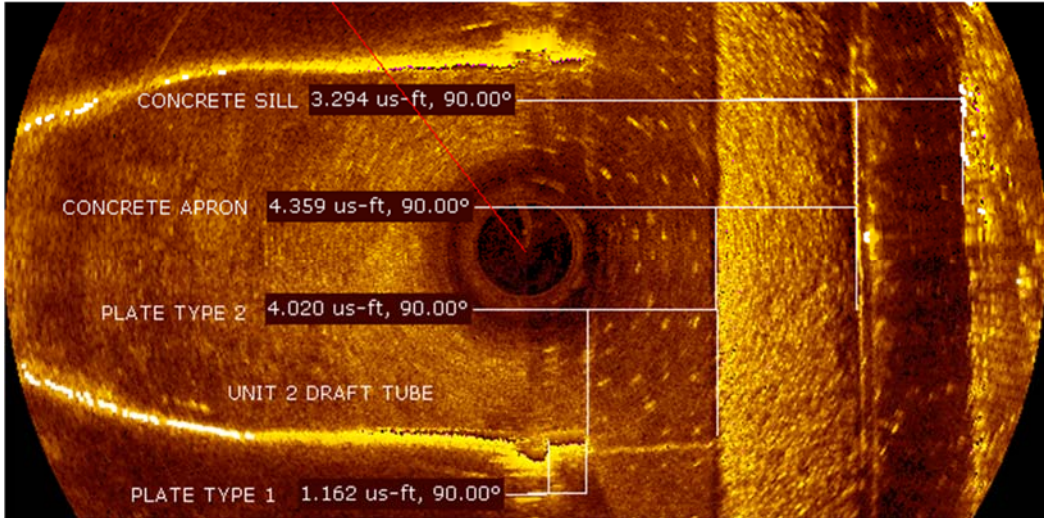
Figure 7 is a plan view acoustic image of Unit 2 tailrace collected using a 15 ft acoustic range with as-built dimensions on the various components of the repair. This image was rotated 90 degrees to facilitate dimensioning.

Figure 7. Rotated plan view image of Unit 2 tailrace collected with a 15 ft acoustic range. Various pertinent features in the images are dimensioned in an as-built condition.

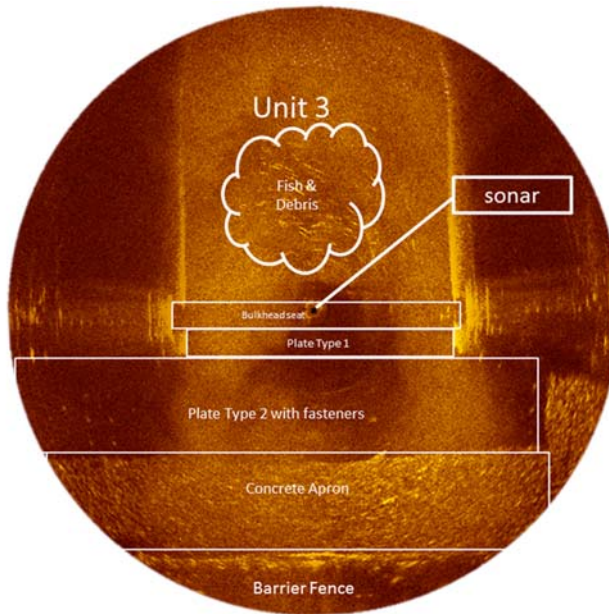
Figure 8 is a plan view acoustic image of Unit 3 tailrace collected with a 12 ft acoustic range. Pertinent features in the image are annotated. This image does not contain the level of detail of the Unit 1 and 2 images because of aeration caused by flow released from a butterfly valve and wicket gate leakage. This flow also created an eddy that holds debris or fish in the Unit 3 draft tube. The concrete apron and tailrace plates appear to be clear of rocks and debris.

Figure 8. Plan view acoustic image of Unit 3 tailrace collected with a 12 ft acoustic range. Pertinent features in the images are annotated. Note: aeration from releases from a butterfly valve prevented detailed imaging from this sonar position.

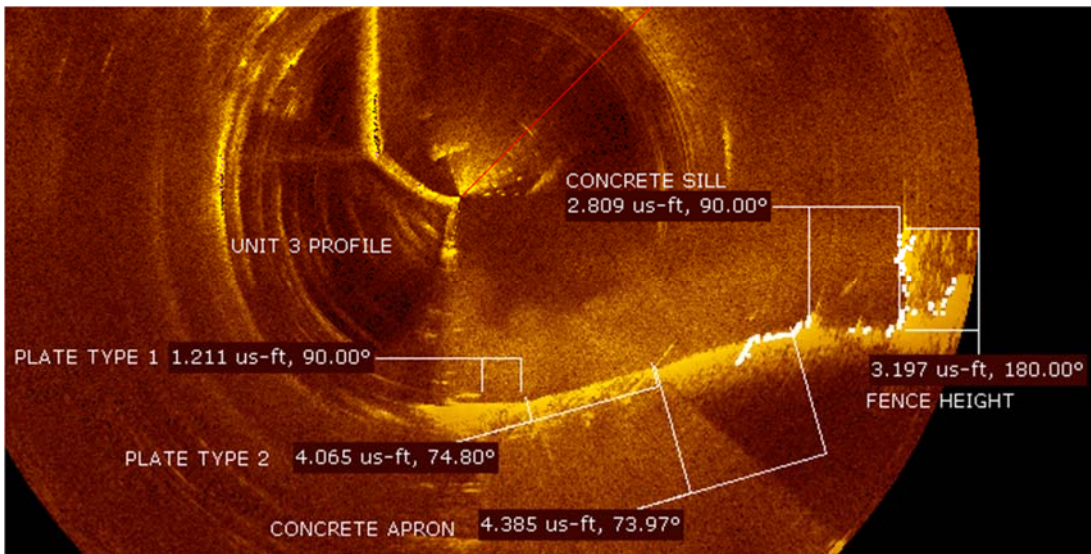
The sonar was removed and reinstalled in a horizontal orientation to collect a sectional profile of Unit 3. The sonar was lowered to El. 5049.88 ft. which is near the upper bulkhead seal plate. Figure 9 is a profile view image along the Unit 3 centerline collected with a 15 ft acoustic range. As-built dimensions measured on the profile image indicate the 4:1 concrete apron is about 4.4 ft long and the concrete sill is approximately 2.8 ft wide. Likewise, the width of type 1 and type 2 plates were measured to be about 1.2 and 4.07 ft wide, respectively. It is important to note, that the dimensioning accuracy of acoustic images is dependent on the image resolution (i.e. acoustic range) and the interpretation of the analyst. As a result, dimensions on images with similar features may not agree perfectly.

The Unit 3 centerline profile image shows the relatively smooth steel and concrete surfaces that are free of any significant debris. It is interesting that many of the structural supports of the barrier fence are not visible in the acoustic image.

Figure 9. Profile view image of Unit 3 centerline collected with a 15 ft acoustic range. Various pertinent features in the image are annotated and dimensioned in an as-built condition.

An acoustic profile image collected along the Unit 3 centerline did not show any offsets or debris on the repaired tailrace apron. The acoustic profile did create a good image of the vertical face of the barrier fence.

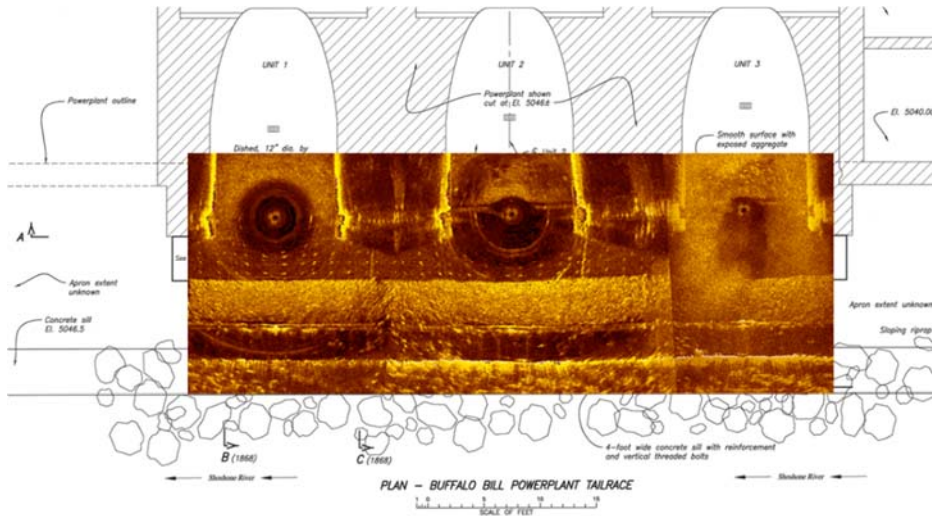
Figure 10 is a composite plan view image of the three tailrace images (22.5 ft acoustic range) draped over a drawing of the Buffalo Bill Power Plant tailrace. The composite image shows slight discrepancies between the plan views of design drawing and the acoustic images. Specifically, the concrete apron and sill widths are not the size indicated on the drawing. In the composite image the effects of Unit 3 aeration on image quality is readily apparent.

Figure 10. Composite of three plan view acoustic images of the Buffalo Bill Power Plant tailrace draped over a plan view drawing of the tailrace.

Sonar images were analyzed to determine as-built dimensions of the repair plates and the barrier fence. The only significant difference was the measured length of the concrete apron (about 4.4 ft) was shorter than the repair drawings indicated (about 6 ft).

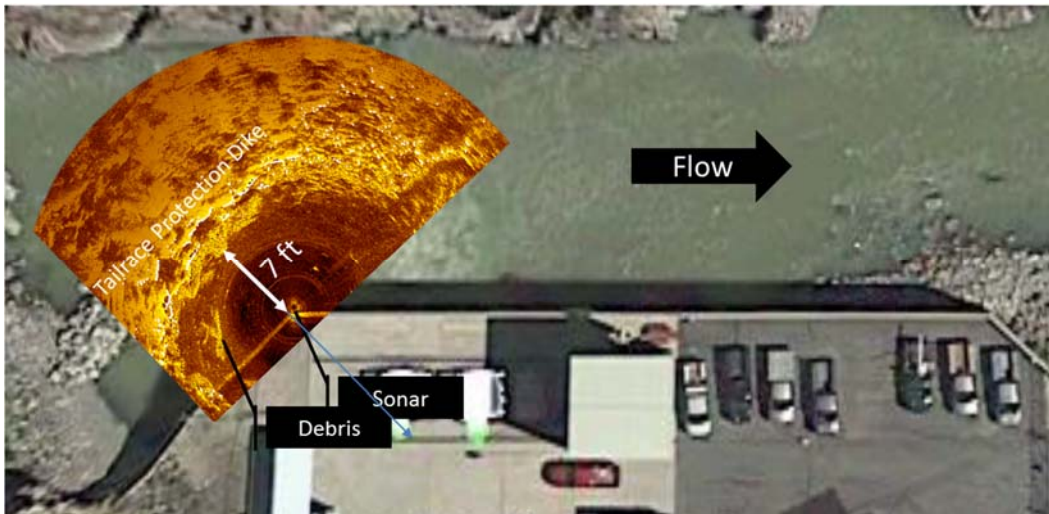
An acoustic image was collected at the corner of the parapet wall and retaining wall to document the as-built condition of the tailrace protection dike. The sonar was lowered 24 ft below the power plant deck (to El. 5057.88 ft) which was one foot below the water surface. Figure 13 is an acoustic image collected with a 15 ft range draped over an aerial photograph of the power plant. This image shows the as-built condition of the downstream face of the dike and the presence of an angular piece of debris (about 4.5 ft long) adjacent to the retaining wall. Note: for this sonar location the image of the dike extends from the water surface to about El. 5056 ft.

Figure 13. Plan view acoustic image draped over an aerial photograph of the Buffalo Bill Power Plant. This acoustic image shows the downstream face of the dike, a piece of unknown debris, and a 7 ft clear distance from the power plant to the face of the dike.
