U.S. Bureau of Reclamation Digital Photogrammetry Research Report

Dam Safety Office

Report No. DSO-04-01
Department of the Interior
Bureau of Reclamation
January 2004

DSO-04-01

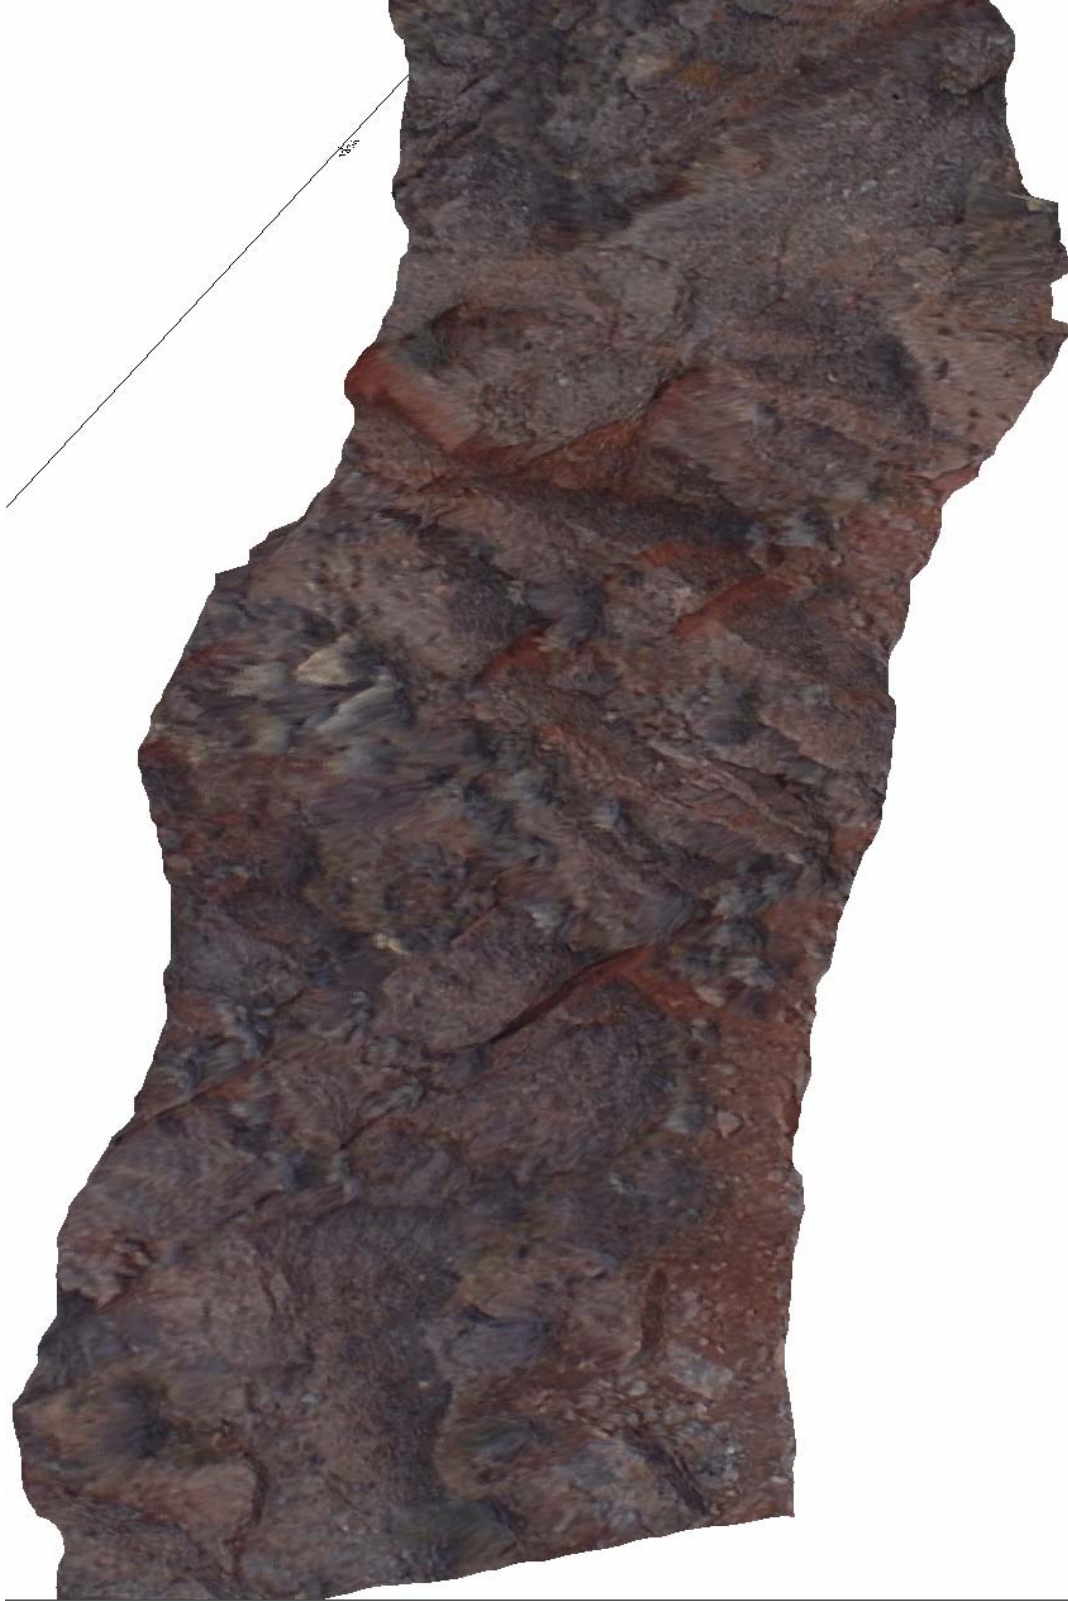
Figure 4.—Color registration of image RGB data onto a TIN surface to produce a three-dimensional image using SiroVision visualization tools. This image can be rotated to facilitate mapping.

Not only was SiroVision found to be quite helpful in providing lens and camera setup positions to obtain the required accuracies, it also directs the user through the processing steps and provides useful pieces of information on the various options. Processing the images to the point of producing a 3D image takes less than 2 hours in most cases, but it could take all day for a difficult site. Siro3D is the program used to find the 3D points, commonly referred to as point cloud data, and the 3D surface or Triangulated Irregular Network (TIN). Siro3D also registers the image pixels and associated RGB colors to the 3D surface to make the 3D image. Figure 2 is an example of point cloud data. The point cloud is the most basic form of data. With the processing complete, the point, or TIN, data (figure 3) can either be exported into a CADD program or exported into SiroJoint. The point cloud image and 3D image (figure 4) are viewable and rotatable in SiroJoint.

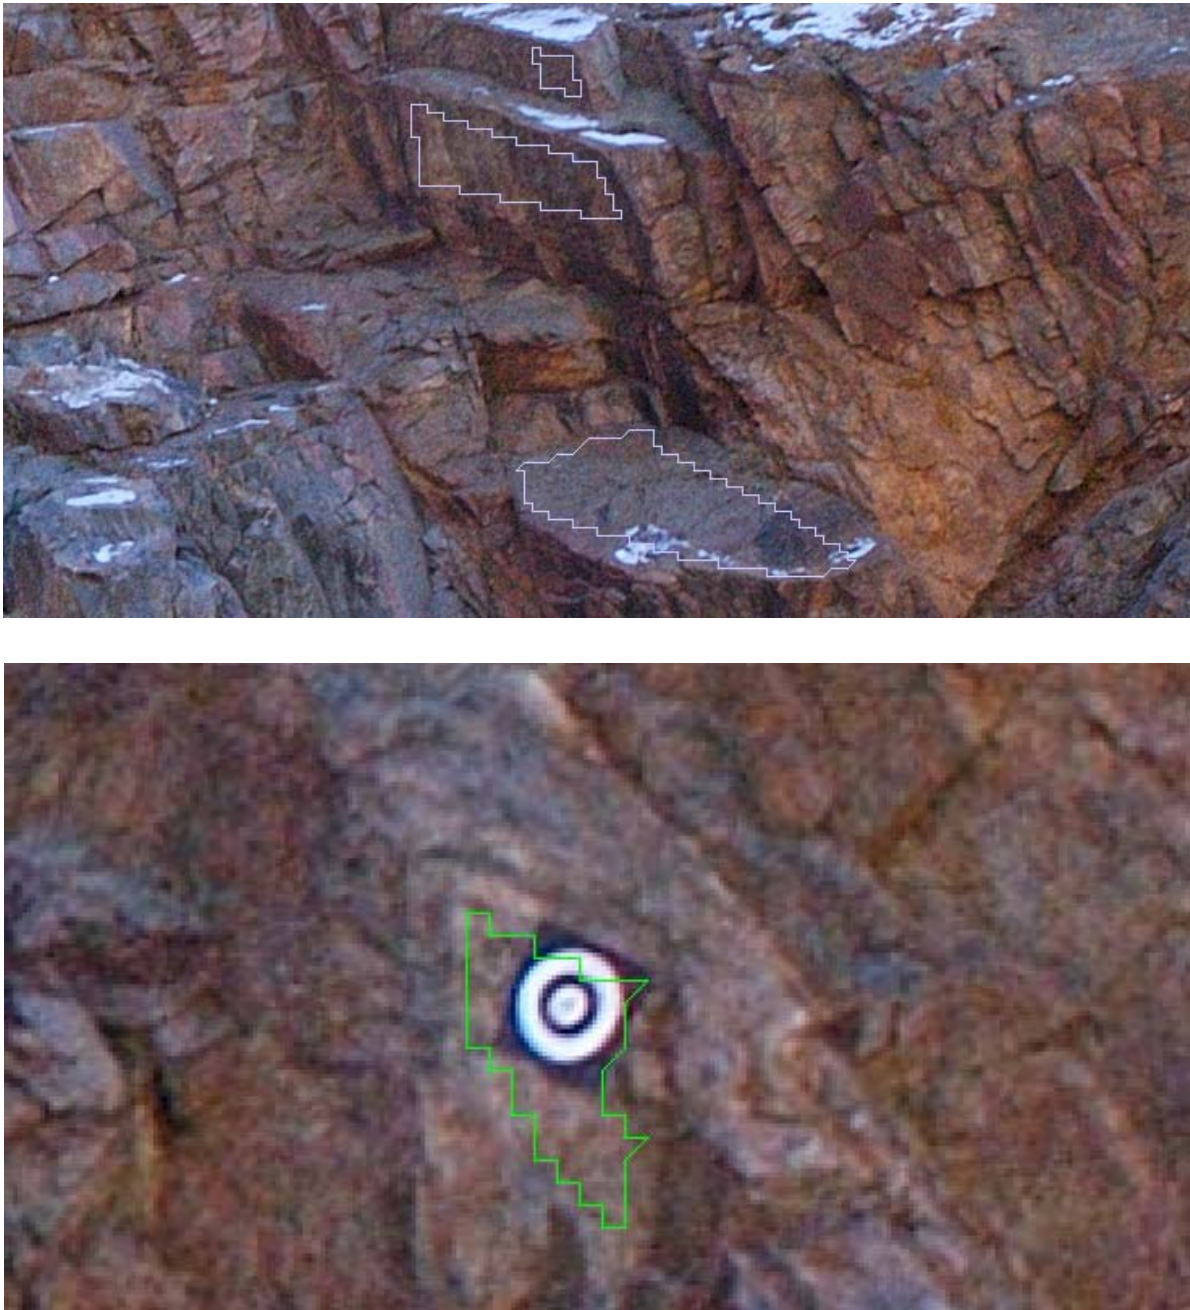
Figure 6.—Polygon drawing objects used to map the orientations of several block faces.

In SiroVision, when a discontinuity face is fully exposed (like that shown in figure 6), a polygon can be drawn that defines the area that would best define the plane. The reliability of the mapped planes can be visually checked, one at a time, immediately after construction (as shown in figure 7). The point cloud data set, or 3D points, that reside within this polygon are applied to an internal least-squares-best-fit routine, and the plane orientation is immediately calculated. The plane attributes window, shown in figure 7, is useful for immediately checking orientation, geometry, and accuracy information of the plane object. This allows one to ascertain that reasonable, expected results are attained.

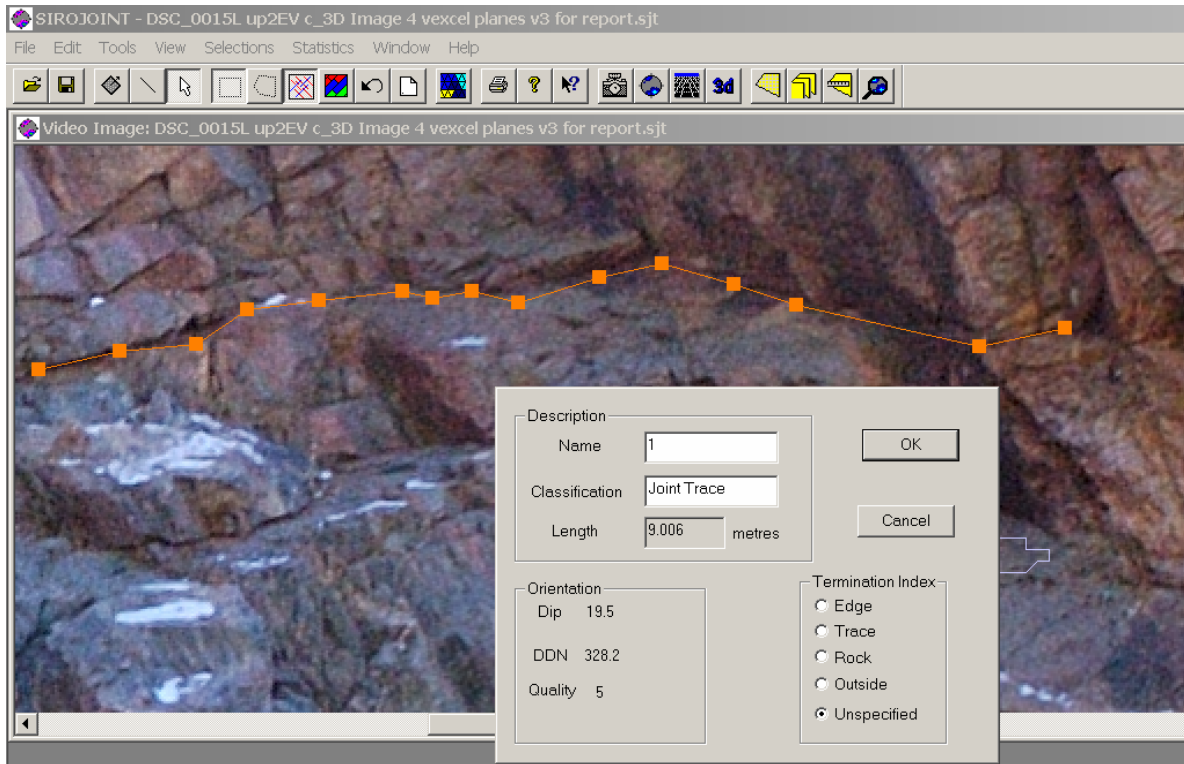
Figure 9.—Orientation and quality information of plane derived from trace feature.

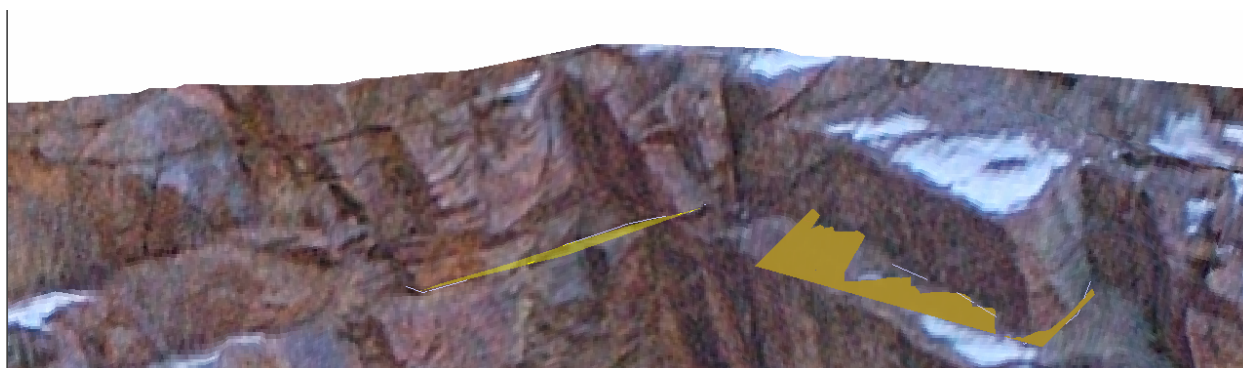
Figure 14.—Using two traces (and planes) to improve the mapping of the actual joints.

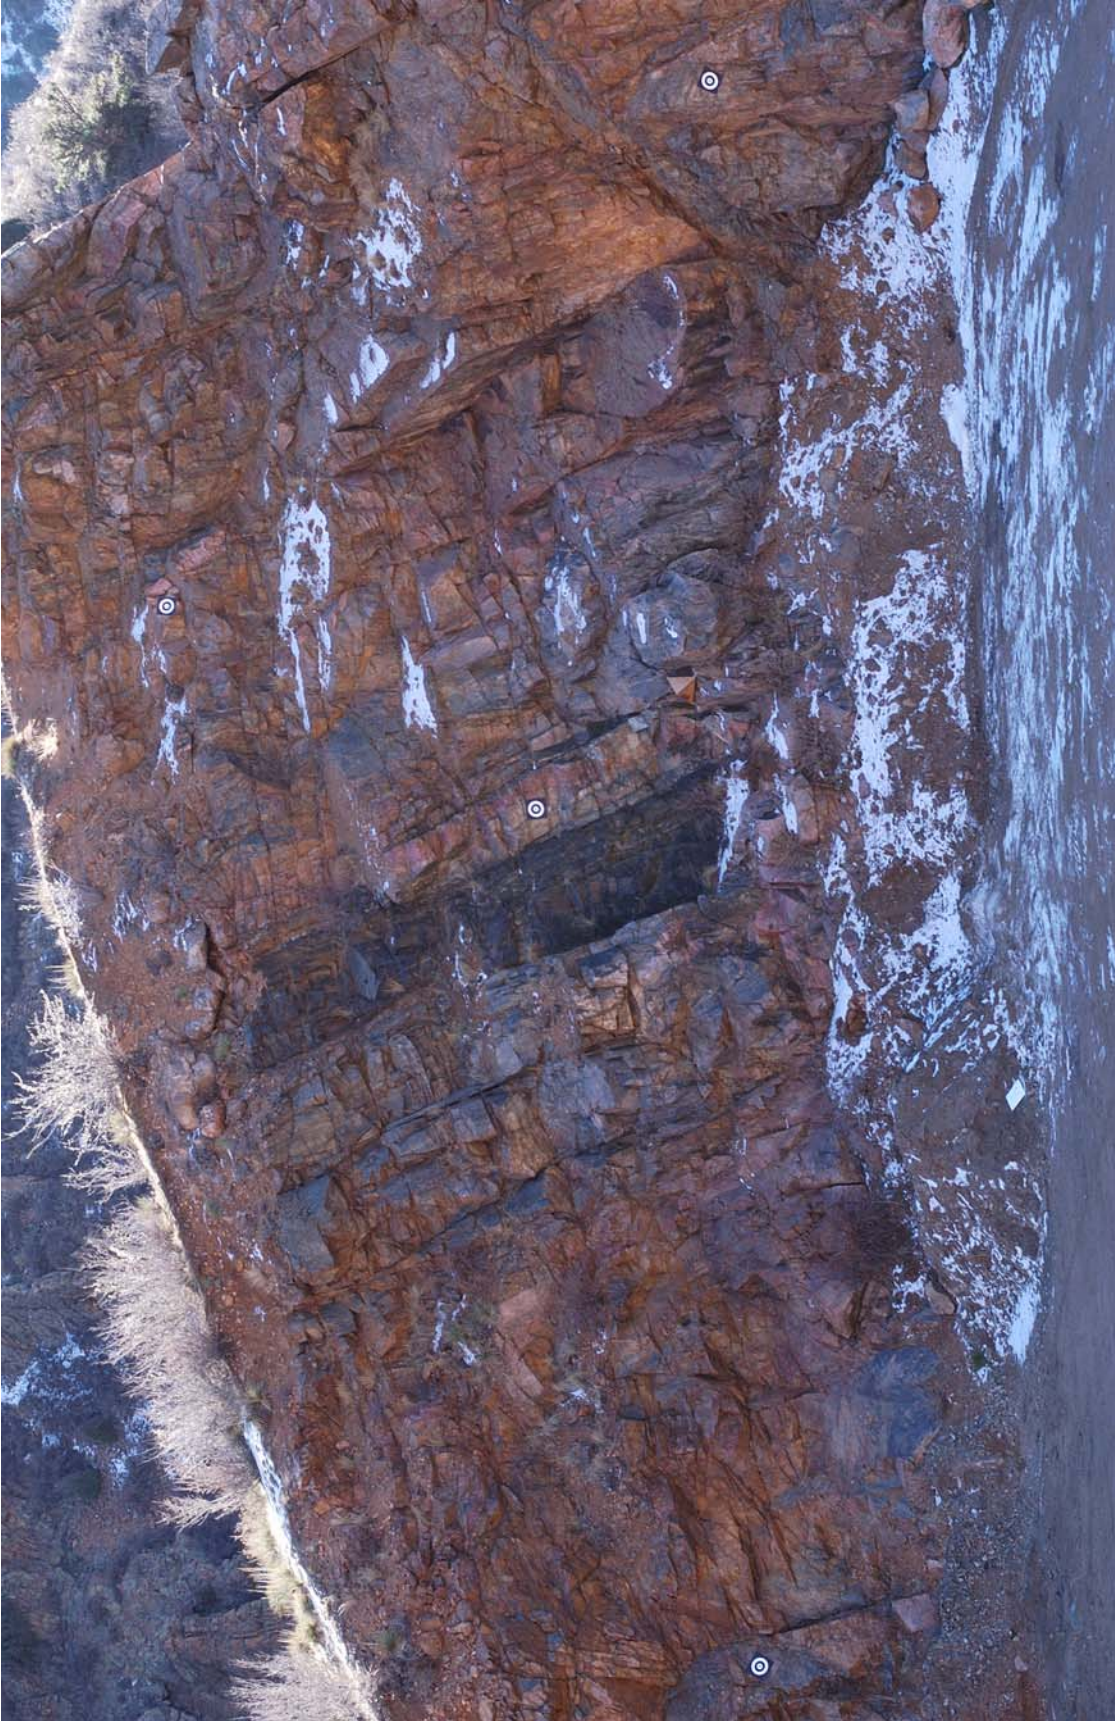
Figure 15.—Targets placed on rock outcrop at Morrison Test Site for evaluating spatial accuracy.

For the three sites used in this report, targets were placed on the rock outcrops (figures 15 and 16) and surveyed using reflectorless total station technology. The surveyed coordinates were typically presented as northing, easting, and elevation in either a world or local coordinate system. The northing, easting, and elevation positions of these targets were also obtained using SiroVision. The SiroVision spatial coordinates were then evaluated for accuracy. Spatial error is defined as the difference in magnitude between the target's surveyed position and the SiroVision position. The surveyed position of the target is presumed to be more accurate; thus, it is the baseline for comparison. That survey data could have errors should be considered as a possibility. For this phase of the research, using the survey as a datum seems justifiable. For each site, the SiroVision errors for the multiple targets were averaged. The average SiroVision errors for each of the three sites and the overall average error are listed in table 2, which appears in a later section.

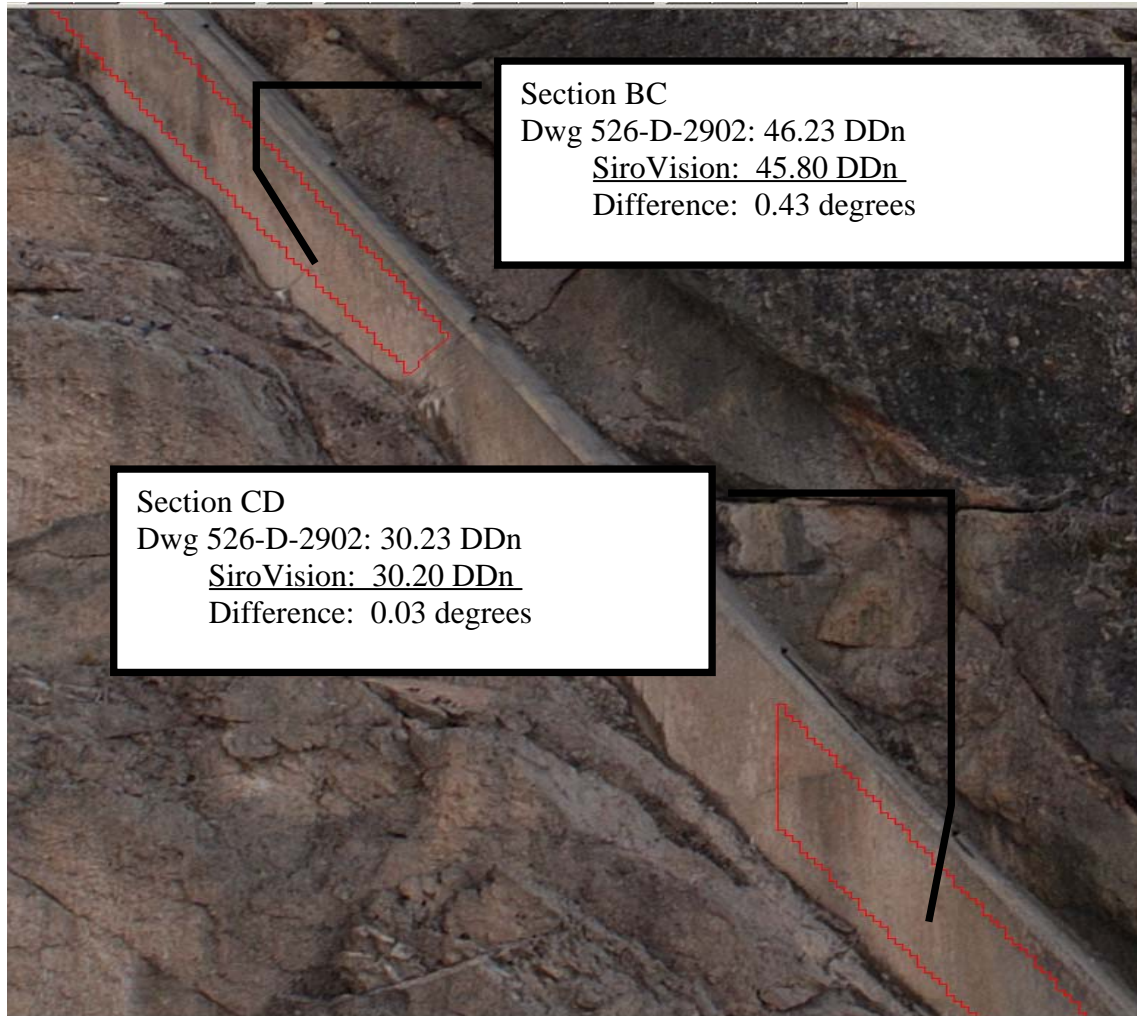
Figure A2.—Protective concrete wall, downstream left abutment, November 2002.

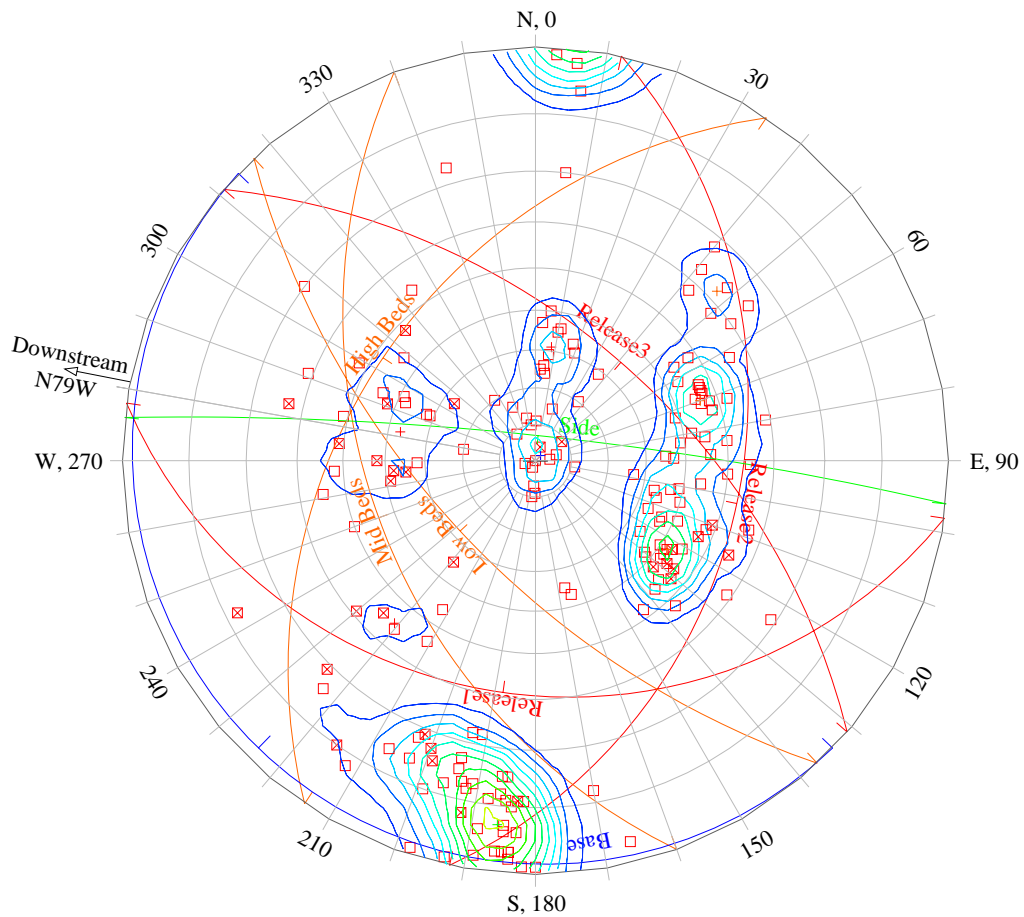
Figure A4.—Orientation data of the left abutment of East Canyon using SiroVision. The plane poles and pole clusters are in good agreement with the site conditions. This comparison aids in verifying the accuracy of data obtained from photogrammetry.

The second check to evaluate orientation accuracies is more qualitative. The data provided by SiroVision of the mapped plane and trace features were visually examined for ambiguities. The data should fall within the bounds of the expected orientations that the geologist visualizes at the site. The judgment of the geologist is a very important tool in verifying data accuracies. The SiroVision orientation data was determined to be reasonable. Stereonets were used as further guidance. Figure A4 is an example of SiroVision orientation data for East Canyon’s left abutment (Krosley et al., 2003). Good pole clusters are present and agree with the site structure.

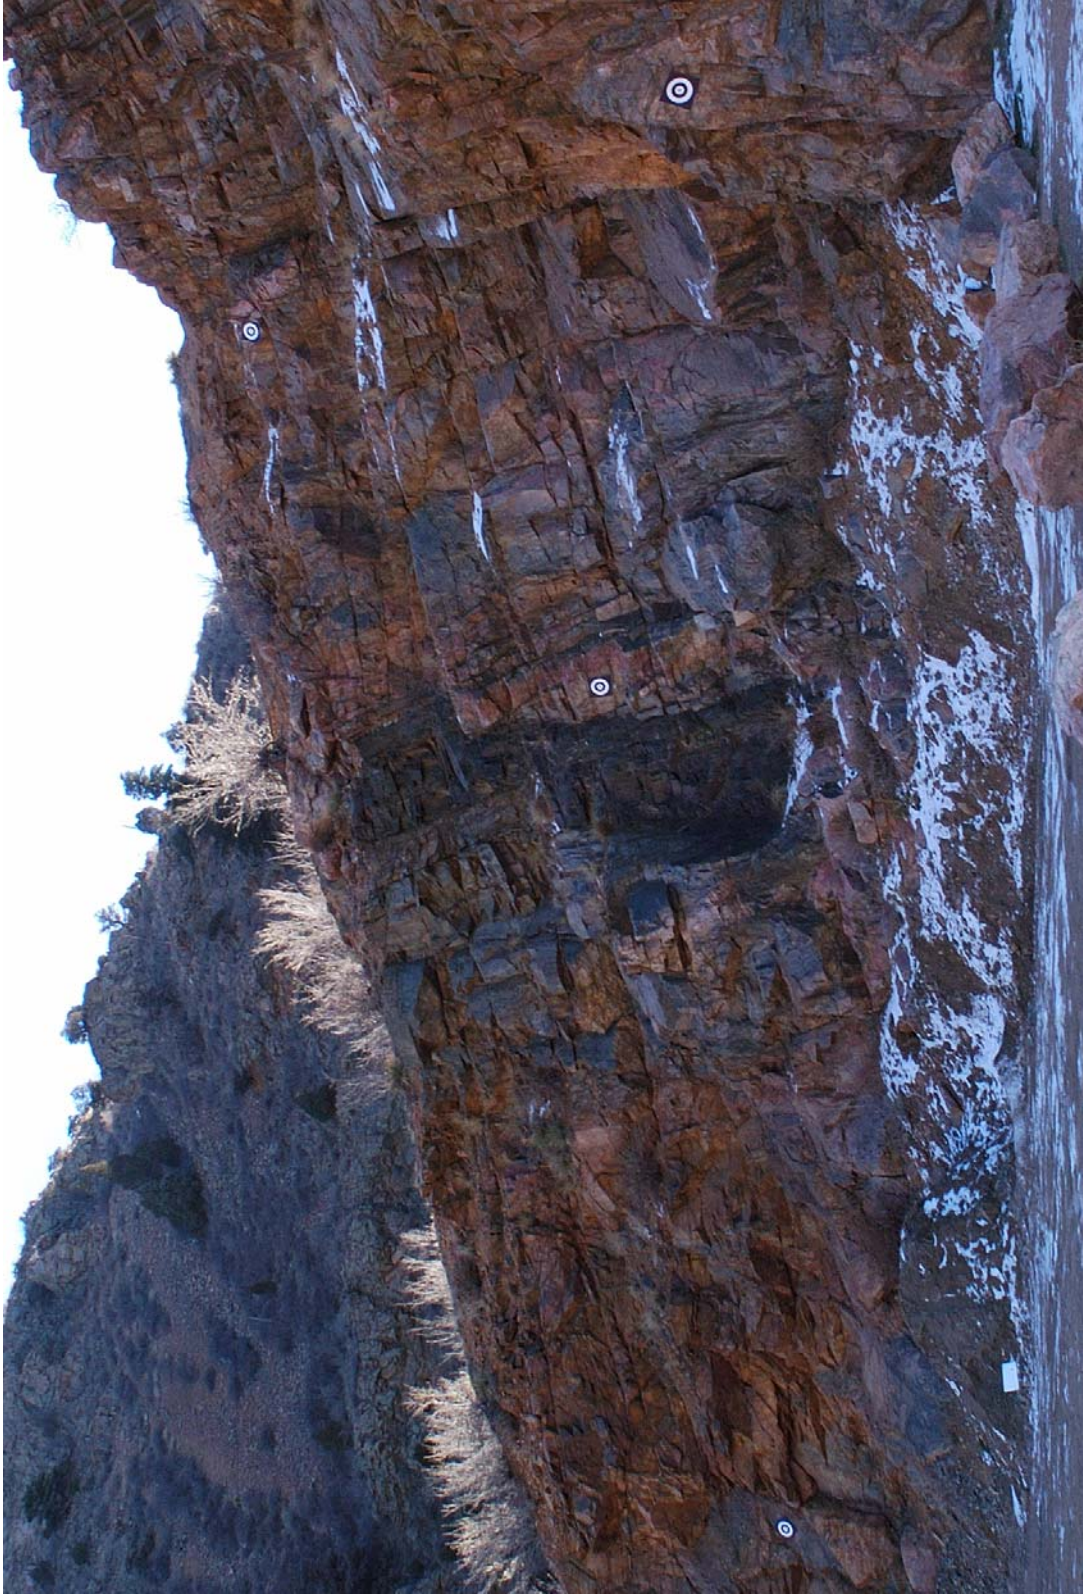
Figure B1.—Morrison Test Site rock outcrop with four targets to evaluate photogrammetry systems. Targets from left to right are T1, T2, T4, and T3.

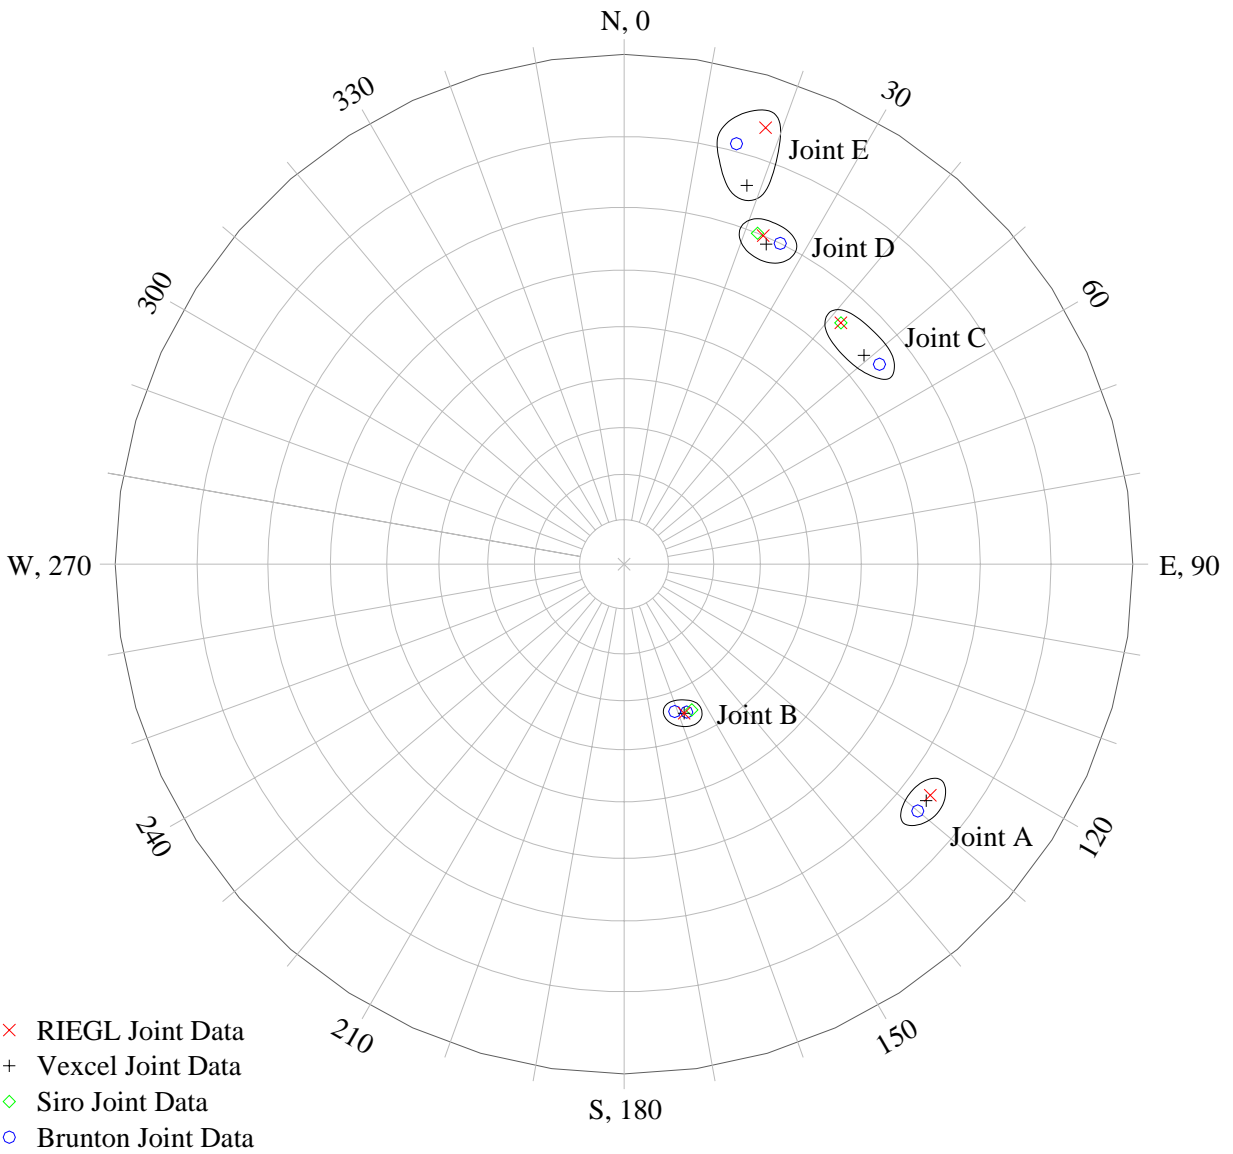
Figure B3.—Stereonet showing normal poles for planes A to E of REIGL, Vexcel, SiroVision results.

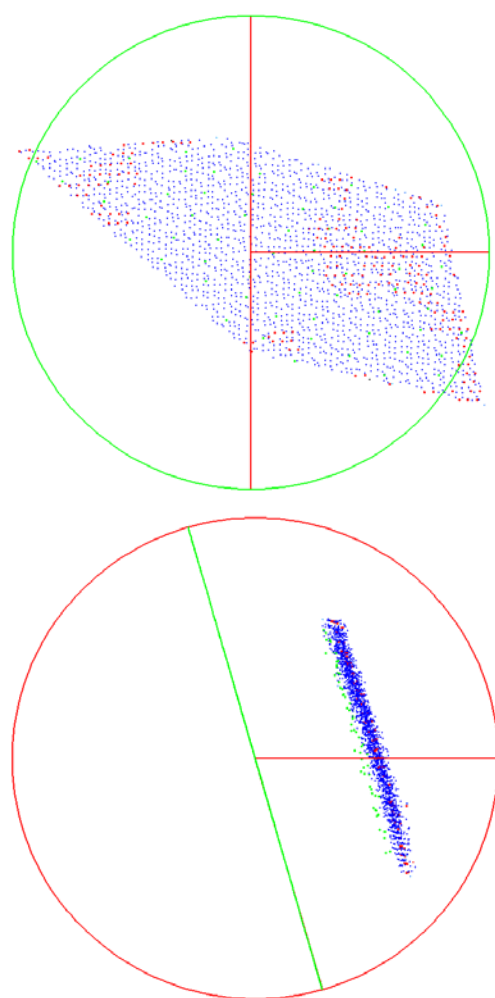
The SiroVision (in green) data is well distributed over the plane; however, the density is the lowest of the three sets. The edge view shows a scatter similar to that of the RIEGL data and that the SiroVision data is shifted to one side. This data is suspect because it is shifted in location from the other two sets. The dip and dip direction do compare well to the other sets, so a translation or a mild stretch in the SiroVision data must exist.

Figure B7.—SiroVision (green), Foto-G (red), and RIEGL (blue) points for plane A, looking normal (top) to the plane and on edge (bottom).

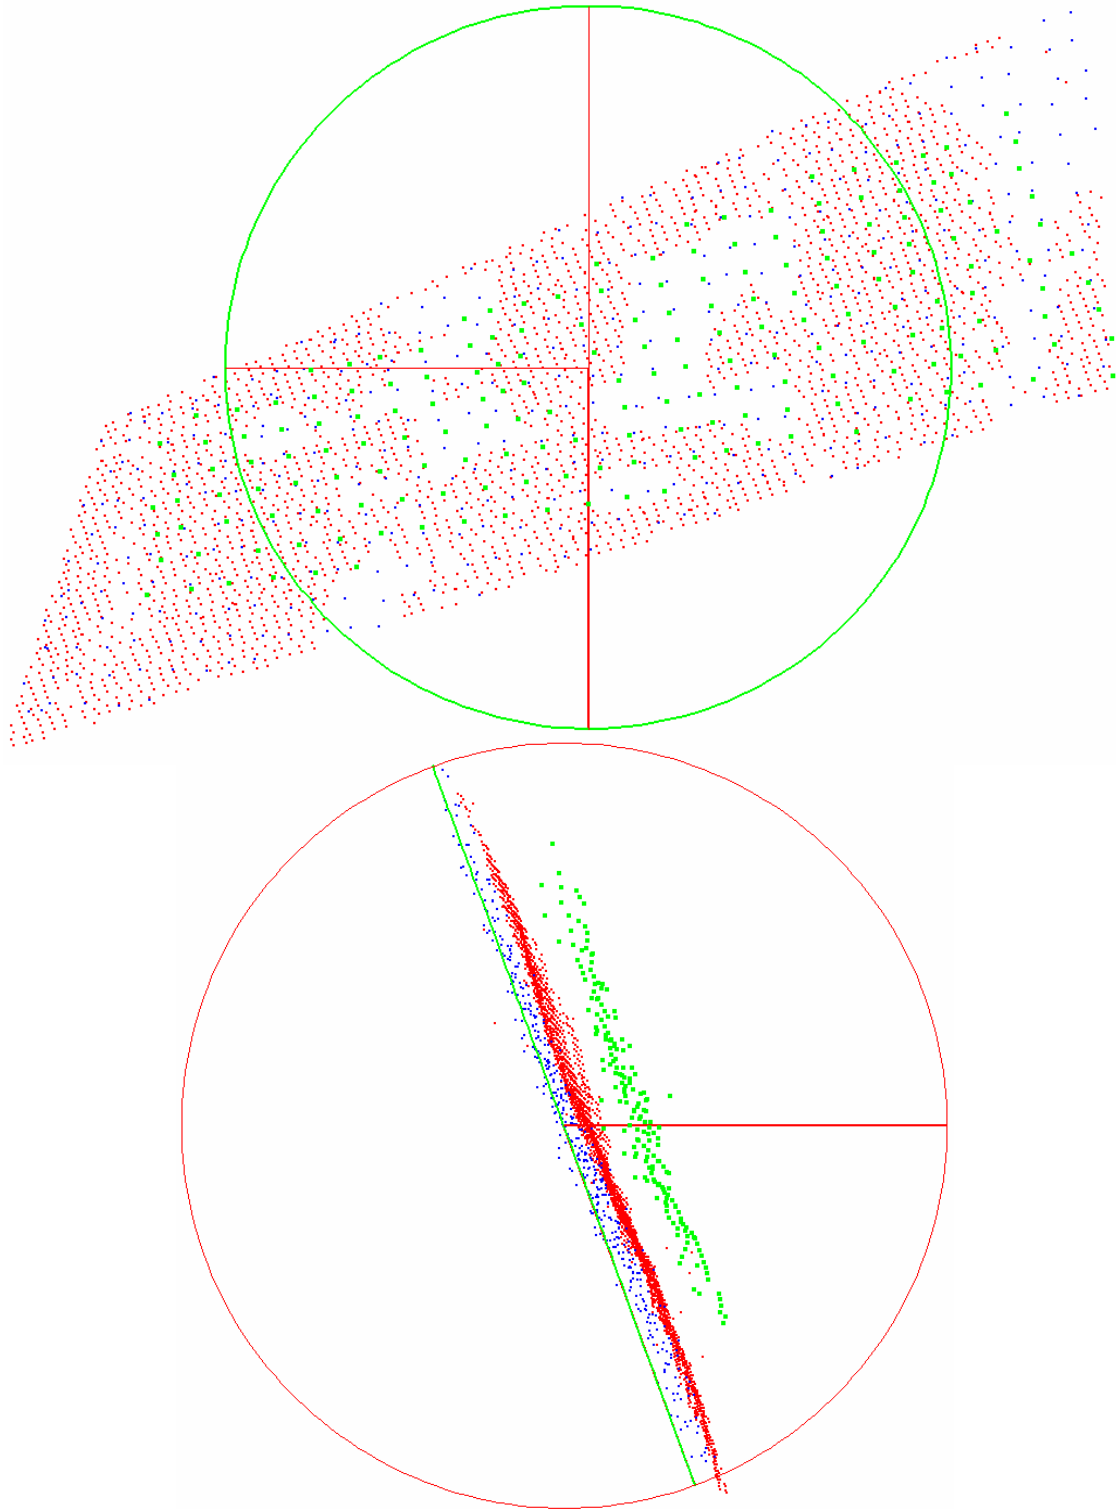
The lower point density can affect the accuracy of the orientation results of the SiroVision joint program.

Figure B10.—SiroVision (green), Foto-G (red), and LIDAR (blue) points for plane D, looking normal (top) to the plane and on edge (bottom).

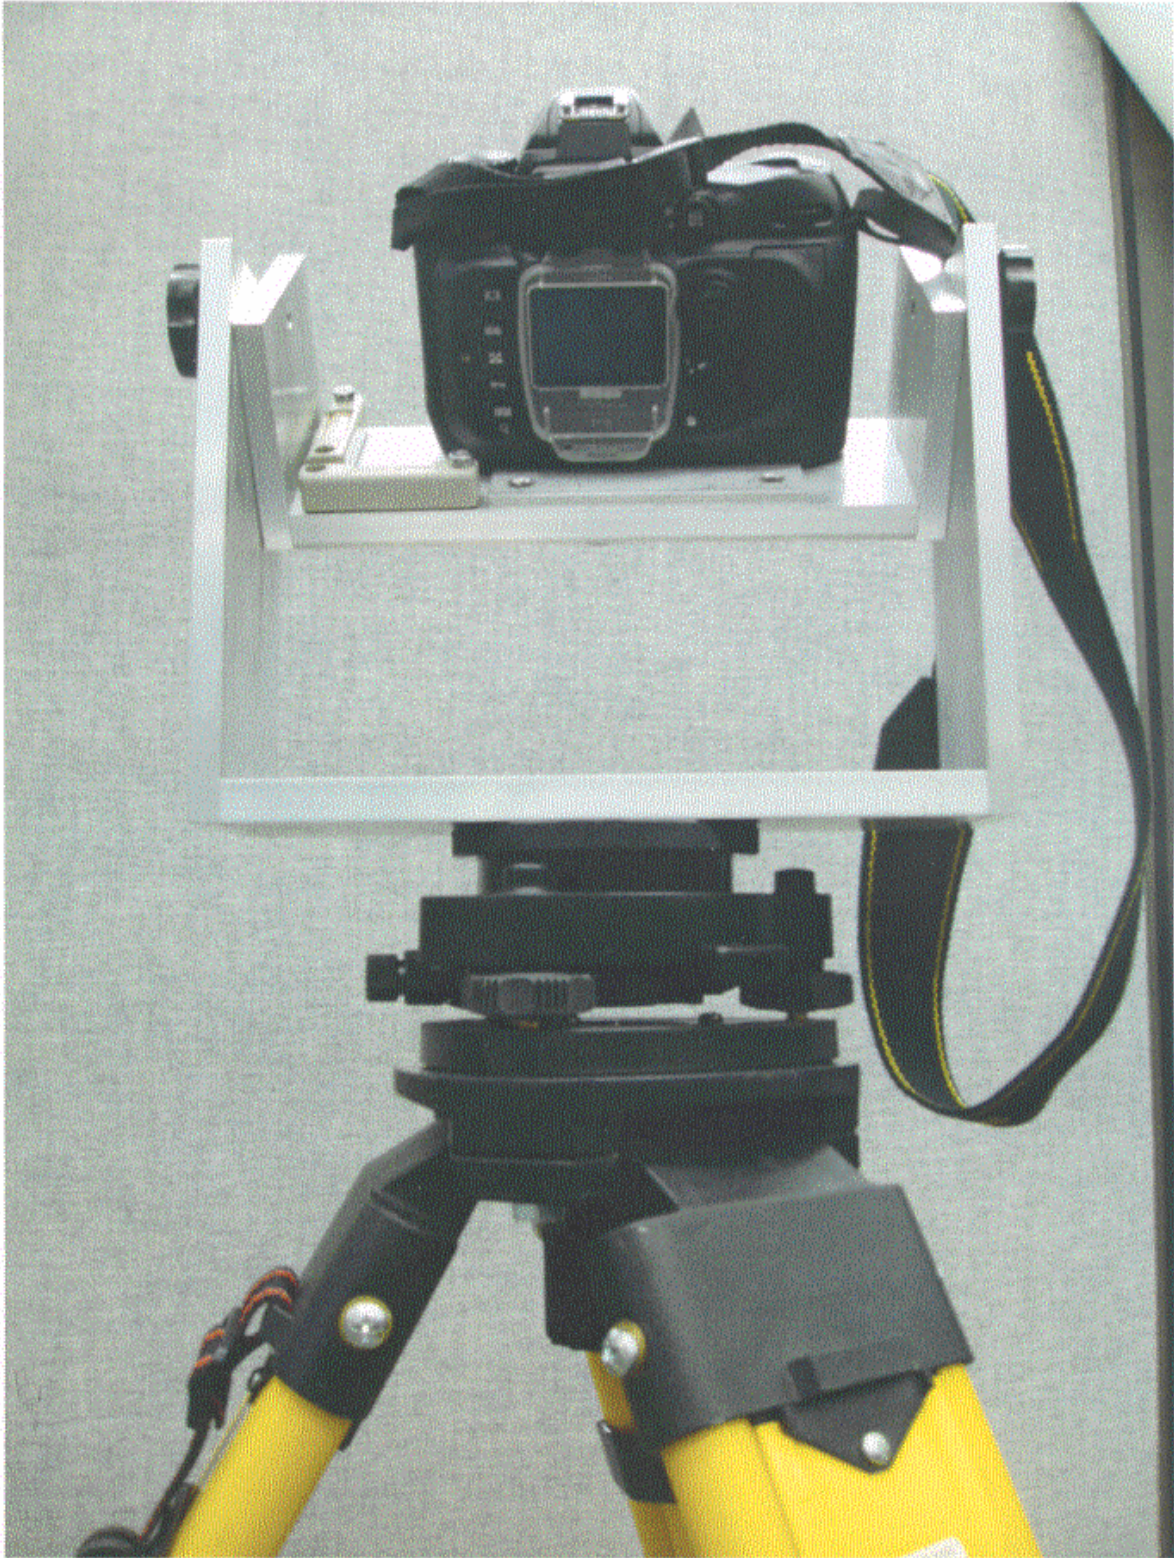
Figure E2.—Complete camera assembly.
