Evaluation of Protective Filter Erosion Boundaries

Dam Safety Office

Report No. DSO-04-03
U.S. Department of the Interior
Bureau of Reclamation
March 2004

By Chris Slaven
Geotechnical Engineering Group 1

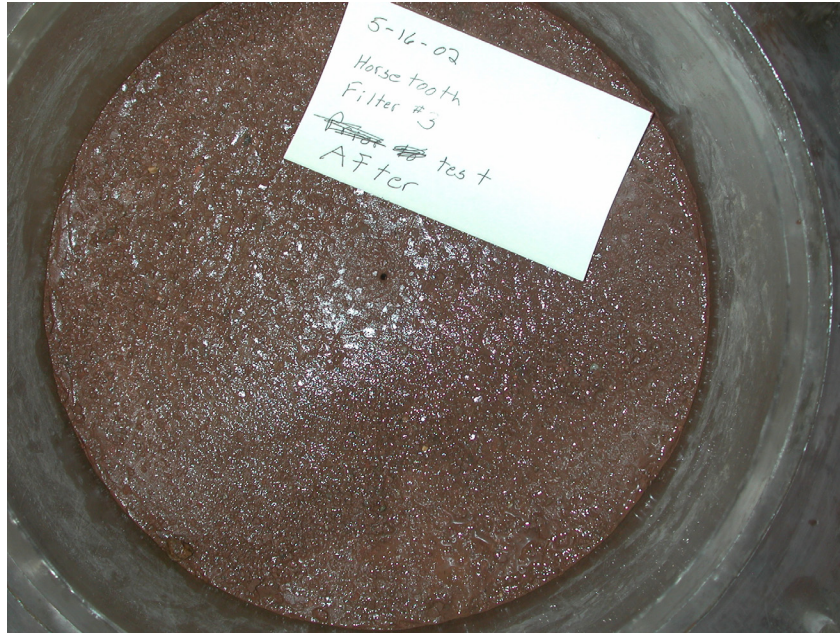
Photo 1 – NEF Test, Horsetooth Material, Filter #3

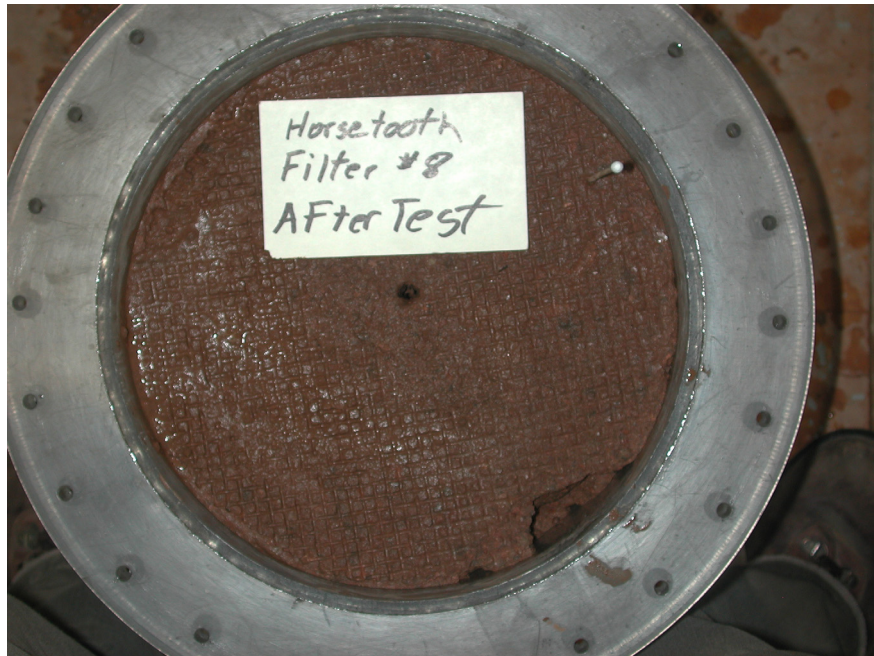
Photo 6 – CEF Test, Horsetooth Material, Filter #8

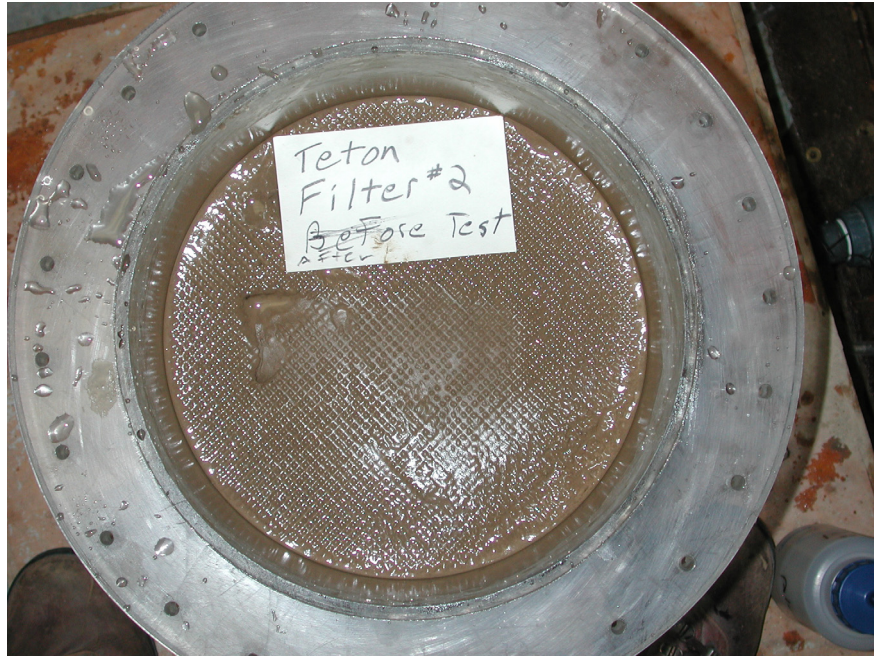
Photo 1 – NEF Test, Teton Material, Filter #2

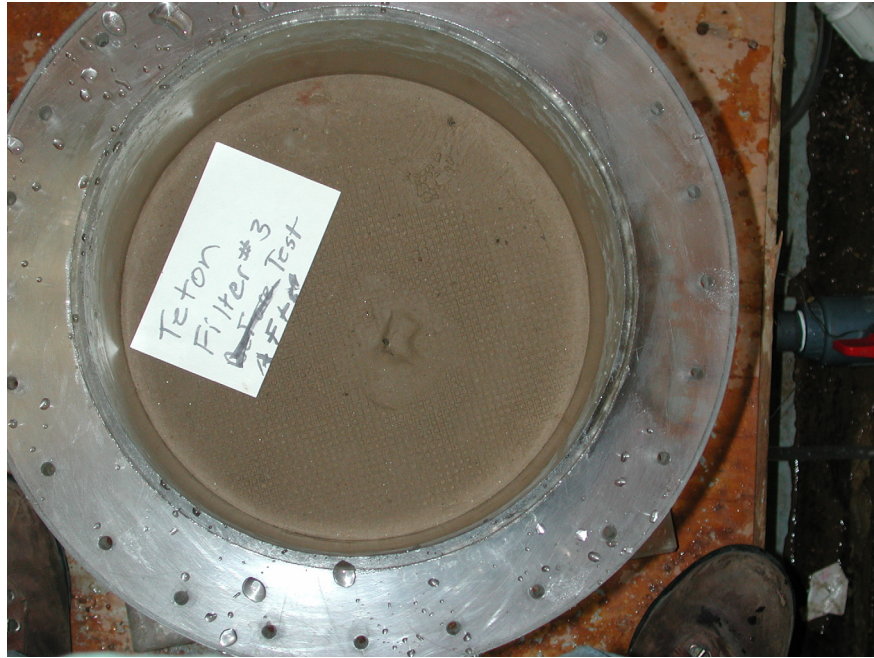
Photo 3 – CEF Test, Teton Material, Filter #4

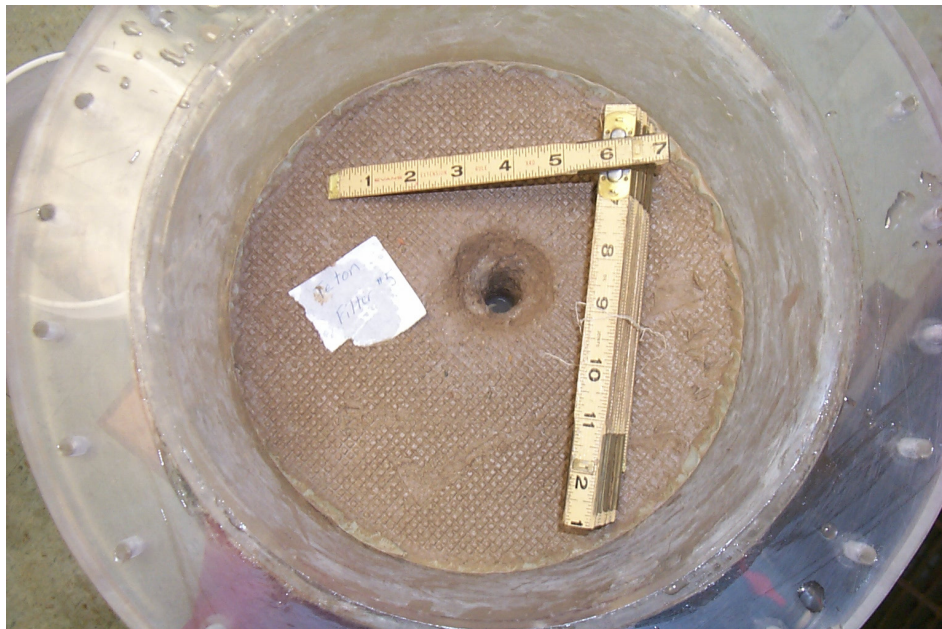
Photo 4 – CEF Test, Teton Material, Filter #5

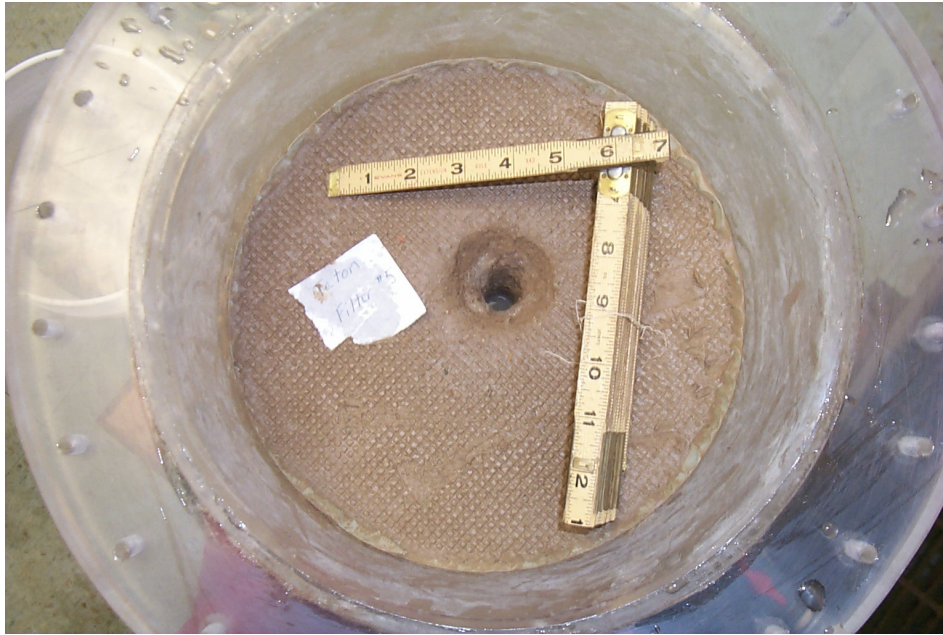
Photo 5 – CEF Test, Teton Material, Filter #6

Once the NEF size (D15F) was determined, progressively coarser filters were used to determine the CEF size. Filters No. 4 through 6 were used for the CEF tests on the Teton material. Testing stopped at filter No. 6. Filter No. 6 was unable to seal the concentrated leak, and large amounts of erosion took place.

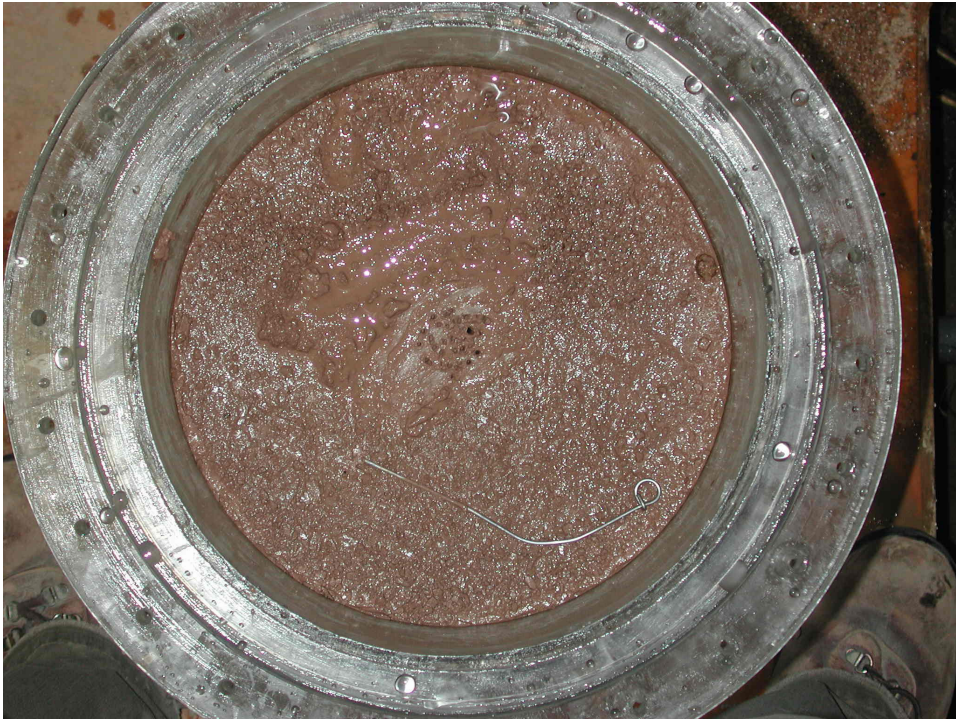
Photo 1 – NEF Test, Tracey Material, Filter #1

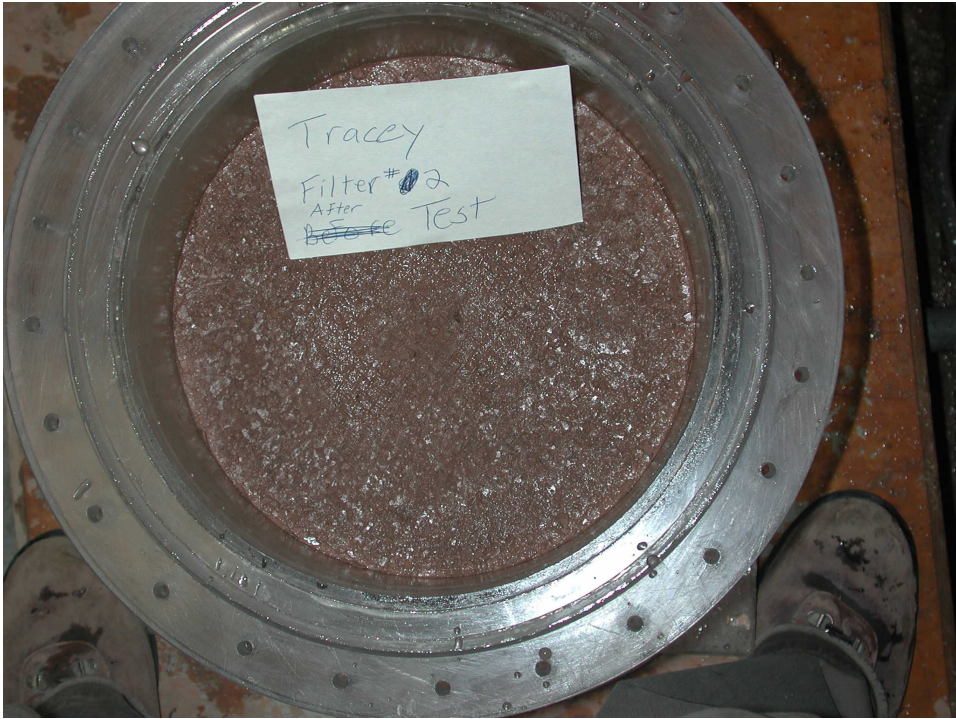
Photo 2 – NEF Test, Tracey Material, Filter #2

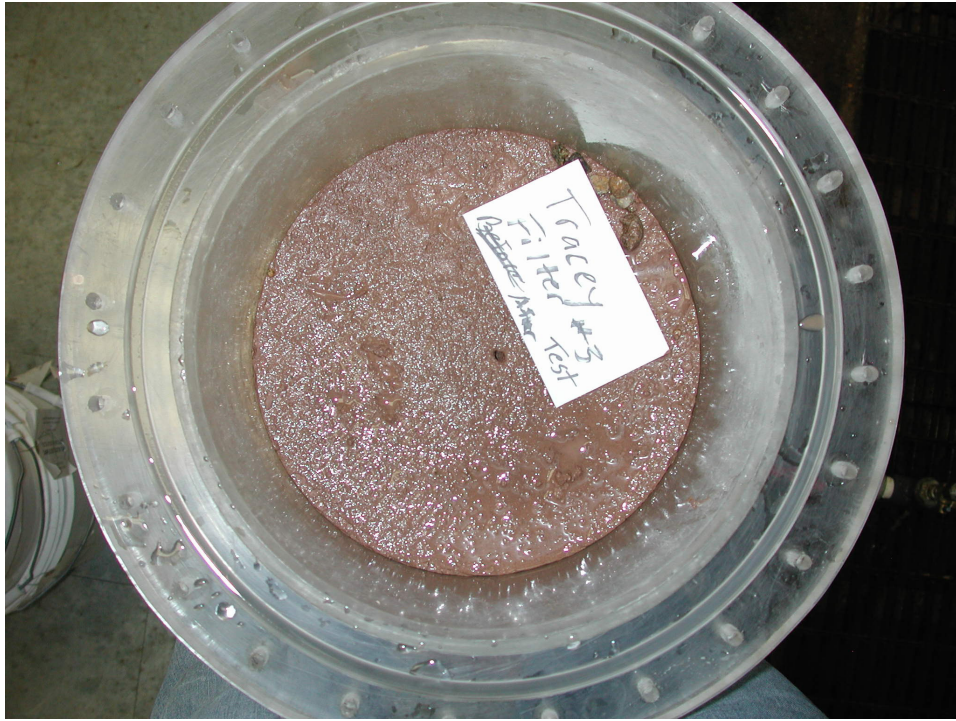
Photo 3 – CEF Test, Tracey Material, Filter #3

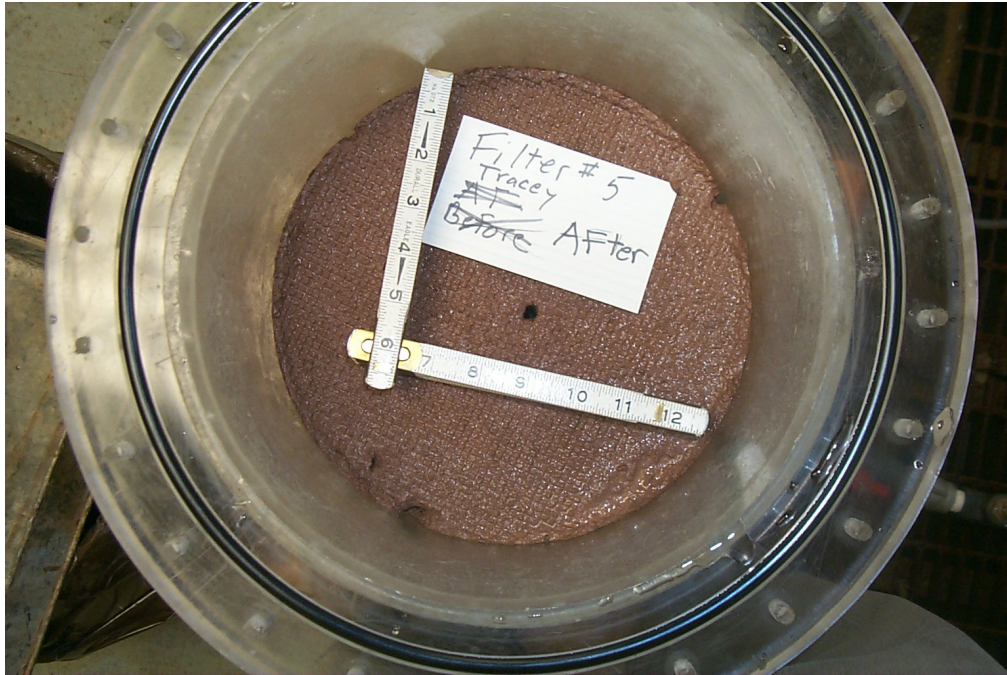
Photo 5 – CEF Test, Tracey Material, Filter #5

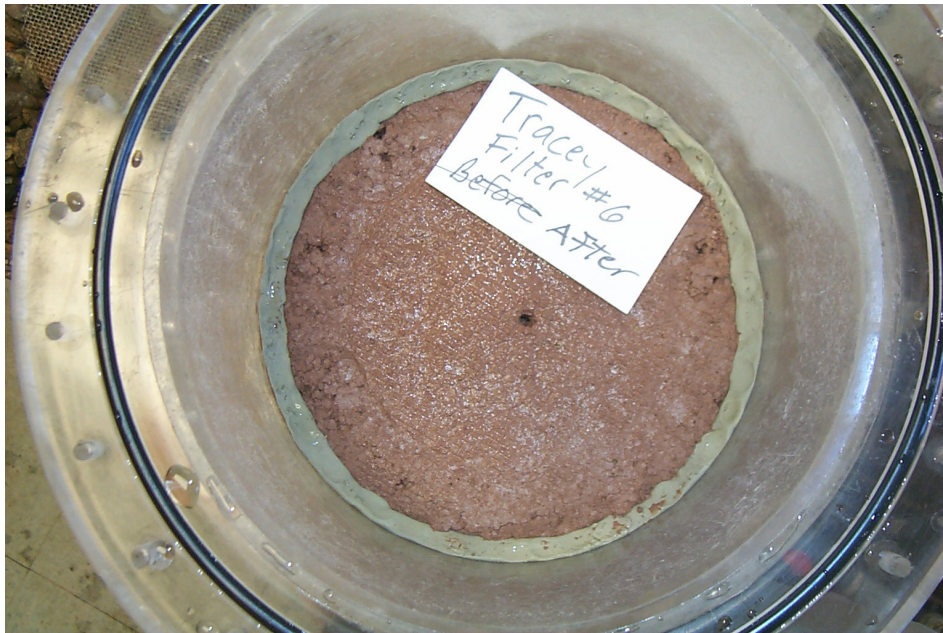
Photo 6 – CEF Test, Tracey Material, Filter #6

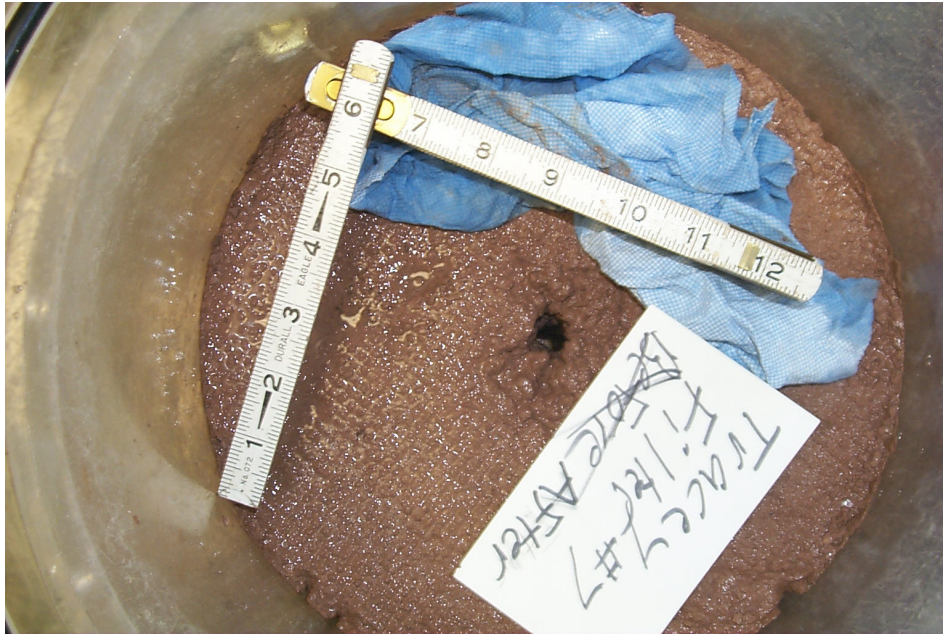
Photo 7 – CEF Test, Tracey Material, Filter #7

Once the NEF size (D15F) was determined, progressively coarser filters were used to determine the CEF size. Filters No. 3 through 7 were used for the CEF tests on the Tracey material. Testing stopped at filter No. 7. Filter No. 7 was unable to seal the concentrated leak, and large amounts of erosion took place.

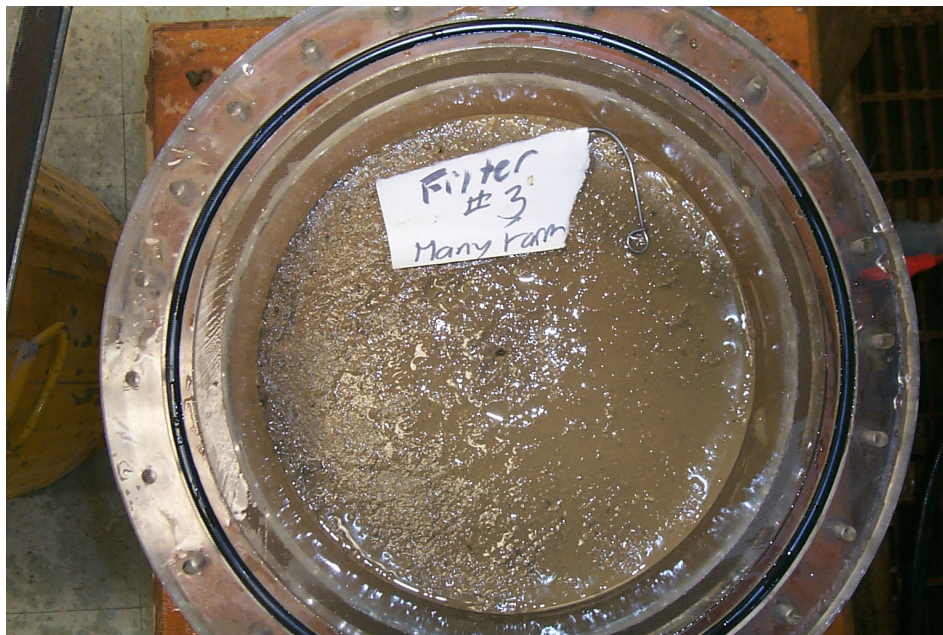
Photo 1 – NEF Test, Many Farms Material, Filter # 3

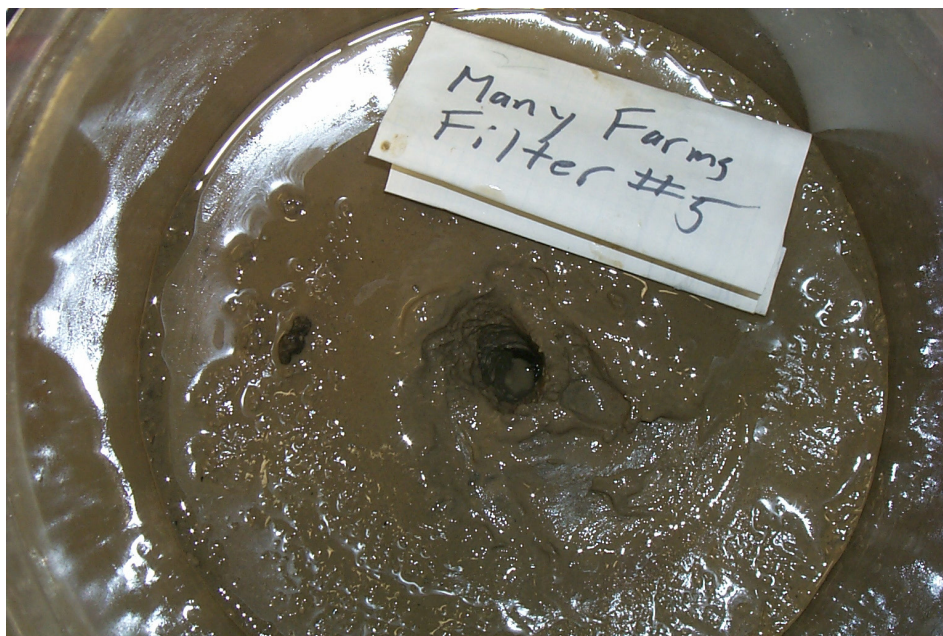
Photo 2 – CEF Test, Many Farms Material, Filter # 5

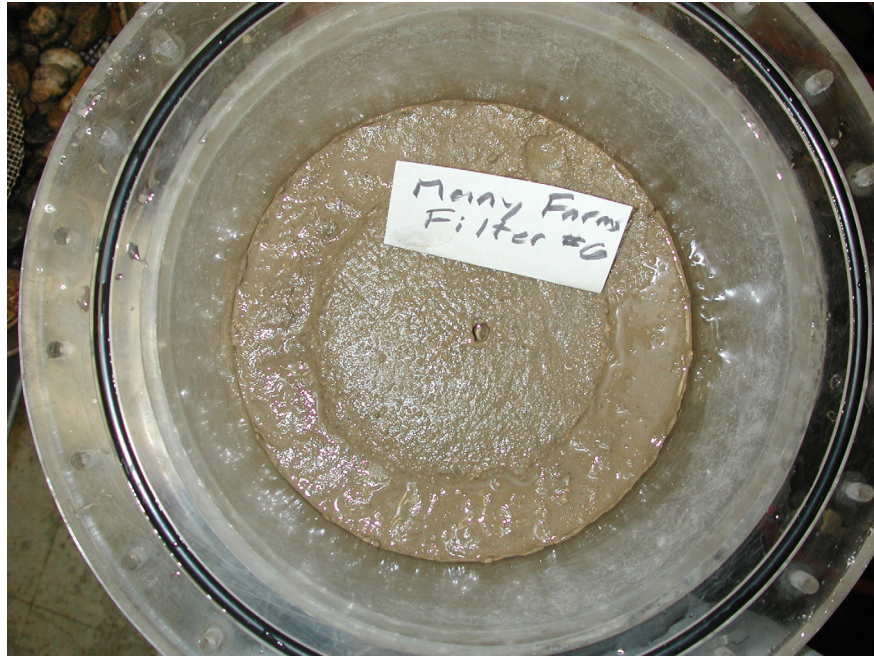
Photo 3 – CEF Test, Many Farms Material, Filter # 6

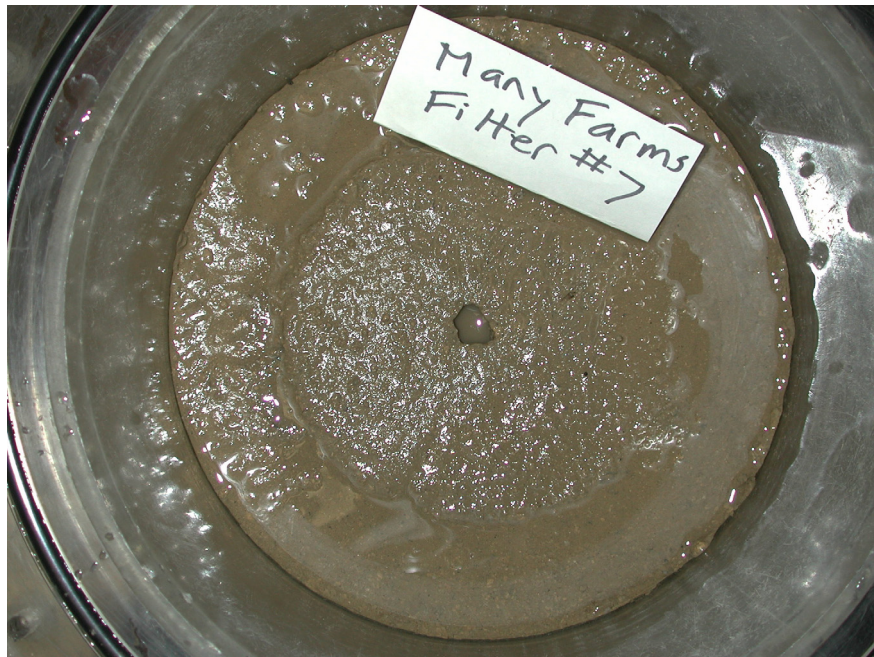
Photo 4 – CEF Test, Many Farms Material, Filter # 7

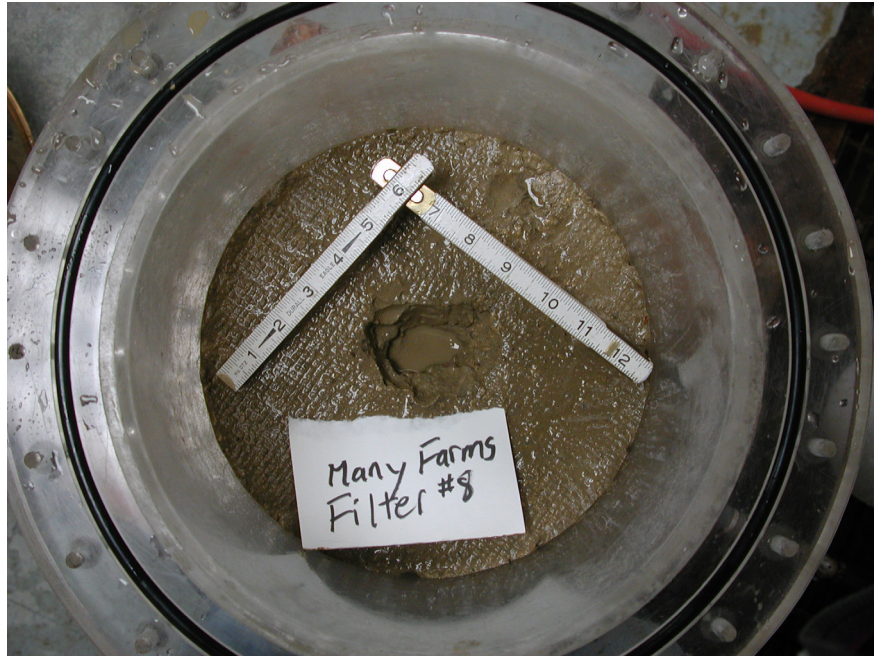
Photo 5 – CEF Test, Many Farms Material, Filter # 8

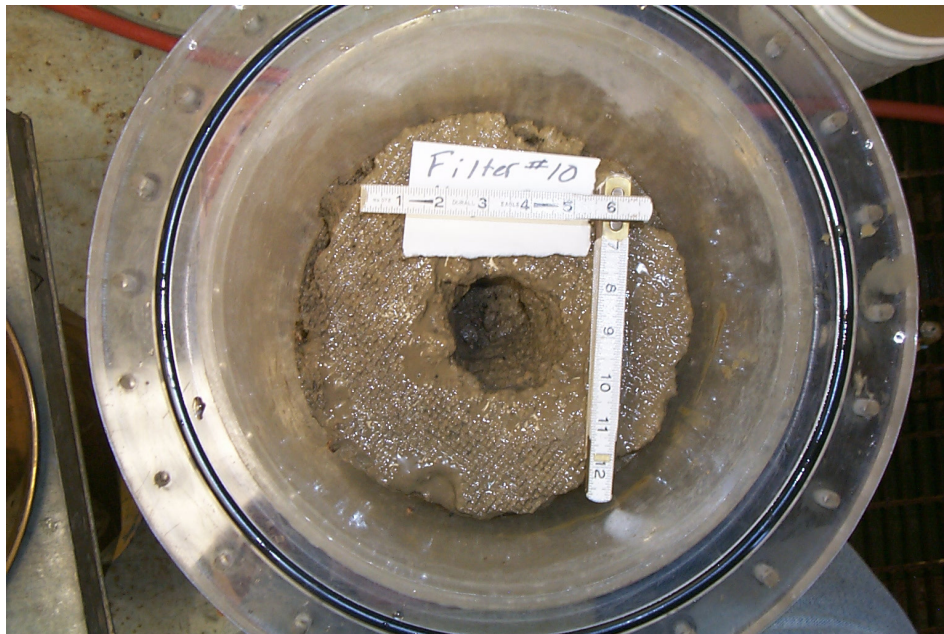
Photo 6 – CEF Test, Many Farms Material, Filter # 10

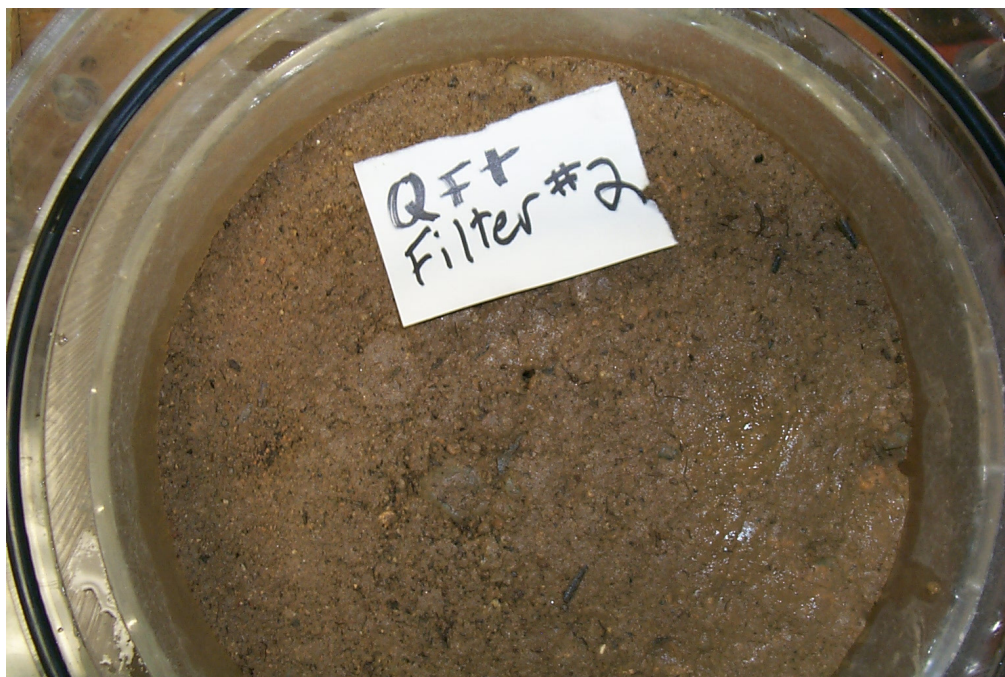
Photo 1 – NEF Test, Keechelus Material, Filter #2

The NEF size (D15F) for the Keechelus material is below Reclamation's soil retention criteria. At the start of the test for Filters No. 2 and 3, a small volume of very fine material passed through the filter. The likely explanation for this behavior is that the Keechelus material is internally unstable. The unadjusted gradation for the Keechelus material plots within Sherard's unstable band [5]. (See figure 21.) It should also be noted that the Keechelus material was still internally unstable after the gradation was adjusted to the No. 4 sieve. The ratio of the coarsest filter sealed in the CEF test to the NEF size was quite large for the Keechelus material. This material is a broadly graded glacial till with 47 percent sand-sized particles. During the series of CEF tests, the self-filtering capability of this material could be observed. The fines within the lower portion of the sample were eroded, leaving the sand and gravel portions left in place. The percentage of fines retained in the base sample typically increased towards the top of the base sample. This behavior can be observed in photos 7 and 8 shown in Appendix 5. Photo 8 in Appendix 5 illustrates the gradation at the bottom of the base material at the end of the CEF test. Photo 7 in Appendix 5 illustrates the gradation at the top of the base material at the end of the same CEF test. The volume of eroded material from the Keechelus samples is not adequately described by the final hole size because of the large amount of fines washed away during the test. The self-filtering capabilities of the Keechelus material provide the likely explanation for the large ratio between the coarsest filter sealed in the CEF test to the NEF size.

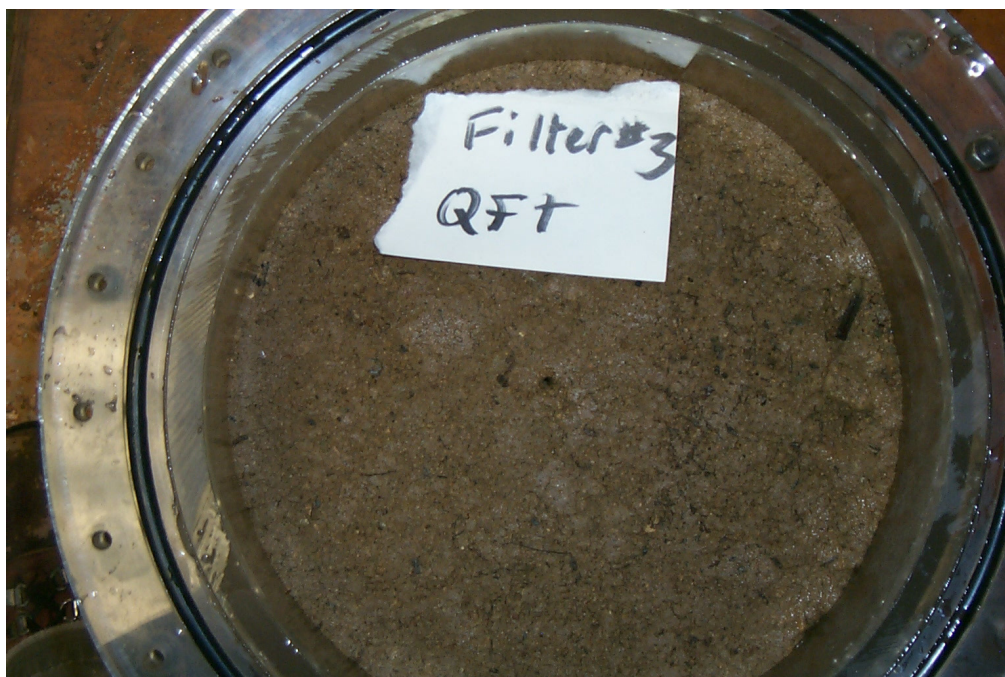
Photo 2 – NEF Test, Keechelus Material, Filter #3

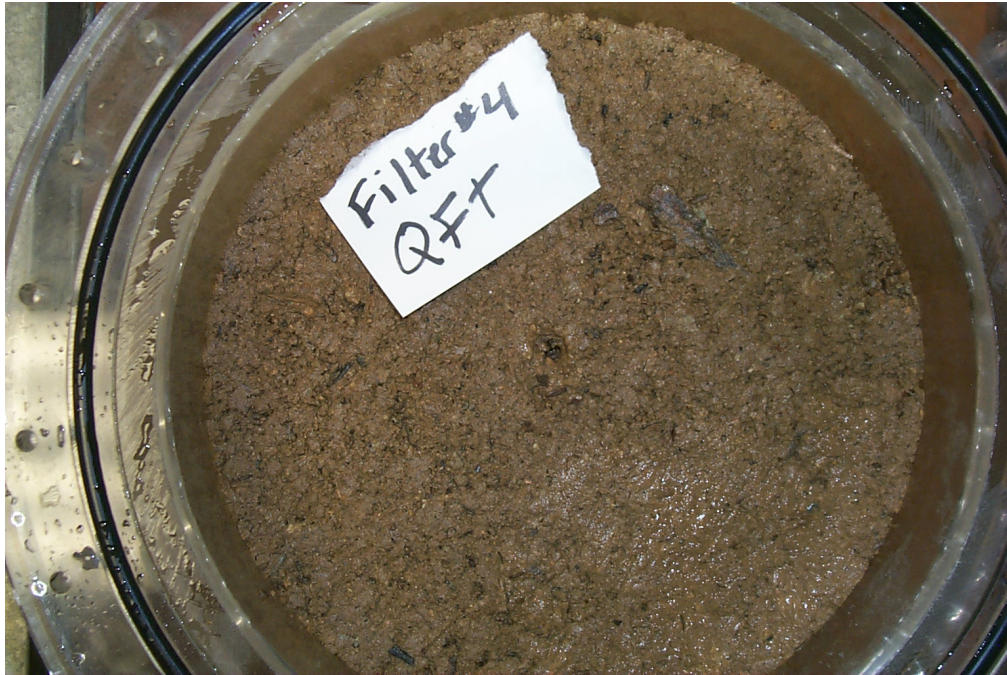
Photo 3 – NEF Test, Keechelus Material, Filter #4

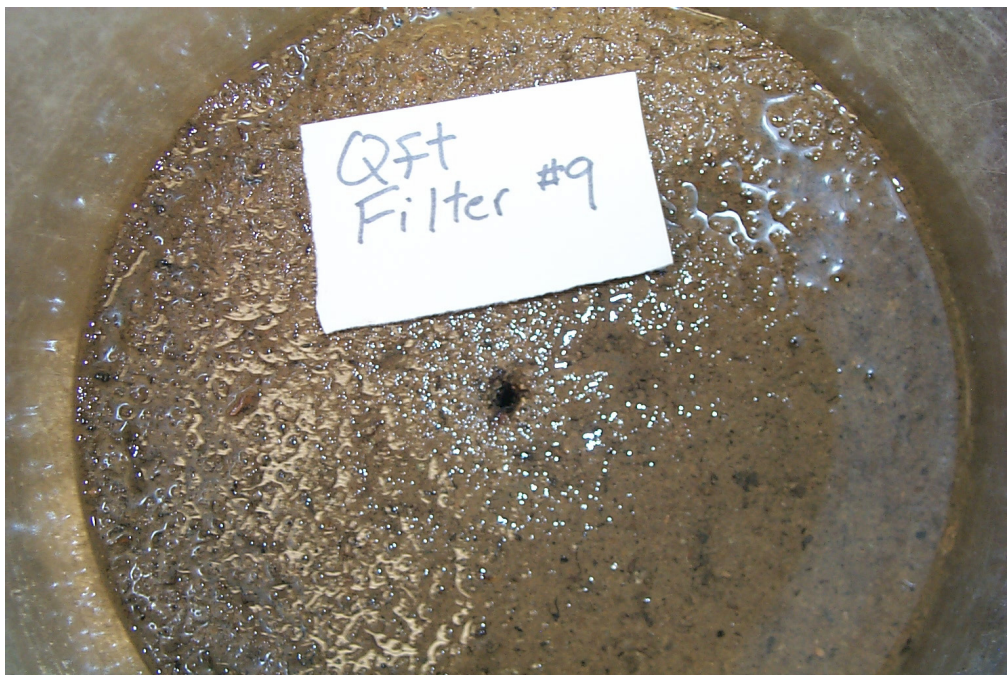
Photo 6 – CEF Test, Keechelus Material, Filter #9

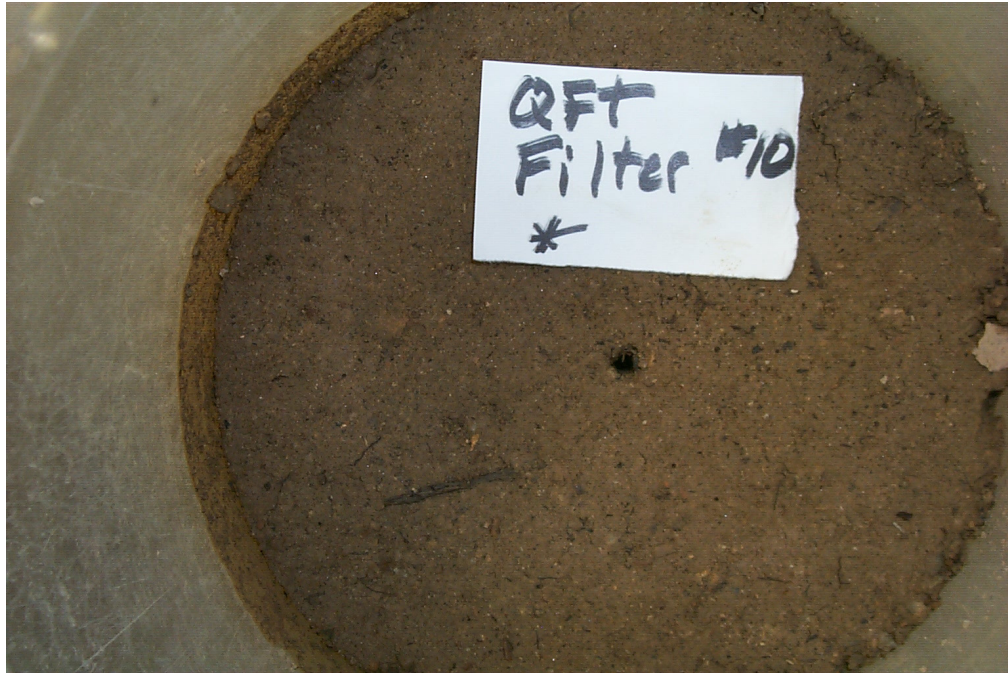
Photo 7 – CEF Test, Keechelus Material, Filter #10 (Top of Base Material)

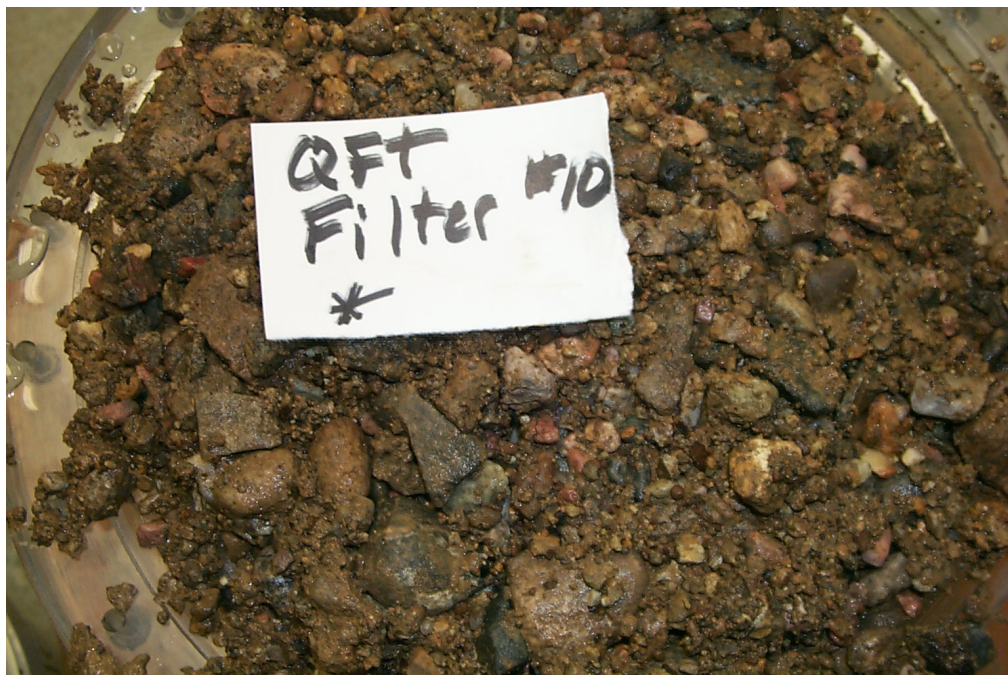
Photo 8 – CEF Test, Keechelus Material, Filter #10 (Bottom of Base Material)

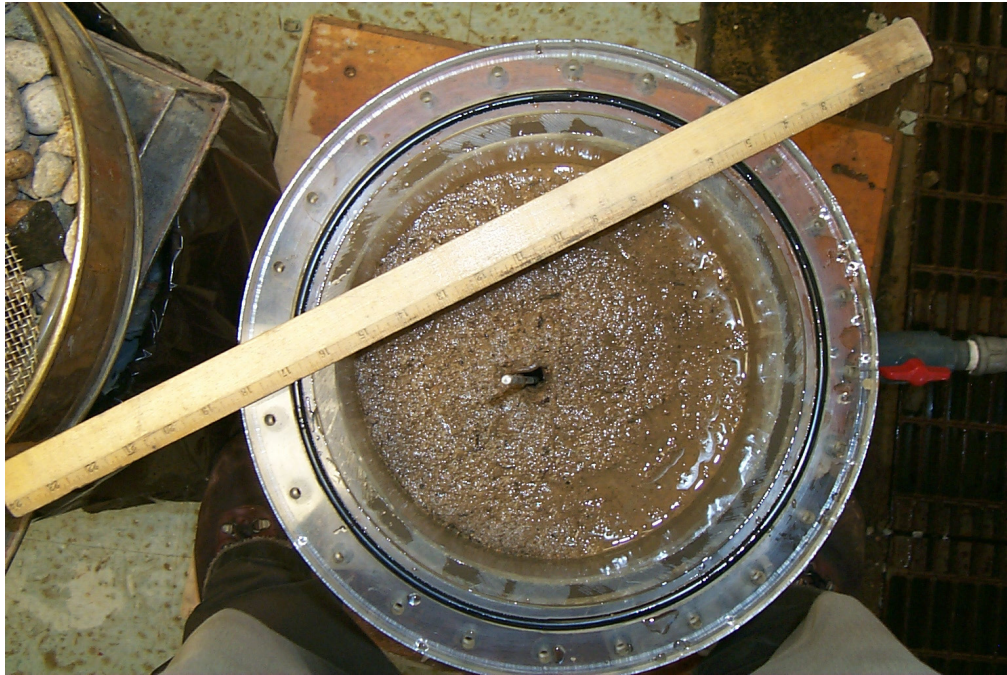
Photo 9 – CEF Test, Keechelus Material, Filter #11

Once the NEF size (D15F) was determined, progressively coarser filters were used to determine the CEF size. Filters No. 5 through 11 were used for the CEF tests on the Keechelus material. Testing stopped at filter No. 11. Filter No. 11 was unable to seal the concentrated leak. The hole through the base increased by approximately 15 mm at the end of the CEF test for filter No. 11. In general, the hole size did not increase significantly for the CEF tests performed on the Keechelus material. During the CEF tests for filters No. 8 through 11, the fines within the material could be seen washing through the filter, leaving the sand and gravel portions retained above the filter. Large amounts of erosion of the finer material did take place for filters No. 10 and 11, but the visible hole size did not increase significantly because the sand and gravel portion did not erode. No settlement was observed as a result of the increase in pore size.
