Report DSO-05-05

Materials Properties Model of Aging Concrete

Dam Safety Technology Development Program

U.S. Department of the Interior
Bureau of Reclamation
Technical Service Center
Denver, Colorado

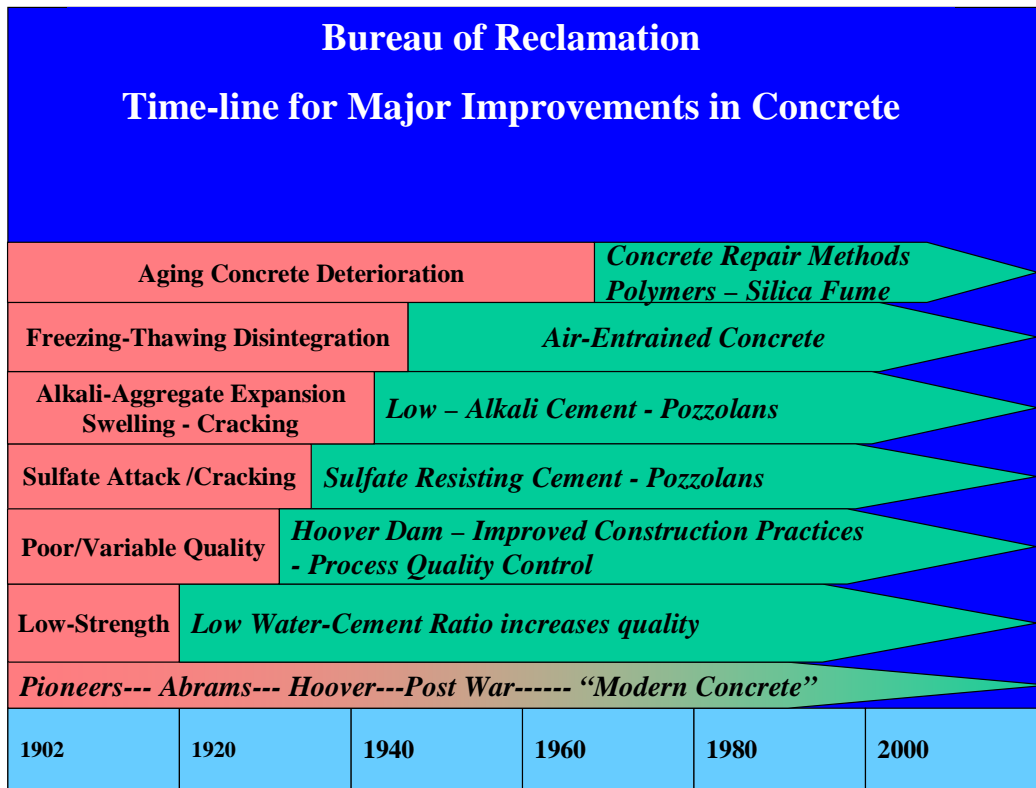
Figure 1.—Timeline for improvements in durable Reclamation concrete.

Reclamation concrete development followed the established trends of the emerging state of the art of concrete technology in the twentieth century. Reclamation concrete is closely aligned with the development of materials properties technology for aggregates and cement, identification of and solutions for deterioration mechanisms caused by the environment and improvements in design and construction practices. These developments are summarized in figure 1. The construction of the early dams raised many questions for both designers and constructors. Concrete materials engineering developed as a means for solving problems at the materials science level. However, these materials science issues were interconnected to improvements in design and construction of major dams. Research in aggregates, cements, and materials properties were spurred on by Abrams in 1918 with his pioneering work in the design of concrete

mixtures and his water-to-cement-ratio “law” (Abrams, 1918). The development of cement chemistry was spurred on in the late 1920s by the need to understand the chemical processes of hydration in order to reduce cracking from thermal heat generation for large dams and in particular Hoover Dam. The design and construction of Hoover and Grand Coulee Dams in the 1930s led to the development of concrete production on a massive scale, including improvements of concrete mixing, transporting, placing, and cooling. Close control of concrete quality led to reductions in the water and cement contents, yielding greater economy and more volumetric stability. The low-heat cements originally developed for Hoover Dam mass concrete also were found to resist deterioration in a sulfate environment. Subsequently, this materials science methodology became the foundation for the investigations in durability of concrete to resist sulfate attack, alkali-aggregate reaction, and freezing and thawing deterioration.

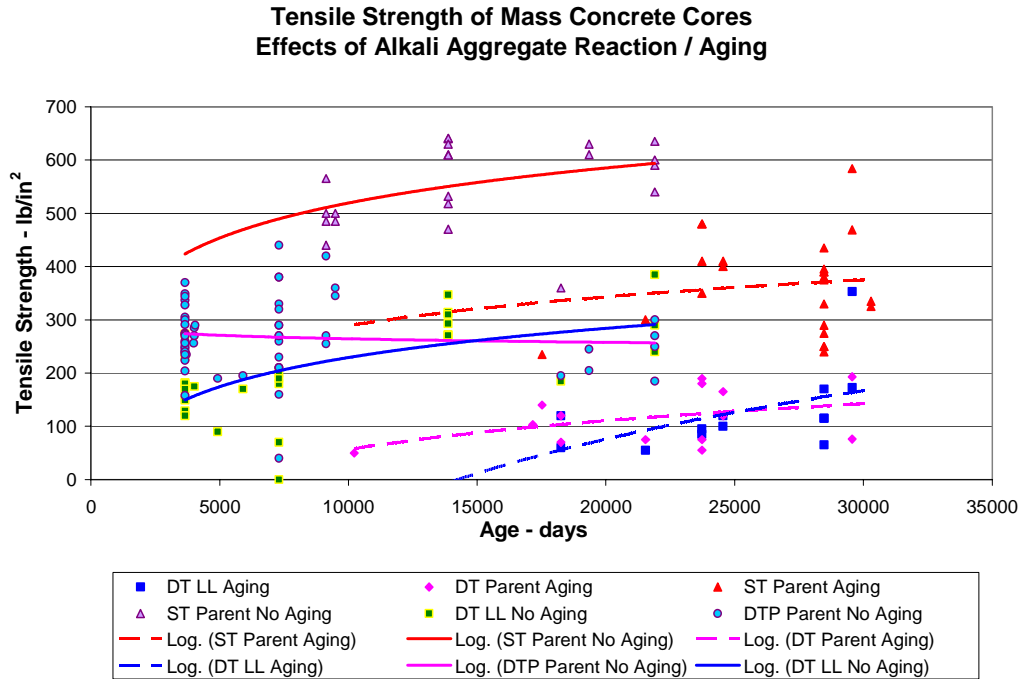
Figure 5.—Comparison of the effects of aging and ASR on tensile strength of mass concrete dams.

Tensile strength is becoming more critical in the structural analysis of concrete dams, particularly for dynamic analysis due to earthquakes. Tensile strength tests were normally not performed until the 1970s, and the tensile strength development for dams constructed prior to this era is unknown. The results of direct and splitting tensile strength of good quality concrete and aging/ASR-affected concrete and are shown in table 3 and figure 5. The tensile strength data are entered in the database as average values for normally only a few tests for each mixture. The aging data also include some tests of old dams not subject to ASR. However, it is clear that the tensile strength of aging/ASR-affected dams averages about 50 percent of the direct tensile strength and 30 percent less in splitting tensile strength compared to dams without ASR degradation or aging. Also, the aging concrete data are often based only on “testable” concrete and do not represent the condition of the deteriorated concrete that could not be tested. Lift line ratios may not be directly comparable since the aging dams often have more disbanded lift lines. This input parameter is being added to more recent test programs and is a factor for some older and newer dams. Shear bond properties are not shown for this data set and have not yet been analyzed due to insufficient records.

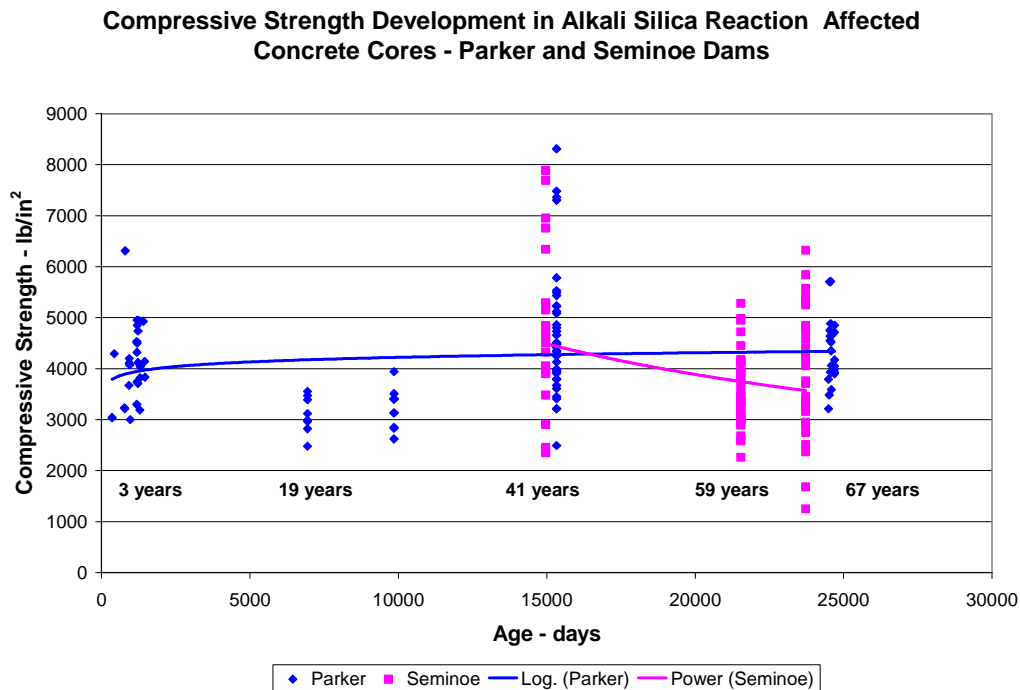
Figure 8.—Compressive strength trends for mass concrete cores at Parker and Seminole Dams.

The compressive strength trends in figure 8 from the two ASR-affected dams show a relatively constant state for Parker Dam and a decreasing strength trend with Seminole Dam. Some of the data scatter is due to the overall sampling not sorted by elevation and includes tests of concrete not significantly affected by ASR either due to the cement alkali content of individual block placements or location in the dam. When sorted by elevation, the rate of change can also be observed for the two dams as shown in figures 9 and 10. The compressive strength trends do not show an overall change with time for Parker Dam, even though some spatial trends may be present. For Seminole Dam, it is readily apparent that the overall compressive strength is decreasing over time and that the compressive strength has significant spatial deterioration near the top of the dam as shown in figure 10. The deterioration is extending more deeply into the dam over time. The modulus of elasticity also shows the same trends as shown in figure 12. If ASR is suspected in dams, the compressive strength to modulus of elasticity ratios and spatial orientation may provide the best supporting documentation for CFR evaluation purposes.

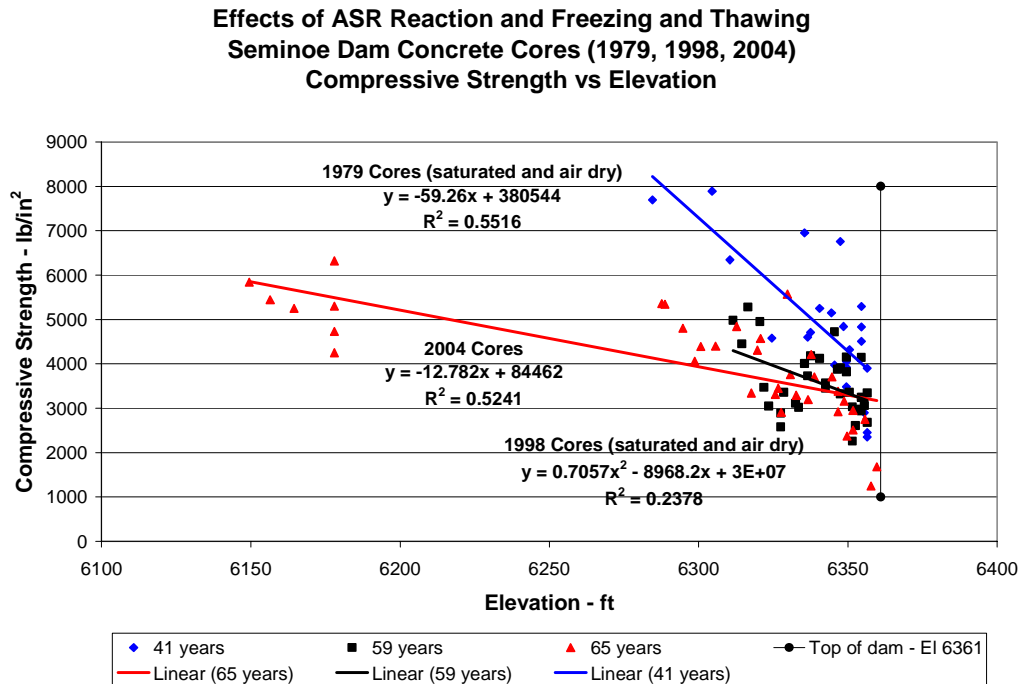
Figure 10.—Compressive strength trends of mass concrete at Seminole Dam, Wyoming, sorted by elevation showing changes in strength over time.

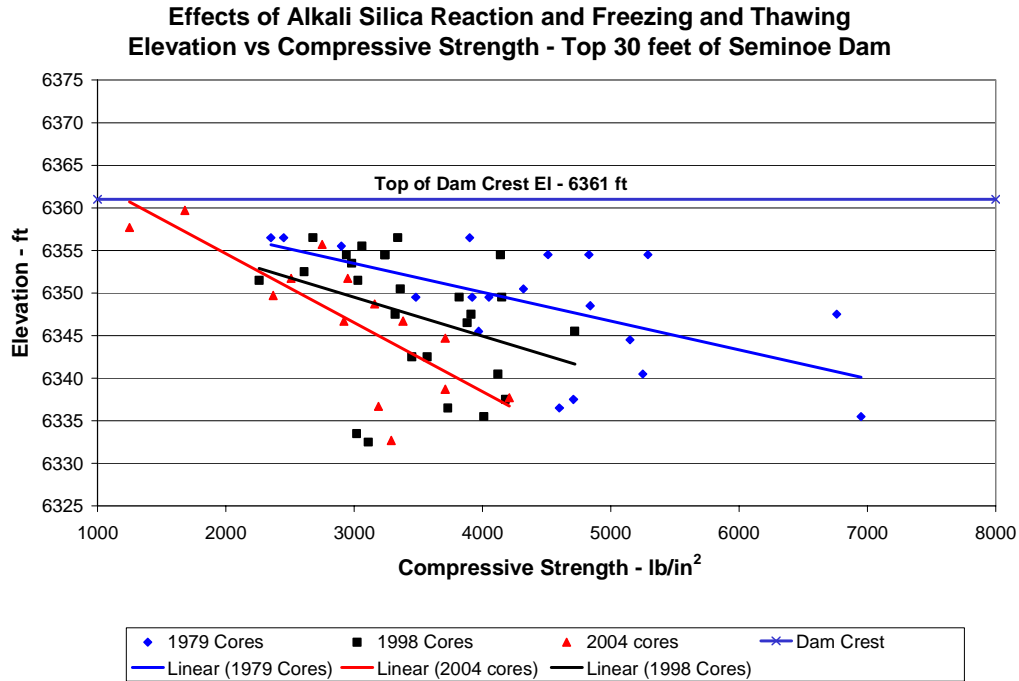
Figure 11.—Compressive strength development in mass concrete at the top of Seminoe Dam, Wyoming, sorted by elevation showing decreasing strength over time.

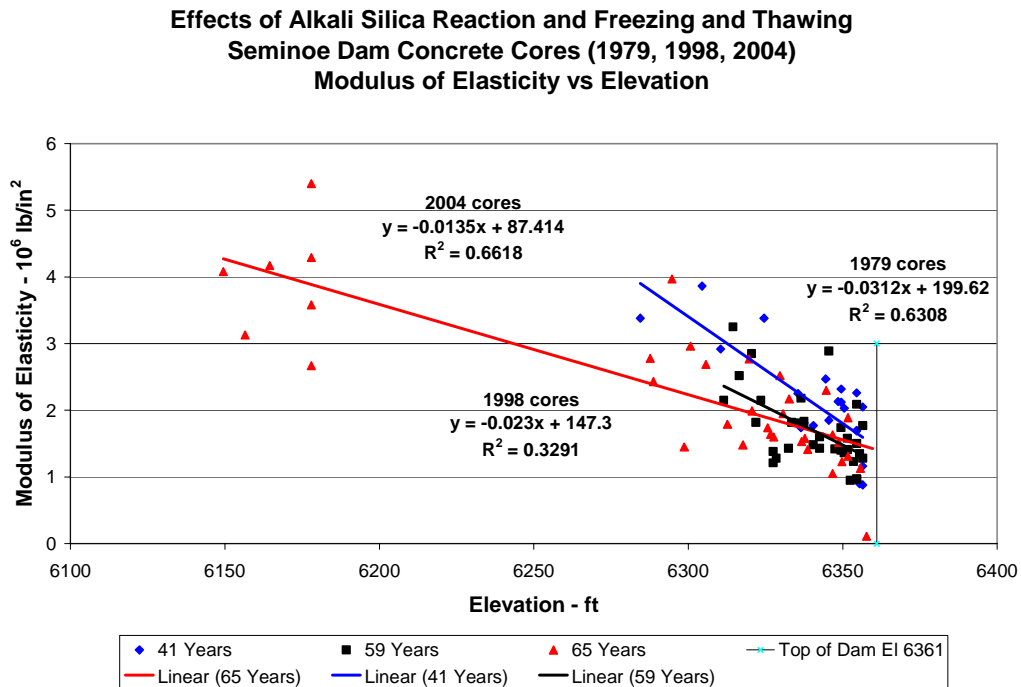
Figure 12.—Modulus of elasticity in compression trends of mass concrete at Seminoe Dam, Wyoming, sorted by elevation showing changes in modulus over time.
