Report DSO-12-01

Development of a Test to Determine Cementation Potential of Embankment Dam Granular Filter Material – Results of Phase III Research

Dam Safety Technology Development Program

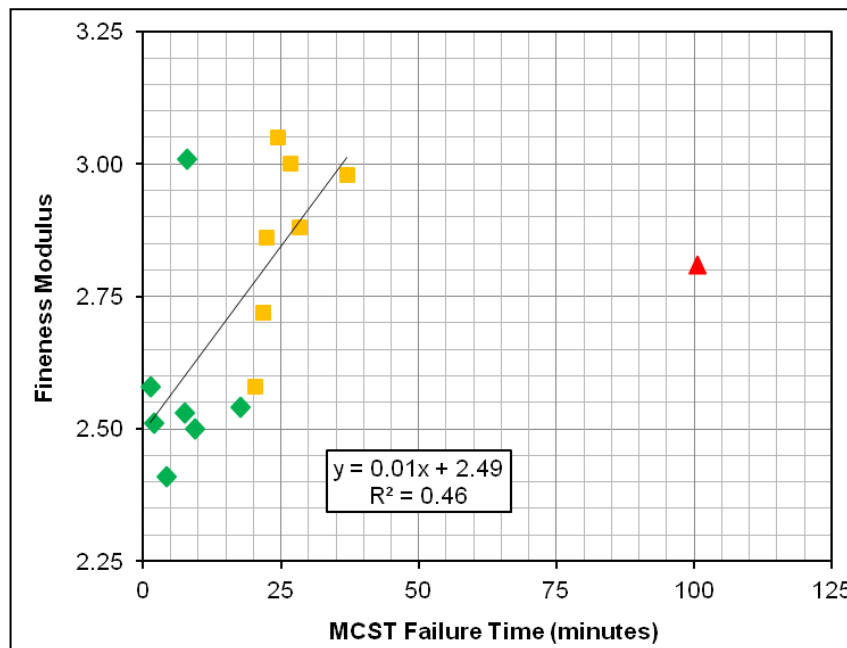
Figure 5.—Relationship between MSCT failure time and fineness modulus, FM. (Note: Best fine line exclusive of Class V and VI materials.)

Figure 4 illustrates that an increase in C_u corresponds to an increase in cementation potential (i.e., MSCT failure time). Similarly, figure 5 shows the same trend exists for FM versus cementation potential. C_u and FM are simple characteristics describing the shape of the grain size distribution curve, and this trend is likely explained as a manifestation of grain size distribution: materials with higher values of C_u or FM are more well graded, which leads to more grain to grain contacts, which leads to stronger overall cementation. This trend is more pronounced for Classes I – IV. Classes V and VI are only represented by a single material, and the physical properties do not necessarily reflect what would be typical for the class. For this reason, the best-fit lines shown on figures 4 and 5 do not take Class V and VI materials into account.

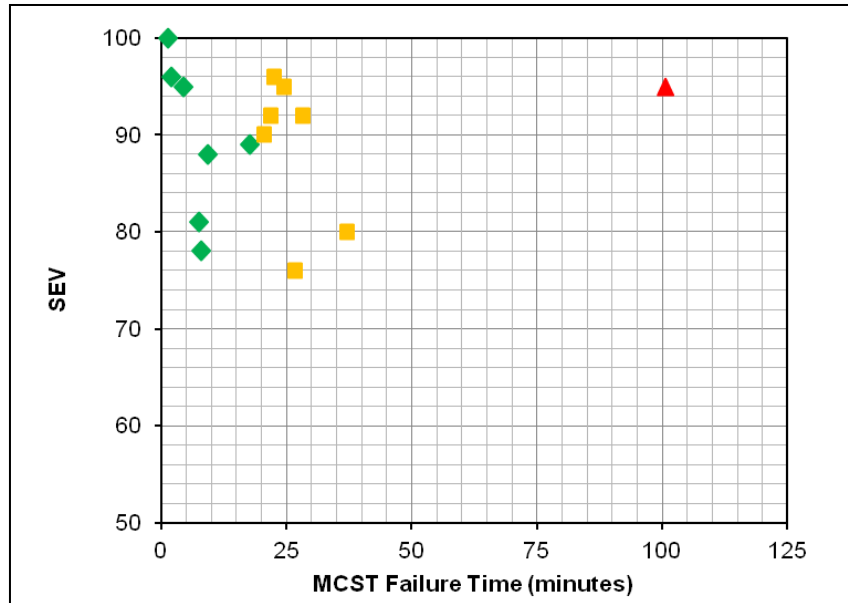
Figure 6.—Relationship between MSCT failure time and Sand Equivalency Value, SEV.

As shown on figure 6, decreasing SEV generally leads to increased failure time for Classes I – IV, although this correlation is poor. The premise that granular filter materials can be evaluated based on SEV alone is not supported by the results presented here. Specifying a minimum value of SEV alone is likely not sufficient to screen out potentially cementitious filter sands.

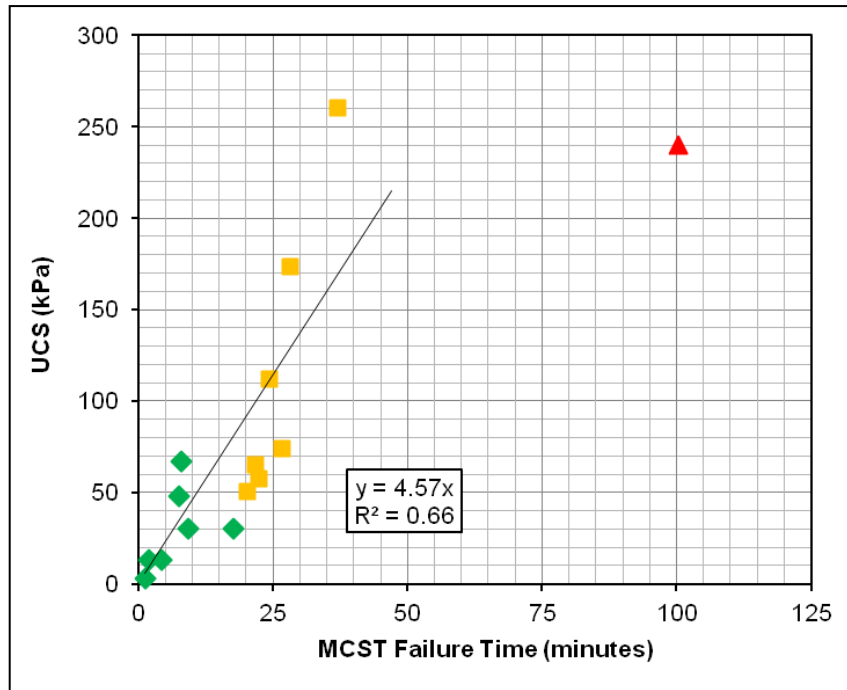
Figure 7.—Relationship between MSCT failure time and UCS.
(Note: Best fine line exclusive of Class V and VI materials.)

As shown on figure 7, a good correlation exists between strength gain due to cementation as gauged by UCS and cementation potential. The specimens used for UCS testing were prepared in the same manner as those for MSCT testing (see section 2.1), although a special split mold, 7.6 cm (3 in) in diameter by 17.1 cm (6.75 in) high (length:diameter ratio = 2.25), was used. The specimens were compacted in a saturated condition in three lifts using the vibratory hammer and an appropriately sized tamping foot. The vibration time per lift was varied from that specified in ASTM D7382 in order to achieve a similar level of compaction (density) in the smaller mold as achieved by following ASTM D7382 in the modified Proctor mold. A vibration time of 15 seconds per lift was found to produce good agreement. After compaction, the UCS specimens were dried to constant mass in a 50 °C (120 °F) oven. UCS was determined in accordance with ASTM D1633 and D2166.

It is important to observe that the recycled concrete does not follow the trend for UCS versus MSCT failure time. Even though the recycled concrete is classified as a Class VI material and did not collapse after being submerged for 24 hours, it exhibited very minimal strength gain according to the UCS Test. This observation provides justification for using multiple test methods, rather than relying on a

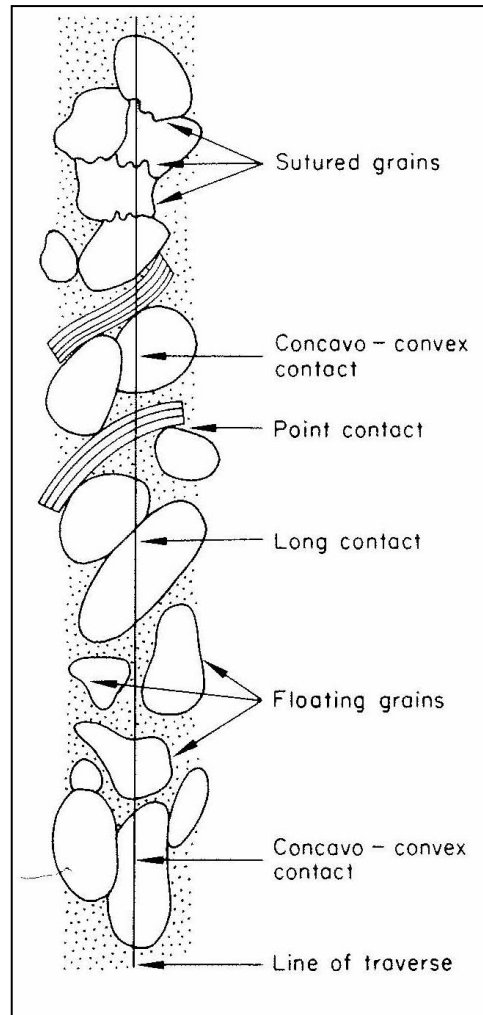
Figure 8.—Illustration of grain-to-grain contact types (illustration from Pettijohn, Potter, and Siever, 1972, *Sand and Sandstone*). Note that the bent and wavy particles represent mica and are shown for illustration only.

The thin sections represent an unoriented, two-dimensional slice of the specimen. Grain-to-grain relations may be referred to as concavo-convex contact, long contact, and/or point contact (figure 8). Any grains that appear suspended in the epoxy matrix (floating grains) are likely in grain-to-grain contact above or below the plane of the thin section.

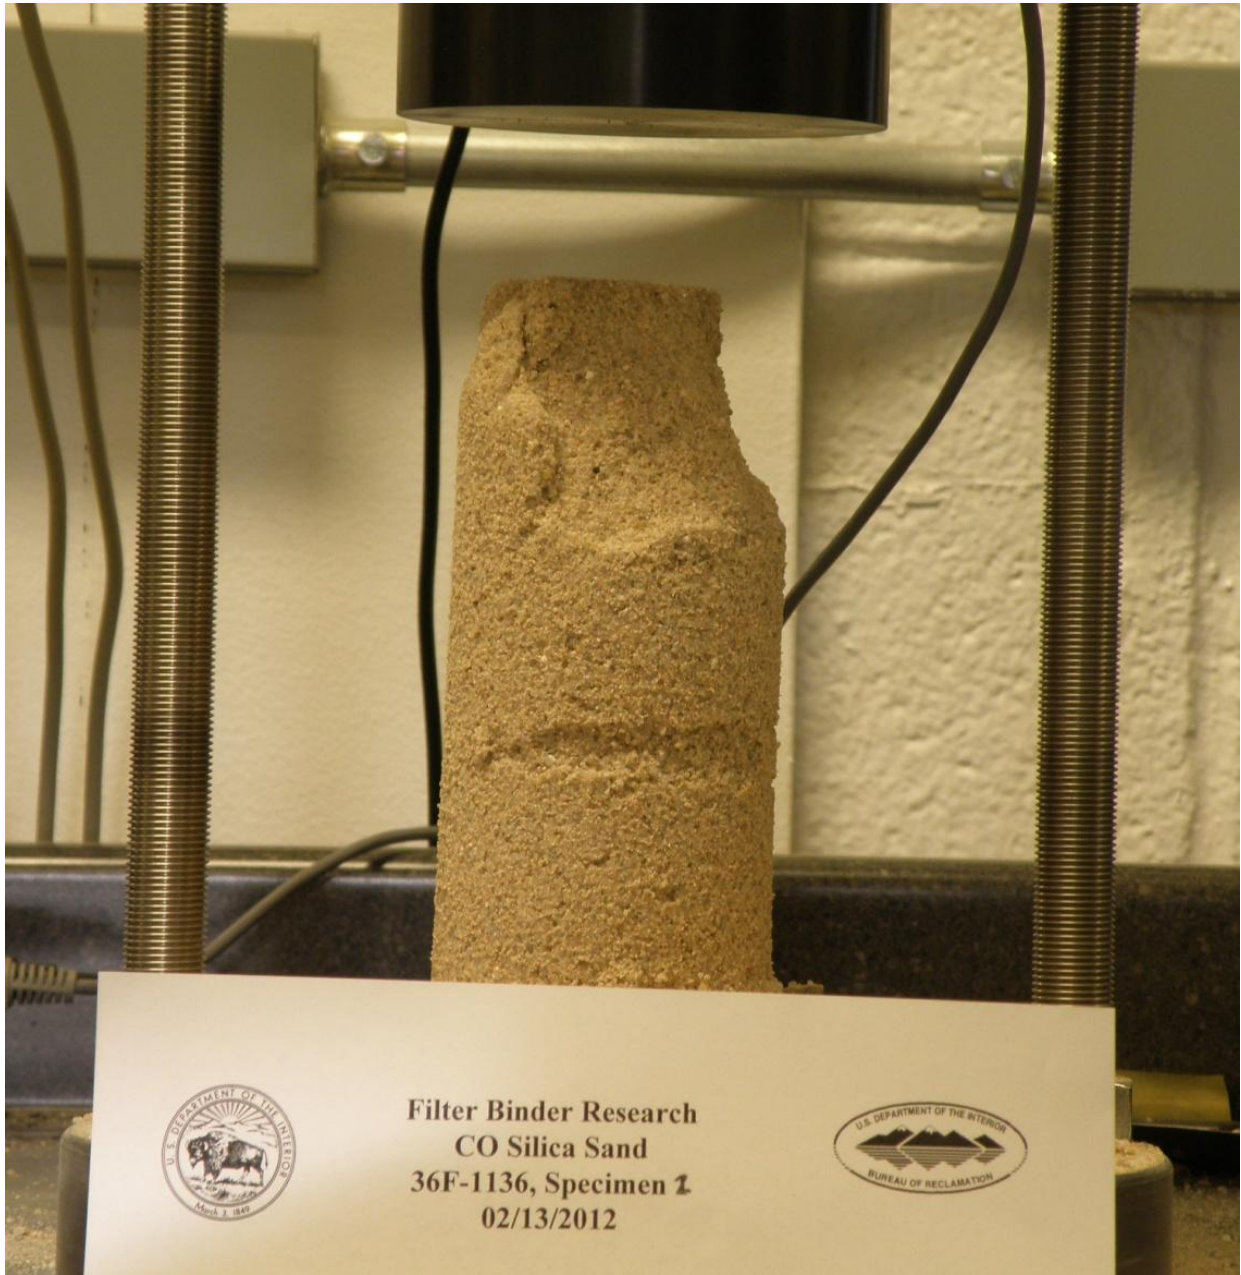
Figure A-4.—Sample showing failure plain after UCS Test.

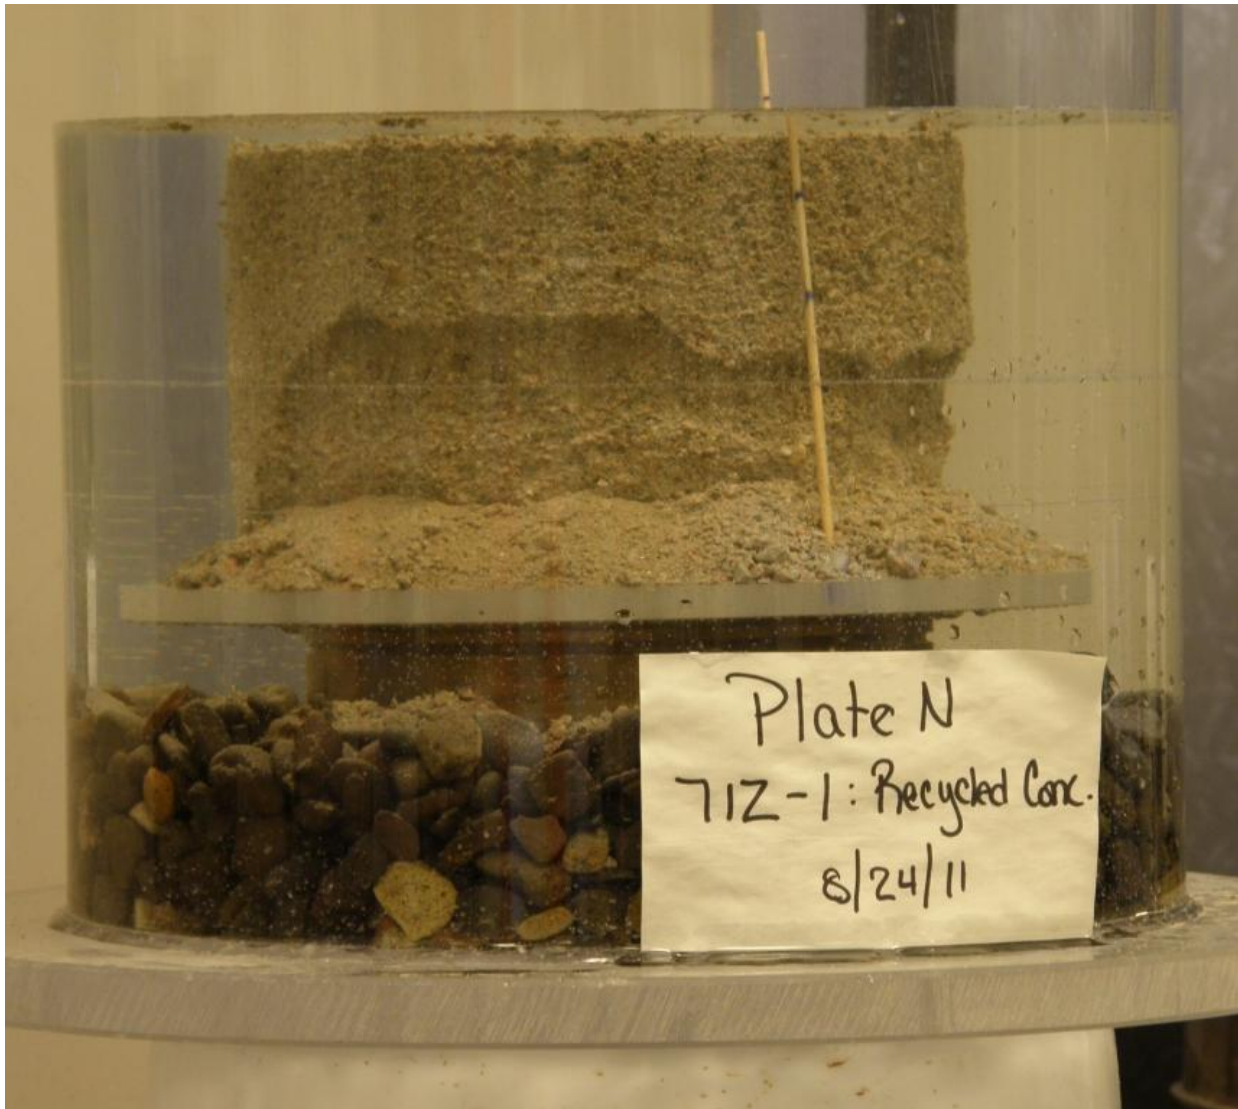
Figure A-31.—Specimen shown completely submerged for over 24 hours. Specimen did not fail during Sand Castle Test.

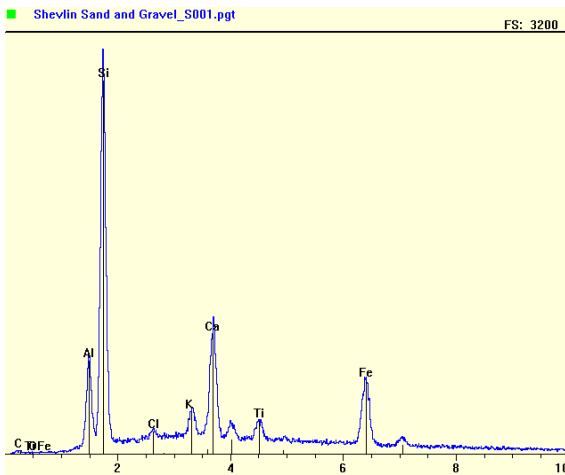
Figure 26. Energy Dispersive X-ray analysis indicates gap filling material in figure 24 (arrow) is likely rock and mineral particles and mineral residue from Denver tap water. The graph shows intensity on the vertical axis and the x-ray energy on the horizontal axis.

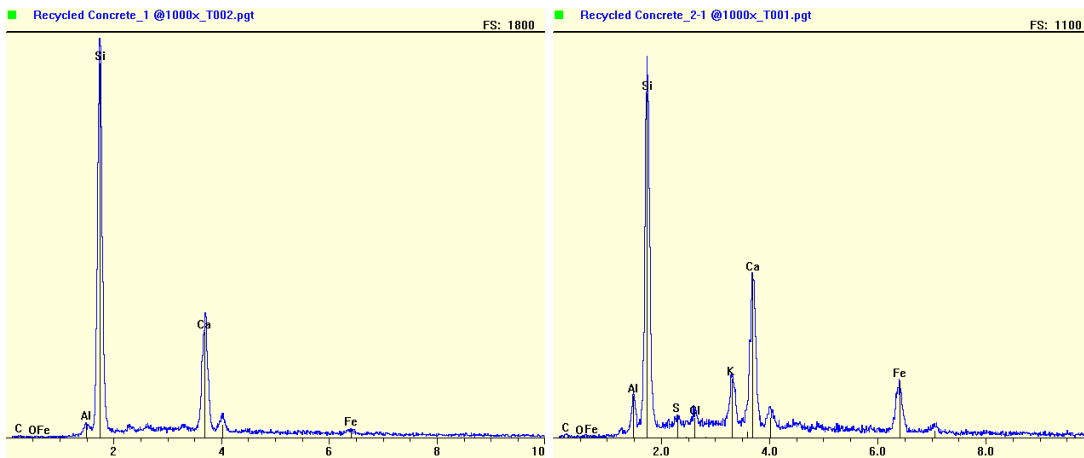
Figure 37. Energy Dispersive X-ray analysis indicates gap filling material in figures 35 and 36 is likely carbonated Portland cement paste and calcium carbonate. The graph shows intensity on the vertical axis and the x-ray energy on the horizontal axis.
