Report DSO-14-01

## Construction Flood Case Histories

Dam Safety Technology Development Program

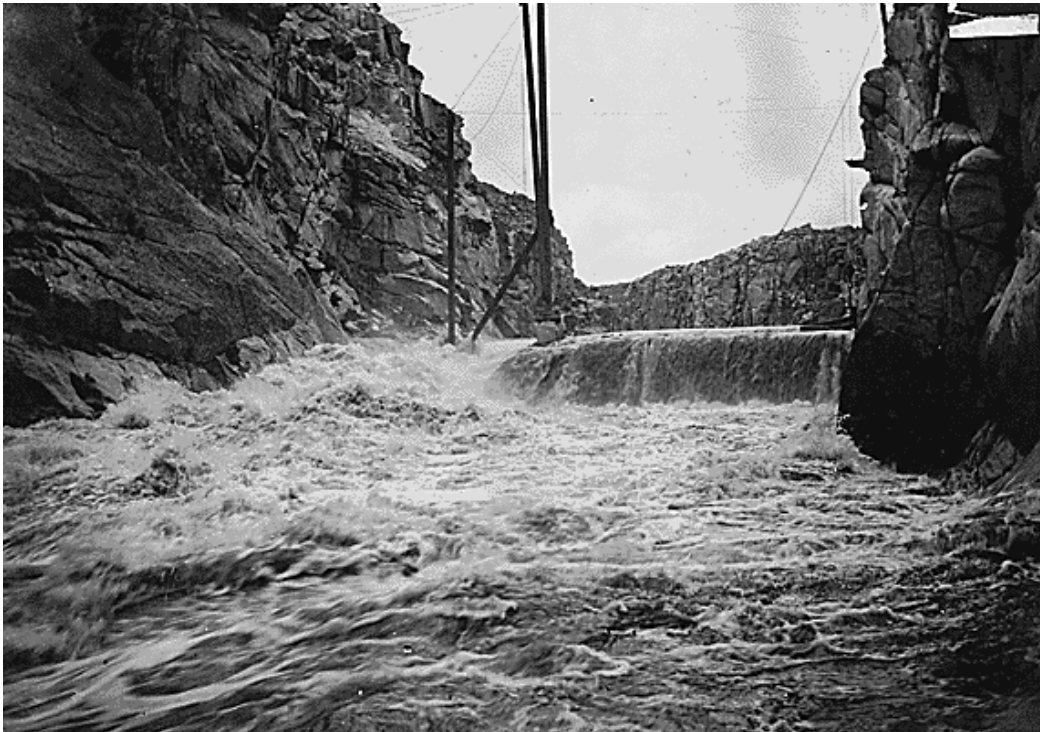
**Figure 1. Partially completed masonry dam overtopping during construction.**

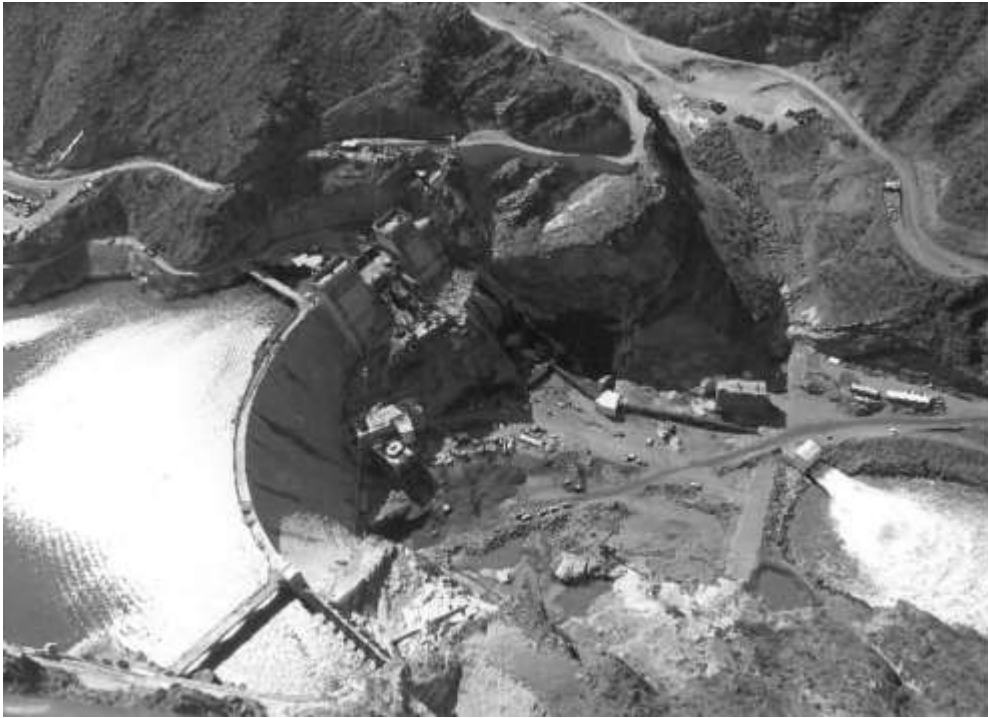
**Figure 2. Photograph of Theodore Roosevelt Dam under construction, showing the cellular cofferdam, thrust block, and spillway on left abutment. This photograph shows the construction progress after the flood event.**

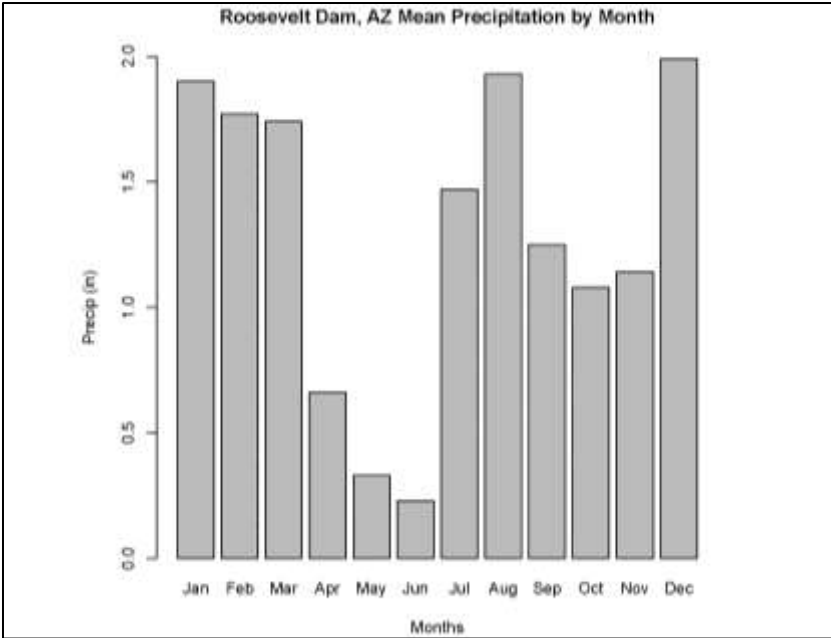
Figure 3. Average monthly precipitation for Theodore Roosevelt Dam, Arizona [5].

It is common for Arizona to receive relatively large amounts of precipitation during the winter (December, January, and February). On average, Theodore Roosevelt Dam receives nearly one-third of its annual precipitation during these 3 months. Only during the month of August in the Monsoon season does it receive more rain (figure 3) [5]. However, the January precipitation totals from 1993 were from 3 to 5 times the normal amount of precipitation that occurs in an average January (see figure 4) [6, 7, 8]. At Theodore Roosevelt Dam, the 14-day rainfall total was 10.81 inches, which corresponds to a return period of about 200 years [4].

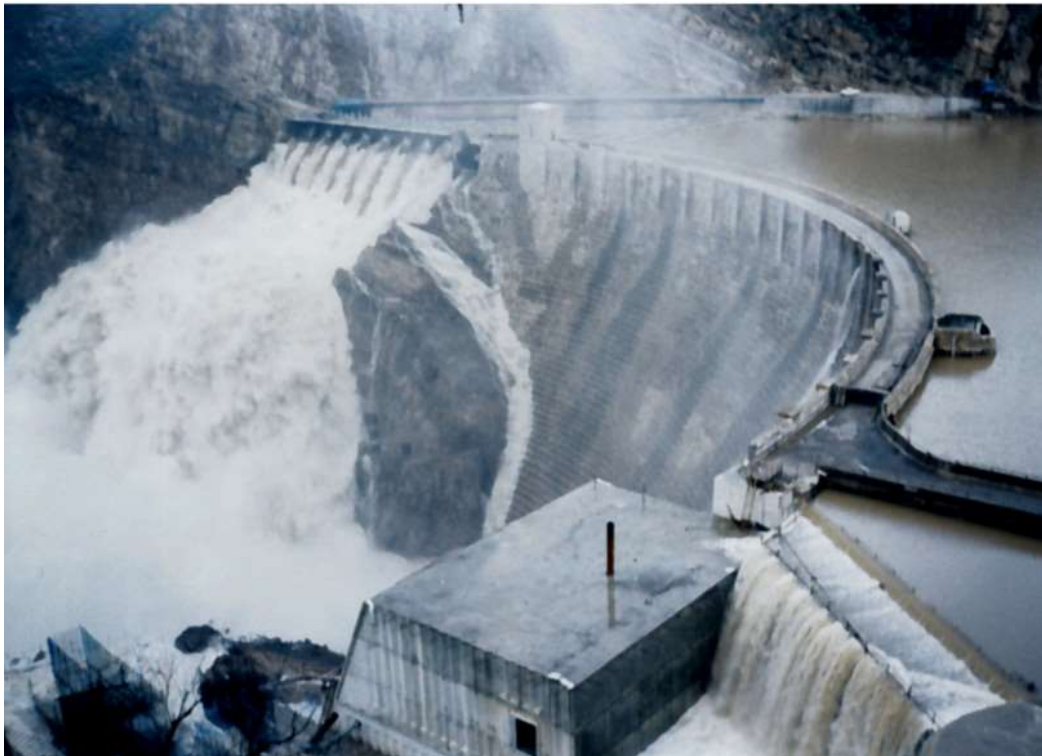
**Figure 5. Theodore Roosevelt Dam during 1993 flood showing partial construction of the left thrust block and overtopping of the cellular cofferdam.**

When the reservoir water surface exceeded elevation 2138 on January 19, overtopping of the left abutment concrete-capped cellular cofferdam and left thrust block began (see figures 5-7). The cofferdam overtopped for about 2 days and ended about midnight on January 21 [10]. The reservoir reached the highest elevation since the original construction of the dam. The flow over the cofferdam and partially constructed spillway was estimated to be about 700 ft<sup>3</sup>/s.

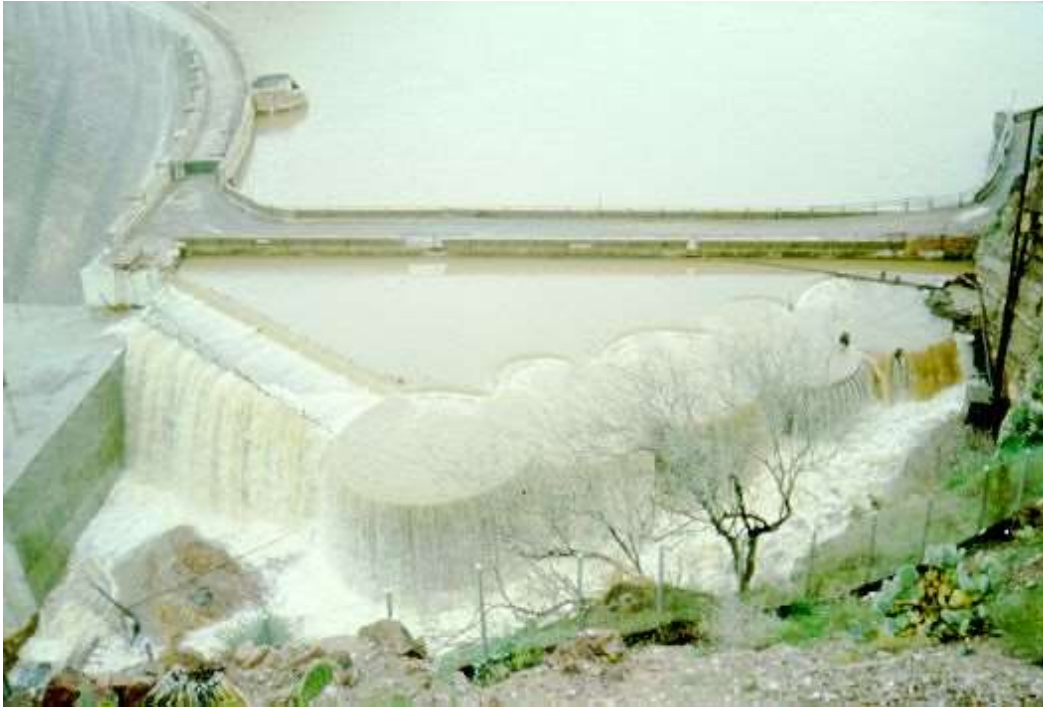
**Figure 6. Aerial view of cellular cofferdams being overtopped in 1993.**

The concrete-capped cofferdam performed fairly well for the approximately 1.5-foot depth of overtopping (see figure 6). The cellular cofferdam sustained minimal increase in deflection and bulging, none of the sheet piles went out of interlock, and the cone-shaped wire mesh inserted in the weep holes helped to minimize sand loss during the overtopping. Releases through the existing right spillway and outlet works continued until the reservoir was lowered. Releases from the right existing spillway gates were made again from February 12 until March 8, 1993, as flooding of the work site continued.

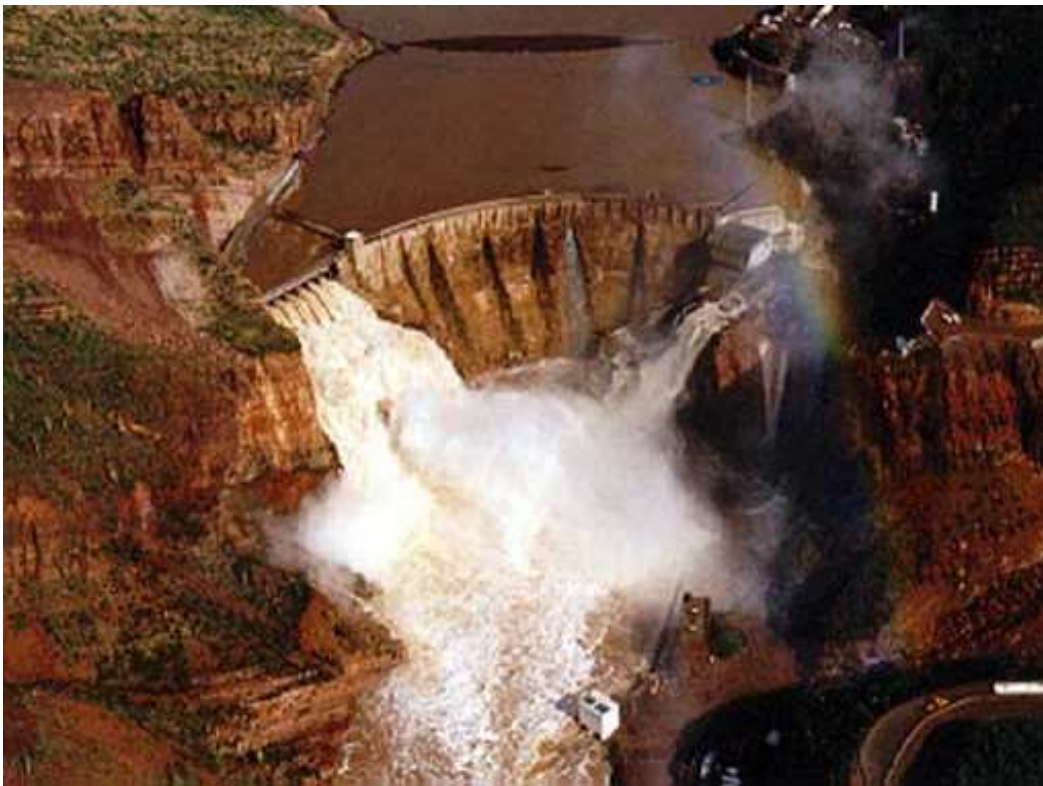
**Figure 7. Aerial view of service spillway operating on the right abutment and flows from the cellular cofferdam overtopping on the left abutment during 1993 flood event.**

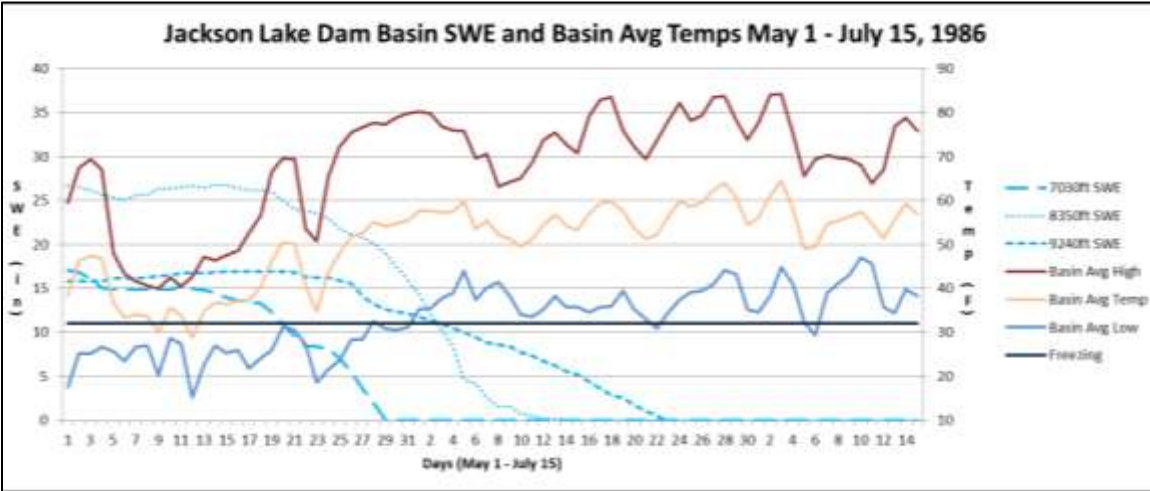
Figure 10. Graph showing the snowpack (light blue) in inches on the left axis for the May 1 to July 15 time period. High temperature, average temperature, low temperature, and 32 degrees are plotted on the right axis for the same time period. Notice how quickly the snowpack begins to melt once the average basin temperature rises above 32 degrees.

Dam basin was 1.99 inches, which is approximately a 2-year event [13]. This flood event was mostly predicated by rapid snowmelt, rather than heavy rainfall (see figures 9 and 10).

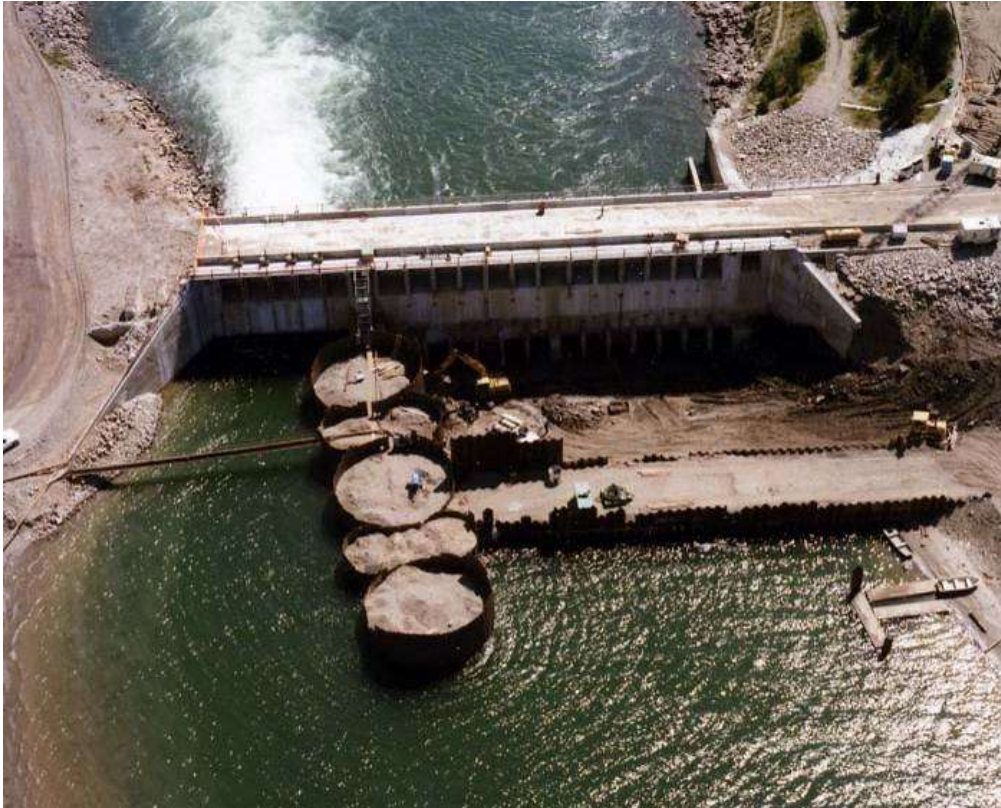
**Figure 11. Aerial view of cellular cofferdam upstream of Jackson Lake Dam during the first stage of construction after July 10.**

be constructed until after July 10 or be removed by May 1 of the following year (see figure 11). In addition, consideration would be given to breaching the tie-in cofferdam if more discharge capacity was needed after the July 10 date.

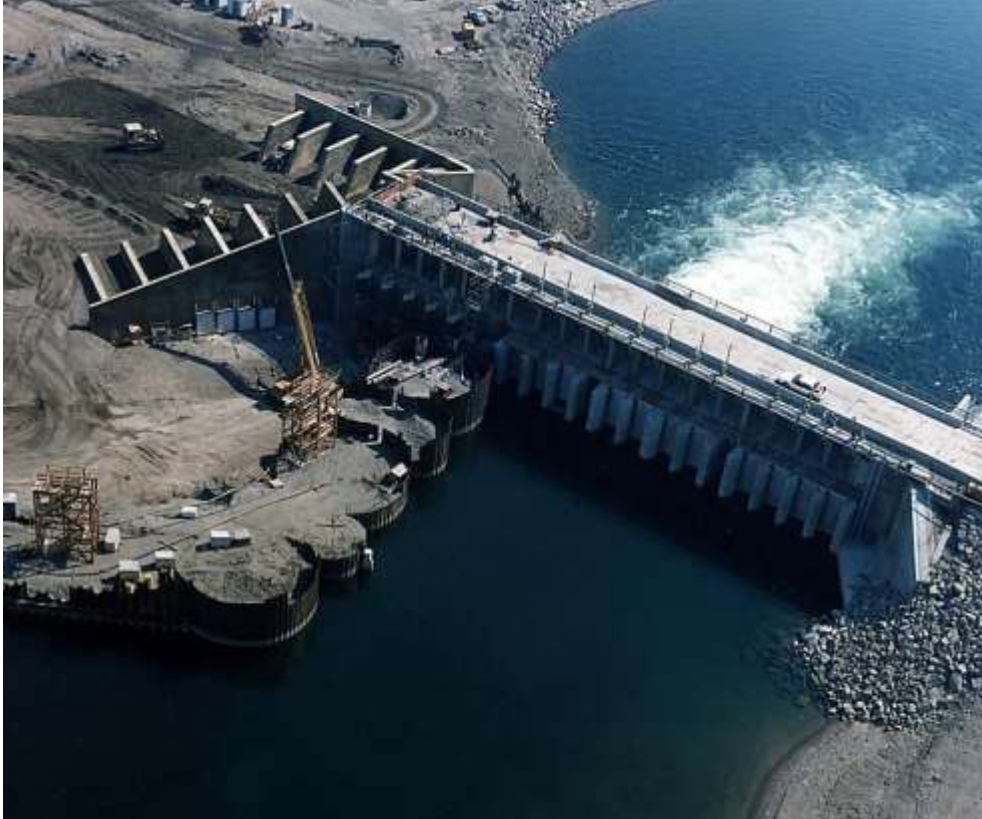
**Figure 12. Aerial view of cellular cofferdam upstream of Jackson Lake Dam during the second stage of construction.**

For diversion during Stage 2 of construction, 11 outlets were available, which satisfied the 9,000-ft<sup>3</sup>/s discharge capacity requirement (see figure 12).

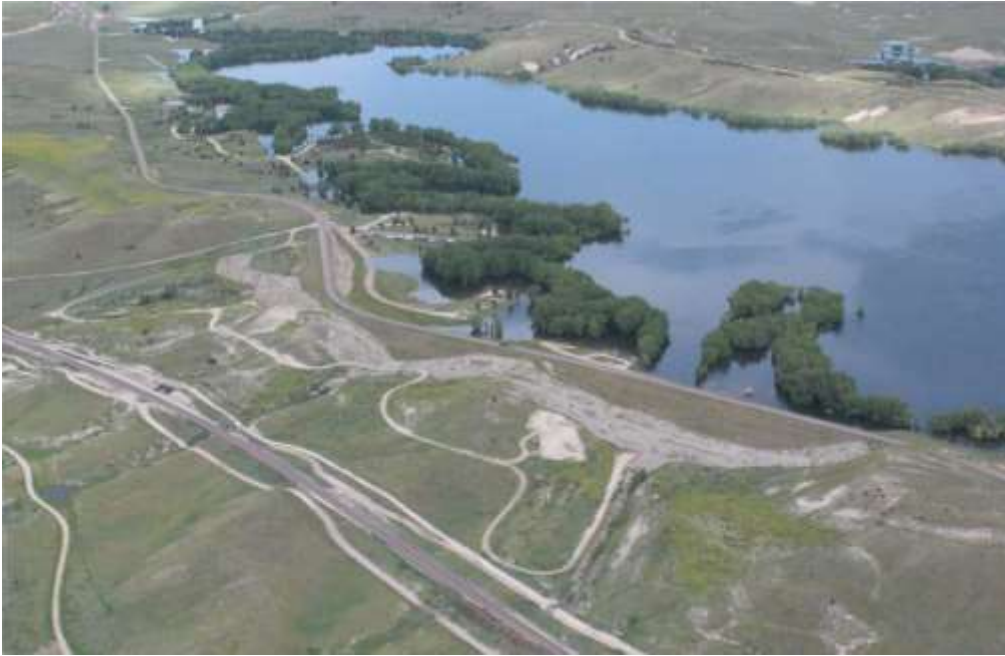
**Figure 15. Aerial view of the Glendo dikes during the 2010 flood.**

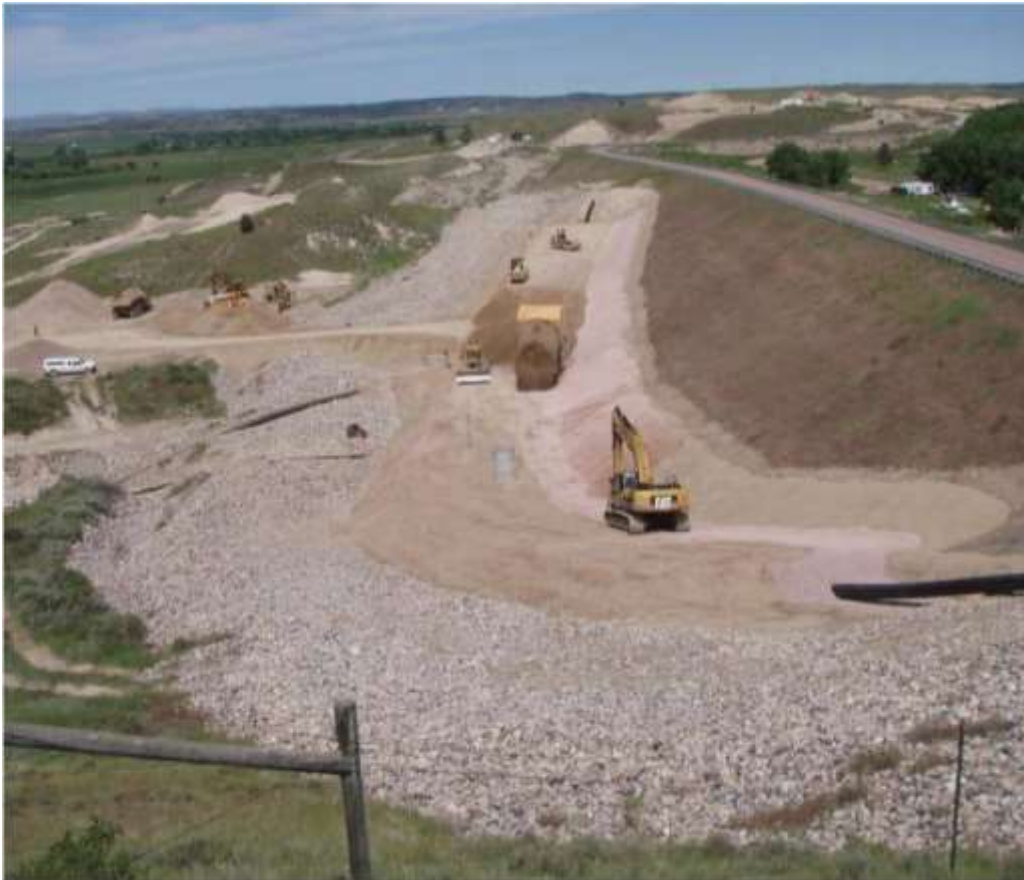
**Figure 16. View of the seepage berm modifications at the Glendo dikes in spring 2011.**

The scope of the modification was limited due to the rate at which the reservoir was rising. Excavation was kept to a minimum, and the construction time period was limited to a few weeks to allow the construction to be completed in advance of the rising reservoir. Given these restrictions, the design intent of the emergency modification was to reduce risk of failure up to the predicted reservoir water surface elevation of 4653 feet. The emergency modification consisted of the construction of an emergency berm, which required removing approximately 2 to 3 feet of cobbles from the top and downstream slope of Dike 1 and Dike 3 in order to expose the sand and gravel zone of the 1989 seepage berms. The topsoil

on a portion of the downstream slope of Dike 1 and Dike 3 was stripped. A small prism or trench was excavated an additional 4 to 5 feet into the sand and gravel of the 1989 seepage berms (see figure 16). The excavated surface was lined with a sand filter zone that was 1.5 feet thick on horizontal surfaces and 3.5 feet thick on sloped surfaces. The sand filter zone extended up the downstream slope of Dike 1 and Dike 3 to a height of about 6 to 9 feet. A gravel drain zone surrounded the perforated toe drain pipe downstream of the sand filter zone. The gravel drain extended to the same elevation up the downstream slope of Dike 1 and Dike 3 as the filter sand. The miscellaneous bermfill extended up the downstream slope about 2 feet above the sand filter and gravel drain zones. The emergency berm had a width of about 45 feet. Toe drain outfalls extended downstream to the existing weir boxes. In addition to the seepage berm modification, additional sand filter and gravel drain material was stockpiled at the dikes and at the dam in case an emergency arose at the dikes or dam.

With the contractor onsite working 7 days a week, the emergency repair work was completed in 5 weeks and was in place by the end of June 9 (see figure 16). Fortunately, a cool spring with no rain-on-snow events allowed the snowpack to

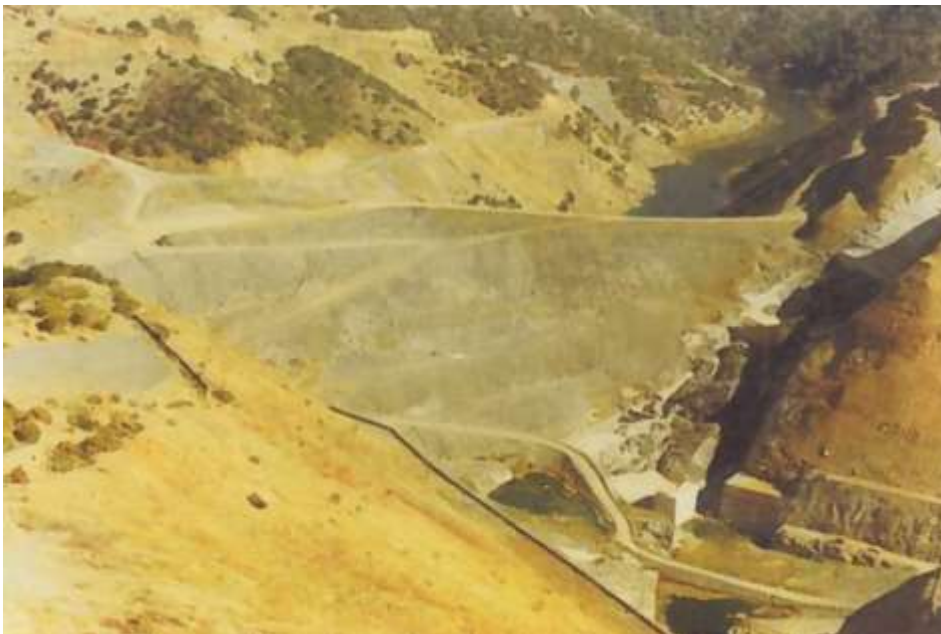
**Figure A1. Aerial photo of downstream face of cofferdam.**

The diversion plan consisted of a diversion tunnel and cofferdam designed for a 25-year flood event. The cofferdam was a zoned earthfill and rockfill embankment and was constructed to elevation 715. The cofferdam had a crest width of 30 feet and was about 1,200 feet long. A 33-foot-diameter, concrete-lined, horseshoe-shaped diversion tunnel was constructed in the left abutment. The diversion tunnel had a discharge capacity of 74,000 ft<sup>3</sup>/s.

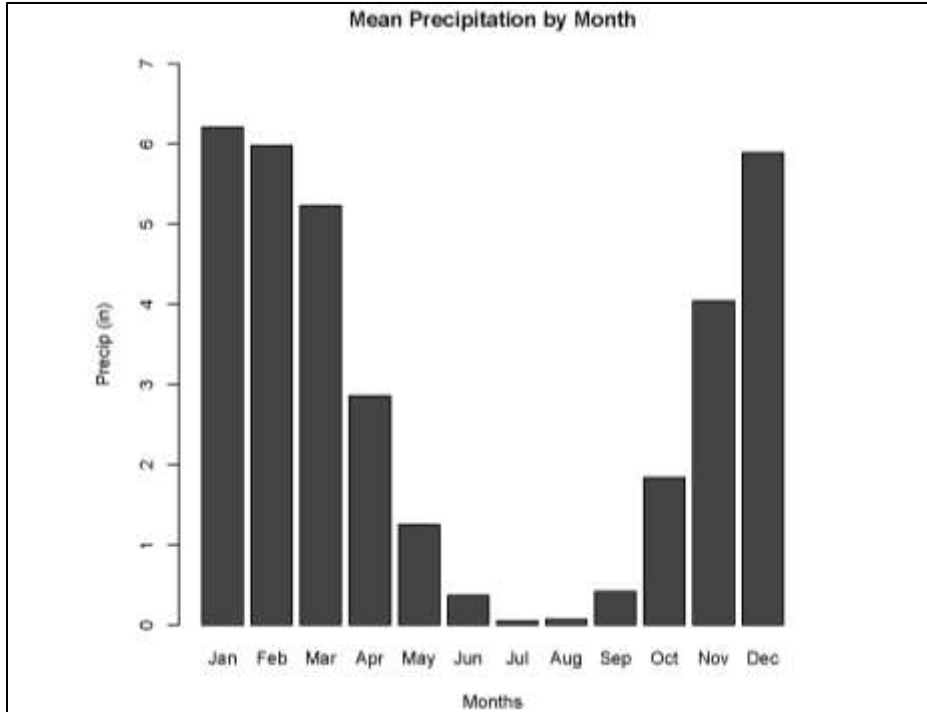
**Figure A4. Mean precipitation by month for Auburn, California. Note that December through March is the general storm seasonality. (Source: National Climatic Data Center, 2014)**

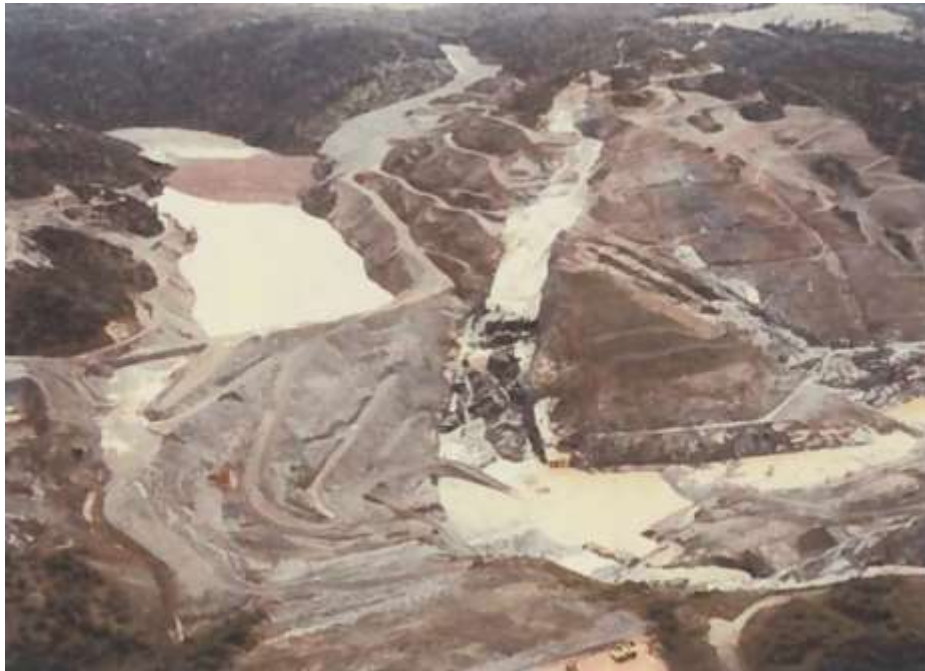
**Figure A5. Aerial photo of the downstream face of cofferdam and foundation excavation during large flood event. The fuse dike and the long buttress fill channel downstream of the fuse dike can be seen to the left of the cofferdam.**

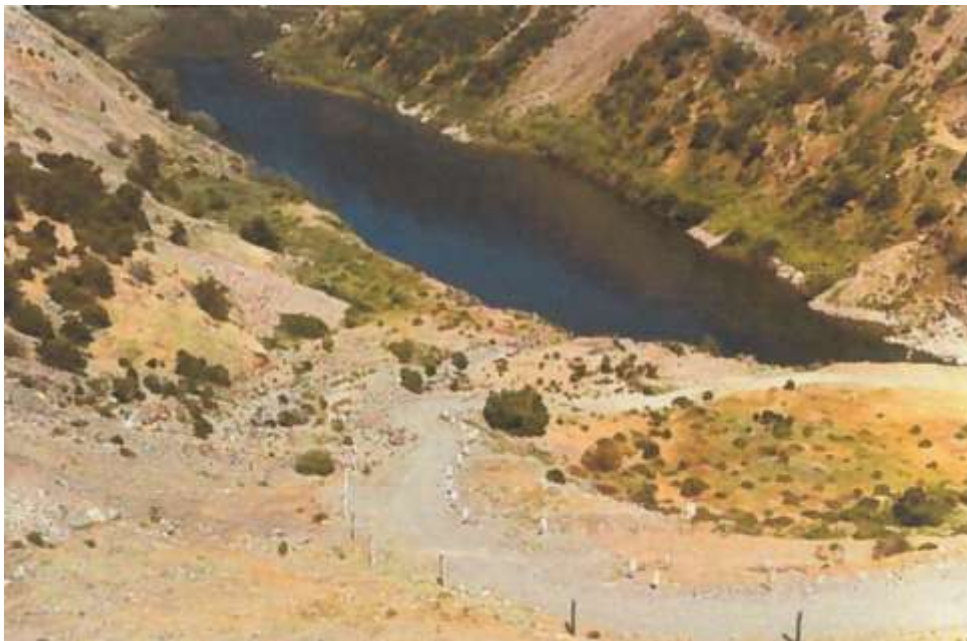
**Figure A6.** Photo of upstream slope of cofferdam showing markers placed every 5 feet in elevation.

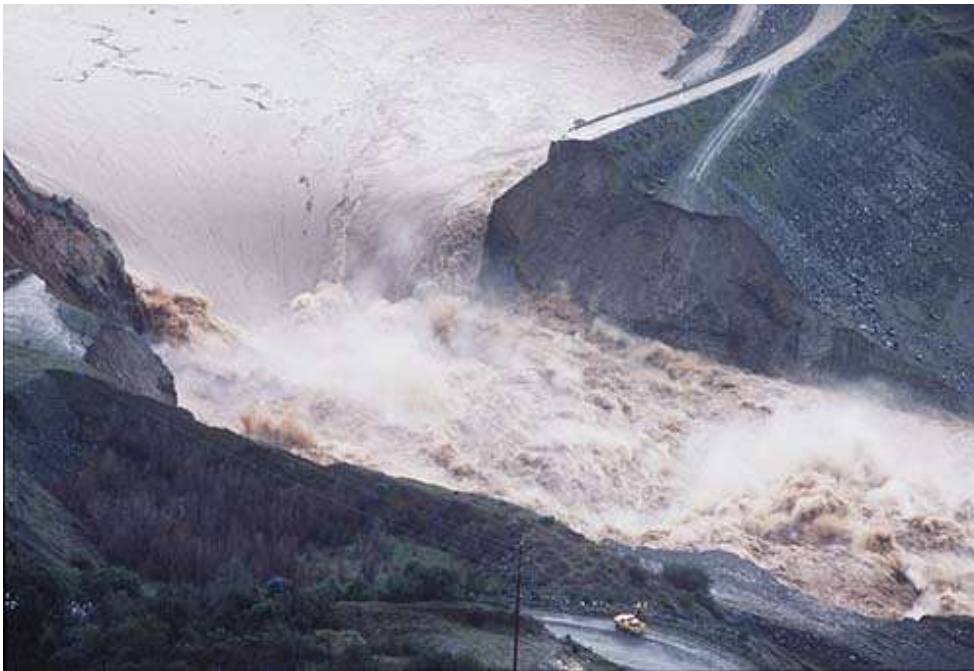
**Figure A7. Aerial photograph of the cofferdam breach during the 1986 flood.**

A large 3-day storm began on February 16, 1986. Project personnel started the flood watch at 3:00 a.m. on February 16. By 11:00 a.m. on February 17, the reservoir created by Auburn cofferdam had filled to about one-third of its capacity. At the rate the reservoir was filling, it would overtop the emergency spillway in 14 hours. The peak inflow of 135,400 cubic feet per second was recorded at midnight on February 17. On February 18 at 5:30 a.m., the water surface had risen to elevation 715, which was above the crest elevation of the fuse dike in the emergency spillway. The cofferdam overtopped from 5:30 a.m. to 12:00 noon without erosion of the core of the cofferdam. The water surface eventually rose to elevation 717.6. By 3:00 p.m. on February 18, the cofferdam had breached. The emergency spillway in the right abutment area with the fuse dike and buttress fill was effective in delaying the breach. Because the failure of the cofferdam was anticipated, storage space including flood surcharge storage space was still available in Folsom Reservoir. As a result of this flood and the breach of the cofferdam, the reservoir water surface at Folsom Dam rose about 1.5 feet into the surcharge storage space with about 8 feet remaining. The peak inflow into Folsom resulting from storm runoff, plus the cofferdam breach, was estimated to be about 553,000 ft<sup>3</sup>/s [A3].
