Report DSO-2014-03

Seminoe Dam - Assessment of Concrete by Quantitative Methods – The Petrographic Damage Rating Index

Dam Safety Technology Development Program

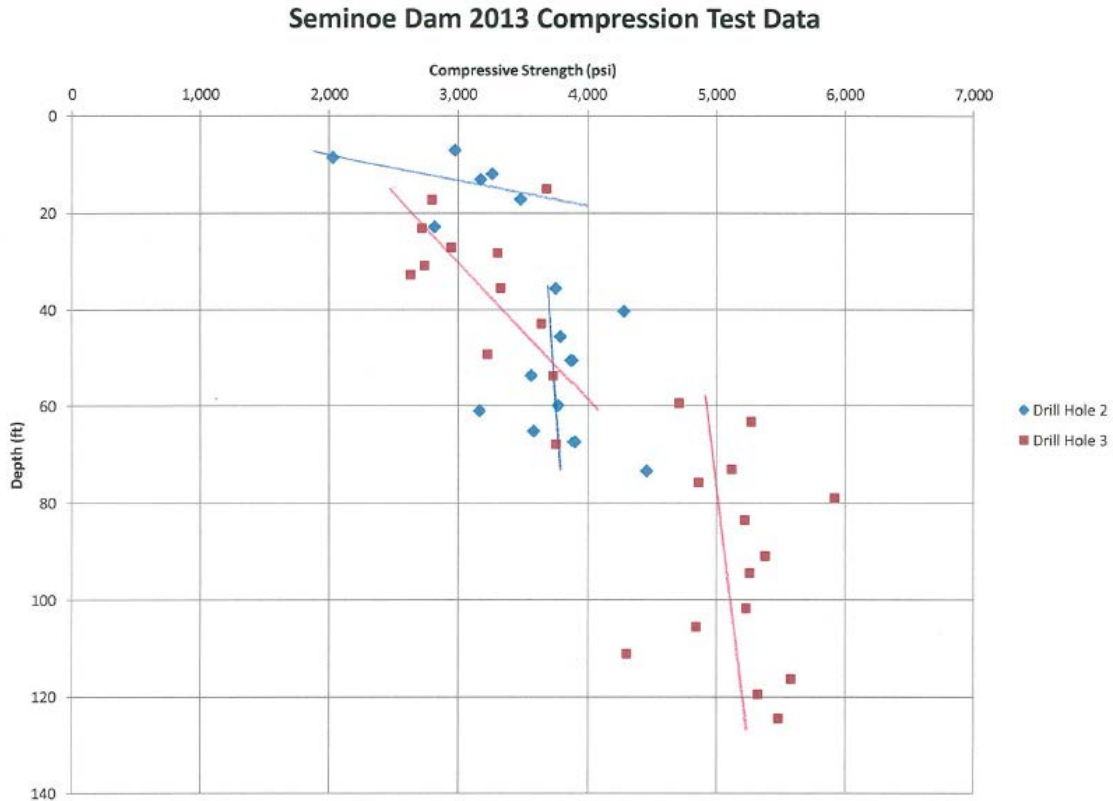
Figure 1, a plot of the 2013 compressive strength data compared to depth, showed compressive strength trends with great amounts of scatter. The dam's principal engineer described the distribution of compressive strength values with depth as "parabolic". Cores from 0 to 5 feet were generally not available for strength testing or DRI analysis due to their poor condition after recovery. At certain depth intervals compressive strength trends were observed, which allowed selection of samples above and below about 35 feet depth for cores from DH13-2 and above and below about 60 feet depth for cores from DH13-3. Sketched trend lines illustrate changes in the concrete's compressive strength with increasing depth. The compressive strength data are provided in Appendix D.

Figure 1. Plot of compressive strength data for the 2013 Seminole Dam Concrete Core Testing Program with trend lines sketched for groups of data points. This data and plot provided by W. Joy and trend lines drawn by author.

The DRI data above and below 35 feet in the Seminole Dam cores from DH-13-2 appear to show changes in compressive strength (figure 1). The subjective relative degree of reaction and DRI values change from moderate to lower values at about 35 feet. The most notable physical change is the width of the cracks in paste that are easily visible without the aid of magnification on the polished surface above about 35 feet in depth to not visible or only barely perceptible below 35 feet in depth (Table 2).

Polished surfaces were prepared on cores from DH13-2 at depths of 9.1, 11.5, 16.6, 22.45, 36.15, 45.15, 60.55, and 74.0 feet. Changes in the compressive strength trends were observed at about 35 feet (figure 1). Polished surfaces were also prepared on cores from DH13-3 at depths of 16.8, 28.75, 36.15, 53.3, 59.95, 72.6, 90.0, and 125.0 feet. Changes in compressive strength trends were observed at about 60 feet.

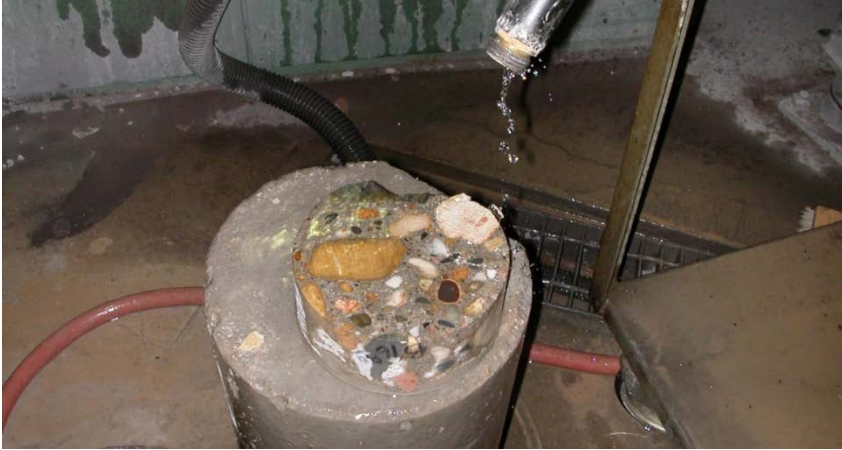
Figure 4. A six-inch diameter concrete specimen sits on a stand during the polishing process. The hose provides limited water to keep the working surface wet and lubricated for polishing.

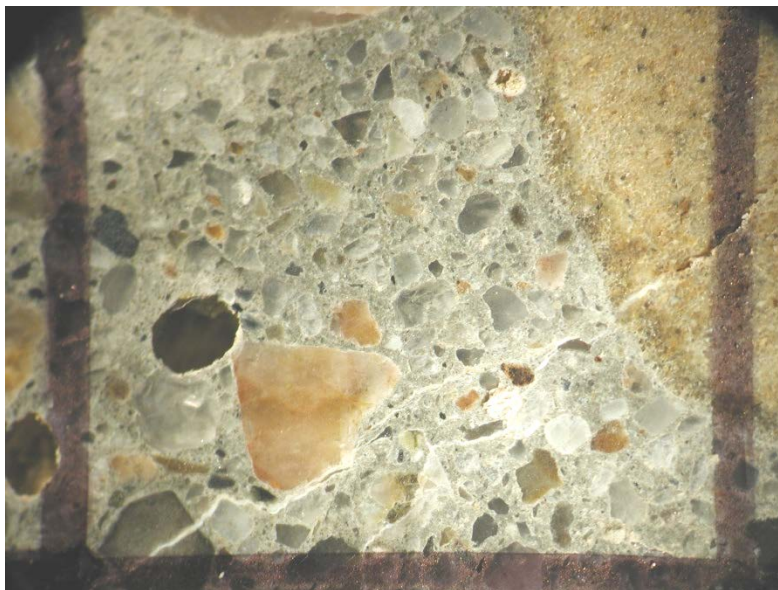
Figure 10. A reactive aggregate particle exhibits an internal crack filled with alkali-silica gel. The filled crack also penetrates paste. The examined square received a count each for coarse aggregate with crack and gel, cement paste with crack and gel, and reaction rim around aggregate (CA+G, CP+G, and R following the defect types of Rivard, 2002). The grid square is about 10 by 10 millimeters in size.

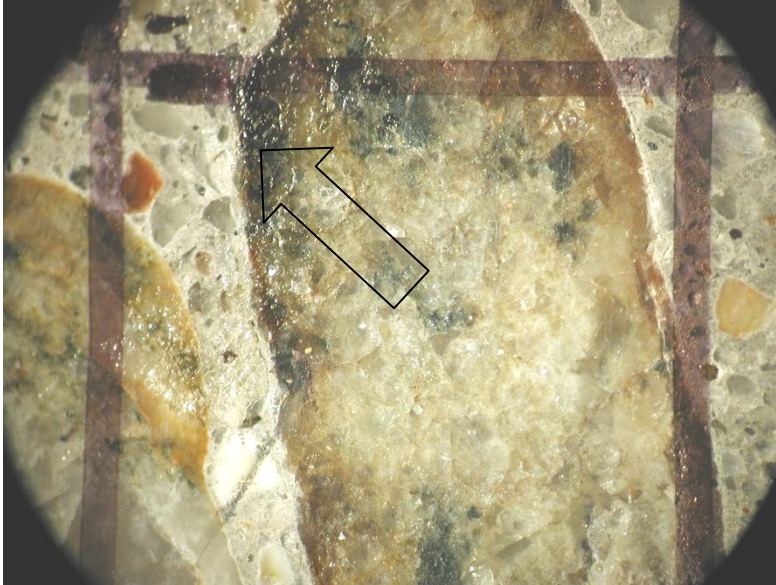
Figure 11 Fresh alkali-silica gel exuded onto the polished surface following sample preparation (arrow). The gel is transparent and the incident light on the irregular surface causes it to sparkle slightly. The grid square is about 10 by 10 millimeters in size.

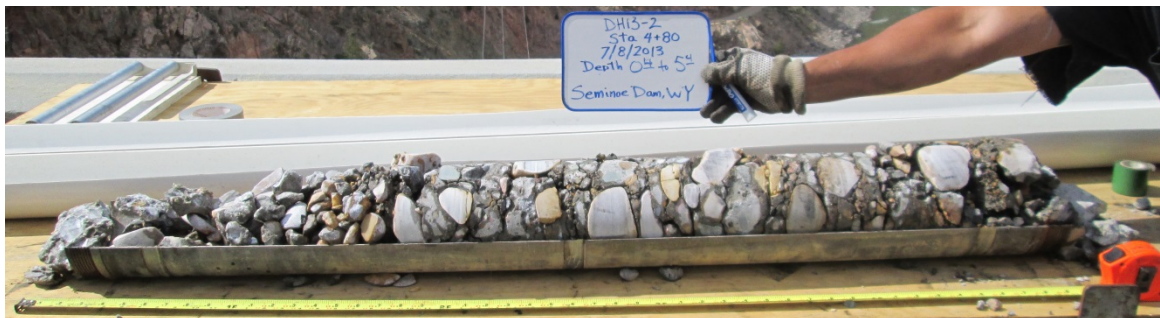
Figure 12 The condition of concrete core DH-13-2, 0.4 to 5.4 feet. The Seminoe Dam core at shallower depths was not available for DRI. The DRI value at the interval 0 to 5.4 feet, if available, would likely be much higher than that observed at greater depths.

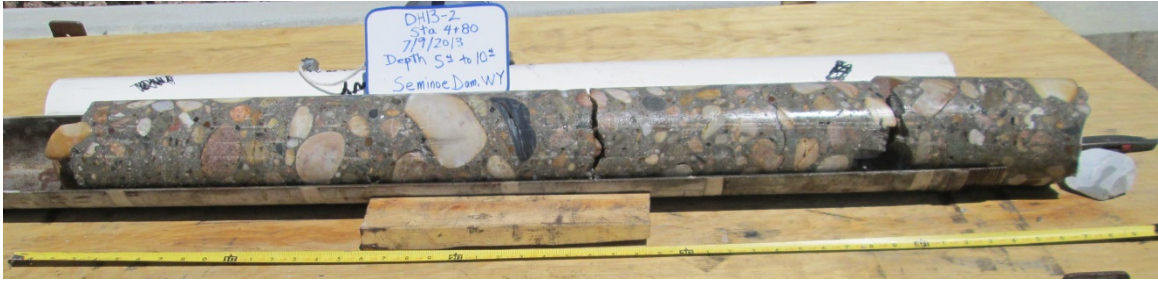
Figure 13 The general condition of concrete core DH-13-2, at depths greater than 5.4 feet for comparison.
