Report DSO-2014-05

# Large-Scale Filter Performance Tests

Results of “Crack-Box” Testing

Dam Safety Technology Development Program  
U.S. Army Corps of Engineers Risk Management Center

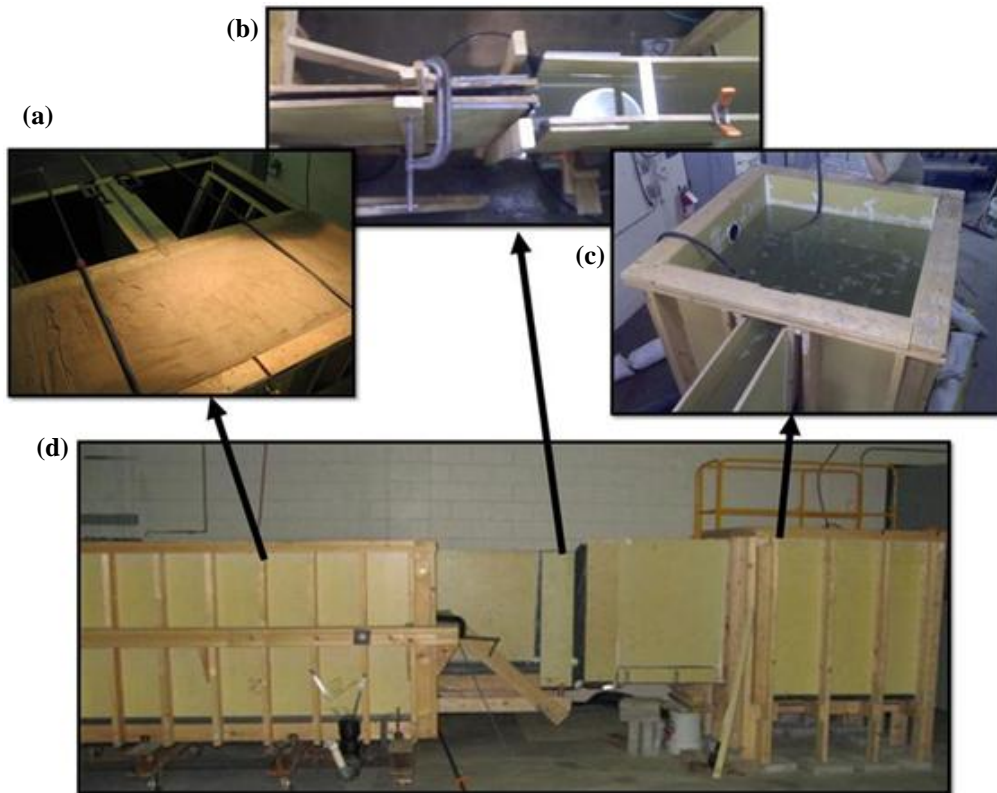
Figure 1.—(a) Material box looking downstream, (b) channel between material box and reservoir, (c) reservoir looking upstream, and (d) profile view of the testing apparatus with the reservoir on the right and the material box on the left, connect by the channel.

The testing apparatus had two main components: (1) the reservoir, and (2) the material box, as shown in figure 1. The reservoir had dimensions of approximately 4 feet by 4 feet by 4.5 feet (length, width, and height, respectively), providing approximately 72 cubic feet ( $\text{ft}^3$ ) of storage. Downstream of the reservoir, a 9-foot-long channel connected the material box to the reservoir. The material box was 8 feet by 8 feet by 4 feet (length, width, and height, respectively). Within the material box was a temporary partition wall, which could be adjusted or removed to allow for different filter thicknesses.

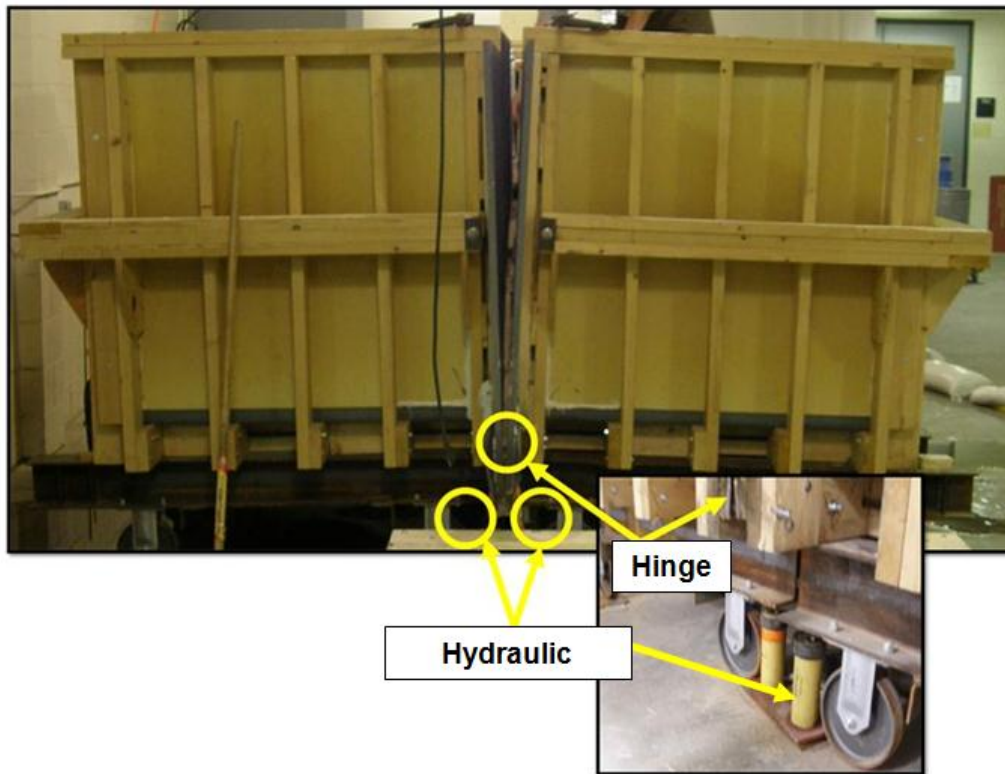
**Figure 2.—Testing apparatus after the material box had been cracked open.**

The material box consisted of two equally sized halves hinged together along the bottom of the box. This hinge allowed the material box to pivot about the bottom center, inducing a crack in the material within the box. The pivoting was initiated by lifting the center of the box (directly below the hinge) with hydraulic rams, as shown in figure 2. When the rams were raised, the weight of the material box and filter material kept the outer ends of the box stationary, causing the box to crack open down the center. The upstream and downstream channels were also hinged and would pivot open with the material box, allowing water from the reservoir to flow through the open cracks.

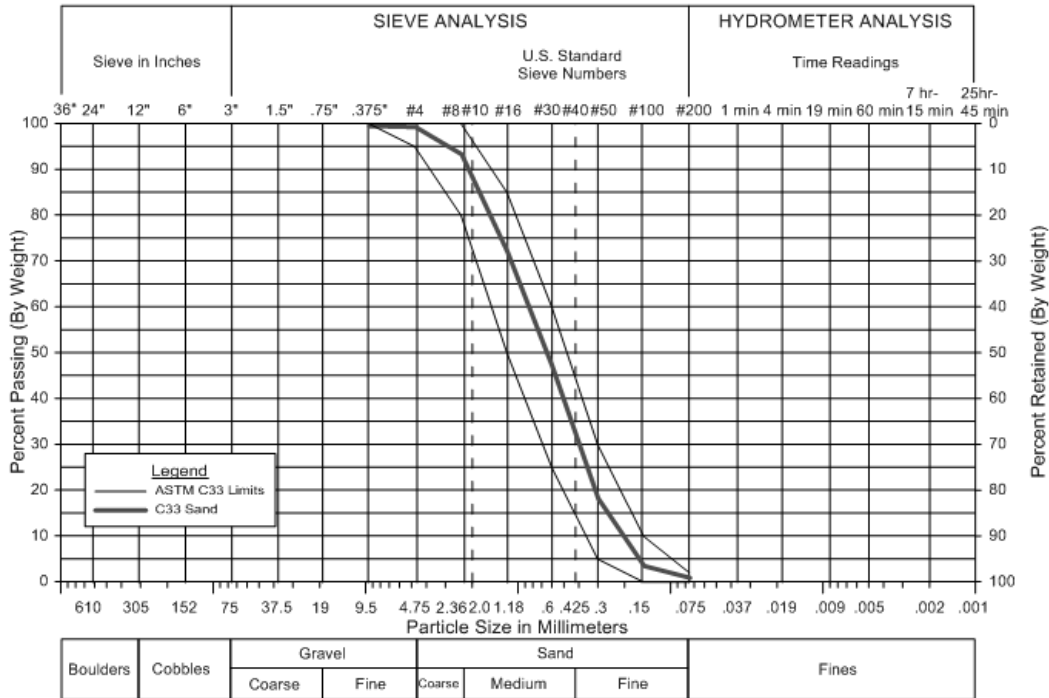
Figure 3.—Sand gradation.

Sand was used in a majority of the 14 tests. An initial gradation analysis found the sand contained 0.9 percent fines and was classified as a poorly graded sand (SP) in accordance with the Unified Soil Classification System (USCS) (see figure 3). Sand was acquired from Albert Frei and Son's pit number four, which is located in Brighton, Colorado. Pit number four is an alluvial deposit that requires washing to remove fines; the sand material is not crushed to meet gradation requirements. The material satisfied ASTM C33 requirements for gradation, material soundness, and limiting deleterious substance content. Appendix A includes results from physical property tests performed by an independent lab on samples taken from pit number four in January 2012. The results include a detailed petrography analysis. Reclamation conducted sand castle tests [3] on samples taken before and after compaction to ensure that the sand did not exhibit signs of cementation. Results determined that cementation was unlikely with this material, and they are shown in appendix B. Maximum dry unit weight tests were also conducted on the material using the vibrating hammer test, according to ASTM D7382 (see appendix E). The average maximum dry unit weight for the sand was 118.5 pounds per cubic foot (lb/ft<sup>3</sup>).

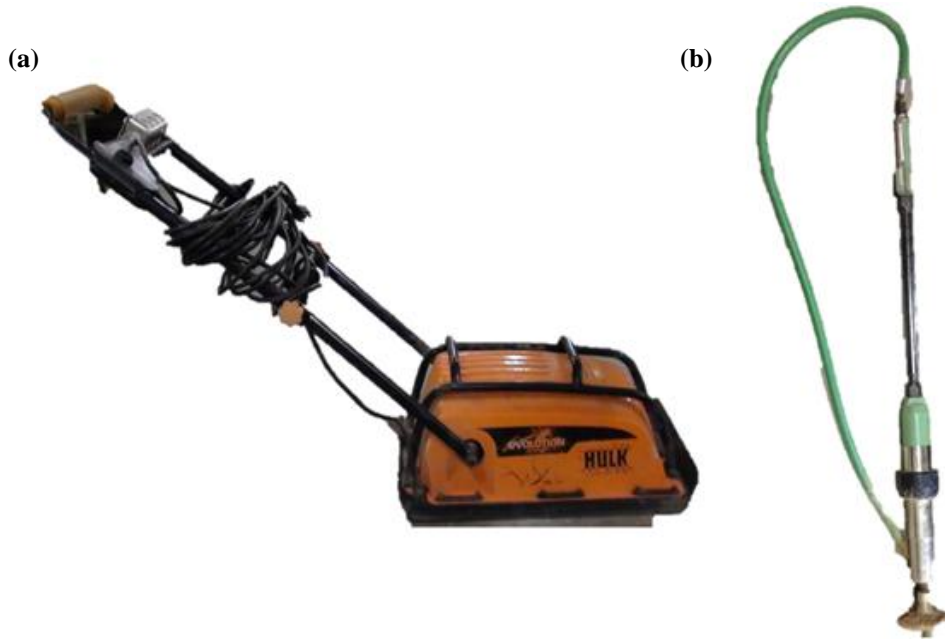
**Figure 4.—(a) Electric vibratory plate compactor, (b) pneumatic pogo tamper.**

Filter materials and configurations varied from test to test, but a general procedure was followed for all tests. The halves of the material box were hinged together, and potential areas of leakage were sealed. Material was then compacted in the material box using various types of equipment. Sand materials in tests 1-3 were compacted using a jumping jack. Granular (sand and gravel) materials for tests 4-13 were compacted using an electric vibrating plate compactor, as shown in figure 4. The silt in test 13 was compacted using the pneumatic tamper, which is also shown in figure 4.

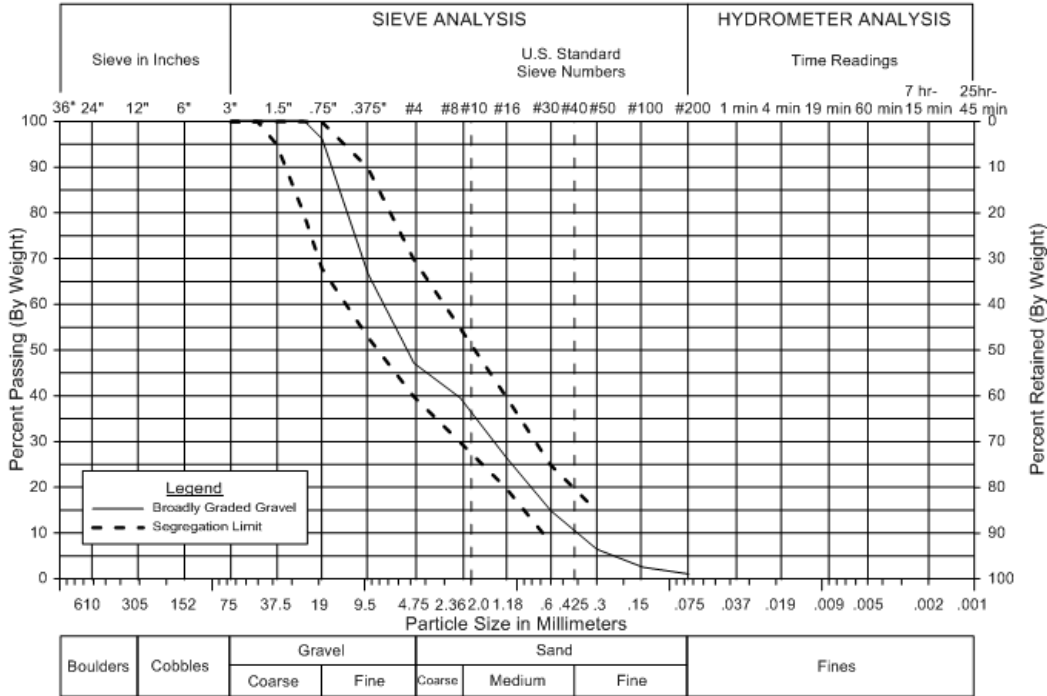
**Figure 5.—Phase II broadly graded filter material gradations.**

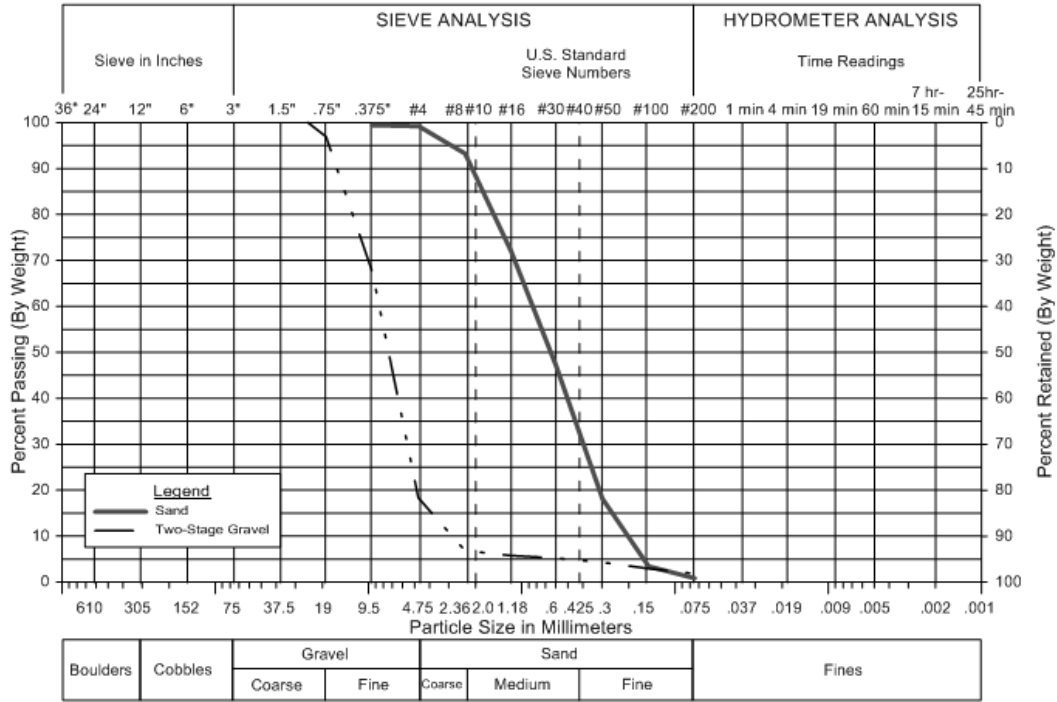
**Figure 6.—Phase III two-stage filter gradations.**

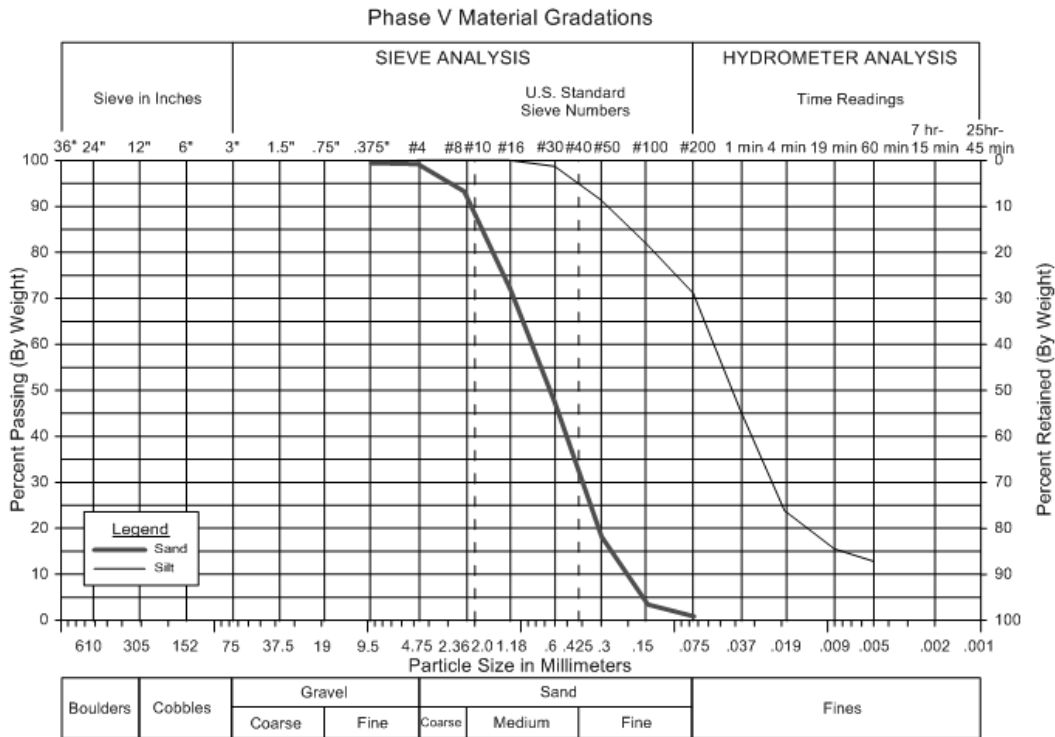
**Figure 7.—Phase V silt and sand gradations.**

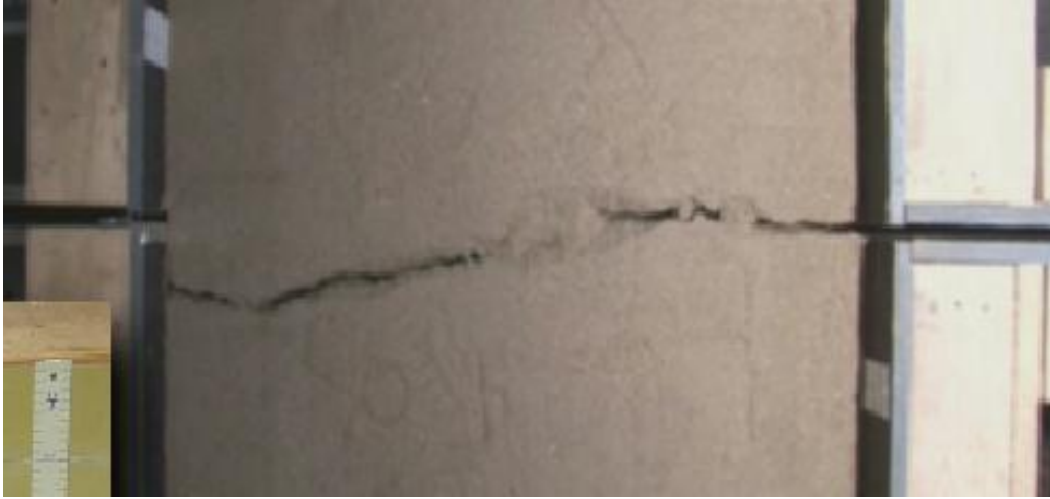
**Figure 8.—Overhead view of Test 1: 3 feet of sand compacted to 94.8% of maximum dry density at 5.8% moisture content.**

Sand was placed up to a height of 42 inches above the bottom of the box. The sand filter was 3 feet wide measured upstream to downstream. All of the figures show an overhead view of the material box and are oriented with the upstream side on the left side. Test 1 took place on September 29, 2009. The box was cracked approximately 0.5 inch (see figure 8). The crack walls appeared to be mostly vertical, and the path of the crack meandered about 1 inch in either direction, but was generally oriented upstream to downstream.

The reservoir was filled to a height of 41 inches and then released. The filter sloughed quickly after the reservoir was released. The concentrated leak was stopped, and water was unable to flow into the downstream channel. Small intermittent sloughing occurred, but the leak was stopped until the box was cracked wider, to approximately 1.5 inches. At this point, the crack sustained almost vertical walls, and water continued to flow into the downstream channel. The velocity of the flow was high enough to suspend sand particles and transport them downstream, outside of the box. This led to more water moving through the crack and eroding filter material. Additional larger sloughs occurred, but the leak was never fully stopped and continued to flow.

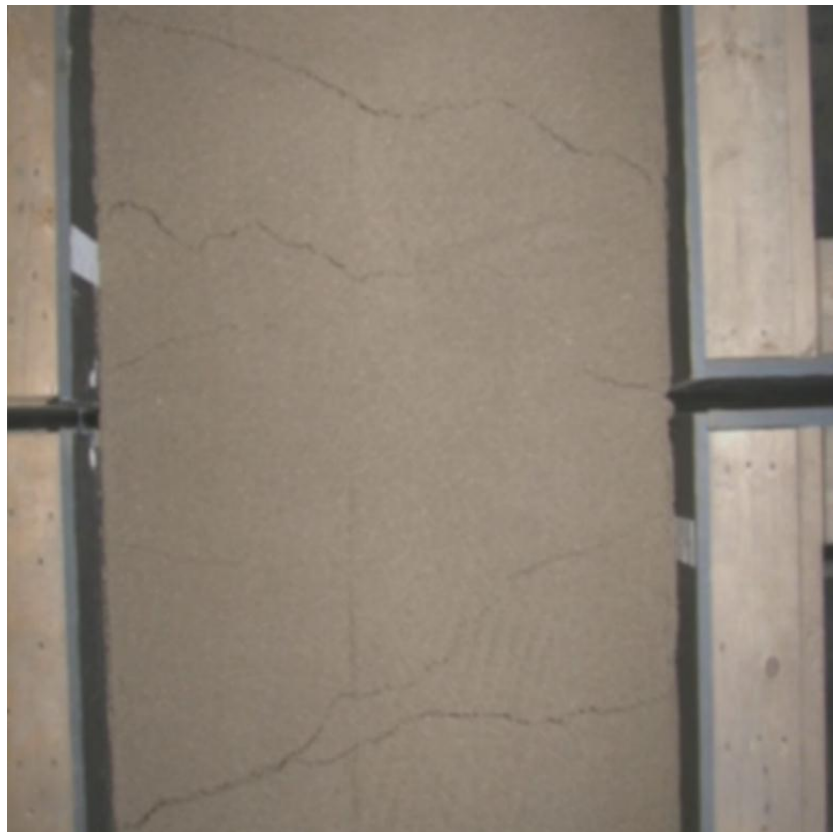
**Figure 9.—Overhead view of Test 2: 3 feet of sand compacted to 81.3%.**

Sand was placed up to a height of 42 inches and was 3 feet wide. The filter material was not compacted during placement. Test 2 took place on November 24, 2009, and November 25, 2009. The box was cracked approximately 1 inch, but the filter did not sustain a large crack. Instead, the material settled, and small tension cracks appeared (see figure 9).

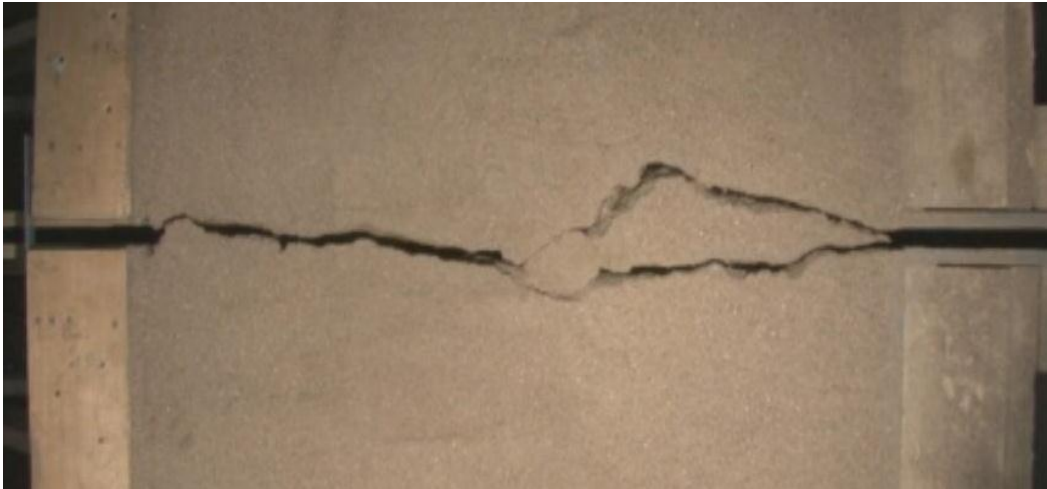
Figure 10.—Overhead view of Test 3: 3 feet of sand compacted to 95.7%.

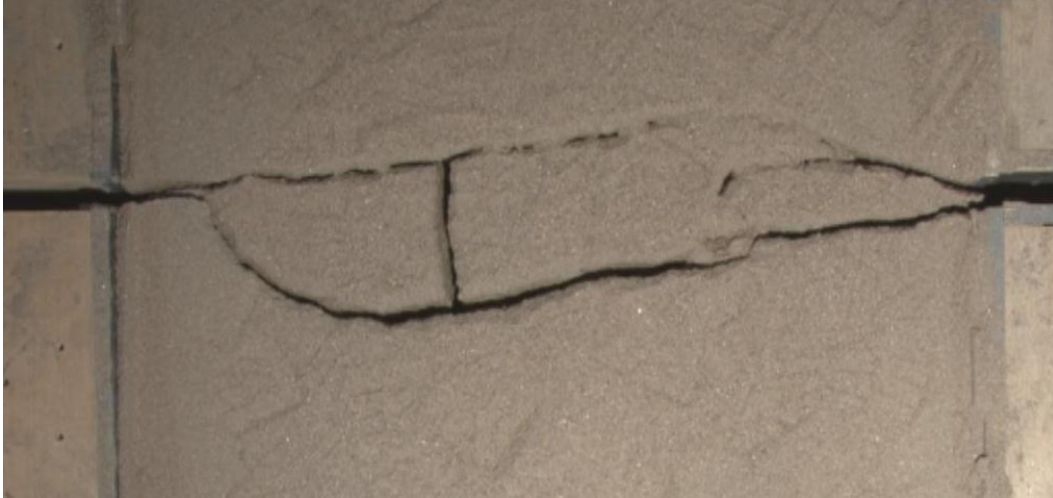
Figure 11.—Overhead view of Test 4: 3 feet of sand compacted to 87.6%.

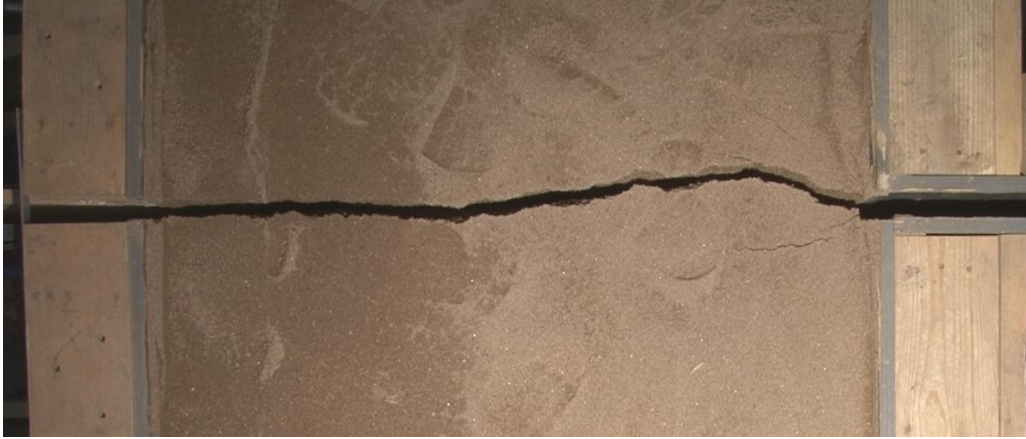
Figure 12.—Overhead view of Test 5: 3 feet of sand compacted to 90.6%.

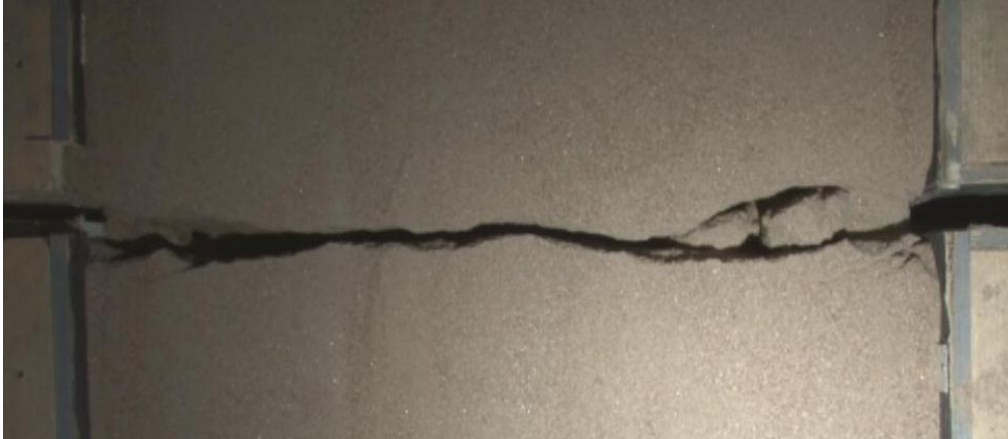
Figure 13.—Overhead view of Test 6: 3 feet of sand compacted to 92.9%.

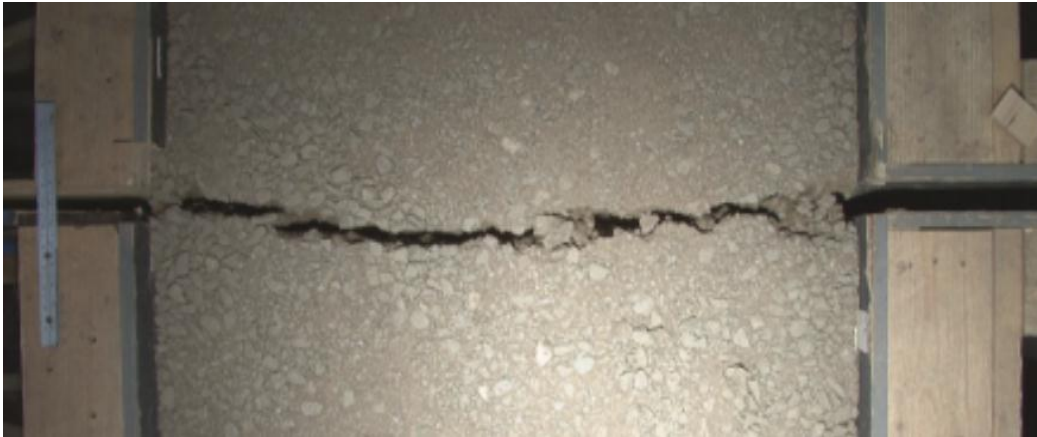
Figure 14.—Overhead view of Test 7: 3 feet of broadly graded material compacted to 94.9%.

some sloughed particles in areas. Orientation of the crack was almost straight from upstream to downstream and meandered less than 1 inch in either direction.

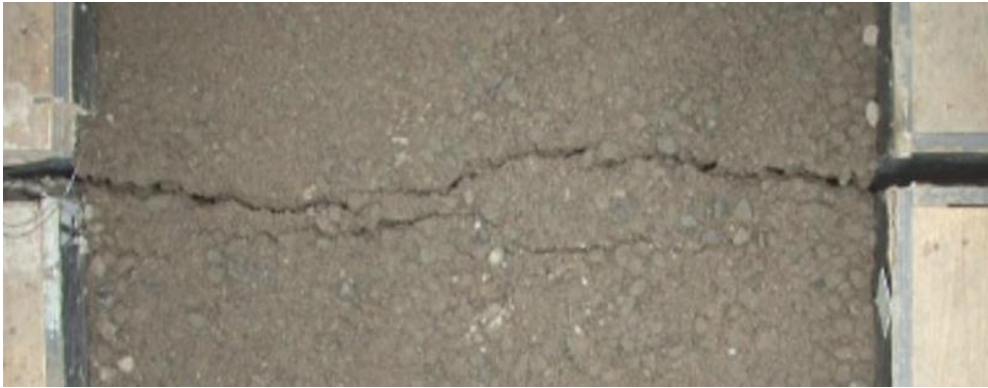
**Figure 15.—Overhead view of Test 8: 3 feet of broadly graded material compacted to 103.4%.**

Broadly graded filter material was placed up to a height of 47 inches and was 3 feet wide. Test 8 took place on July 25, 2011. The box was cracked approximately 1 inch (see figure 15). The crack was not vertical and was branched in several locations. Large aggregate pieces extended into the crack, making the crack appear much narrower.

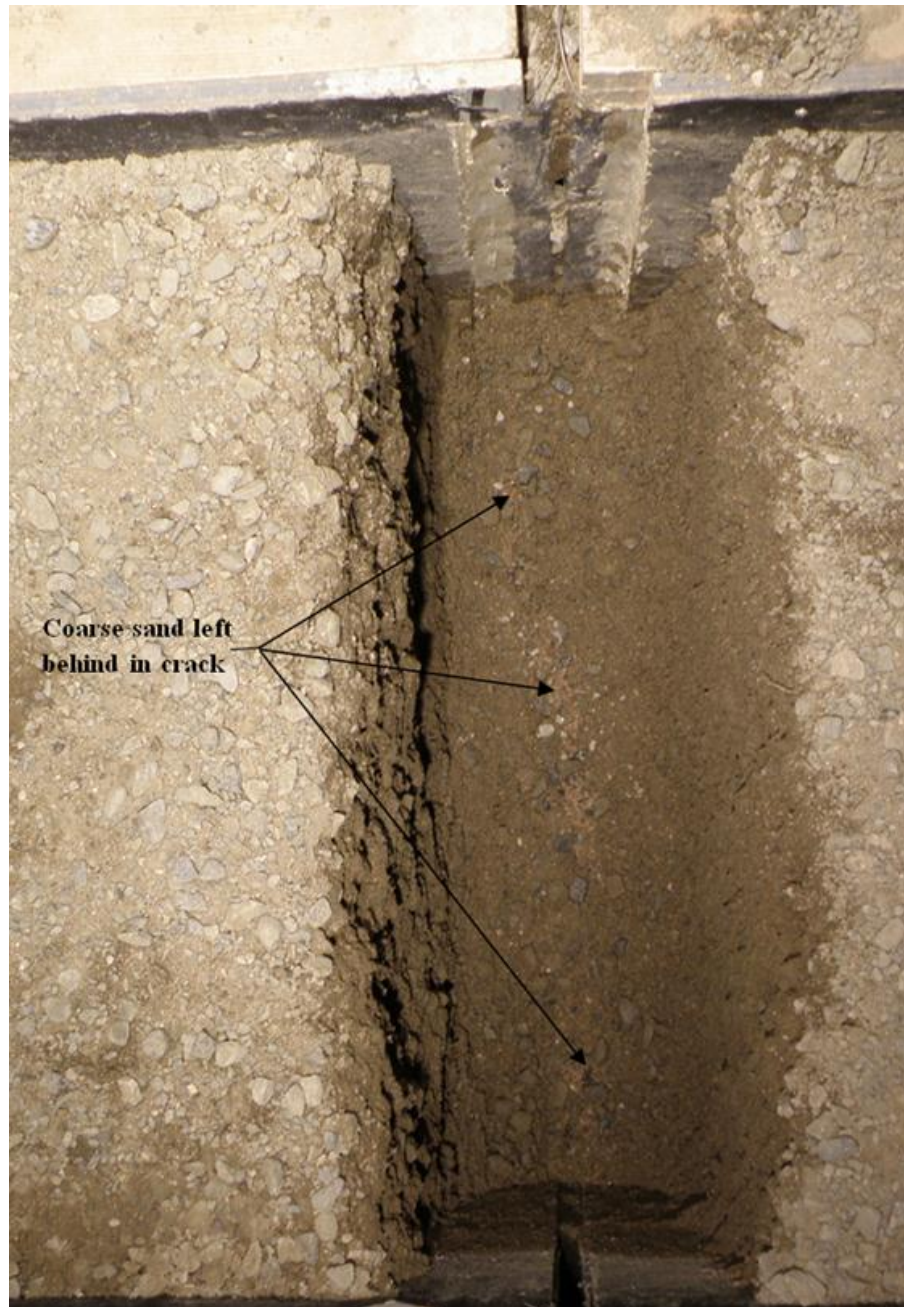
**Figure 16.—Picture taken during excavation of test 8 material. The coarse sand (lighter in color) was evident throughout the entire excavation.**

During excavation of the broadly graded material, clean coarse sand was identified in the location of the crack, as shown in figure 16. The coarser sand is further evidence that the crack did not fully heal. As water flowed through the crack, finer sands were transported downstream, leaving behind the larger particles that were retained on the gravel. When silt was added to the upstream channel, flow through the filter did not reduce because the finer silt washed through the coarser sand and gravel.

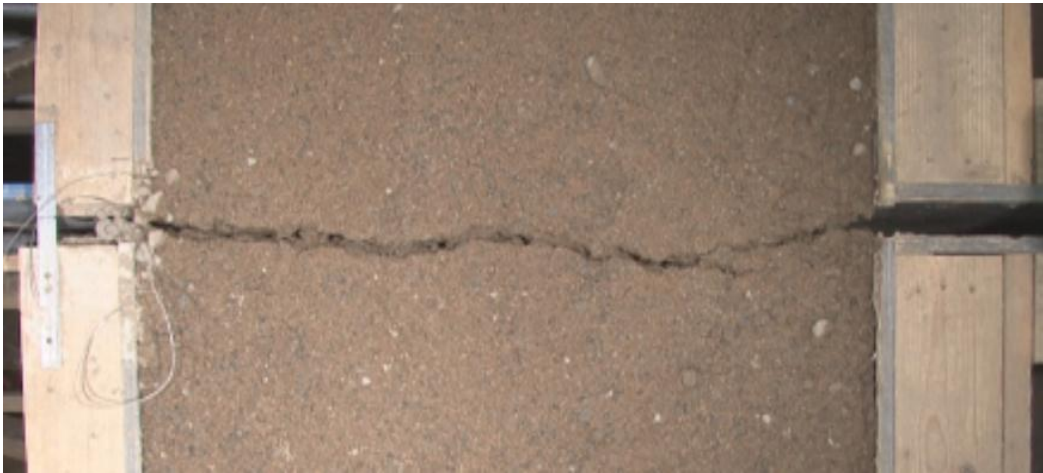
**Figure 17.—Overhead view of Test 9: 3 feet of broadly graded material compacted to 92.5%. (Note: the materials in tests 7, 8, and 9 are identical. The lighting in each photo affects the appearance of the material.)**

Broadly graded material was placed up to a height of 48 inches, and the filter was 3 feet wide. Test 9 took place on August 15, 2011. The box was cracked approximately 1 inch, as seen in figure 17. The crack walls appeared to be mostly vertical, with some areas of sloughed particles. The crack orientated straight from upstream to downstream, and it meandered less than 1 inch in either direction. The crack branched about 8 inches from the downstream end of the filter.

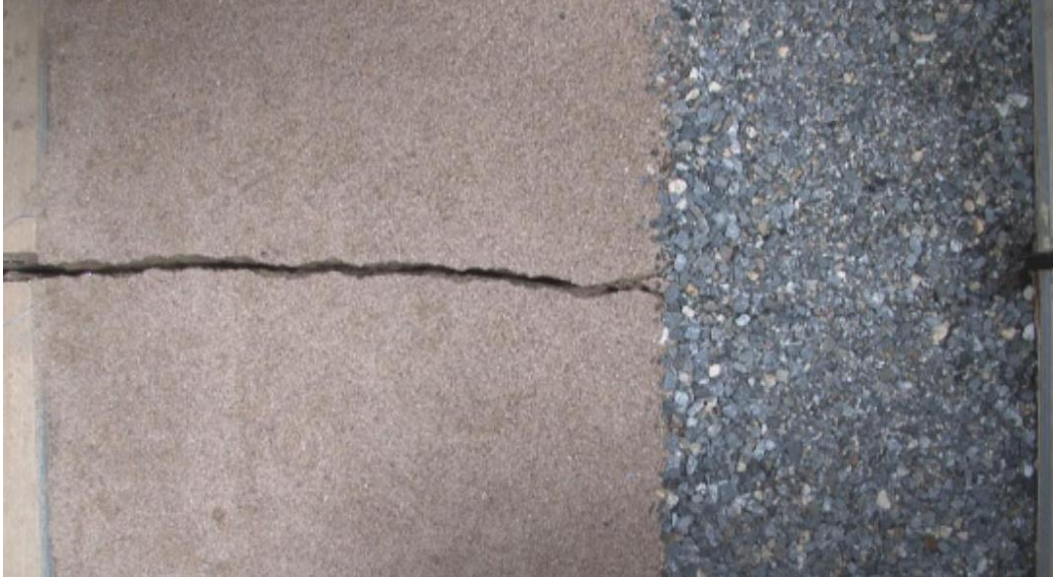
**Figure 18.—Overhead view of Test 10: 3 feet of sand compacted to 91.8% and 2 feet of compacted gravel.**

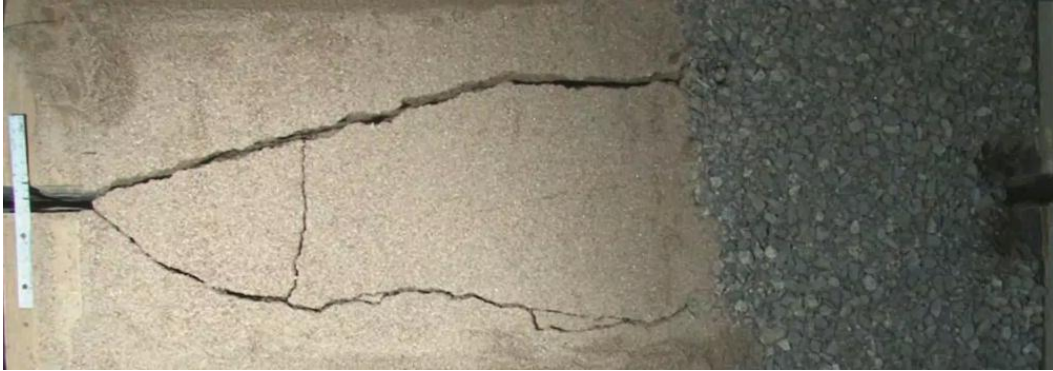
**Figure 19.—Overhead view of Test 11: 3 feet of sand compacted to 89.3% and 2 feet of compacted gravel.**

that meandered less than 1 inch in either direction. The two branches led into the gravel and were about 12 inches apart at that point.

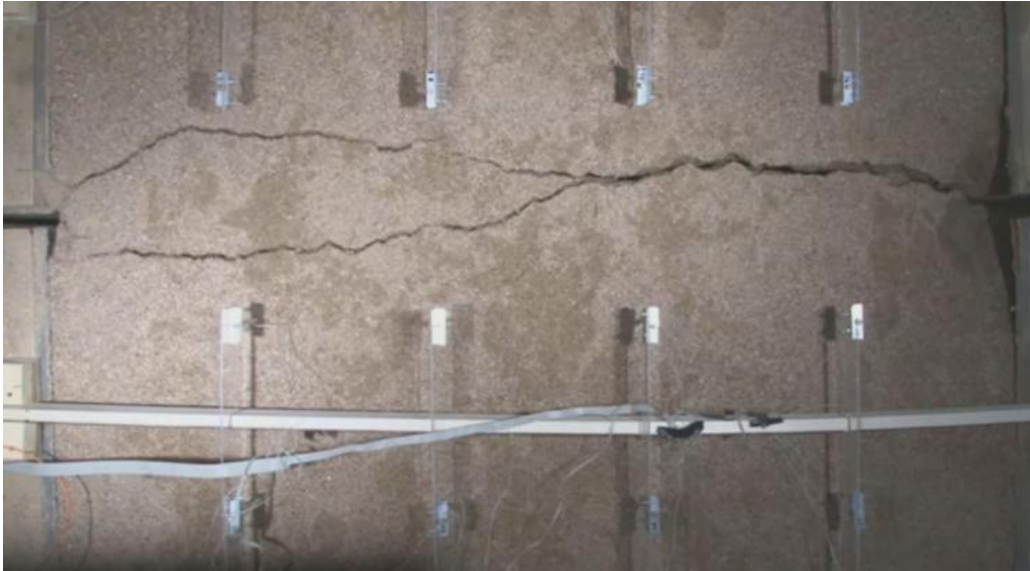
**Figure 20.—Overhead view of Test 12: 5 feet of sand compacted to 92.9%.**

Sand was placed up to a height of 48 inches, and the filter was 5 feet wide. Test 12 took place on January 17, 2012. Geophysics instrumentation was also included in this test. The geophysics equipment had no impact on the filter's performance, which is explained in detail in appendix D. The box was cracked approximately 1 inch (see figure 20). The crack walls were not vertical, and the crack branched at the upstream face. The branch caused a large wedge to form over the first 2.5 feet of the filter.

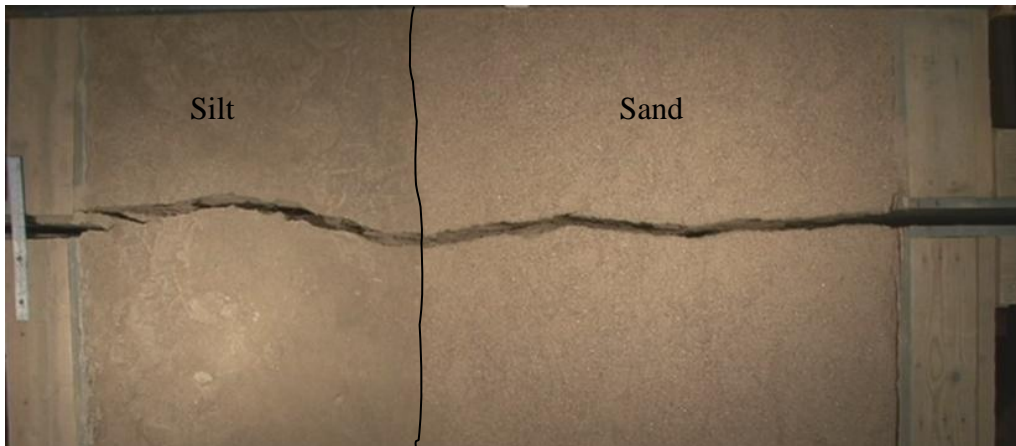
**Figure 21.—Overhead view of Test 13: 2 feet of silt compacted to 94.9% and 3 feet of sand compacted to 91.8%.**

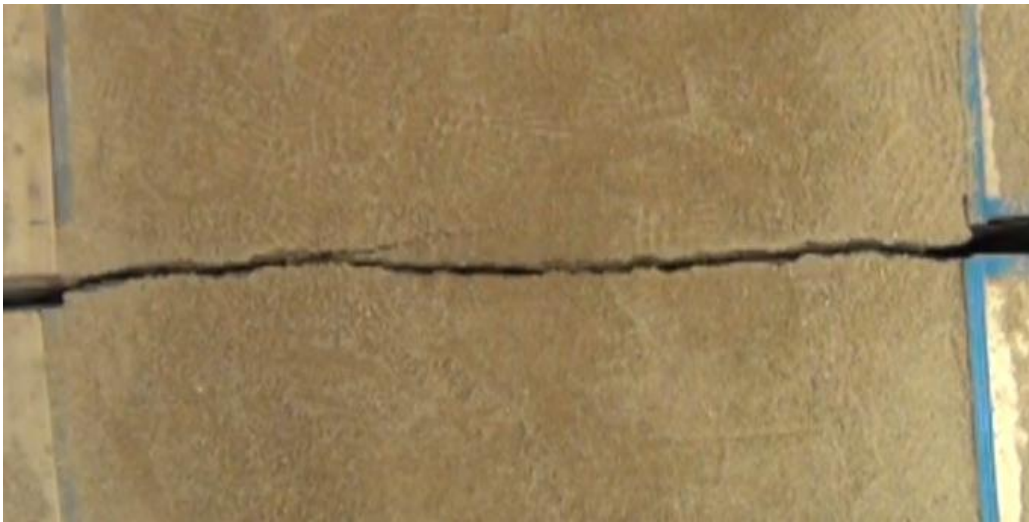
**Figure 22.—Overhead view of Test 14: 3 feet of sand compacted to 91.3%.**

The box was cracked approximately 1 inch (see figure 22). The sand sustained a crack that was mostly vertical and meandered less than 1 inch in either direction.

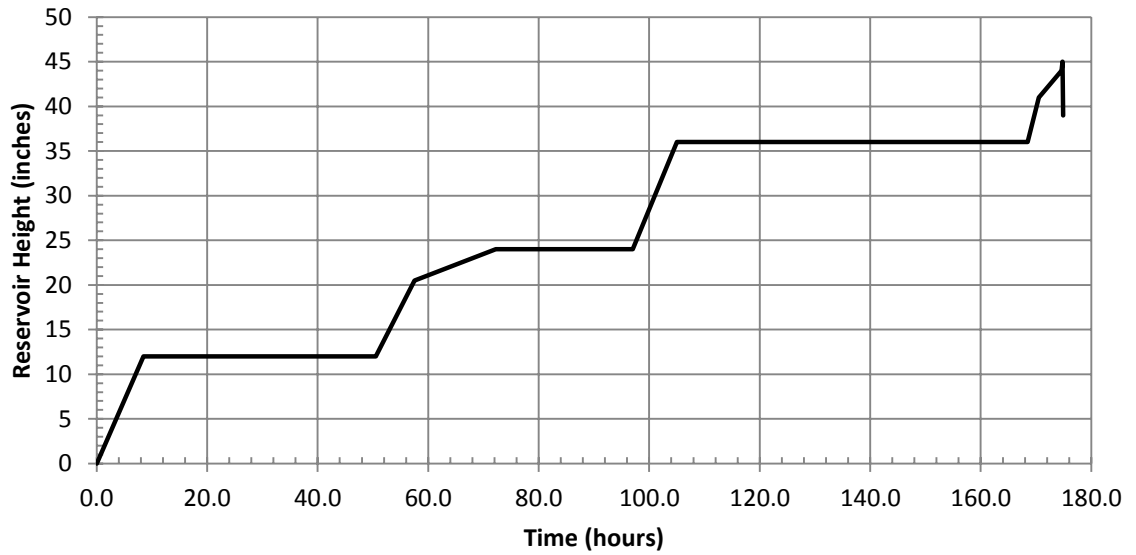
**Figure 23.—Test 14 reservoir timeline.**

This cycle can be seen clearly in Phase VI (test 14). In test 14, the filter stops any concentrated leaks until the reservoir is raised to within a few inches of the original height of the uncracked filter, and there is insufficient material above the water surface available to slough into and fill the crack.

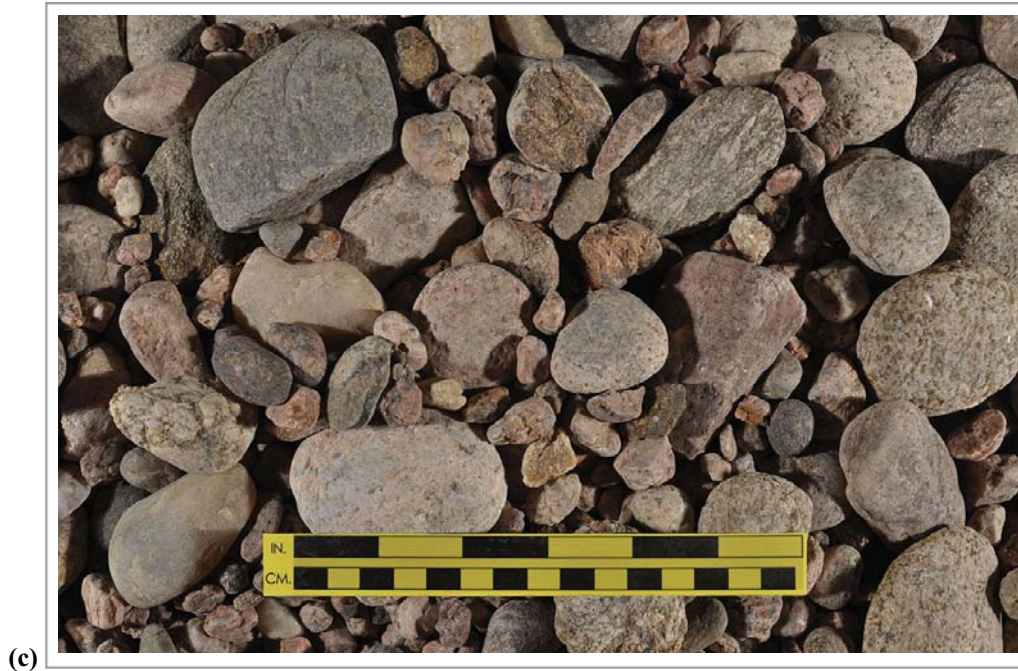
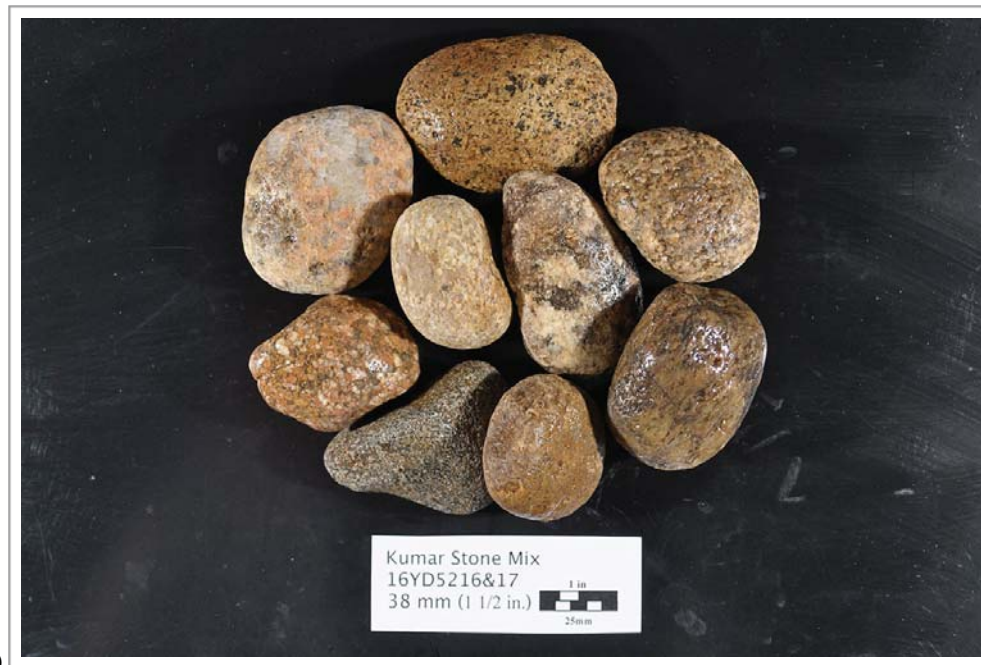
Figure 1. (a) Photograph of #4 stone in as-received condition. (b) Photograph of #57/67 stone in as-received condition.

**Figure 1 (cont'd).** (c) Photograph of #467 stone derived from mixing the #4 stone and the #57/67 stone. (d) Photograph of fraction retained on the 38 mm (1 1/2 in.) sieve.

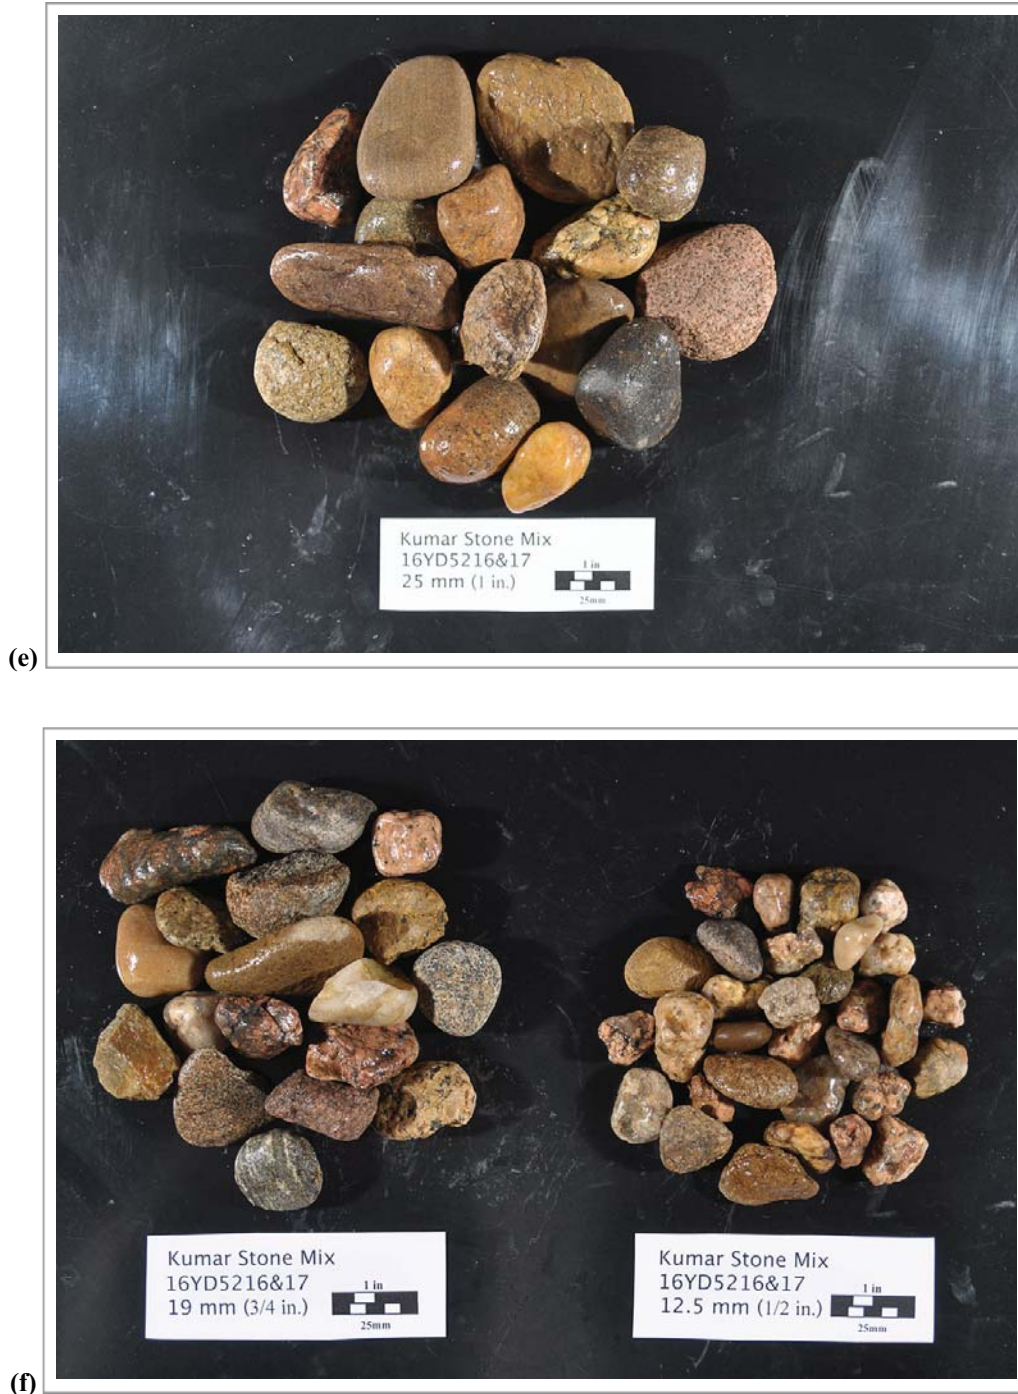
Figure 1 (cont'd). Photographs of #467 stone showing fractions retained on the (e) 25 mm (1 in.) sieve and the (f) 19 mm (3/4 in.) and 12.5 mm (1/2 in.) sieves.

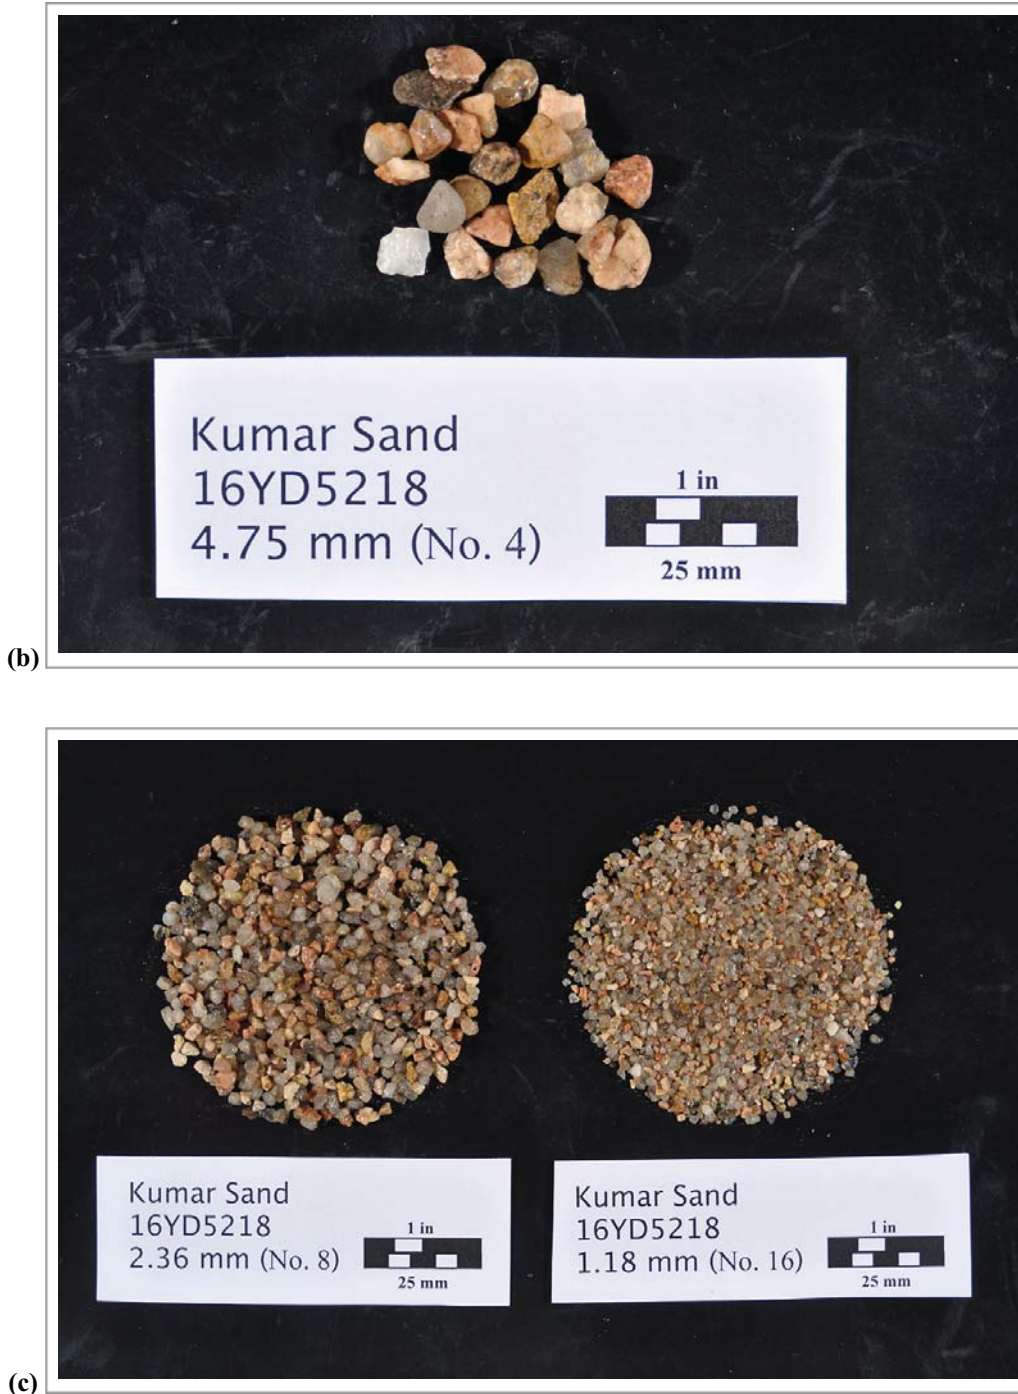
Figure 2 (cont'd). Photographs of concrete sand showing fractions retained on the (b) 4.75 mm (#4) sieve and the (c) 2.36 mm (#8) and 1.18 mm (#16) sieves.

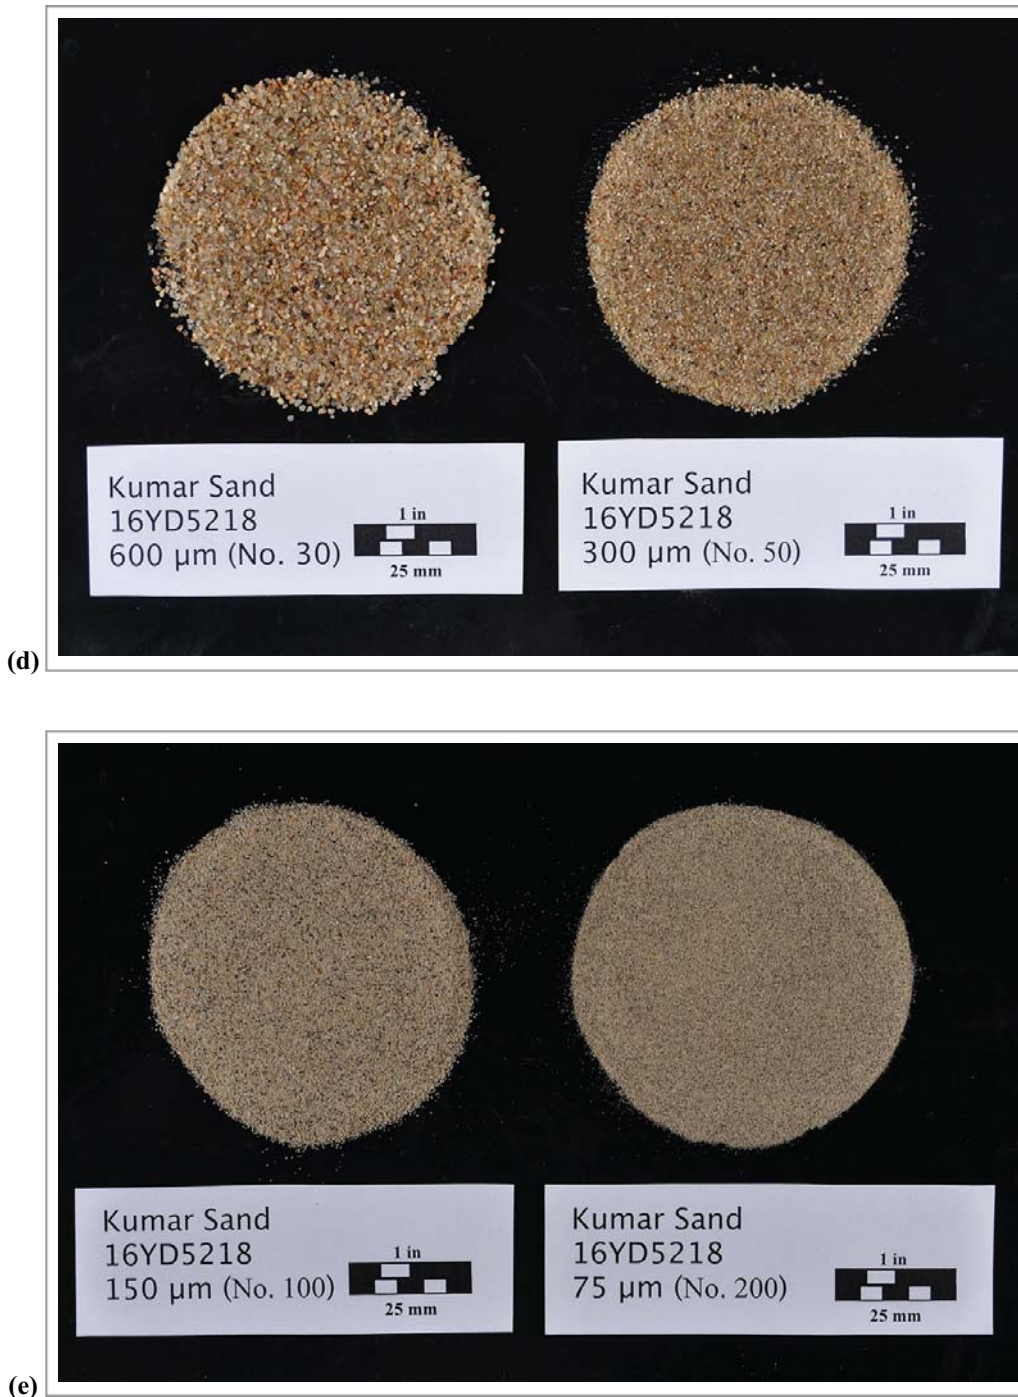
**Figure 2 (cont'd).** Photographs of concrete sand showing fractions retained on the (d) 600  $\mu\text{m}$  (#30) sieve and 300  $\mu\text{m}$  (#50) sieve and the (e) 150  $\mu\text{m}$  (#100) and 75  $\mu\text{m}$  (#200) sieves.
