Report DSO-2014-05

# Large-Scale Filter Performance Tests

Results of “Crack-Box” Testing

Dam Safety Technology Development Program  
U.S. Army Corps of Engineers Risk Management Center

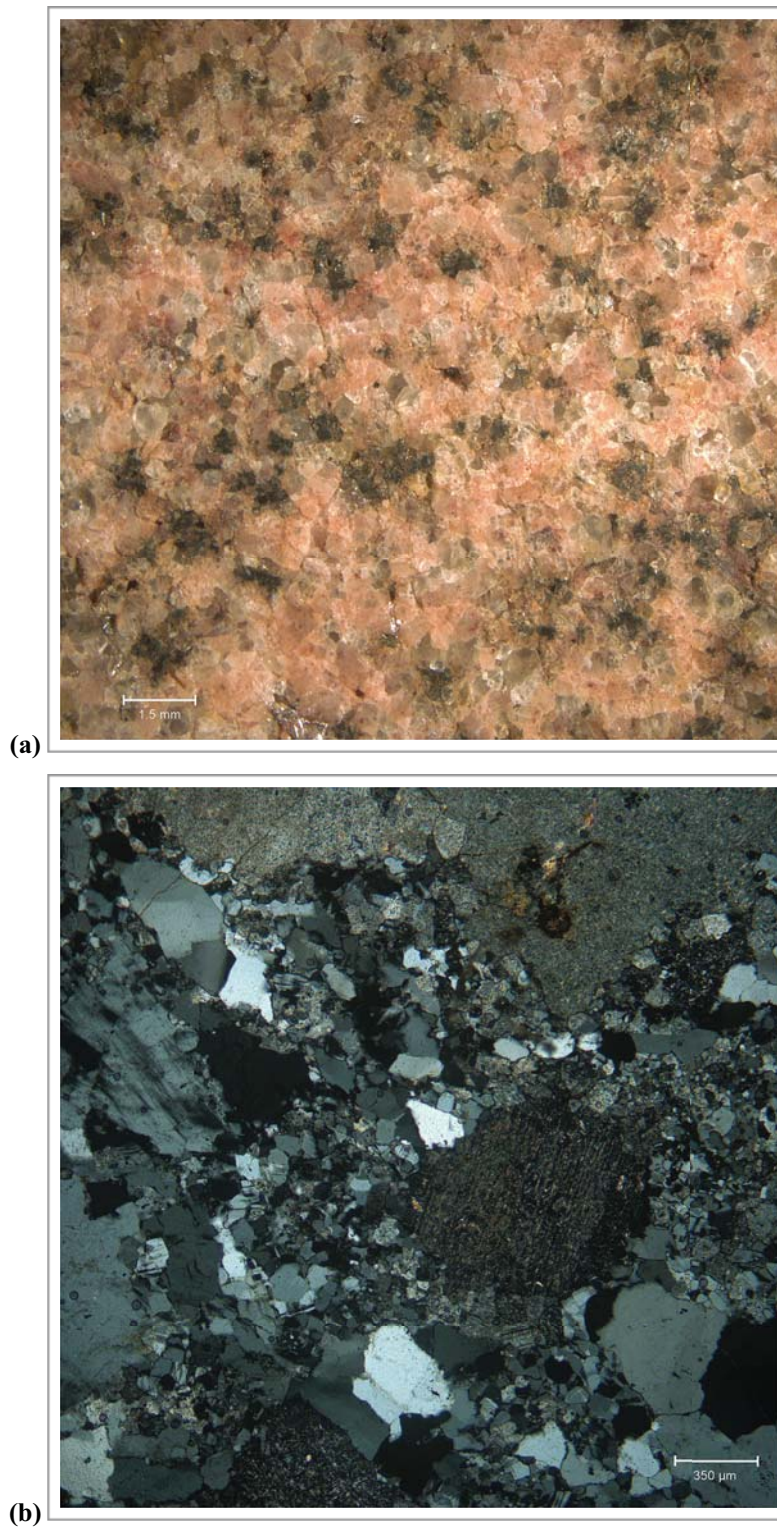
**Figure 3. (a) Reflected light photomicrograph of polished surface of red granite particle. (b) Cross-polarized transmitted light photomicrograph of thin section of red granite particle.**

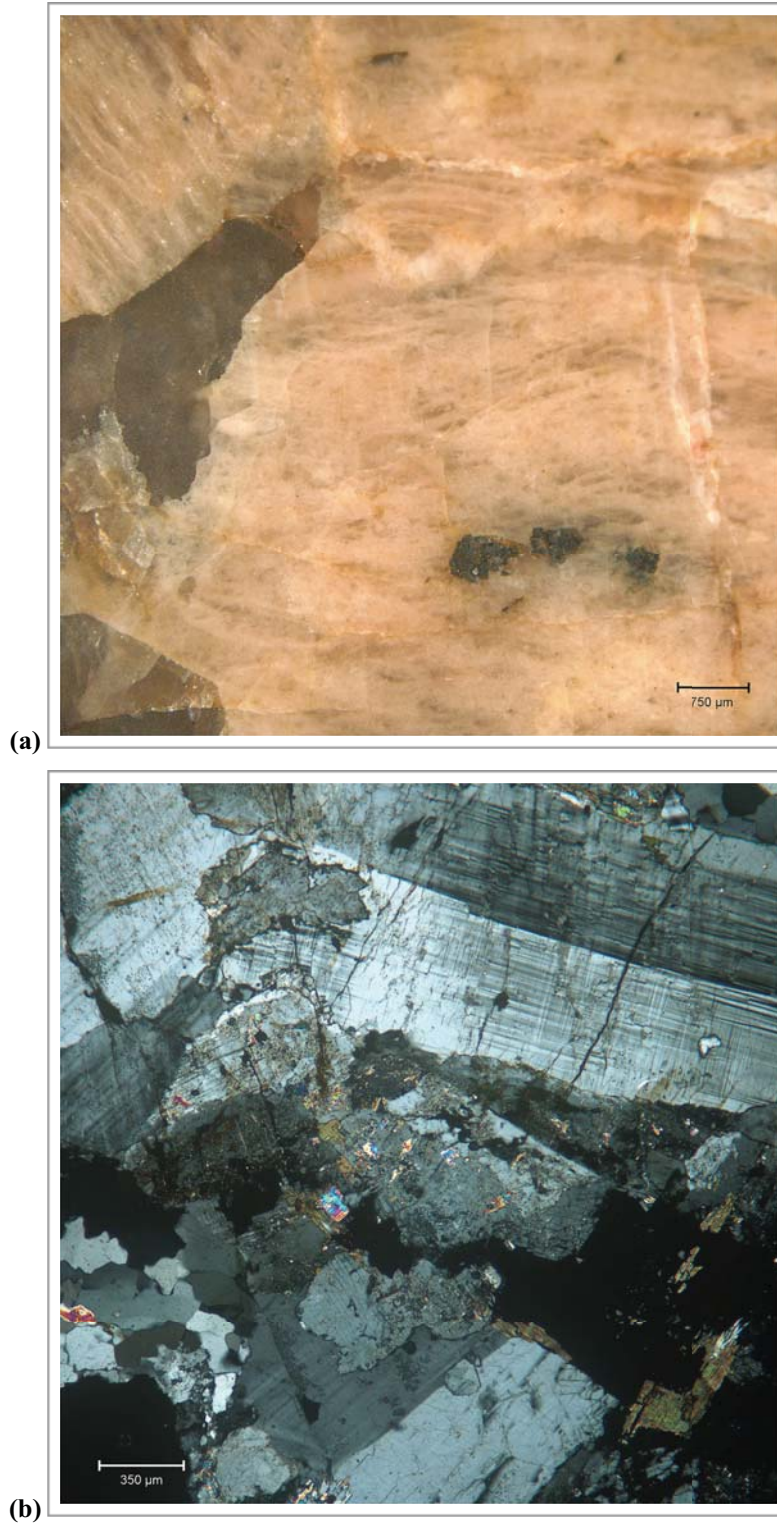
**Figure 4. (a) Reflected light photomicrograph of polished surface of white granite particle. (b) Cross-polarized transmitted light photomicrograph of thin section of white granite particle.**

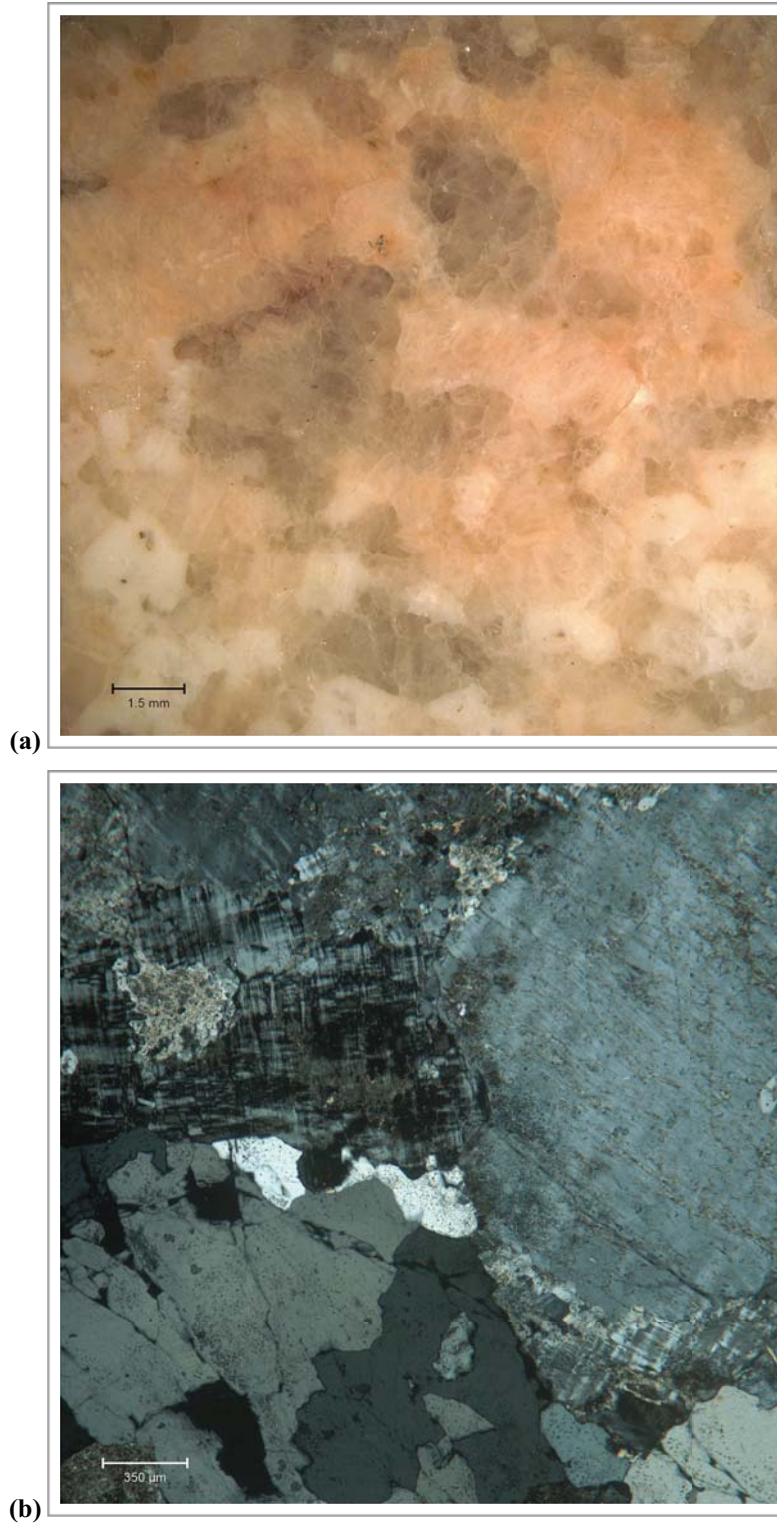
**Figure 5. (a) Reflected light photomicrograph of polished surface of leucogranite particle. (b) Cross-polarized transmitted light photomicrograph of thin section of leucogranite particle.**

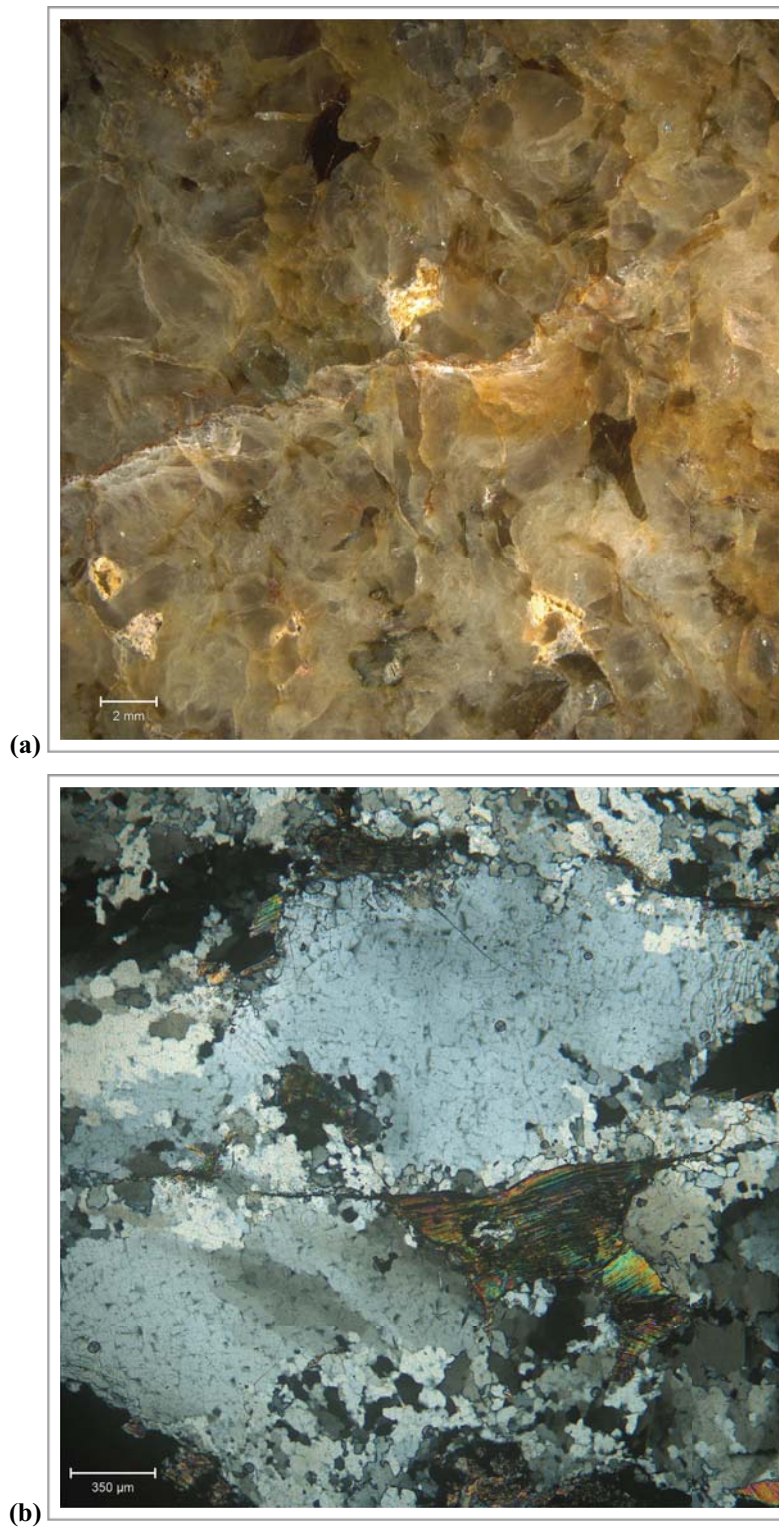
**Figure 6. (a) Reflected light photomicrograph of polished surface of black granite particle. (b) Cross-polarized transmitted light photomicrograph of thin section of black granite particle.**

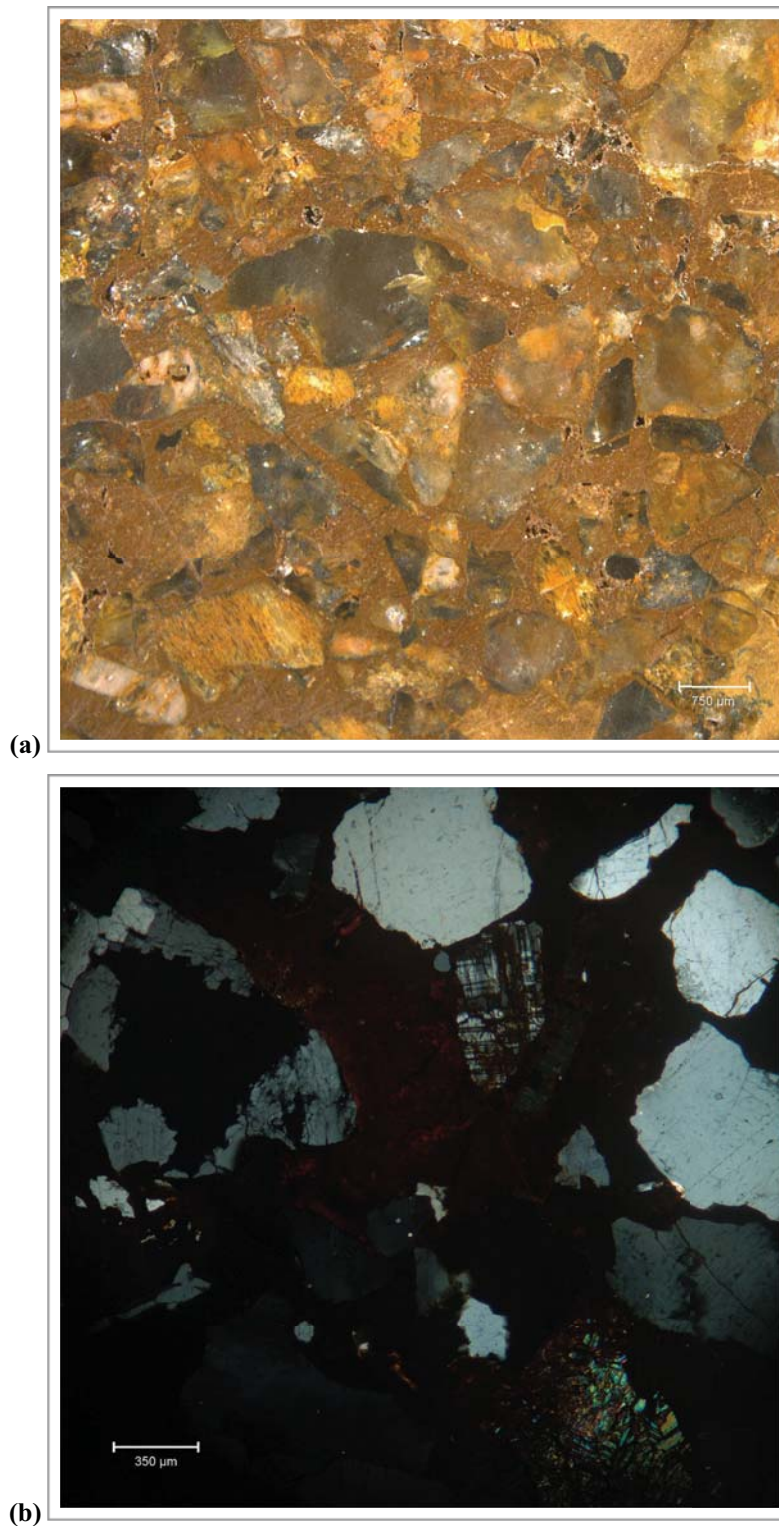
**Figure 8. (a) Reflected light photomicrograph of polished surface of arkosic quartzite particle. (b) Cross-polarized transmitted light photomicrograph of thin section of arkosic quartzite particle.**

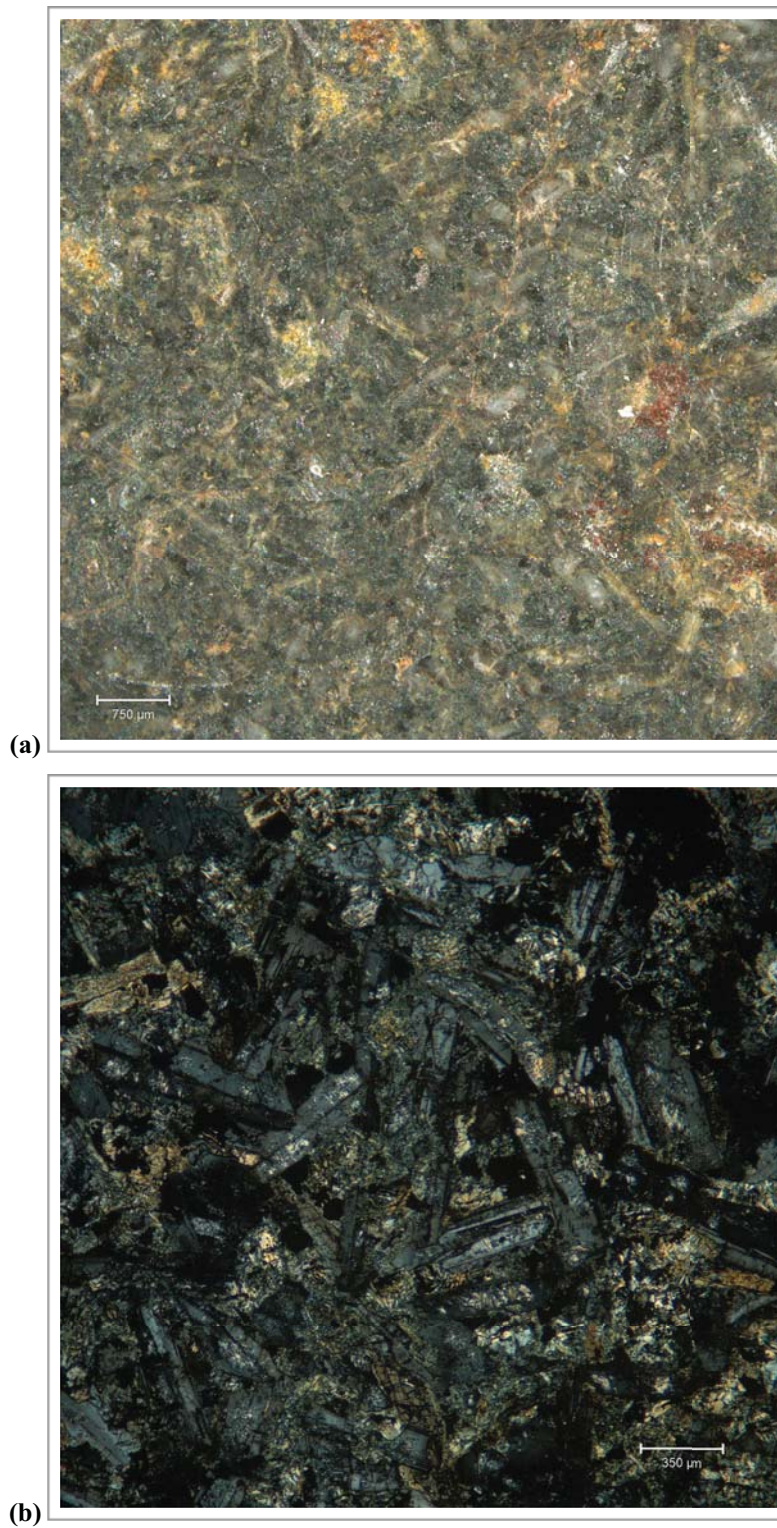
**Figure 9. (a) Reflected light photomicrograph of polished surface of diorite particle. (b) Cross-polarized transmitted light photomicrograph of thin section of diorite particle.**

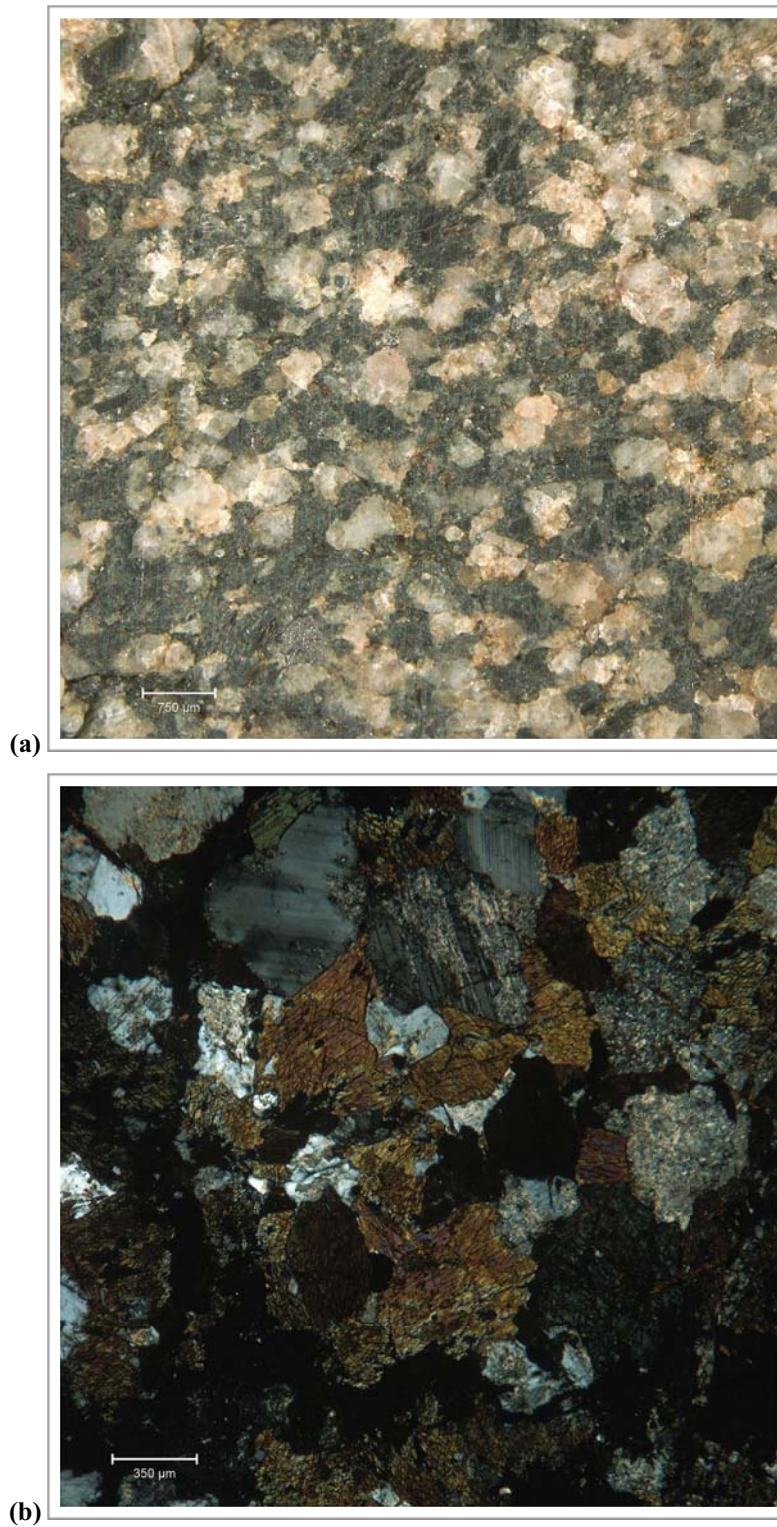
**Figure 10. (a) Reflected light photomicrograph of polished surface of amphibolite particle. (b) Cross-polarized transmitted light photomicrograph of thin section of amphibolite particle.**

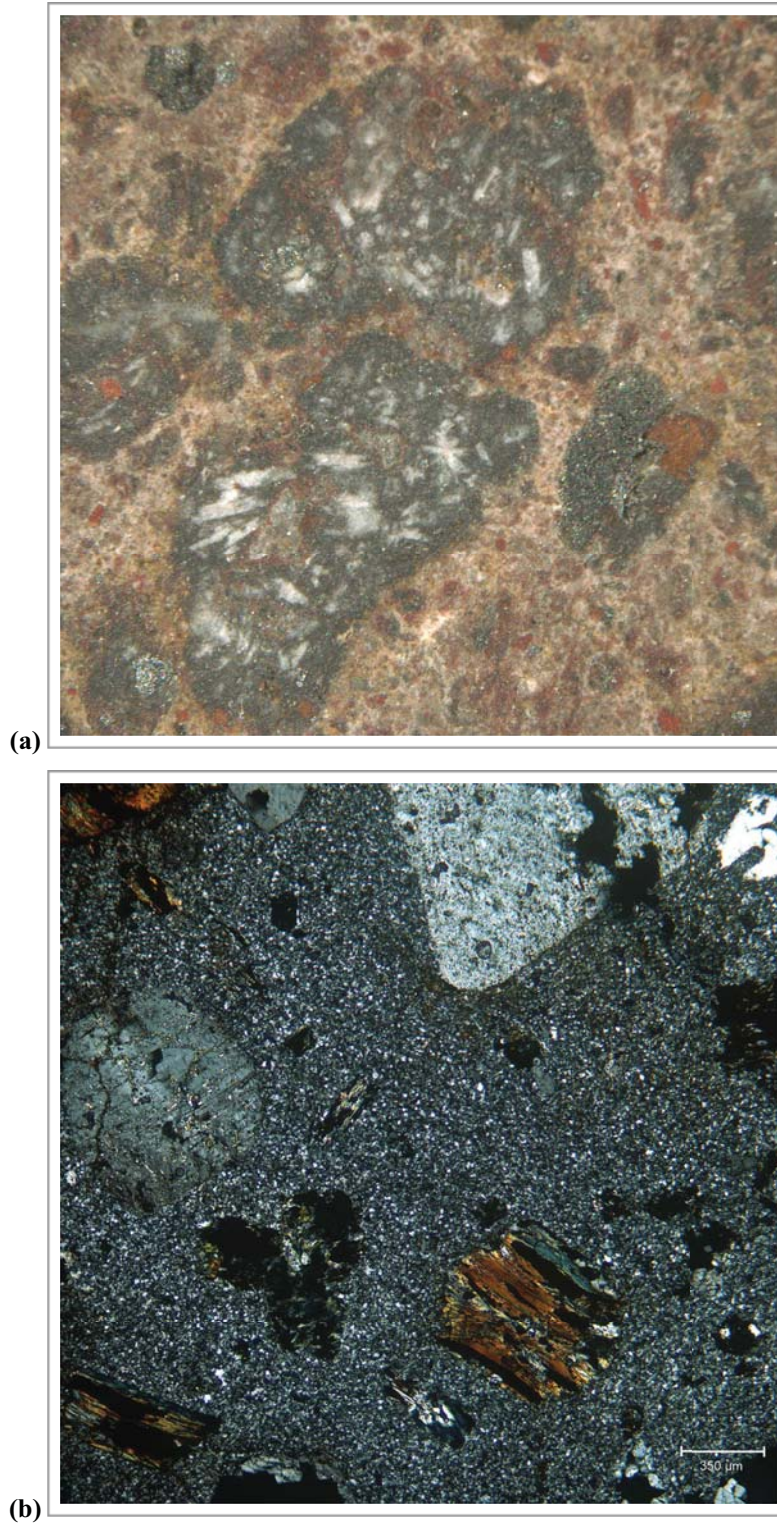
**Figure 11. (a) Reflected light photomicrograph of polished surface of rhyolite particle. (b) Cross-polarized transmitted light photomicrograph of thin section of rhyolite particle.**

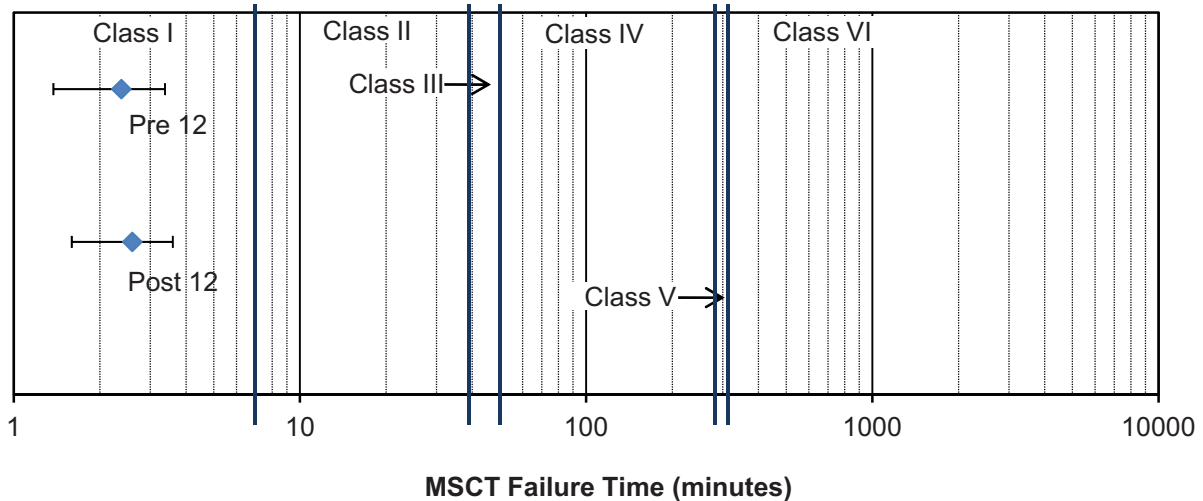
Figure 1: MSCT Failure times

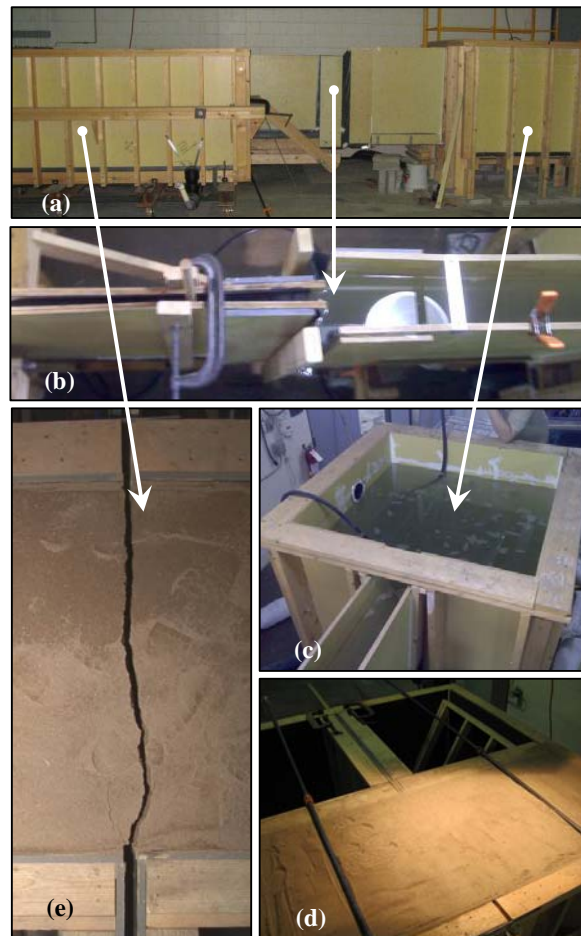
**Figure 1: Laboratory layout of filter model showing: (a) assembled model, (b) upstream channel, (c) constant head reservoir, (d) uncracked filter, and (e) cracked filter (2.5 cm)**

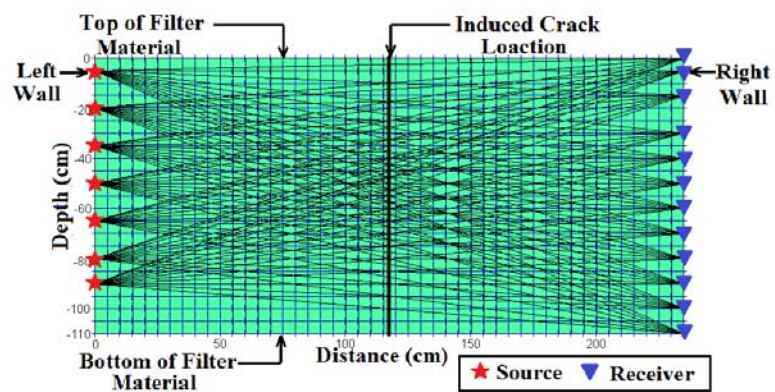
Figure 2. Approximate CT raypath coverage between source (left edge) and receiver (right edge) locations for T11 and T12 (boxes represent discretization for tomography modeling)

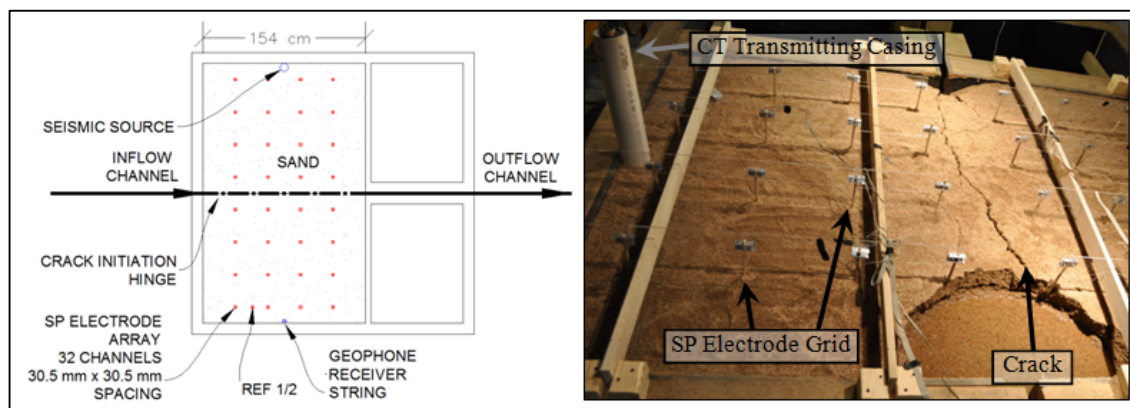
**Figure 4. Schematic (left) and post-crack photograph (right) of filter geometry and instrumentation for T12 – single stage filter**

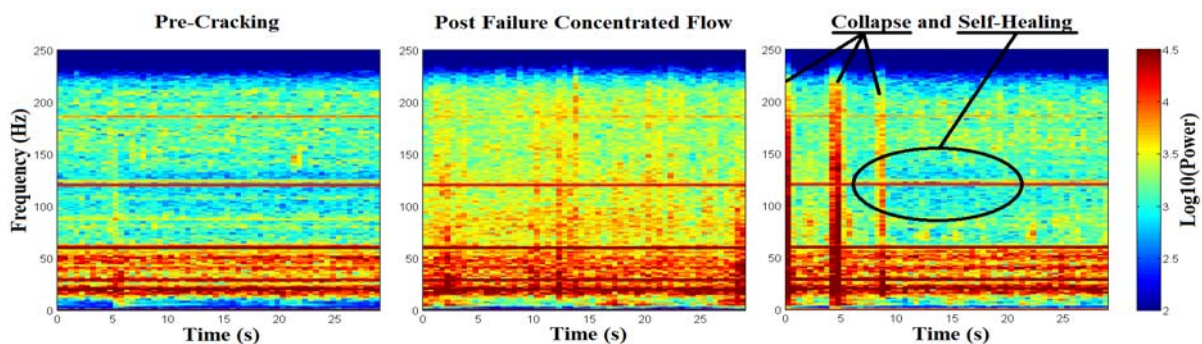
Figure 5. AE signatures during three stages of T12: Pre-cracking baseline (left), post filter cracking during concentrated flow (center), and subsequent sidewall-collapse and self-healing events (right)

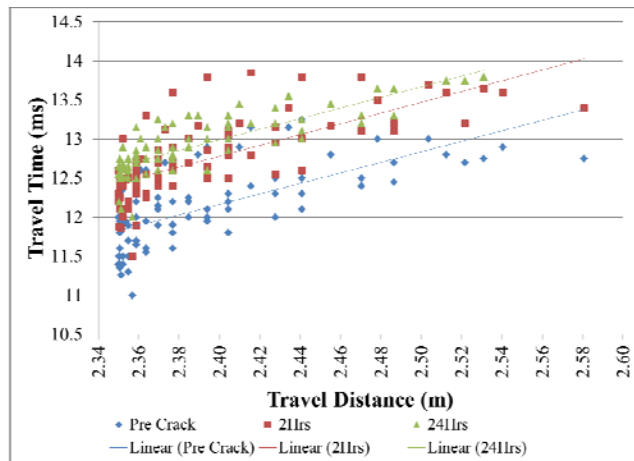
Figure 6. Scatter plots of p-wave travel time versus source-receiver separation for T12 data. Trend lines have been added to depict the overall relative decrease in calculated velocities over the course of T12.

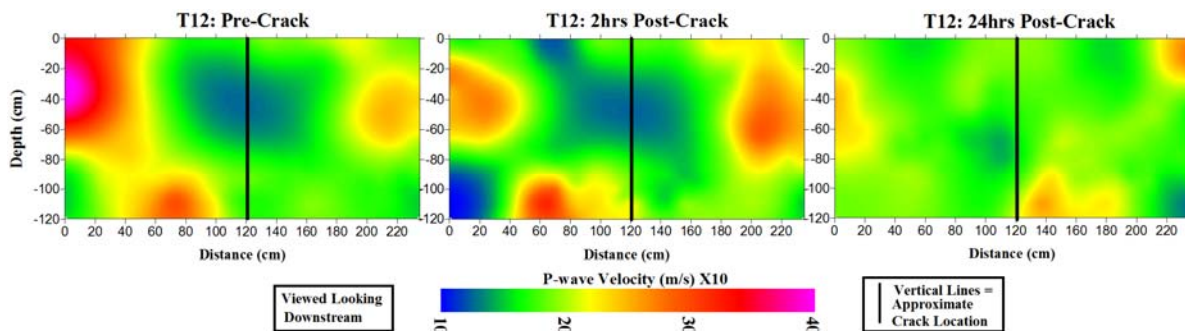
Figure 7. P-wave tomograms for T12 data collected pre-crack (left panel), and 2hrs and 24hrs after cracking of filter material and subject to concentrated flow (center panel and right panel respectively)
