# **Upper Verde River Habitat Analysis Executive Summary 2020 - 2023**

Prepared by the U.S. Rocky Mountain Research Station and Northern Arizona University in cooperation with the Prescott National Forest and the U.S. Bureau of Reclamation.

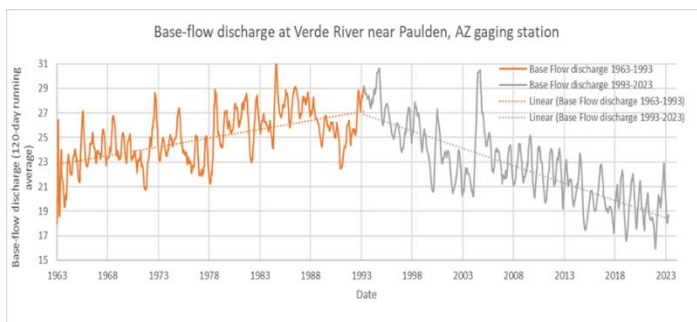
**Figure 4** Baseflow decline in the Upper Verde River since 1993. Data taken from the USGS stream gauge at Paulden, Arizona. Credit Joel Unema, USGS  
URL: <https://waterdata.usgs.gov/nwis/monthly?>

high of 30.6 cubic feet per second (cfs) in 1995 to recent lows in 2023 of just over 18 cfs (Figure 4). Inputs from the upper Verde Valley sub-basin, the portion of this study which extends from Hell Canyon down to Sycamore Canyon, while subject to climatic trends are less impacted by human development and may prove to be more resilient (Garner et al. 2013).

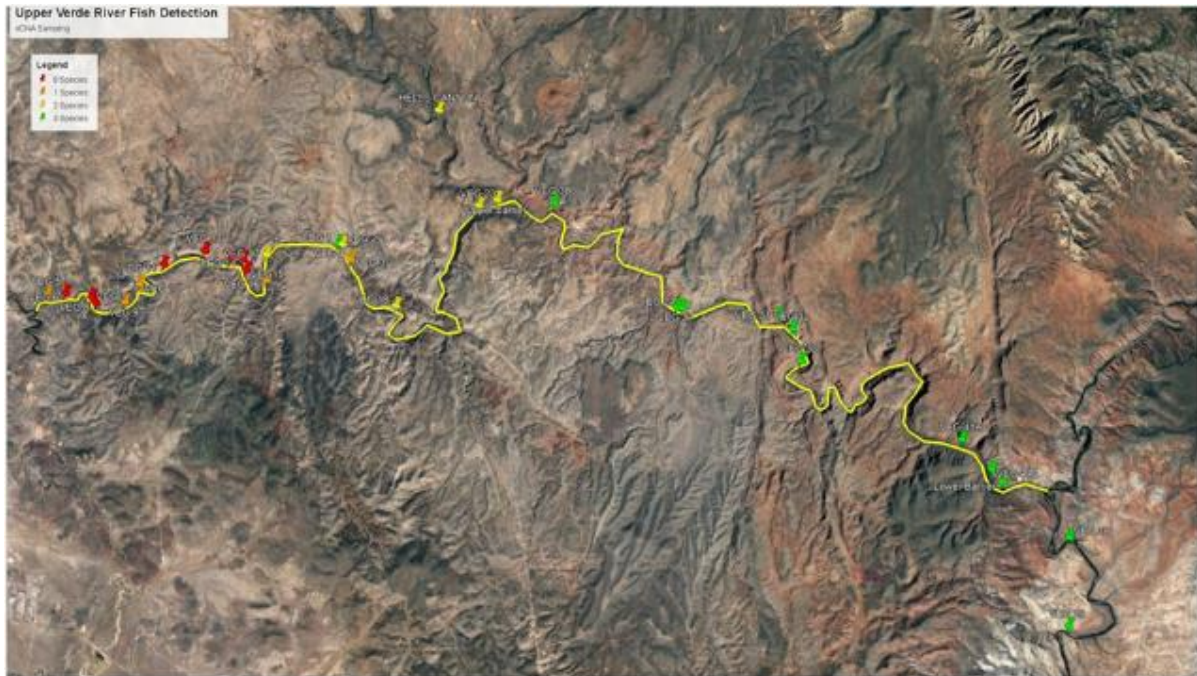
**Figure 10:** Locations sampled with eDNA species detection methodology. Of the native species sampled, Red pins = no native species present, orange pins = 1 species present, yellow pins = 2 species present, and green pins = 3 species present.

Both species of sucker were detected at the seventeen remaining sites with the exception of desert sucker at a single site near kilometer twelve. Roundtail chub was detected at eleven of the remain seventeen sites, continuously present from the confluence with Hell Canyon down to the confluence with Sycamore Creek, approximately the lower half of the study area (Table 6). The results of this sampling is supported by similar results gathered by the Arizona Game and Fish Department in 2022/23 using canoe mounted electrofishing methods at several sites along the UVR (Stites and Chmiel 2022, Jackson and Chmiel 2023).

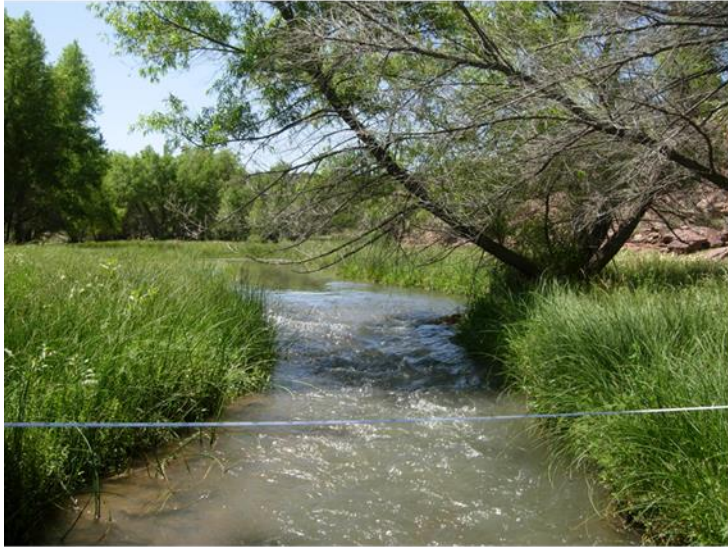
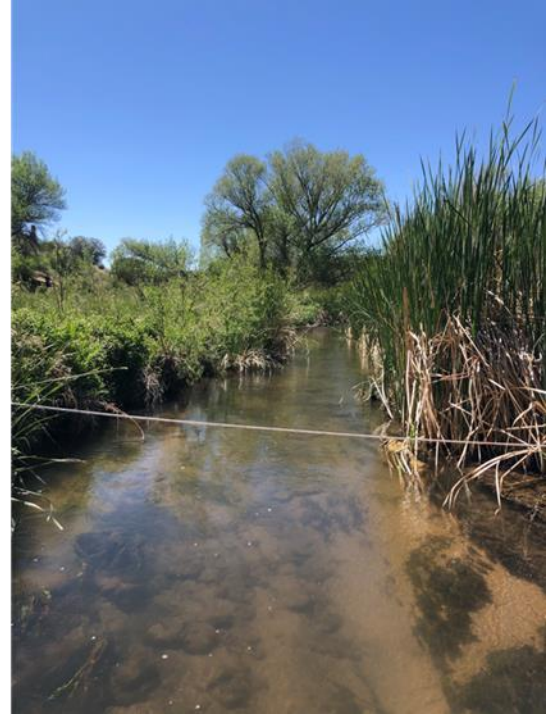
**Figure 12:** Photographs from 2009 (Panel A) and 2021 (Panel B) at Plot #1 illustrating the changes in riffle habitat and cattail density over the study period.
