Enhanced Recharge Demonstration Project, Increasing Treated Effluent Recharge Rates in the Santa Cruz River, Tucson, Arizona

U.S. Department of the Interior
Bureau of Reclamation
Phoenix Area Office

April 2012

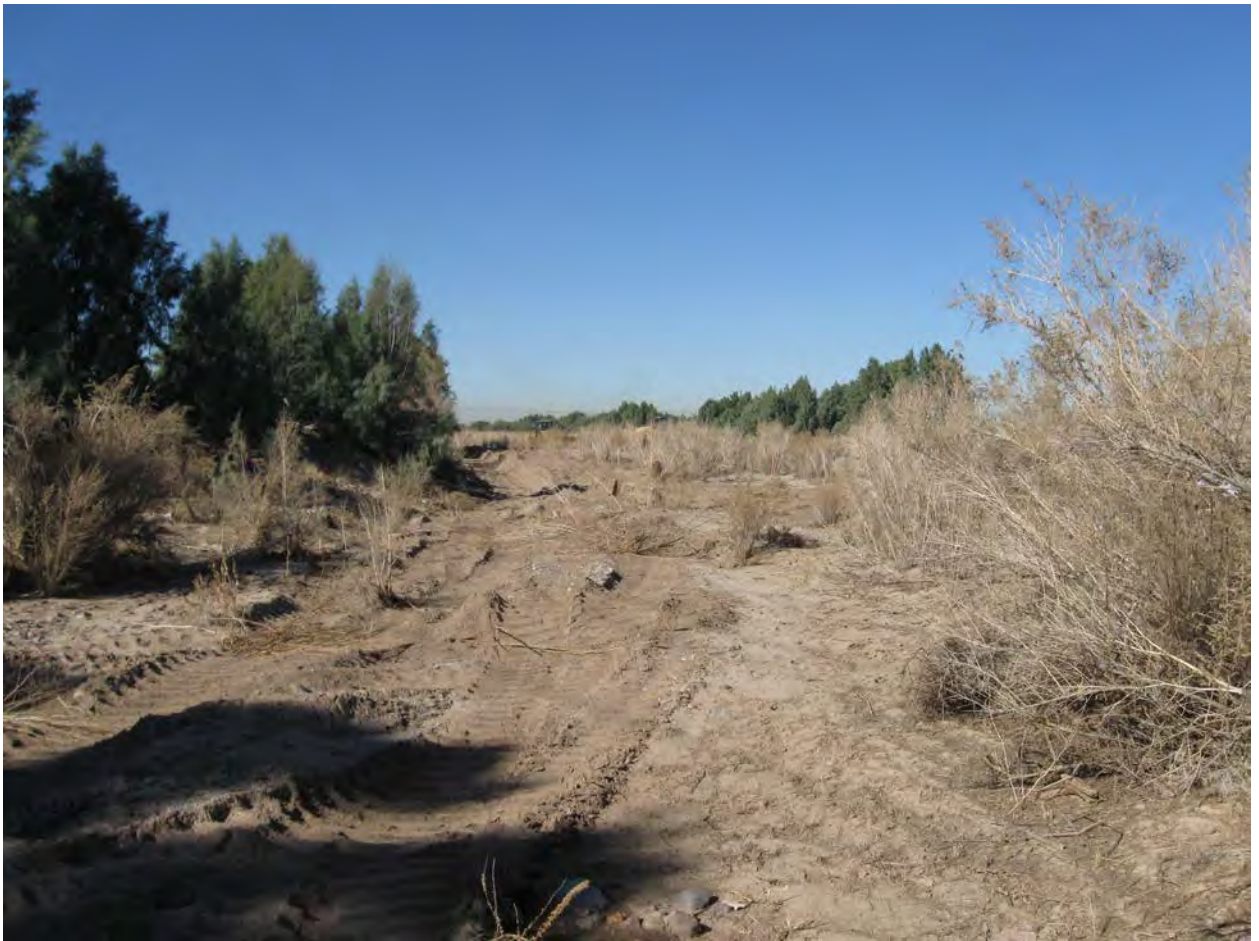
Photo 1. – Vegetation Cleared and Start of Excavation in Channel 1.

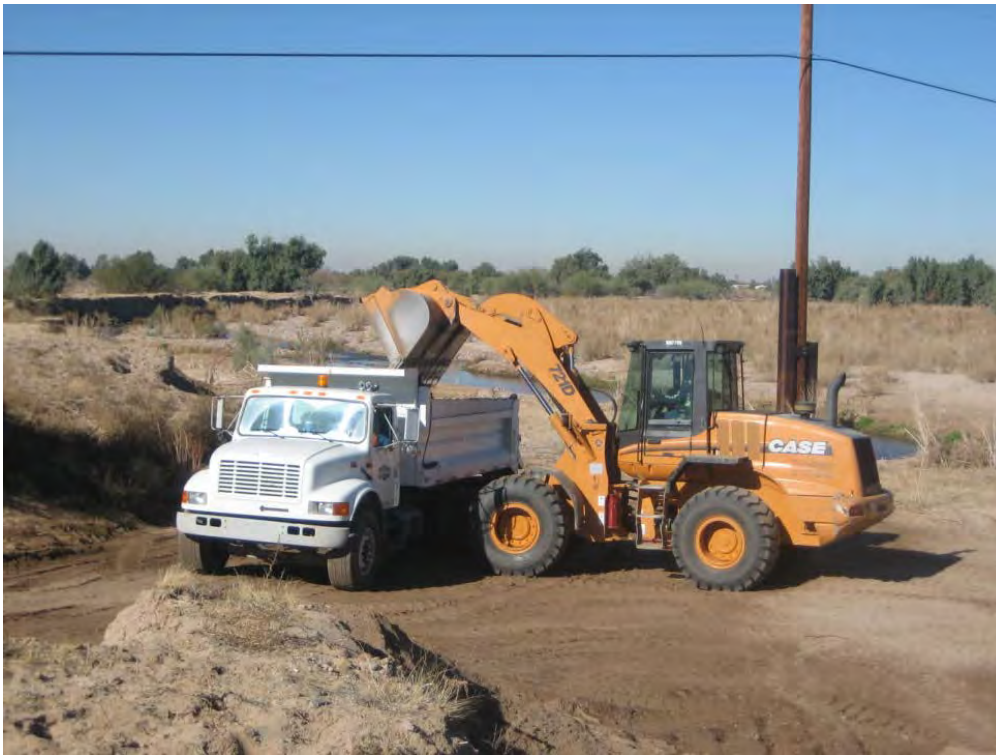
Photo 2. – Removal of Excavated Material during Excavation.

All excavated material was placed in a dump truck and transported out of jurisdictional waters and deposited on the access roads up to the oxbow culvert crossing. Additional excavated material was stock piled at the culvert crossing until it was spread by front end loaders.

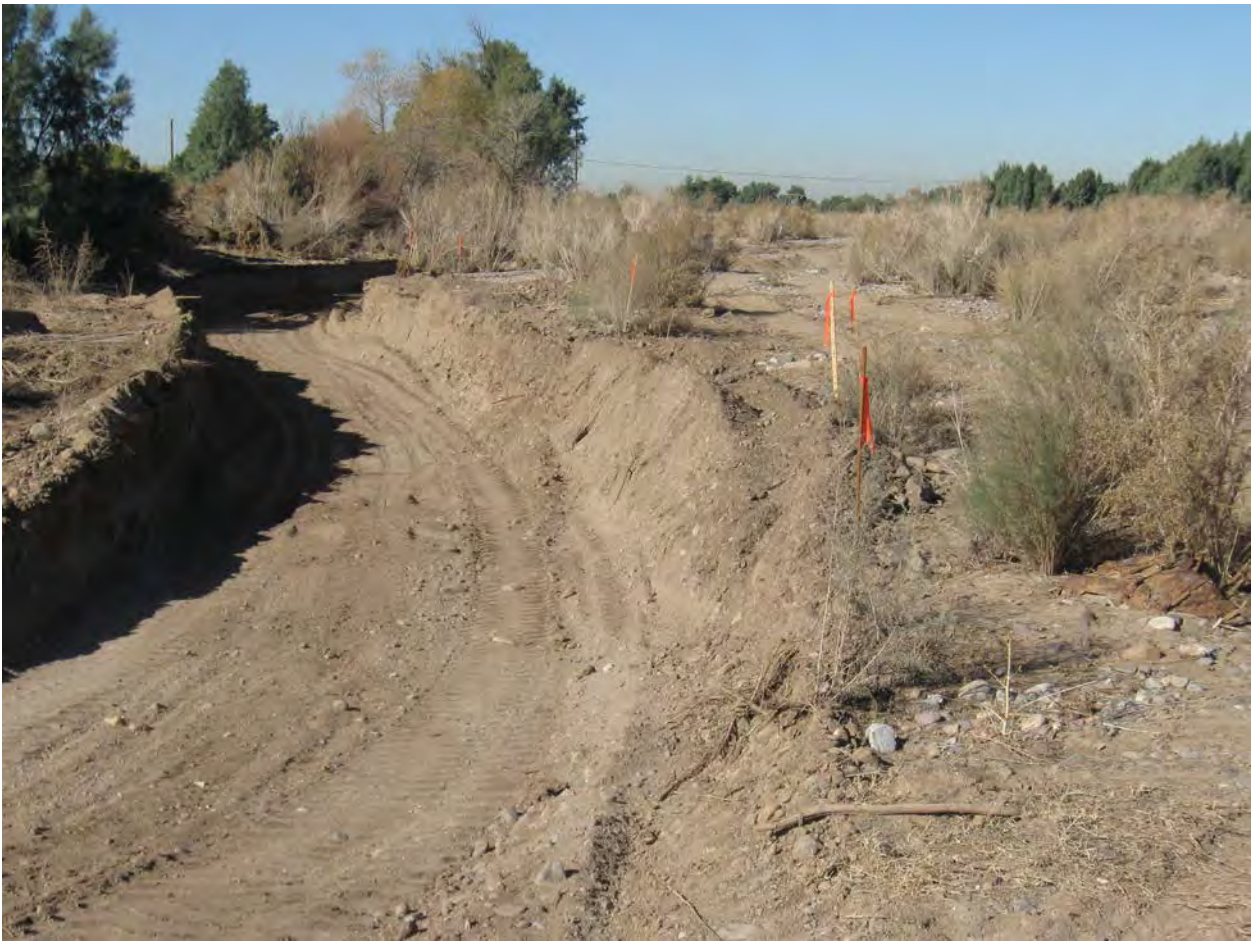
Photo 3. – Completion of Channel 1 Excavation.

Excavation at Channel 1 was completed on January 7, 2011. Excavation began at Channel 2 on January 6, 2011 and was completed on January 12, 2011. Construction was originally estimated to take 10 to 15 days and instead was completed in 8 days.

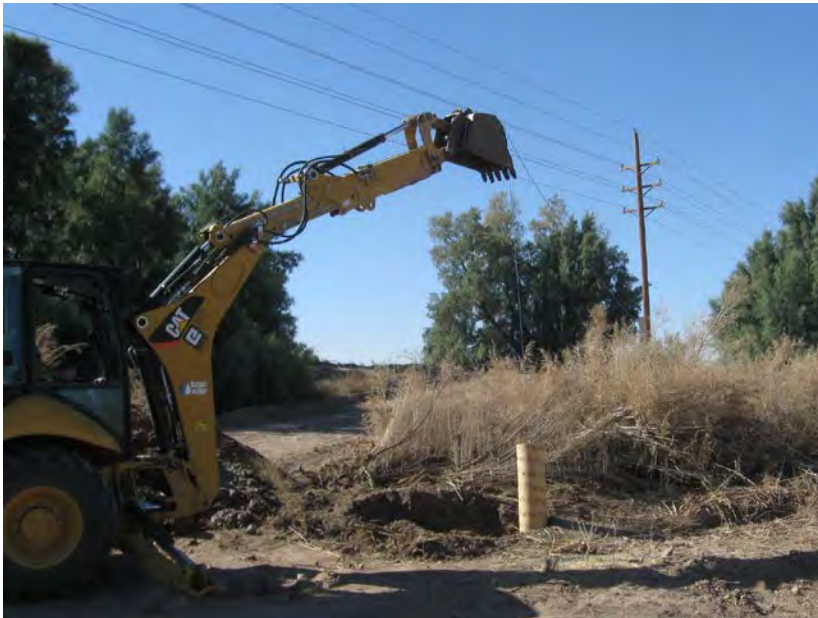
Photo 4. – Placement of Concrete Anchor for Upstream Flume.

On January 28th, a backhoe was used to excavate holes for the flume anchors which consisted of buried concrete weights. During excavation of the downstream anchor hole, soil moisture was encountered at approximately 7 feet below land surface (ft, bls). The upstream anchor hole was excavated to approximately 10 ft, bls and seeping water was observed at approximately 7 ft, bls. The upstream anchor hole consisted of sand and silt from 0 to 7 ft, bls, pebbles from 7 to 7.5 ft, bls, and clay at 7.5 ft, bls. Another hole was excavated to approximately 10 ft, bls between the SCR flow channel and the east side of Channel 2. The material consisted of brownish-tan sand and silt with lenses of black sand. Water seeped into the hole at approximately 6 ft, bls.

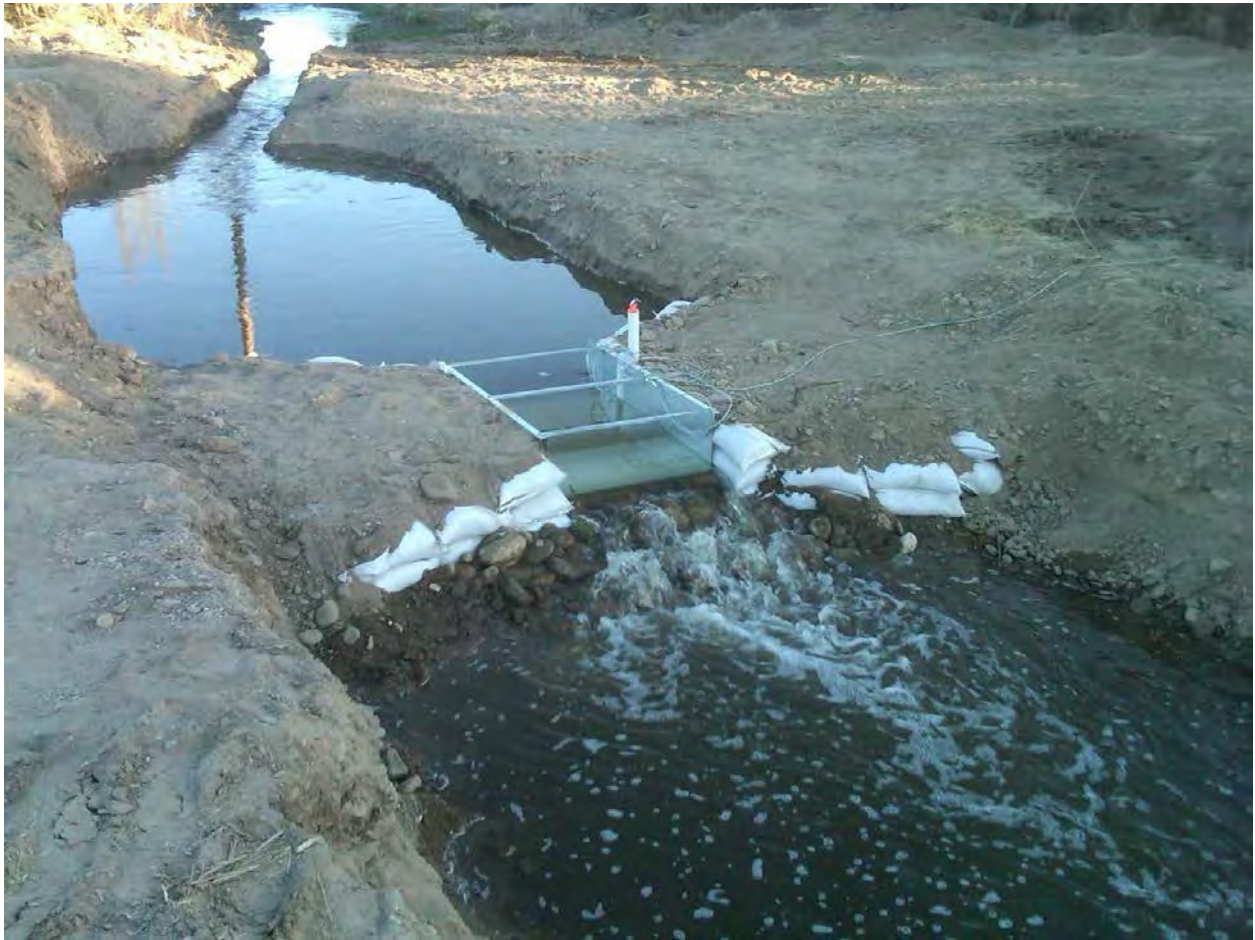
Photo 5. – 10 cfs Maximum Capacity Non-Adjustable EF10 Galvanized Steel Nuway “EZ Flow” and Stilling Well with Locking Cap.

The flumes were equipped with direct reading, 1 to 10 cfs, sidewall gauges for on-site flow volume readings. PVC stilling wells with locking caps were attached to the flumes for transducer/datalogger installation. The stilling wells were vented to the atmosphere. The flumes were anchored with a cable to a concrete weight buried in the channel alluvium below scour depth to secure the flumes during flood events. The scour depth was determined by the project engineers to be 10 ft below the river bed.

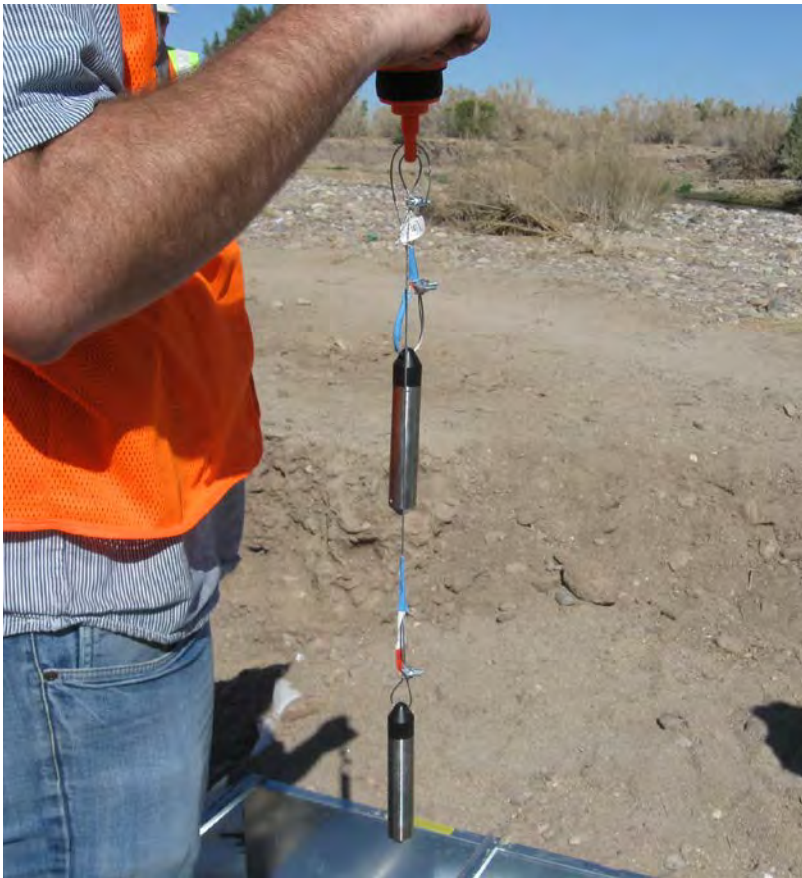
Photo 6. – HOBO U20 Water Level Logger's.

Reclamation purchased three HOBO U20 Water Level Logger's, a Waterproof shuttle, and HOBOWare Pro data processing software for Windows. The U20 HOBO Water Level Loggers measure absolute pressure that is later converted to water level measurements and ultimately into flow volumes. The loggers measure within a water depth range of zero to thirteen feet and have a pressure range of zero to twenty-one pounds per square inch. Absolute pressure includes atmospheric pressure and water head which is compensated with barometric pressure measurements. Three loggers were installed in the stilling wells. Two loggers were installed in the upstream flume, one to measure barometric pressure and one to measure water levels. One logger was installed in the downstream flume to measure water levels. The loggers were programmed to store data every half hour and were downloaded during site visits.

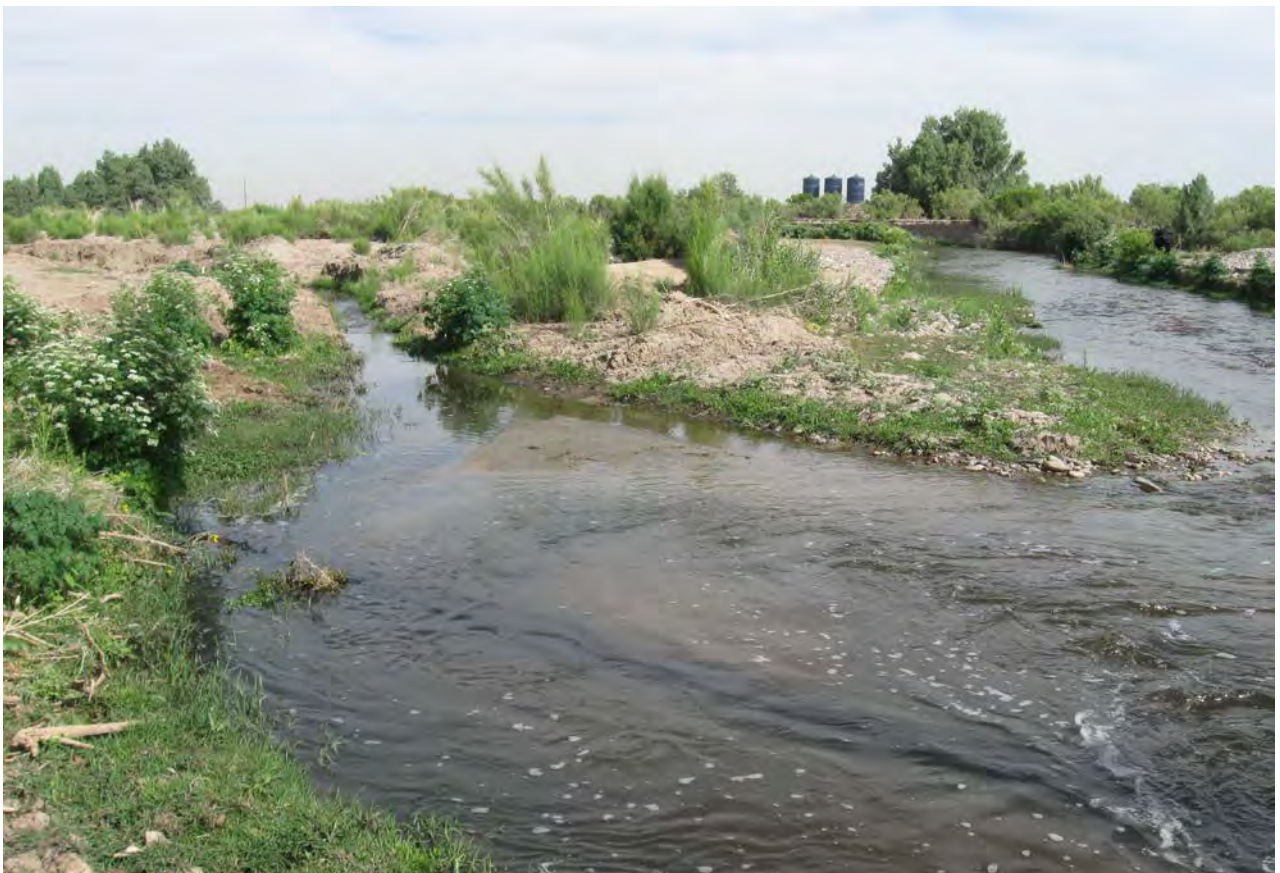
Photo 7. – Looking Downstream at the Diversion from the SCR Flow Channel (on Right) into the ERDP (on Left).

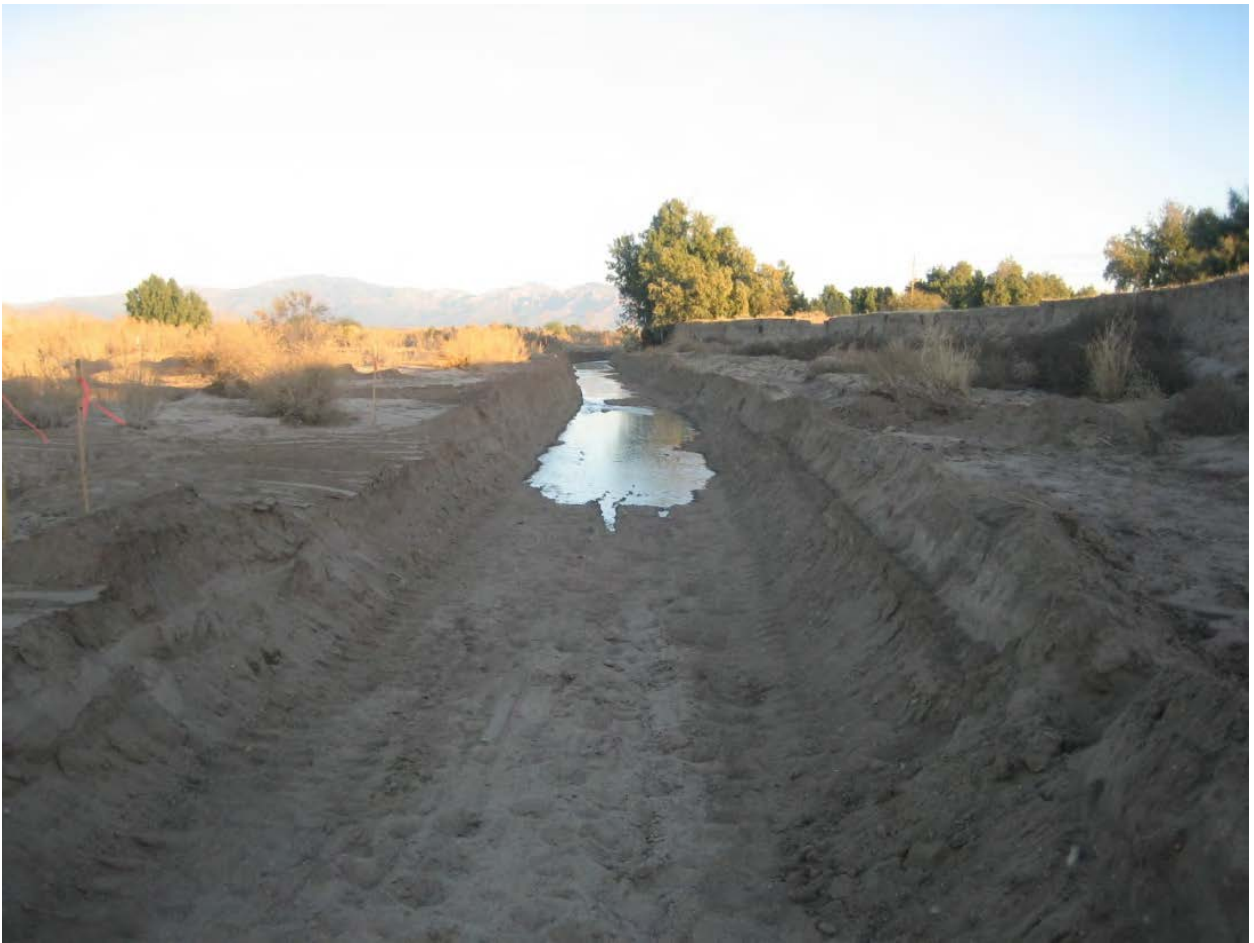
Photo 8. – Water First Diverted to ERDP on January 28, 2011. Note fines on bottom of Channel 1.

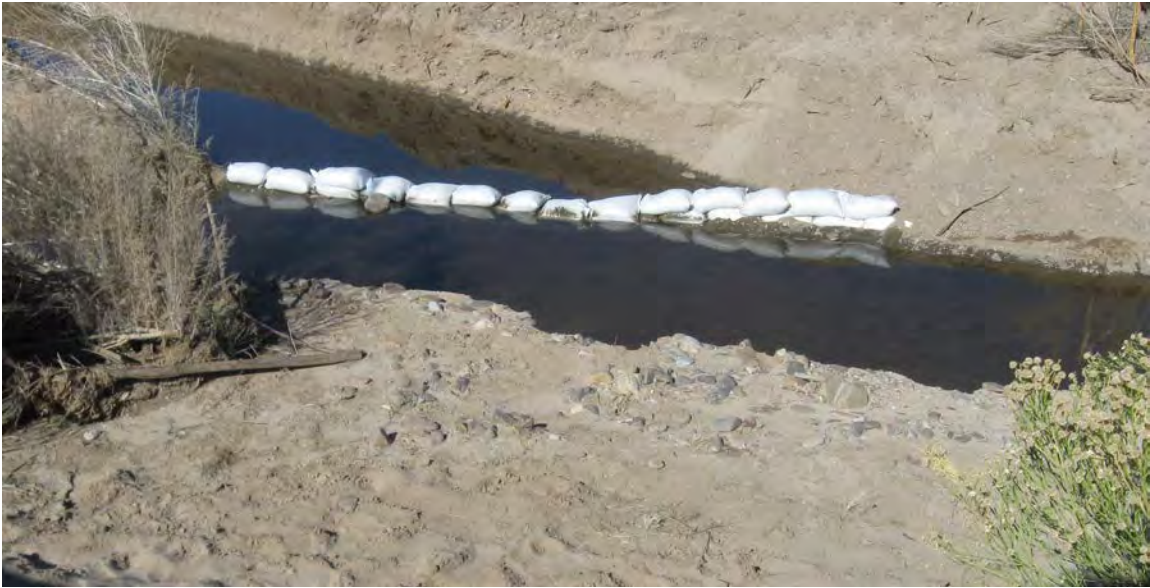
Photo 9. – Sandbag and Dirt Berm Barrier Breached at Divergence of Channels 1 and 2.

maintenance. To accomplish this, a low dirt berm and a row of sand bags were placed at the divergence between Channel 1 and Channel 2. A low dirt berm was also placed at the downstream convergence between Channel 1 and Channel 2. These flow barrier measures were not effective. When water was diverted into the project, the berm and sand bags were breached at the divergence and the berm was breached at the confluence and Channel 2 was wetted. Throughout the duration of the project both channels were wetted during operations and both channels were dried during maintenance. In the future, more rigorous designs are required to ensure that water barriers are not breached.

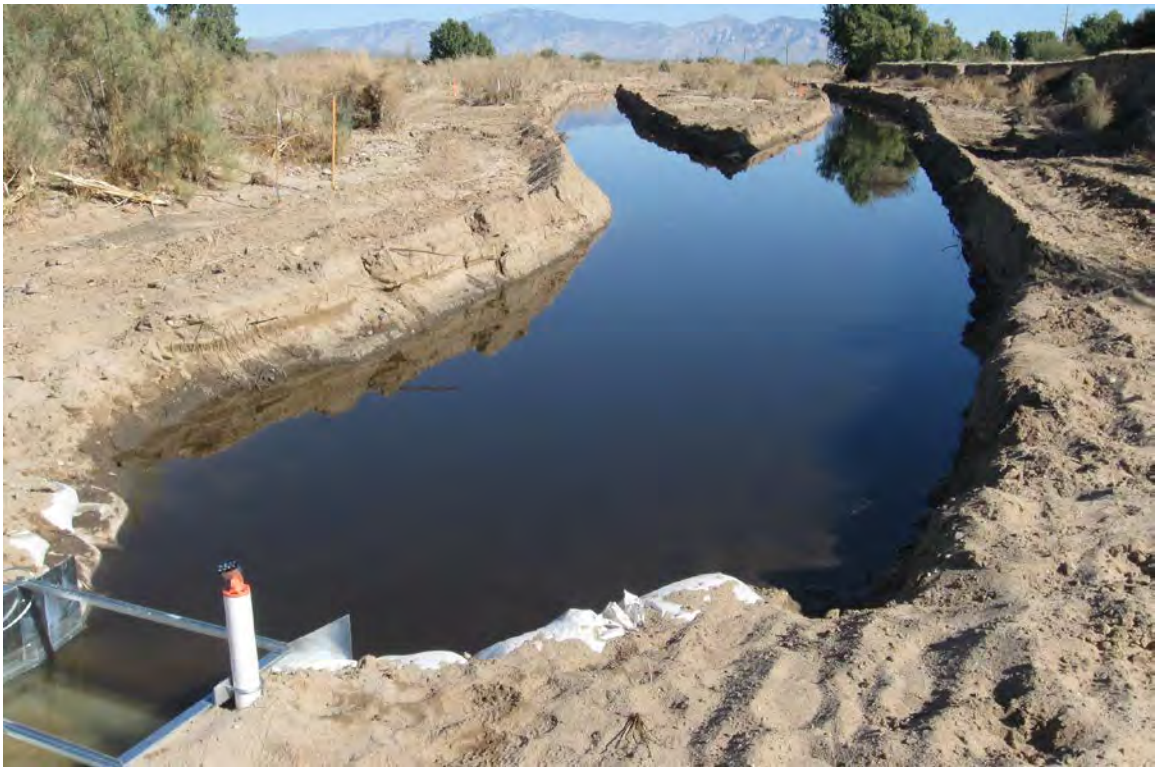
**Photo 10. – Looking Upstream at the Dirt Berm Barrier that was Breached
at the Convergence of Channels 1 and 2.**

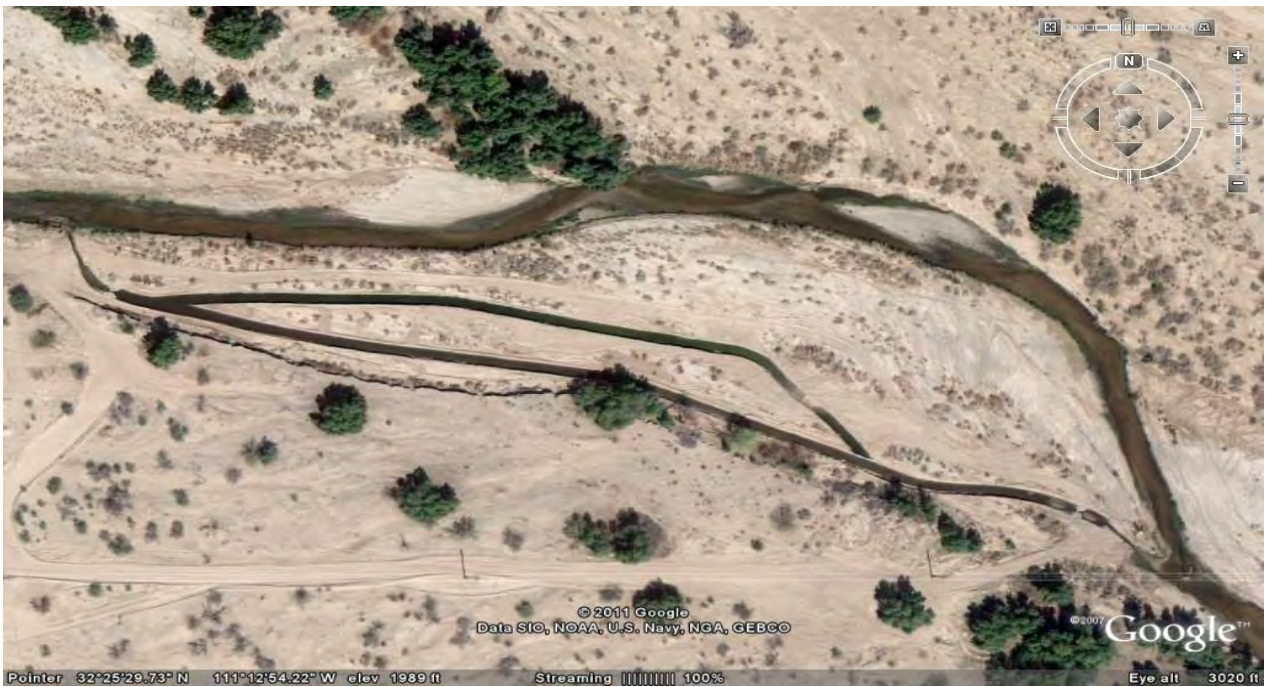
Photo 11. – Aerial Image of Constructed ERDP.

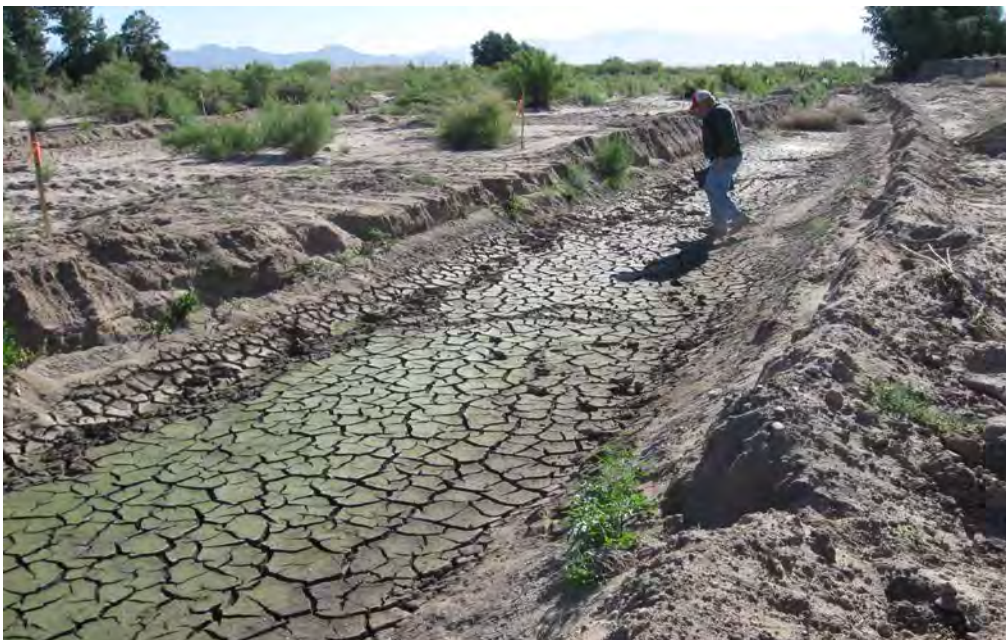
Photo 12. – Mudcracks in Channel 1 after 7 Days of Drying during First Maintenance Event. Brad Despain is crossing channel.

The first maintenance effort began on March 29, 2011 when the diversion channel was dammed and flows into the ERDP ceased. The ERDP was allowed to dry for two weeks before doing channel maintenance work, although the area 40 feet above the downstream flume remained too wet for passage of heavy equipment and maintenance was not completed in this area. In most locations along Channels 1 and 2, a fine sediment layer up to 2 inches thick had been deposited on the channel bottom and formed desiccation or mud cracks after drying. Activities completed during this maintenance effort included: excavation of sediment deposits from the mouth of the diversion inlet channel, excavation of sediment deposits in the approach basin above the upstream flume, removal of sandbags from the mouth of Channel 2 at its divergence with Channel 1, scraping and removal of fines from Channels 1 and 2 to locations outside of jurisdictional waters, and ripping of Channels 1 and 2 once with a 36-inch ripper.

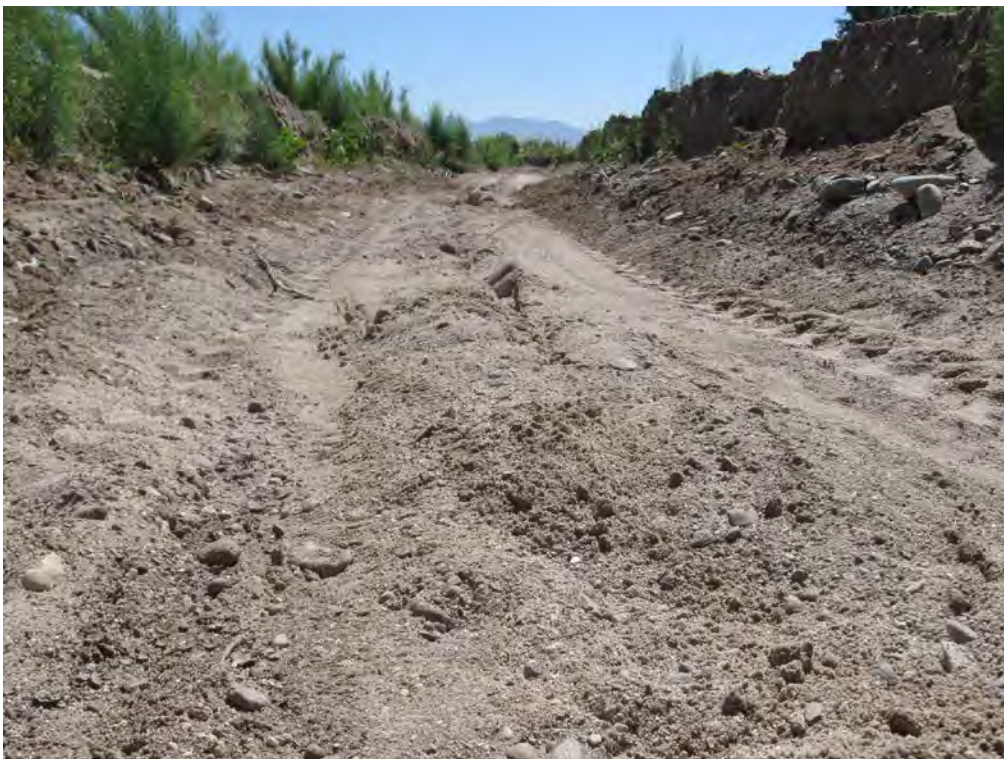
Photo 13 – Channel 2 after Drying, Scraping, and Ripping during Maintenance Event 1.

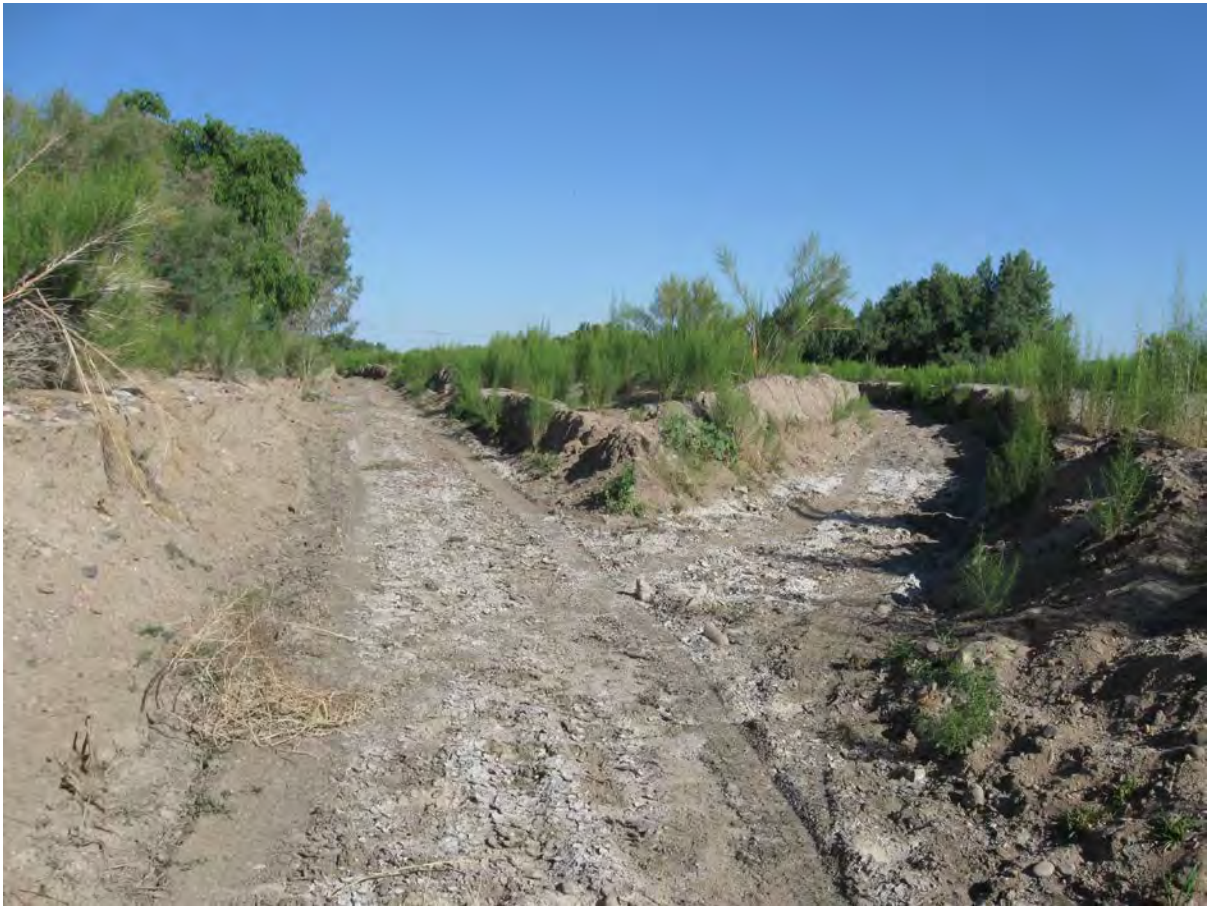
Photo 14. – Looking Downstream at the Divergence between Channels 1 and 2 after Drying during Second Maintenance Event.

included: excavation of sediments from the diversion inlet, leveling of high spots in Channel 2, and ripping of Channels 1 and 2 twice.

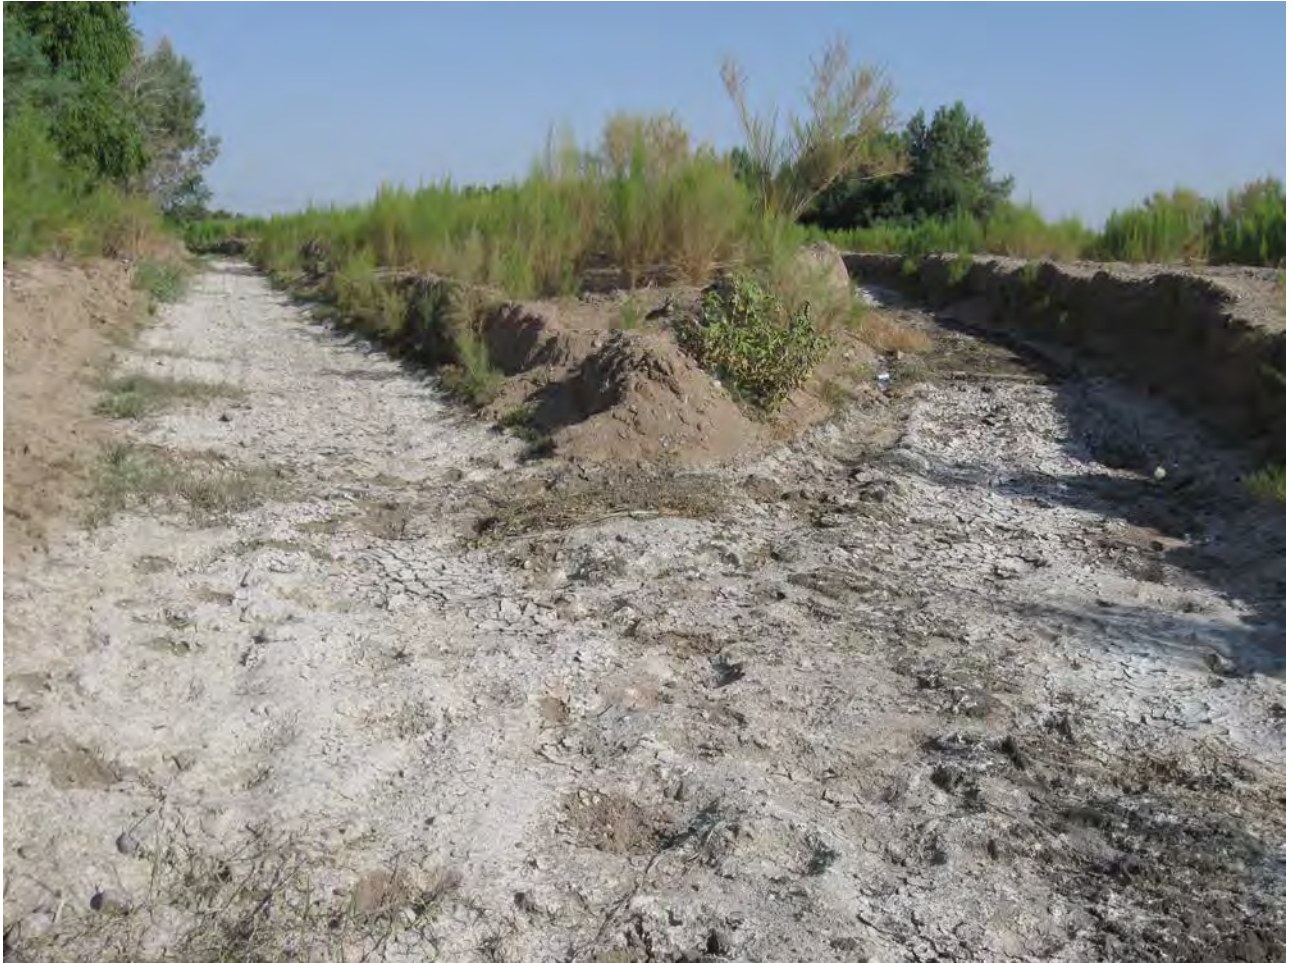
Photo 15. – Looking Downstream at the Divergence between Channels 1 and 2 after Drying during Third Maintenance Event.

consisted primarily of a whitish dried and cracked algal mat. Desiccation cracks were present immediately downstream from the upstream flume and immediately upstream from the downstream flume. Cattle tracks in the bottom of the channel were observed. An increase in vegetation was present in the diversion inlet above the plug.

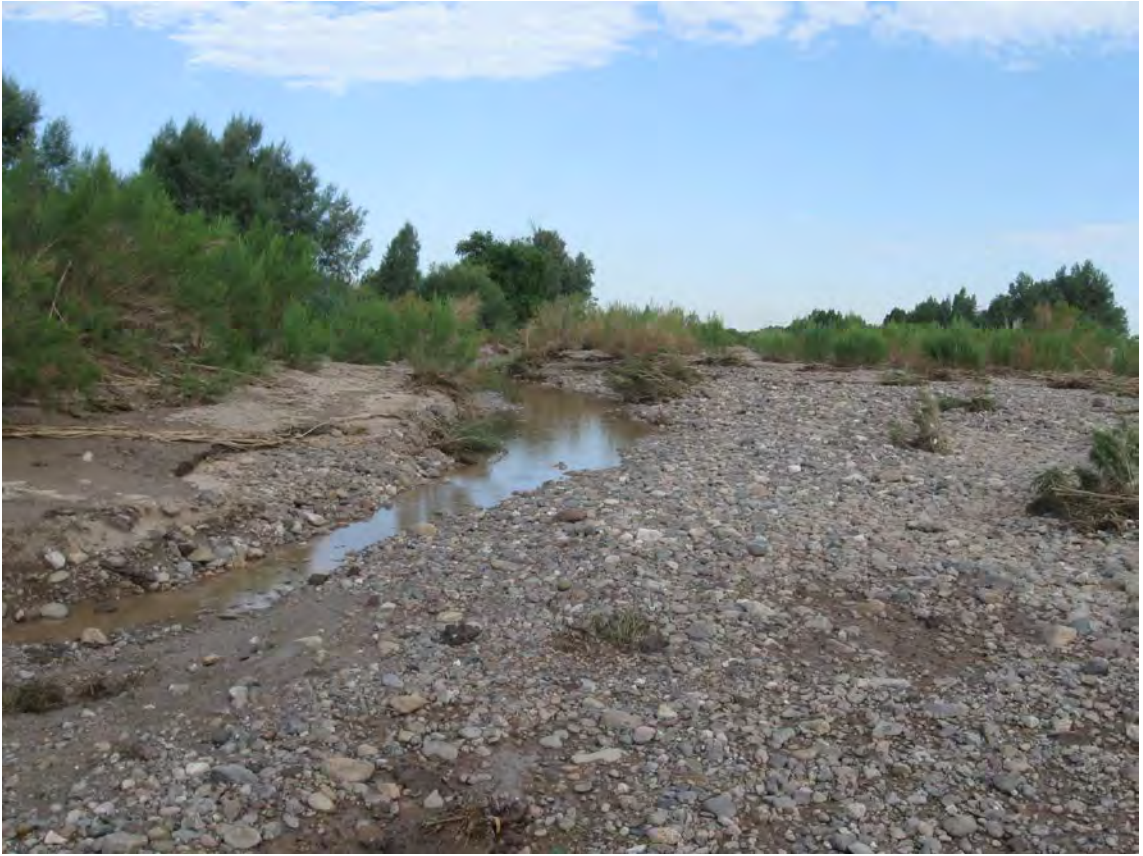
Photo 16. – Looking Downstream at Channel 1 and Buried Upstream Flume after July 5th and 6th Stormflows Washed Out Project.

The project was rewetted on June 29, 2011 at 8:30 AM. Flows reached the downstream flume on June 30, 2011 at 5:00 AM. The project was operated for 5 days before it was washed out on July 5, 2011 by storm flows in the SCR. On July 5th, the Cortaro gage recorded a maximum flow rate of 917 cfs and on July 6th a maximum flow rate of 2,070 cfs was recorded.

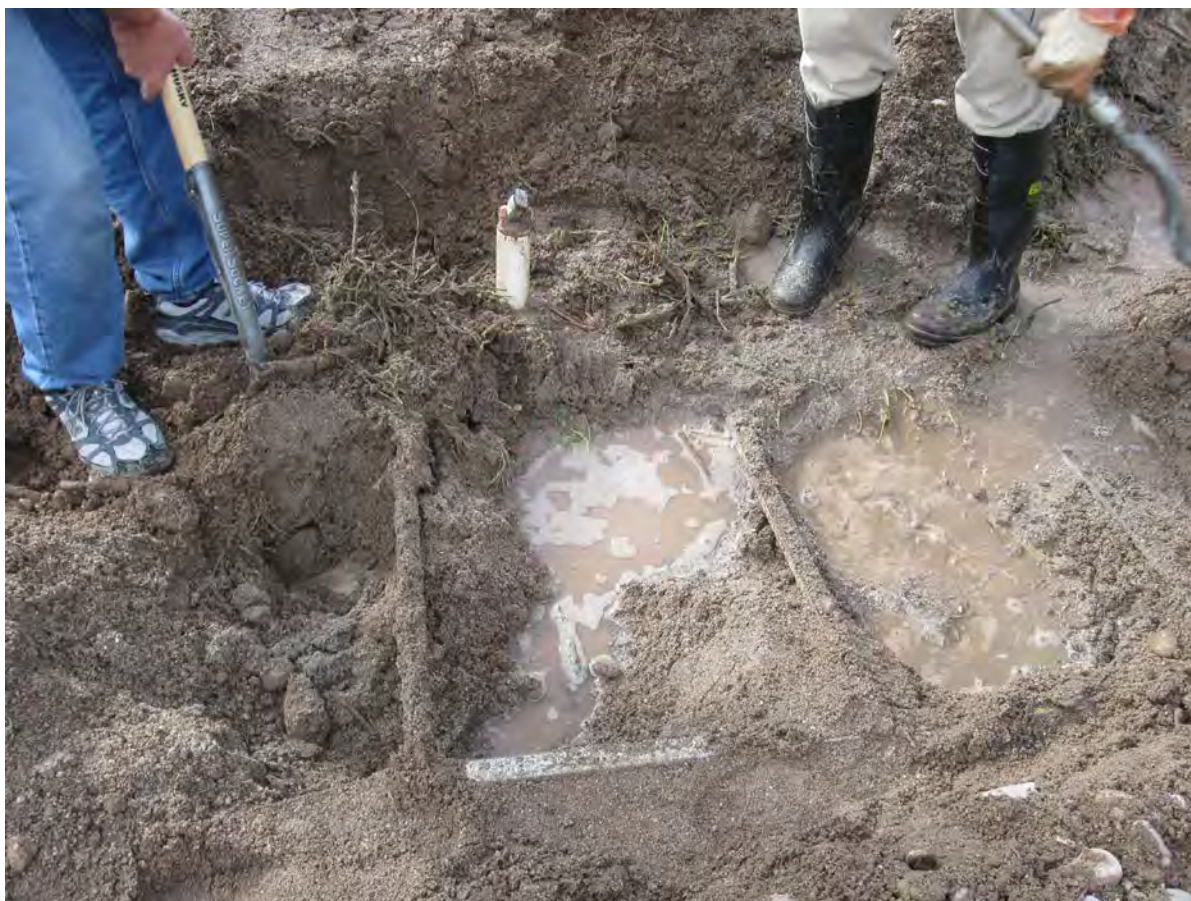
Photo 17. – Buried Upstream Flume after July 5th and 6th Stormflows.

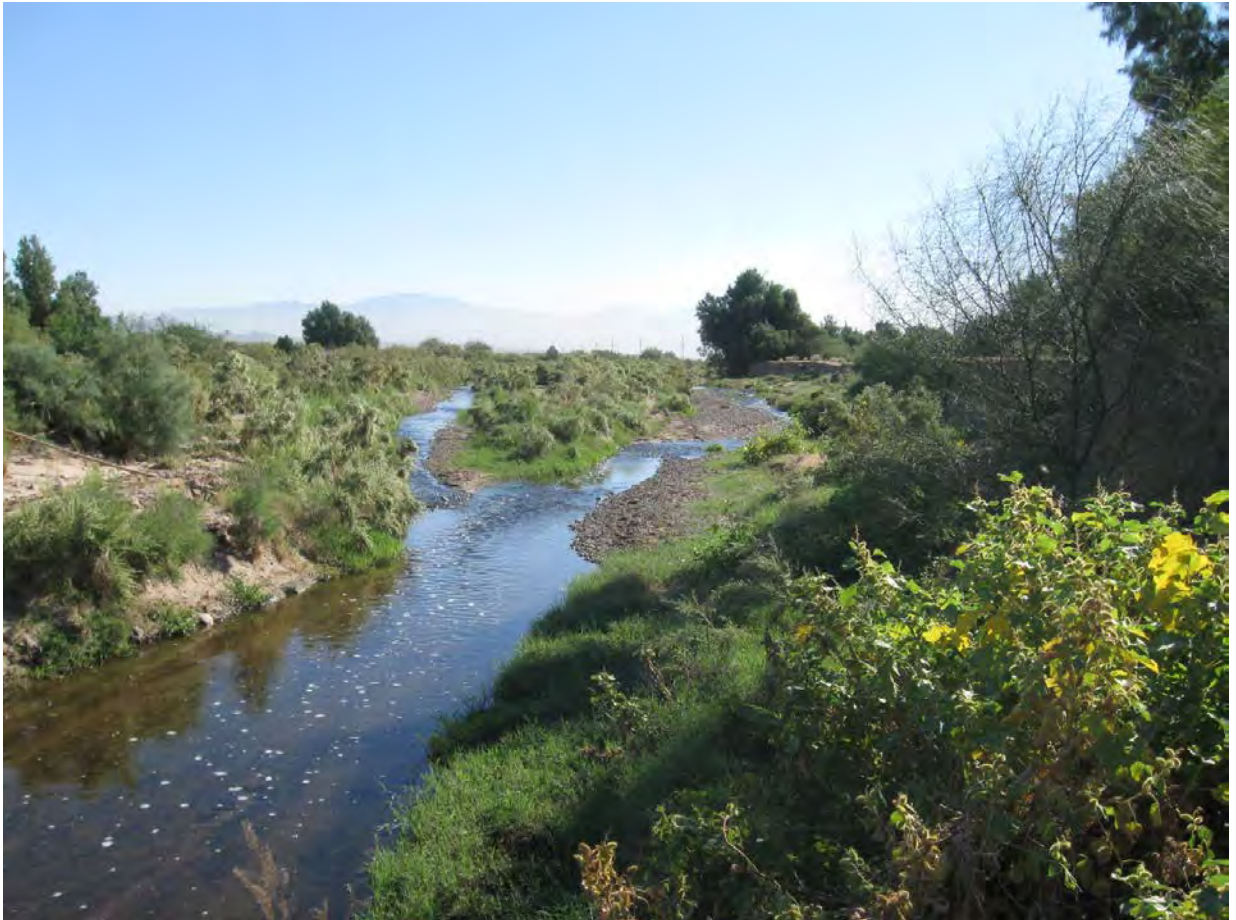
Photo 18. – Looking Upstream at Confluence of Channels 1 and 2, Flow in ERDP Continues Following September 2011 Storm Flows.

ERDP, although no longer monitored for flow volumes, is again flowing and additional acreage is infiltrating. While the dynamic nature of the SCR is a constant challenge when locating projects of this type, the excavation of ERDP may have influenced the river's return to this abandoned channel.

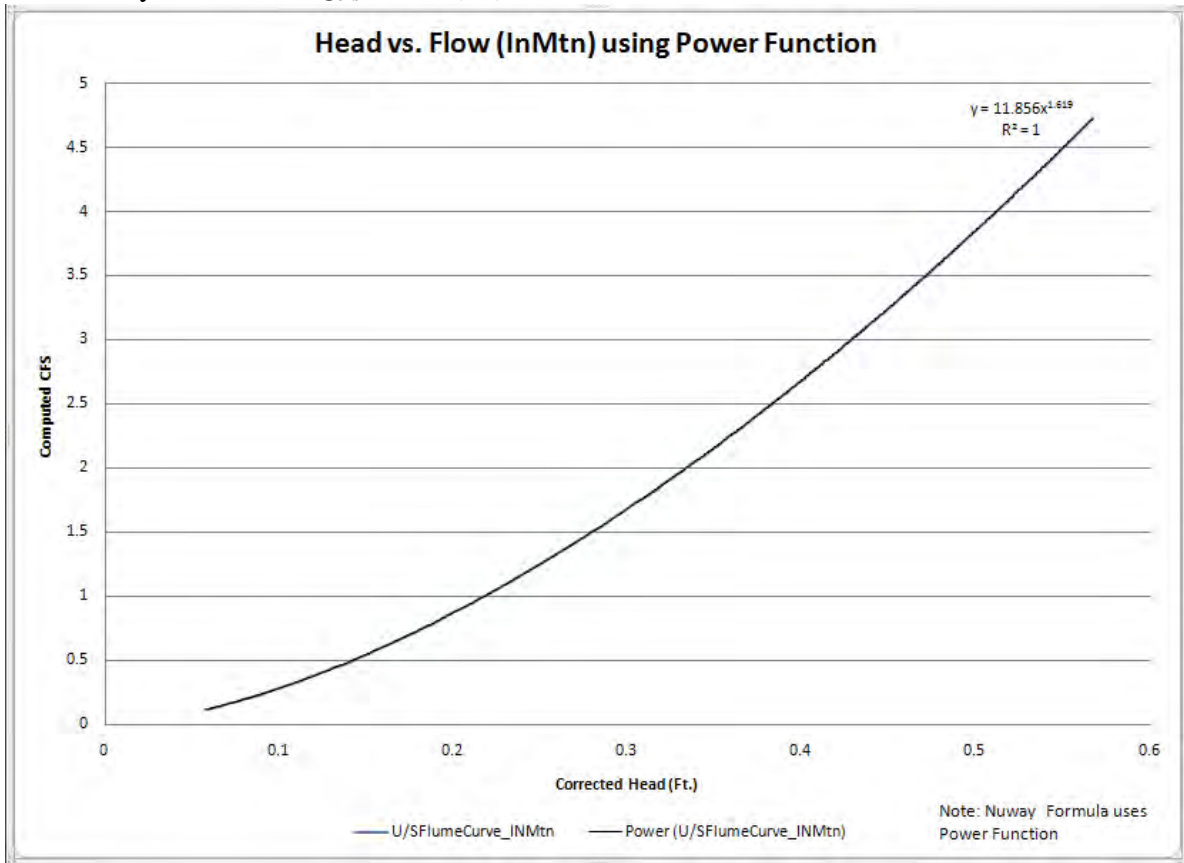
Figure 4 – Stage - Discharge Relationship for the 10 CFS Nuway EZ Flume

The Nuway formula is: $Q_{cfs} = K1*(h1)^{1.619}$

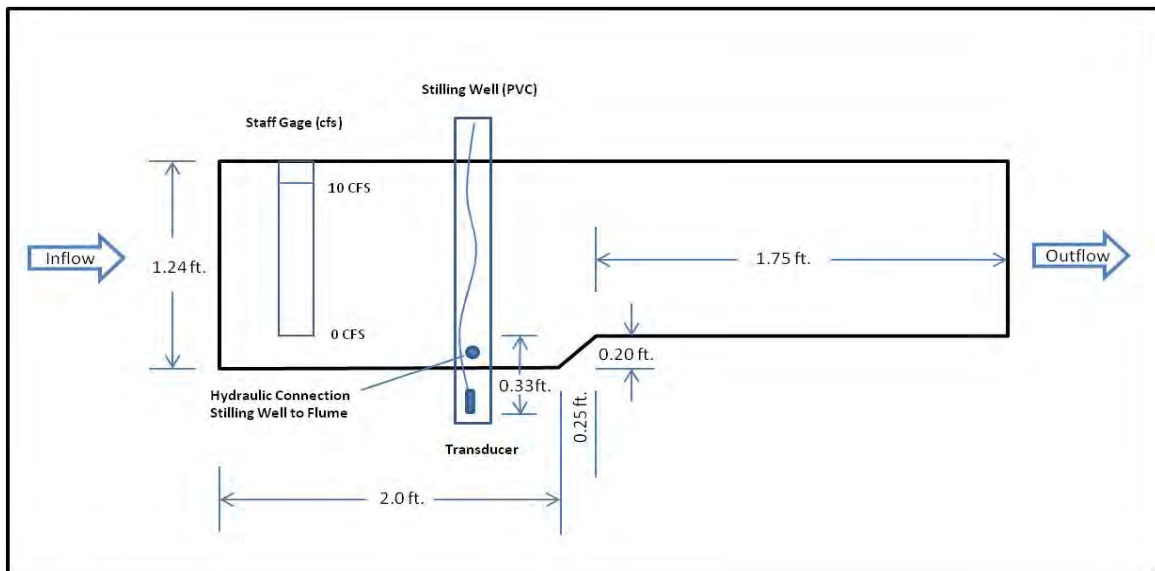
Figure 5. – Profile of Nuway EF10 EZ Flow Flume Showing Pressure Transducer Location (Upstream flume shown with 0.33-foot offset)

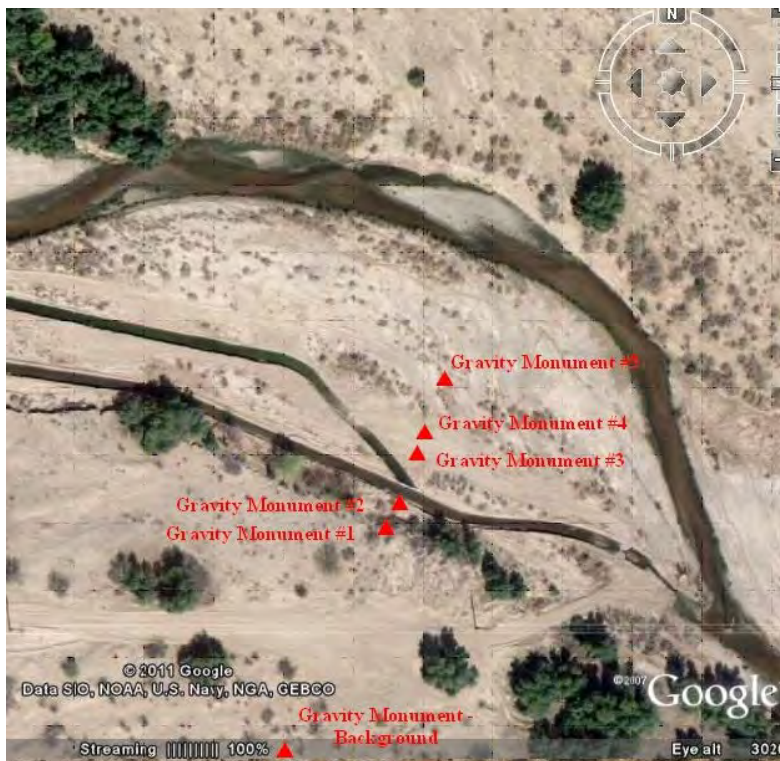
Figure 7. – UA Gravity Monitoring Station Locations at the ERDP.

Five gravity monitoring stations were installed perpendicular to the ERDP (Figure 7) and were designed to capture both vertical infiltration and lateral subsurface water movement away from the excavated channel. During the survey, background gravity values were collected prior to release of water to the ERDP and subsequent measurements were taken after water was diverted into the ERDP. Gravity surveys began January 18, 2011.

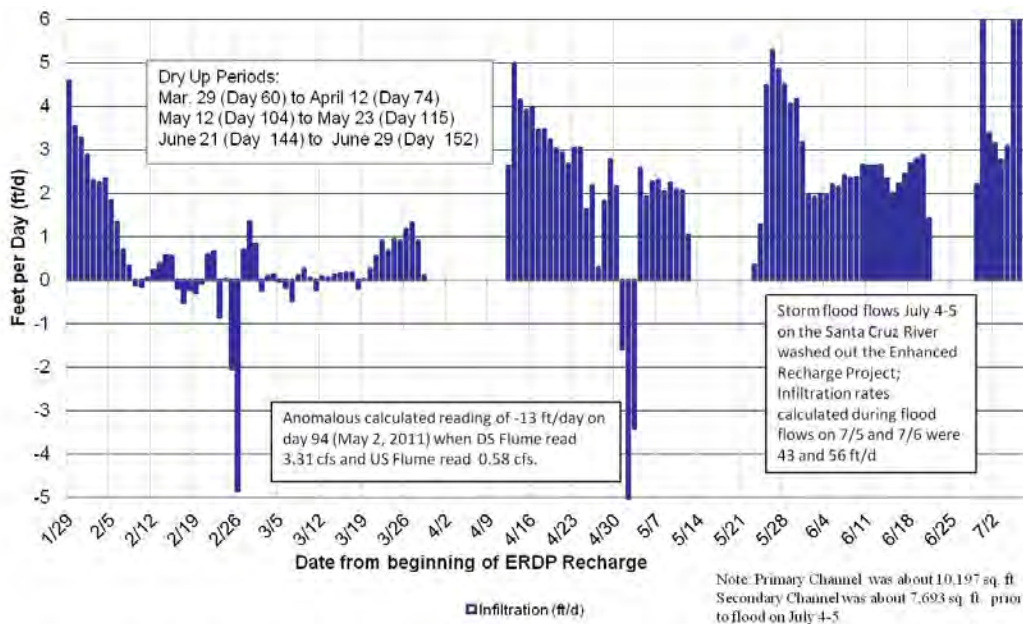
Figure 8. – Daily Average Infiltration Rate using Computed (Nuway) Formula January 28 through July 8, 2011.

The ERDP was initially operated undisturbed for eight weeks or 60 days while inflows and outflows from the project were monitored. Measured flow rates into the project during this time ranged from 4.81 cfs to zero cfs and averaged 1.96 cfs. Total volume of water recharged during this time was 16.8 AF with a daily average recharge rate of 0.27 AF. Infiltration rates, shown in Figure 8 and Table 3, averaged 1 foot per day (ft/d), and ranged from a maximum of 15 ft/d to a minimum of 0 ft/d. Infiltration rates declined steadily to February 6, 2011 when they remained below 1 ft/d until the first maintenance event.
