Enhanced Recharge Demonstration Project, Increasing Treated Effluent Recharge Rates in the Santa Cruz River, Tucson, Arizona

U.S. Department of the Interior
Bureau of Reclamation
Phoenix Area Office

April 2012

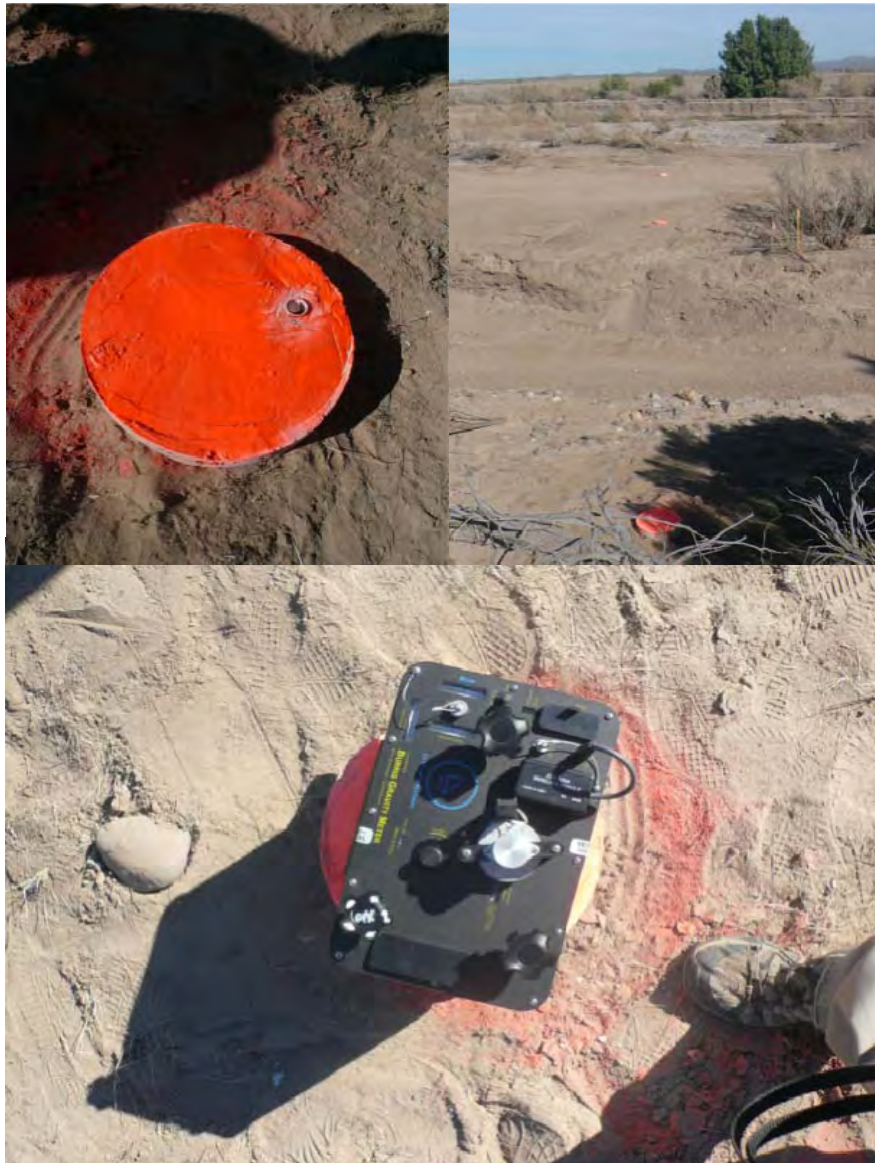
Figure 3: top left, gravity monitoring pad; top right, transect of gravity stations; bottom gravimeter placed on a monitoring pad.

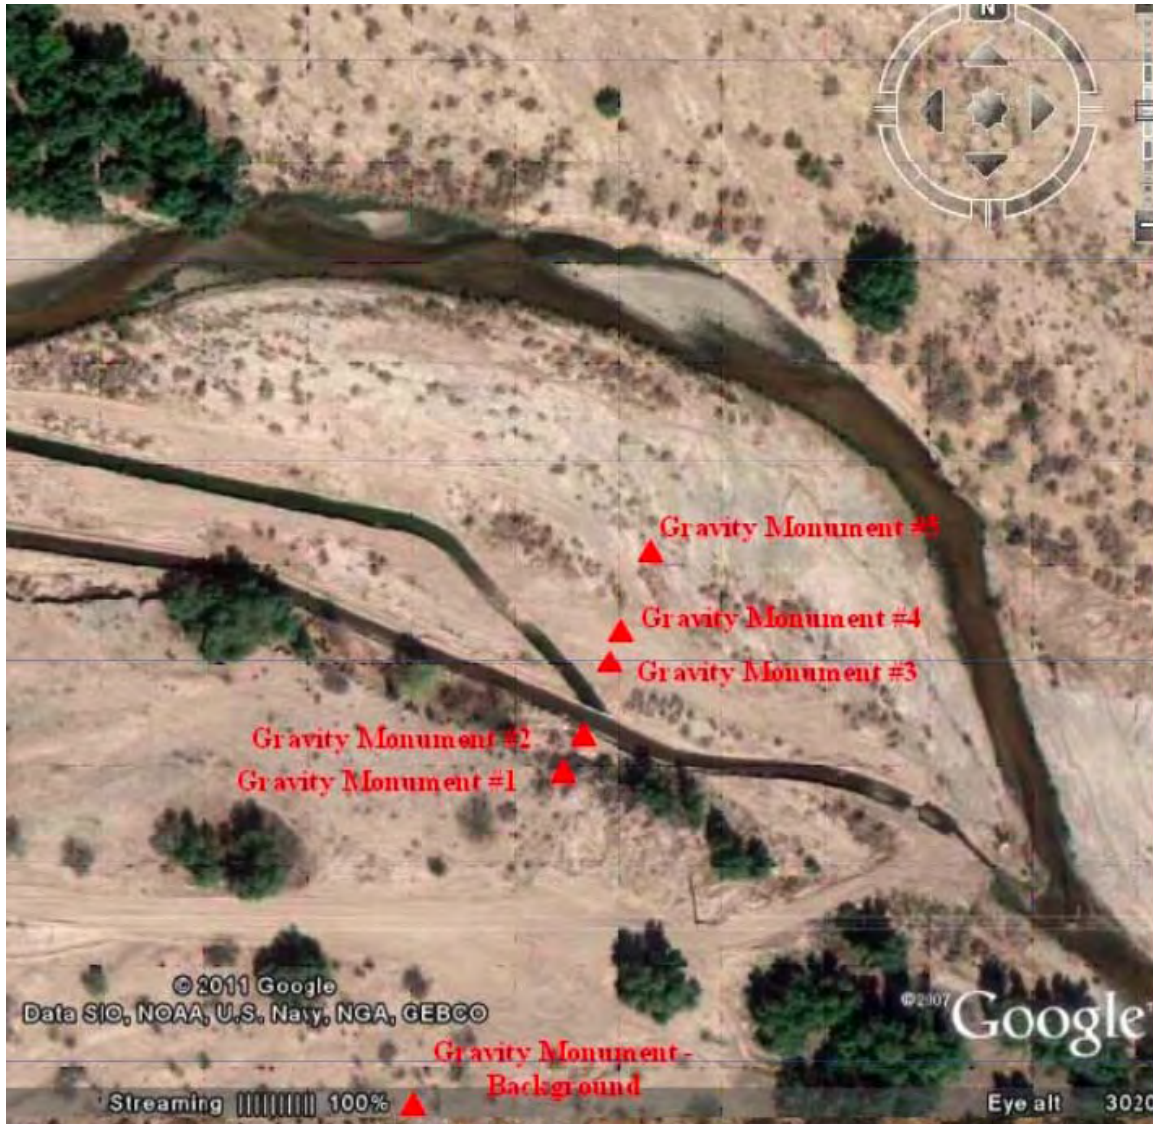
Figure 4: Map of gravity station locations relative to active and excavated channels.

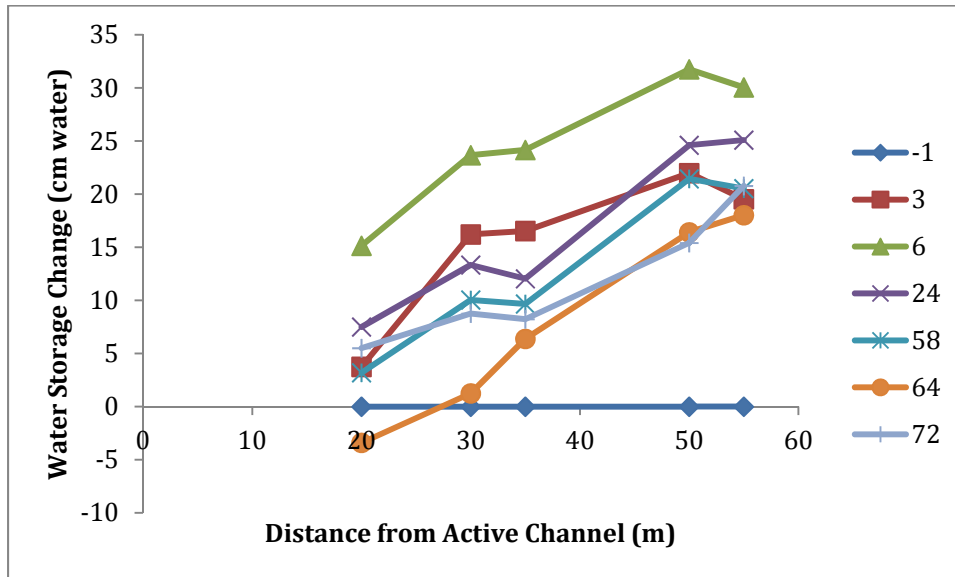
Figure 6: Relative gravity changes through time following the initial flooding of the excavated channel on January 29th. Each series is labeled with the elapsed time, in days, since release of water into the excavated channel. These times correspond to those given in Table 2.
