Clear Creek Technical Team

Summary of Activities for Water Year 2021

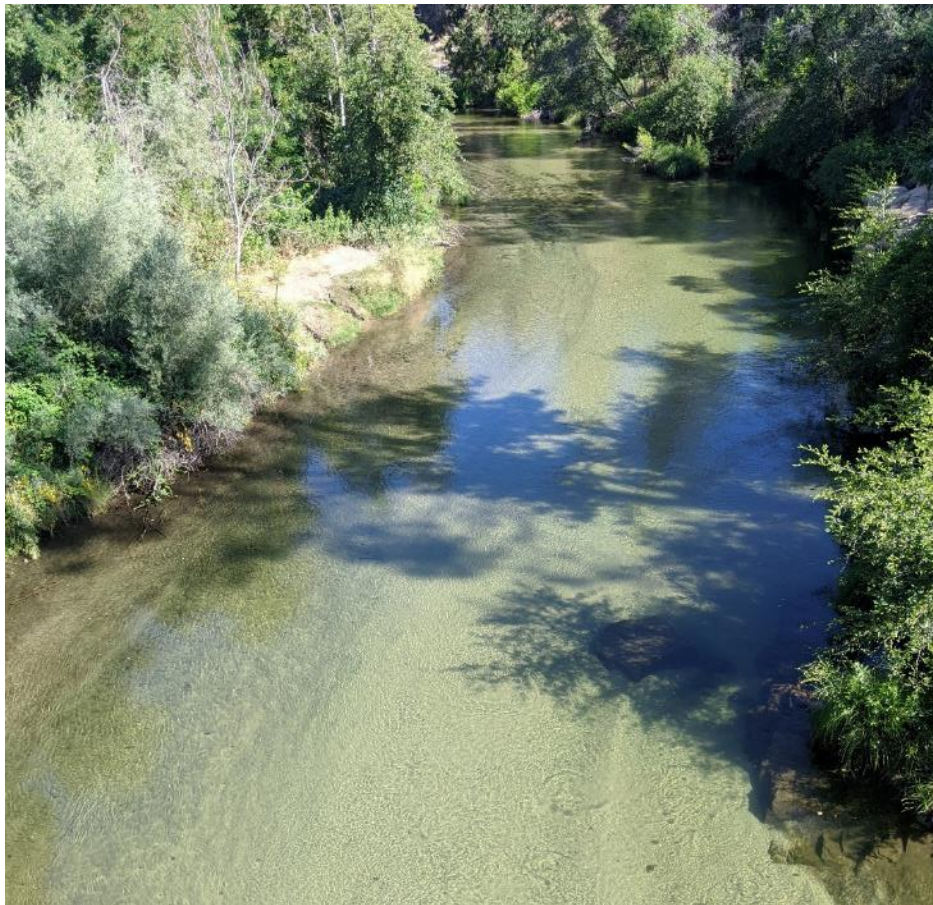
Figure 3. Decomposed granite (a sand-like sediment) coats the stream channel upstream of Clear Creek Road Bridge. Large inputs of fine sediments occurred following the Carr Wildfire in 2018. Photo credit: Derek Rupert, Bureau of Reclamation.

Some reaches of Clear Creek continue to be negatively impacted from excessive fine sediments from the 2018 Carr Wildfire, which burned most of the Lower Clear Creek watershed. Large amounts of decomposed granite (a coarse sand-like material) are entering Clear Creek from the tributaries (e.g., South Fork Clear Creek) that burned during the 2018 Carr Wildfire. These materials are small and light enough to move during low flows, coating the stream bottom as they move downstream. Excessive fine sediments in the stream channel have several major negative impacts, such as filling in holding pools, degrading spawning habitat, and a potentially lowered emergence percentage of Chinook salmon and steelhead fry. The lack of natural and managed geomorphic flows in WY2021 limited the creek's ability to force these sediments out of the creek channel and onto the floodplains.

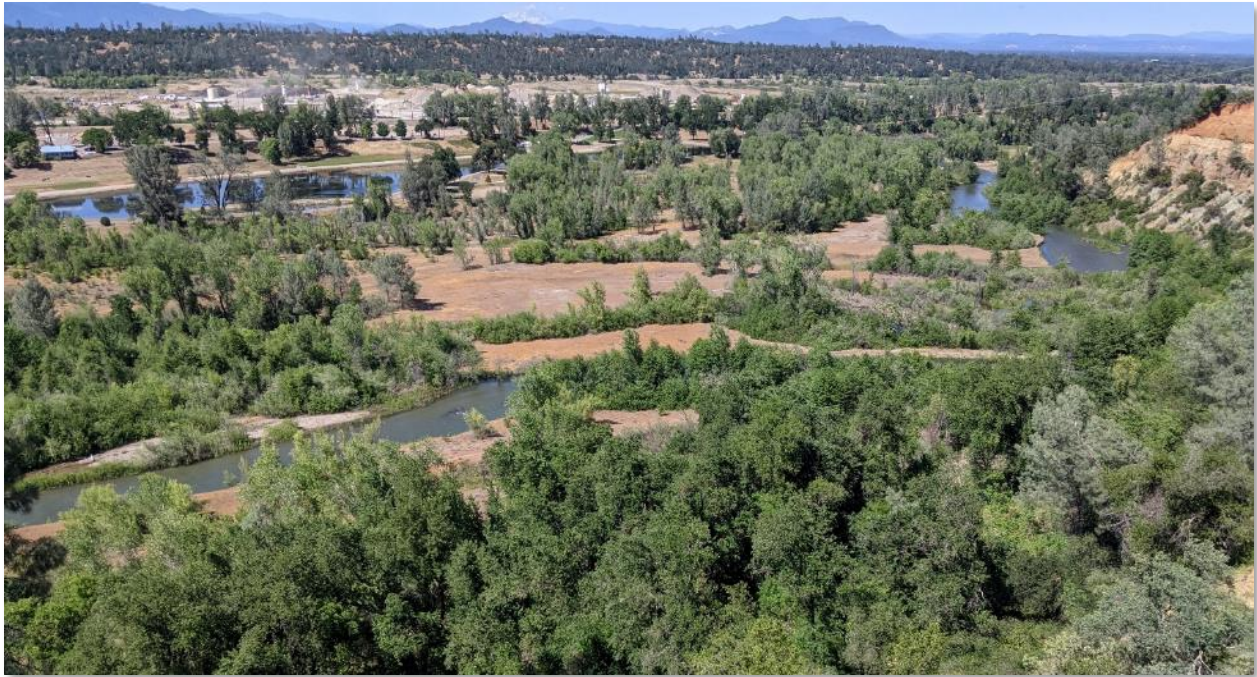
Figure 4. The restoration reach experienced little inundation during the spring attraction pulse flows (May 11), which was Clear Creek’s highest flow in water year 2021. Photo credit: Derek Rupert, Bureau of Reclamation.

Clear Creek continues to suffer from a lack of frequent and long-duration floodplain inundation. Both morphology and hydrology limit the potential for floodplain inundation. The reaches with wide alluvial valleys and low slopes (i.e., areas downstream of Clear Creek Road Bridge) generally have overly large channels, with thick riparian berms. Some areas with overly large channels are confined by tall tailings piles that completely block lateral migration. Other areas, such as the Restoration Reach (between RM2 and RM5), have accessible floodplains, but inundation only occurs with rare, short duration high flow events (Figure 4). Complete inundation of the valley floor is very rare. During the spring pulse flow (840 cfs peak) in WY 2021, some localized floodplain areas located in direct proximity to gravel augmentation sites

were inundated. These gravel augmentation sites can reduce the channel capacity and allow elevated water levels to engage the floodplains more easily. However, with only two days of elevated flows in WY2021 (stemming from the managed spring pulse flows), little seasonally inundated habitat was provided to rearing fish, and for too short a period to provide much benefit. More in-channel restoration actions are required to effectively increase seasonally inundated habitats. The CCTT has discussed the use of Beaver Dam Analogues (BDAs), Post-Assisted Log Structures (PALs), gravel augmentations, floodplain lowering, and a change to the annual hydrograph to address the oversized morphology of the Clear Creek channel.

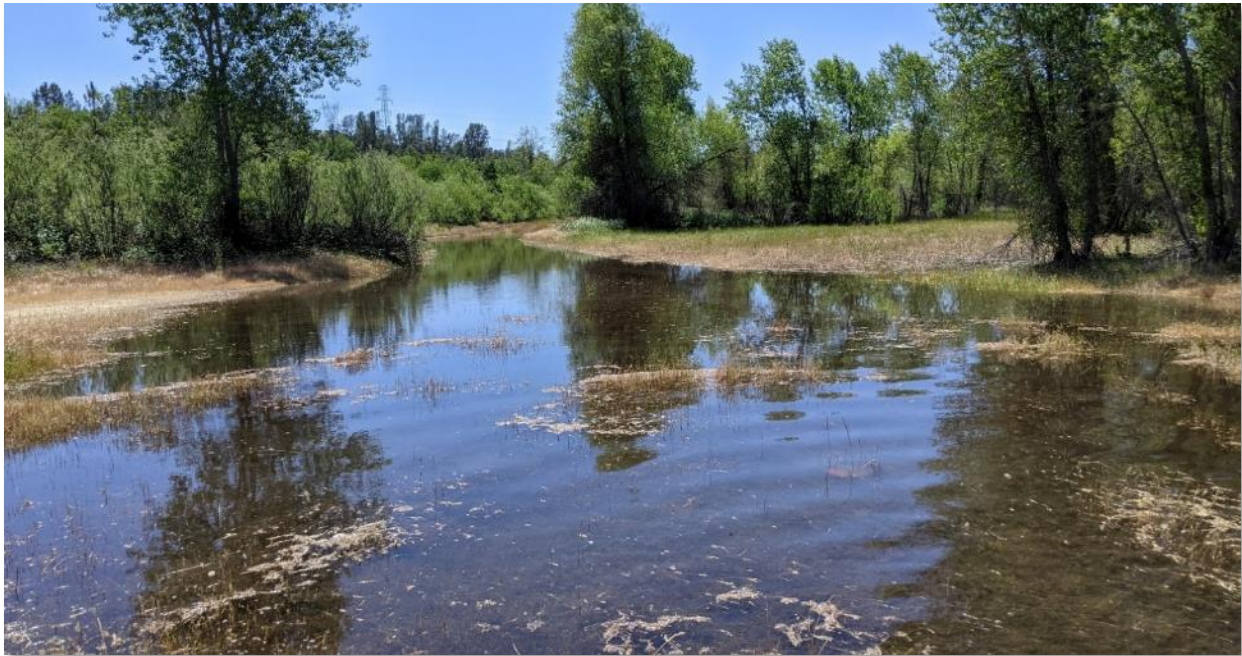
Figure 5. Off-channel floodplains inundated during the May 2021 spring pulse flows (840 cfs release) at the Gold Dredge/Phase 2A site. The 2020 gravel augmentations at this site improved conditions for localized floodplain inundation. This area only experienced 2 days of inundation in WY2021. Photo credit: Derek Rupert, Bureau of Reclamation.

The CCTT plans to pursue habitat restoration projects that will fulfill the NTRS’s recommended actions for Clear Creek. These include juvenile salmonid habitat restoration and maintaining salmonid spawning habitat. The CCTT understands that all future Clear Creek restoration actions must increase the quantity and quality of both perennial and seasonally inundated juvenile salmonid habitats to address the goals of the NTRS. The CCTT has several restoration project plans for future projects and will be seeking funding to implement them. The CCTT will also look to continue ongoing habitat management projects which are showing positive habitat improvements (Figure 5).

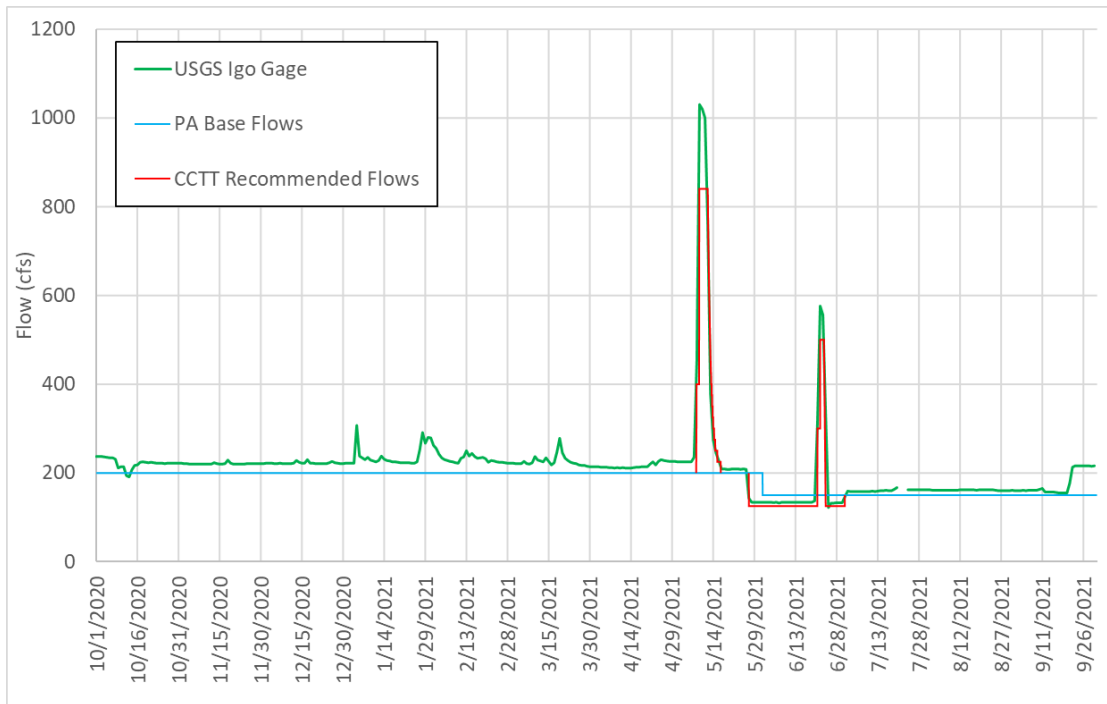
Figure 6. Mean daily flow on Clear Creek during WY2021, measured at Igo gauge (USGS 11372000; green line). The Proposed Action’s base flow minimums are shown as a blue line. CCTT recommended flow actions shown as a red line.

Additionally, small flow discrepancies occurred in WY2021 when the USGS performed several gage calibrations. The USGS struggled to find repeatable and precise readings at the Igo gage during low flow periods. Some of these issues may stem from the heavy loads of decomposed granite that continually change the cross-sectional area at the gaging location (see Section 2.3 for more information on decomposed granite).

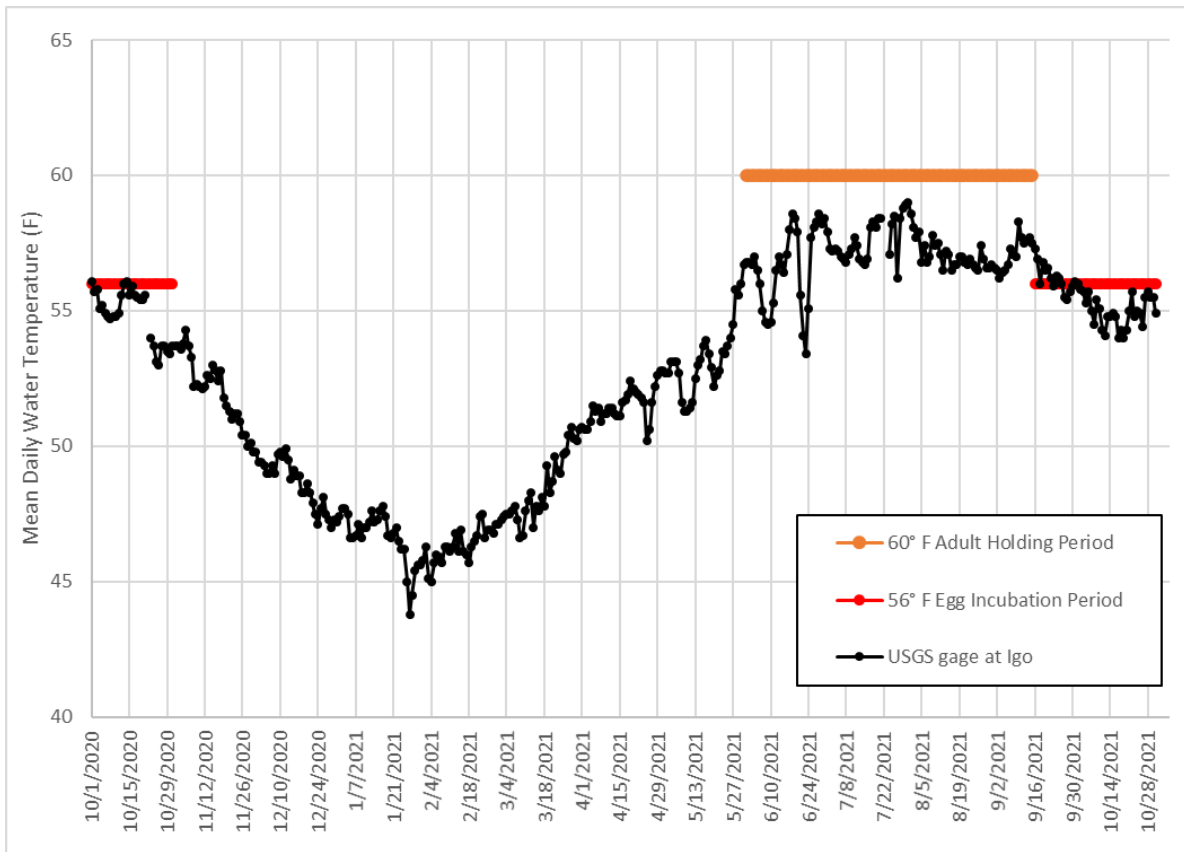
Figure 7. Mean daily water temperature on Clear Creek at the Igo gaging station in 2021 compared to the mean daily temperature criteria for spring-run Chinook Salmon holding (60°F June 1 to September 15) and spawning and incubation (56°F September 16 to October 31). Data from October 2021 (WY2022) shown for reference.

Year	Holding temperature ≤60°F June 1 to September 15	Spawning temperature ≤56°F September 16 to October 31
Pre-2009 (average)	99%	93%
2009	100%	26%
2010	100%	26%
2011	100%	62%
2012	100%	64%
2013	100%	96%
2014	100%	0%
2015	100%	0%
2016	98%	15%
2017	100%	100%
2018	99%	87%
2019	98%	67%
2020	100%	74%
2021	100%	80% (37 of 46 days)

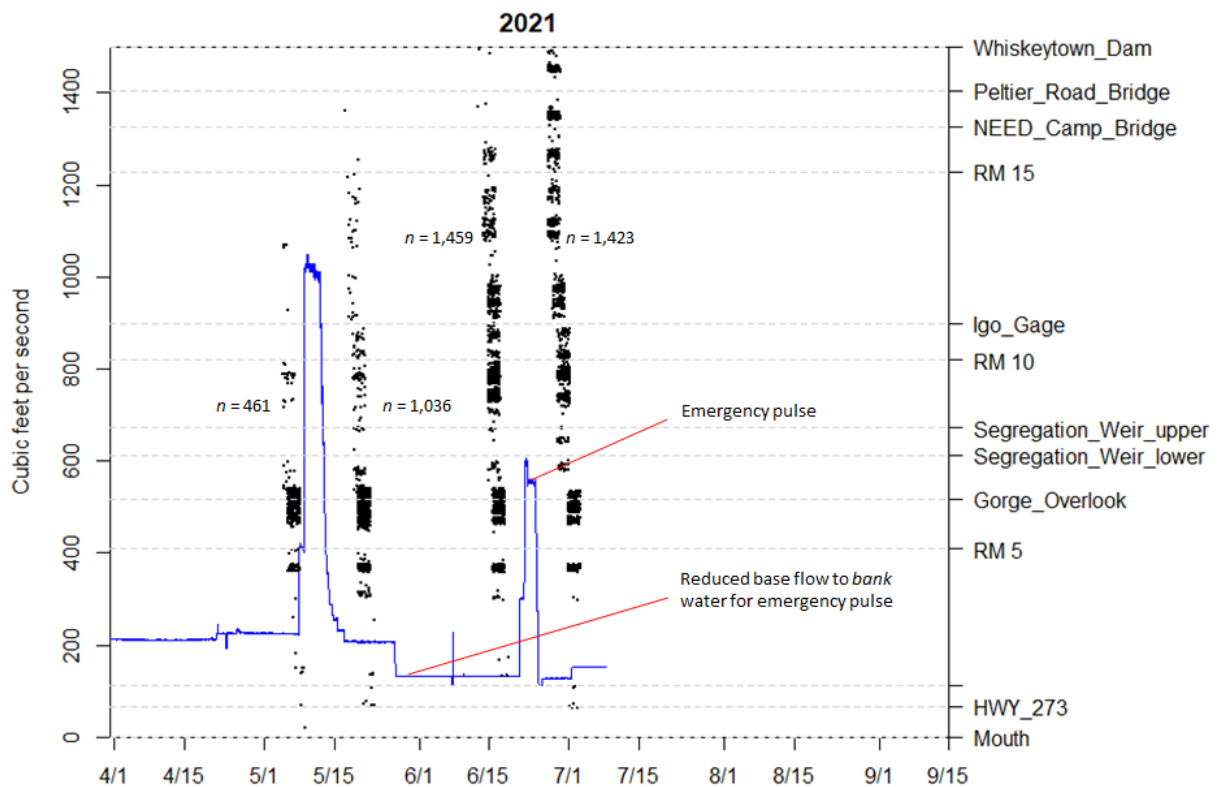
Figure 10. Distribution of spring-run Chinook Salmon before and after the spring pulse flow and emergency pulse-low flow action. USFWS Red Bluff unpublished data.

Snorkel surveys were conducted by the USFWS before and after each pulse flow to help determine the response of spring-run Chinook Salmon to the flow action. These surveys provided an index of abundance of adult spring-run Chinook Salmon (diver efficiencies are not determined), and spatial information on the distribution of adults within Clear Creek (Figure 10).

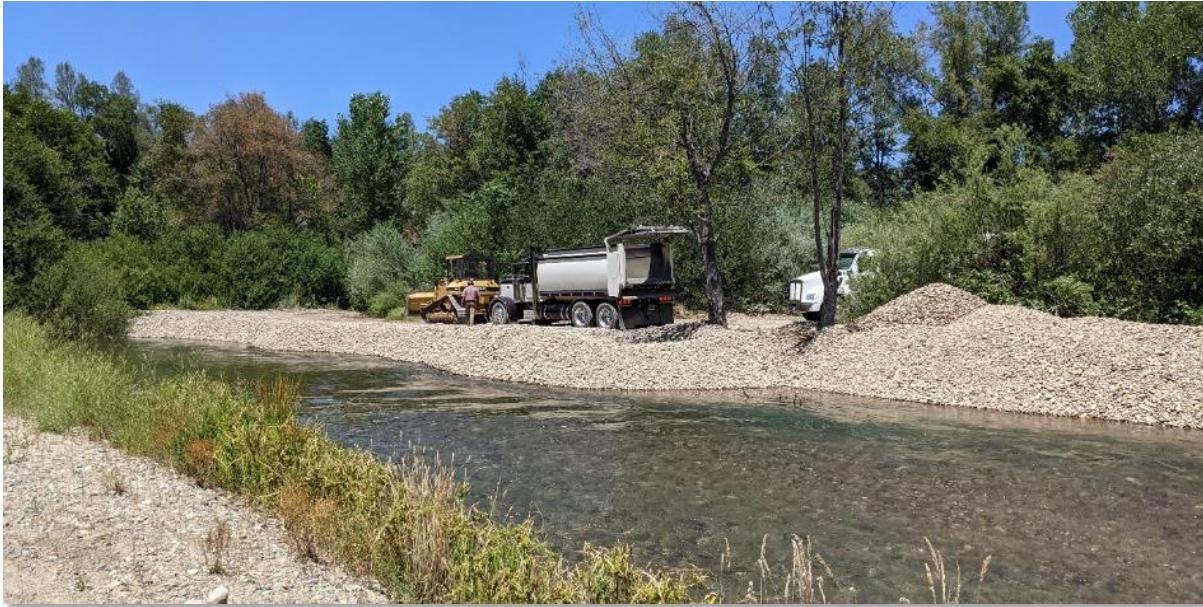
Figure 14. Construction of the lateral berm at the Above Phase 3A site. Photo credit: Derek Rupert, Bureau of Reclamation.

Location	Coarse Sediment (tons)	Boulders
Whiskeytown Dam (RM 18.24)	1,013	-
Below Dog Gulch (RM 17.64)	1,976	6
Above Phase 3A (RM 4.24)	2,022	-
Total	5,011	6

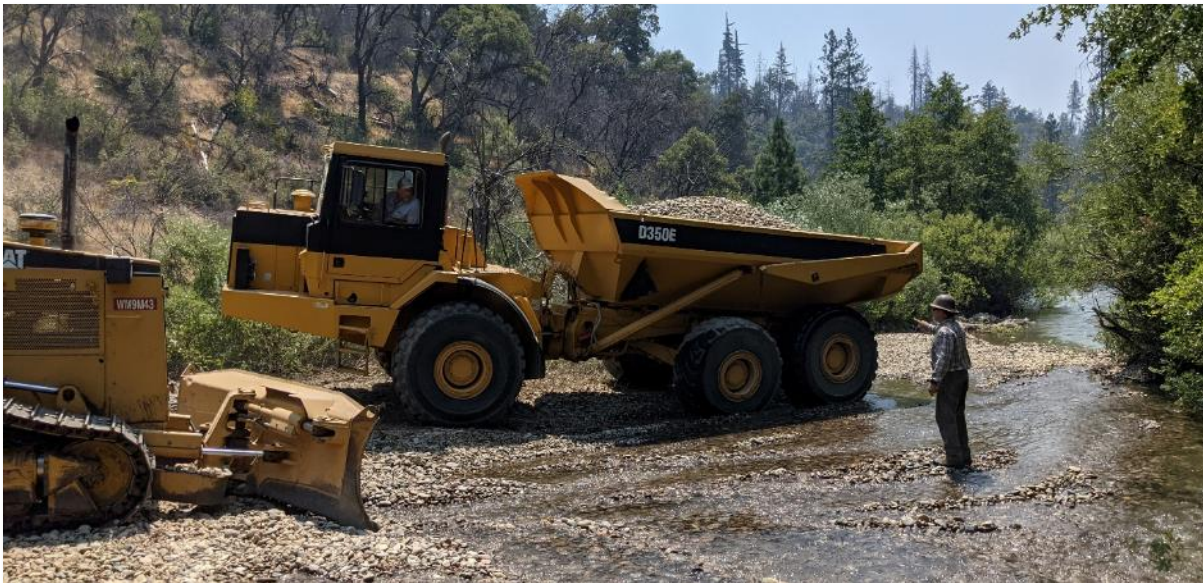
Figure 15. Implementation of the gravel augmentation project at the Below Dog Gulch site. Photo credit: Derek Rupert, Bureau of Reclamation.

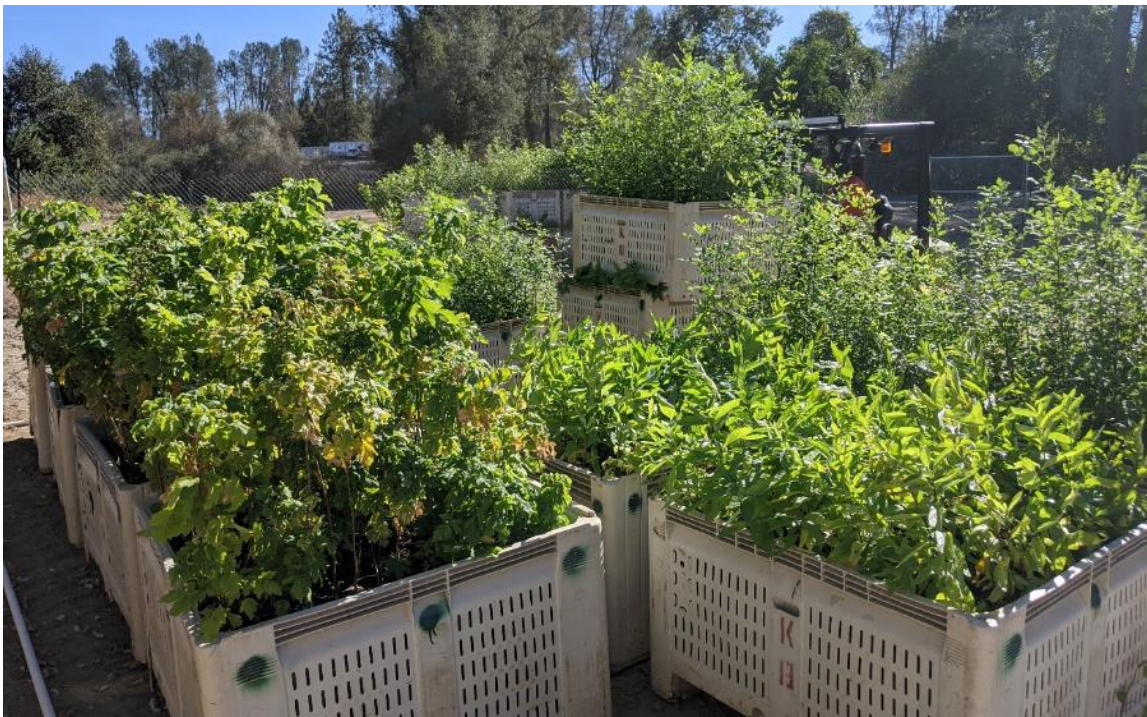
Figure 17. Crates of containers stock plants ready for planting across the Phase 3C project area. Photo credit: Derek Rupert, Bureau of Reclamation.

The revegetation design was described in the Lower Clear Creek Floodplain and Stream Channel Restoration Project – Phase 3C 90% Design document (Yurok Tribe Design Team, 2019). The revegetation at Phase 3C was initiated in late 2019 and continued through January 2021. A diversified revegetation strategy was implemented to improve the ecological function, habitat potential, and esthetics of the construction area (Figure 18). Willow clusters and trenches, container stock plants and trees, acorn dispersal, and seeding mulching were used throughout the site (Figure 17). In total, there were 13,784 willow pole cuttings used (representing 5 native species), approximately 70,000 container stock plants were planted (representing 13 native species), and more than 1,300 pounds of seed (representing 6 native species) was dispersed. Some deviations from the original revegetation design occurred, as there were less disturbed/bare areas created during construction than anticipated (Yurok Tribe Design Team, 2021).

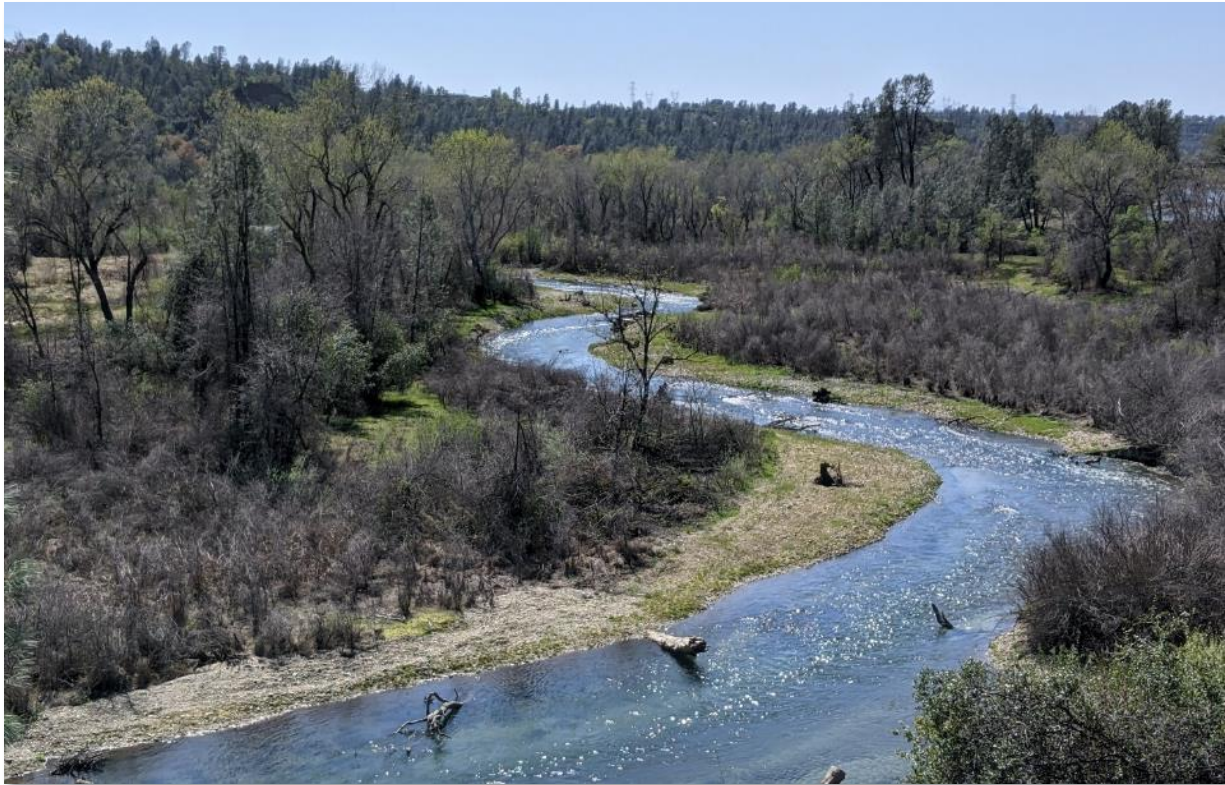
Figure 18. Clear Creek flowing through the Phase 3C stream channel restoration project area. Spring (March 2021) plant growth reveals that the revegetation efforts were successes on the newly created river bars. Photo credit: Derek Rupert, Bureau of Reclamation.

In WY2021, planting and seeding were completed at Phase 3C (Figure 18). Irrigation of planted trees and plants continued through the summer of 2021. Additional irrigation will occur in 2022. Once irrigation ceases and the materials are removed, the Phase 3C project will be considered complete.

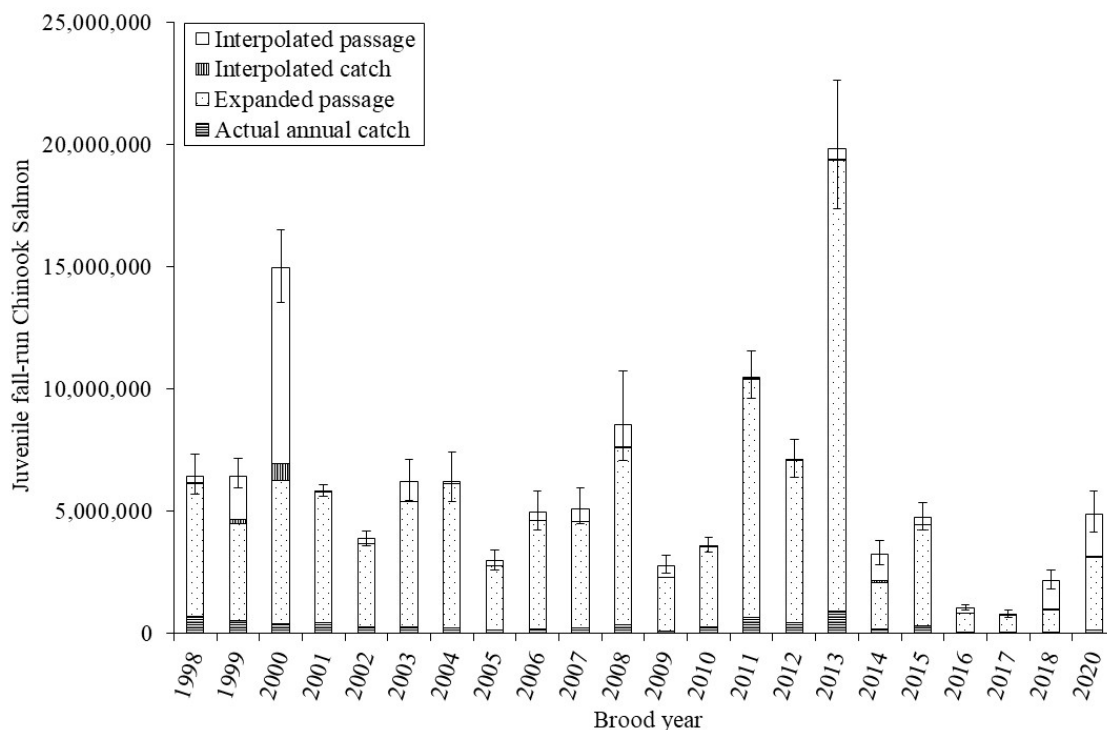
Figure 19. Annual passage indices of fall-run Chinook Salmon by brood year at the lower Clear Creek rotary screw trap from 1998 to 2020. Passage data from brood year 2019 are being summarized at the time of this report; delays in report development were due to COVID-19 related issues. USFWS-Red Bluff unpublished data.

The juvenile fall-run Chinook Salmon passage index at LCC RST near China Garden was 4,877,452 fish (Figure 19). The *O. mykiss*/steelhead passage index at LCC RST was 39,316 fish (Figure 20). This passage is not adjusted for redds below LCC. Spring-run Chinook Salmon passage index at UCC near Clear Creek Road Bridge was 58,787 fish (Figure 21). This passage is not adjusted for redds between the separation weir and UCC. Spring-run Chinook Salmon passage estimate at LCC was 19,798. Note that the official reported index is from UCC, and the LCC passage index is calculated for comparison purposes. The Brood Year 2020 Juvenile Report is in progress.

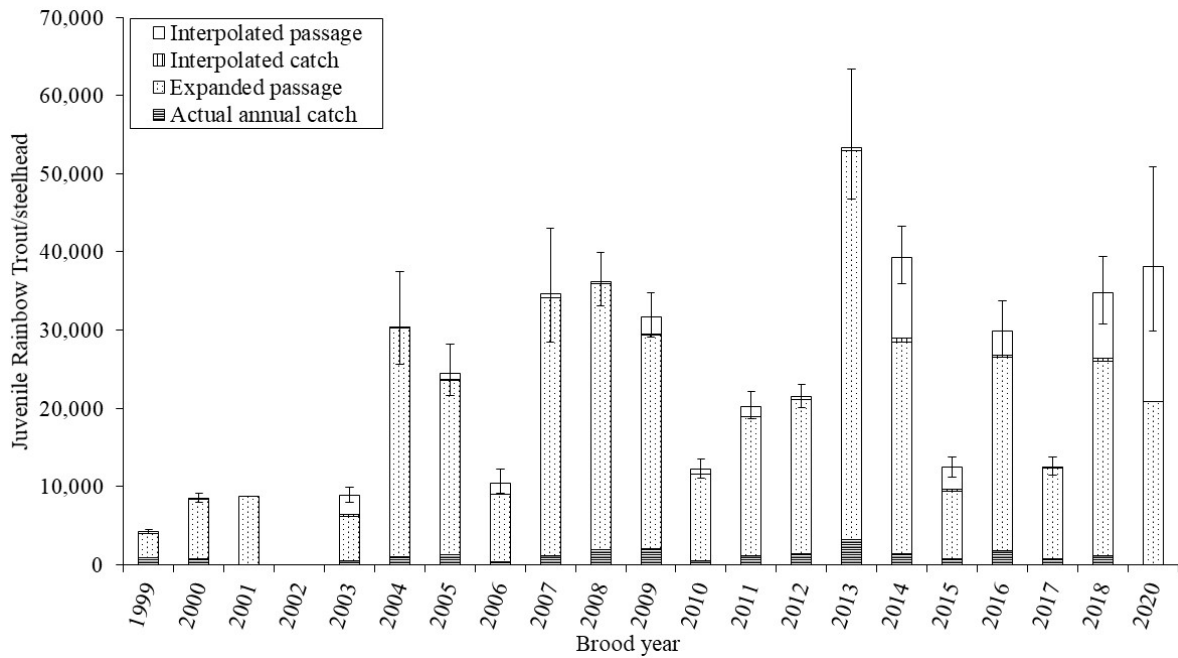
Figure 20. Annual passage of rainbow trout/steelhead by brood year at the Lower Clear Creek rotary screw trap from 1999 to 2020. There is no passage index for brood year 2019 because the trap was not fished during peak out-migration due to COVID-19 stay at home orders. USFWS-Red Bluff unpublished data.

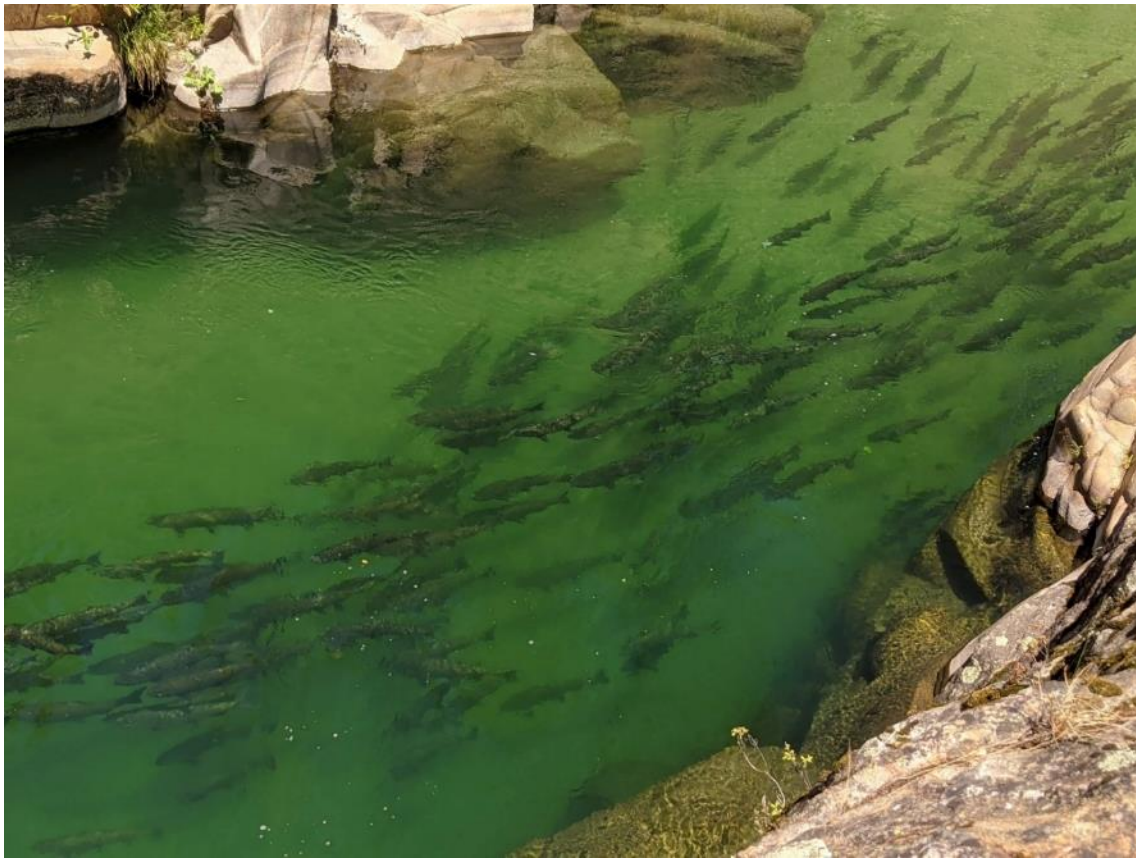
Figure 23. Spring-run Chinook Salmon in Clear Creek in a deep pool. Holding habitat for these fish improves as they migrate upstream. Note the decomposed granite coating the bottom of the pool. Photo credit: Derek Rupert, Bureau of Reclamation.

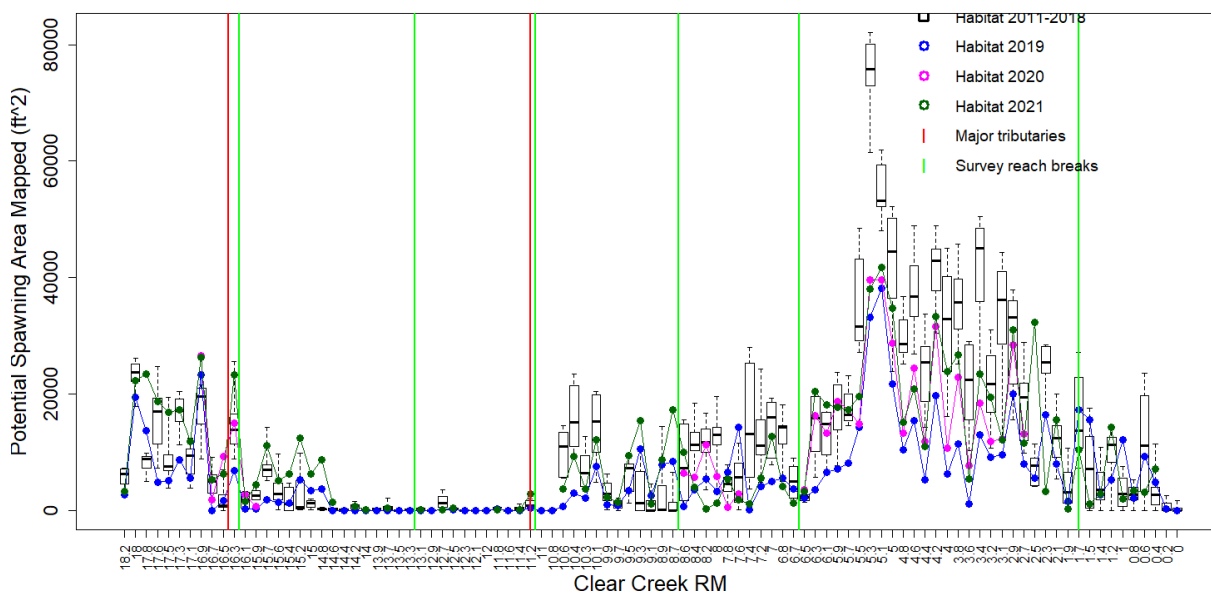
Figure 24. Anadromous fish spawning habitat mapped on Clear Creek 2011–2021. The X-axis indicates river mile breaks of roughly 1,000 ft. The Y-axis indicates the magnitude of habitat within each break. Years 2011–2018 are displayed by boxplot, 2019, 2020 and 2021 are presented as points. In 2020 only a subset of reaches was completed. USFWS-Red Bluff unpublished data.

The USFWS completes an annual survey of Clear Creek’s potential spawning habitat available to salmon and steelhead. Data collected in July 2021 indicates a continuing “recovery” of spawning habitat area following the fine sediment inundation from the 2018 Carr Fire, with more spawning habitat mapped in 2021 (907,569 ft²) when compared to 2019 (573,051 ft²) and 2020 (Figure 24). Total suitable spawning area mapped in 2021 is still less than the average habitat mapped 2011–2018, primarily from reduction in habitat in “Renshaw Riffle” (RM 5–5.5), which is a key area for fall-run Chinook Salmon spawning.

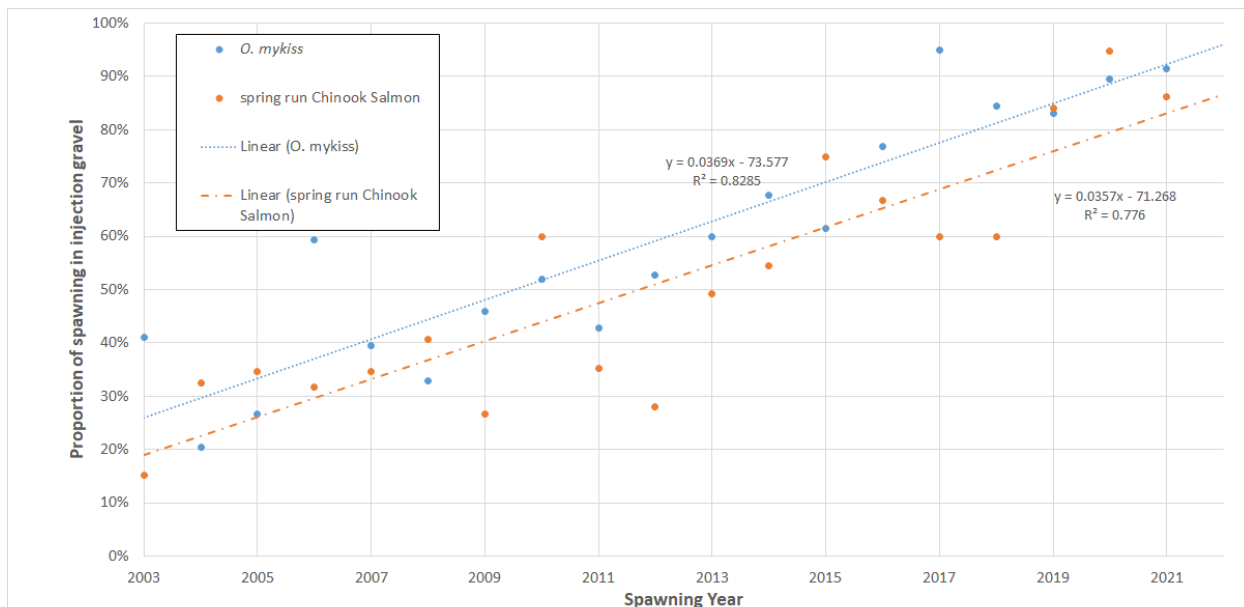
Figure 26. Annual proportion of spring-run Chinook Salmon and steelhead spawning in injection gravels, 2003–2021. Results limited to Clear Creek upstream of the spring- and fall-run Chinook Salmon separation weir. USFWS-Red Bluff unpublished data.

The gravel augmentation program’s influence on spawning habitats in Clear Creek is assessed empirically by (1) identifying the habitat used by spring-run Chinook Salmon and CCV steelhead for spawning, and (2) by annually surveying the amount of habitat available for spawning by these runs/species. Data from 2013 through 2021 show the proportional use of injected gravels vs. native gravels has increased for both spring-run Chinook Salmon and CCV steelhead (Figure 26).
