## Categorical Exclusion Checklist

# MARBLE BLUFF DAM SPILLWAY REPAIR

LO-2012-1014

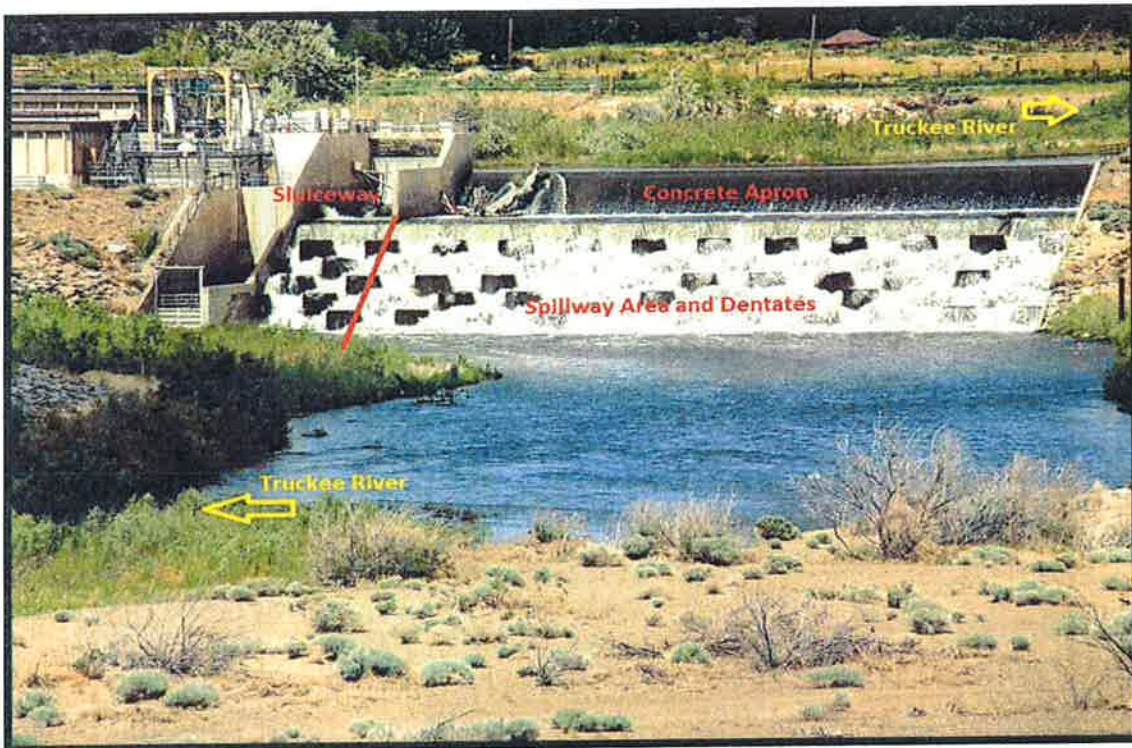
Figure 3 – View of Marble Bluff Dam

Significant erosion and damage was encountered on the Marble Bluff Dam sluiceway and spillway during an inspection that occurred December 2009. This inspection identified the need to repair erosion and damage that is occurring on the concrete dentates and spillway apron. Erosion is occurring due to continued water and debris flow over the concrete dentates and spillway apron. (Figure 3)

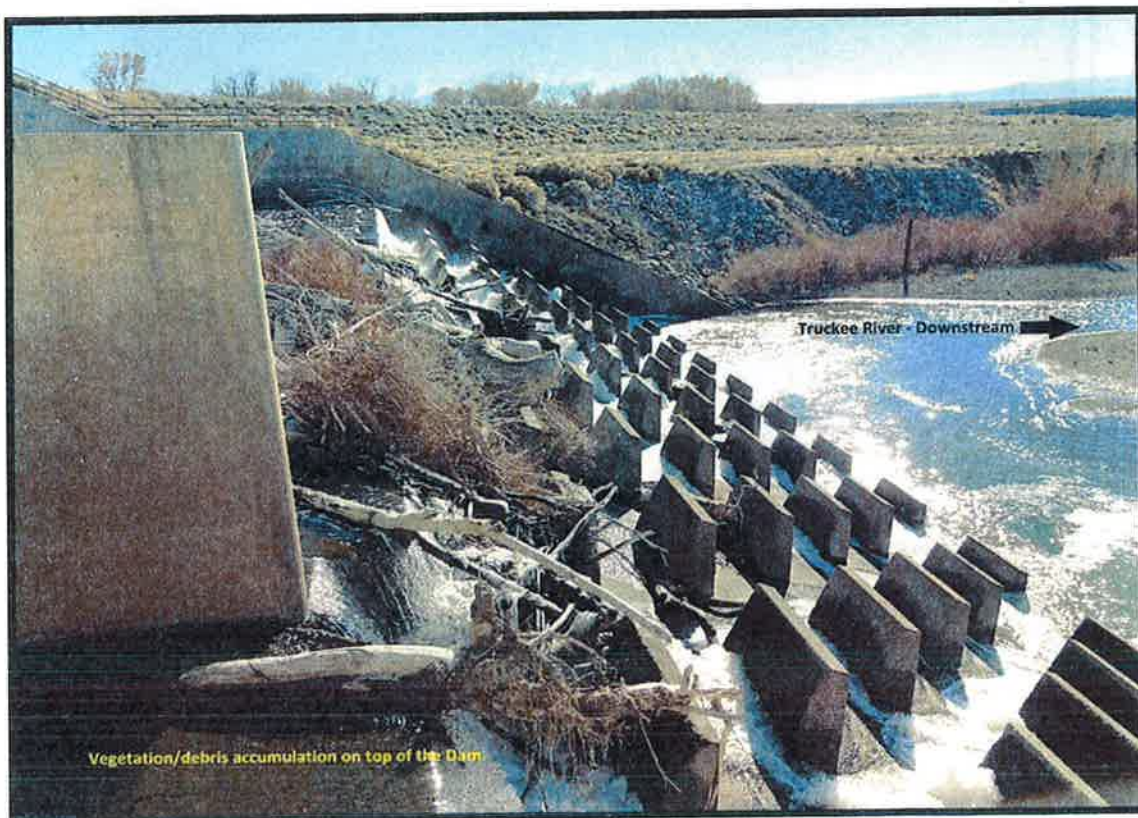
Figure 4 – Vegetation accumulation on Marble Bluff Dam

- Replace three dentates that are completely or partially missing within the sluiceway area (Figure 6)
- Repair surface concrete on twenty-two dentates within the sluiceway and spillway areas (Figure 6)
- Add detachable stainless steel armor on twelve dentates within the sluiceway area (Figure 6)
- Repair approximately 375 square feet of concrete on the apron
- Inspect inoperable drains and repair as needed
- Large woody debris that has accumulated on the dentates will be removed and will be deposited at an upland location (Figure 4)

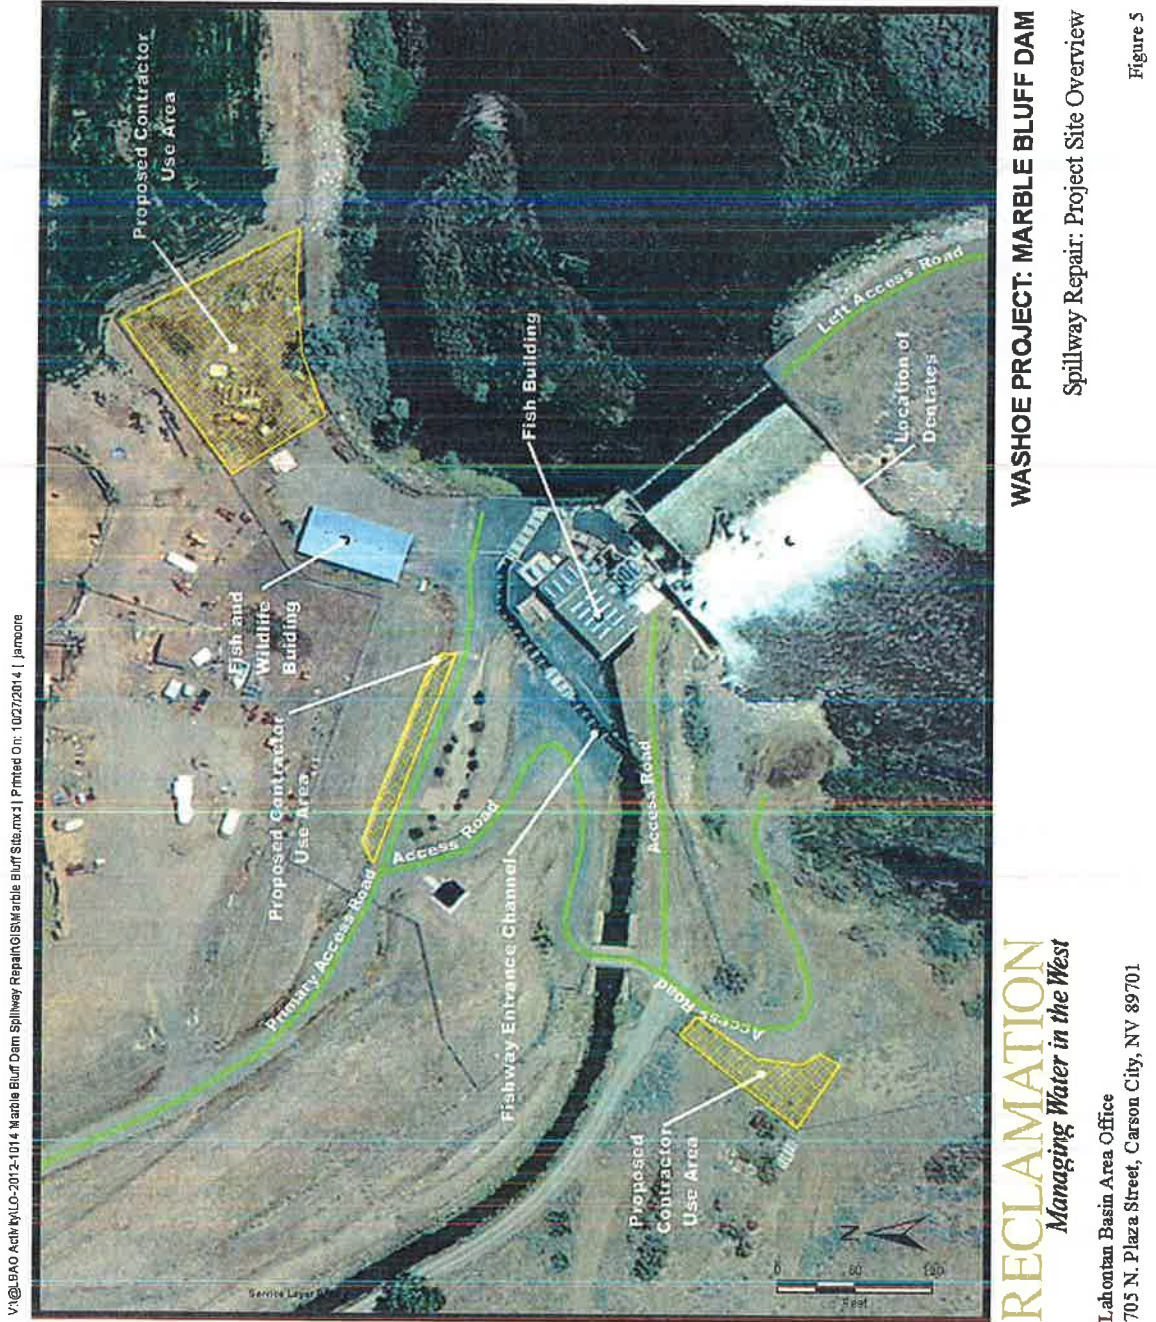
Figure 5

Spillway Repair: Project Site Overview

**Figure 5 – Project Site Overview**

Vehicles and heavy equipment will be staged in designated contractor use areas that are devoid of vegetation and/or exhibit compacted surface material. Three existing locations that are identified for contractor use are currently fenced around the perimeter and used for equipment storage (Figure 5).
