JURISDICTIONAL DELINEATION TECHNICAL STUDY REPORT

JURISDICTIONAL DELINEATION REPORT

PIXLEY GROUNDWATER BANK

Tulare County, California

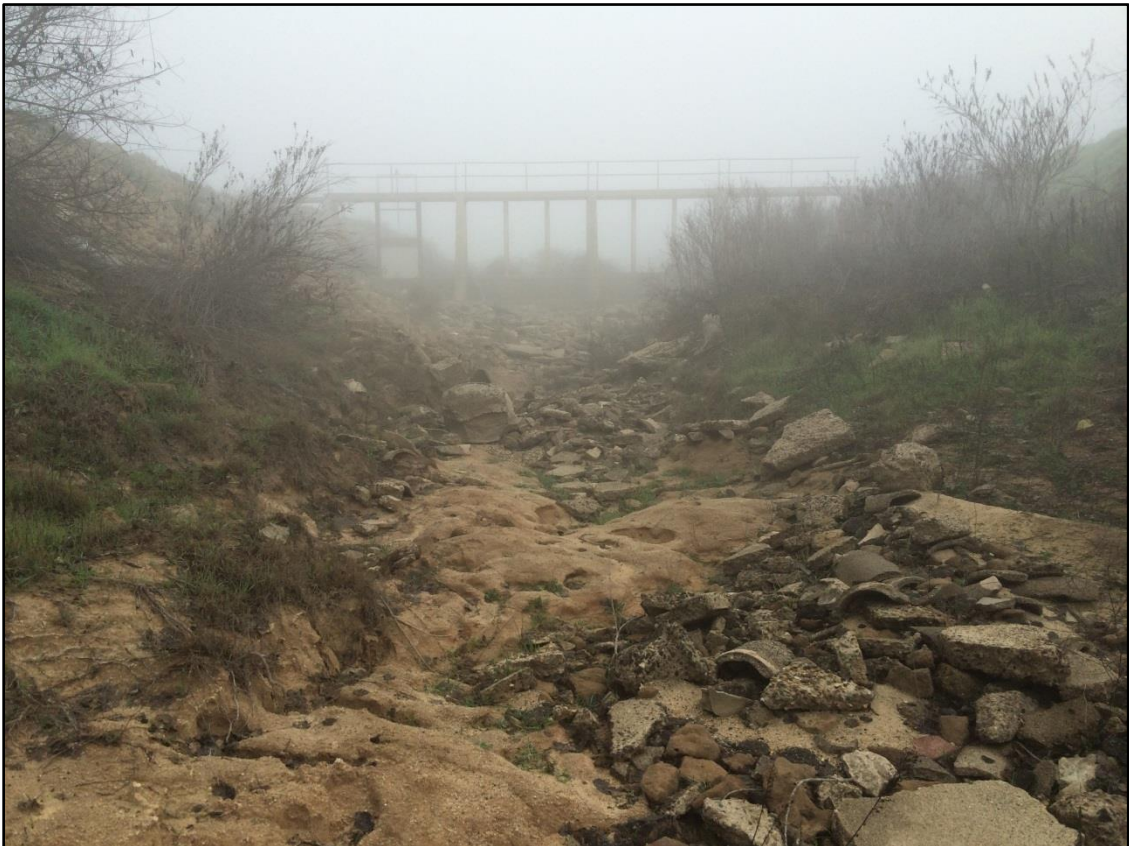
Photo Point 2 – Facing Up (Northeast) Deer Creek

A highly disturbed reach of Deer Creek channel enters the study area from the east and exits to the west. This part of Deer Creek, which appears to have been straightened prior to 1994, is bracketed by levies and contains a diversion structure with wing walls. Most of the streambed lacked vegetation. Woody riparian species observed growing on the banks and levees include eastern cottonwood (*Populus deltoides*), narrow-leaf willow (*Salix exigua*), mule's fat (*Baccharis salicifolia*), Himalayan blackberry (*Rubus armeniacus*), and polished willow (*Salix laevigata*). The herb stratum consisted of stinging nettle (*Urtica dioica*), ripgut brome (*Bromus diandrus*), curly dock (*Rumex crispus*), Douglas' wormwood (*Artemisia douglasiana*), rough cocklebur (*Xanthium strumarium*), wall barley (*Hordeum murinum*), poison-hemlock (*Conium maculata*), and wetland and upland species.

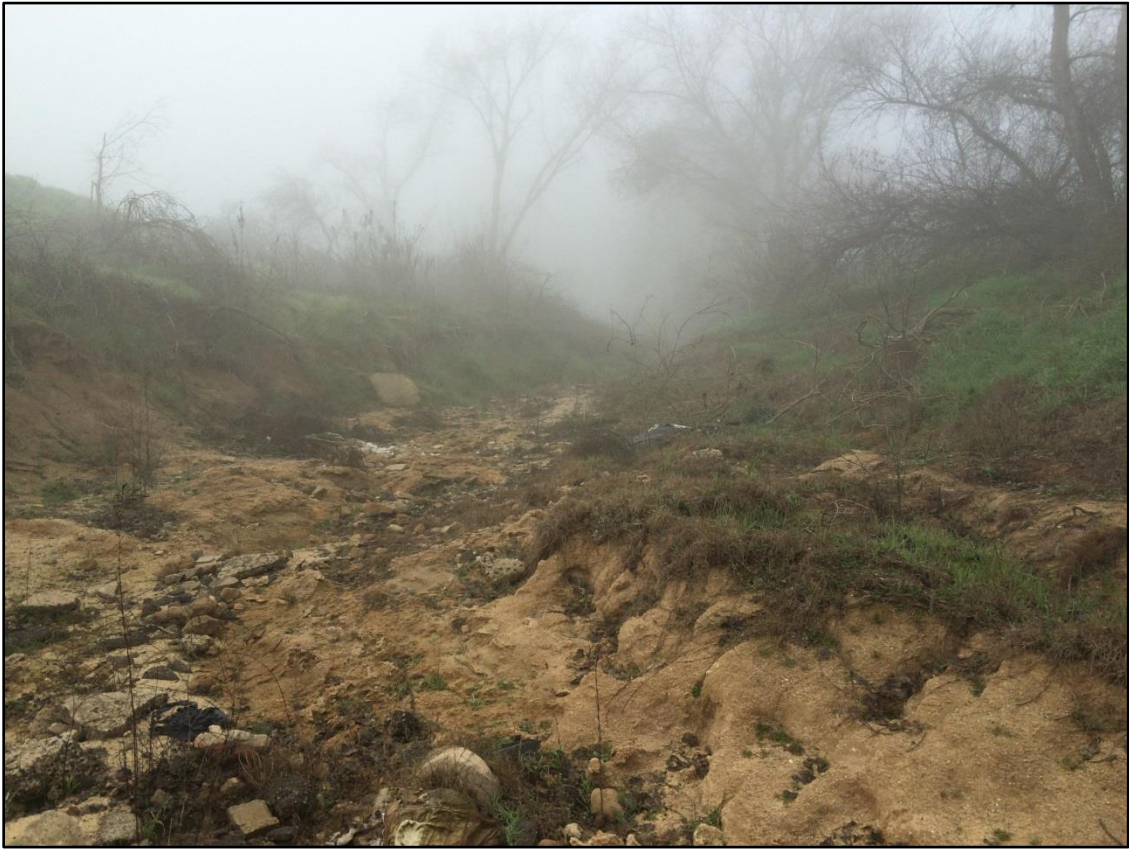
Photo Point 2 – Facing Down (Southwest) Deer Creek

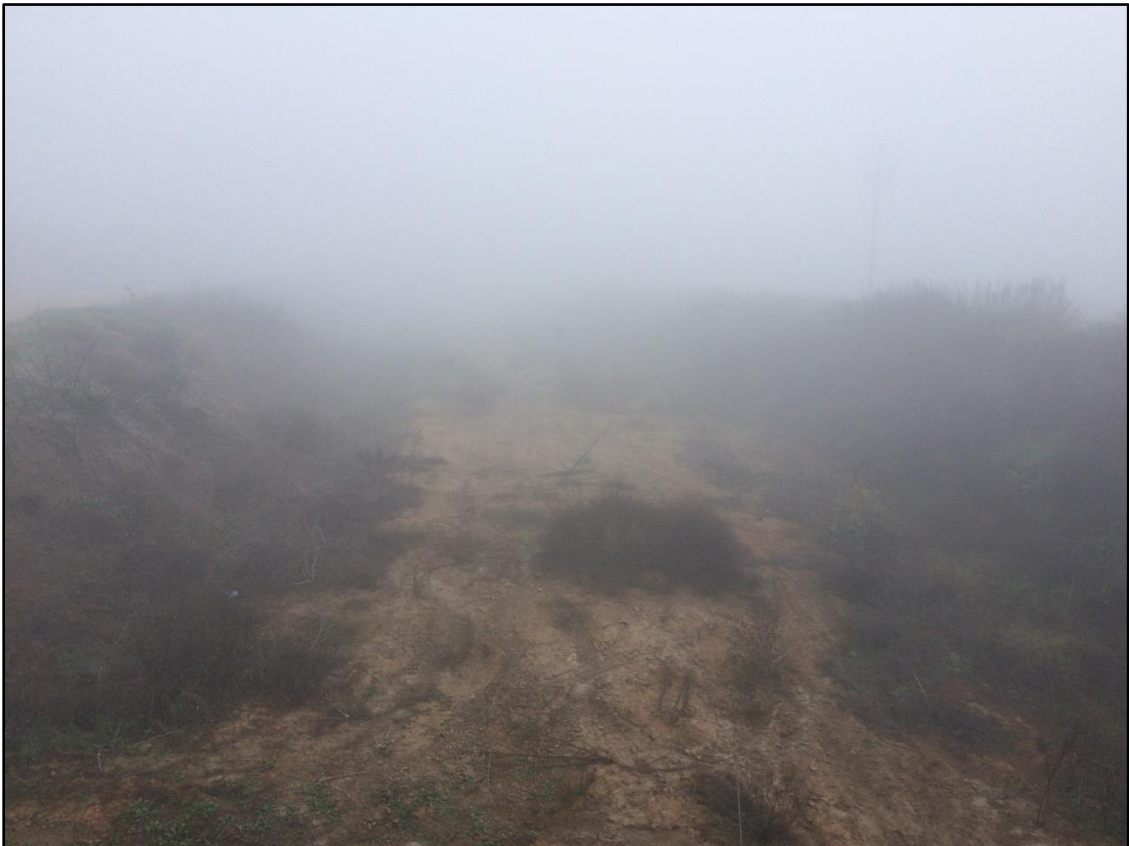
Photo Point 3 – Facing Up (Northeast) Deer Creek

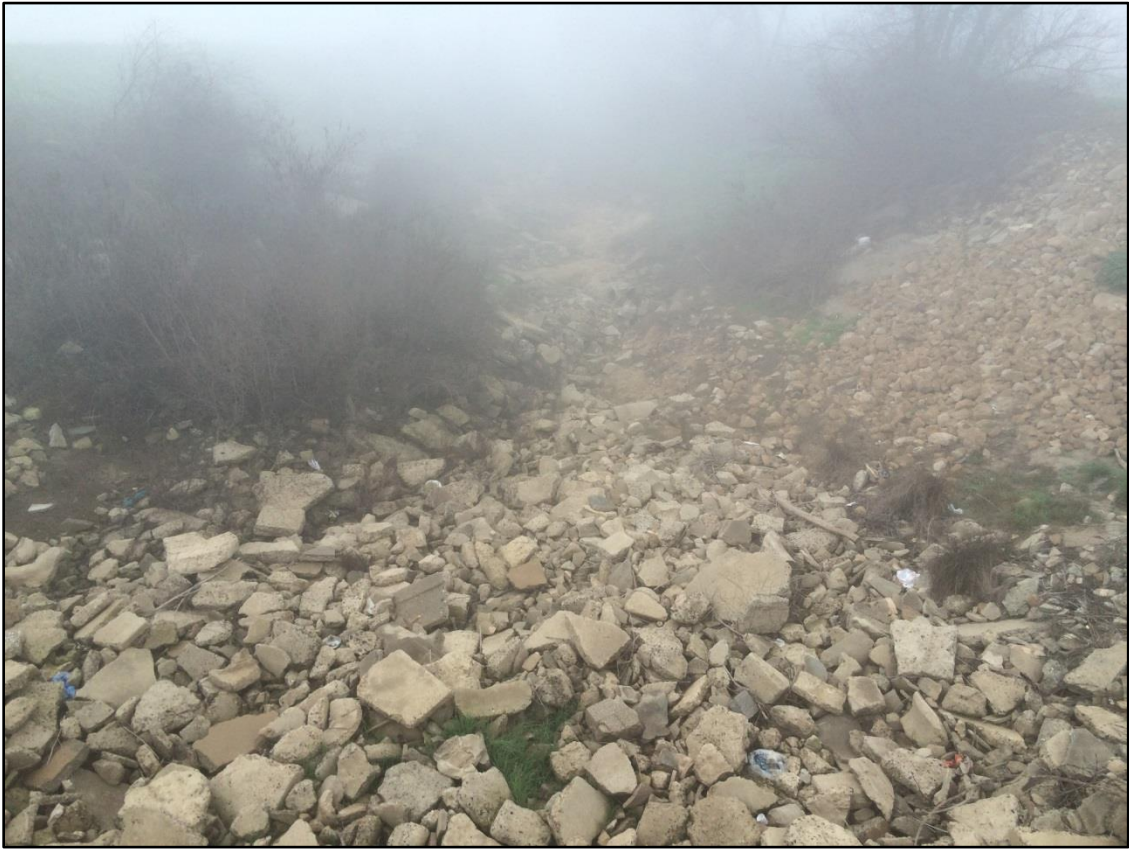
Photo Point 3 – Facing Down (Southwest) Deer Creek

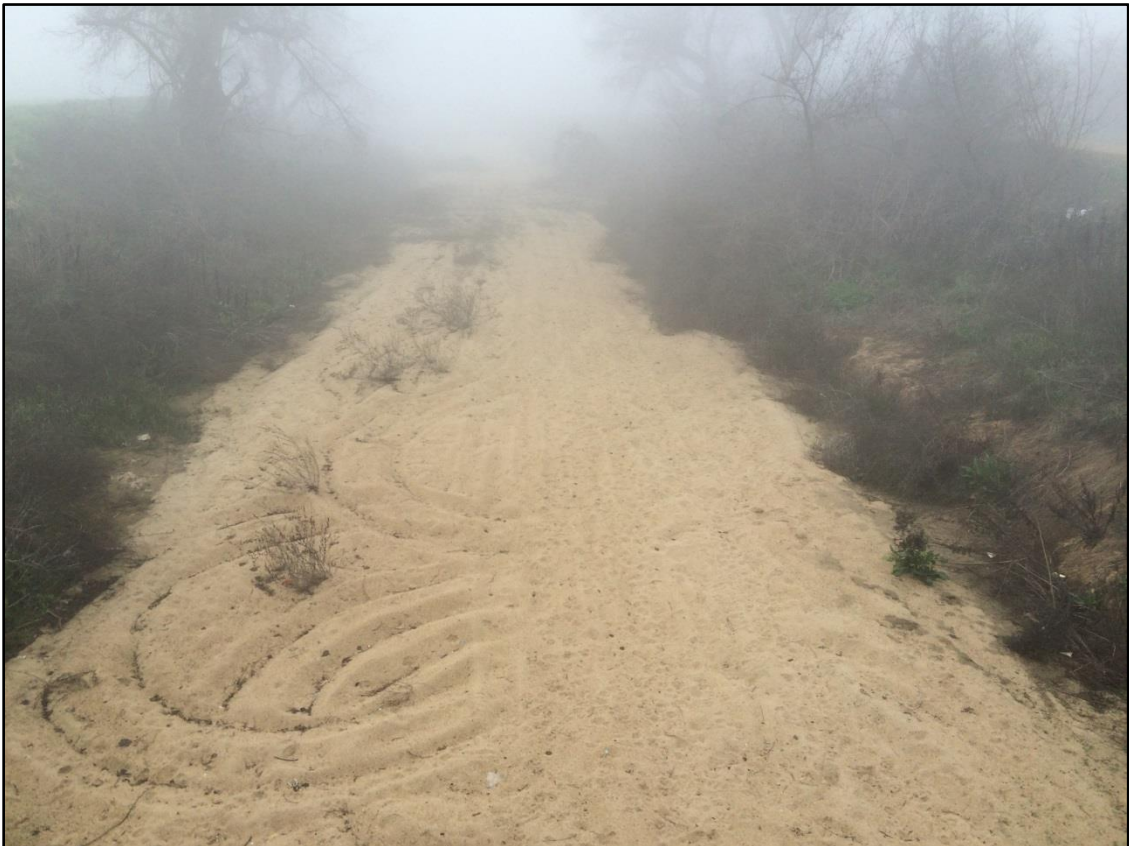
Photo Point 4 – Facing Down (Southwest) Deer Creek
