## 3.3 Water Resources

### 3.3.1 Surface-water Hydrology and Management

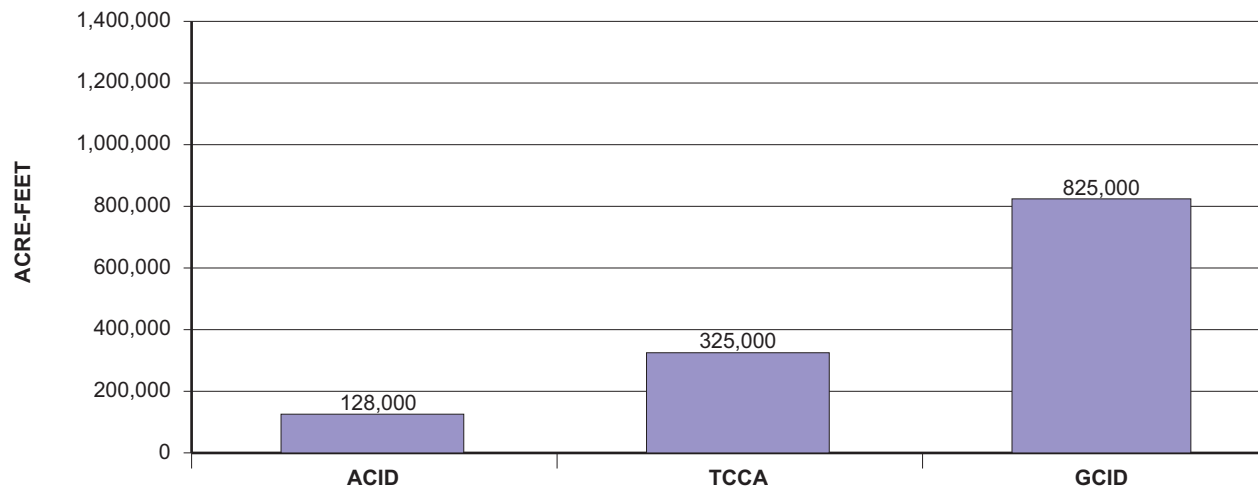
**FIGURE 3.3-2 (REVISED)**  
**CVP WATER CONTRACT VOLUMES**  
**FROM THE SACRAMENTO RIVER**  
**(VICINITY OF RBDD)**  
FISH PASSAGE IMPROVEMENT PROJECT  
RED BLUFF DIVERSION DAM EIS/EIR

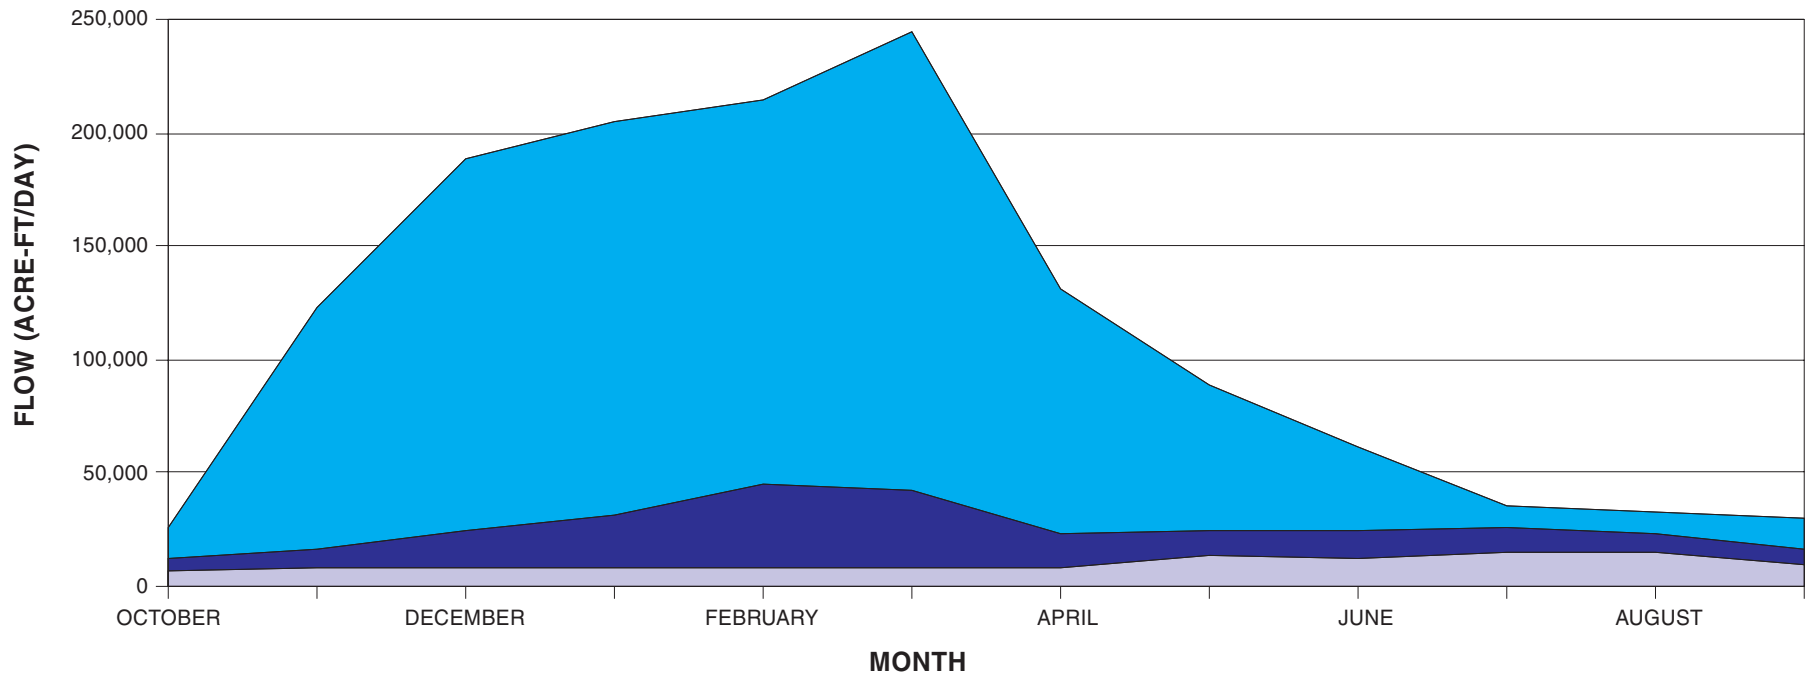
- MAXIMUM FLOW
- AVERAGE FLOW
- MINIMUM FLOW

**FIGURE 3.3-6**  
**MINIMUM, AVERAGE, AND MAXIMUM**  
**MONTHLY SACRAMENTO RIVER FLOWS**  
**FOLLOWING RBDD CONSTRUCTION (1980 TO 2000)**  
 FISH PASSAGE IMPROVEMENT PROJECT  
 RED BLUFF DIVERSION DAM EIS/EIR

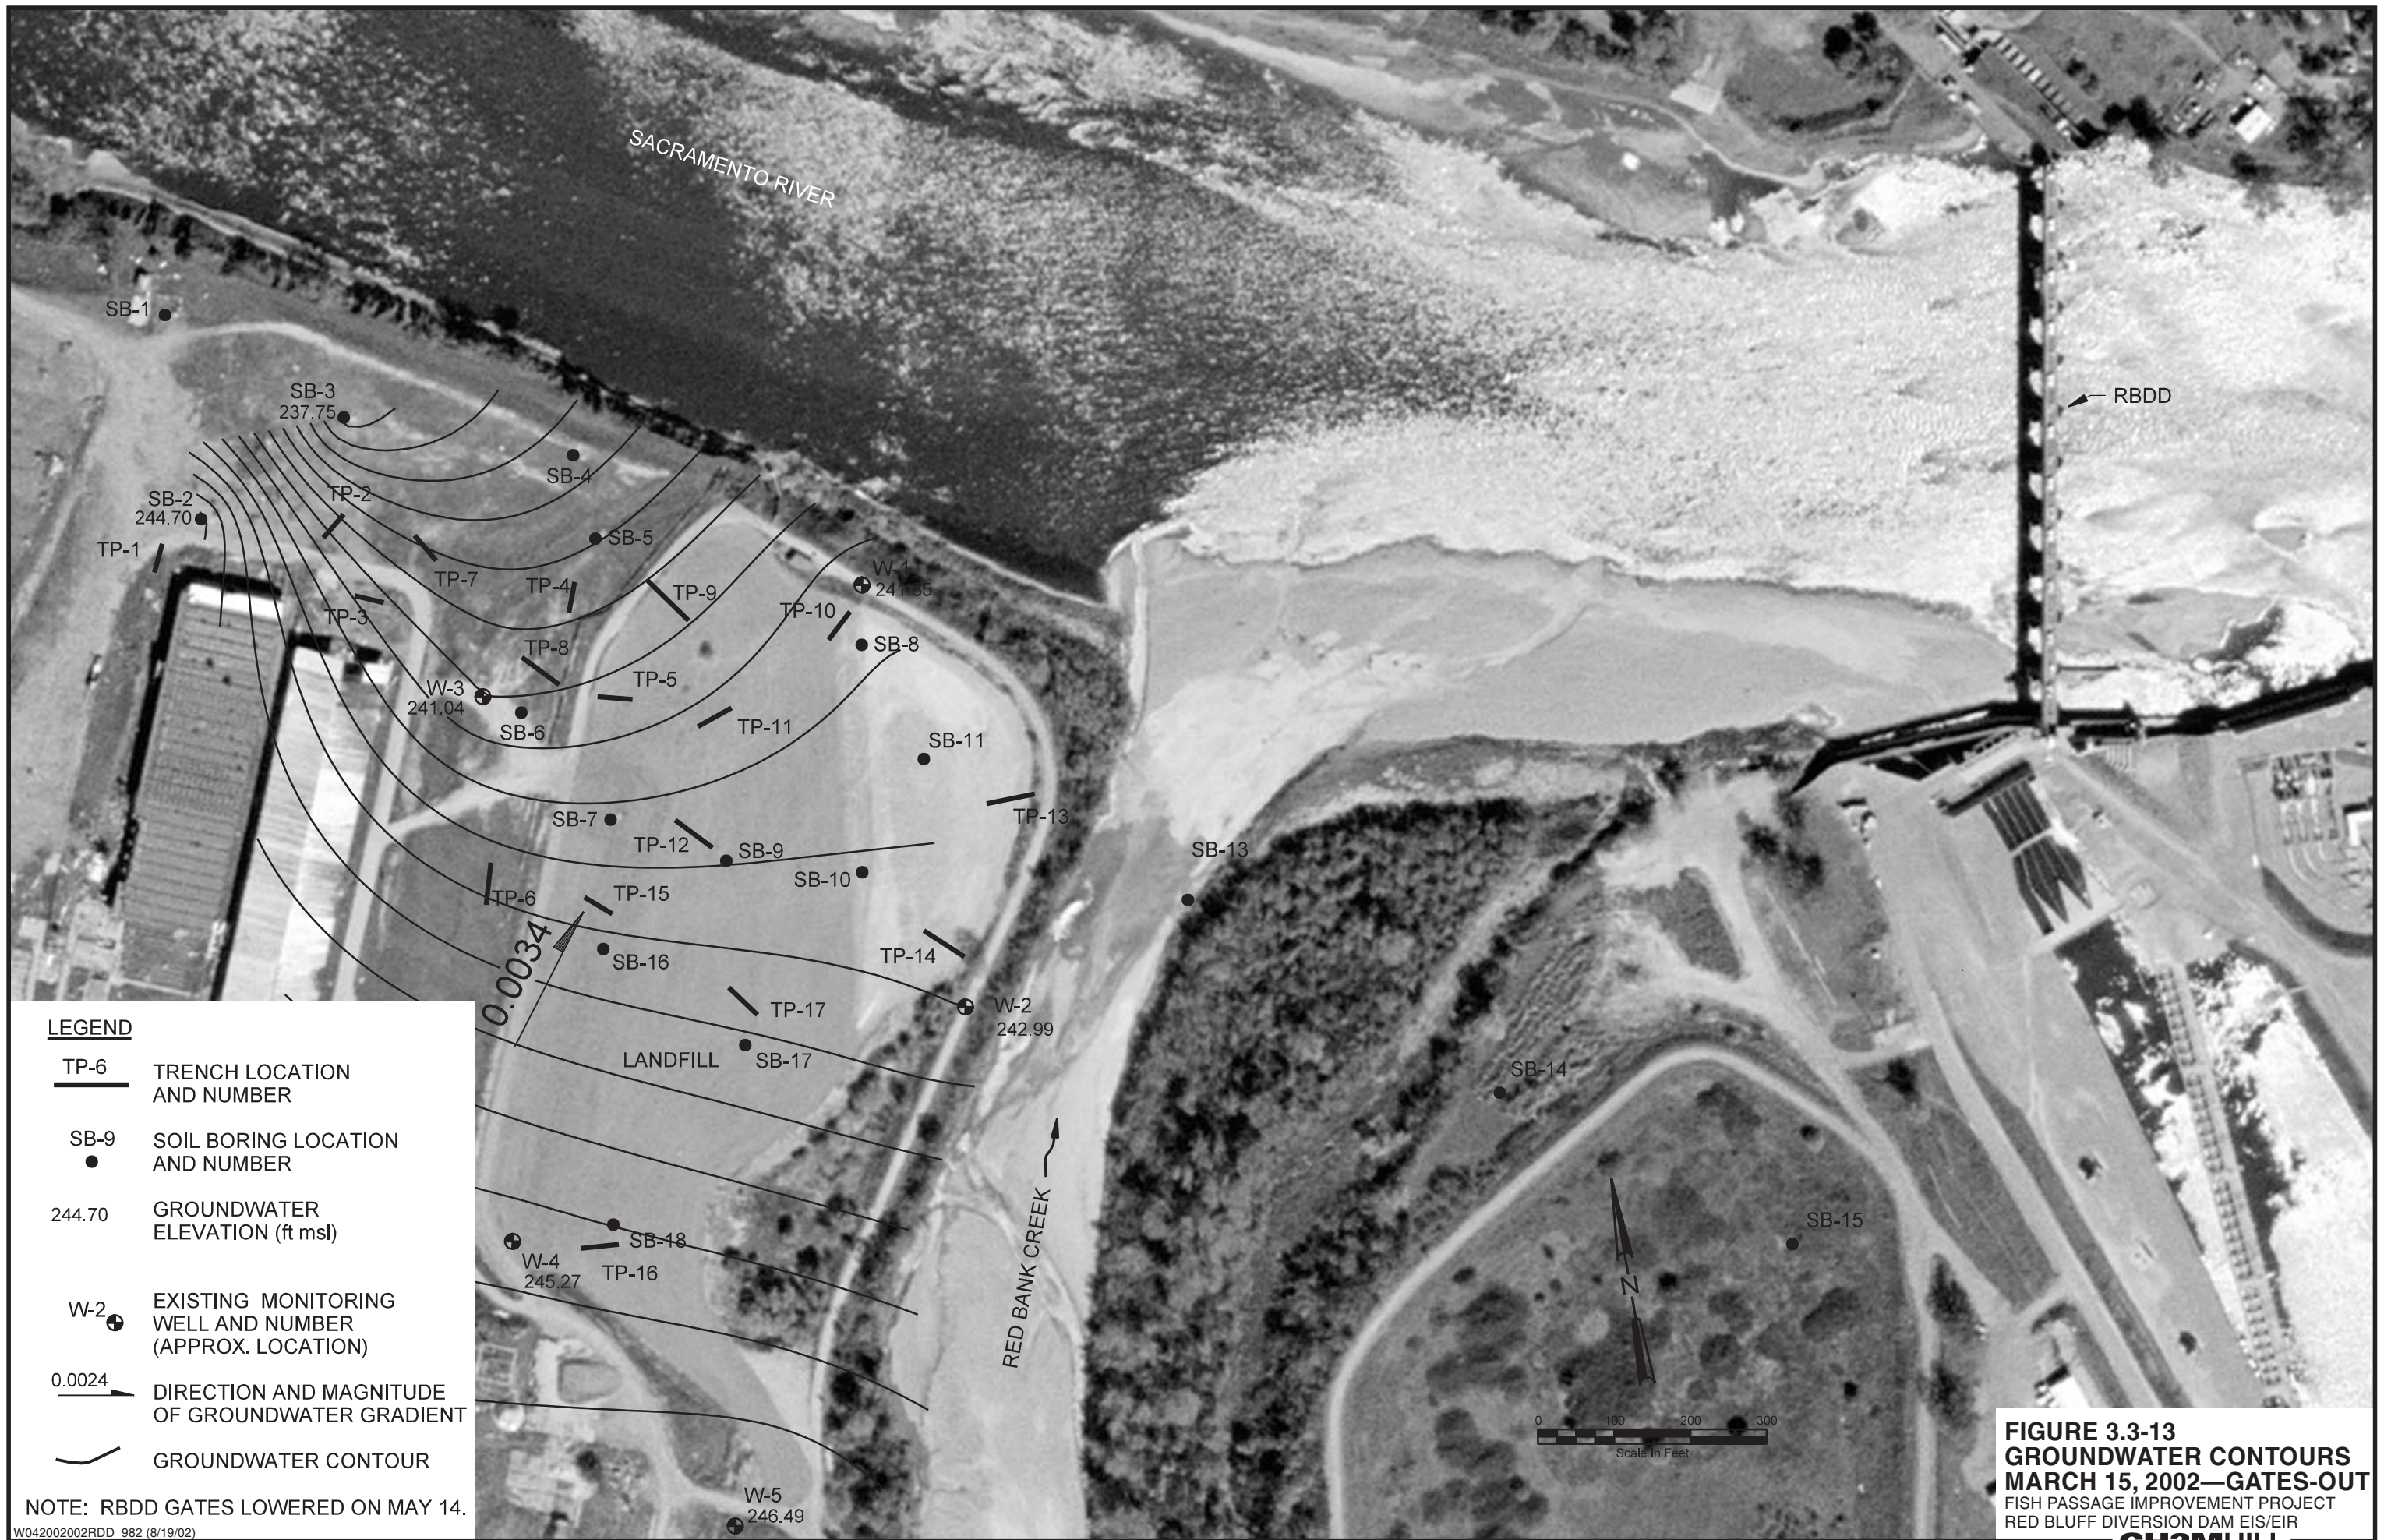
**FIGURE 3.3-12**  
**GROUNDWATER CONTOURS**  
 JULY 11, 2002—GATES-IN  
 FISH PASSAGE IMPROVEMENT PROJECT  
 RED BLUFF DIVERSION DAM EIS/EIR  
**CH2MHILL**

**Soil Contamination.** CH2M HILL (2002) advanced 14 soil borings and completed 8 test pits (see Figure 3.3-12) within the project site to assess the quality of soils that may be impacted as the result of project construction. In general, soil was found to be free of significant contamination throughout the site. However, motor oil was detected in several soil samples, chromium was found to exceed state hazardous waste criteria in one soil sample, and polychlorinated biphenyls were detected above the EPA Region IX industrial PRG in one sample.

With the exception of the high chromium found in one of the test pits at the Mill Site (TP-12), all other sample locations contained metals below their respective PRG values. Contaminants such as volatile and semivolatile organic compounds were below method reporting limits in all samples analyzed.

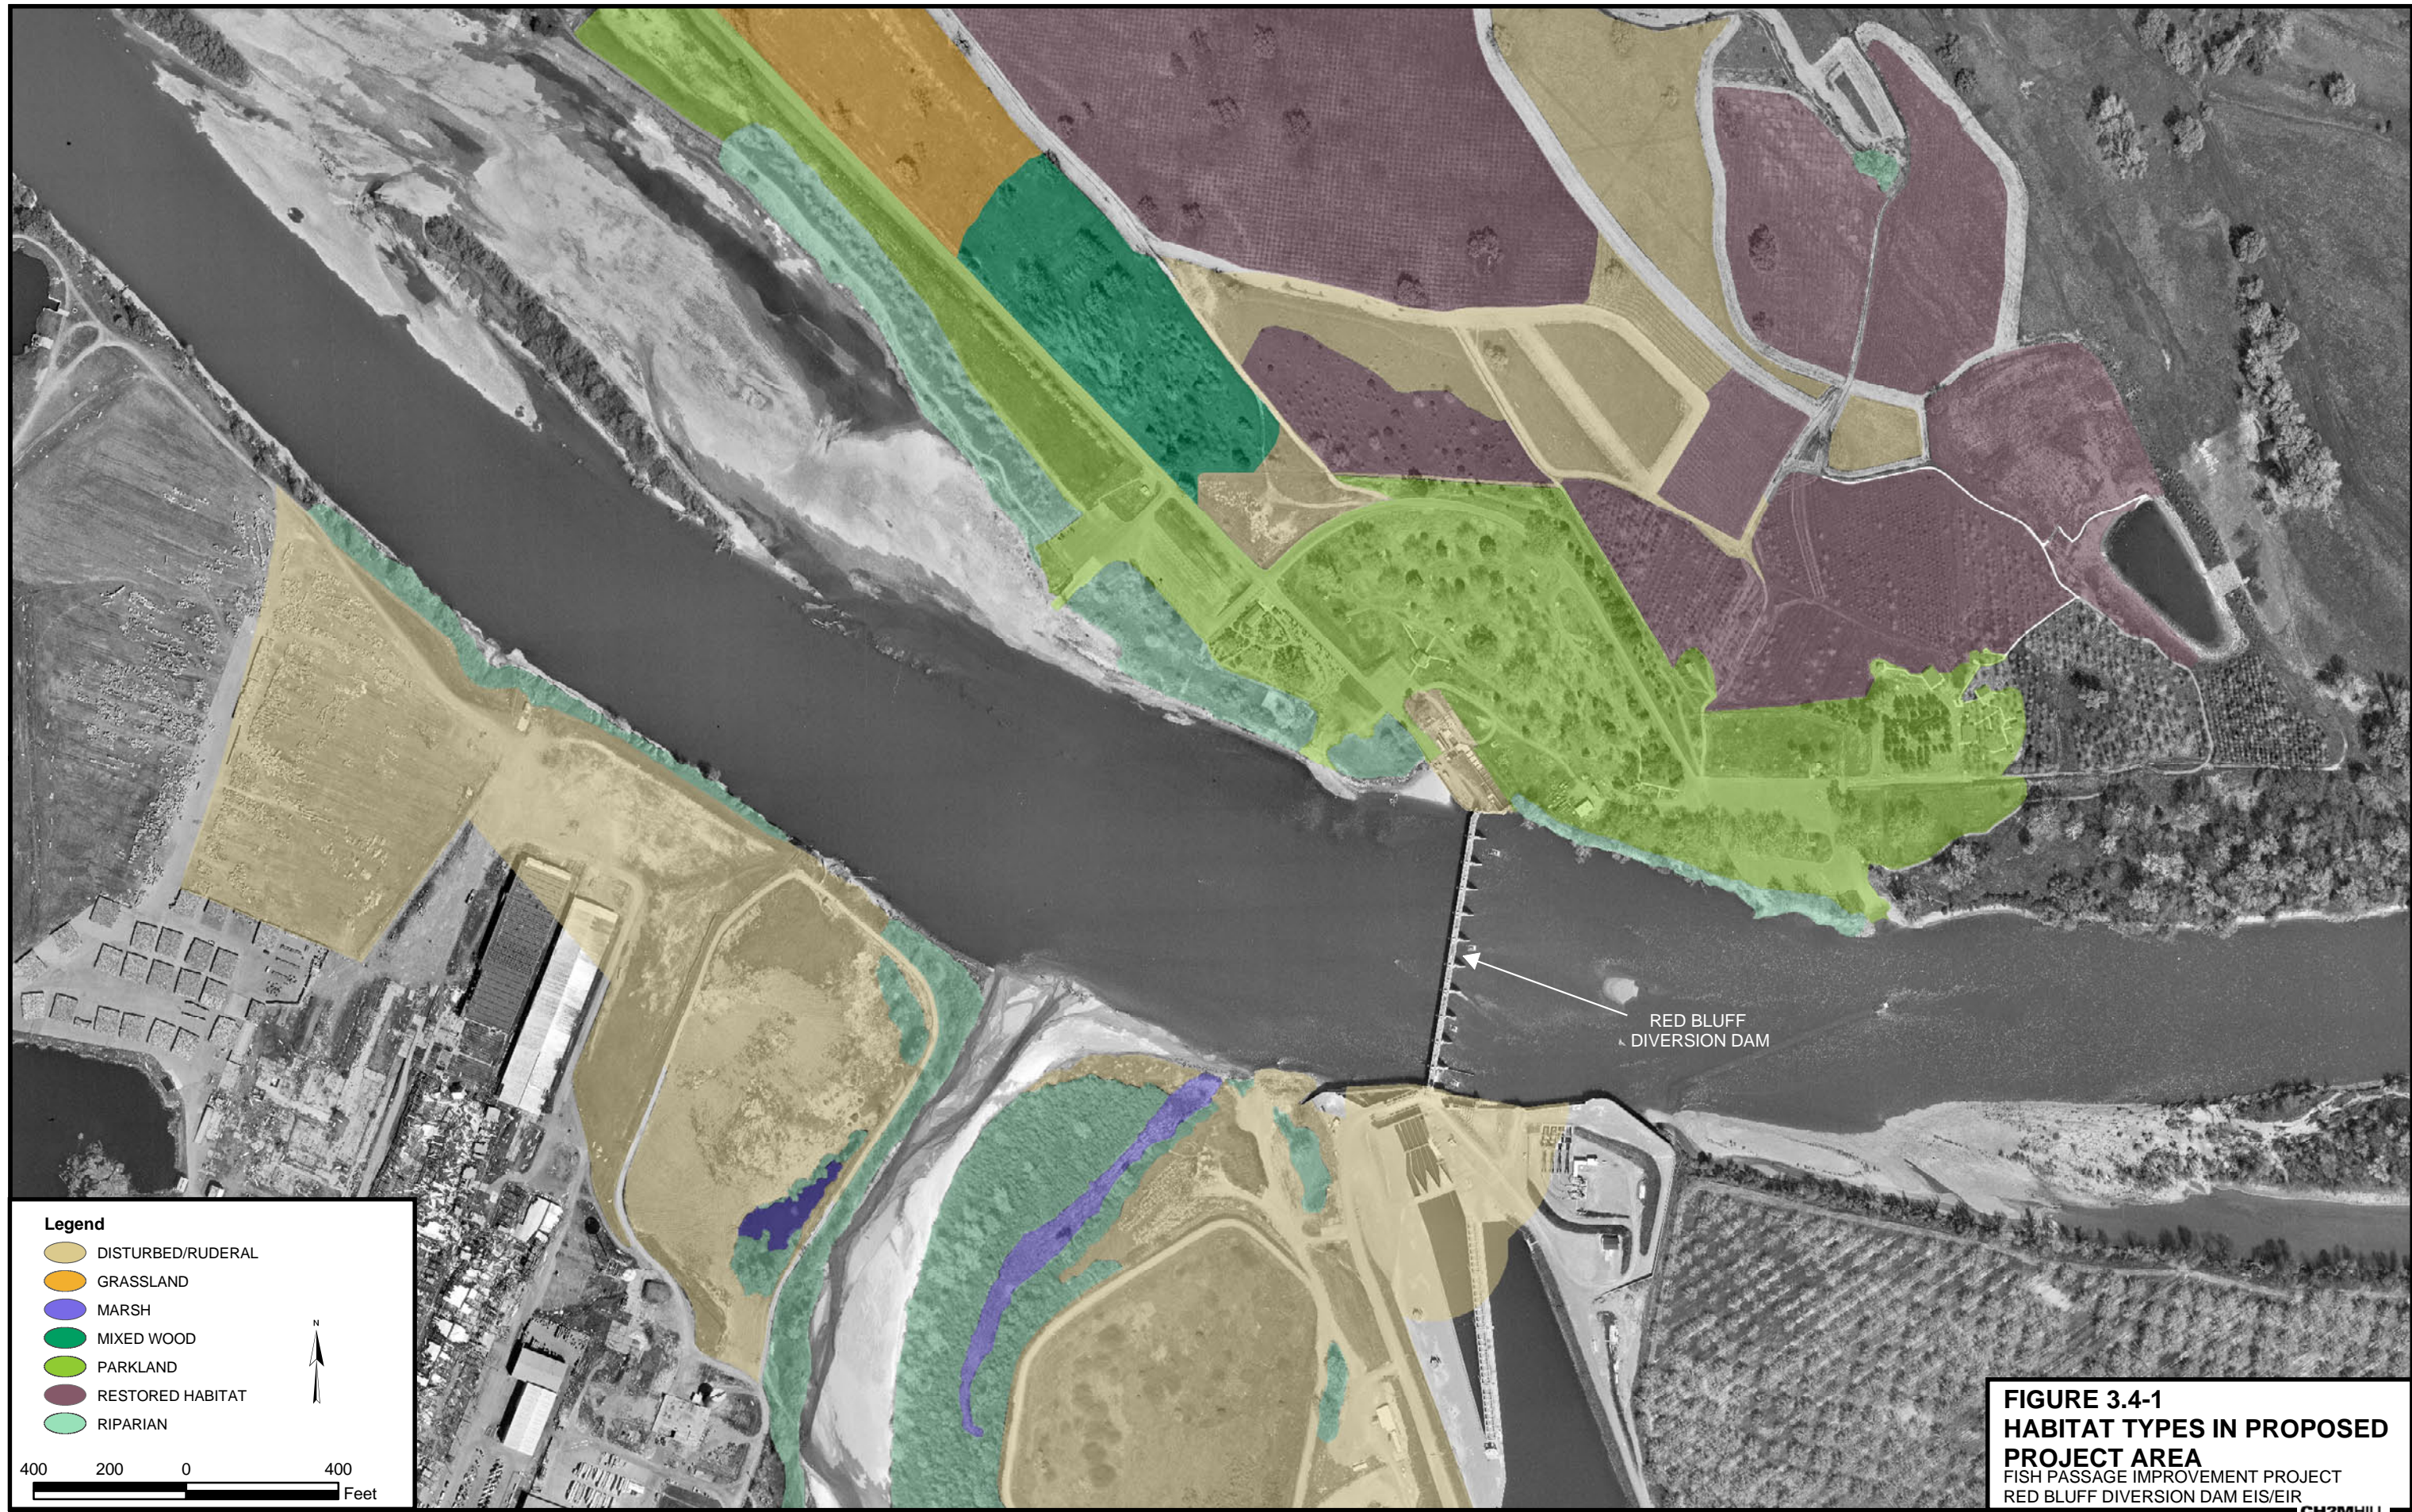
**FIGURE 3.4-1**  
**HABITAT TYPES IN PROPOSED**  
**PROJECT AREA**  
 FISH PASSAGE IMPROVEMENT PROJECT  
 RED BLUFF DIVERSION DAM EIS/EIR

The immediate project area contains about 26 acres of riparian habitat. Most of the riparian habitat occurs along Red Bank Creek, with additional narrow bands located along the mainstem of the Sacramento River (Figure 3.4-1). Primary plant species are cottonwoods (*Populus fremontii*), willows (*Salix* sp.), and sycamores (*Platanus racemosa*). The riparian zone also contains many non-native species, including star thistle, sticky weed, tree-of-heaven, pyracantha, and pampas grass. As with much of the Sacramento River, blackberries are found in abundance on the banks and levees.
