2 **Bed Sediment Sampling**

4 **Geomorphology, Sediment Transport,**
5 **and Vegetation Assessment**

SAN JOAQUIN RIVER
RESTORATION PROGRAM

San Joaquin River Geomorphic Assessment Using Historical Aerial Photographs, California Friant Dam to Route 99 Bridge

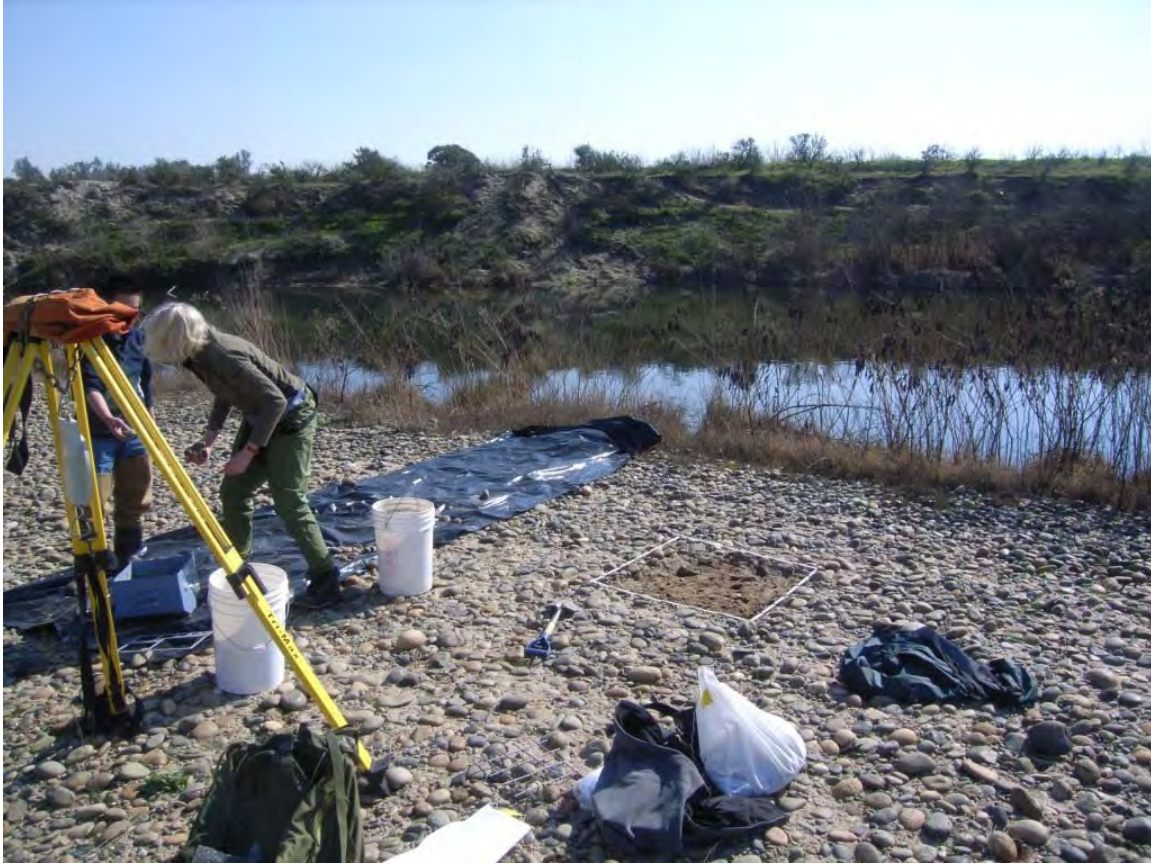
Figure 2-1.
Photograph of Field Sieving Setup

27 To limit the volume of sediment transported to the laboratory, the sample was typically
28 passed through a 32-millimeter (mm) sieve in the field. Particles larger than 32 mm were
29 classified by size using a Wolman board and each size class was weighed on a scale
30 supported by a survey tripod (typically a 70-pound (lb) scale with 0.1-lb increments).
31 The material passing the 32-mm field sieve was put in a sample bag and labeled to be
32 sent to a laboratory for further sieve analysis. A picture of the field sieving setup is given
33 in Figure 2-1.

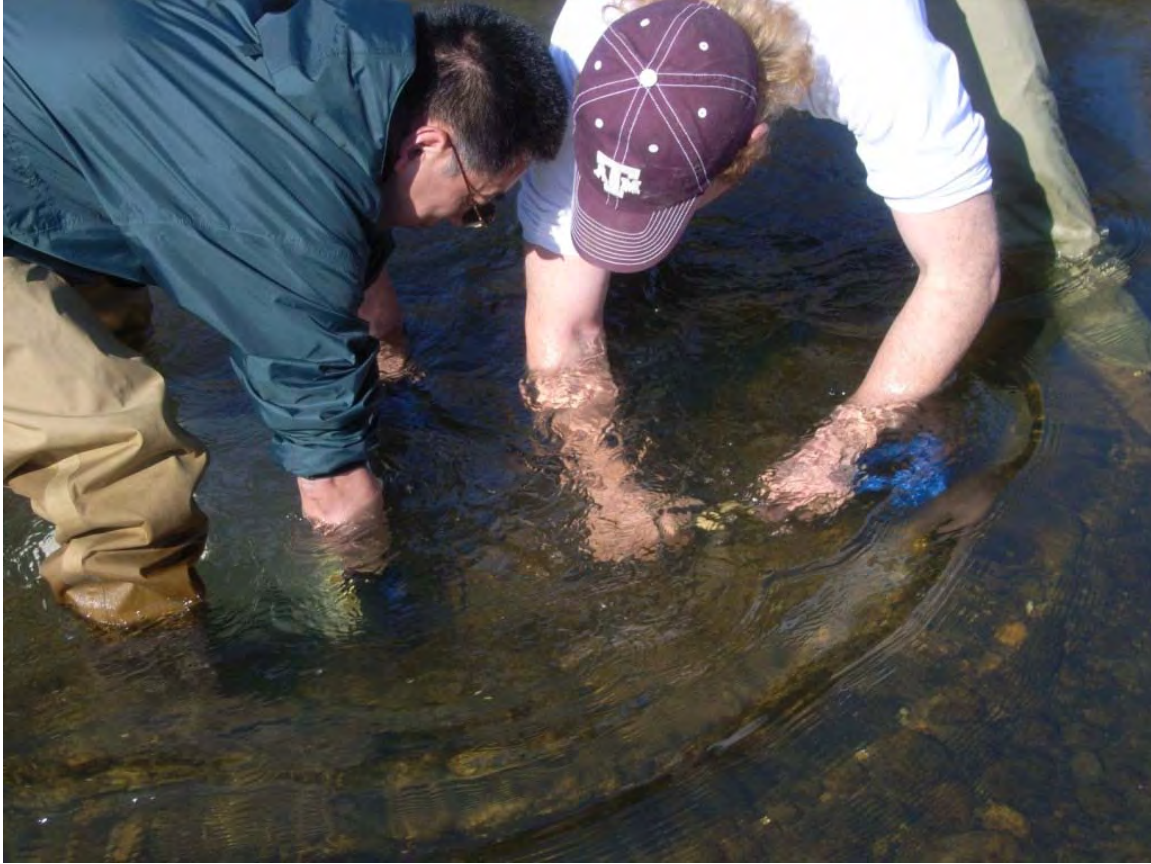
**Figure 2-2.
Under Water Sediment Sample Collection**

11 Subsurface material samples are likely biased for three reasons. First, surface material
12 from upstream may have rolled atop the newly exposed subsurface material before the
13 subsurface sample may be collected. Second, exposed subsurface material may have
14 winnowed away after the coarser surface layer was removed and before a subsurface
15 sample was taken. Lastly, because the sample is collected underwater, more sands, silts,
16 and clays may be lost as the material goes under, around, and through the permeable
17 sample bag. An underwater surface sample is shown being collected in Figure 2-2.

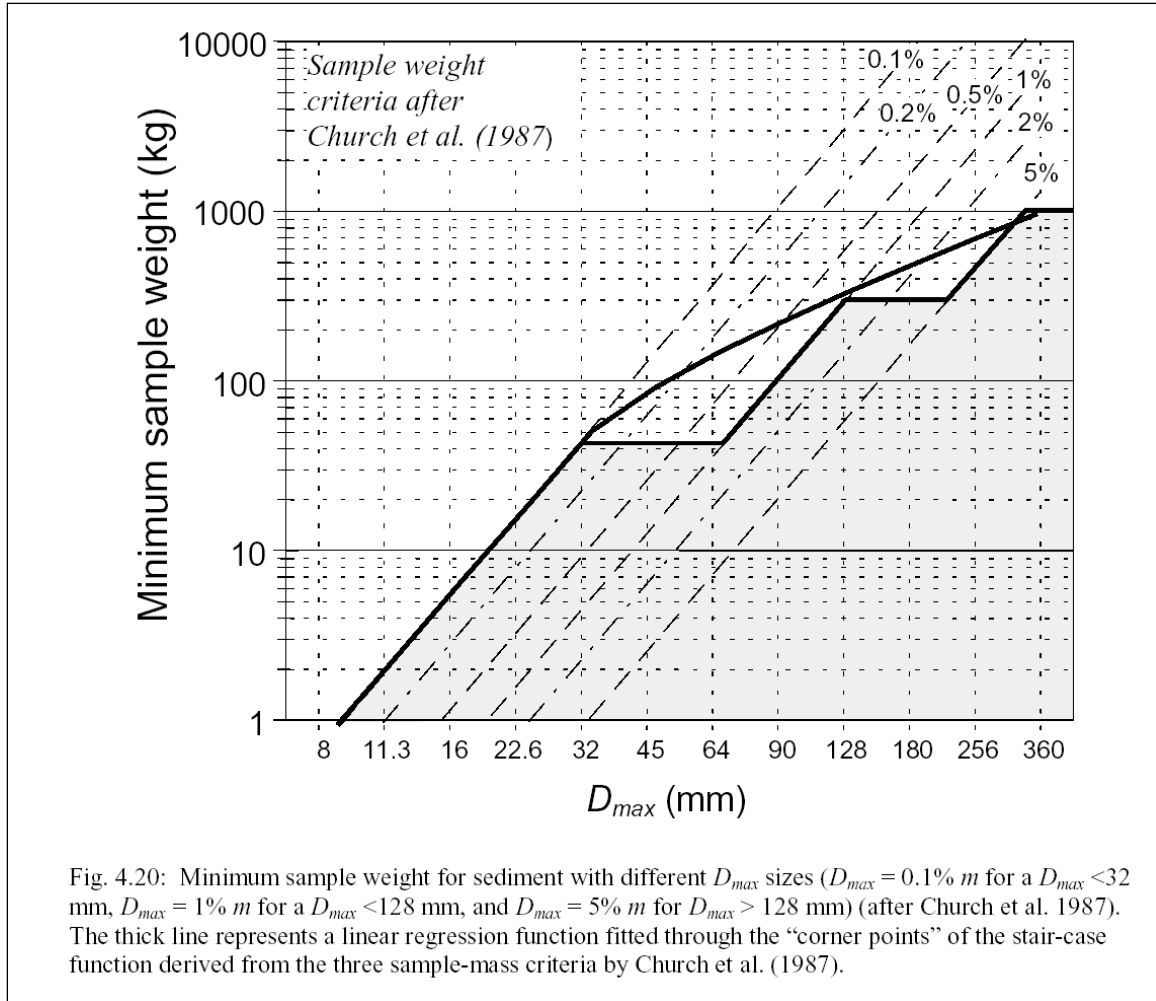
Figure 2-3.
Figure Taken from Bunte and Abt, 2001, Summarizing Recommendations from Church et al., 1987

12 The total weight of the bulk sample should be related to the maximum particle size in the
13 sample (Bunte and Abt 2001, Haschenburger 2005). Figure 2-3 contains recommended
14 sample weights given the maximum diameter of the sample. This guideline may not have
15 been met for the coarser reaches of the river due to time and budget limitations.

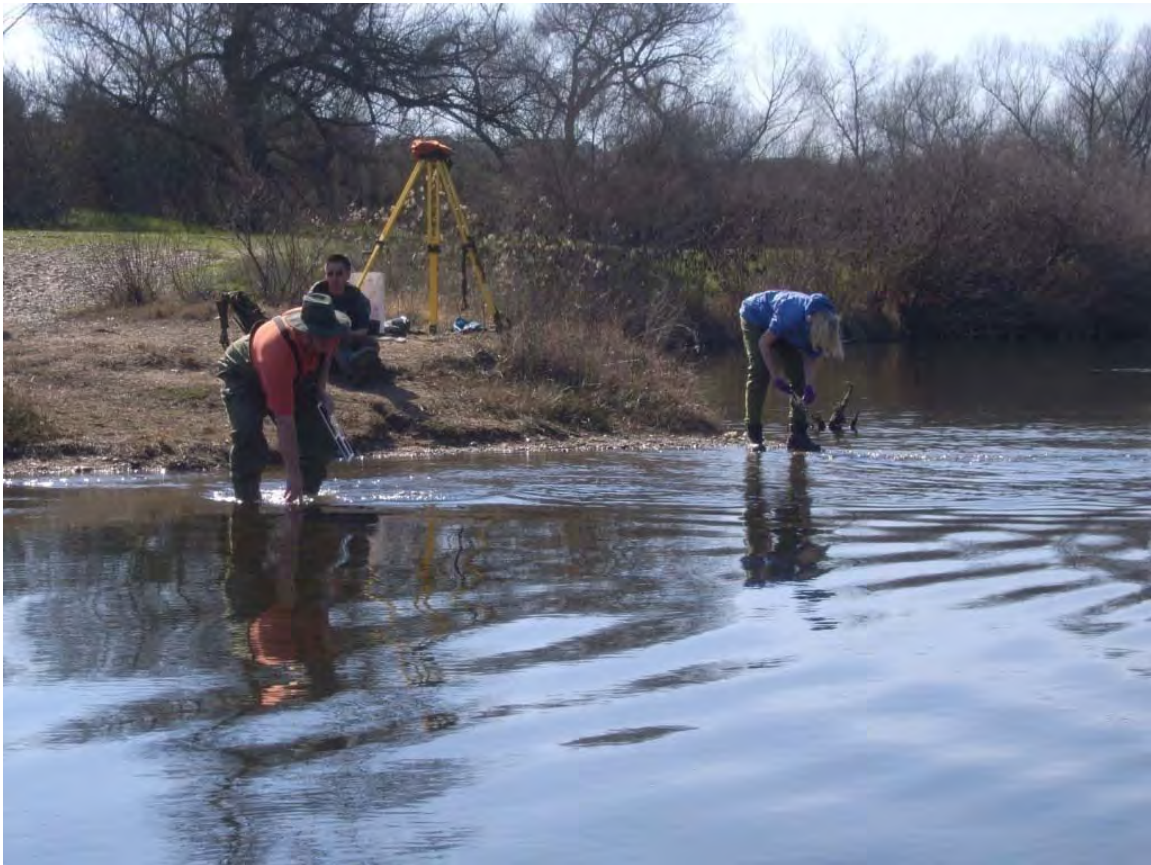
17
18 **Figure 2-4.**
19 **Photograph of Adjacent In-Channel Wolman Pebble Counts**

4 If the bar or channel being sampled was narrower than 100 feet wide or edge effects
5 (vegetation) began to occur along the outer edges, the pebble count was collected in
6 adjacent lines or in a grid. For the adjacent lines, two 50- or four 25-foot lines were
7 placed and the same method as described above is used. At least 100 total data points
8 were collected. Figure 2-4 is a photo of two adjacent in-channel pebble counts in a wet
9 channel less 100 feet wide.

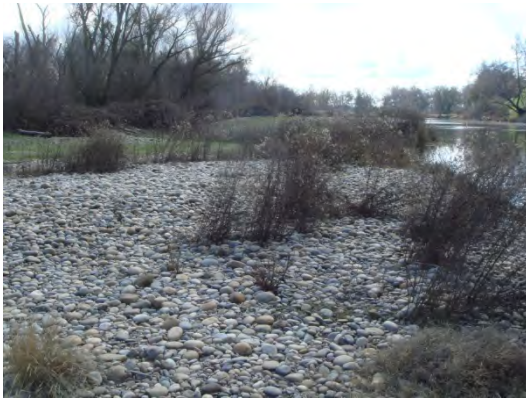
Figure 3-1.
Cobble and Gravel Bar in Reach 1a

3 Reach 1 begins at Friant Dam and continues down to Gravelly Ford. The reach has been
4 subdivided at State Highway 99 into Reaches 1a and 1b. The bed material in Reach 1 is
5 primarily gravel and cobble with a sandy substrate, and transitions to a sand-bed in the
6 downstream section of the reach. There are multiple gravel mining operations in Reach
7 1. The river is narrow due to the levees that are in place to protect agricultural lands and
8 golf courses, as well as preventing gravel pits from capturing the river in the reach. The
9 lower portion of Reach 1a runs along the north side of the Fresno Metropolitan Area as a
10 further need for levees in this reach. Water was present throughout Reach 1 during the
11 sediment sampling trip. The source of flow for Reach 1 is primarily the releases from
12 Friant Dam. Grassy vegetation along with cottonwoods are found in the riparian corridor
13 of Reach 1. Figure 3-1 is a photograph from a cobble bar on the Defehr Property (Reach

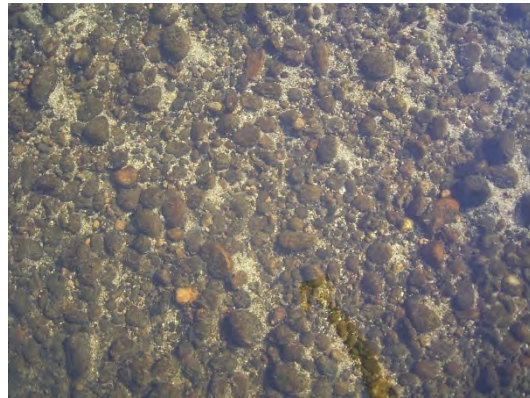
Figure 3-2.
Gravel and Sand in Reach 1b

14 1a), and Figure 3-2 is a photograph of the gravel bed with interstitial sands in Reach 1b.

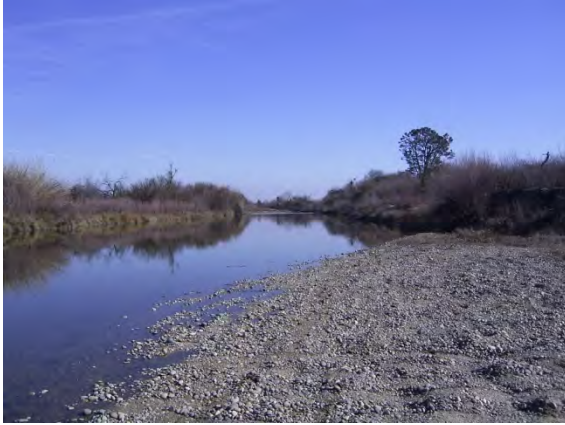
Figure 3-3.
Transition Zone in Upper Portion of
Reach 2a

1 The bypass is a flood control channel that eases the stresses on and the potential for
2 flooding of the San Joaquin River. The river has levees on both sides for most of this
3 reach to protect agricultural lands adjacent to the river corridor. Figure 3-3 is a
4 photograph of the upper transition zone of Reach 2a, and Figure 3-4 is a photograph from
5 the middle of Reach 2a (after the transition zone from gravel to sand).

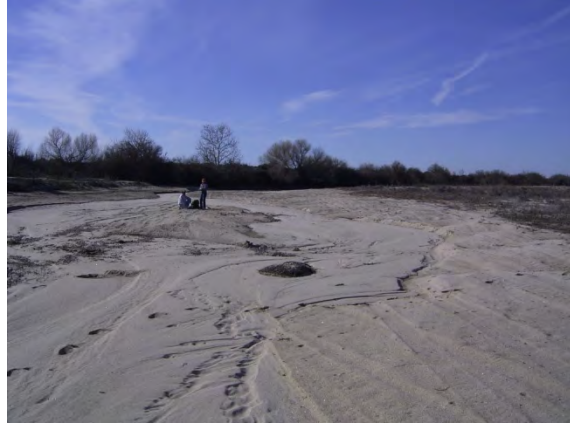
Figure 3-4.
Sand-Bed Channel in Reach 2a

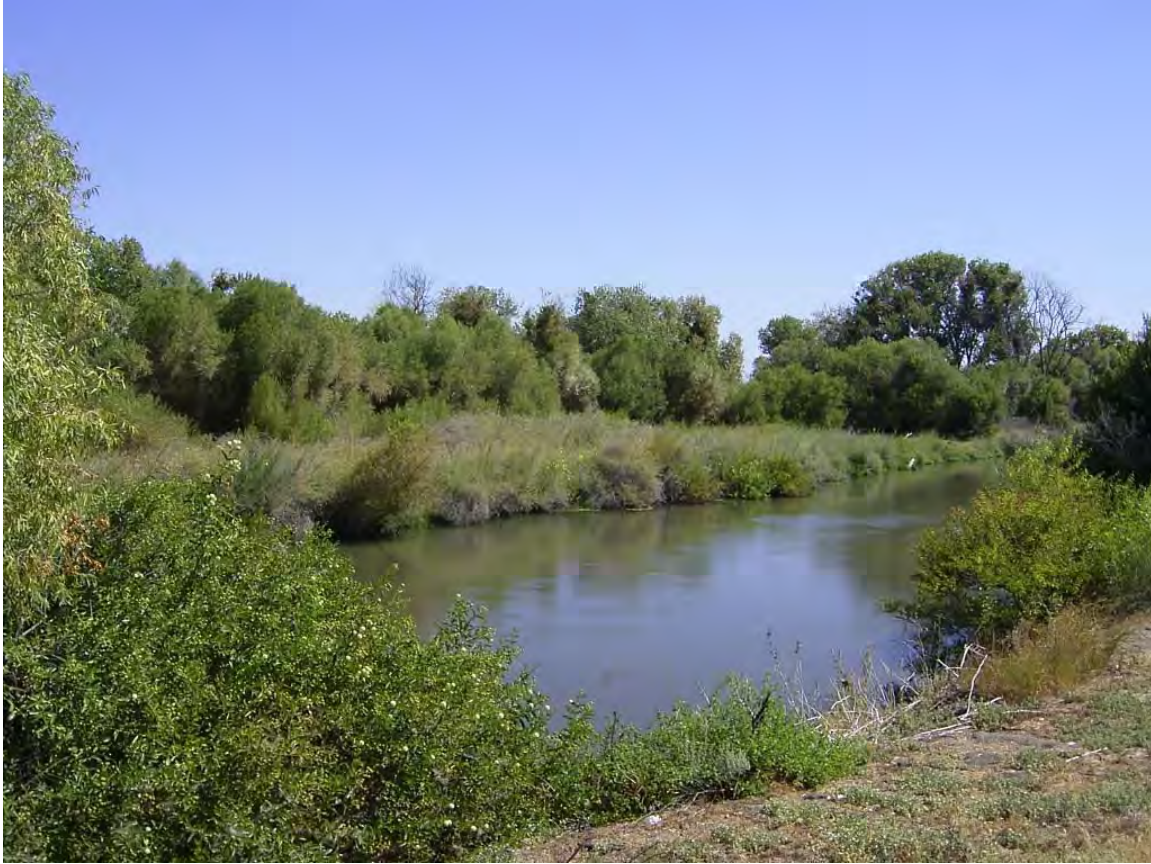
1
2
3
Figure 3-5.
San Joaquin River in Middle of Reach 3

7 Reach 3 begins at Mendota Dam and extends downstream to Sack Dam. Access was not
8 provided for the San Joaquin River in any portion of this reach during the sediment
9 sampling trip. This reach was characterized during a previous site visit (August 2007),
10 by a narrow, sand-bed channel with ample bank vegetation. In-channel flow was present
11 during the previous August 2007 site visit. Flow in Reach 3 can be a combination from
12 three potential sources: Reach 2 of the San Joaquin River, the Fresno Slough, and the
13 Delta-Mendota Canal. Figure 3-5 is a photograph of the San Joaquin River in the middle
14 of Reach 3 from the August 2007 site visit.

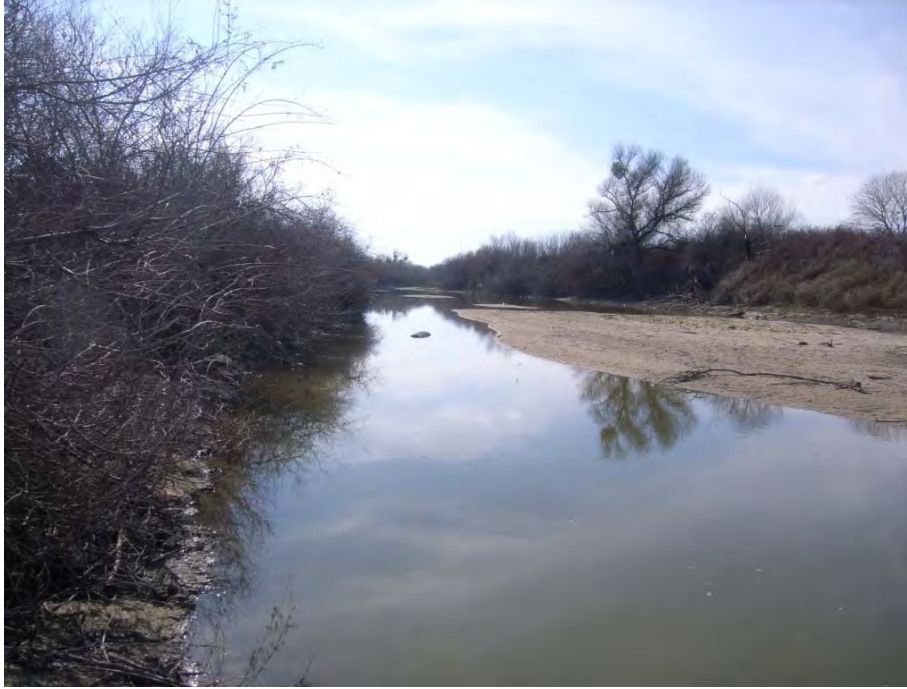
Figure 3-6.
Ponded Water in Sand-Bed Reach 4a

5 Reach 4a begins at Sack Dam and continues downstream to Bear Creek. The Sand
6 Slough Control Structure (SSCS) divides the reach into Reaches 4a and 4b, and the
7 Mariposa Bypass further divides Reach 4b into Reaches 4b1 and 4b2. The SSCS can
8 divert flow from the San Joaquin River into the Eastside Bypass. Access was not
9 provided to the San Joaquin River between Sack Dam and State Highway (SH) 152. The
10 river downstream from SH 152 consisted of a sand-bed channel. Some ponded water in
11 the San Joaquin River was present for 1 or 2 miles upstream from Washington Road.
12 Active groundwater pumping was occurring during the sampling trip to irrigate the fields
13 adjacent to the river in Reach 4a. Irrigation return flows are thought to be the source of
14 the ponded water in the river (Figure 3-6). The bed material is dominated by sand.

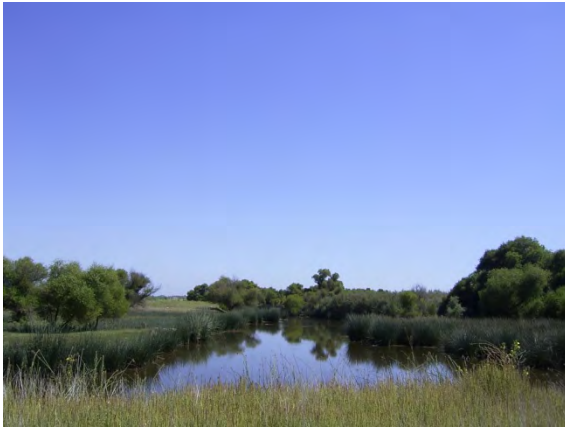
Figure 3-7.
**San Joaquin River in Reach 4b1 During
August 2007 Field Visit**

15 Access was not provided to Reach 4b1 during the sediment sampling trip although the
16 reach was accessed during the August 2007 site visit (Figure 3-7). Water was present in
17 the San Joaquin River in Reach 4b2. The river runs through the San Luis National
18 Wildlife Refuge in this reach. Vegetation is more prevalent in the river for this reach,
19 and the sandy bed material appears to have a higher percent of fines in it. Figure 3-8 is a

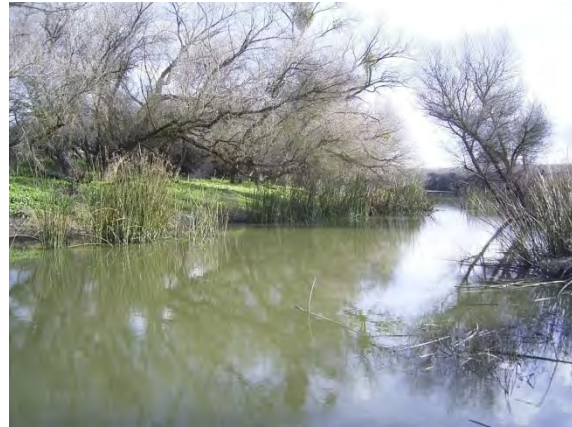
Figure 3-8.
**San Joaquin River in San Luis Wildlife
Refuge, Reach 4b2**

1 photograph of the San Joaquin River in the San Luis National Wildlife Refuge in Reach
2 4b2.

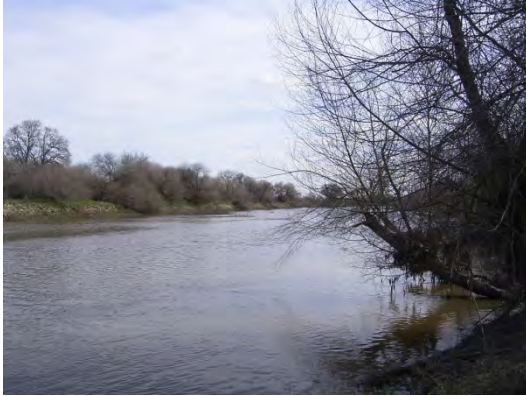
Figure 3-9.
San Joaquin River in Upstream Portion
of Reach 5

7 The flows from the Eastside Bypass join with Bear Creek in Reach 4b2, and Reach 5
8 begins at the confluence of Bear Creek and the San Joaquin River. Reach 5 ends at the
9 confluence of the Merced River and the San Joaquin River. The bed material in Reach 5

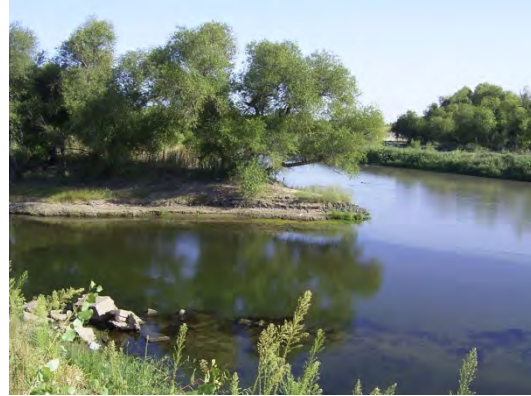
Figure 3-10.
Confluence of the San Joaquin and the
Merced Rivers

1 is characterized as sandy with a more prevalent concentration of fines and organic
 2 material. Levees are found in Reach 5 but the river is typically wider with more
 3 floodplain connectivity than is found in the more upstream reaches. The reach is similar
 4 to Reach 4b2 in that there are number of slough inputs, remnant channels, and in general
 5 the river is not intrinsically well defined and discernable. More grassy and woody
 6 vegetation is found in the riparian corridor, and flow was present during the sediment
 7 sampling trip. Figure 3-9 is a photograph of the San Joaquin River in the upstream
 8 portion of Reach 5. Figure 3-10 is a photograph of the confluence of the San Joaquin
 9 River (background) and the Merced River (foreground).

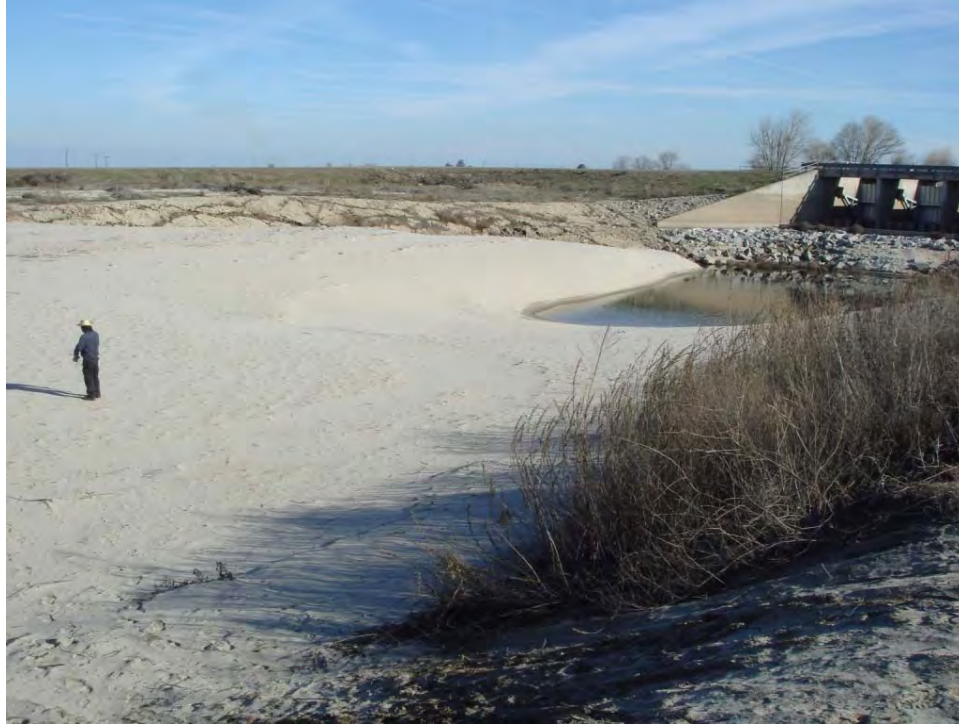
Figure 3-11.
Sand-Bed Channel in Chowchilla Bypass Just Downstream from Bifurcation Structure

11 At the Chowchilla Bifurcation Structure (start of Reach 2b) the San Joaquin River flows
 12 can be diverted into the Chowchilla Bypass. The Bypass is a flood control channel that
 13 eases the stresses on and the potential for flooding of the San Joaquin River. The bypass
 14 is leveed for most of its length to protect the agricultural lands adjacent to the river
 15 corridor, and runs essentially parallel to the San Joaquin River until it empties into Bear
 16 Creek, which subsequently empties into the San Joaquin River (start of Reach 5). The
 17 bypass channel consists of a sand-bed for most of its length. Figure 3-11 is a photograph
 18 just downstream from the Chowchilla Bifurcation Structure. Erosion of the native silty-
 19 sand material near SH 152 is evident in the bypass channel (Figure 3-12), and there is a
 20 layer of sand on the bed of the channel. The erosion of the native material likely happens

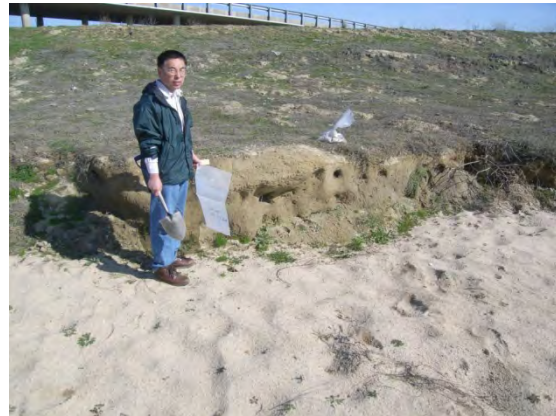
Figure 3-13.
Sand-Bed and Silt Bank in Reach 4a Chowchilla Bypass

21 during rising limbs of storm hydrographs and the deposition of the relatively coarser sand
 22 occurs during the falling limb. Figure 3-13 is a photograph of the sandy bed material and
 23 the native silt material in the Chowchilla Bypass in Reach 4a. There was no water
 24 present in the Chowchilla Bypass channel during the sampling trip. Some vegetation was
 25 present on the banks of the Chowchilla Bypass and the bed was mostly unvegetated.

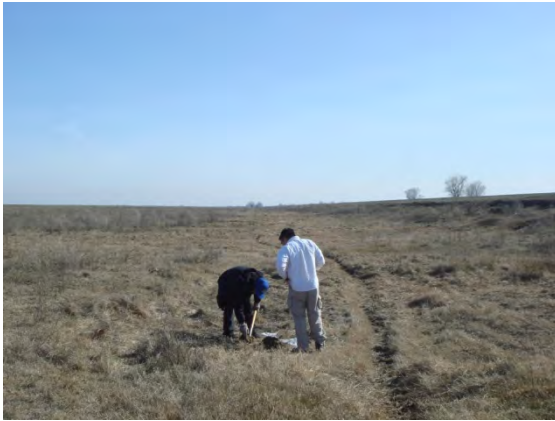
Figure 3-14.
Grassy Sand-Bed Channel of the
Mariposa Bypass

1 The Mariposa Bypass intersects the Eastside Bypass approximately 9 miles downstream
2 from the SSCS on the bypass side. The Mariposa Bypass is an equilibration structure that
3 allows water to pass either to or from the San Joaquin River and the Eastside Bypass,
4 depending on the need. The bed material of the Mariposa Bypass is sandy and overlain
5 with grassy vegetation (Figure 3-14) and water was not present during the sampling trip.
6 More in-channel water was present in the Eastside Bypass downstream from the
7 Mariposa Bypass, with the bed material apparently having a higher percentage of fine
8 material mixed in with the sand. Figure 3-15 presents a photograph of the Eastside
9 Bypass near the confluence with Bear Creek. The flows from the Eastside Bypass join
10 with Bear Creek, and Reach 5 of the San Joaquin River begins at the confluence of Bear
11 Creek and the San Joaquin River.

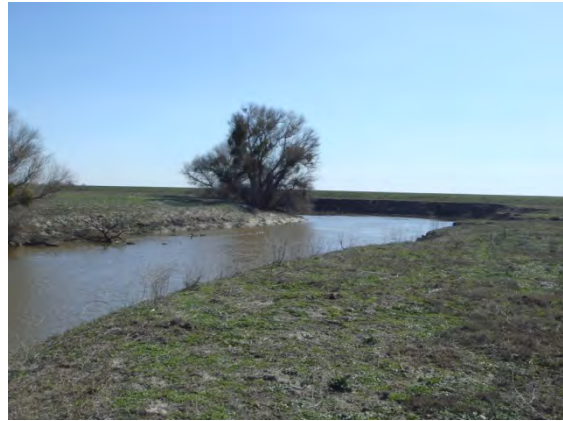
Figure 3-15.
Eastside Bypass near Confluence with
Bear Creek

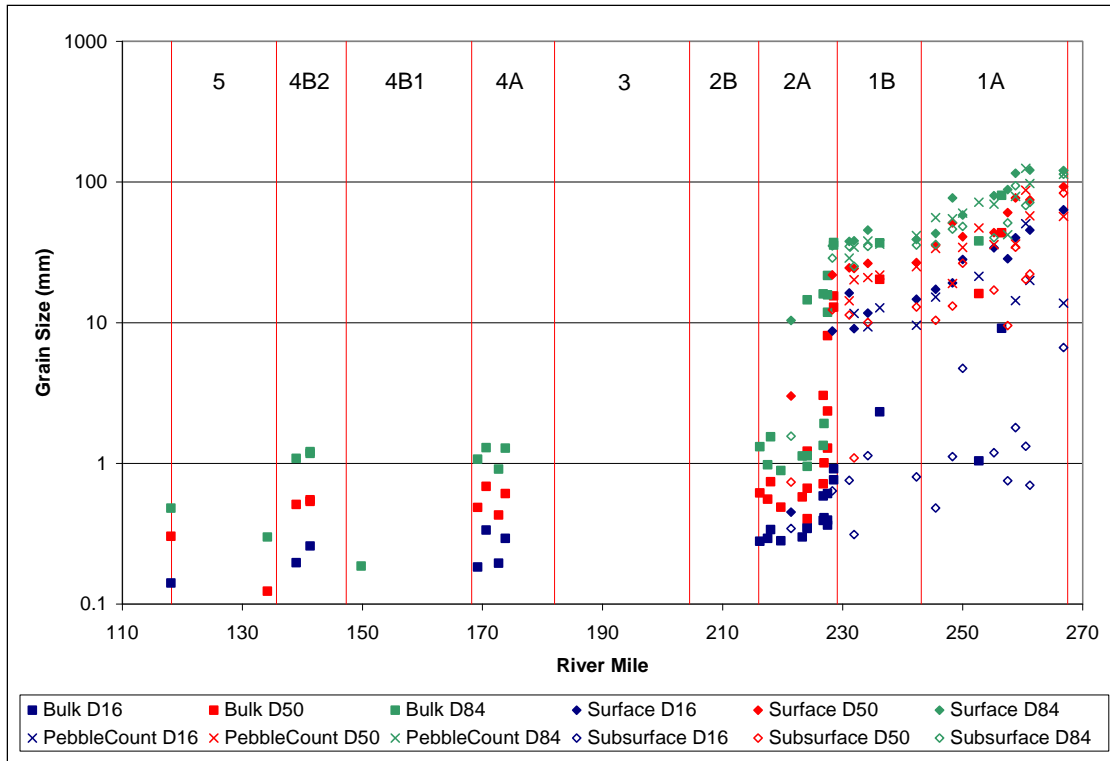
Figure 4-2.
Data Sample Representative Diameters from Friant Dam to Merced River

5 Figures 4-2 through 4-9 present sediment sample representative diameters (D16, D50,
6 and D84) for all samples collected on the San Joaquin River. Figures 4-10 and 4-11
7 present the same information for samples in the bypasses. A river mile system was
8 created for the bypass with “0” occurring at the confluence of Bear Creek with the San
9 Joaquin, and the Chowchilla Bifurcation Structure occurring at River Mile 52.1.

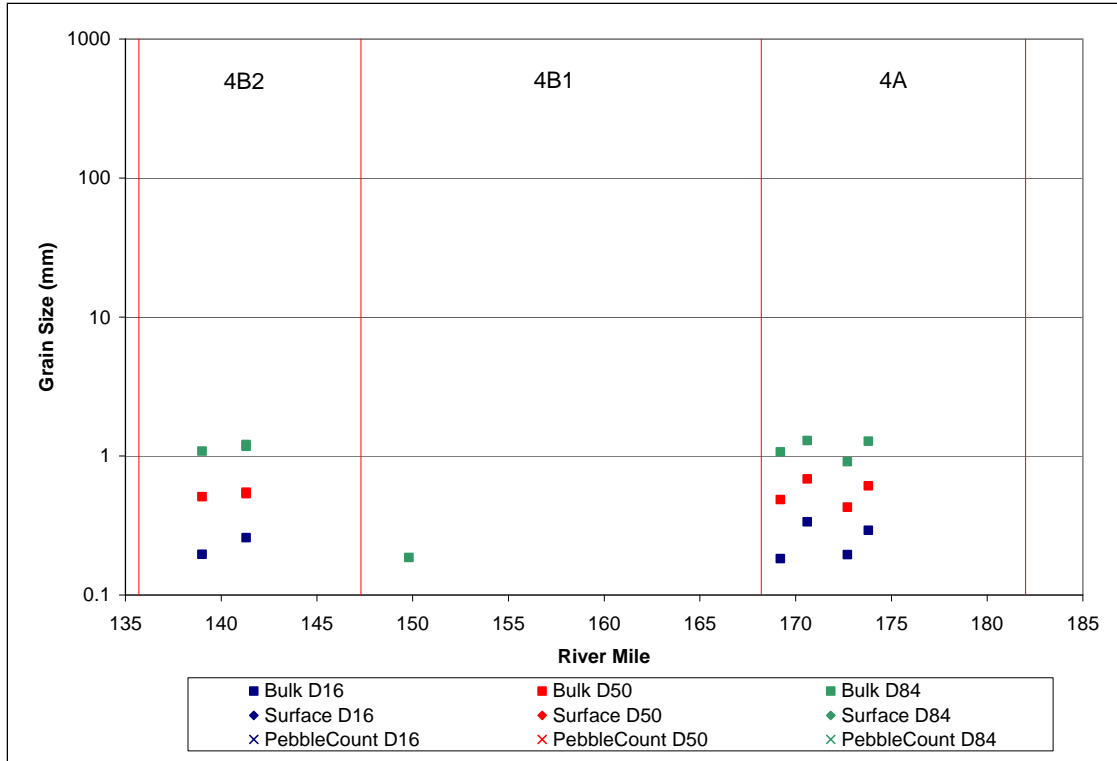
Figure 4-4.
Surface, Bulk, and Pebble Count Representative Diameters for Reach 4

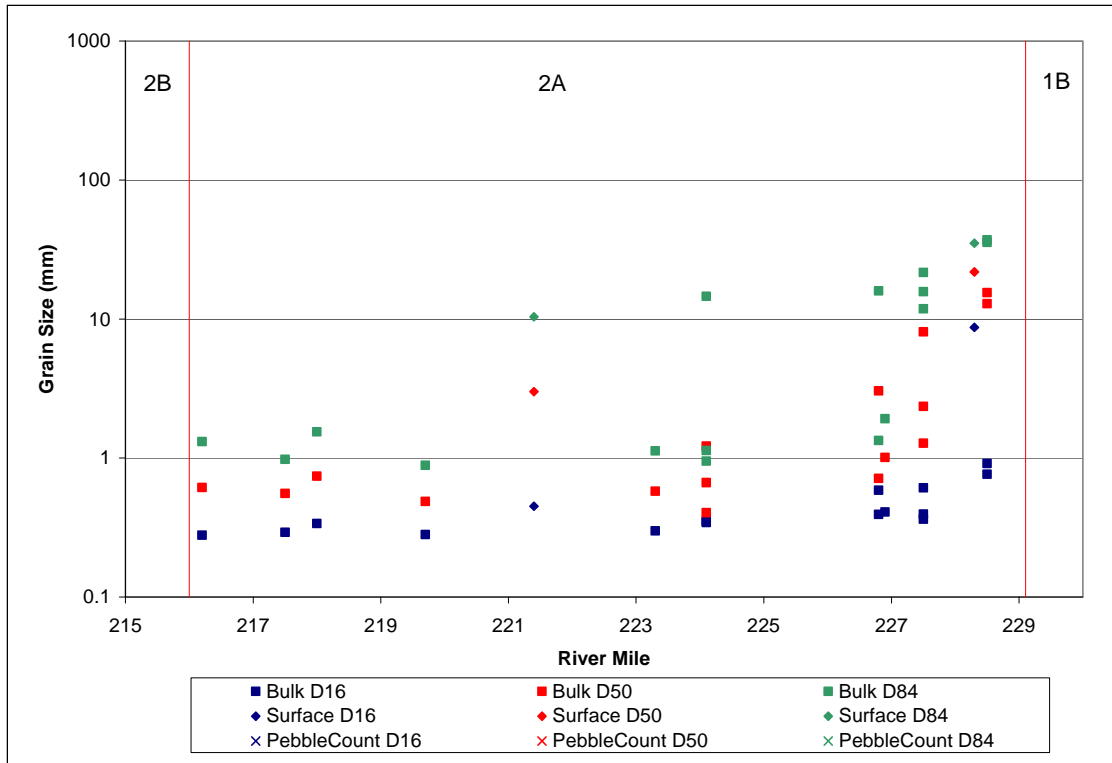
Figure 4-6.
Surface, Bulk, and Pebble Count Representative Diameters for Reach 2a

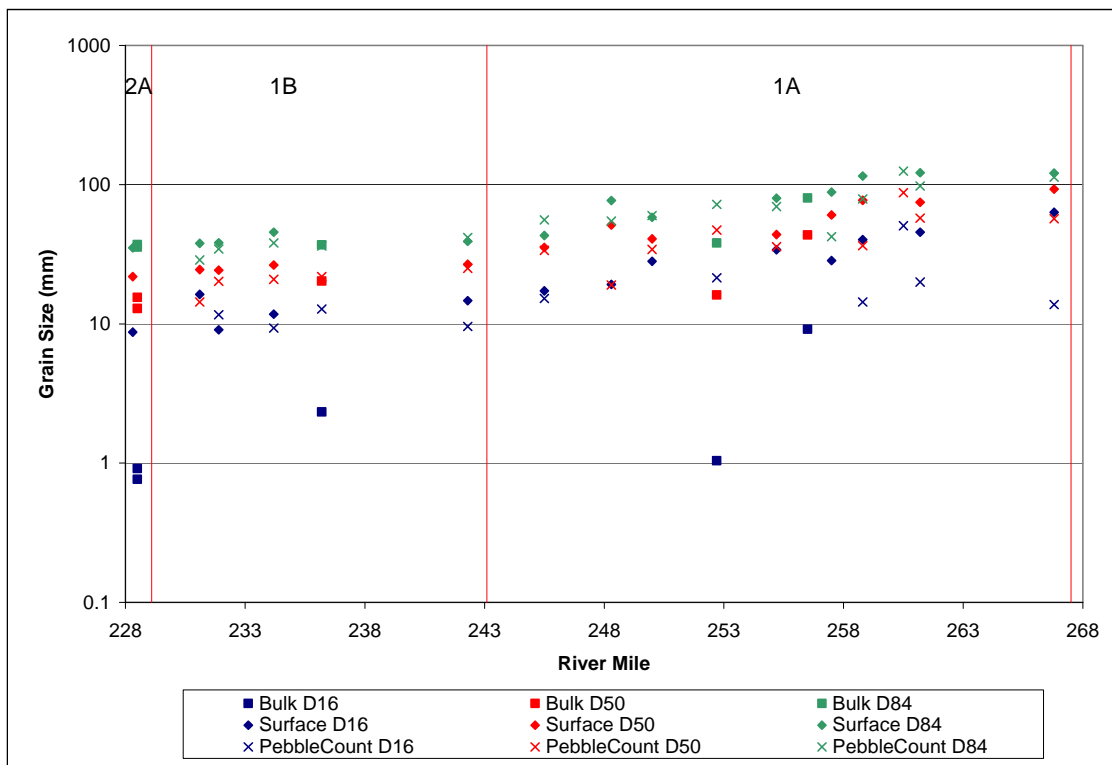
Figure 4-7.
Surface, Bulk, and Pebble Count Representative Diameters for Reach 1

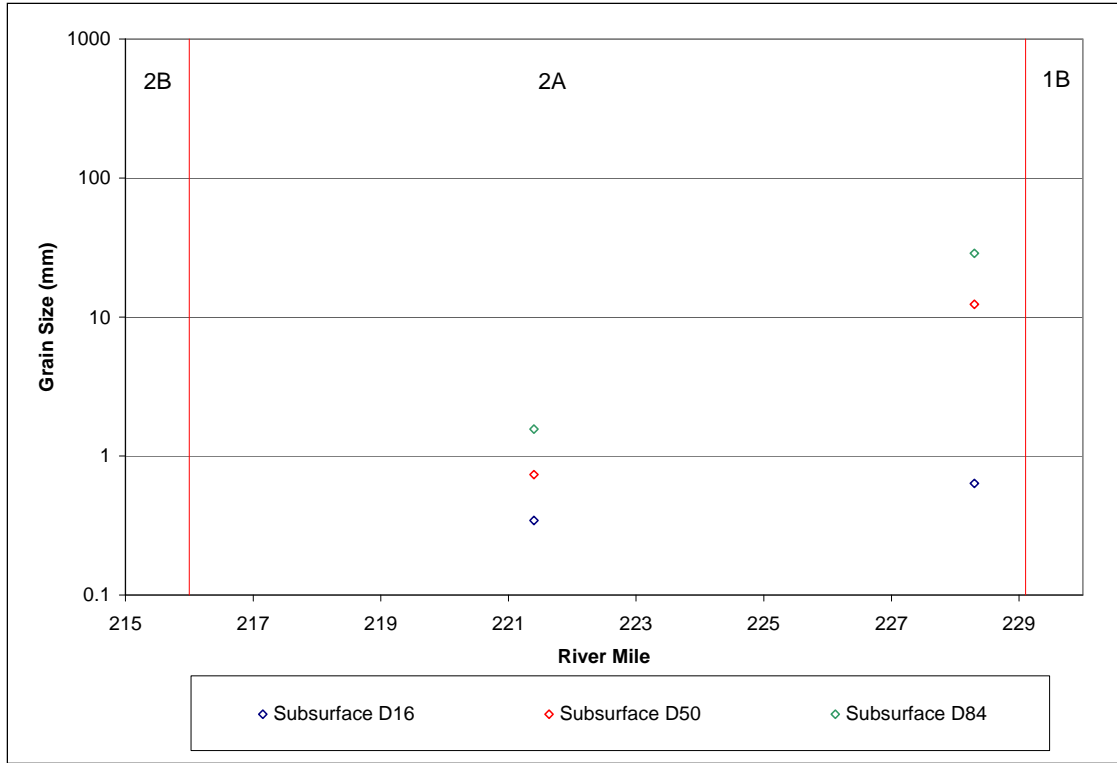
Figure 4-8.
Subsurface Representative Diameters for Reach 2a

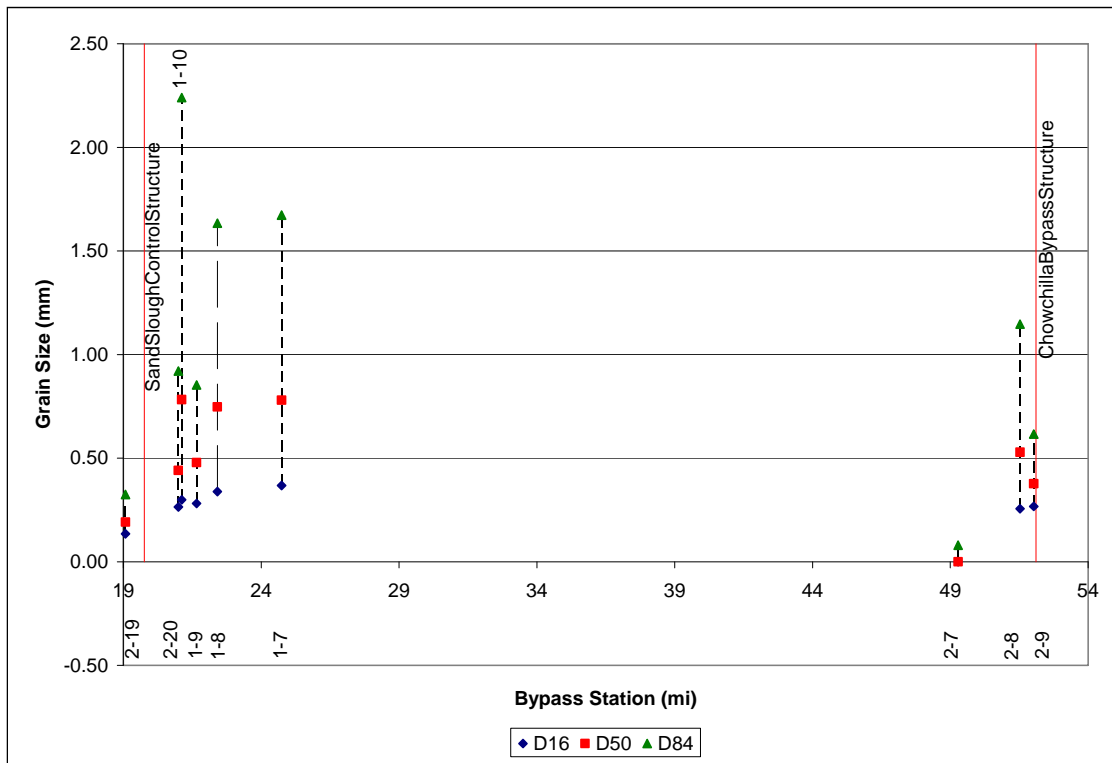
Figure 4-11.
Bulk Sample Representative Diameters for Samples in Chowchilla Bypass

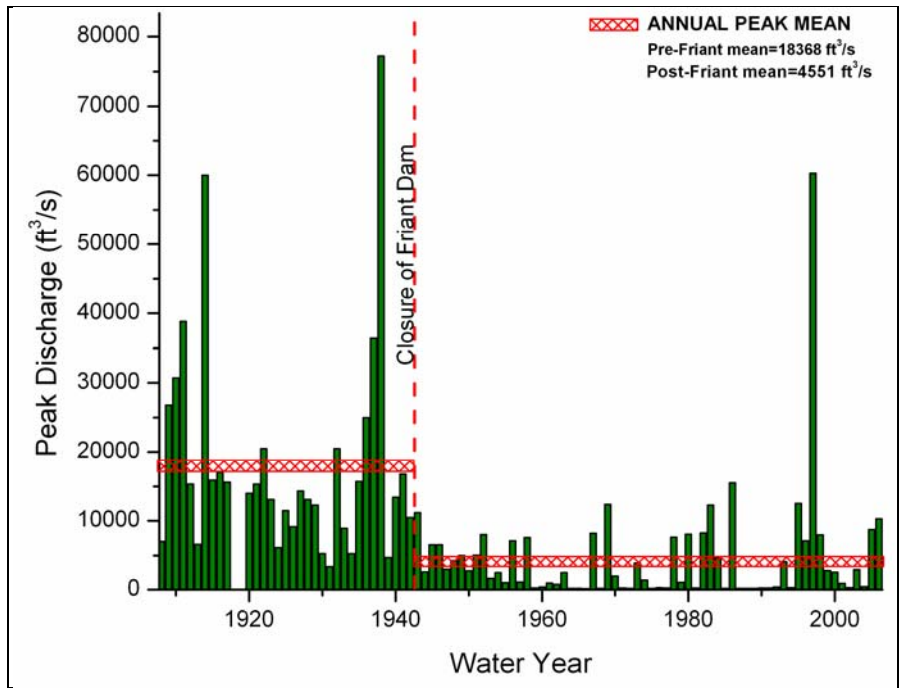
**Figure 5-1.
Annual Peak Discharges, San Joaquin River Below Friant, California
(USGS Gaging Station No. 11251000)**

Average channel width decreased by a factor of two between 1938 and 2007. The change is largely a result of the altered flow regime in which annual peak flows were dramatically reduced by a factor of four following the construction of Friant Dam (Figure 5-1).

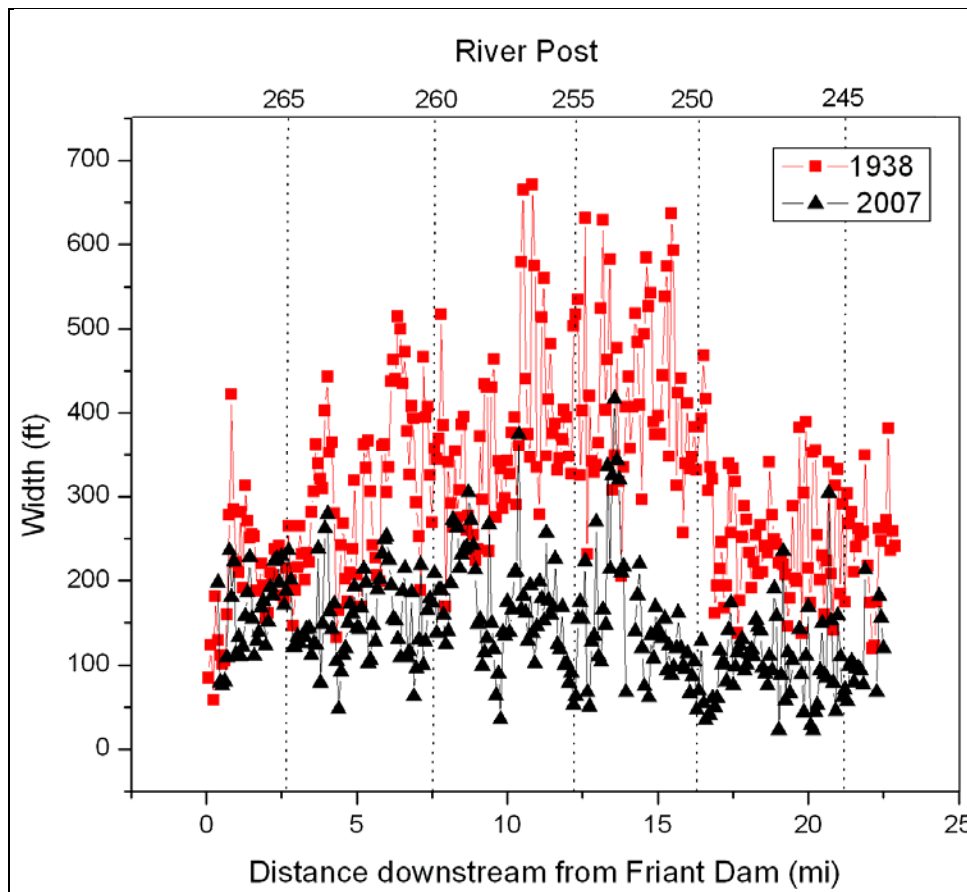
16
 17 **Figure 5-2.**
 18 **Active Channel Width Comparison by Location**

1 Comparing width measurements over time, active channel widths are, for the most part,
 2 narrower in 2007 when compared to 1938 at each location along the length of the study
 3 reach (Figure 5-2). A few exceptions do occur, most of which are in areas where gravel
 4 mining may have taken place in the channel, but is not obvious. Between 11 and 15 miles
 5 downstream from Friant Dam, several locations have greater channel width in 2007 when
 6 compared to 1938. This particular area has been heavily mined and the channel currently
 7 flows between two large gravel pits. The width of the channel in this area is
 8 predominantly a function of the constructed channel through the pits and does not reflect
 9 channel response to fluvial processes or geologic controls. In 1939, channel width
 10 measurements were wider at about 11 miles downstream from Friant Dam, or between
 11 River Posts 254 and 257, when compared to other channel widths in 1939. Aerial

12 photography shows this reach as predominantly single channel with a few side channels.
 13 Thus, the greater width in this reach does not appear to be caused by a greater number of
 14 side channels included in the width measurements, but rather by a single main channel
 15 that was wider and most probably shallower than comparative reaches.

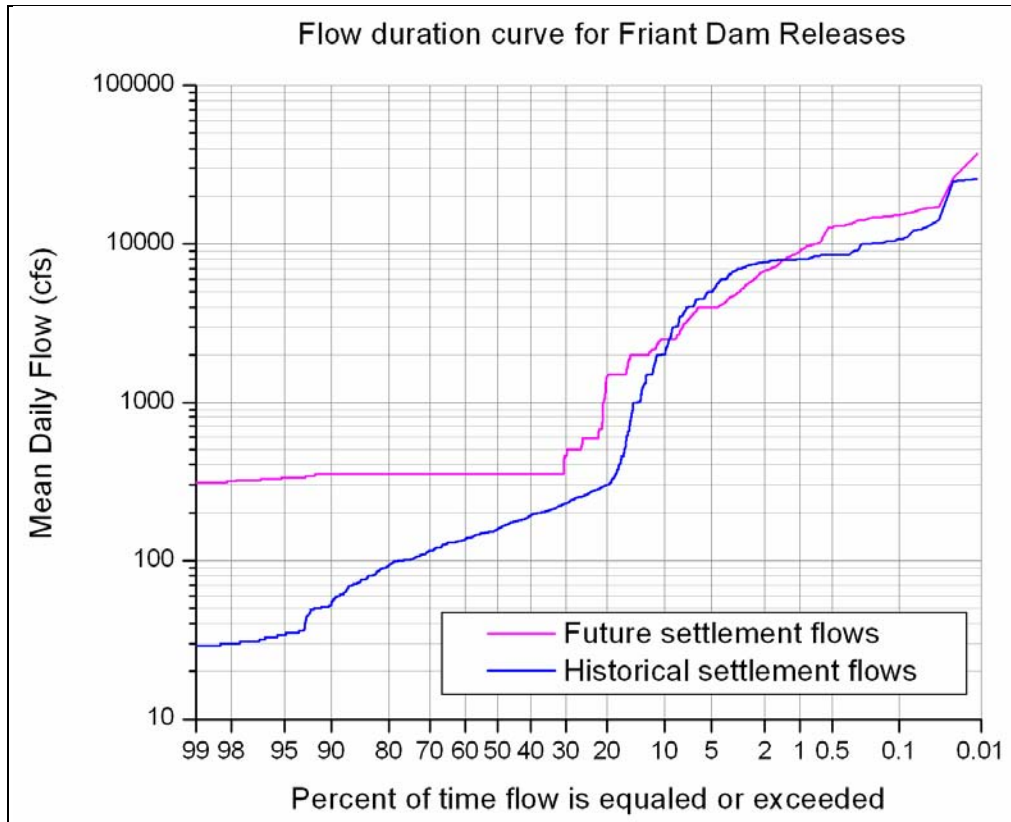
Figure 5-4.
Flow-Duration Curves for Future and Historical Settlement Flows

19 The proposed target flows for the river restoration alternatives range from 475 cfs to
20 4,500 cfs for the entire reach of the San Joaquin River from Friant Dam to its confluence
21 with the Merced River (Initial Program Alternatives Report Draft (SJRRP 2008)). Future
22 settlement flows are proposed to reach 8,000 cfs in the various restoration alternatives for
23 Reach 1A (Friant Dam to Rt. 99). Results from this analysis are preliminary; actual
24 settlement conditions may contain slightly lower peak discharges. Based on flow-
25 duration curves, flow in Reach 1A will not drop below 300 cfs, versus 30 cfs under the
26 historic settlement flows, or gage flows adjusted to the settlement conditions (Sutley
27 2008) (Figure 5-4). Major increases in mean daily flow between the historic and future
28 settlement flow-duration curves occur between the 30- and 10-percent exceedence, mean
29 daily flow with the greatest increase occurring at the 20 percent exceedence where the

30 flow increases from 300 cfs to 1,050 cfs. After the 10-percent exceedence, the differences
31 between the historic and future settlement flow-duration curves are minor, amounting to
32 about 100 to 200 cfs.
