Teton Dam Construction and geology

Teton Dam quick facts

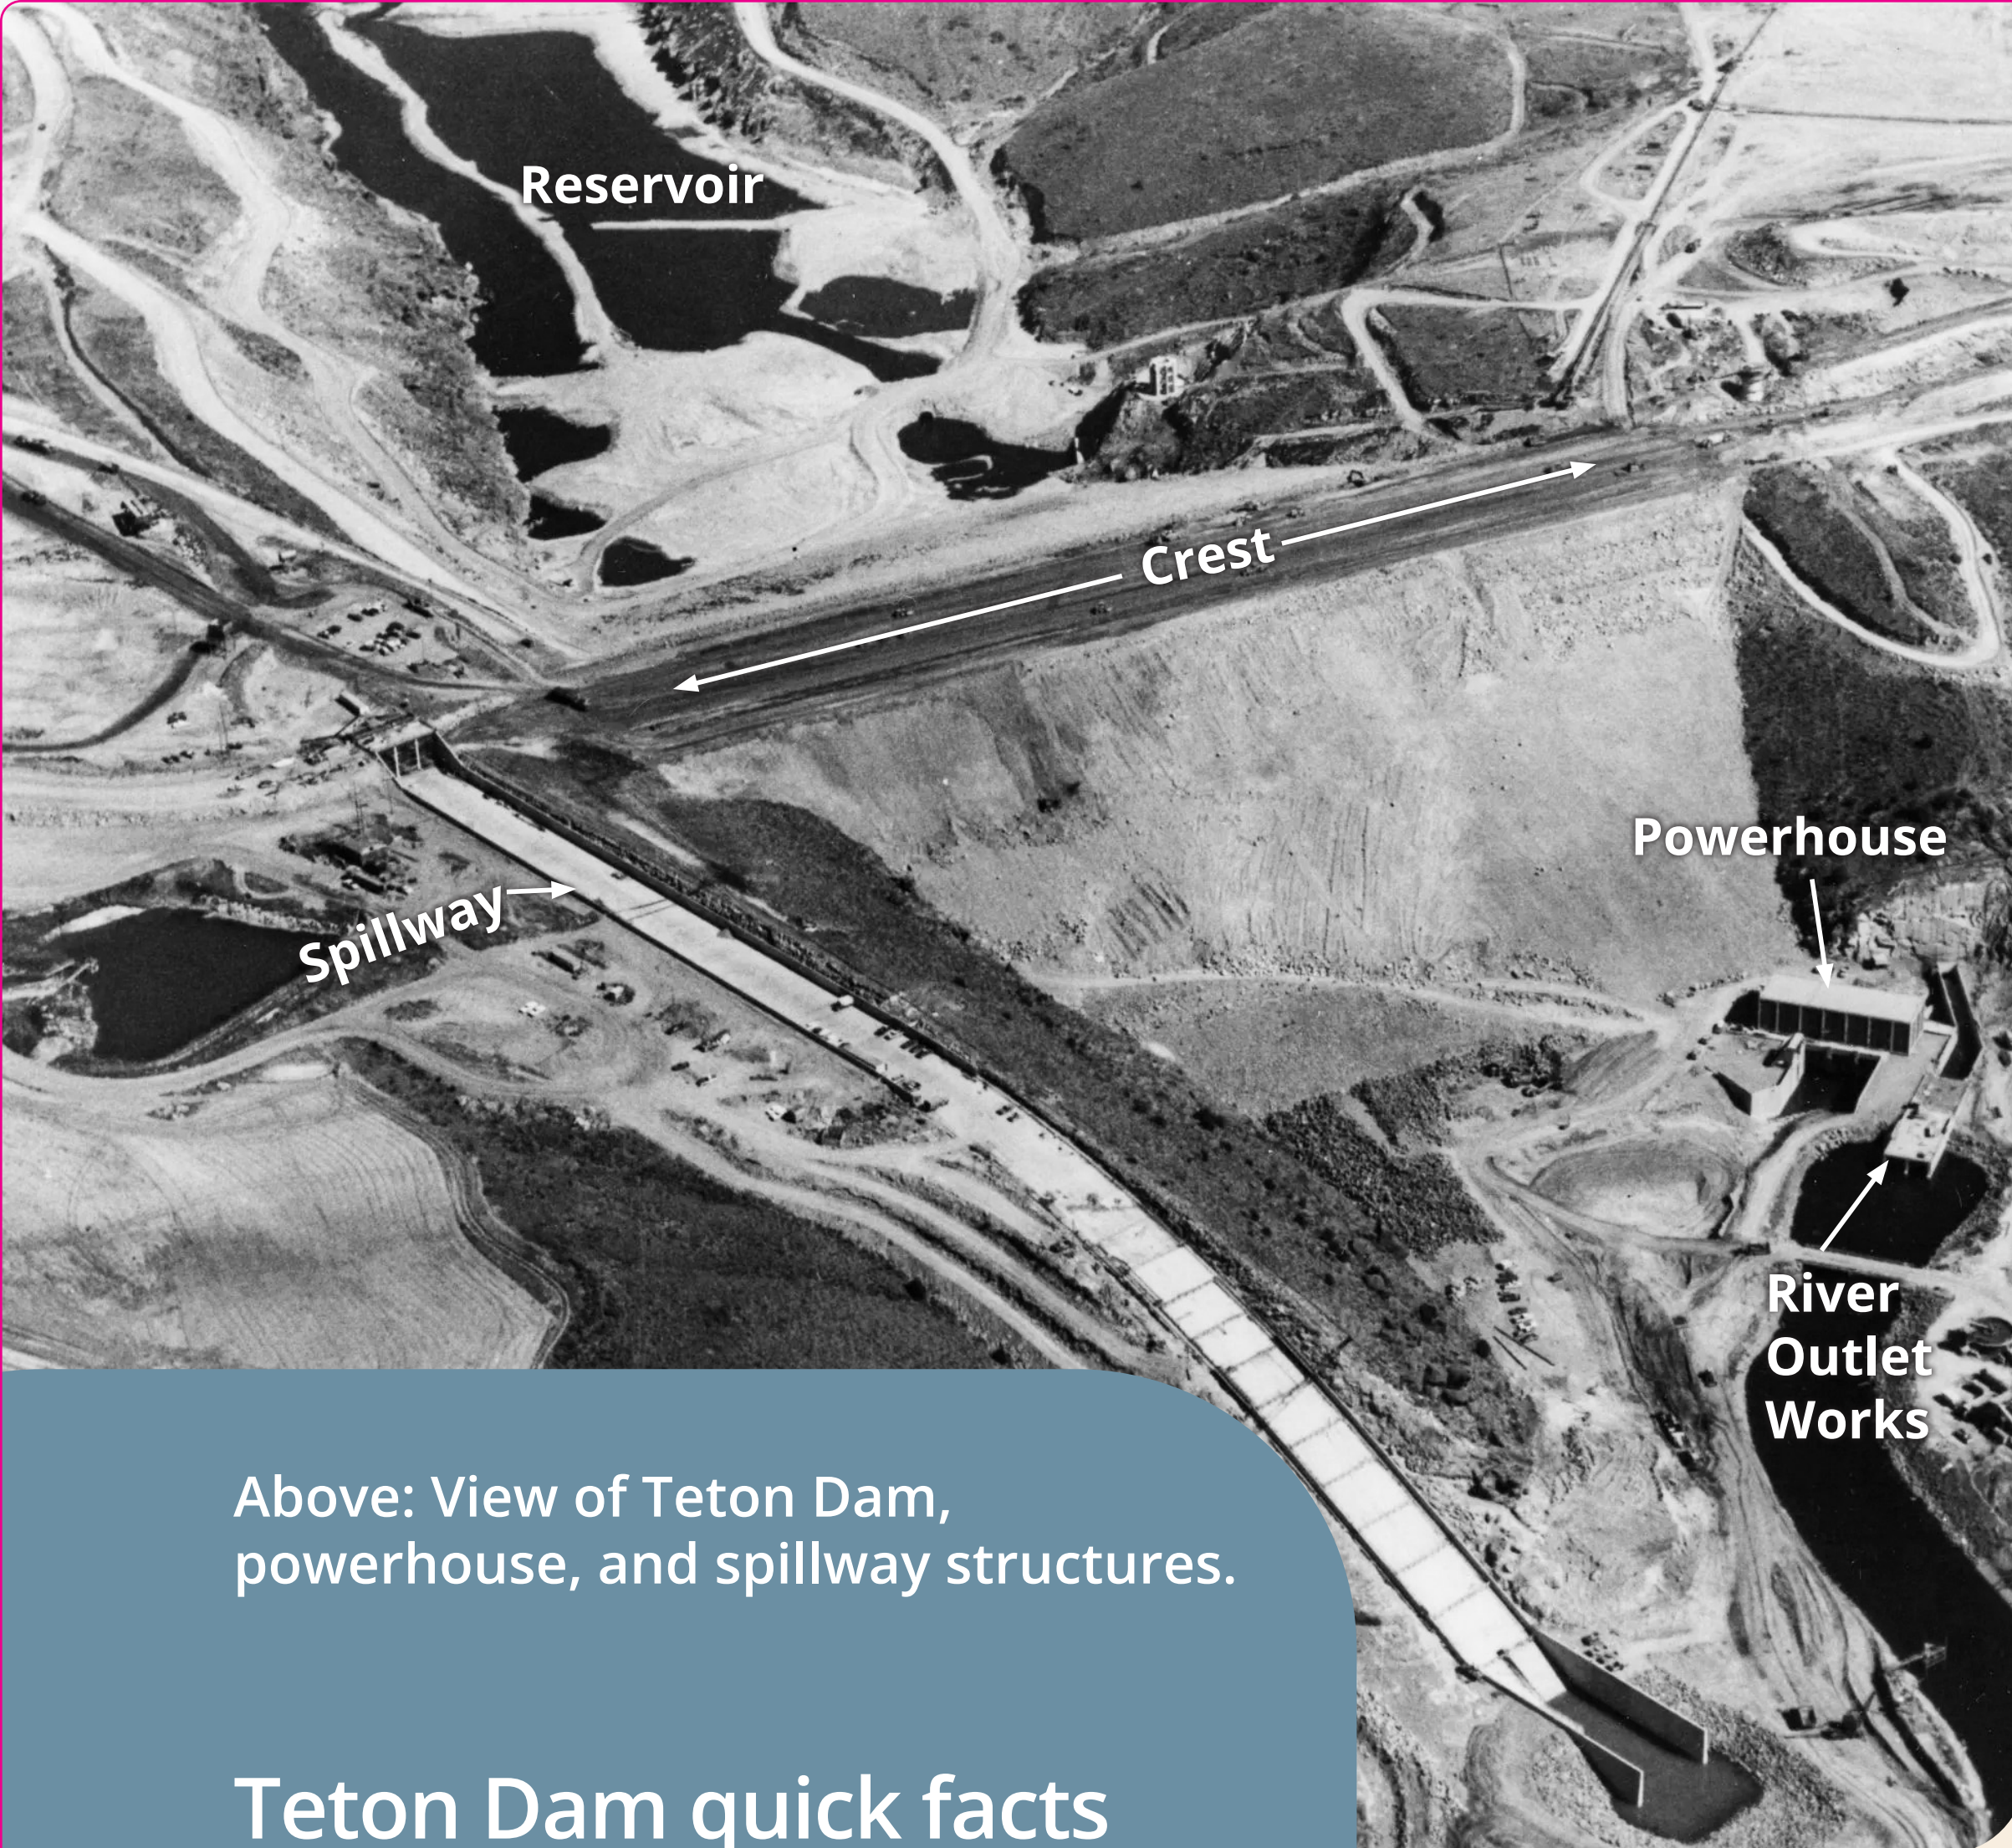
Above: View of Teton Dam, powerhouse, and spillway structures.

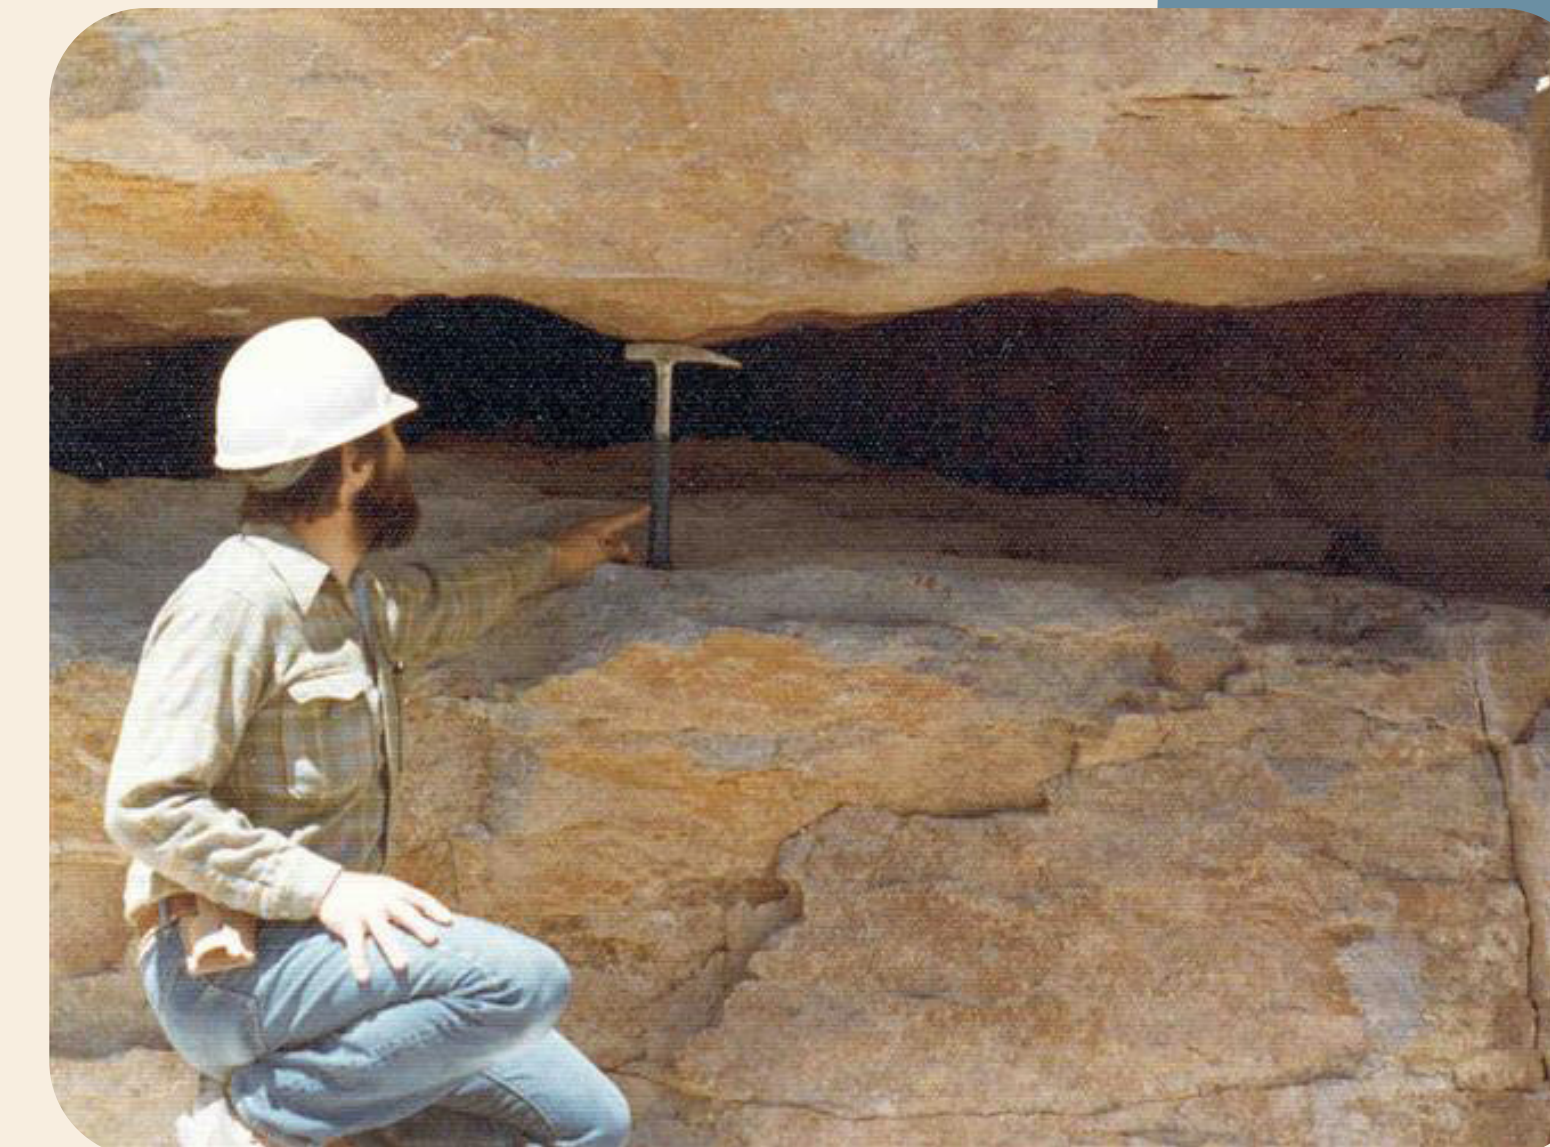
A worker examining a fissure in the bedrock.

Sealing the bedrock was harder than expected. Workers pumped in over twice the budgeted amount of grout, but the fissures—especially those near elevation 5200—continued to absorb the material. Eventually, grouting stopped because of cost overruns, leaving some fractures partially sealed.

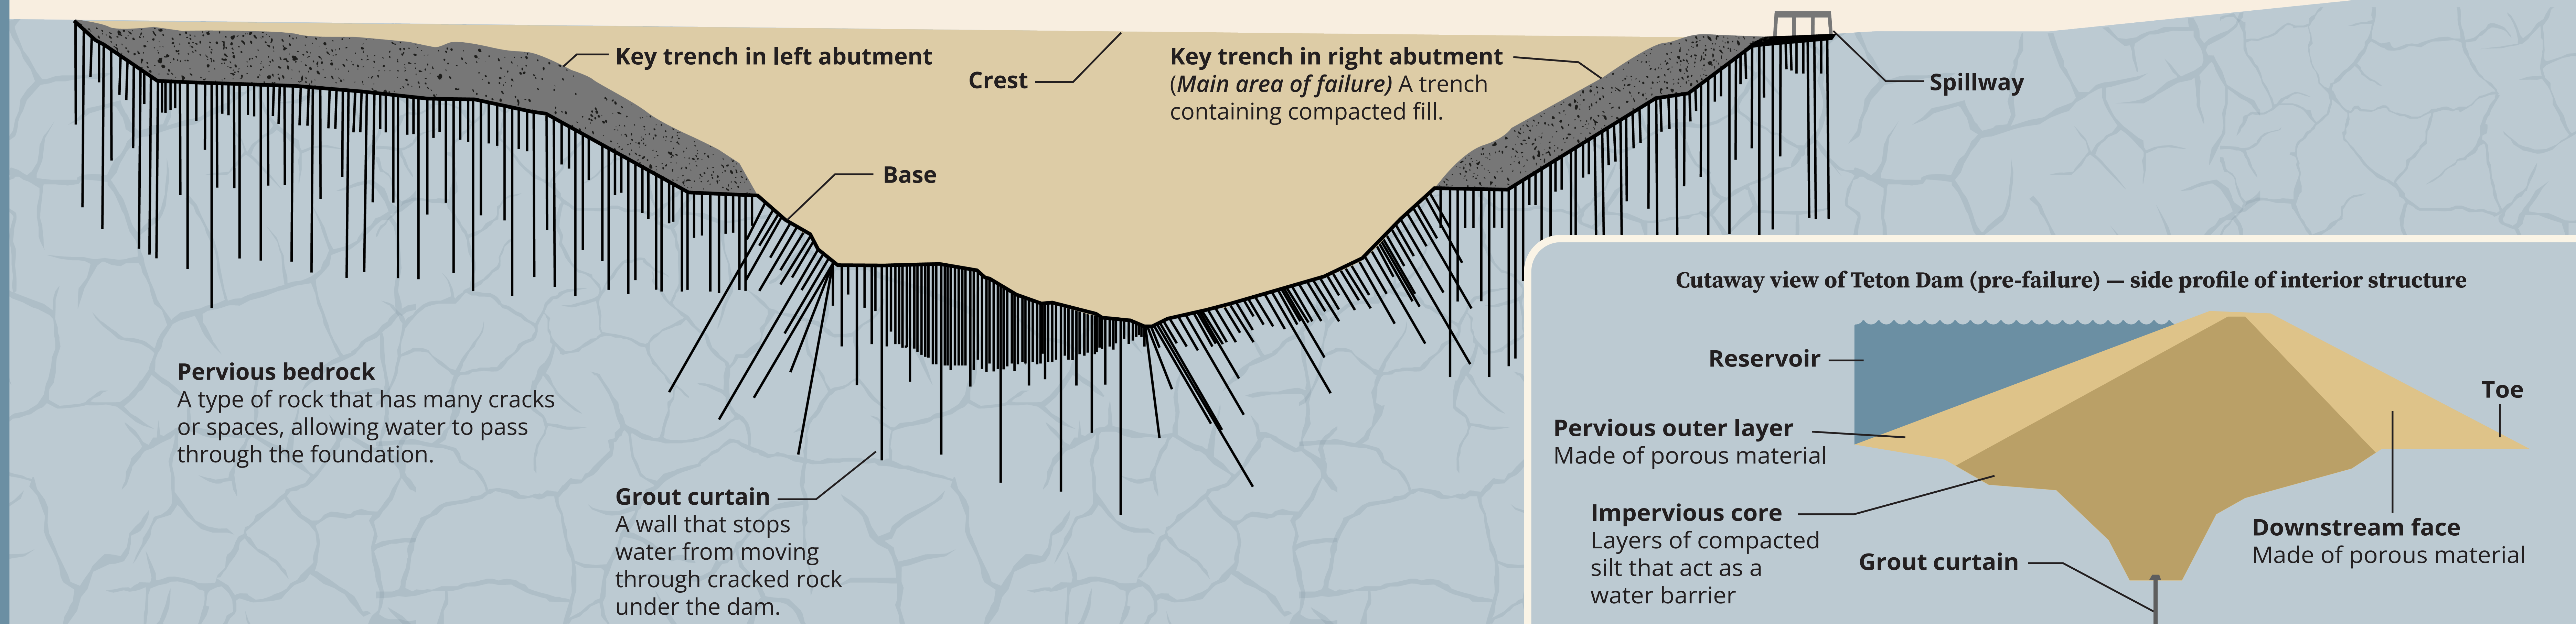
Teton Dam profile (pre-failure, looking downstream)

In an effort to reduce the need for grouting, key trenches were included as part of the foundation design. The failure process initiated when reservoir water was able to break through the right key trench, allowing the erodible backfill material to be carried into open fractures downstream.
