MEASUREMENT OF EFFECTS ON THE GORGE
POWERHOUSE AND ITS EQUIPMENT AND TUNNELS
DURING BLASTING IN THE ADJACENT ROCK
FOR THE DEPARTMENT OF LIGHTING
CITY OF SEATTLE, WASHINGTON

Structural Research Laboratory Report No. SP-24

Subject: Measurement of effects on the Gorge Powerhouse and its equipment and tunnels during blasting in the adjacent rock.

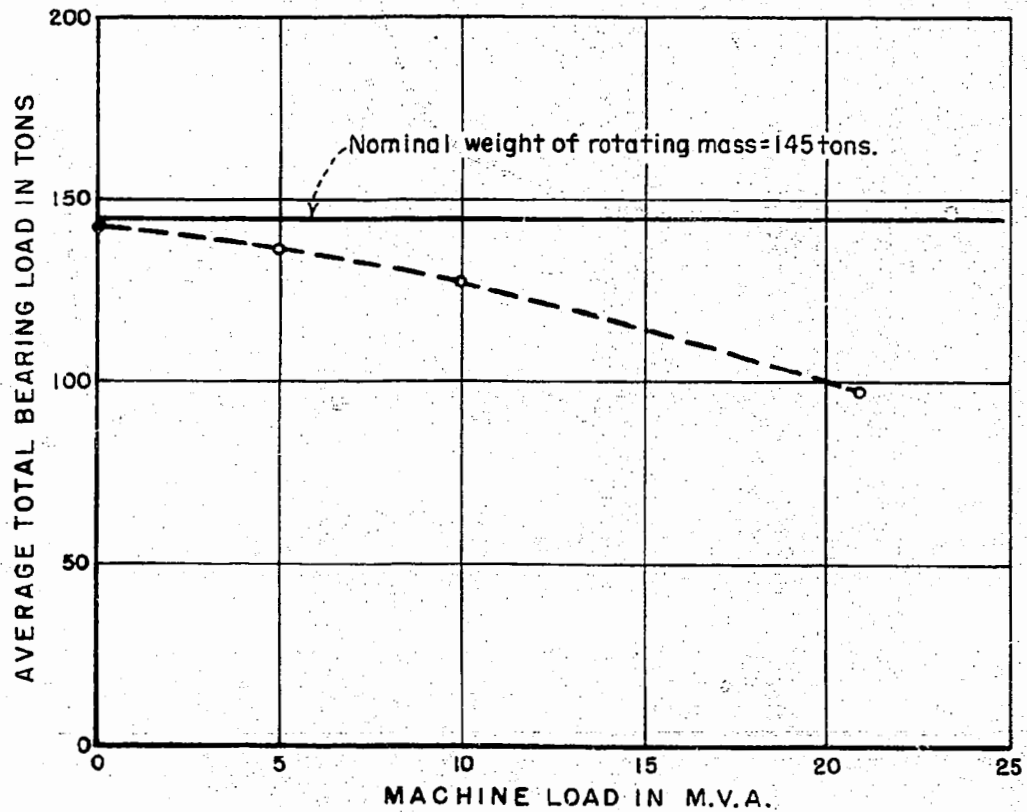
MACHINE LOAD	AVERAGE TOTAL LOAD	DYNAMIC LOAD	
M.V.A.	TONS	TONS	FREQUENCY CYCLES / SEC.
21	97	53	75
10	127	42	73
5	137	26	72
0	142	23	74
-2	140	22	68

FIGURE 3
AVERAGE TOTAL BEARING LOAD VS. MACHINE LOAD
(AS MACHINE LOAD IS REDUCED BY CLOSING WICKETS)

It was found that the load on the thrust bearing reduced from 145 tons under static condition to approximately 90 tons when the machine was operating at its rated load of 20,000 kva. (Figure 3). Thus, an increase of 80 tons in the load as a consequence of the disturbance caused by blasting would increase the bearing load over the static condition by only 17 percent. During the first part of the investigation this was considered a safe upper limit upon which to base the calculations, recognizing the possibility of a combination of factors which might allow the effect of any one blast to exceed the effects of the average blasts by as much as 100 percent. On November 4, a communication was received by the City engineers from the Westinghouse Electric Corporation, manufacturer of the Kingsbury type thrust bearings used, indicating that the maximum load on the thrust bearing should not exceed 350 pounds per square inch during continuous operation and 525 pounds per square inch during blasting. They considered the critical factor to be not the unit loading on the bearing surface but the strength of critical sections at the upper bracket and thrust collar mounting. However, in spite of their reassurance, some concern was felt for the ability of the babbitt of the thrust bearing to withstand shock loading of this magnitude.
