TECHNICAL SERVICE CENTER
DENVER, COLORADO

UPPER GILA RIVER FLUVIAL GEOMORPHOLOGY STUDY

CATALOG OF HISTORICAL CHANGES ARIZONA

JUNE 8, 2001

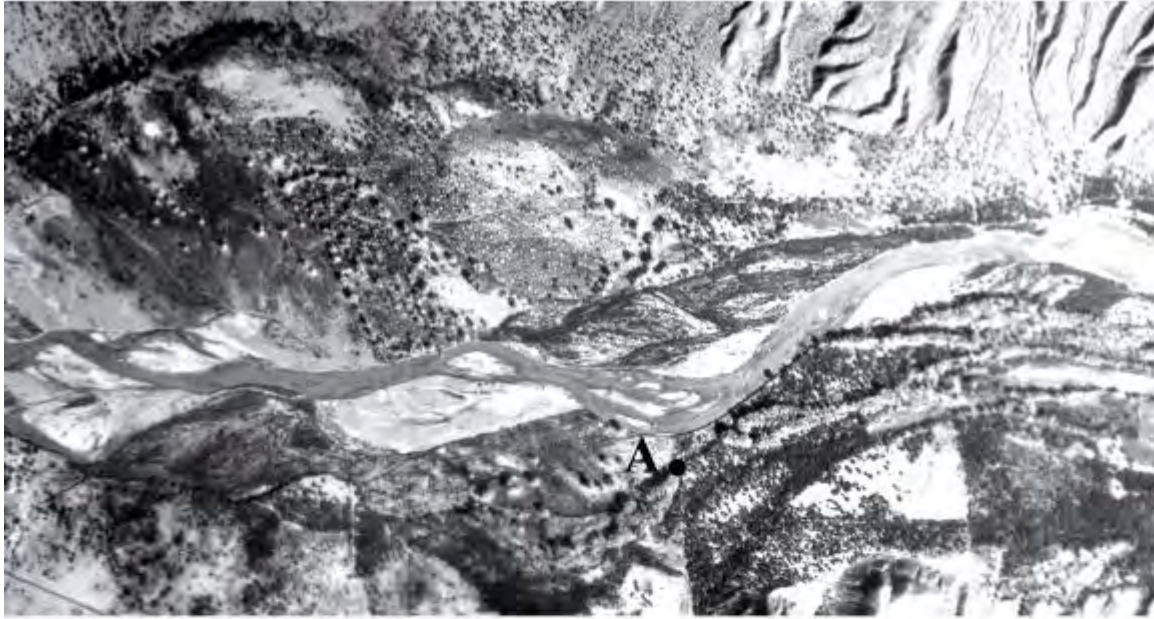
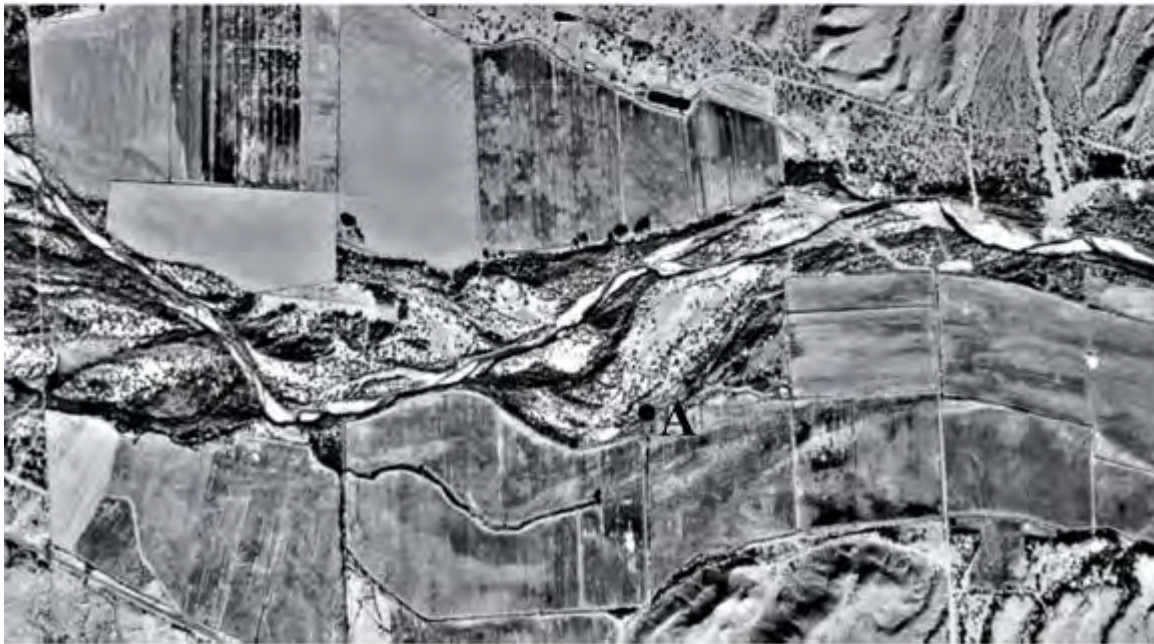
Figure 9. Case Study 1: Near San Carlos Apache Indian Reservation. From (a) 1935 to (b) 1953, channel width had decreased significantly in the study reach. See point A for reference. Flow is from right to left.

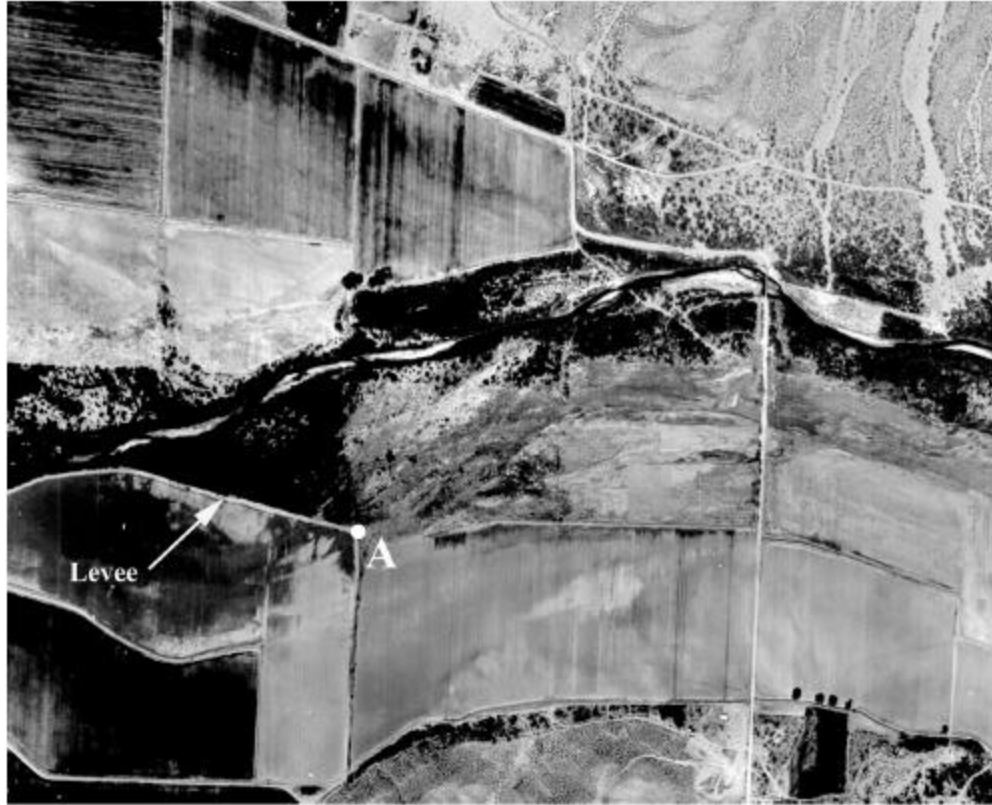
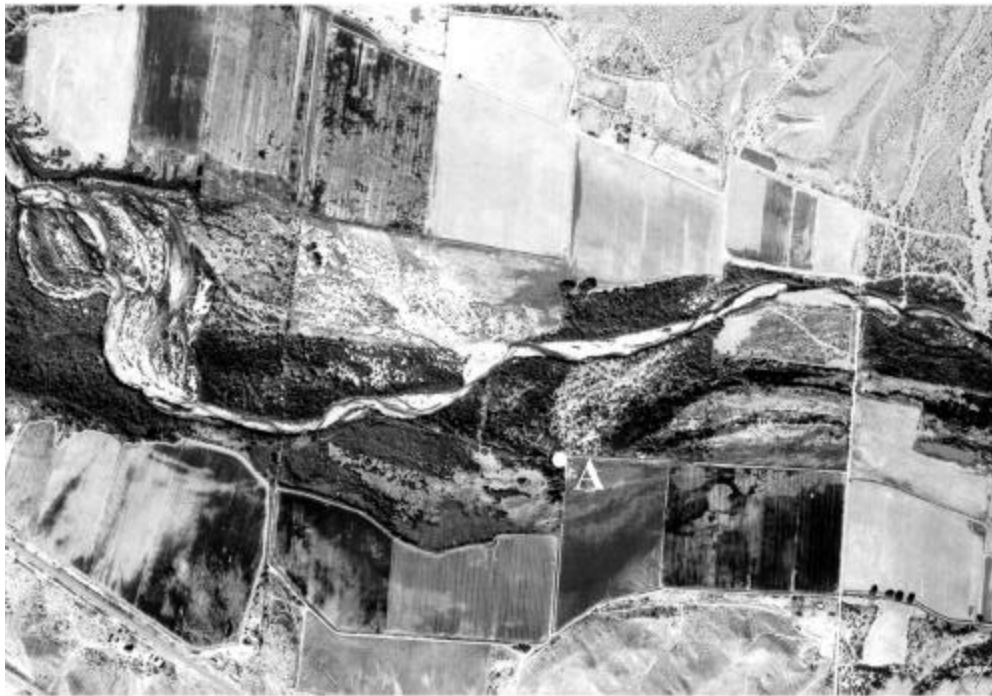
Figure 9 (cont.) Levees built at point A in (c) 1967 further restrict the channel; by (d) 1978, these levees have disappeared. Flow is from right to left.

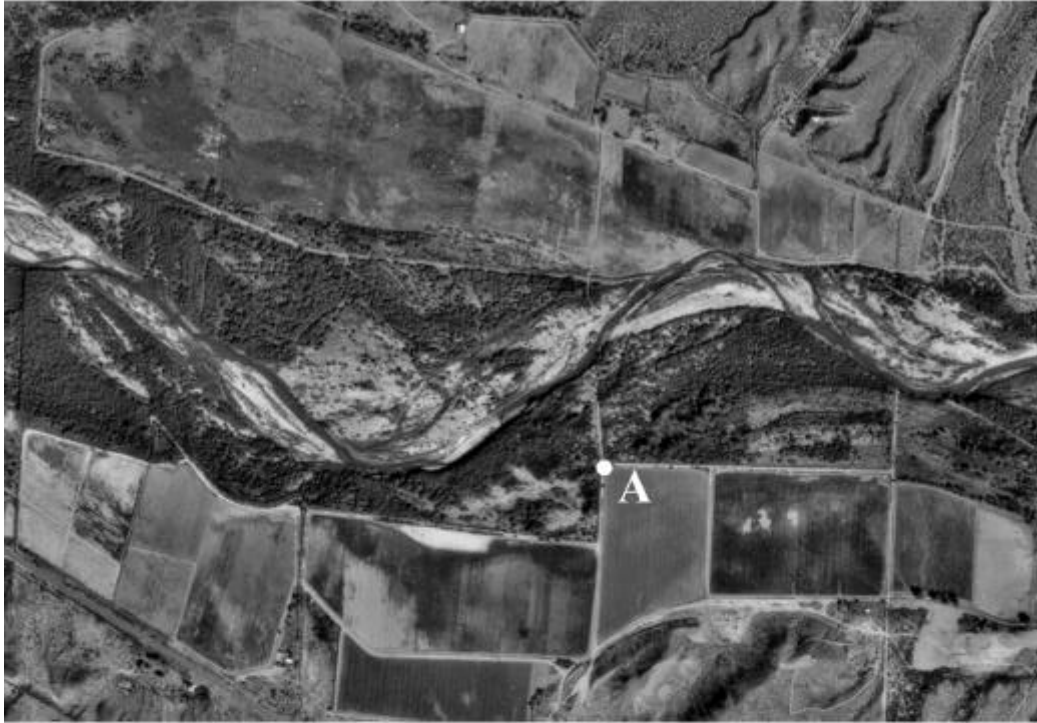
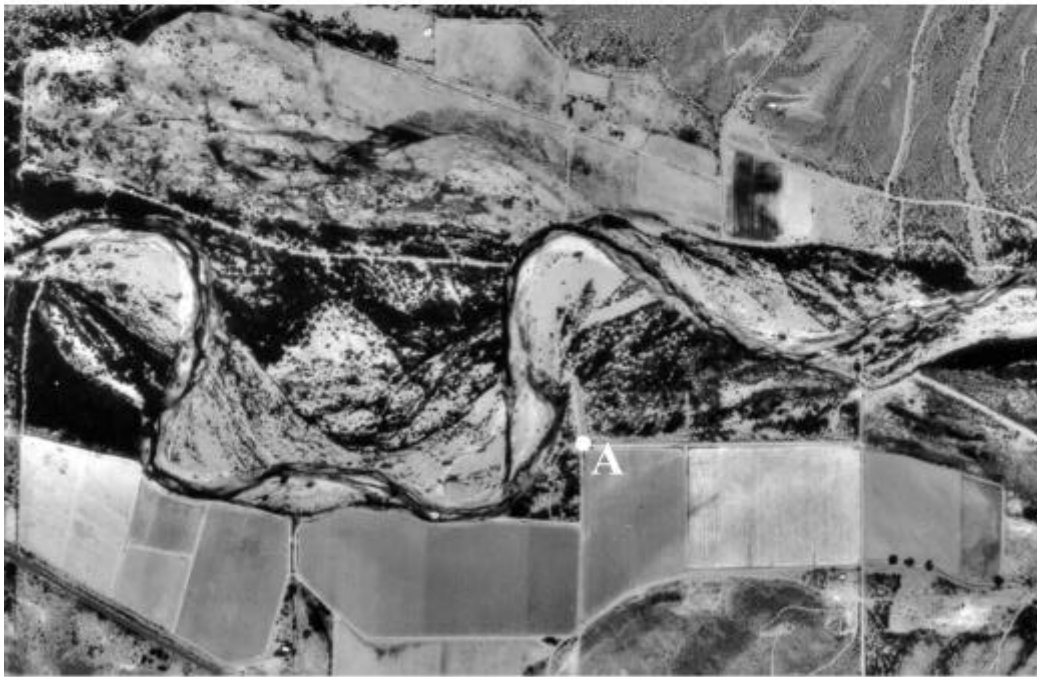
Figure 9 (cont.) By (e) 1992, the Gila River channel had reoccupied the left bank channel downstream of point A. By (f) 1997, the channel pattern had changed dramatically to a more sinuous channel with nearly 90-degree bends from bank to bank. This pattern is associated with erosion into right and left bank levees and channel modification. Flow is from right to left.

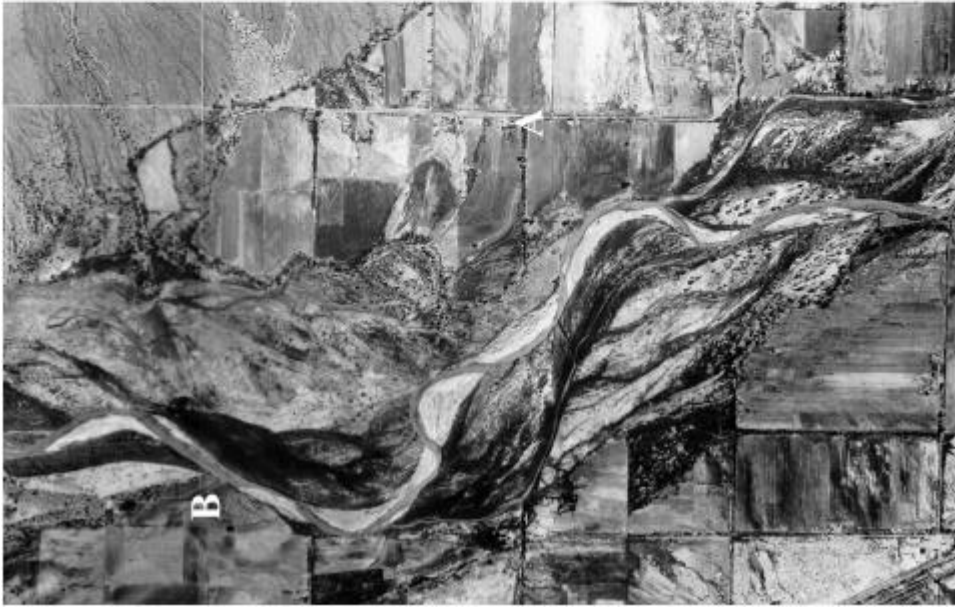
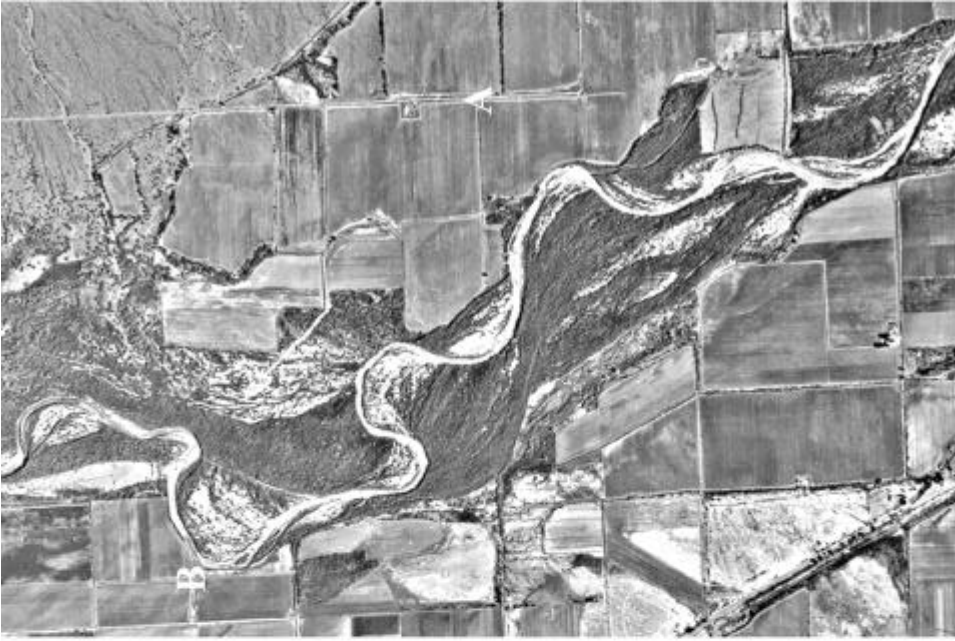
Figure 10. Case Study 2: Ashurst to Fort Thomas. From (a) 1935 to (b) 1953, flood widths decreased in conjunction with an increase in the sinuosity of the low flow channel. Note the right-bank meander at point A and the left bank meander at point B. Flow is from bottom to top in the figure.

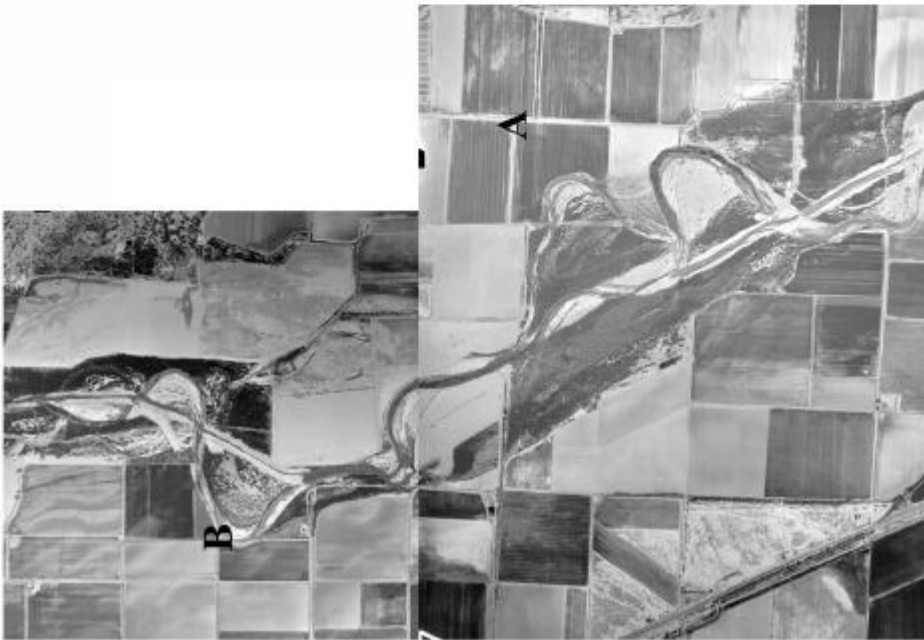
Figure 10. (cont.) Attempts to channelize this reach are apparent in the 1967 photos, where flow has been partially rerouted down the new channel. By (d) 1973, right bank meanders at point A had been abandoned, while a new meander formed near point B. Flow is from bottom to top in the figure.

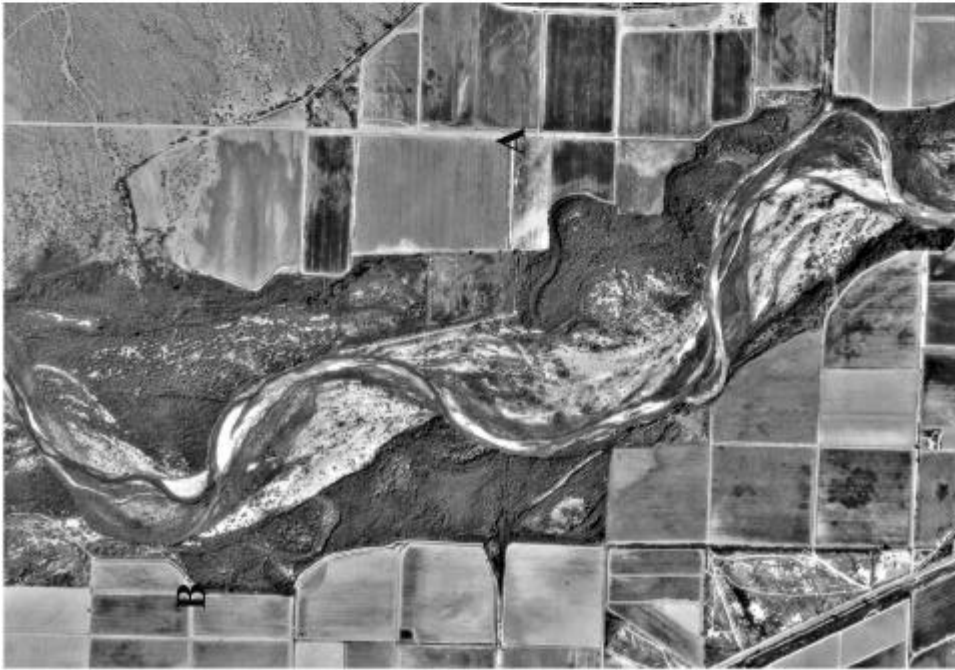
Figure 10 (cont.) (g) 1992 photos show additional change to a more sinuous meander pattern than that of 1973. Meanders at points A and B have been abandoned and vegetated. (h) The river channel continued to increase in sinuosity through 1997. Flow is from bottom to top in the figure.

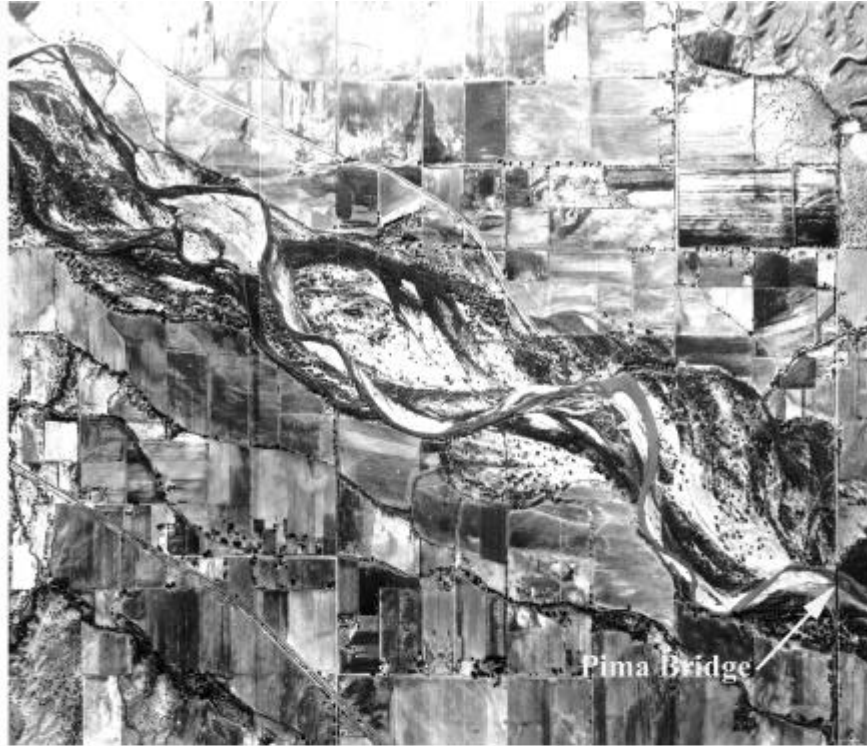
Figure 11. Case Study 3A: Pima Bridge to Markham Wash. The photographs in this figure show channel narrowing from (a) 1935 to (b) 1953 downstream of Pima Bridge. Flow is from the right to left corner of the figure.

This reach is a good example of lateral channel change in Safford Valley (Figure 11). The channel in this reach was generally wider in 1935 than in other photograph years. The 1953 photographs show a narrowing of the channel, imposed by levees near the Pima Bridge, and widening downstream of the bridge. In 1967, it is apparent that there was channelization that continued upstream to at least Thatcher. The 1967 photographs also show an increase in sinuosity downstream of Pima Bridge. The sinuosity is accentuated in 1973 in the same area and in 1978, new channelization efforts are apparent in the center of a meandering low flow channel. By 1997, meander locations and flood width values have changed, resulting in the high variability in channel location and width for this reach.

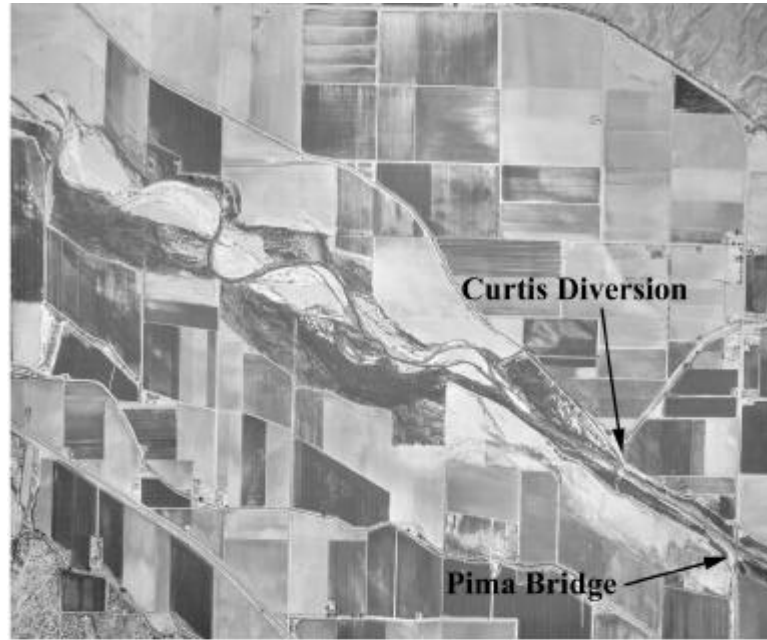
Figure 11 (cont.) (c) 1967 photographs show channelization and an increase in sinuosity downstream of Pima Bridge; (d) by 1973, the sinuosity had increased when compared to that of 1967. Flow is from the right to left corner in the figure.

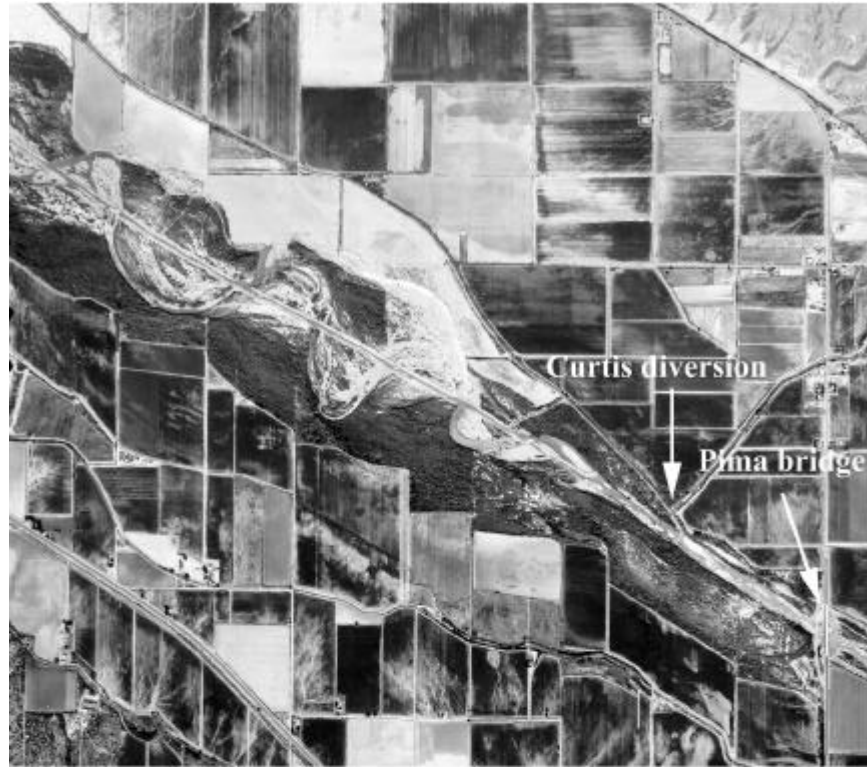
(e) 1978

Figure 11 (cont.) In (e) 1978, new channelization efforts are apparent; by (f) 1997, meanders had been accentuated and some incorporated into the flood flow channel. Flow is from the right to left corner in the figure.

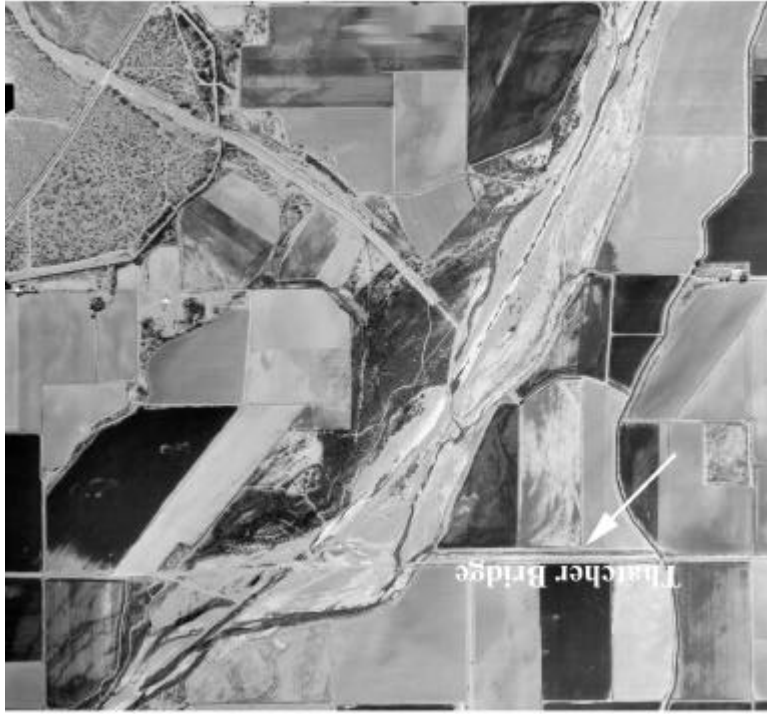
(b) 1967

Figure 12. Case Study 3B: Thatcher Bridge and vicinity. From (a) 1935 to (b) 1967, the channel narrowed considerably due to the abandonment of a 1935 right bank meander and left bank meander (shown by the arrow). Flow is from right to left.

1935 photographs show the presence of a wide channel; from 1935 to 1967, the channel narrowed considerably on the right and left banks on account of the abandonment of 1935 meanders (Figure 12). In 1973, some widening is apparent following the 1972 flood and by 1981, the 1935 right and left bank meanders were again part of the flood channel. The 1981 photographs also show efforts to channelize this reach upstream and downstream of the Thatcher Bridge. 1992 and 1998 photographs show a channel similar to that of 1981 with added vegetation in the channel.

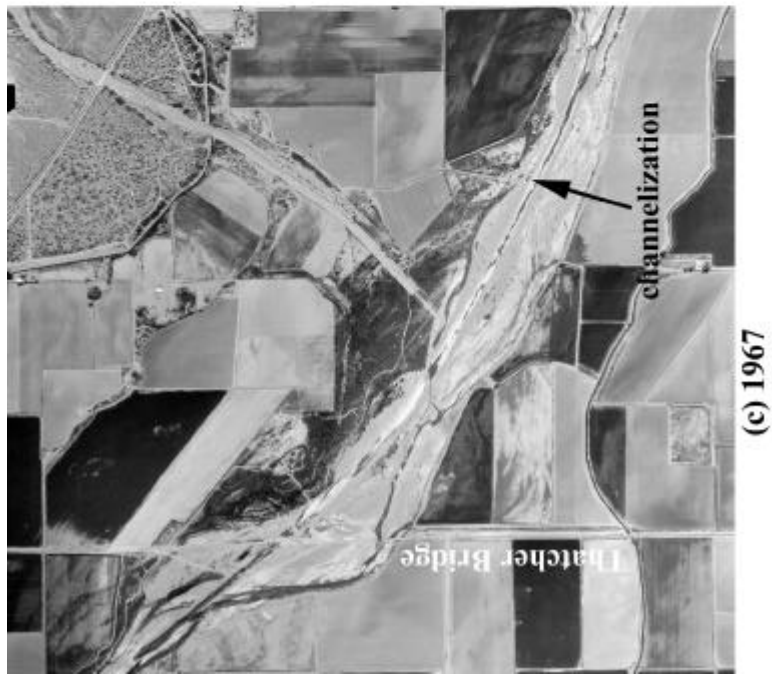
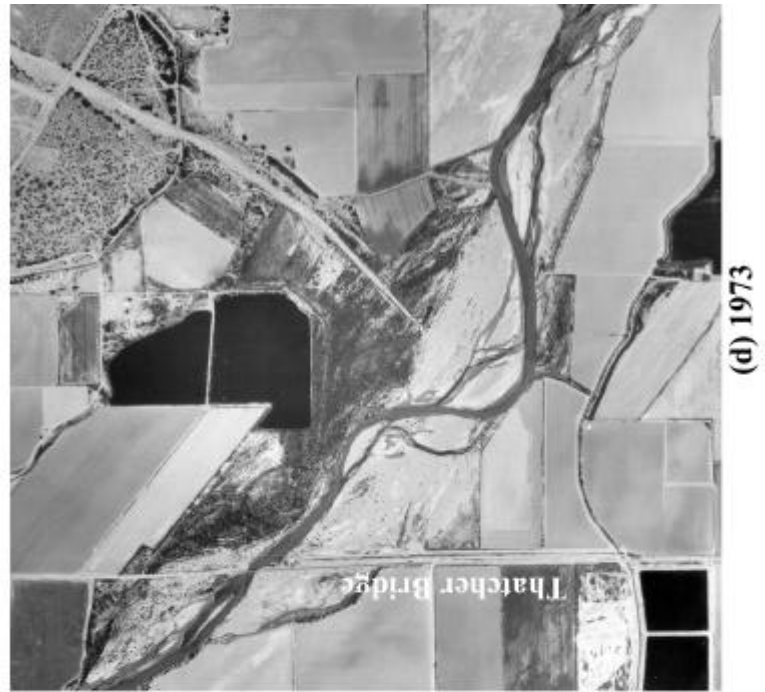
Figure 12 (cont.) From (c) 1967 to (d) 1973, channel widening is apparent due to the 1972 flood. Note the channelization in the 1967 photographs. Flow is from right to left.

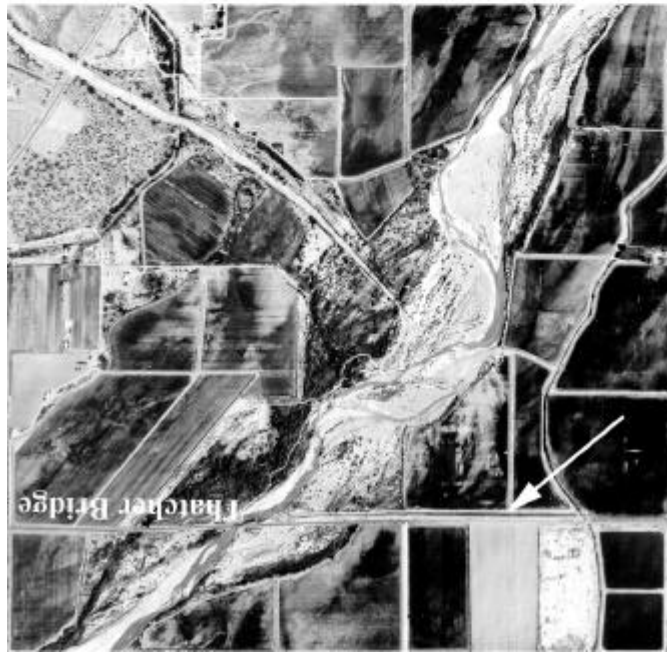
Figure 12 (cont.) (e) 1978 photographs show migration of the right bank toward the old right bank meander; by (f) 1981, the river channel had fully cut into the 1935 right and left bank meanders. Note the change in width upstream from the Thatcher Bridge indicated by the white arrow. Flow is from right to left.

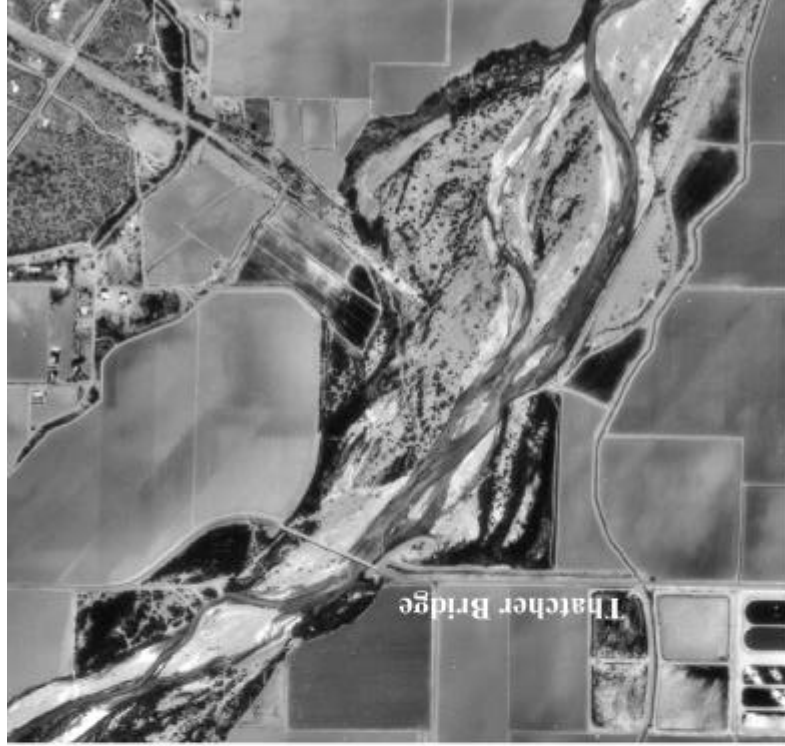
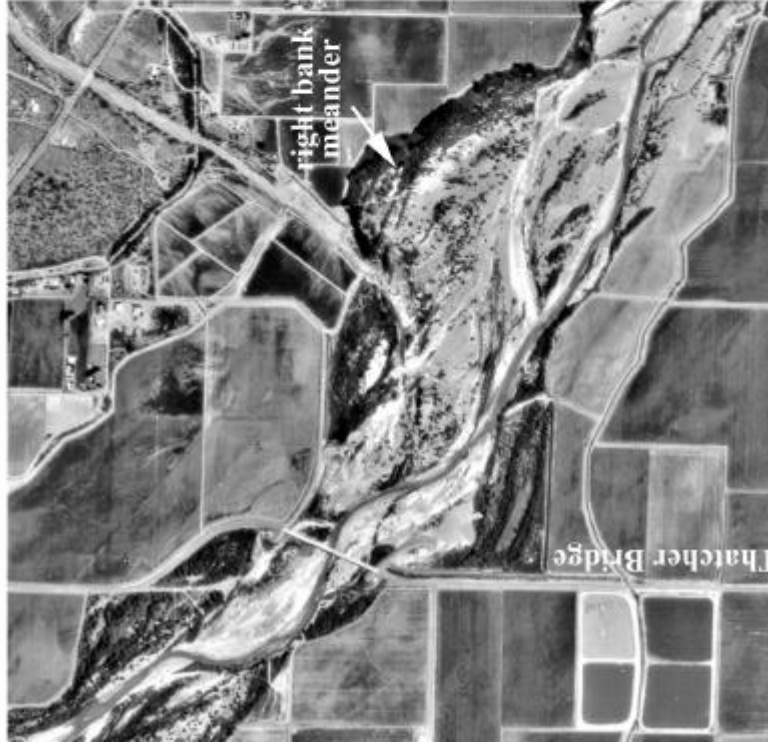
Figure 12 (cont.) (g) 1992 and (h) 1998 photographs show a channel similar to that of 1981 with additional vegetation in the channel. Flow is from right to left.

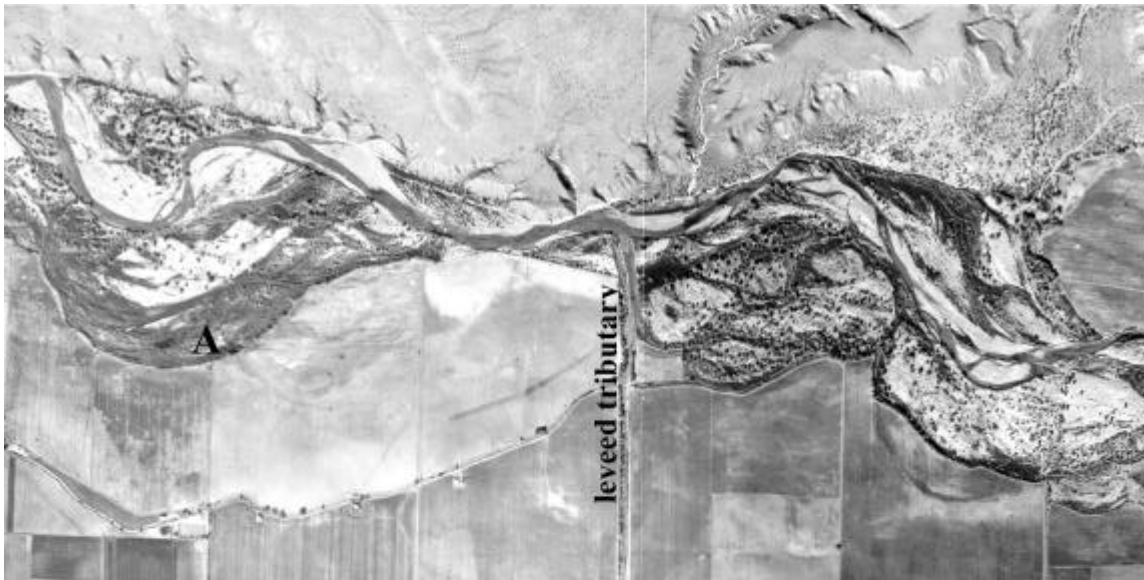
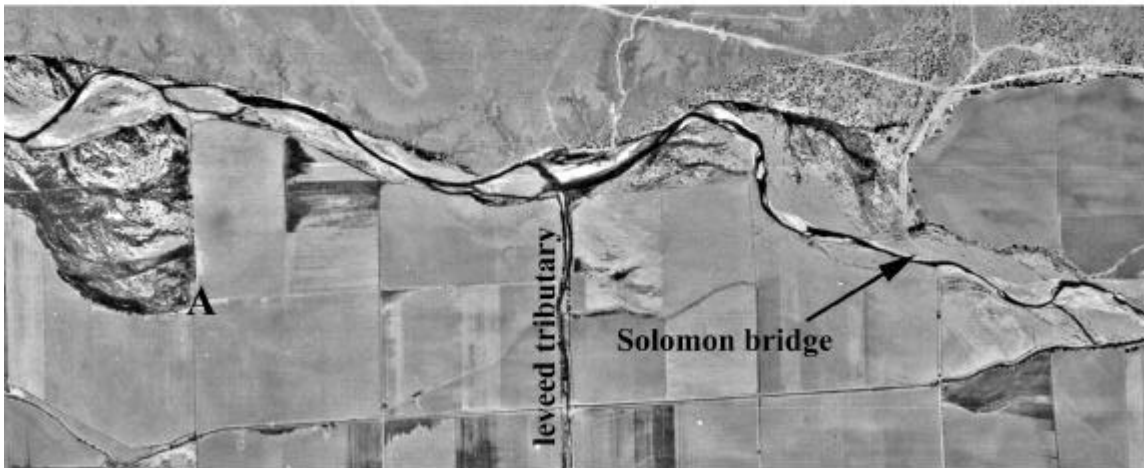
Figure 13. Case Study 4A: Solomon Bridge and vicinity. In (a) 1935, the channel was relatively wide and a meander existed on the left bank upstream of the leveed tributary. By (b) 1953, the channel had reduced considerably in width for the reach as a whole and agriculture had reoccupied the channel upstream of point A. Flow is from right to left.

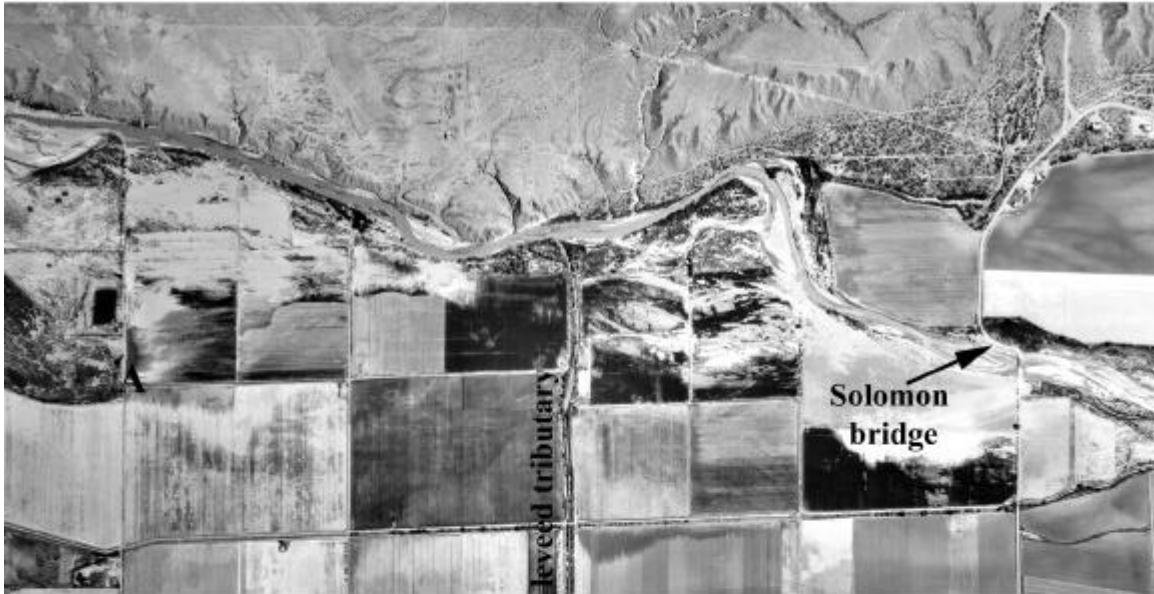
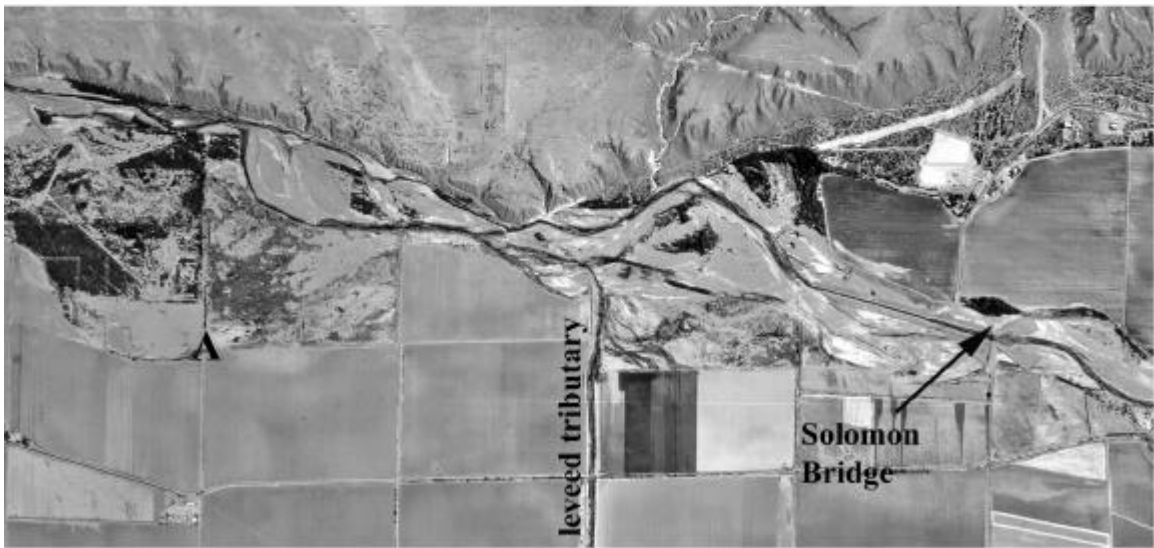
Figure 13 (cont.) (c) Channel widening occurred in response to the 1972 flood; (d) by 1981, the channel had widened further some channelization apparent downstream from the Solomon Bridge. Flow is from right to left.

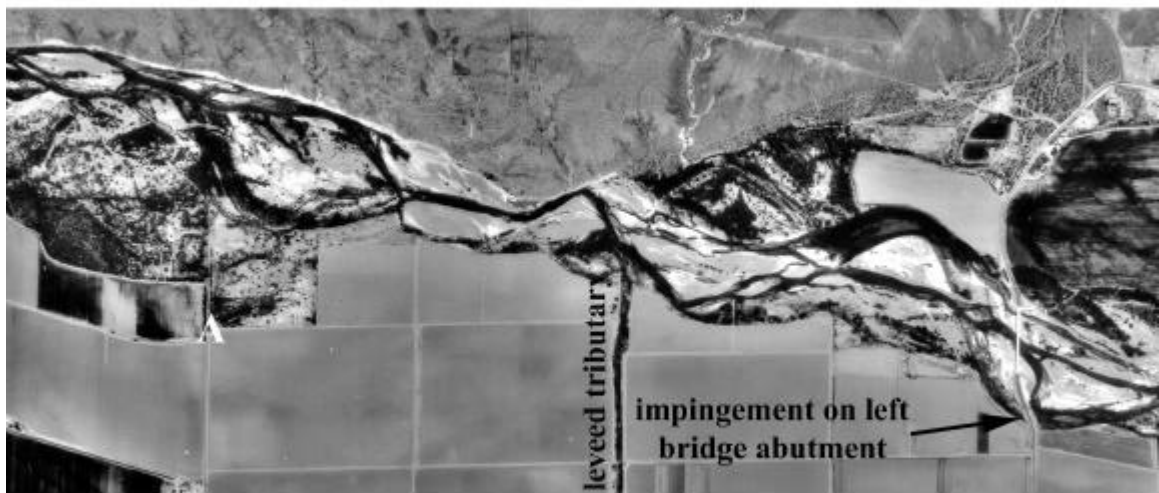
Figure 13 (cont.) By (e) 1998, the channel had widened and cut into the right bank downstream of Solomon Bridge. Flow is from right to left.

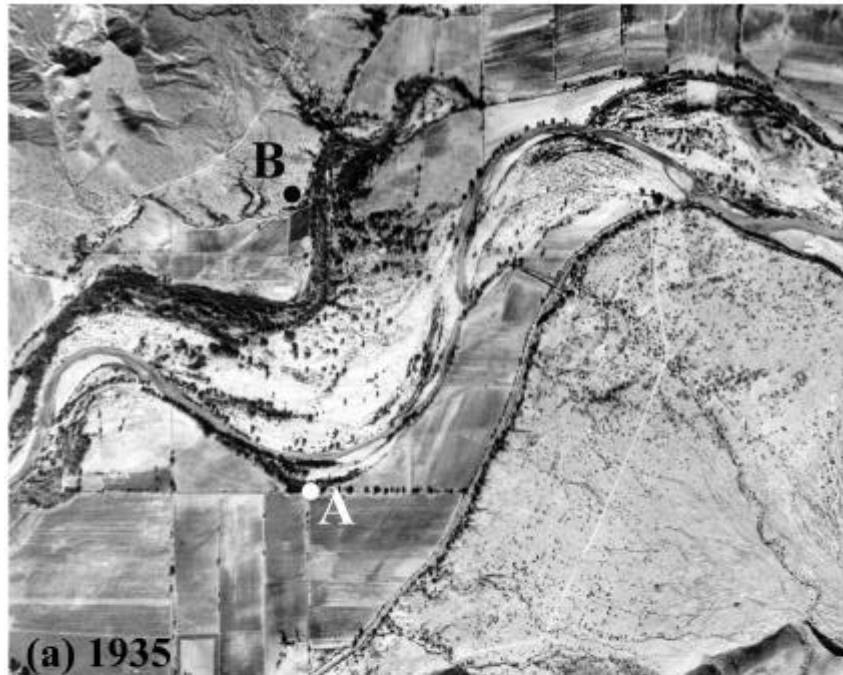
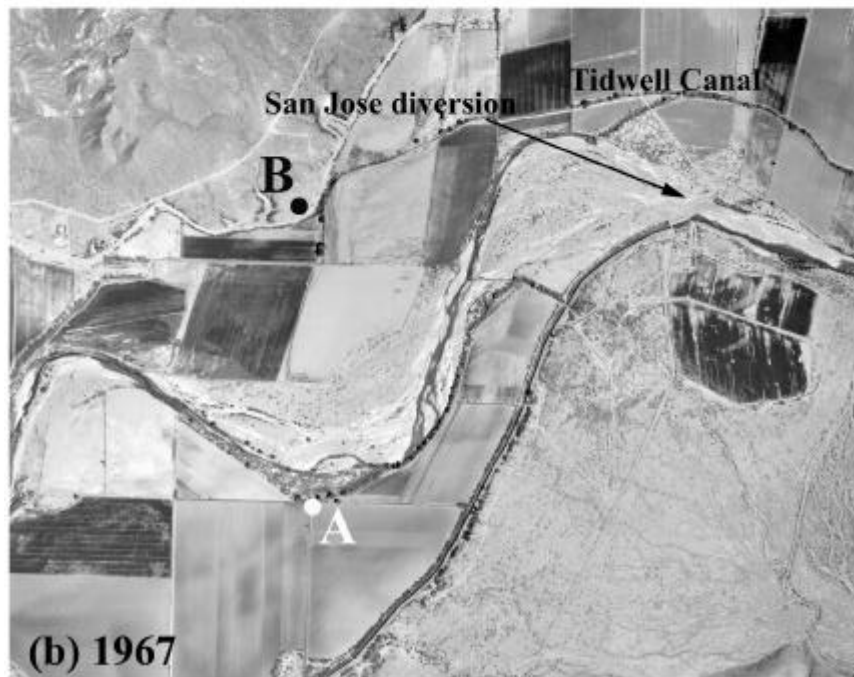
Figure 14. Case Study 4B: San Jose Diversion. From (a) 1935 to (b) 1967, the flood width decreased slightly, while the position of the channel remained similar. Note points A and B for reference. Flow is from right to left.

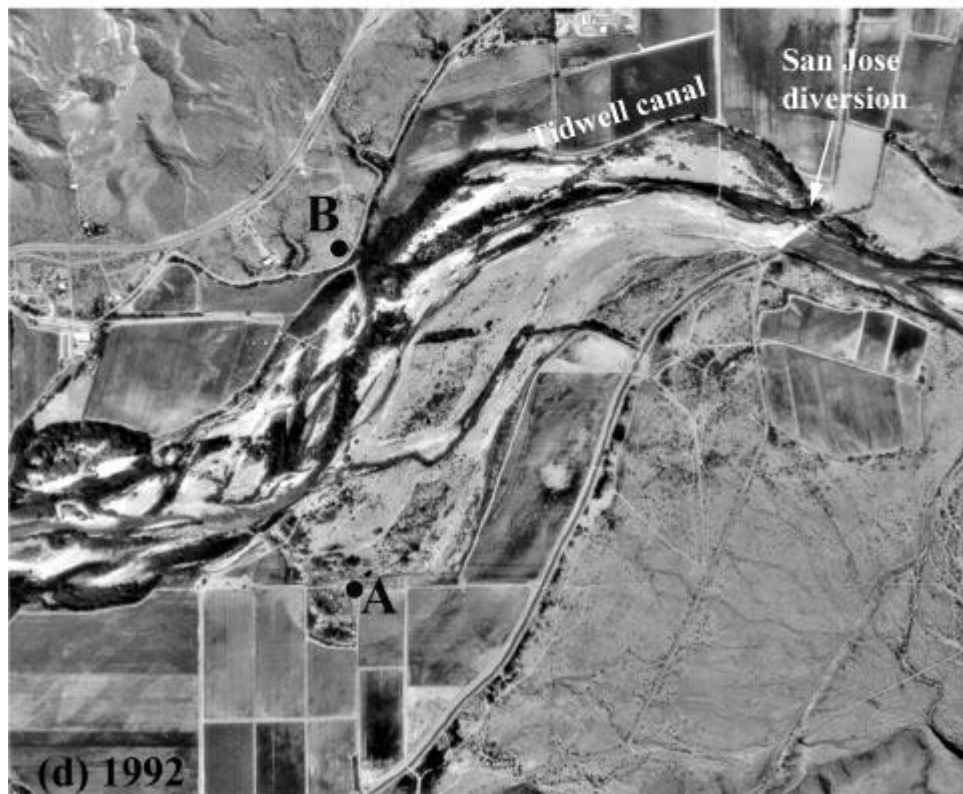
Figure 14 (cont.) By (c) 1981, lateral movement had occurred on the right and left banks (points A and B) downstream of the San Jose Diversion. Further lateral migration had occurred by (d) 1992 on the right bank at point B. Flow is from right to left.

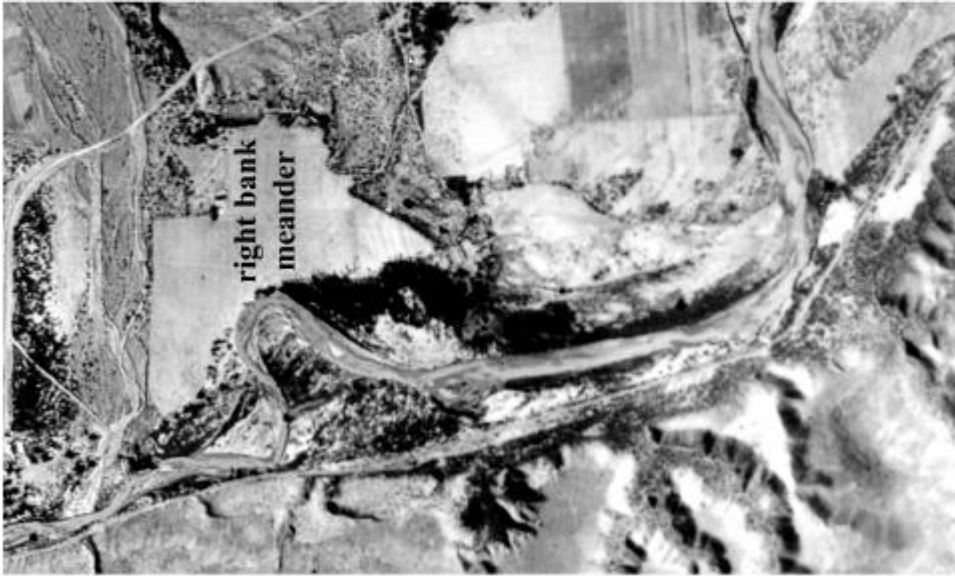
Figure 20. Case Study 1: Kaywood Wash area. From (a) 1935 to (b) 1958, channel width decreased, especially on the right bank. Flow is from bottom to top in the figure.

The 1935 channel was the widest documented during the measurement period; by 1958, the record of floods in adjacent fields had been obliterated (Figure 20). In 1967, the right bank meander was abandoned and the channel continued to decrease in width to 1978, which is the narrowest width in the record. Prominent levees were located at the upstream end of this study reach in 1978. In 1992, the right bank meander was reoccupied by lateral migration and in 1997 was further scoured presumably by floods in 1993 and 1995. Erosion also occurred behind the levees at the upstream end of the study reach prior to 1992 and between 1992 and 1997.

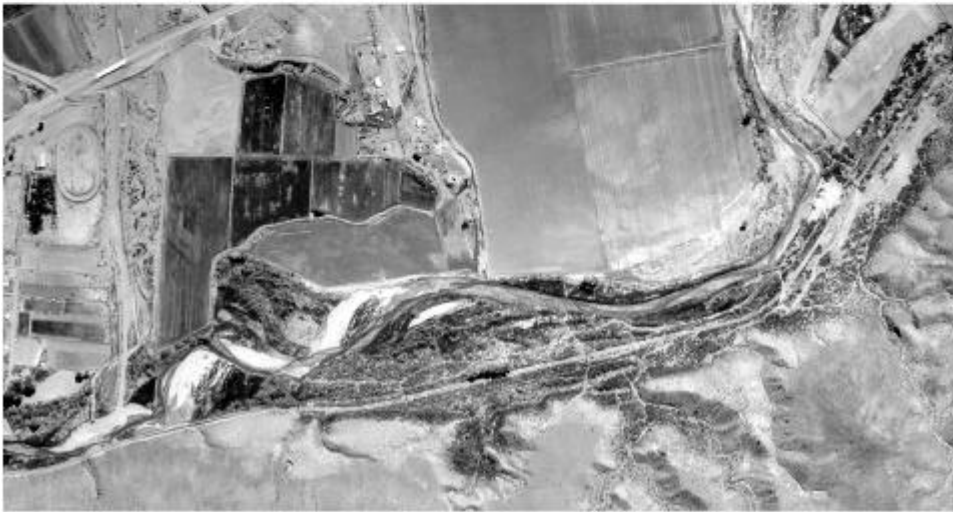
Figure 20 (cont.) The right bank meander in (c) 1967 was abandoned and reoccupied by agriculture by (d) 1973. Levees were also constructed in 1973 on the right-bank at the upstream end of the study reach. Flow is from bottom to top in the figure.

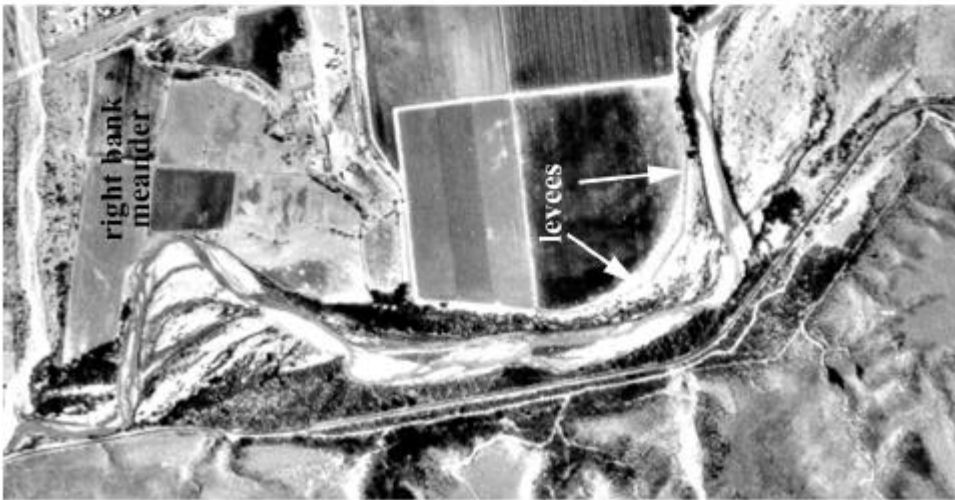
(e) 1992

Figure 20 (cont.) (e) Inundation behind levees on the right bank and lateral migration of the right bank in 1992 created a channel similar to that of 1958. By (f) 1997, the right bank had become the main channel.

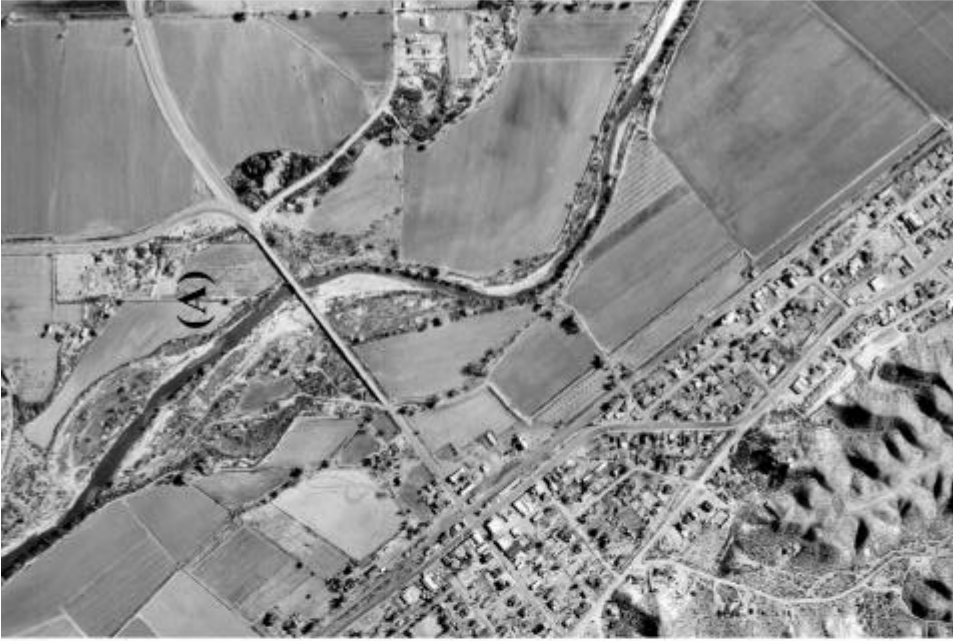
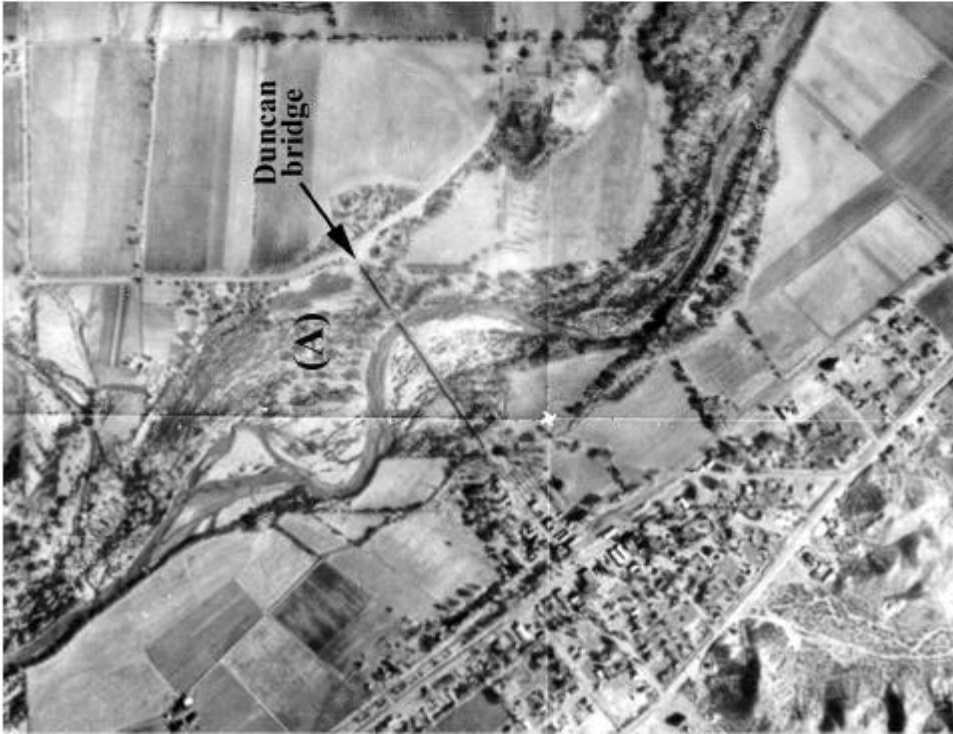
Figure 21. Case Study 2: Duncan Bridge. Channel narrowing occurred between (a) 1935 and (b) 1958, particularly on the right-bank at point A and upstream of Duncan Bridge. Flow is from bottom to top in the figure.

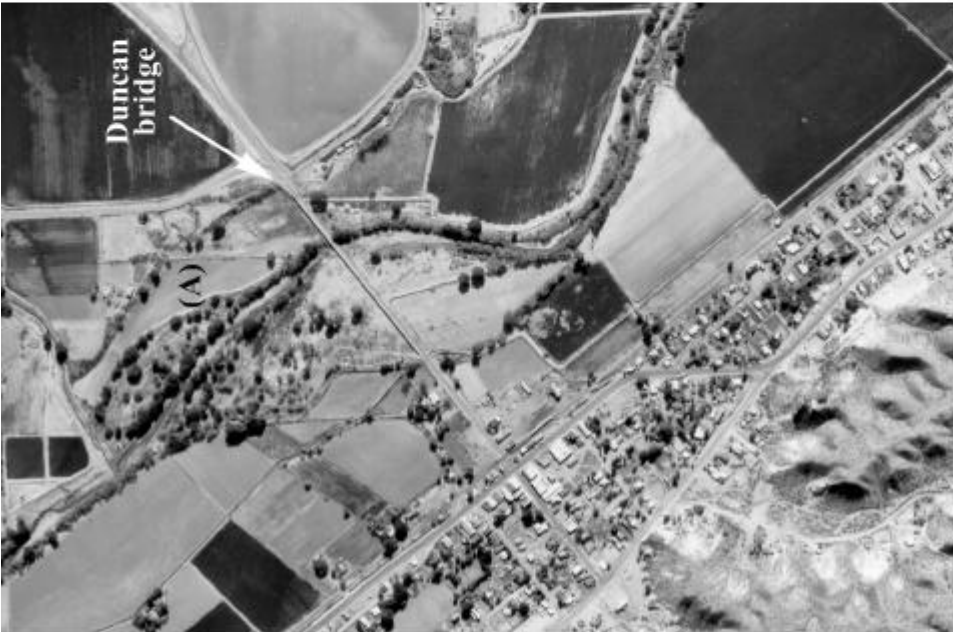
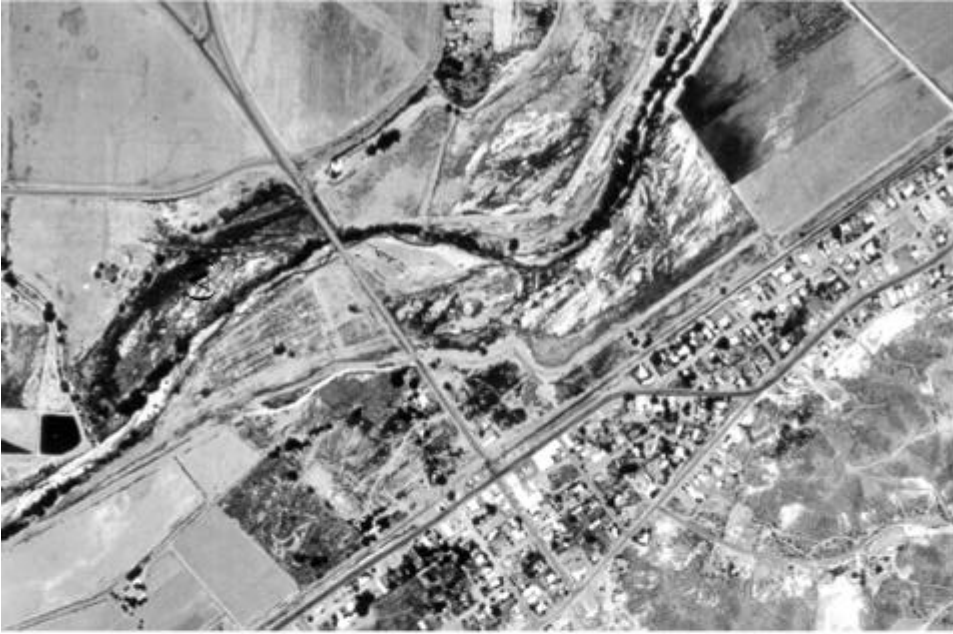
Figure 21 (cont.) (c) The 1967 channel was the narrowest channel in the historical period. By (d) 1981, the channel had increased to its widest extent in the historical period due to the 1978 flood.
