TECHNICAL SERVICE CENTER
DENVER, COLORADO

UPPER GILA RIVER FLUVIAL GEOMORPHOLOGY STUDY

CATALOG OF HISTORICAL CHANGES ARIZONA

JUNE 8, 2001

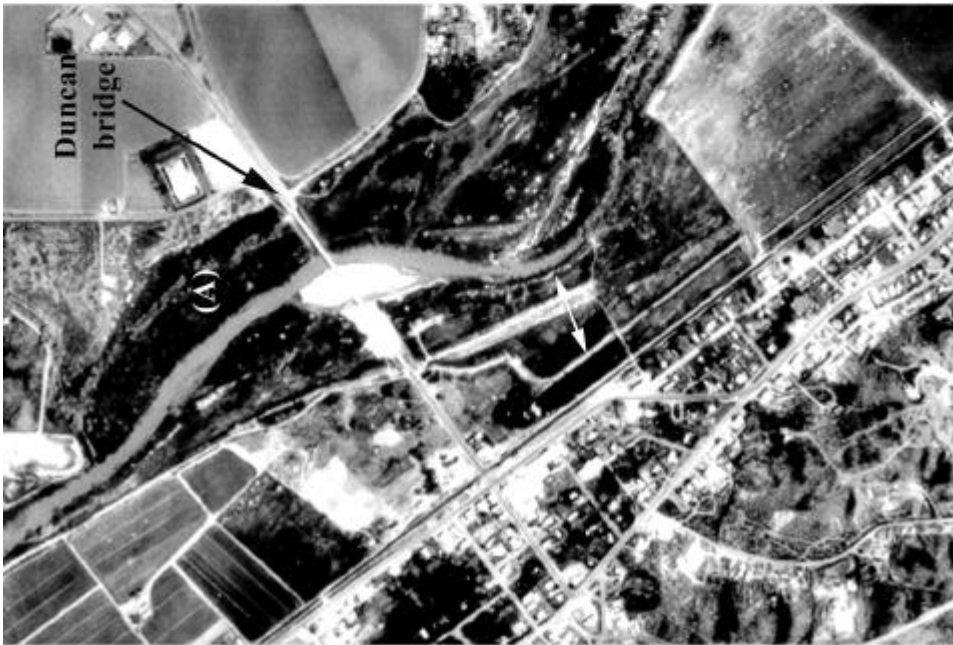
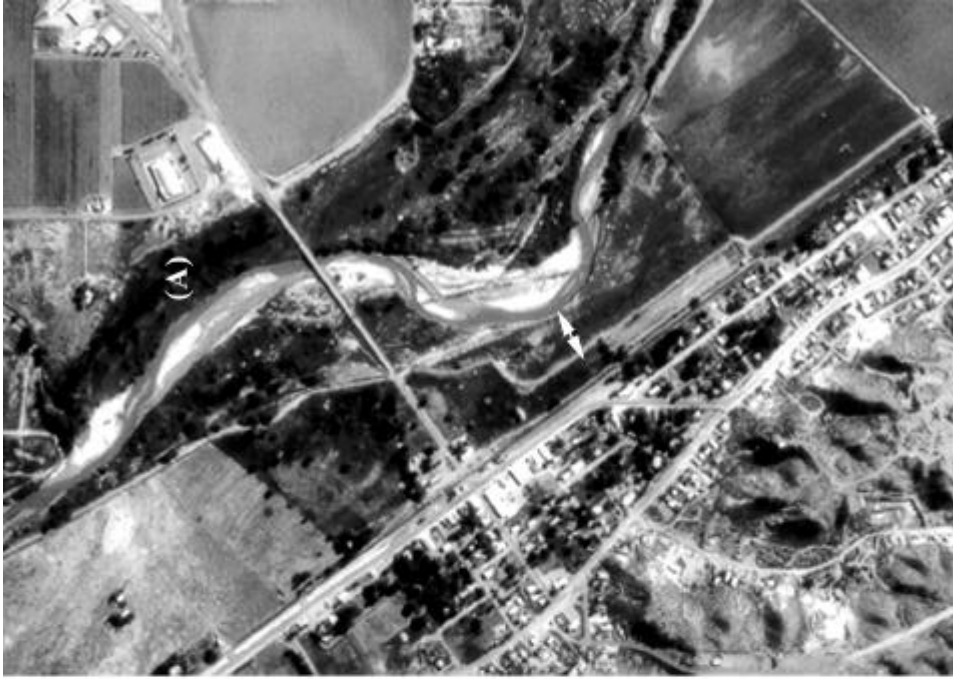
Figure 21 (cont.) By (e) 1992, much of the 1981 flood width had been eroded presumably by floods in 1993 and 1995 (shown by arrows). Flow is from bottom to top in the figure.

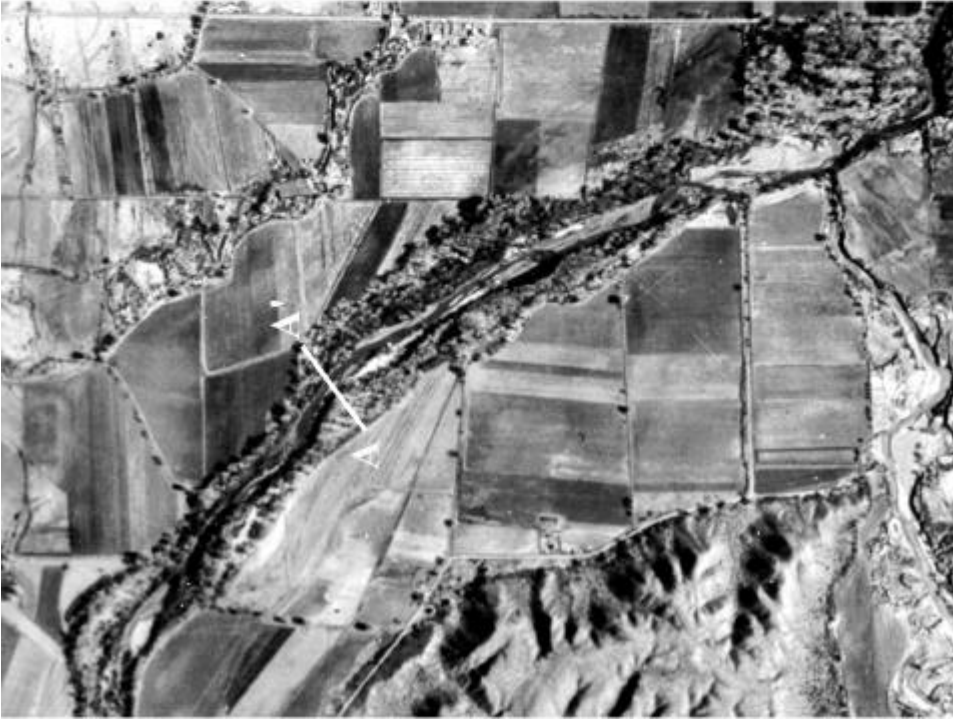
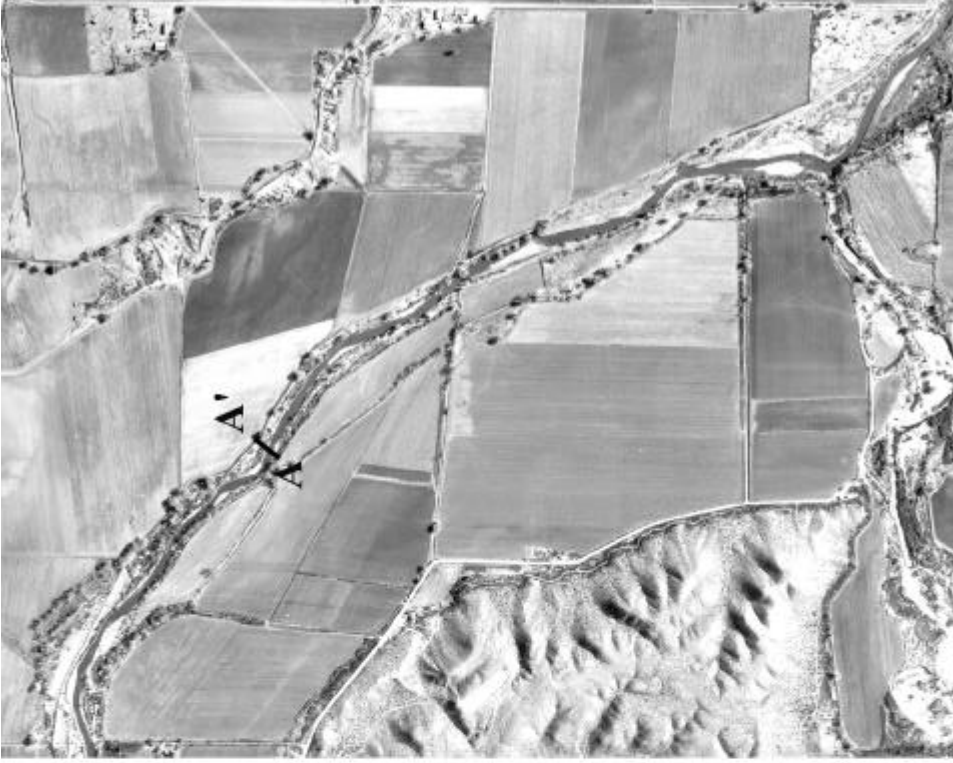
Figure 22. Case Study 3: Railroad Wash area. From (a) 1935 to (b) 1967, the channel decreased in width although its position remained similar. The segment from A to A' illustrates this reduction in width. Flow is from bottom to top on the figure.

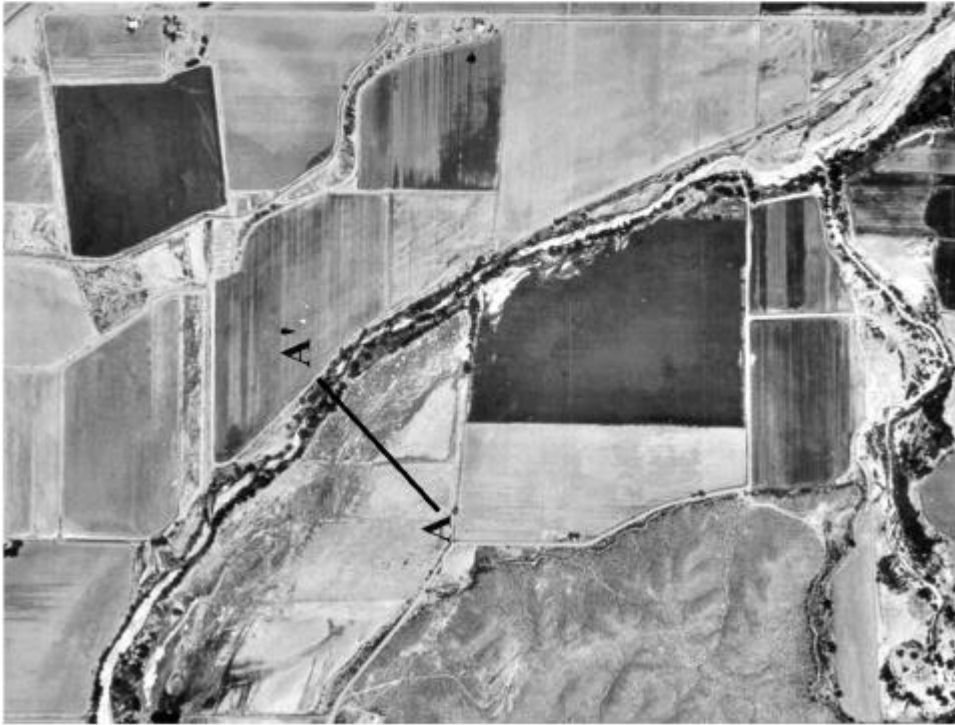
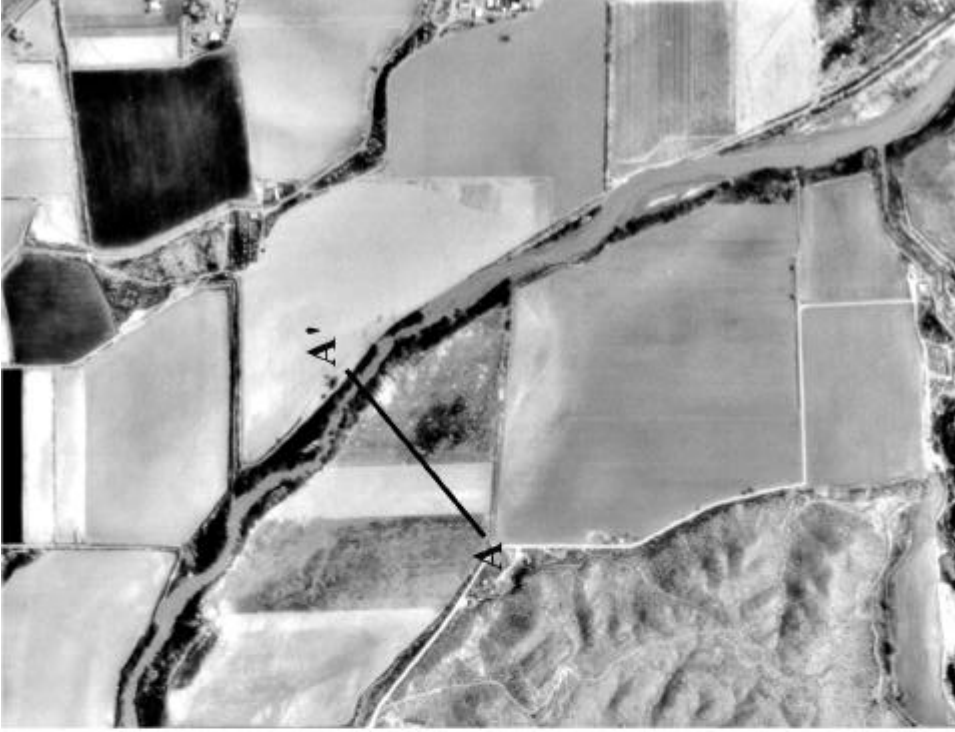
Figure 22 (cont.) In (c) 1981 and (d) 1992, overbank flooding is evident. The approximate flood width is illustrated by the A-A' segment and is an increase when compared to flood widths in previous decades. Flow is from bottom to top in the figure.

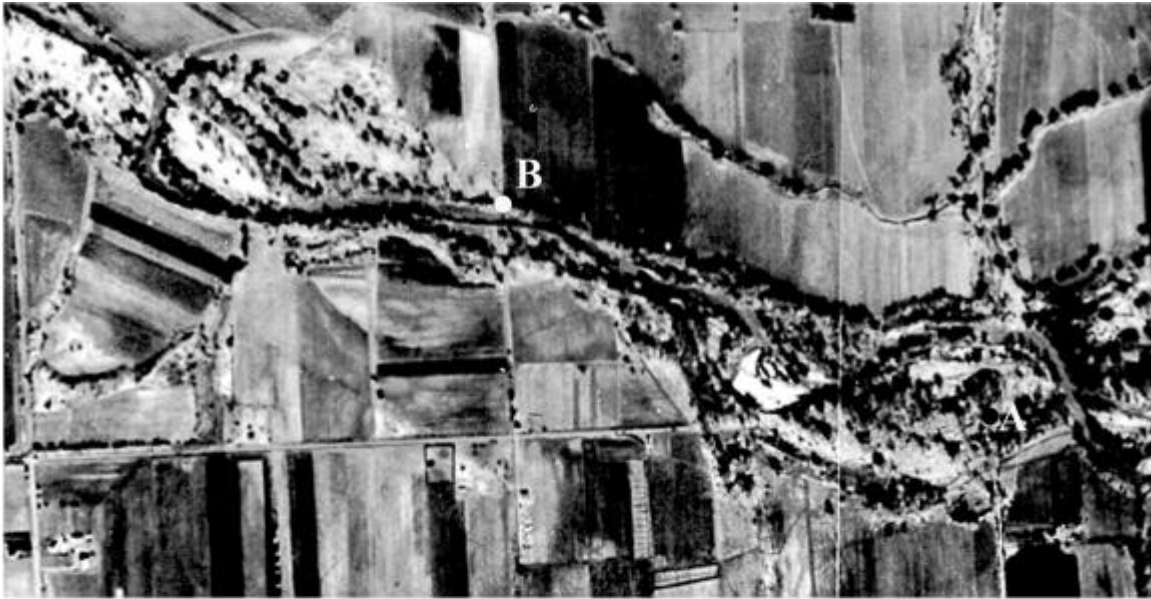
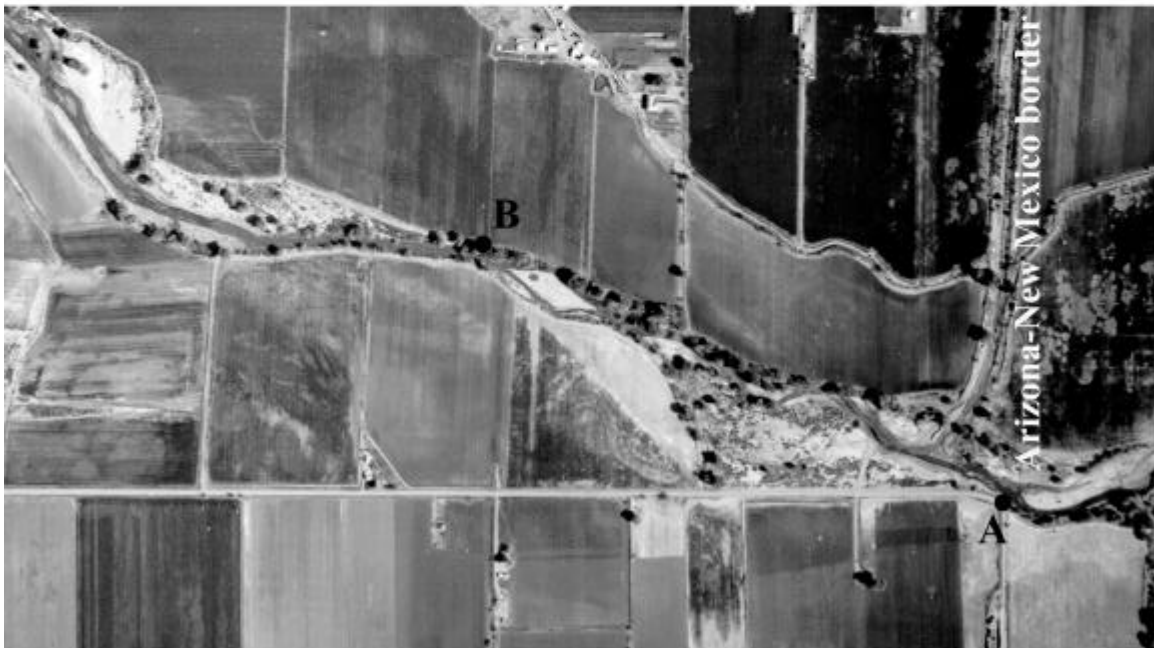
Figure 23. Case Study 4: Arizona-New Mexico border. From (a) 1935 to (b) 1967, the flood width decreased. Note that the channel widened downstream of point B in 1935, whereas in 1967, levees constricted its width. Point A is located at the Arizona-New Mexico border and in 1935 is located in the middle of the channel whereas in the 1967 it is located on the left bank. Flow is from right to left.

Photograph sets for this reach show a relatively wide channel in 1935, narrowing of the channel and occupation of the channel by agriculture from 1935 to 1967 (Figure 23). The 1978 photographs show channel splays in the farmland adjacent to the channel; however, the channel narrows again by 1981 and is similar in 1992. Also note the left bank erosion just upstream of the Arizona-New Mexico border in 1992.

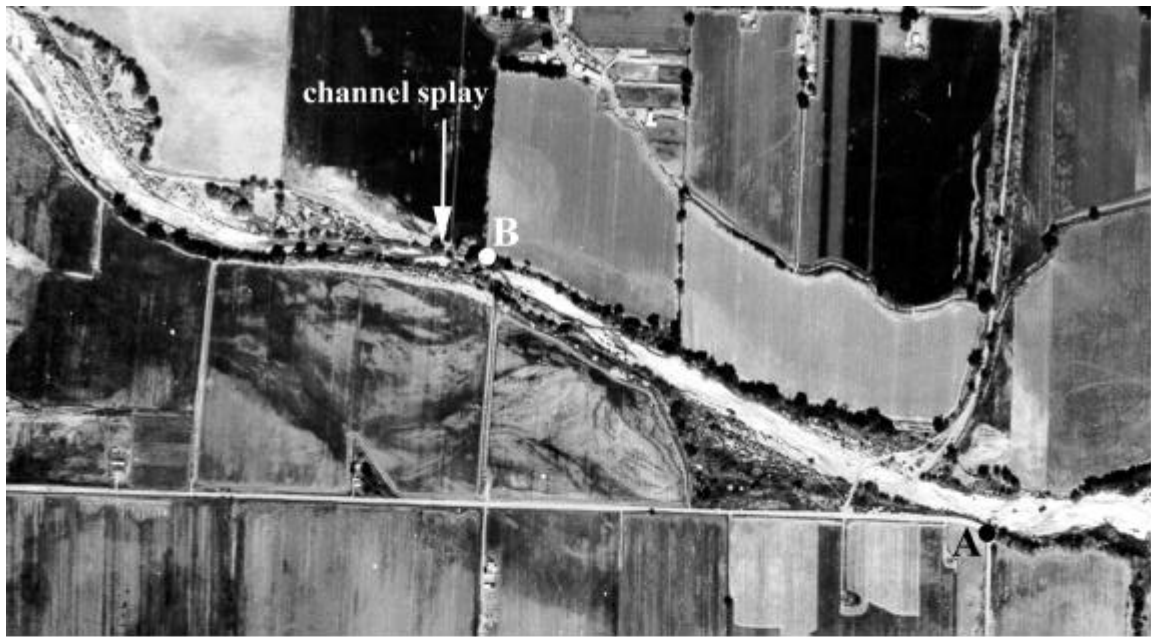
(c) 1978

Figure 23 (cont.) (c) The 1978 photographs show channel splays downstream of point B and evidence of flooding on the left bank. (d) The channel was again constricted in 1992. Also note the erosion on the left bank upstream of point A. Flow is from right to left.

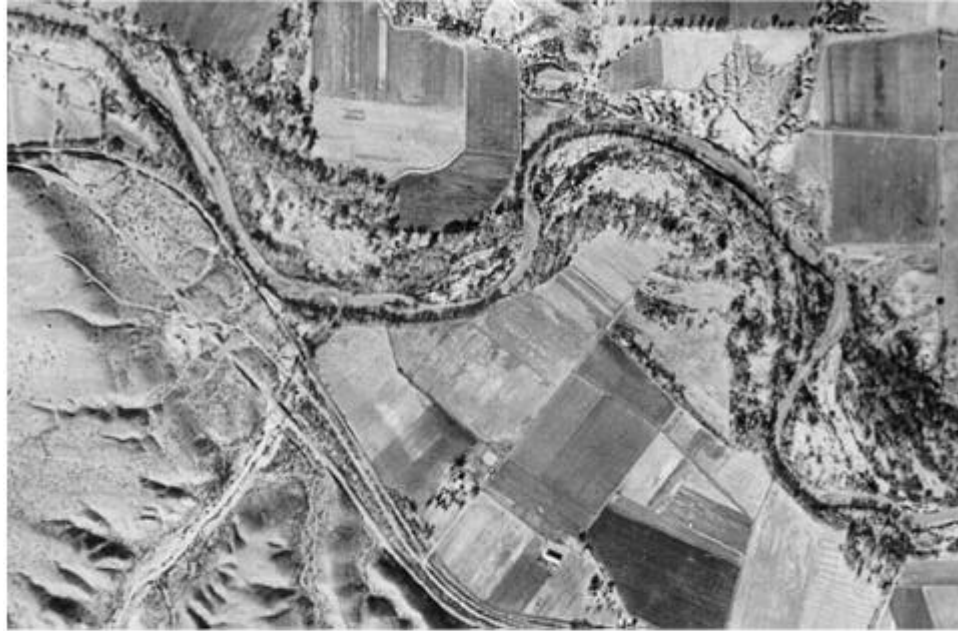
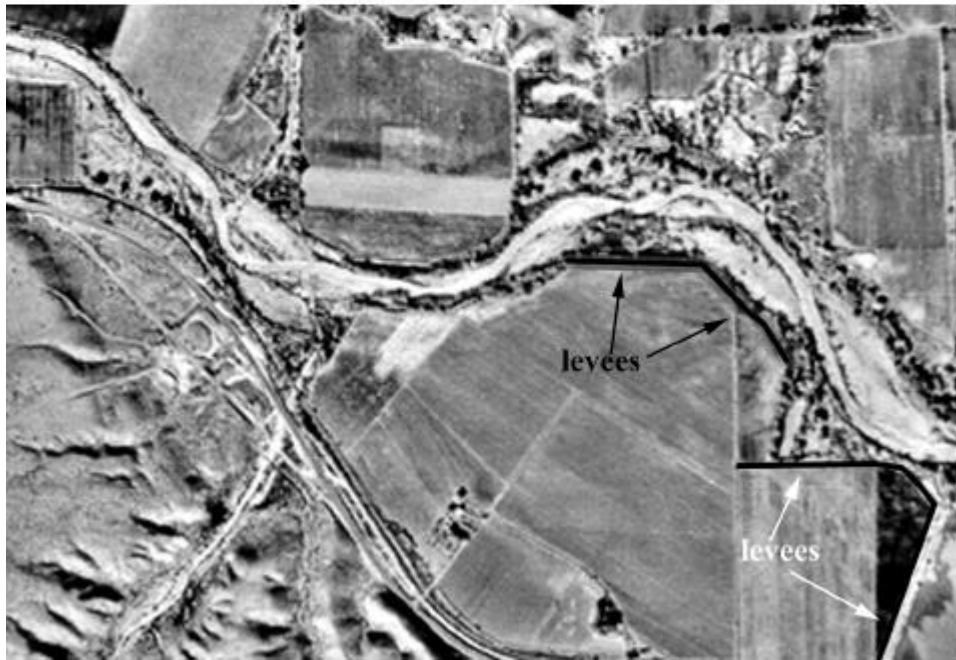
Figure 24. Case Study 5: Whitefield Wash levees. Levees imposed on the left bank caused changes in channel morphology from (a) 1935 to (b) 1953. Flow is from right to left.

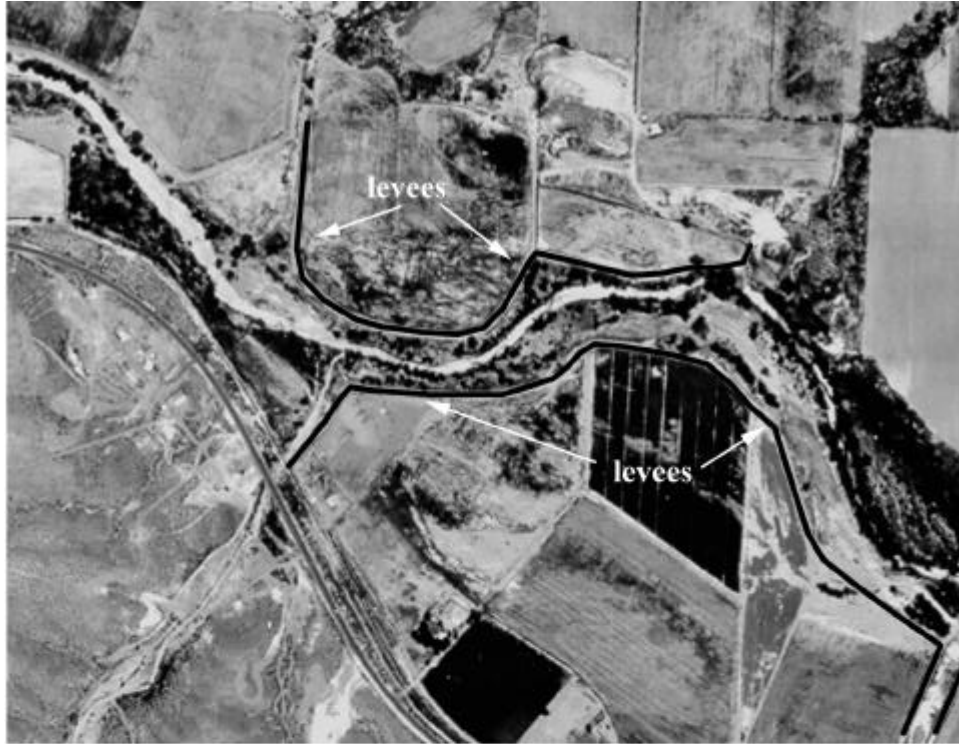
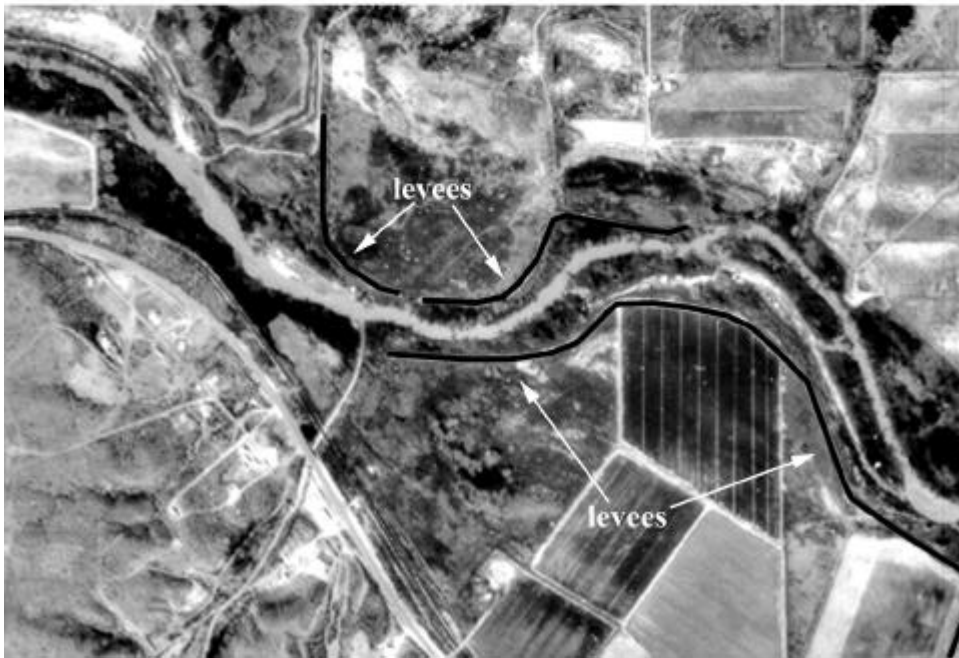
Figure 24 (cont.) (c) Additional levees constructed by 1981 on the right and left banks imposed further restrictions on the channel and by (d) 1992, some of these levees had been eroded and not replaced. The majority of the erosion probably occurred during the 1984 flood. Flow is from right to left.

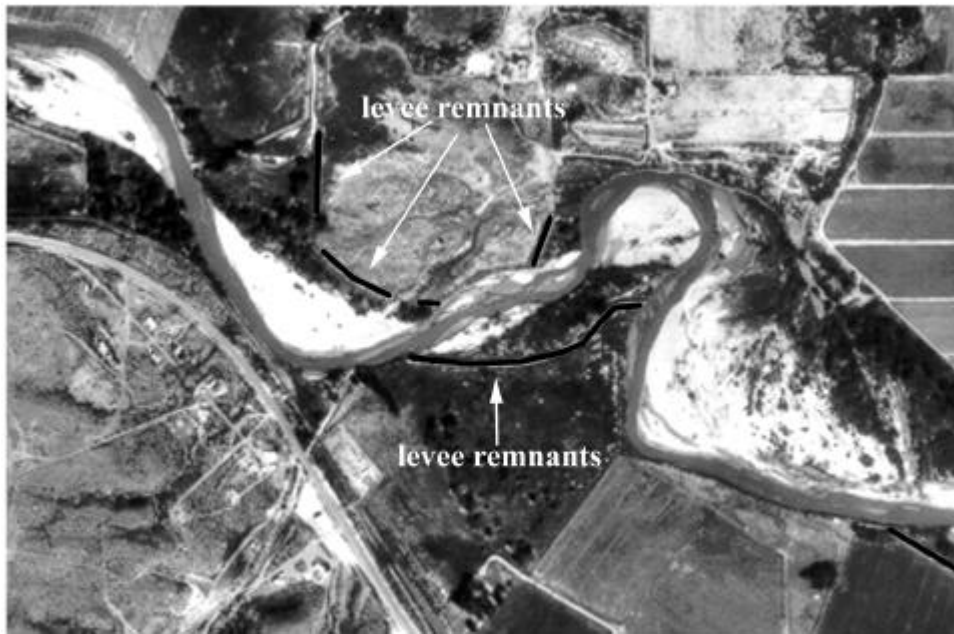
(e) 1997

Figure 24 (cont.) (e) In 1997, the majority of the left bank levee and parts of the right bank levee had been eroded and a new right bank meander had been cut into the floodplain that was previously part of the flood channel in 1935. Flow is from right to left.

This reach is generally similar throughout most of the period of record, but exhibits major channel changes between 1992 and 1997 (Figure 24). The 1935 channel exhibited more sinuous channel morphology, but was generally similar to subsequent years. This difference is most likely due to the construction of levees in 1953, which forced the channel to conform to a particular pattern. This pattern persisted through 1981, where levees were constructed in a slightly different arrangement and more thoroughly. This was probably in response to the 1978 flood, in which inundation is apparent behind the levees on reoccupied farmland on the 1981 photograph set. The 1992 channel had a similar configuration, although some levees had been eroded in the intervening years. In 1997, the left bank levee had been eroded where it was built up after the 1978 flood, and a new right bank meander cut into the floodplain that was previously a part of the flood width in 1935. In sum, although a seemingly new channel was created, high flows between 1992 and 1997 cut into areas that were previously part of the inundation area.
