TR-2015-04

Travel to Trabuco Creek, San Juan Capistrano, CA and Los Angeles River, Los Angeles, CA

Site visit to impassable fish barrier location on Trabuco Creek where proposed engineered fishway may be constructed and site visit to LA River to view site where future river restoration efforts are planned.

TRAVEL REPORT

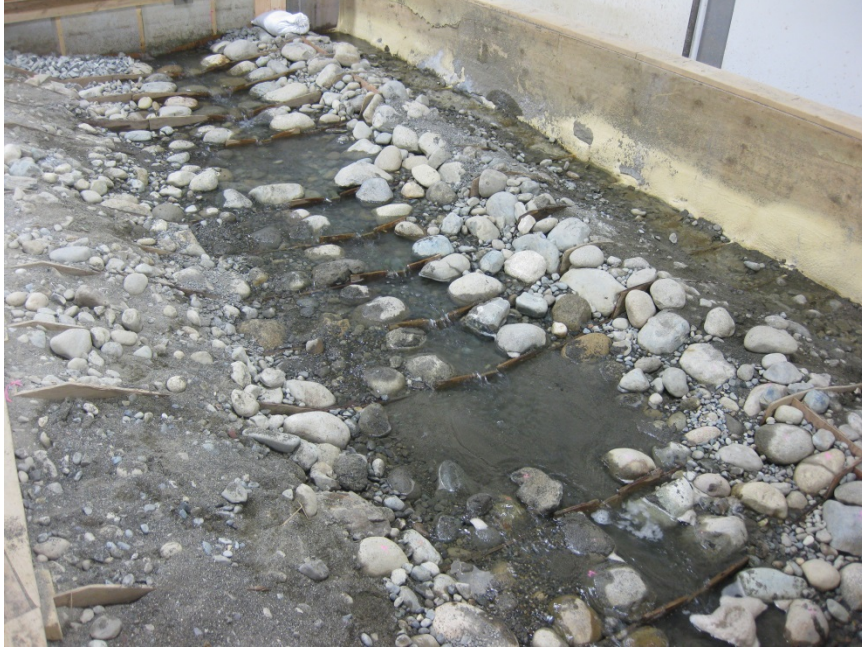
Figure 1. Physical hydraulic model (1:6 scale) of a section of the proposed Trabuco Creek fishway design at Northwest Hydraulic Consultants hydraulics laboratory in Seattle, WA.

Northwest Hydraulic Consultants (NHC) constructed a 1:6 and 1:20 scale physical hydraulic model at their hydraulics laboratory in Seattle, WA to evaluate the performance of the proposed design (Figures 1 and 2, Northwest Hydraulic Consultants 2015). Reclamation supported the project by providing Endangered Species Act (ESA) funds for the sediment testing. Connie traveled to NHC in December 2014 to observe and provide input on sediment testing occurring in the 1:6 scale model (Svoboda 2015). Trout Unlimited is currently seeking financial support from project partners to complete the project. It is anticipated that Reclamation may be able to provide support in terms of technical advice and design review for this ESA-related project.

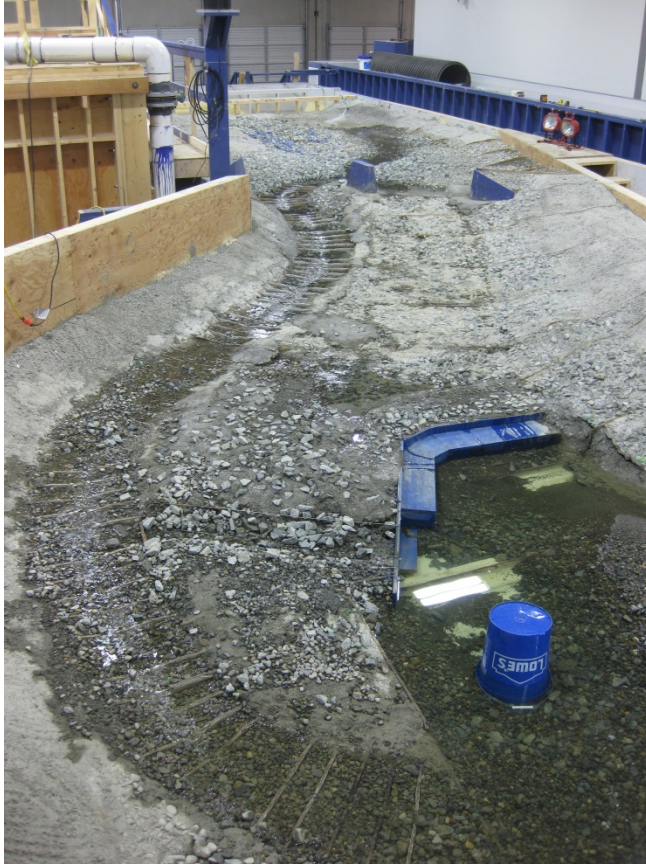
Figure 2. Physical hydraulic model (1:20 scale) of the proposed Trabuco Creek fishway design at Northwest Hydraulic Consultants hydraulics laboratory in Seattle, WA.

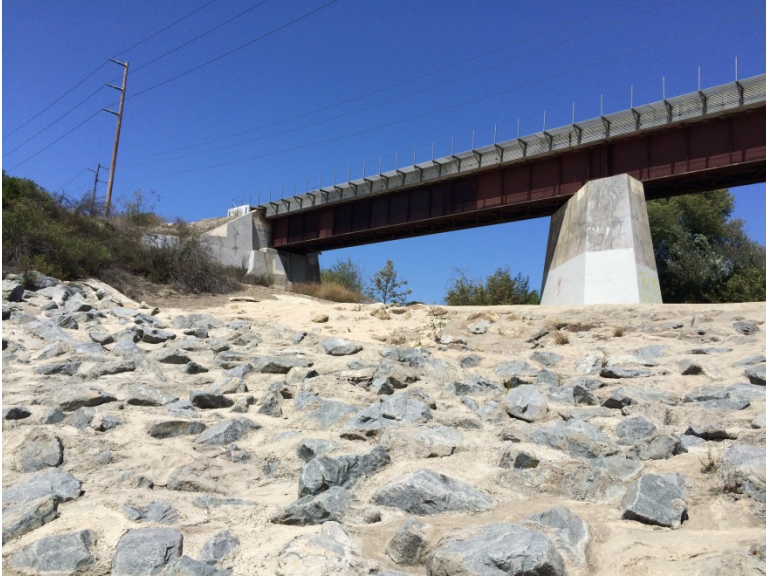
The team walked to the Metrolink light rail fish barrier on Trabuco River where the proposed cascade and pool fishway would be constructed during the first phase of the restoration project. The existing grouted drop structure was severely undermined by scouring and stream degradation. Significant erosion of Oso Creek due to urban runoff has incised the channel and degraded the bed of Trabuco Creek.

Figure 3. Upstream view of grouted grade control structure at the Metrolink light rail crossing on Trabuco creek.

The lower structure is a large concrete and grouted rock drop structure at the Metrolink light rail crossing that is an impassable fish barrier in a critical habitat area for endangered southern steelhead. The project goal is to replace the existing structure with an engineered fishway. At the request of Trout Unlimited, CDM Smith designed a proposed cascade and pool fishway to provide passage for steelhead. The fishway consists of a sequence of pools with one large pool followed by four small pools. Concrete sills separate pools, and boulders and larger rock are placed strategically to provide hydraulic control in the fishway.

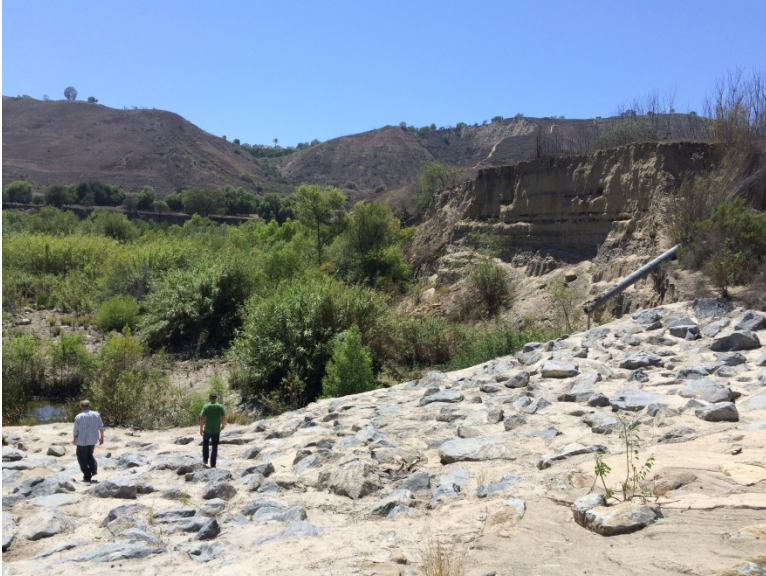
Figure 4. Downstream view of grouted grade control structure at the Metrolink light rail crossing on Trabuco creek.

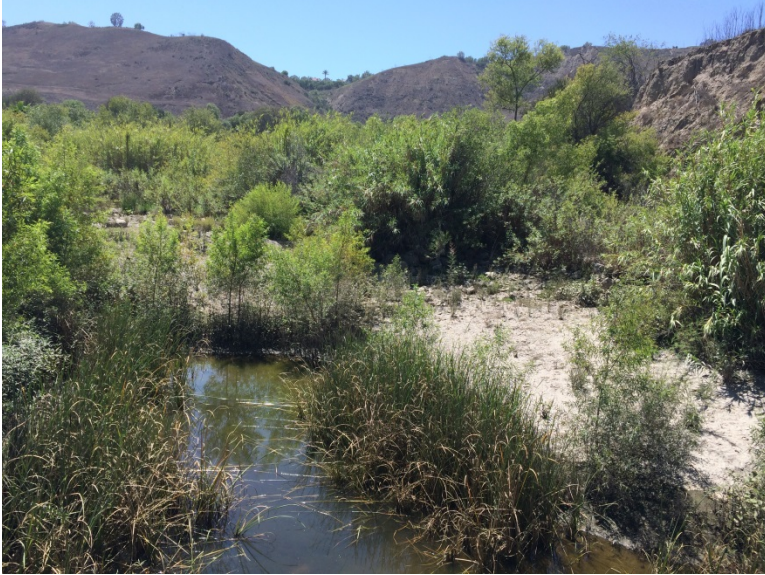
Figure 5. Vegetation downstream of the existing grade control structure.

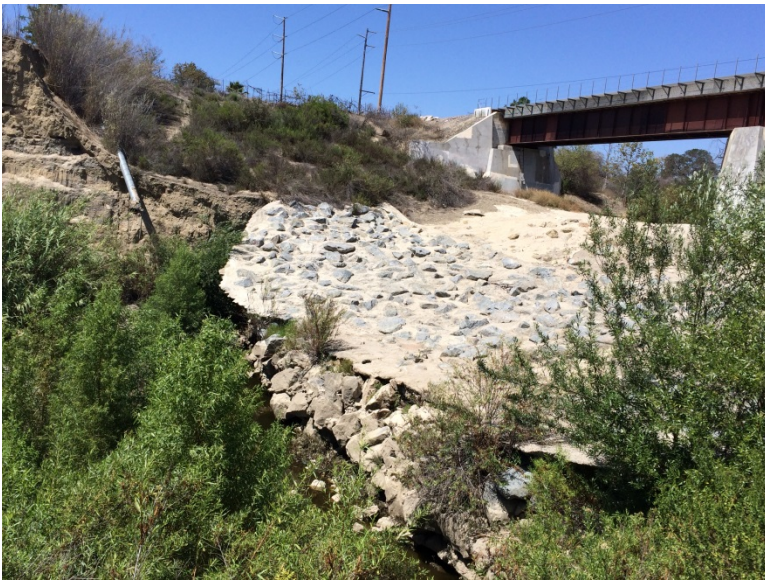
Figure 6. Significant scour hole and stream degradation downstream of the grouted section.

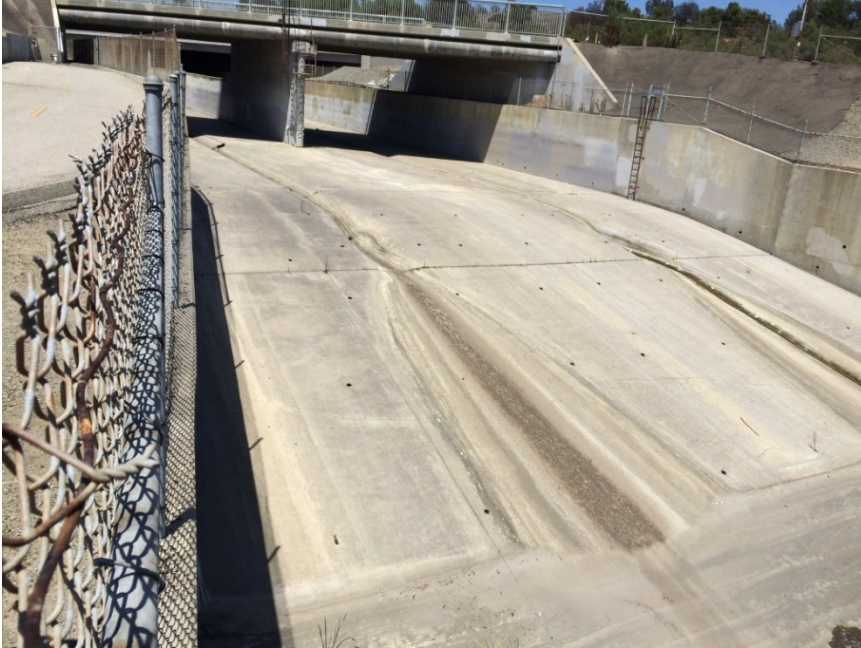
During the site visit, Connie, Kent, Doug, and Drew also stopped at the upstream fish barrier which is roughly 0.5 miles upstream from the Metrolink grade control structure. This upstream drop structure will be the second phase for the Trabuco Creek fish passage project. The concrete drop structure includes 2 notched low-flow channels and a stilling basin with baffles and an endsill. It is unlikely that modifications to the low-flow channels can occur due to concerns about embedded piping. Fish passage would likely need to be provided adjacent to the drop structure. If steelhead are able to pass this barrier, they can move upstream into Cleveland National Forest without further obstructions.

Figure 7. Upstream concrete drop structure produces an impassable fish barrier.

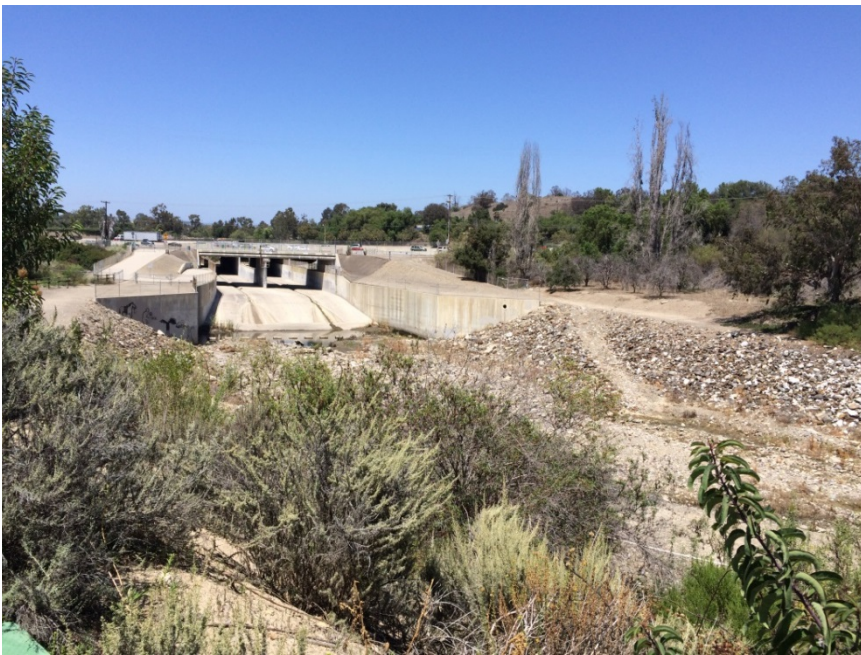
Figure 8. View of concrete drop structure looking upstream.

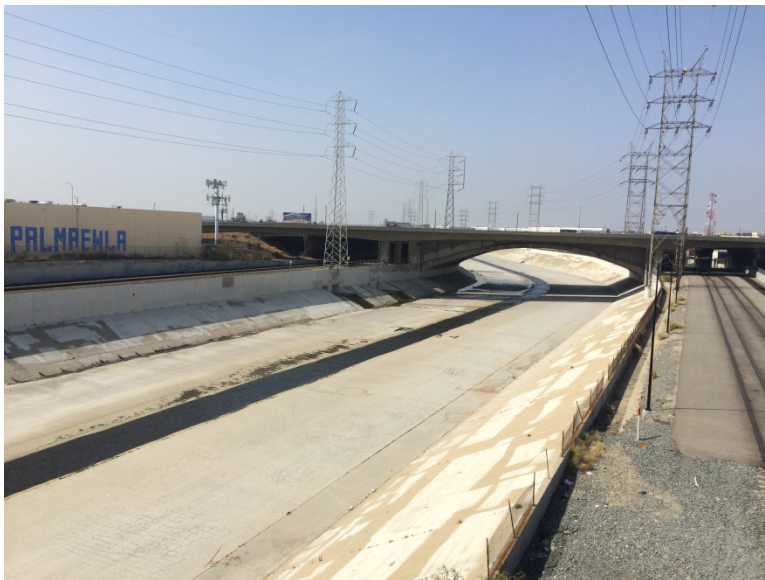
A highly modified, hard-bottomed section of the LA River was viewed from East Cesar Chavez Avenue bridge. The low-flow channel with recycled water can be seen at the center of the concrete channel. A soft-bottomed section of the LA River was viewed from the Los Angeles River Greenway Trail approximately 3 miles north of downtown. Heavy vegetation and fish were observed in the soft-bottomed section of the river.

Figure 9. View of LA River from the East Cesar Chavez Avenue bridge.

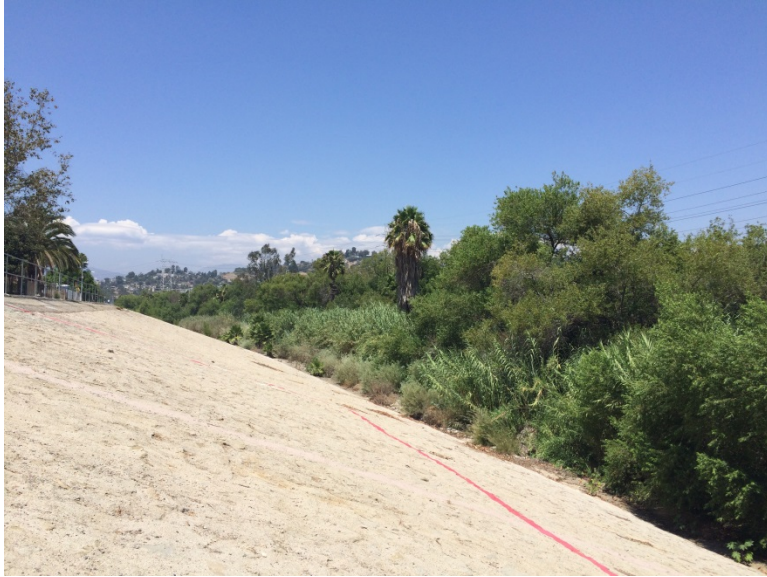
Figure 10. View of the LA River approximately 3 miles north of downtown Los Angeles. The soft-bottomed portion of the trapezoidal channel was heavily vegetated.

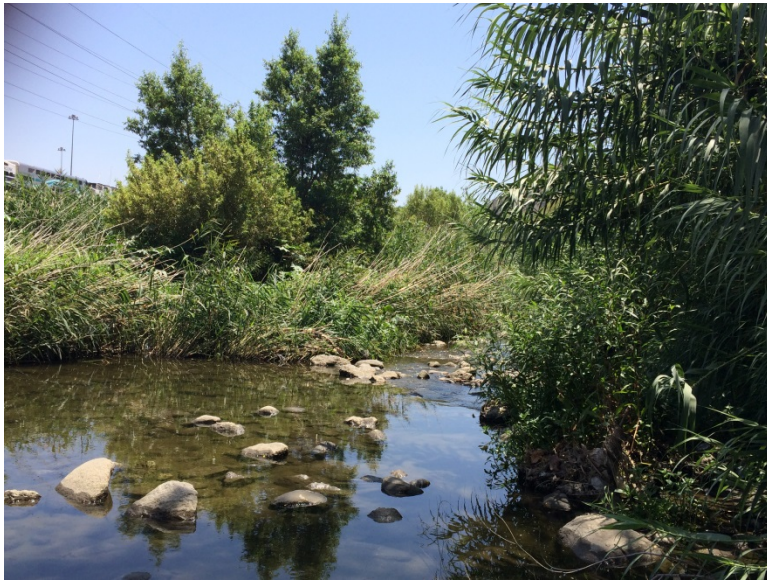
Figure 11. View of the LA River approximately 3 miles north of downtown Los Angeles. Fish were observed in the river.
