Technical Report No. SRH-2008-4

Elephant Butte Reservoir 2007 Sedimentation Survey

U.S. Department of the Interior
Bureau of Reclamation
Technical Service Center
Denver, Colorado

September 2008

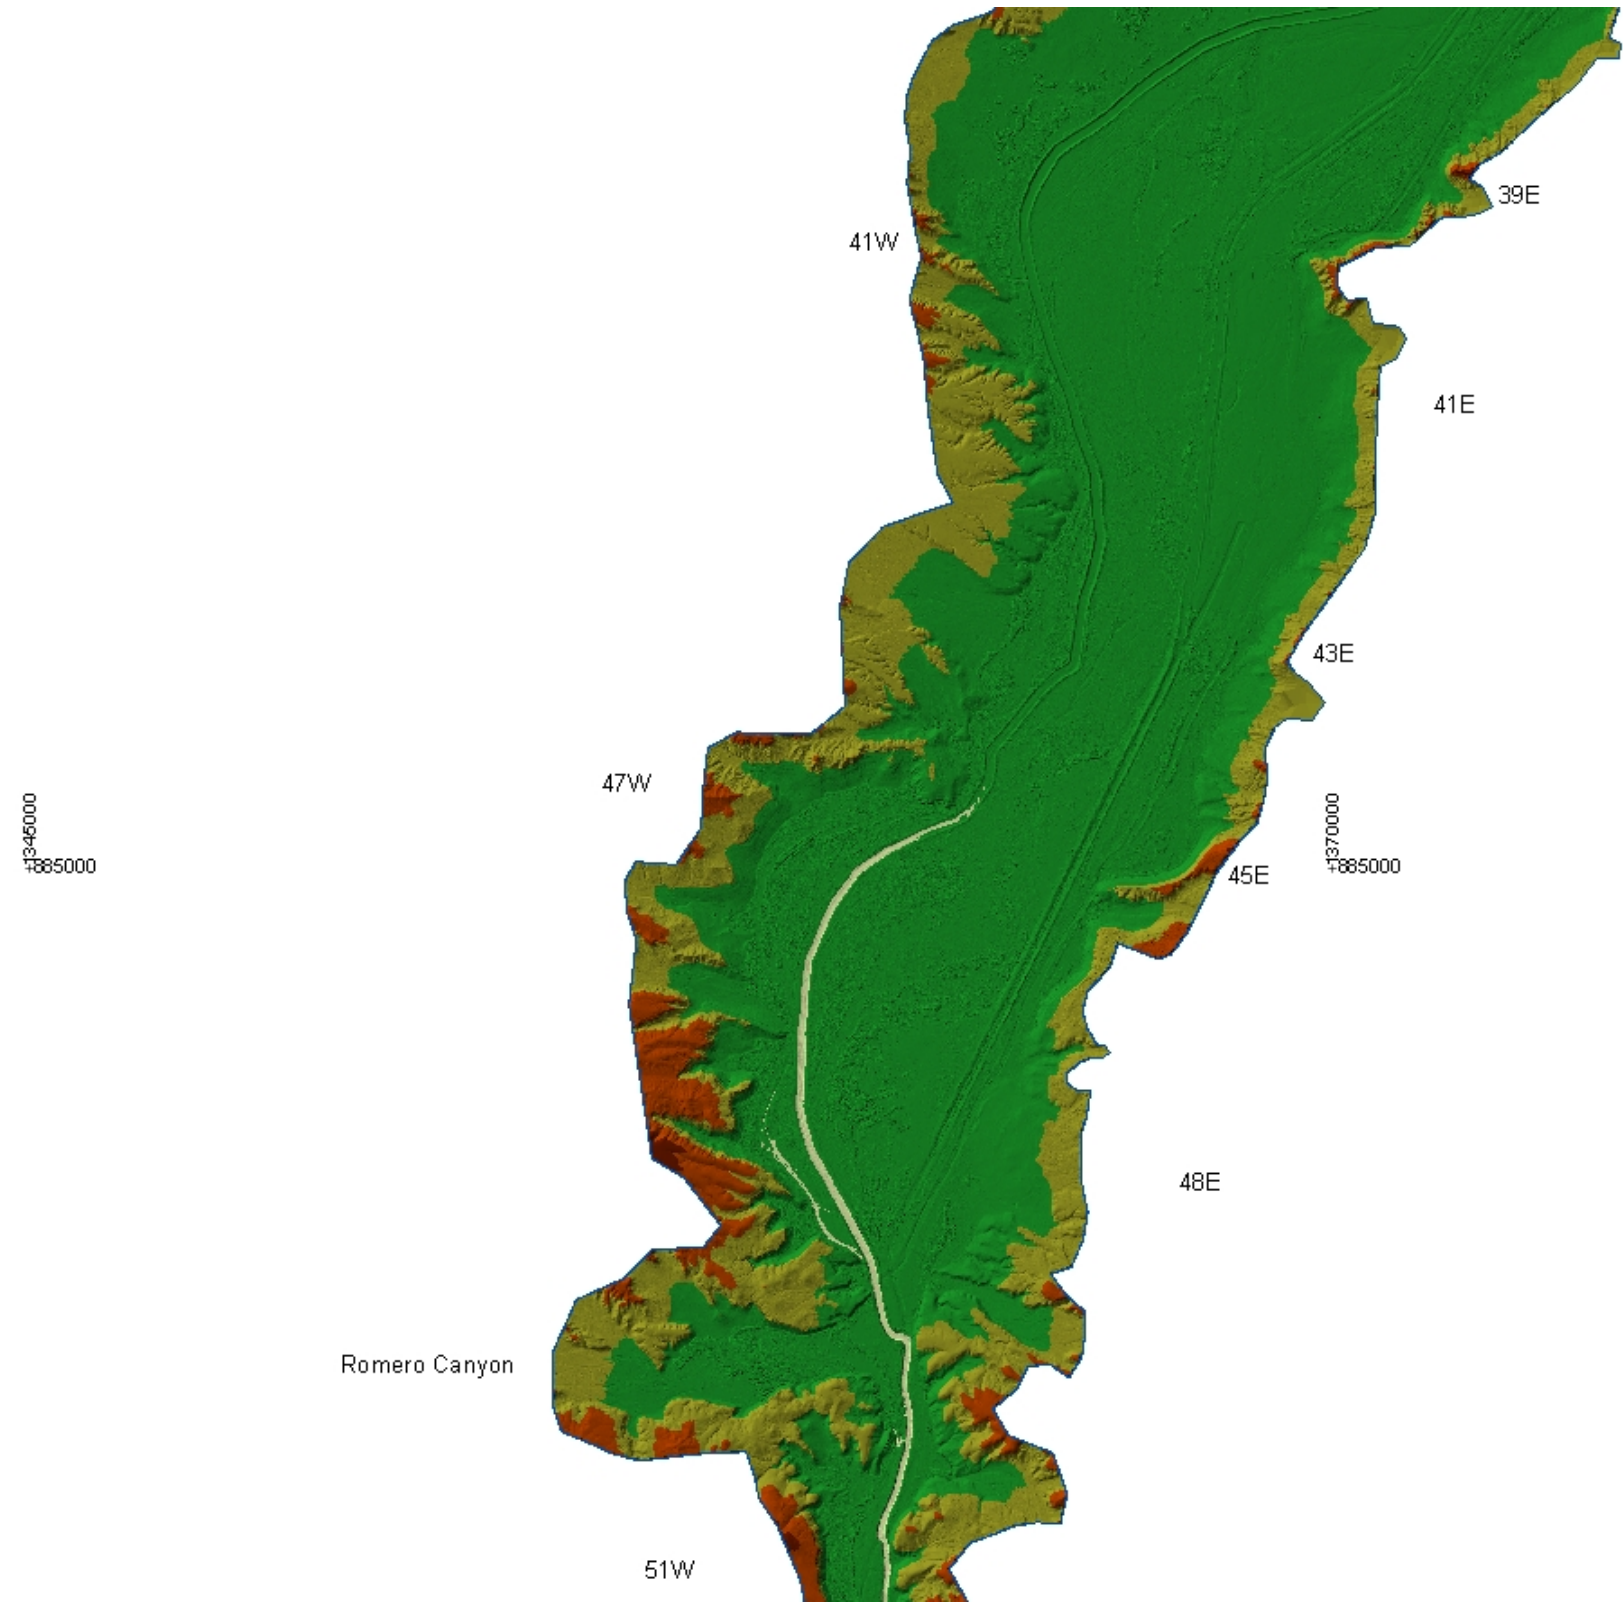
Figure 101 - Elephant Butte Reservoir TIN, 5 of 8.

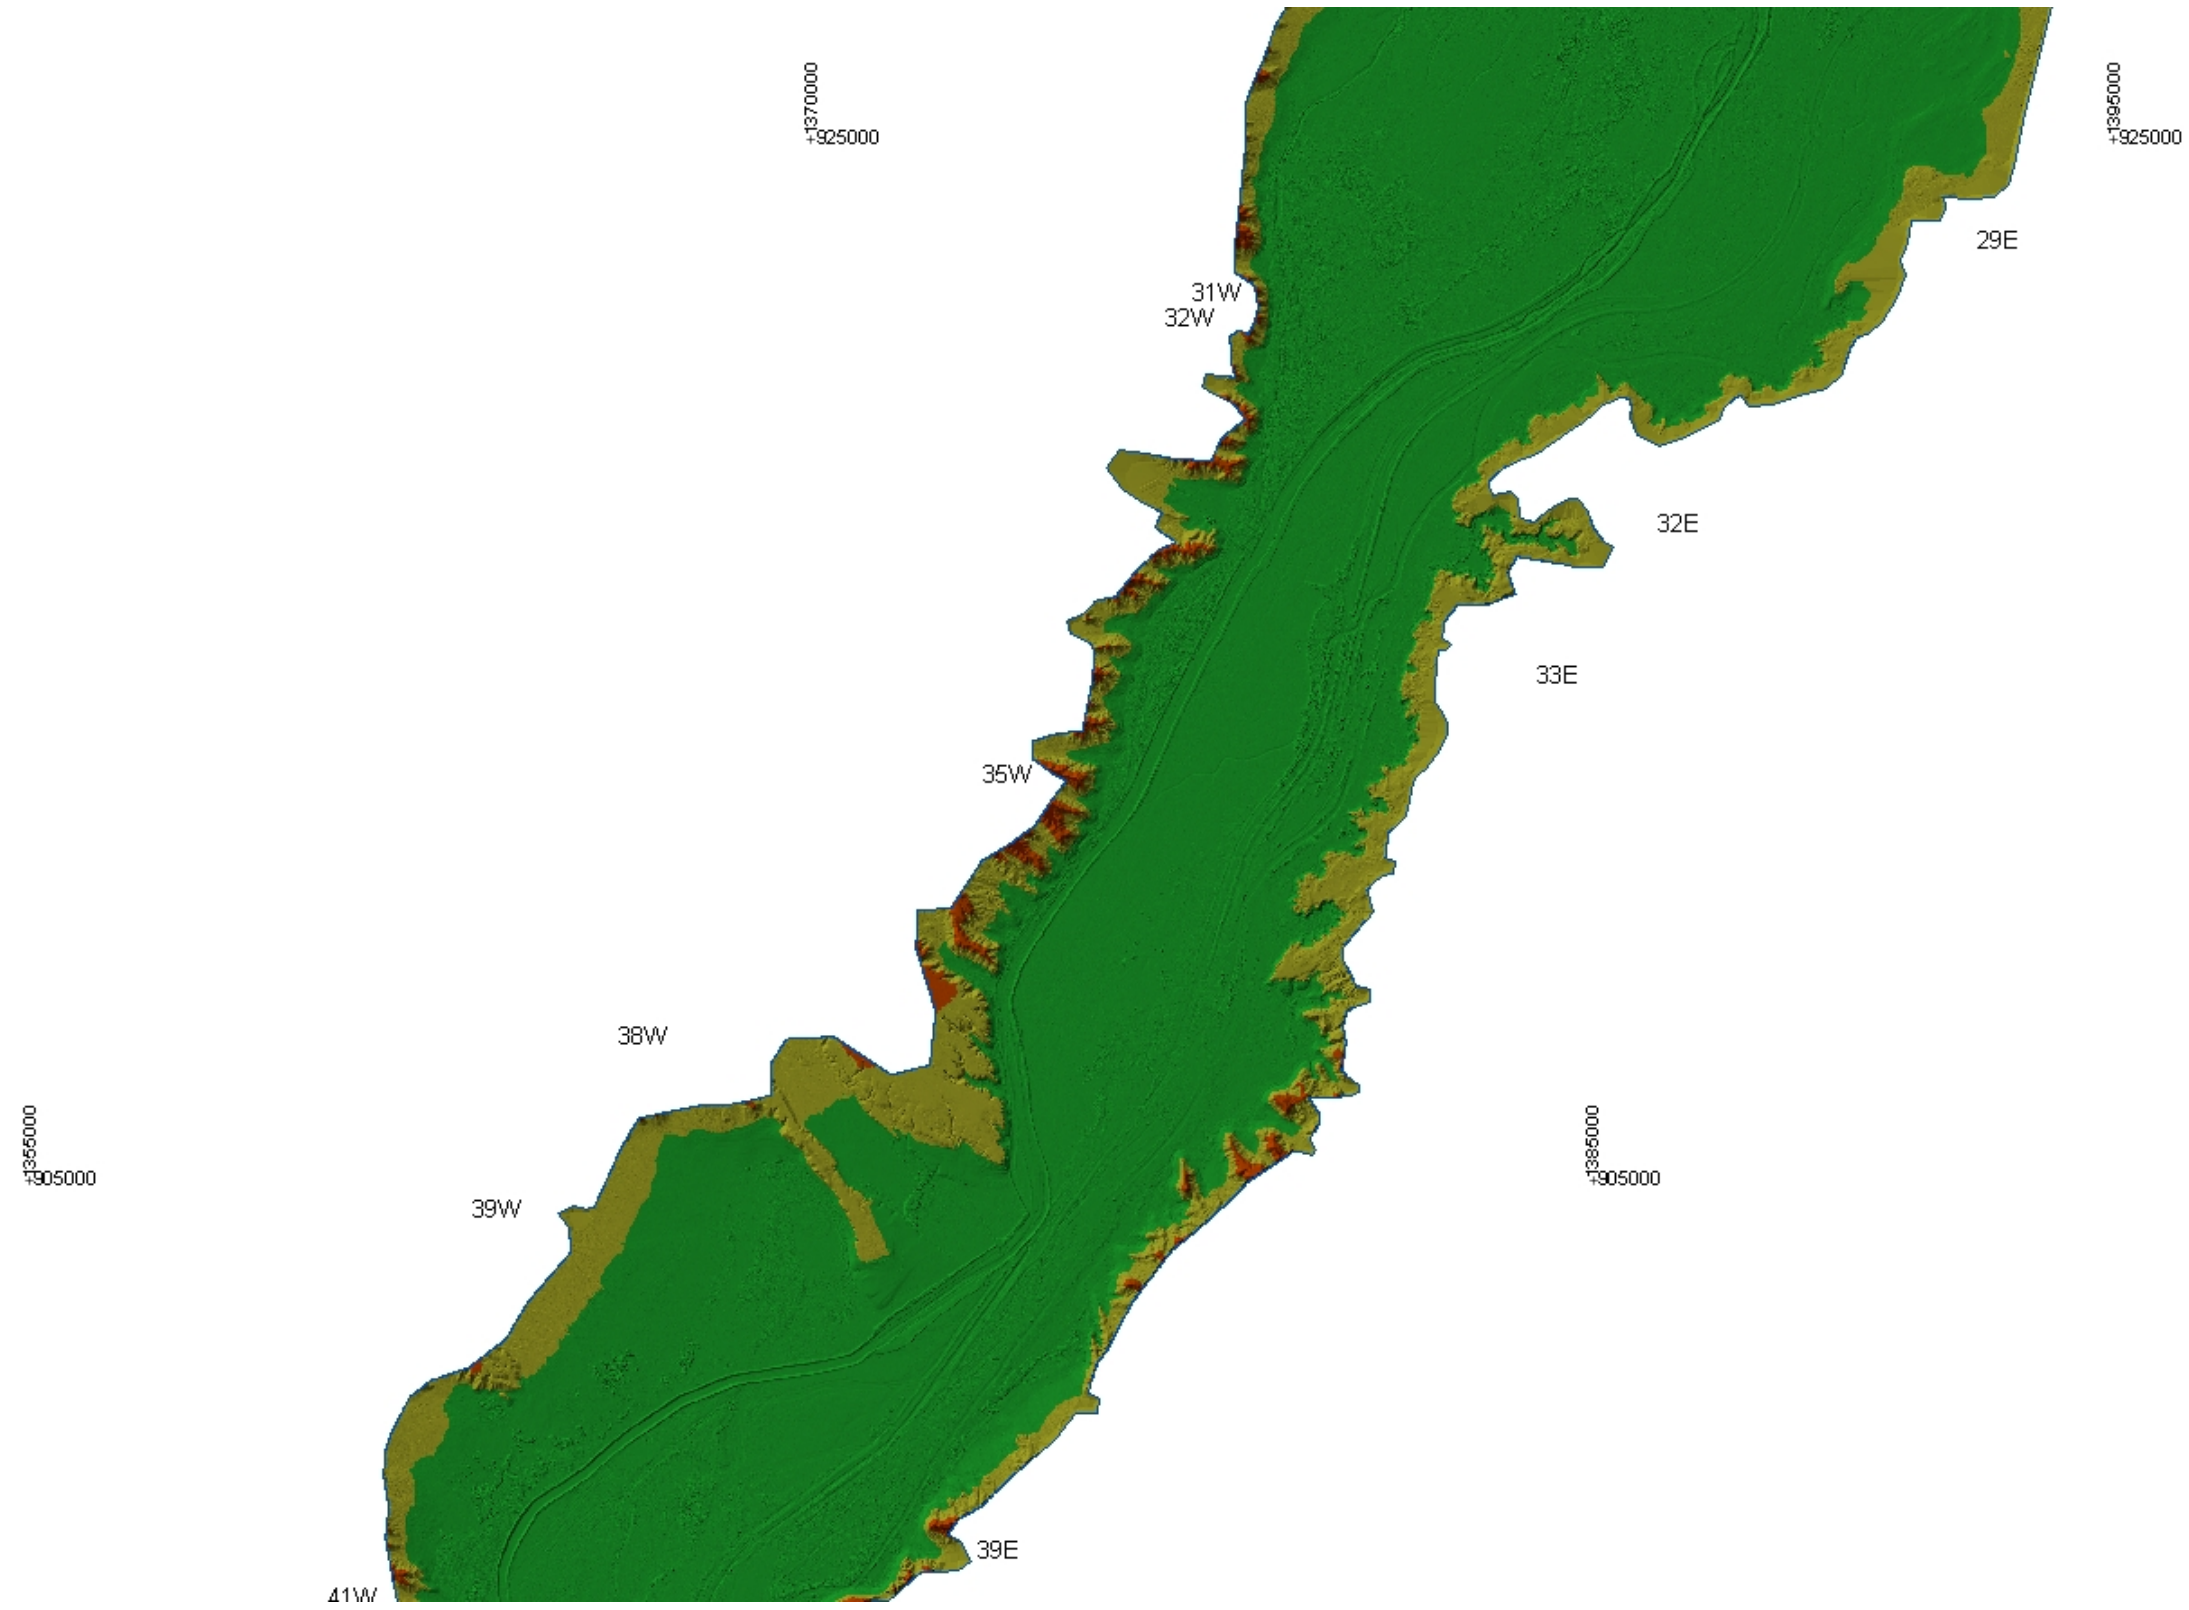
Figure 102 - Elephant Butte Reservoir TIN, 6 of 8.

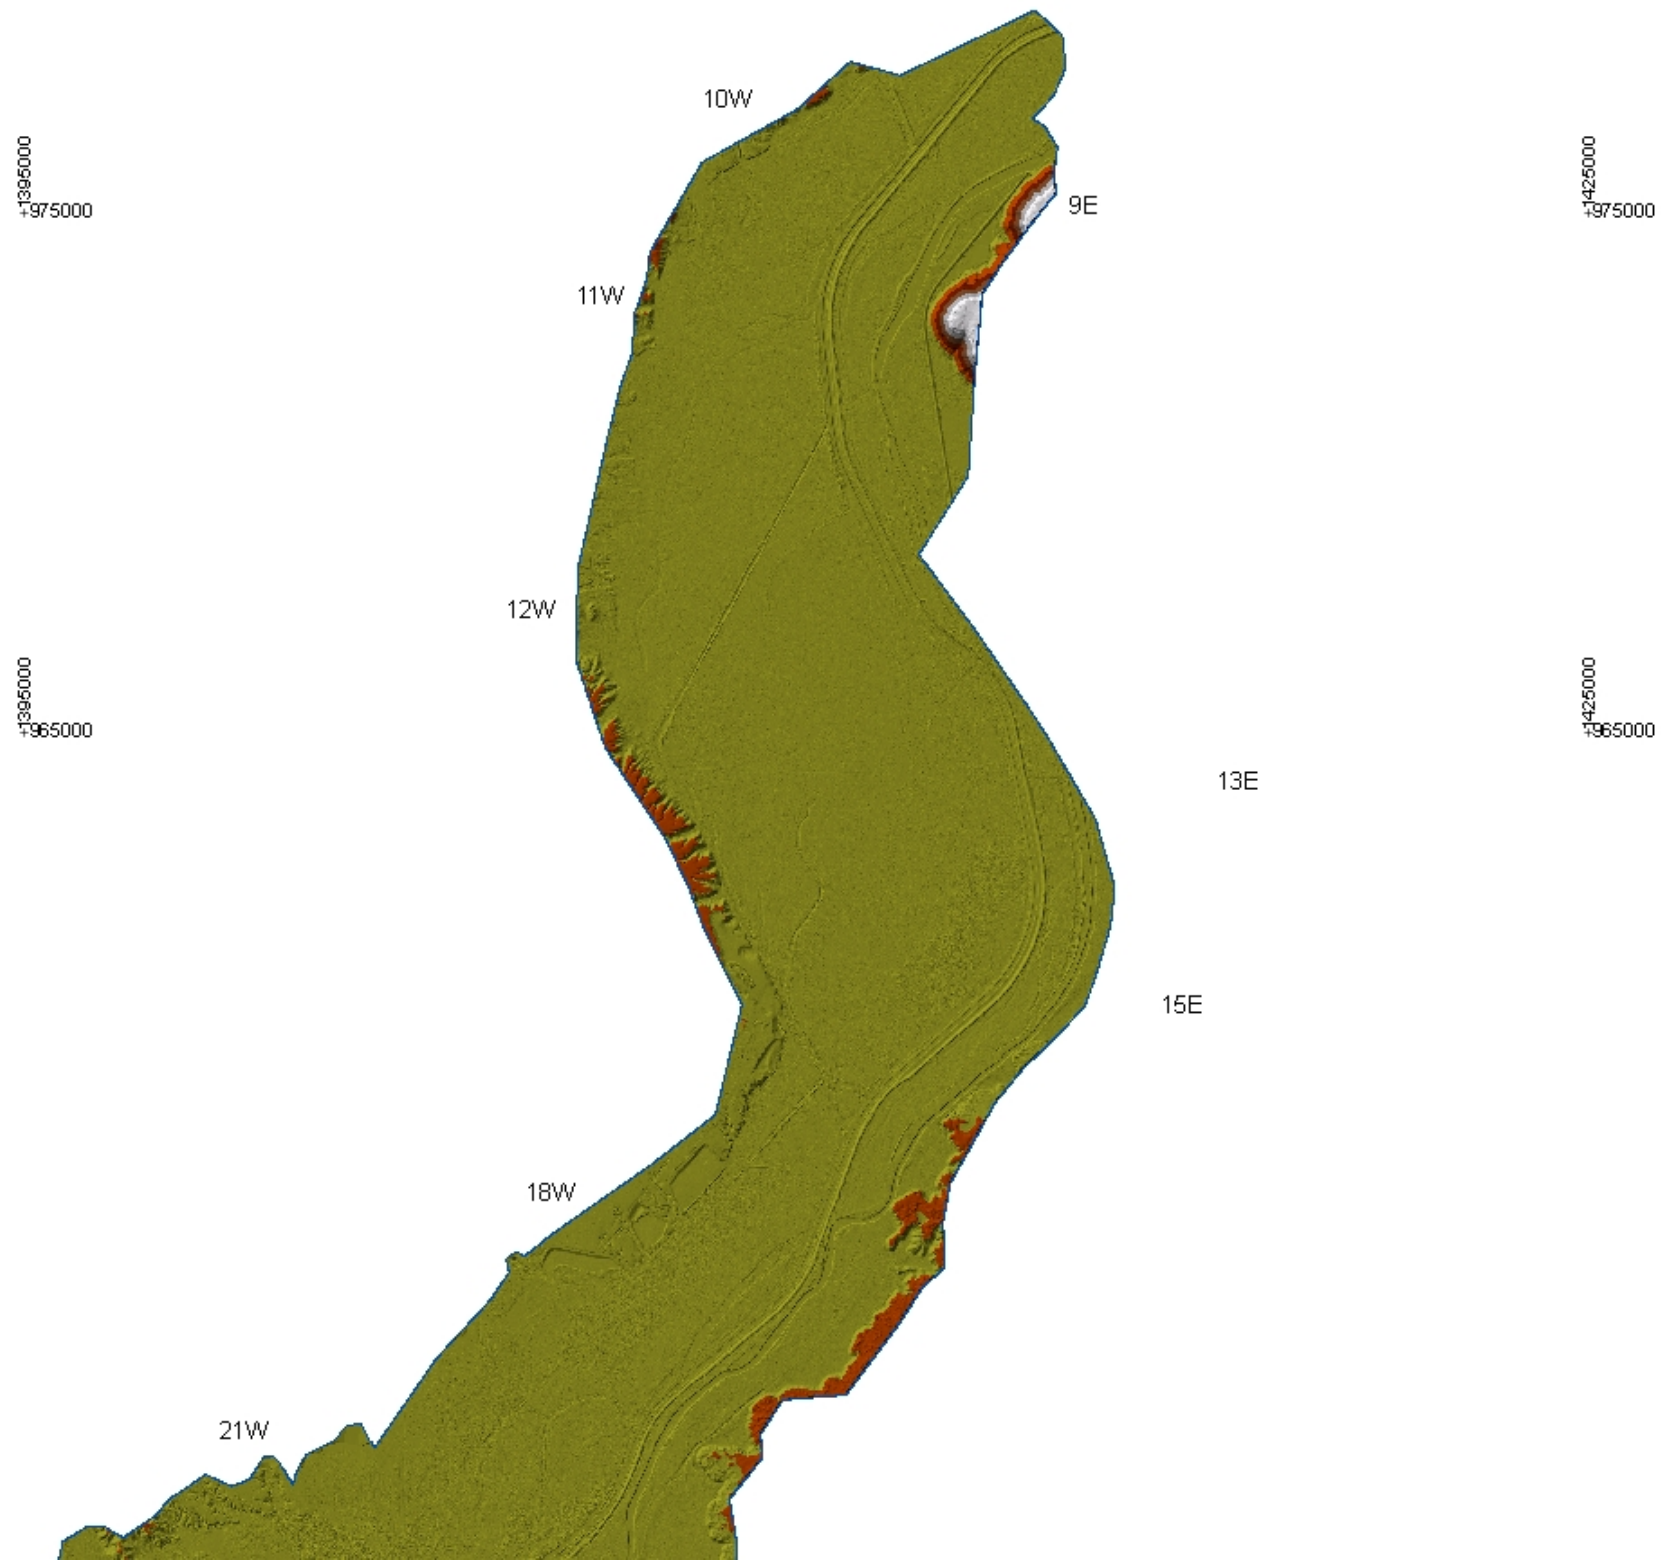
Figure 104 - Elephant Butte Reservoir TIN, 8 of 8.

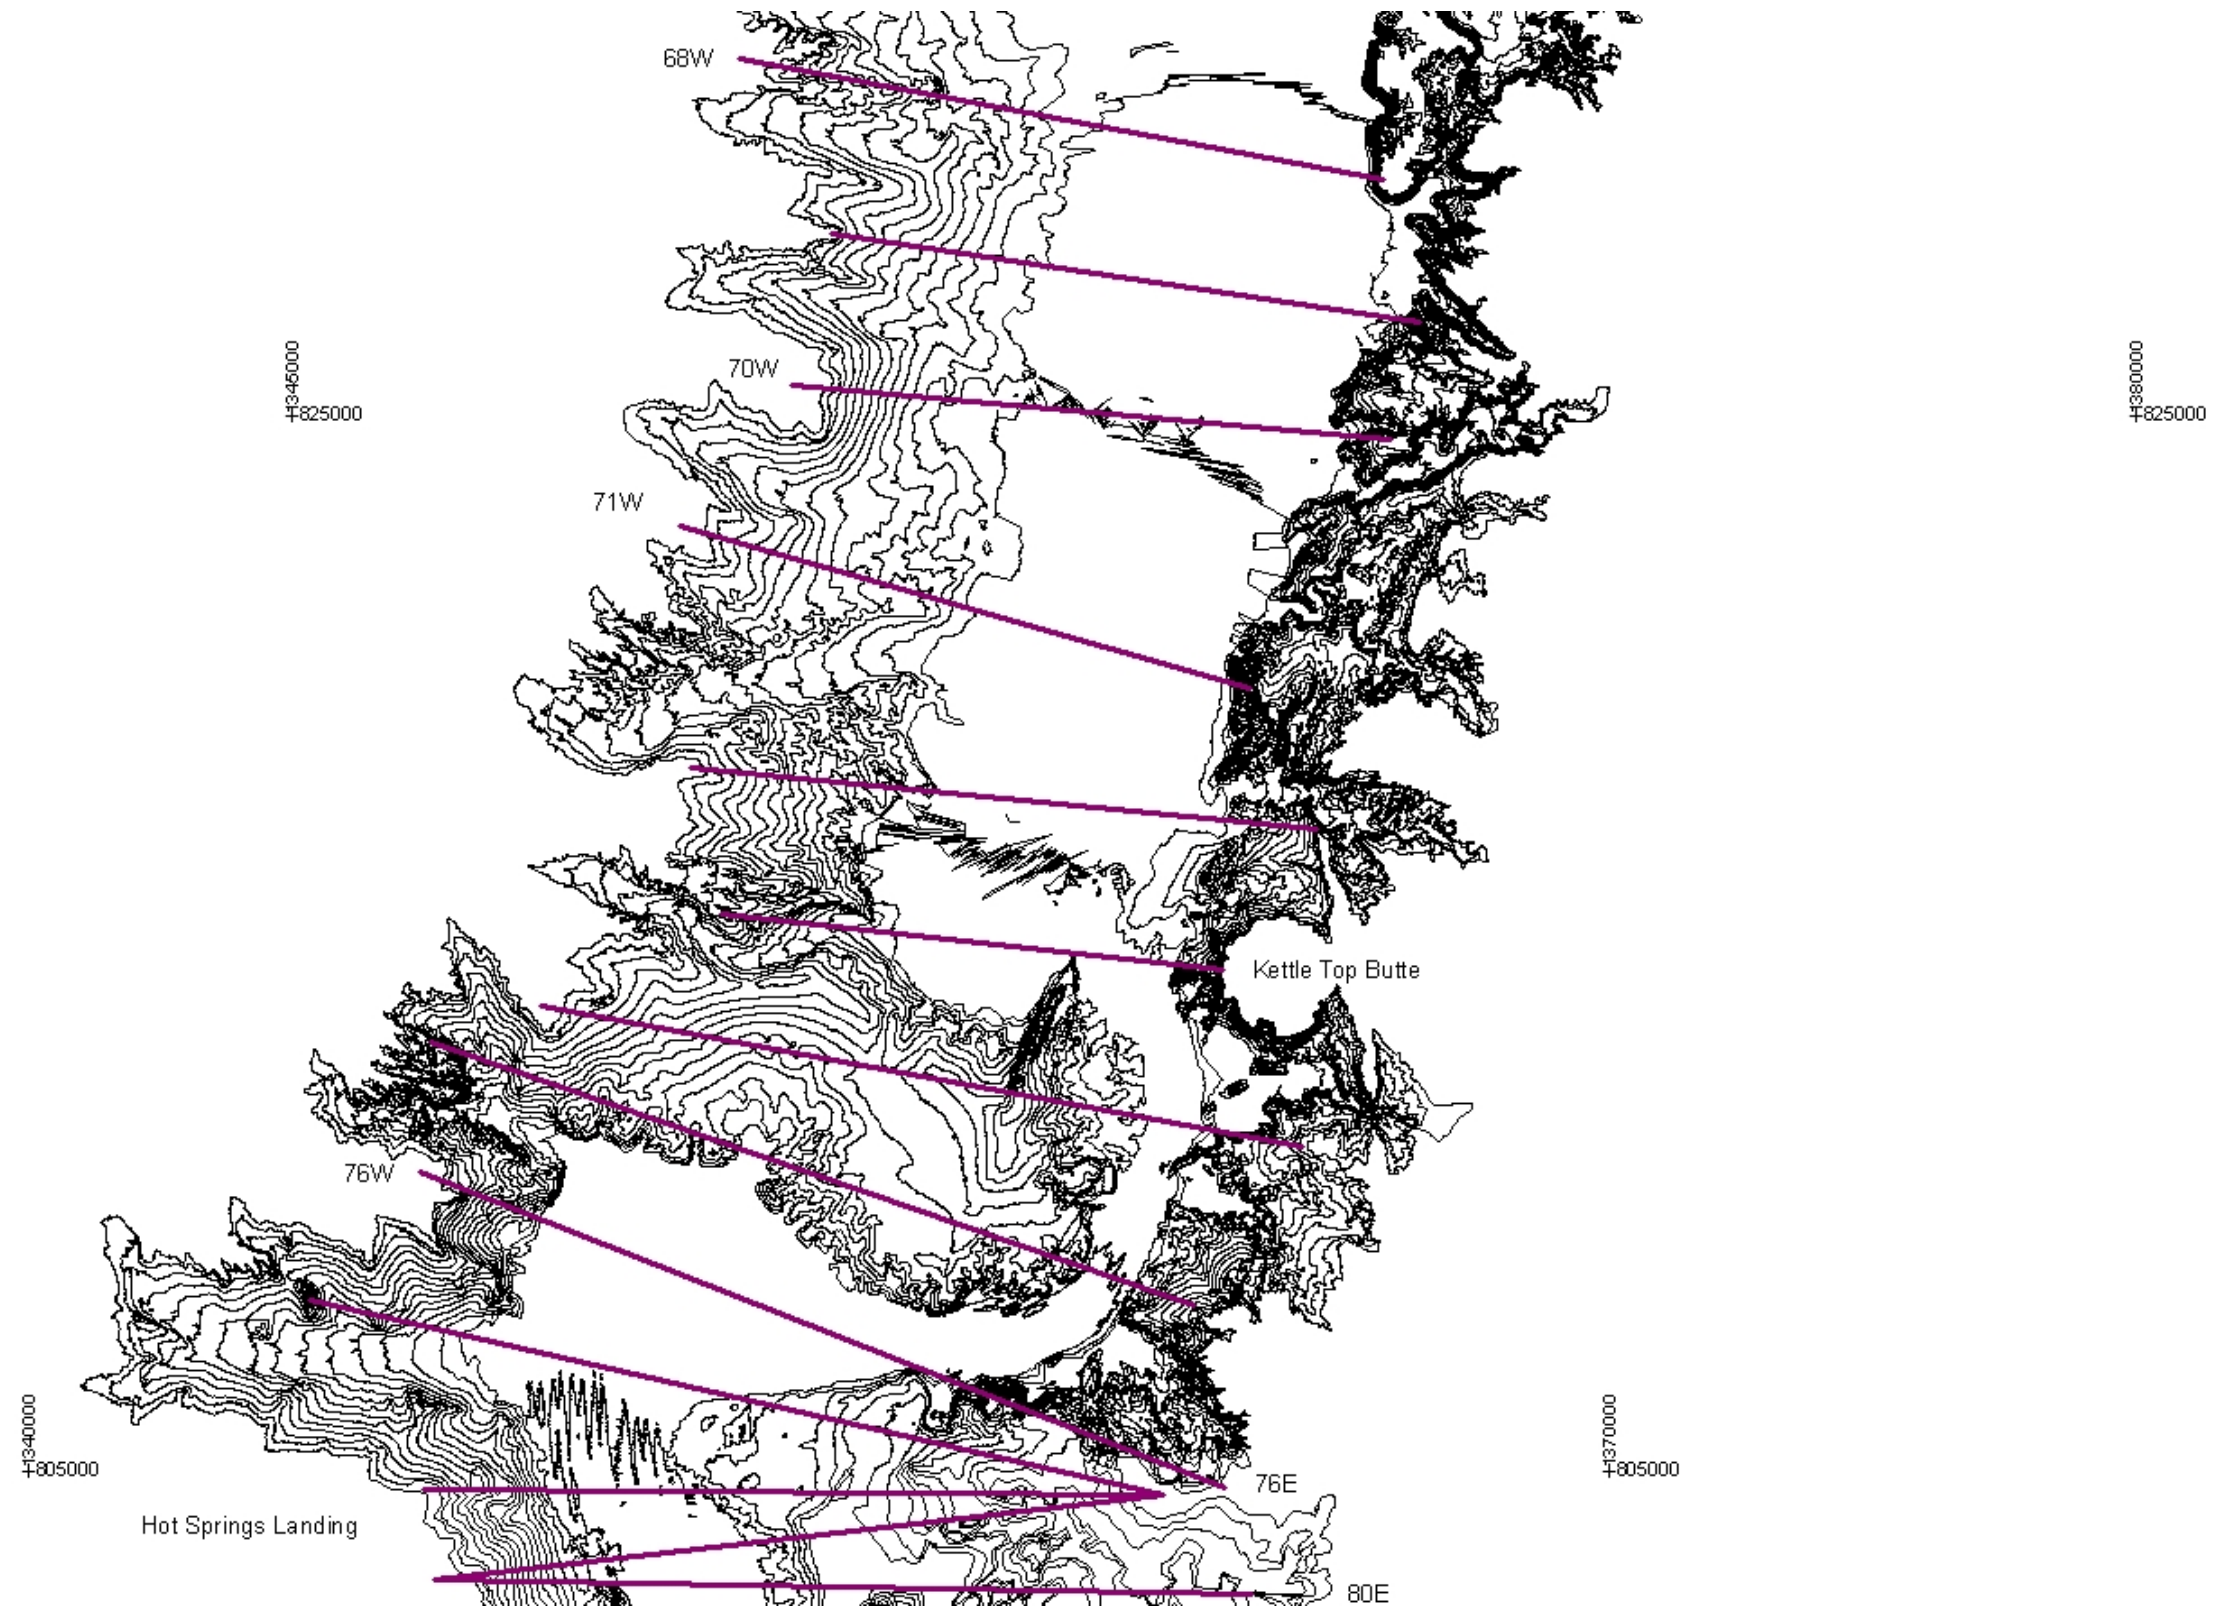
Figure 106 - Elephant Butte 2007 Reservoir Topography, 2 of 8.

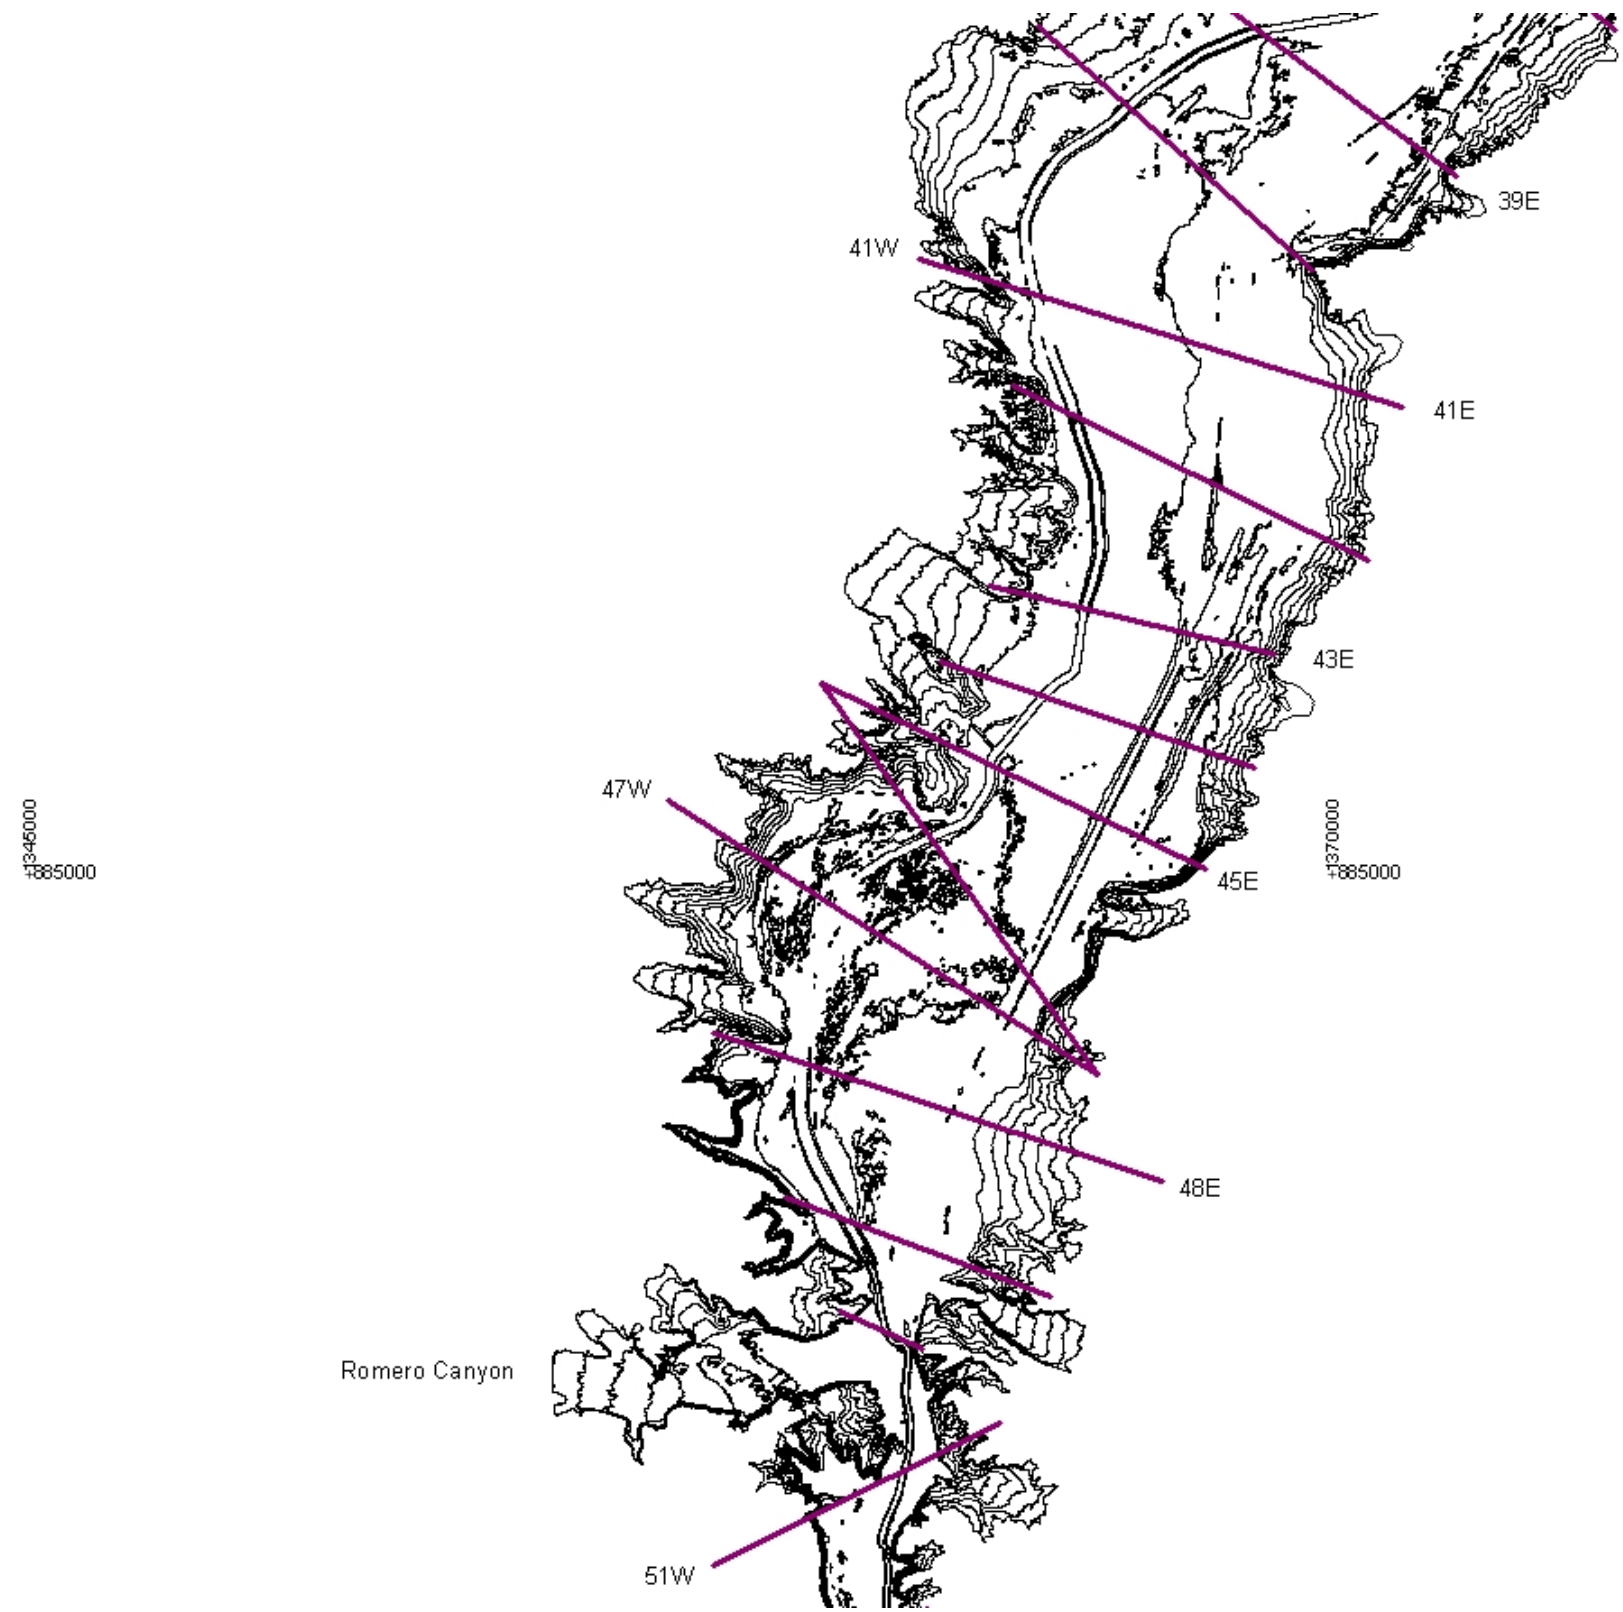
Figure 109 - Elephant Butte 2007 Reservoir Topography, 5 of 8.

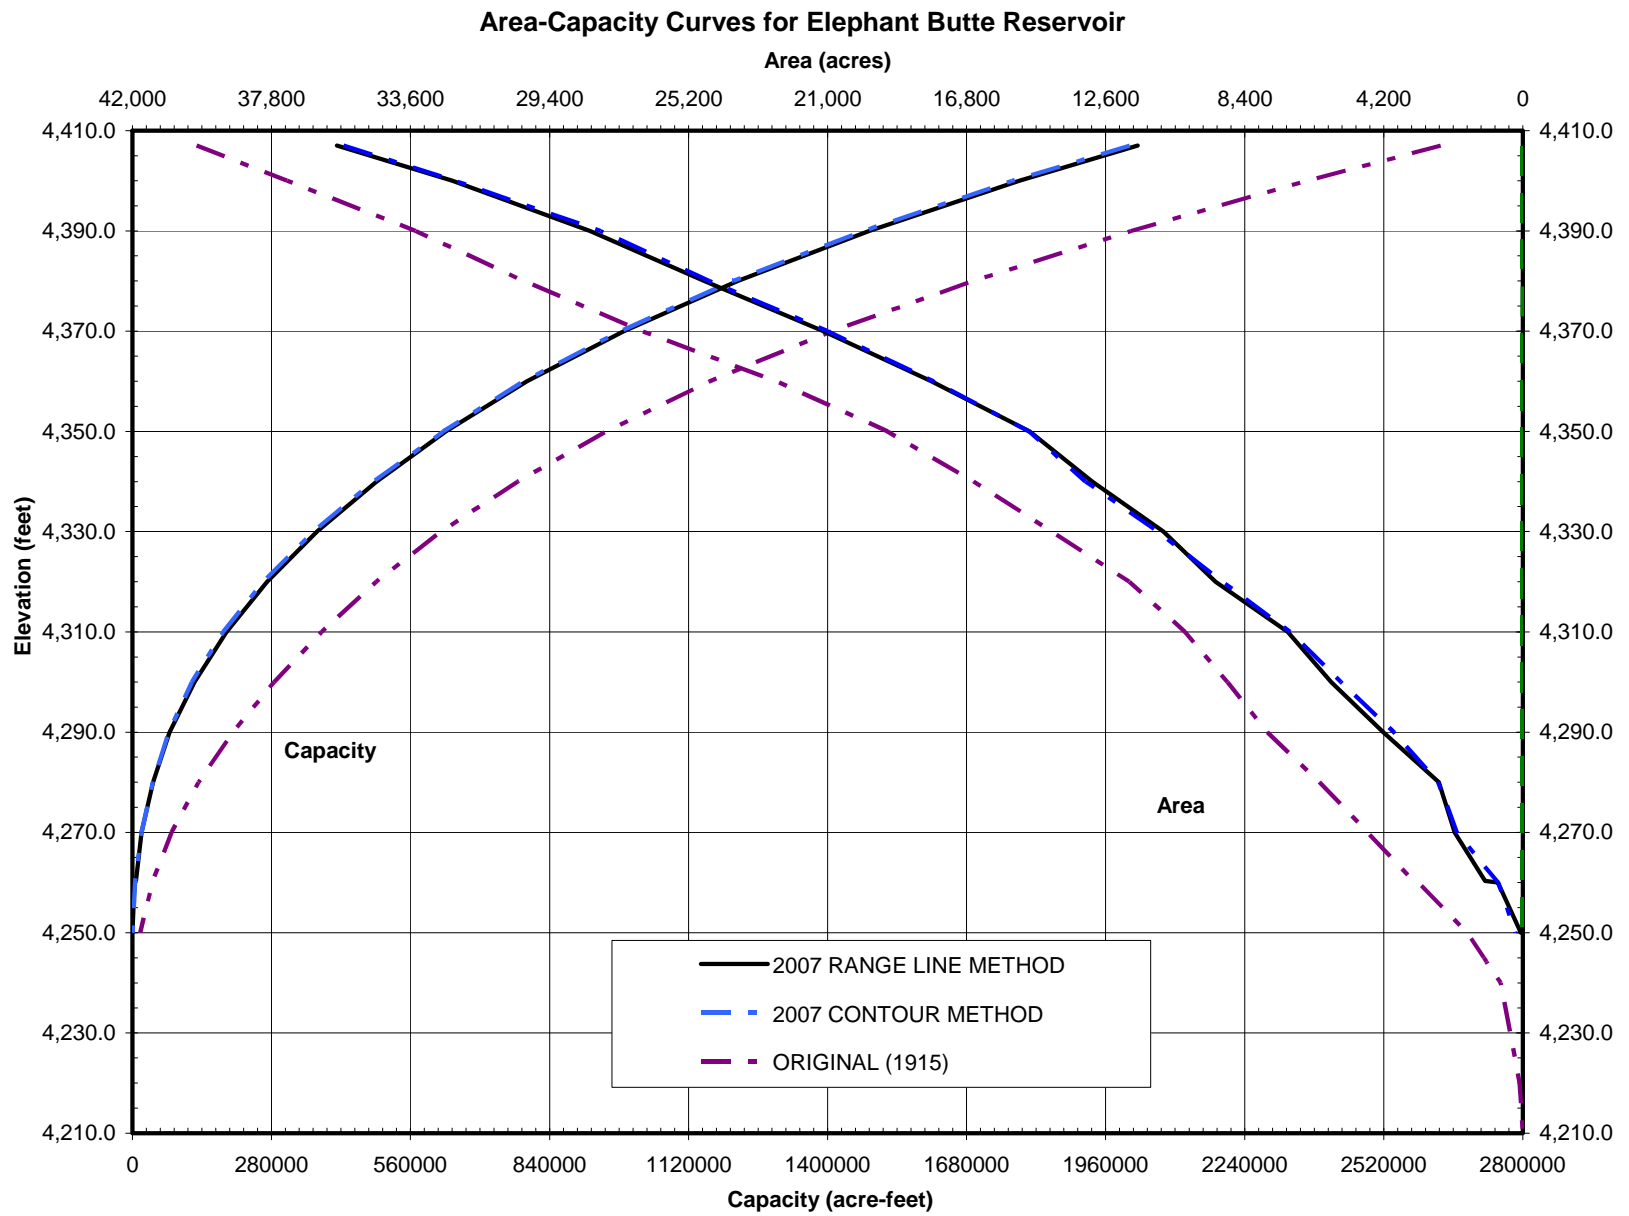
Figure 113 - Elephant Butte Reservoir Contour and Range Line Comparison Plots.

Table 3 and Figure 113 list and illustrate a comparison between the range line and contour methods. Comparison of the results of the two methods was favorable. The contour method computed a reservoir capacity of 2,008,244 acre-feet at elevation 4,407 compared to the range line method of 2,024,586 acre-feet. The difference is 16,342 acre-feet or less than 1 percent between the two analysis methods. The contour method was affected in the lower end of the reservoir where LiDAR coverage was not available, but overall the results are very good. It is recommended that future aerial surveys should cover the lower portion of the reservoir to the dam. Ideally the whole reservoir should be flown at one time, but budgets usually prevent such extensive coverage for larger reservoirs. Obtaining LiDAR type collection from the dam upstream to where the 2004 LiDAR coverage began will allow upper contours to be developed with more confidence.
