Technical Report No. SRH-2012-06

Franklin D. Roosevelt Lake – Grand Coulee Dam 2010-11 Survey

Grand Coulee Dam Washington

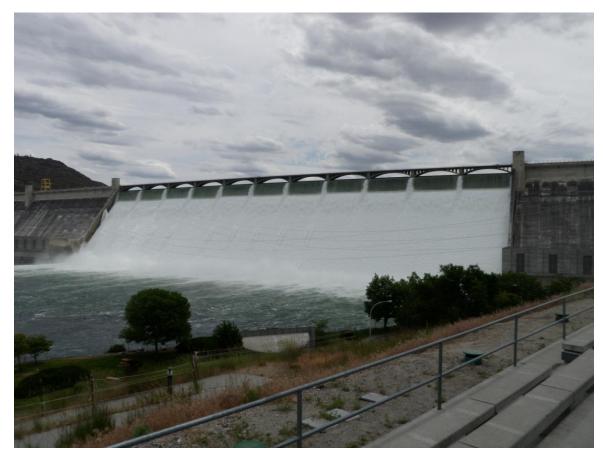
Figure 3 - Grand Coulee Dam spilling, July 2011.

The dam's spillway, located in the center of the original portion of the dam, is controlled by 11 drum gates each 135 feet long and 20 feet high. The spillway crest elevation is 1,260.0 with top elevation 1,288.0 with gates closed. Two-foot flashboards raised the reservoir normal operation to elevation 1,290.0. At crest elevation 1,290.0; the spillway provides a maximum discharge of 1,000,000 cubic feet per second (cfs).

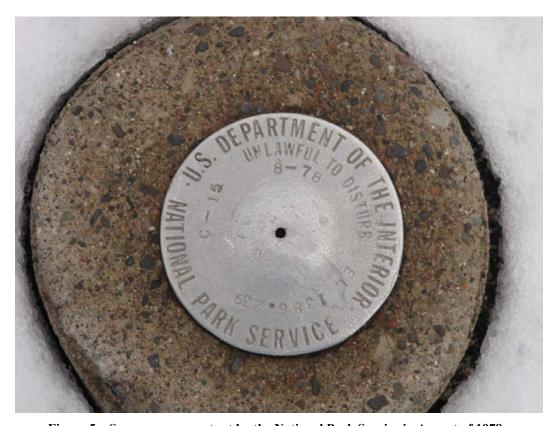
Figure 5 – Survey monument set by the National Park Service in August of 1978.

The NGS published data in the study area shows NAVD88 elevations are around 3.92 feet higher than NGVD29. The difference between the elevation stamped on the monument and the NAVD88 measured elevation matched the NGS reported shift, meaning the monument elevation is likely tied to NGVD29.

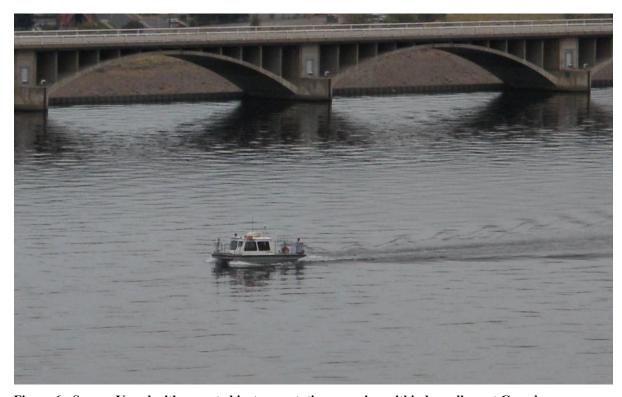
Figure 6 - Survey Vessel with mounted instrumentation mapping within buoy lines at Grand Coulee Dam - Lake Roosevelt, Washington.
