Technical Report No. SRH-2013-19

Nambe Falls Reservoir 2013 Bathymetric Survey

**Nambe Falls Dam
New Mexico**

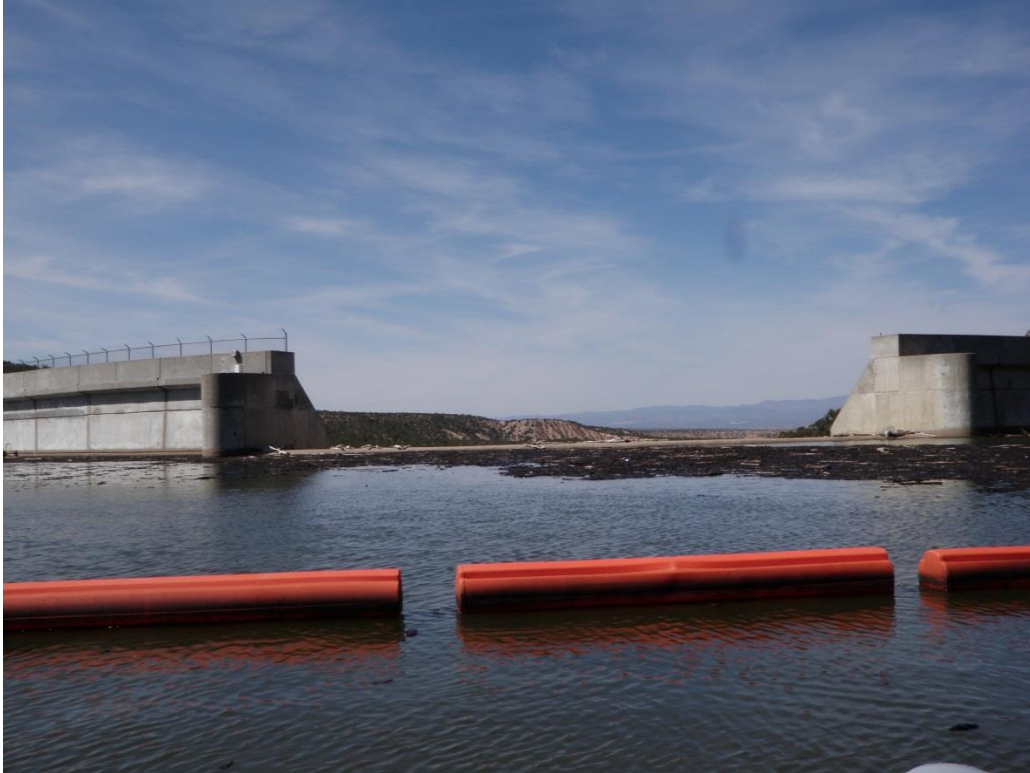
Figure 2 - Nambe Falls spillway, located in the concrete section of Nambe Falls Dam, with spillway crest elevation 6826.6 (NGVD29), March 2013.

The spillway is an uncontrolled overflow section in the center of the concrete arch dam with crest elevation 6826.6 and provides a discharge of 22,500 cubic feet per second (cfs) at maximum reservoir elevation 6839.8, Figure 2. The outlet works are located through the concrete arch dam and consist of two 18-inch-diameter and one 6-inch-diameter conduits. The inlet elevation of the outlets is 6761.5 with a discharge capacity of 107 cfs at reservoir elevation 6826.6. The reservoir is about 3,700 feet in length with an average width of around 690 feet.

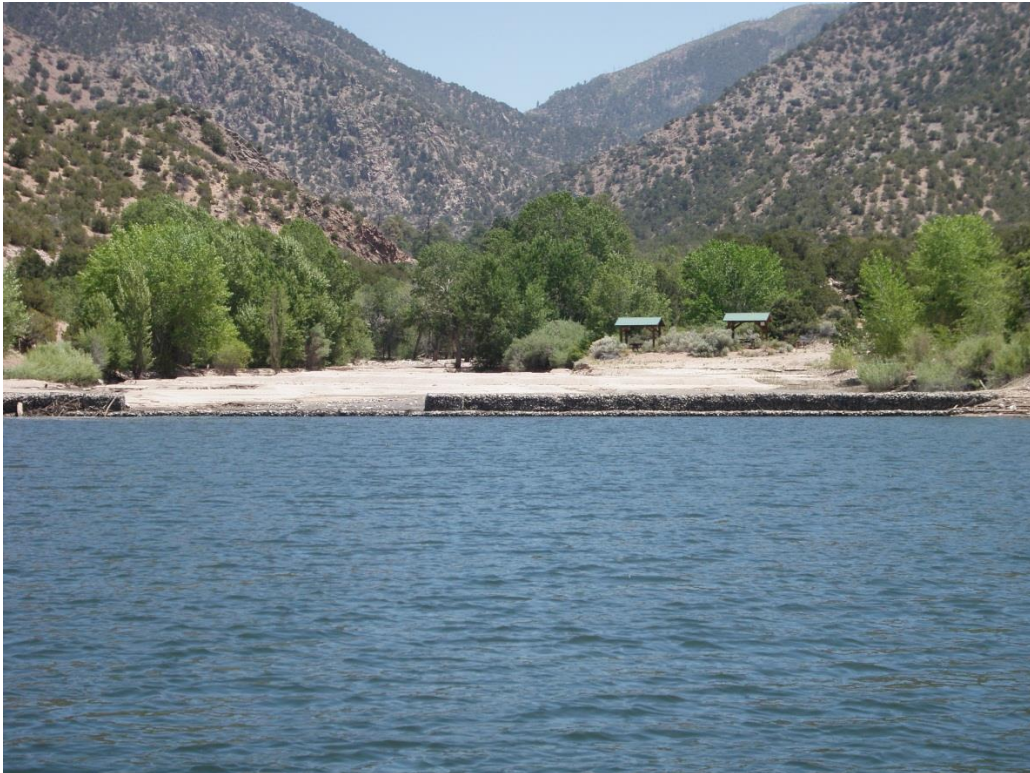
Figure 3 - Nambe Falls Reservoir retaining wall located in upper reservoir, June 2013.

Since the 2004 survey, a retaining wall was constructed in the upper reservoir area in an attempt to trap the sediment inflows, but failed under the stress of the inflows, Figure 3. On February 19, 2009, a U.S. Army Corps of Engineers dive team conducted underwater work at the dam’s outlet trash-rack that included a hydrographic survey in the immediate area around the intake. From the developed topographic map it appears the bottom was near elevation 6748 compared to the 6742 elevation measured in 2004.

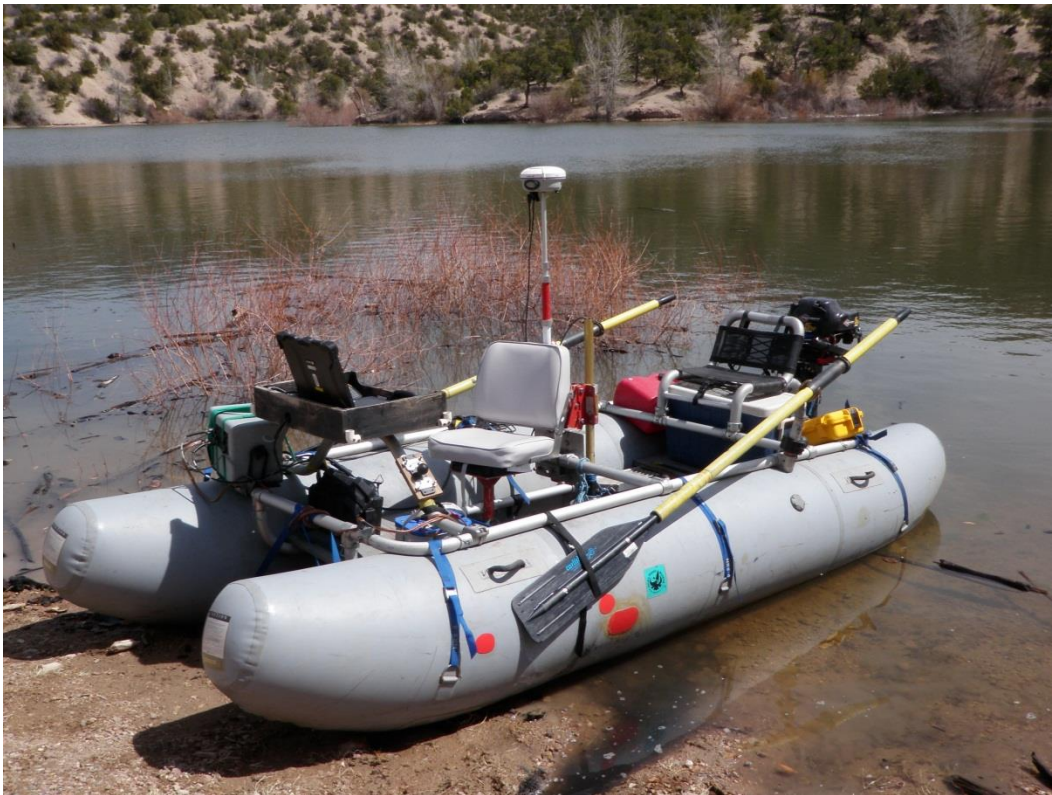
Figure 6 - Survey vessel used for the March 2013 Nambe Falls Survey.

The March 2013 bathymetric survey equipment was mounted on a pontoon raft with the transducer and RTK GPS unit located in the center of the vessel, Figure 6. The hydrographic system included a GPS receiver with a built-in radio, a depth sounder, a helmsman display for navigation, a computer, and hydrographic system software for collecting the underwater data. The depth sounder was paperless, 208 kHz, and provided a continuous trace of the bottom. The shore equipment included a second RTK GPS receiver with an external radio. The shore GPS receiver and antenna were mounted on survey tripods over a known datum point and powered by a 12-volt battery. The June confirmation survey used a larger boat that allowed for mounting a more robust multifrequency sounder and transducers that ranged from 12 to 208 kHz. This more stable vessel also allowed the survey crew to probe the bottom of the reservoir to confirm previous depth soundings.

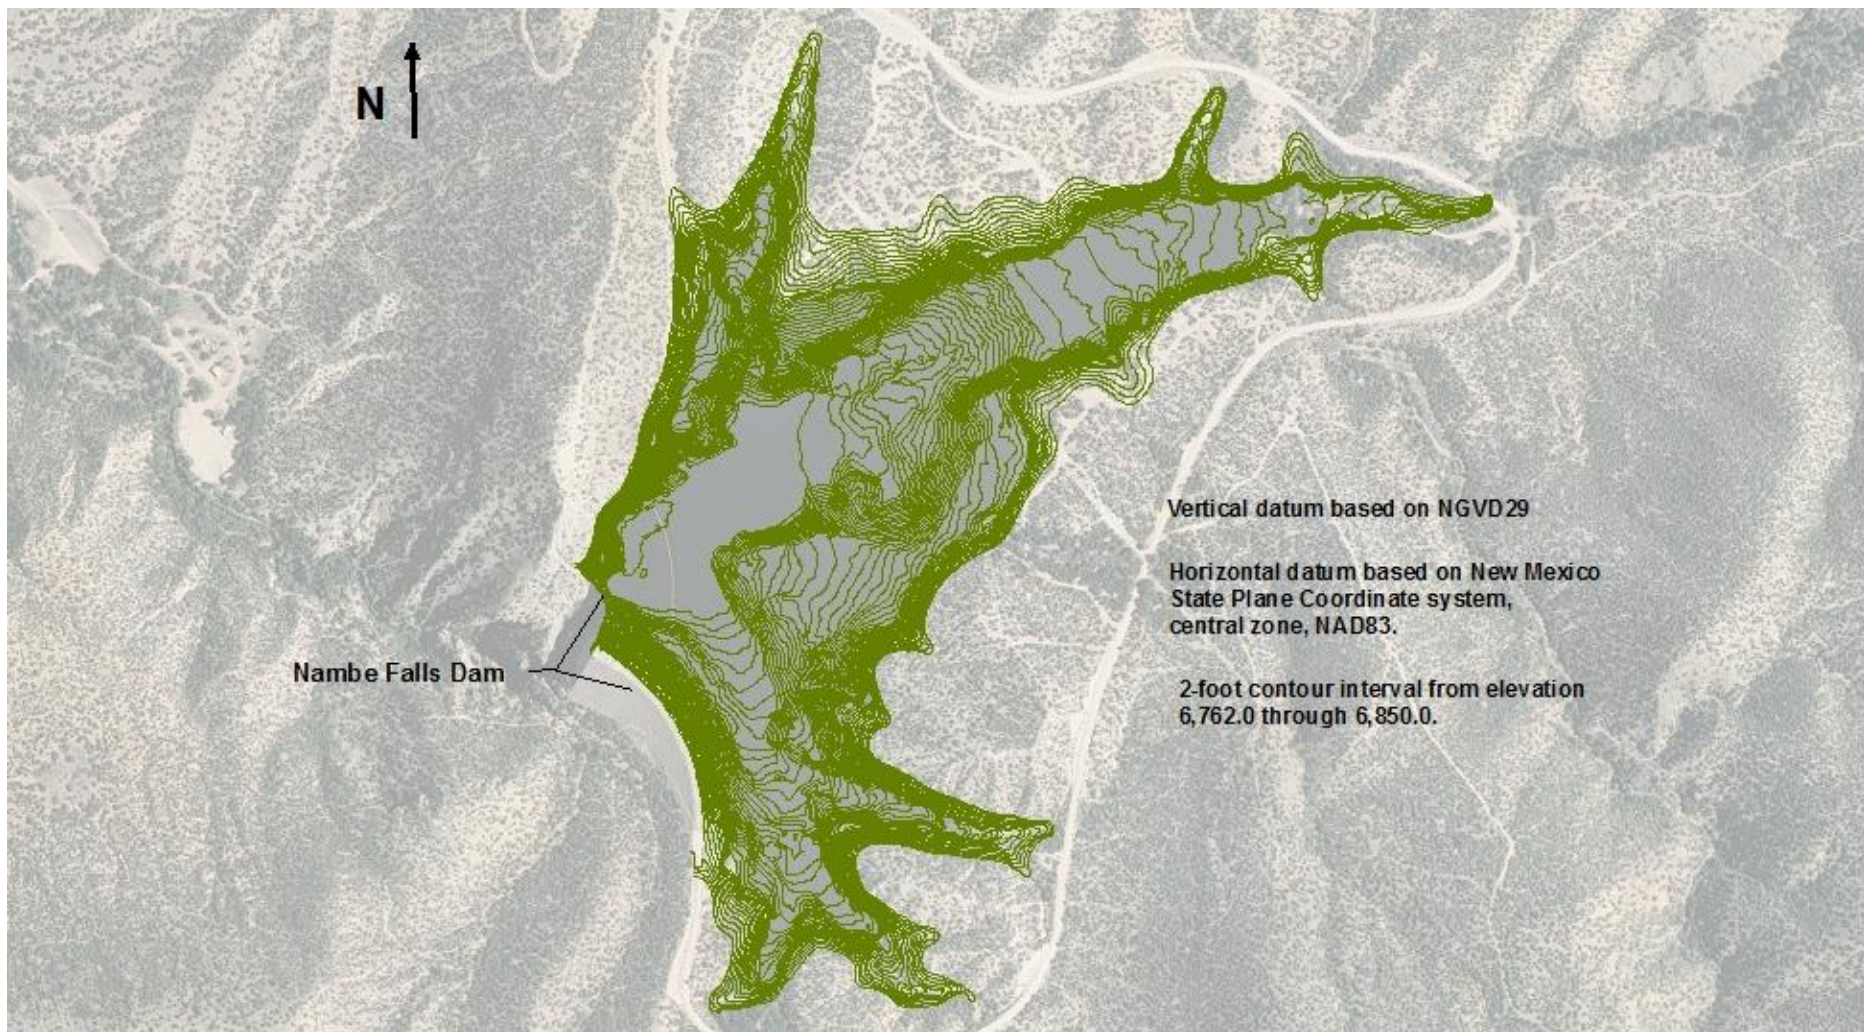
Figure 8 - Nambe Falls Reservoir 2013 contours, NGVD29 (map 1 of 4).

Figure 9 - Nambe Falls Reservoir 2013 contours, NGVD29 (map 2 of 4).

Figure 10 - Nambe Falls Reservoir 2013 contours, NGVD29 (map 3 of 4).

Figure 11 - Nambe Falls Reservoir 2013 contours, NGVD29 (map 4 of 4).

The linear interpolation and CONTOUR commands were used to interpolate contours from the Nambe Falls Reservoir TIN. The surface areas of the enclosed contour polygons at 1-foot increments were computed for elevation 6761.0 and above. The reservoir contour topography at 2-foot intervals is presented in Figures 8 through 11 from elevation 6762.0 and above.

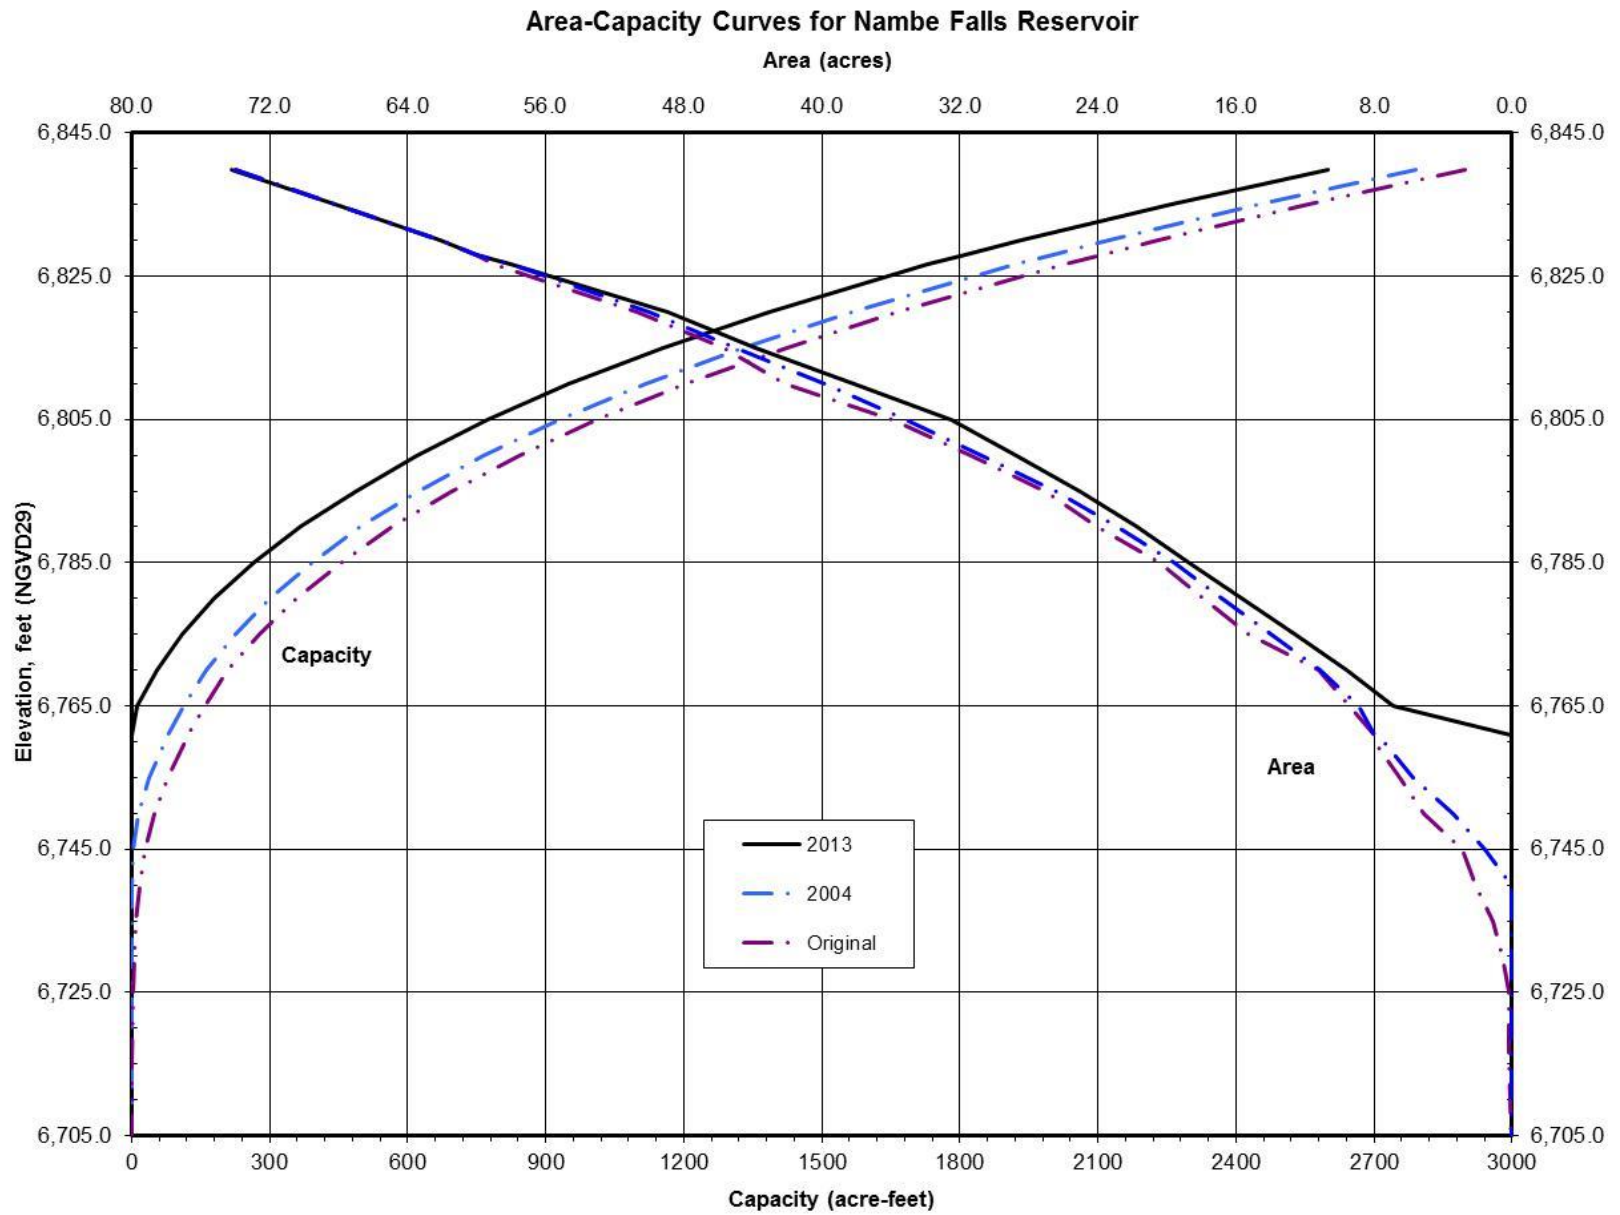
Figure 12 - Nambe Falls Reservoir area and capacity plots.

Figure 12 is a plot comparison of the surface areas and capacities of the reservoir's original, 2004, and 2013 survey results. For calculating the 2004 and 2013 sediment accumulation, the original capacities were recomputed using *ACAP85* that was also used to compute the 2004 and 2013 capacities. Since dam closure in 1976, the measured total volume change at reservoir elevation 6826.6 was 106 acre-feet in 2004 and 297 acre-feet in 2013. The 2013 estimated average annual rate of capacity lost for the 37-year operation period was 8.0 acre-feet per year. The 2013 storage loss in terms of percent of original storage capacity was 14.6 percent at elevation 6826.6.

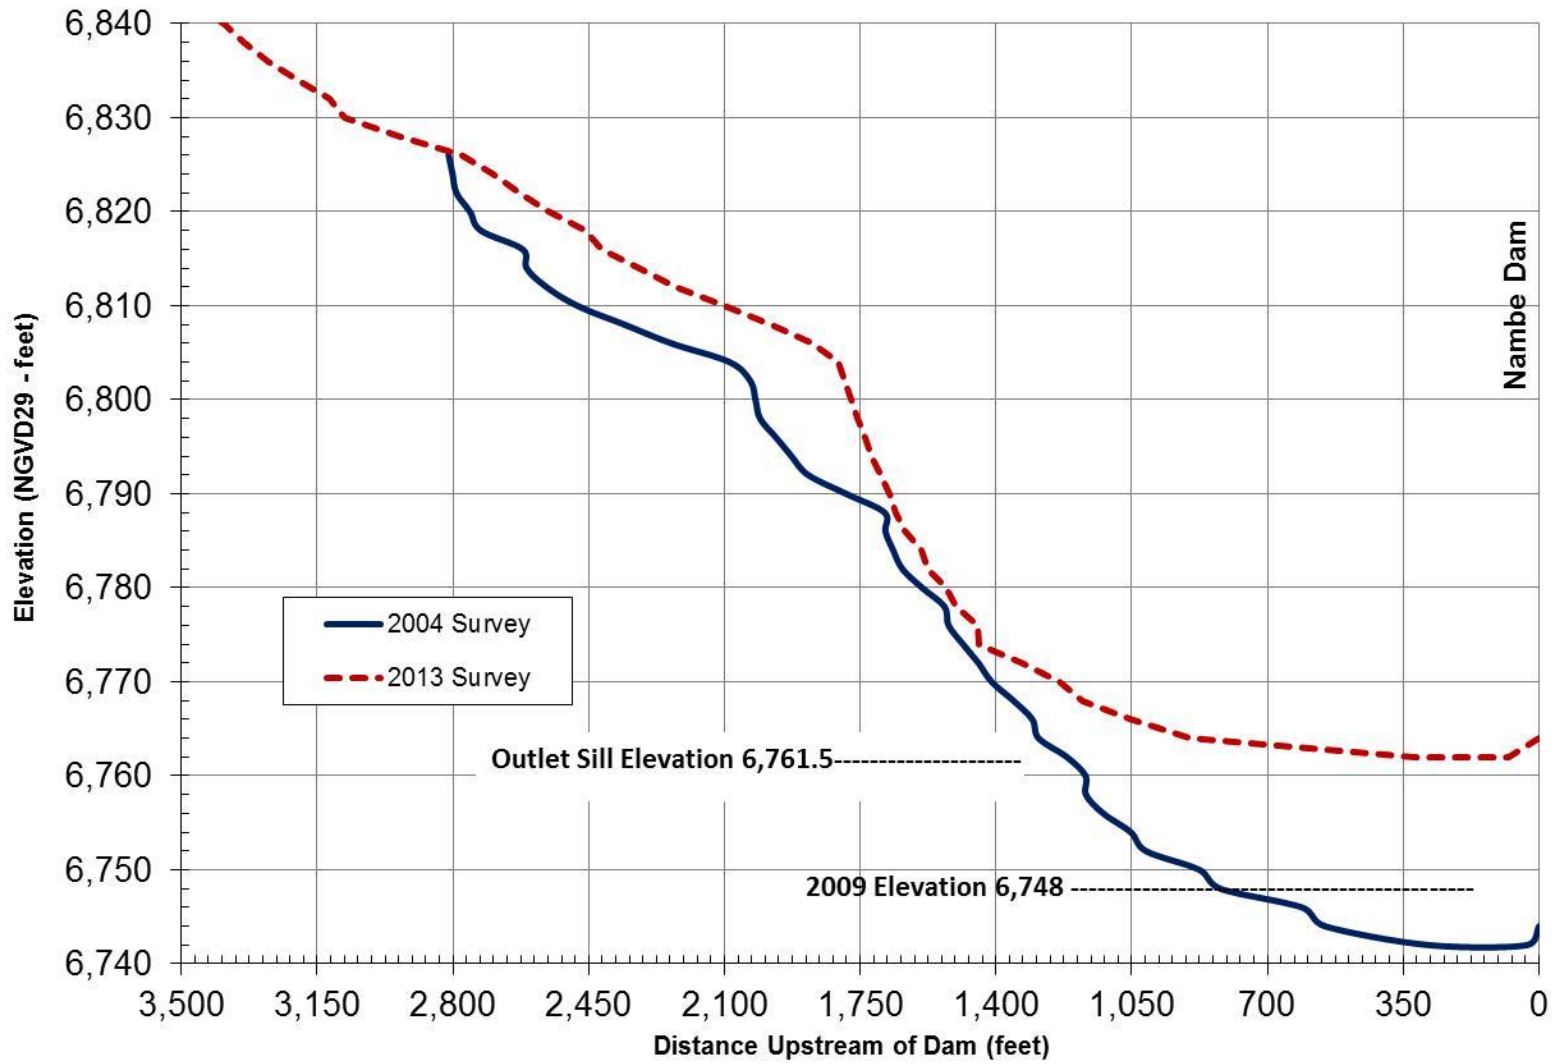
Nambe Reservoir Longitudinal Profiles 2004 and 2013 Comparison

Figure 13 - Longitudinal profile of the Rio Nambe from the dam upstream.

To illustrate the present reservoir bottom and change over time, the reservoir thalweg profile was plotted from the dam to the upper reservoir area for the 2004 and 2013 conditions, Figure 13. The original profile was not available, but it appears that starting at the dam the original thalweg was below elevation 6700. The original capacity at elevation 6710.0 was only 0.1 acres, meaning it didn't take much to fill in this area with sediment. For the 2004 and 2013 longitudinal profiles the thalweg was cut through the developed 2-foot topographic contours from each study with the 2004 contours being used to develop the thalweg alignment starting from the dam and continuing upstream of the Rio Nambe. The 2004 plot ended at elevation 6826.0 using available data while the 2013 plot extended to elevation 6842.0 using the collected RTK GPS topography data.

The 2013 thalweg started near elevation 6764.0 at the dam and dropped to elevation 6762.0 through the developed contours. The 2013 minimum bottom data elevation was around elevation 6761.6 compared to the outlet sill elevation of 6761.5 and the reservoir's dead pool elevation of 6761.9. The collected March 2013 data, spot checked in June 2013, confirmed that the original dead pool area is currently silted in.

The 2013 thalweg shows the majority of the sediment deposition occurring near the dam since 2004 and then slopes upstream to the top of a typically developed sediment delta near elevation 6774. The 2013 top of the pivot point of the delta is

near elevation 6804, which is near the average annual minimum reservoir elevation for the available years of reservoir operations (Table 1). The 2004 plot doesn't show a typical sediment delta formation that was surveyed near reservoir elevation 6803. It must be noted that prior to the 2004 survey the reservoir was much lower in elevation for an extended period due to limited runoff, and land excavation was conducted to move the delta. Some of this material was removed from the reservoir area, but the 2004 survey observed where some of the sediment and other material were placed into large slash piles within the normal reservoir pool. Soon after the 2004 survey the reservoir did fill and spill and it's assumed these slash piles were never removed.

The 2013 plot illustrates the present condition of the reservoir and how the sediment deposition and inflows are impacting the inlet of the outlet works. The plots show nearly 20 feet of sediment deposition at the dam since the 2004 survey and around 14 feet of deposition since the 2009 dive team survey. The 2013 plot also illustrates that sediment inflows have settled in the upper reservoir area where the upper sediment delta has formed and a failed retaining wall was constructed. Sediments have flushed downstream from this formed delta, filling the original dead pool zone and above. With no dead pool area much of the future sediment inflow will deposit throughout the reservoir with small portions being flushed downstream through the outlet works when in operation.
