DICKINSON DAM
EDWARD ARTHUR PATTERSON LAKE
1991 SEDIMENTATION SURVEY

4. TITLE AND SUBTITLE
Dickinson Dam/Edward Arthur Patterson Lake
1991 Sedimentation Survey

September 1995

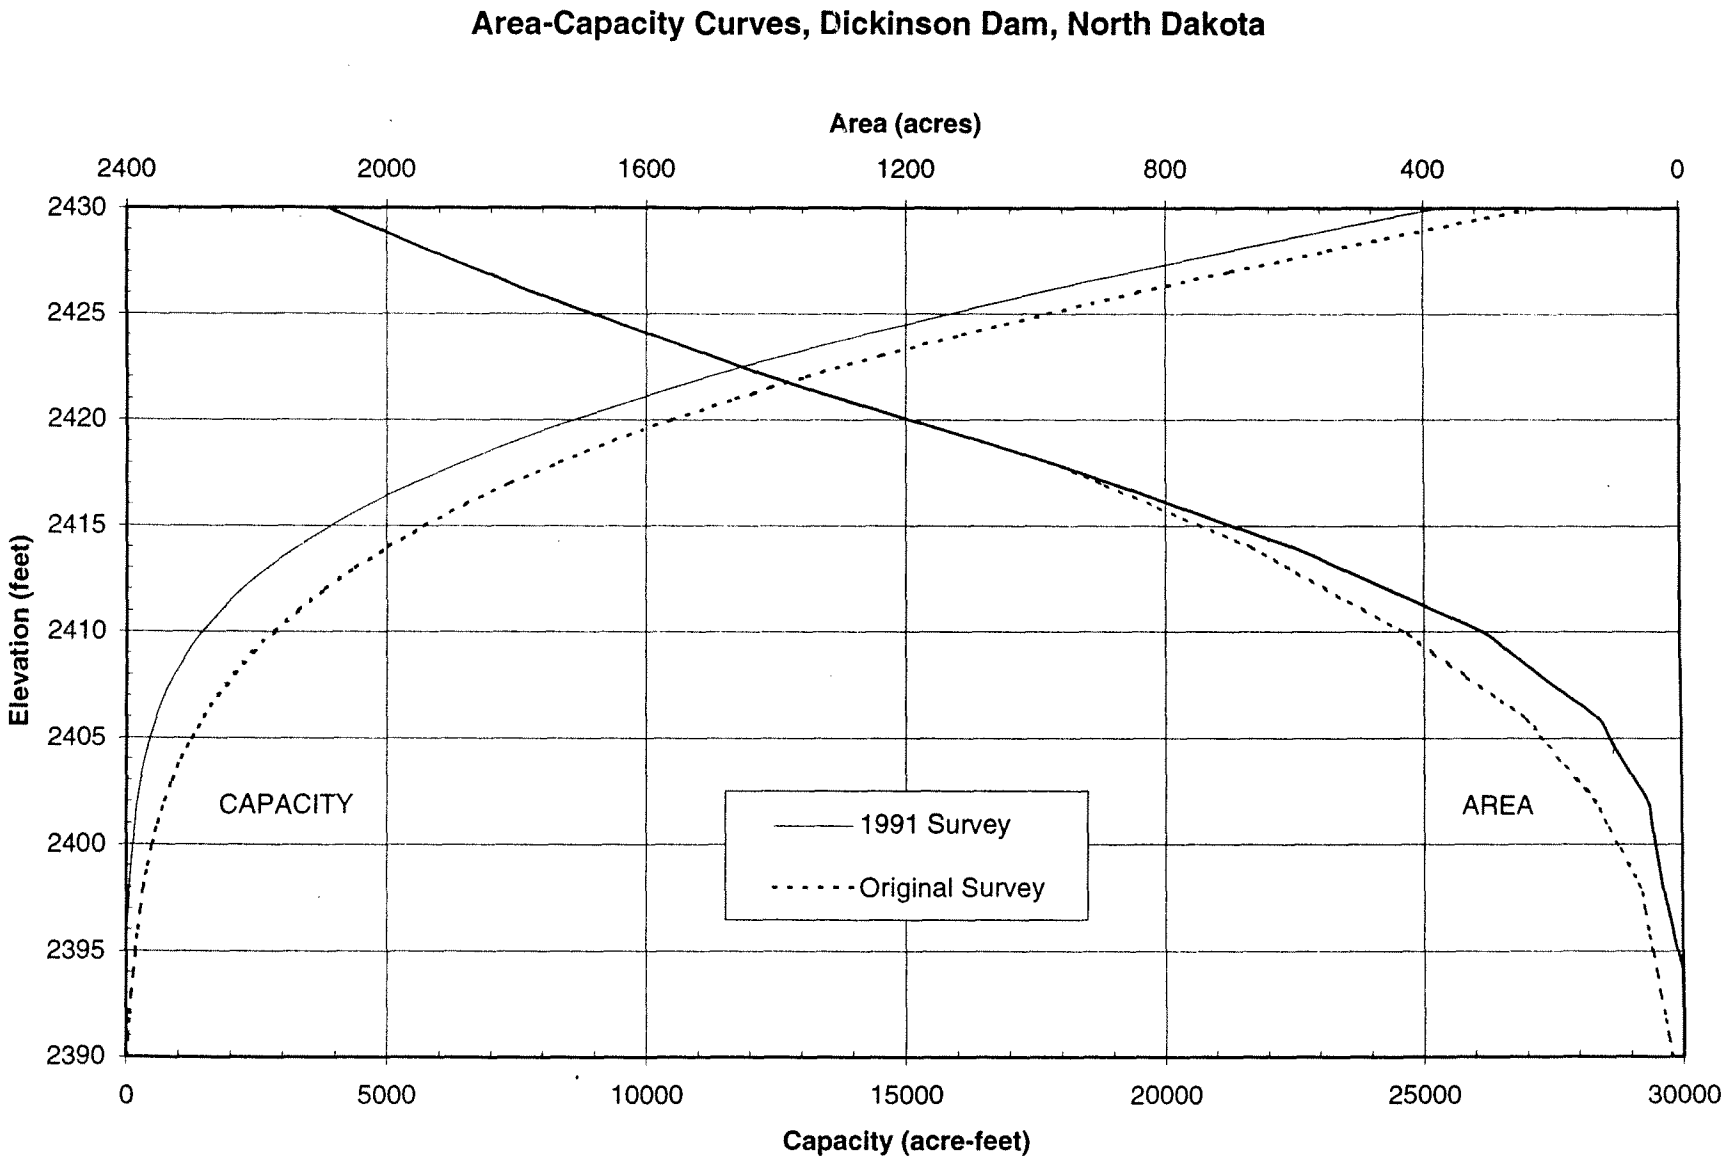
Figure 3. - Area and capacity curves for Dickinson Dam and Edward Arthur Patterson Lake.

The maximum elevation of the reservoir was 2,421.13 feet on June 9, 1982; therefore, no surface area change was assumed to occur above elevation 2,420.0. This assumption is illustrated by the cross-section plots of the range lines which show that the sediment did not accumulate above the spillway crest elevation of 2,420.0. Everything below elevation 2,398.0 has filled in with sediment. The original area-capacity table was done using 4-foot contour intervals from elevation 2,390.0 to 2,430.0 feet; therefore, the new table is consistent with the original.

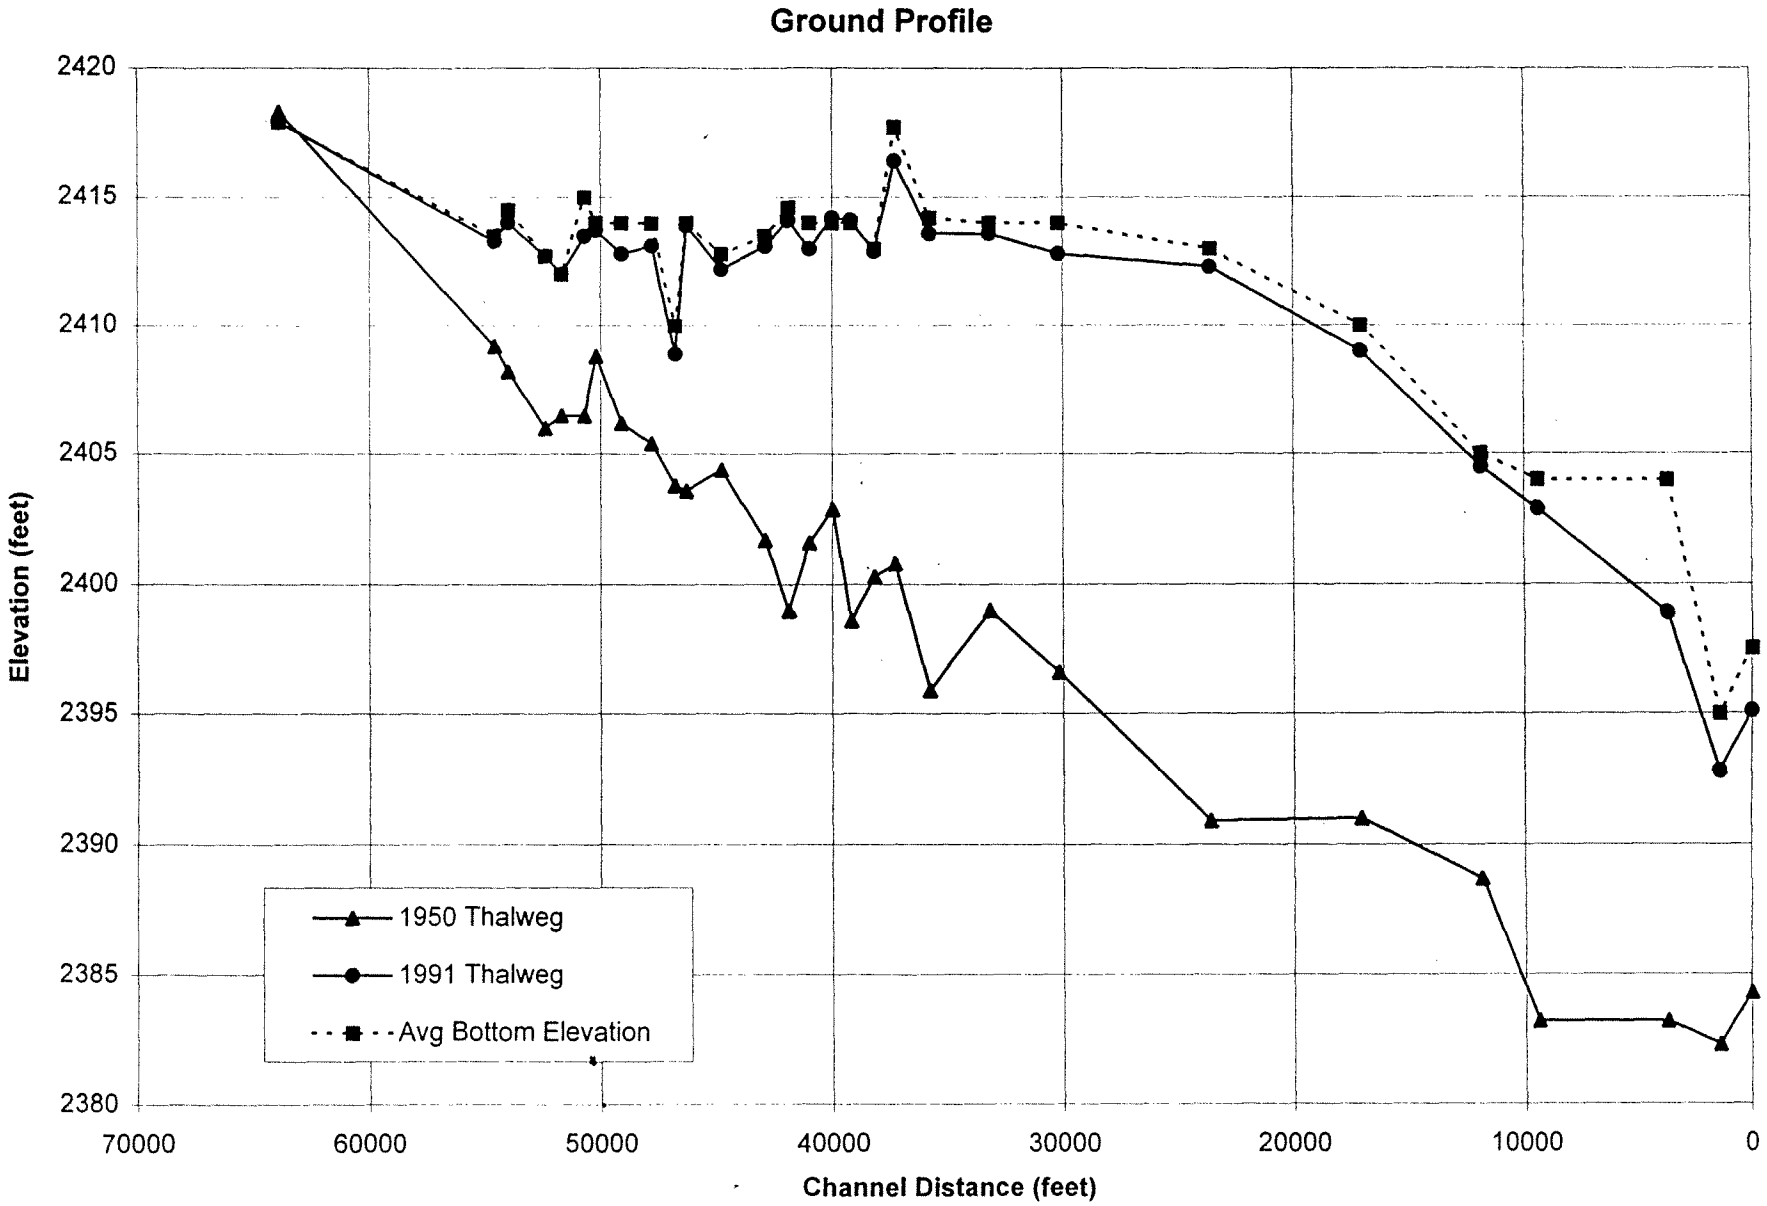
Figure 4. - Edward Arthur Patterson Lake, thalweg profiles.

The distribution of sediment throughout the length of the reservoir is illustrated in part by plots of the thalweg profiles representing the original and 1991 resurveyed profiles of the main channel (fig. 4). Field notes describing the location of the thalweg were not available for either survey. Therefore, the lowest elevation at each range line was used as the thalweg.

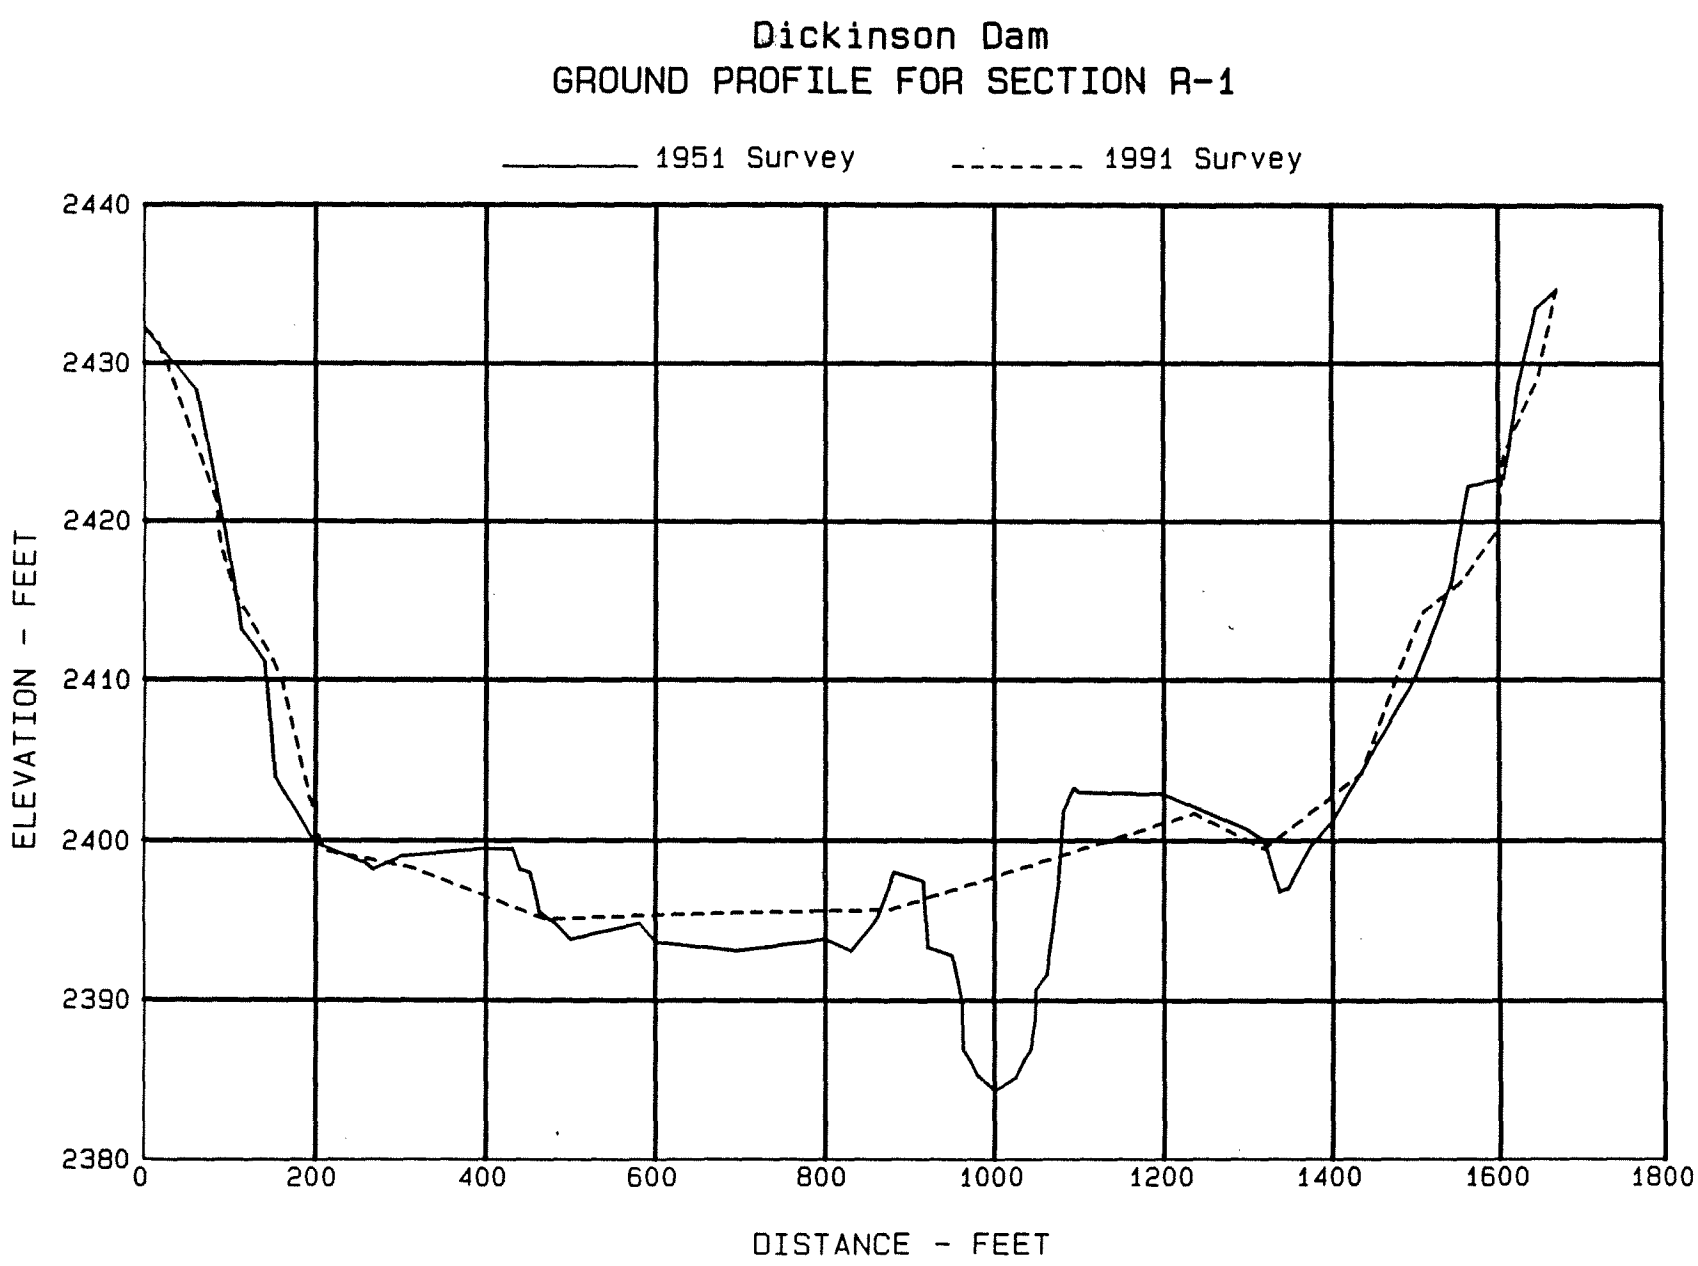
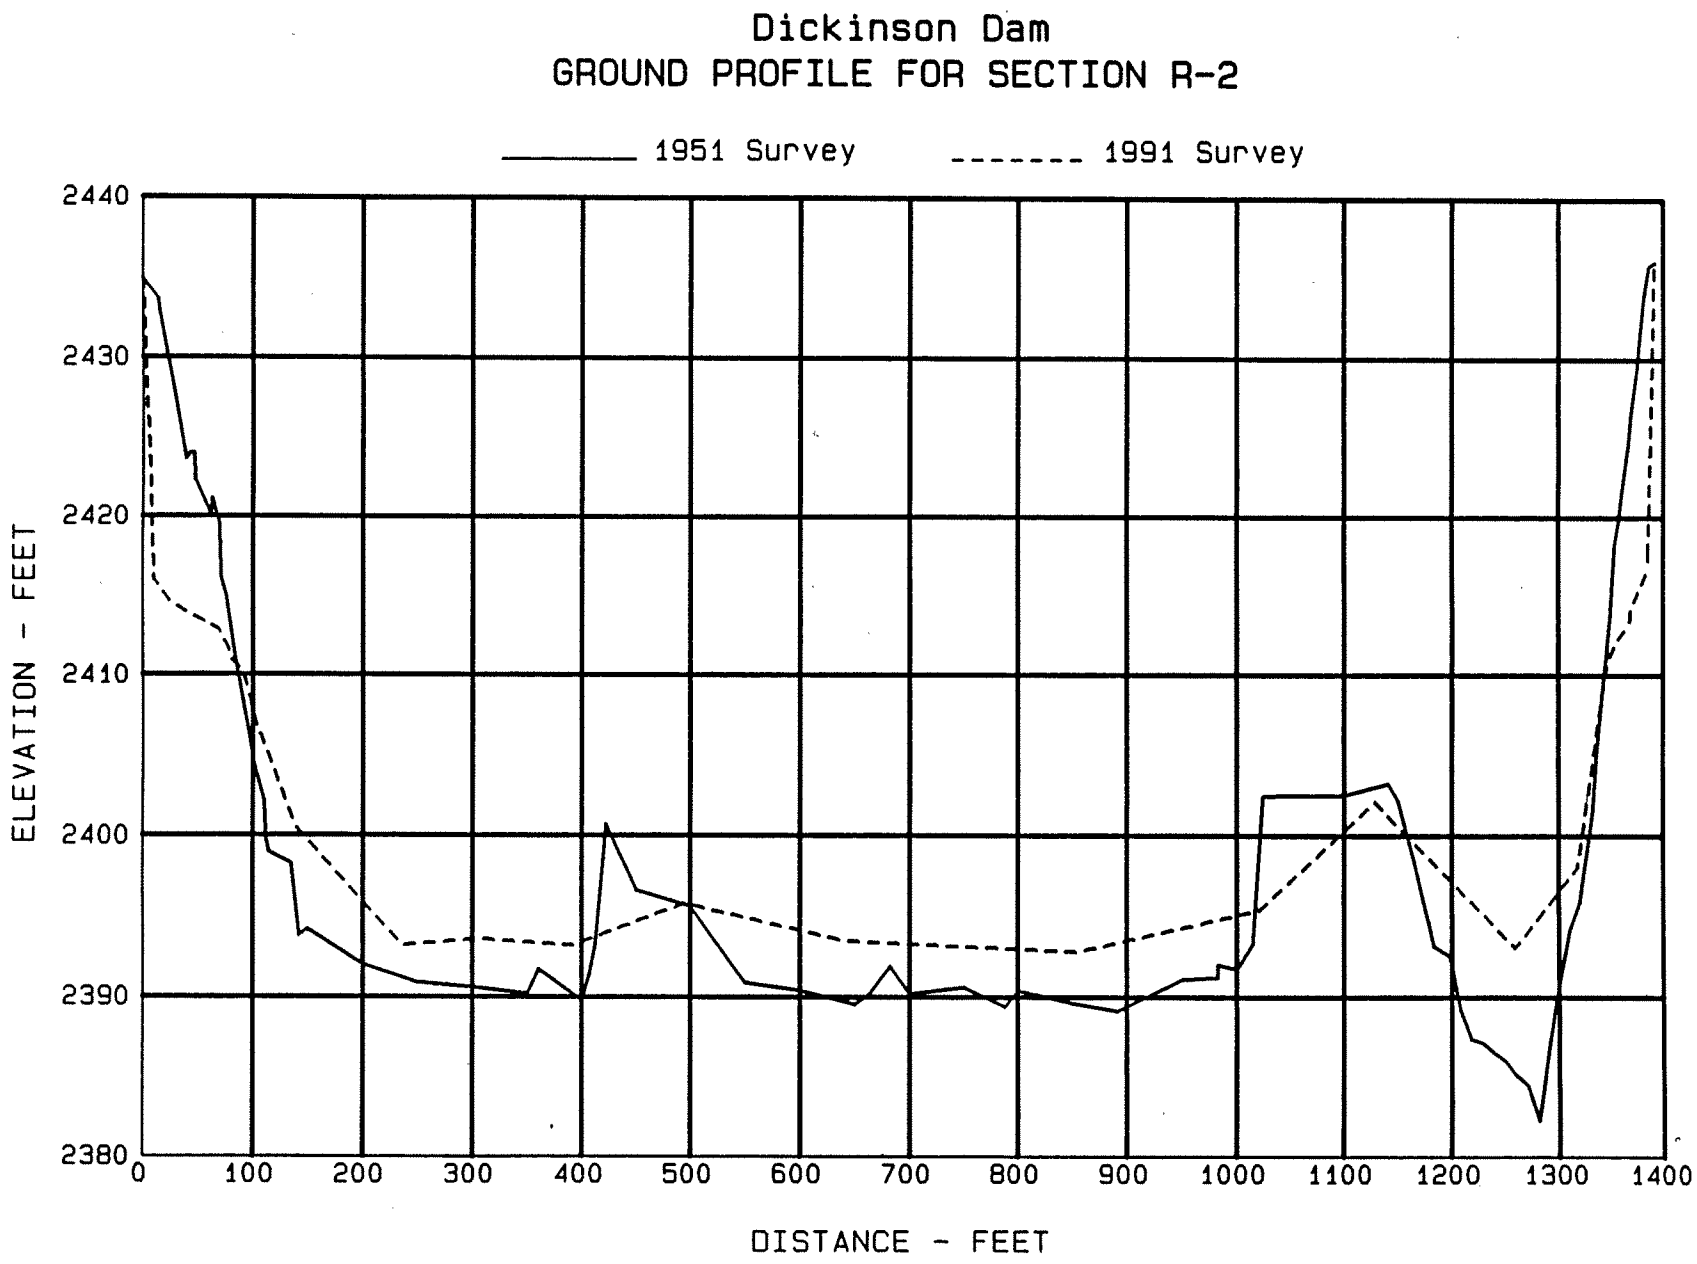
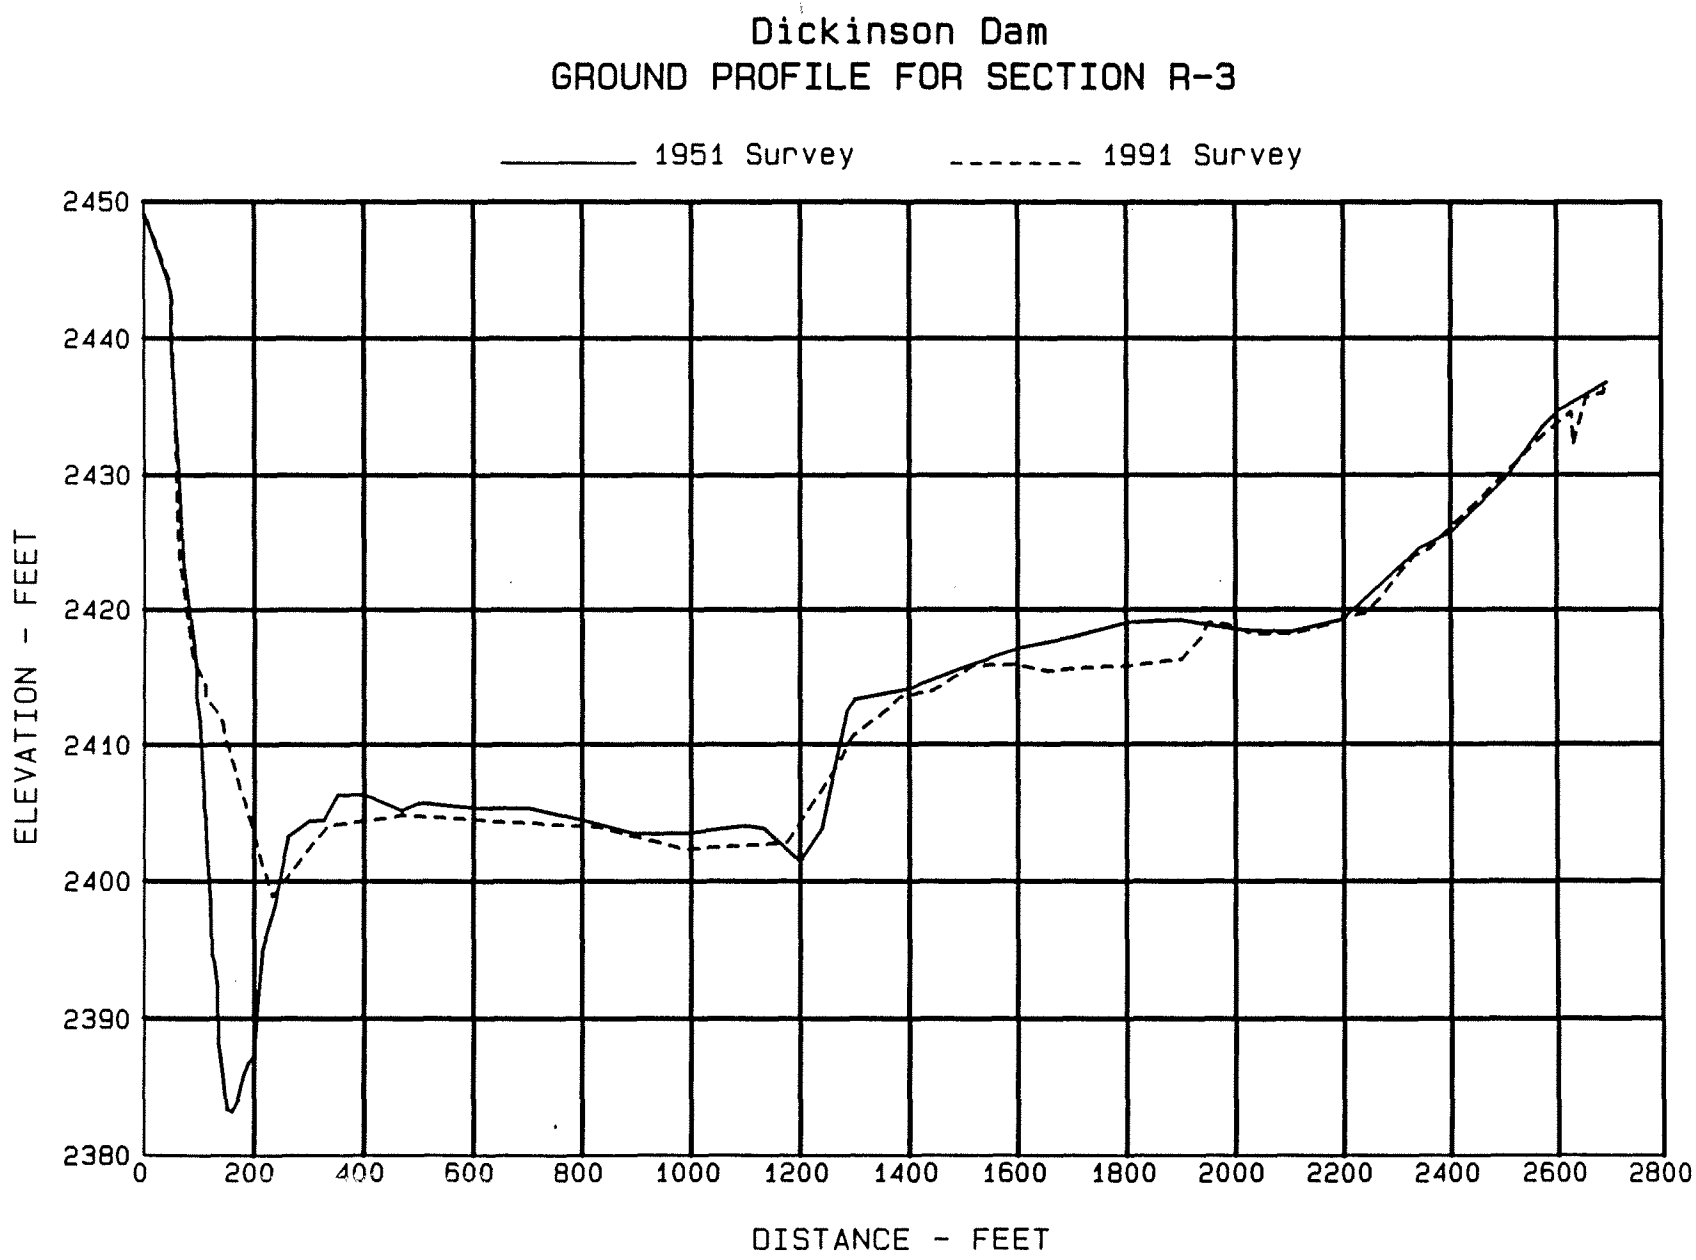
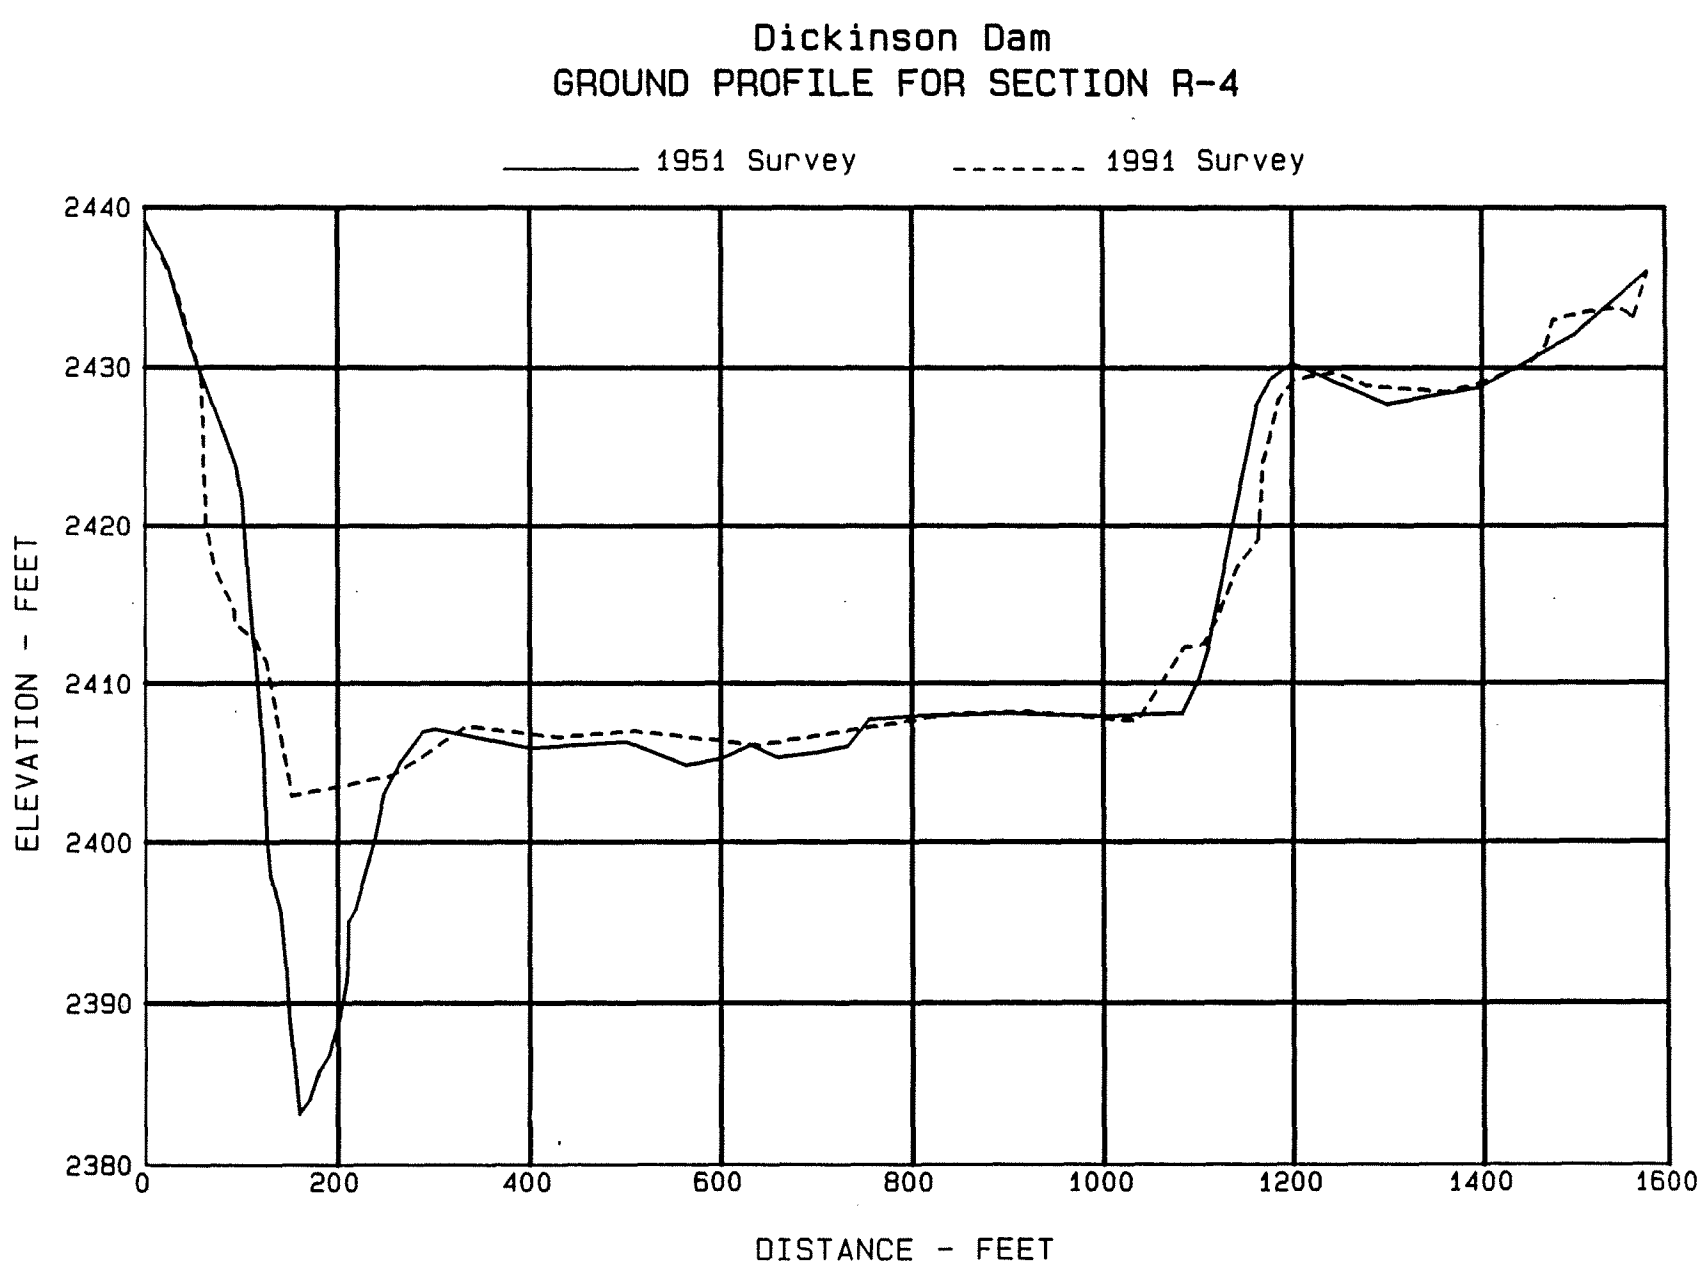
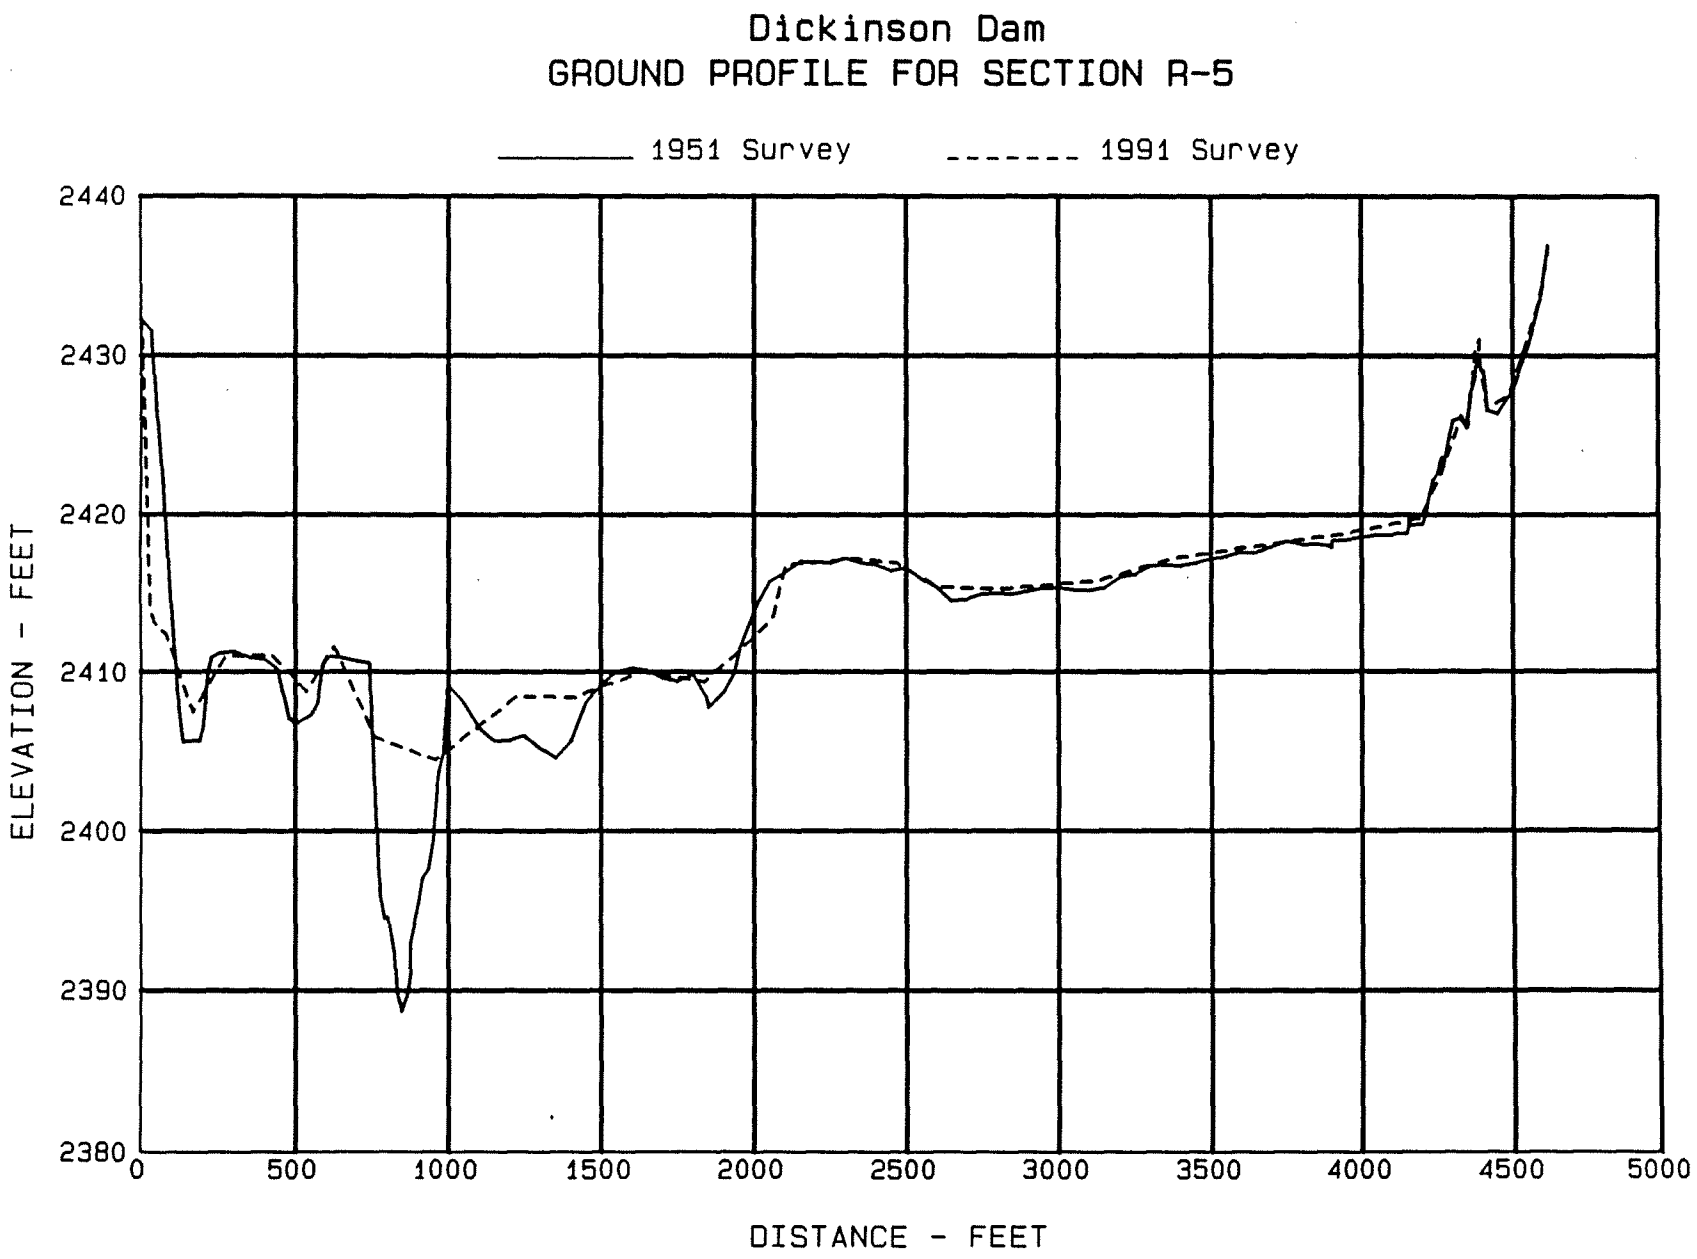
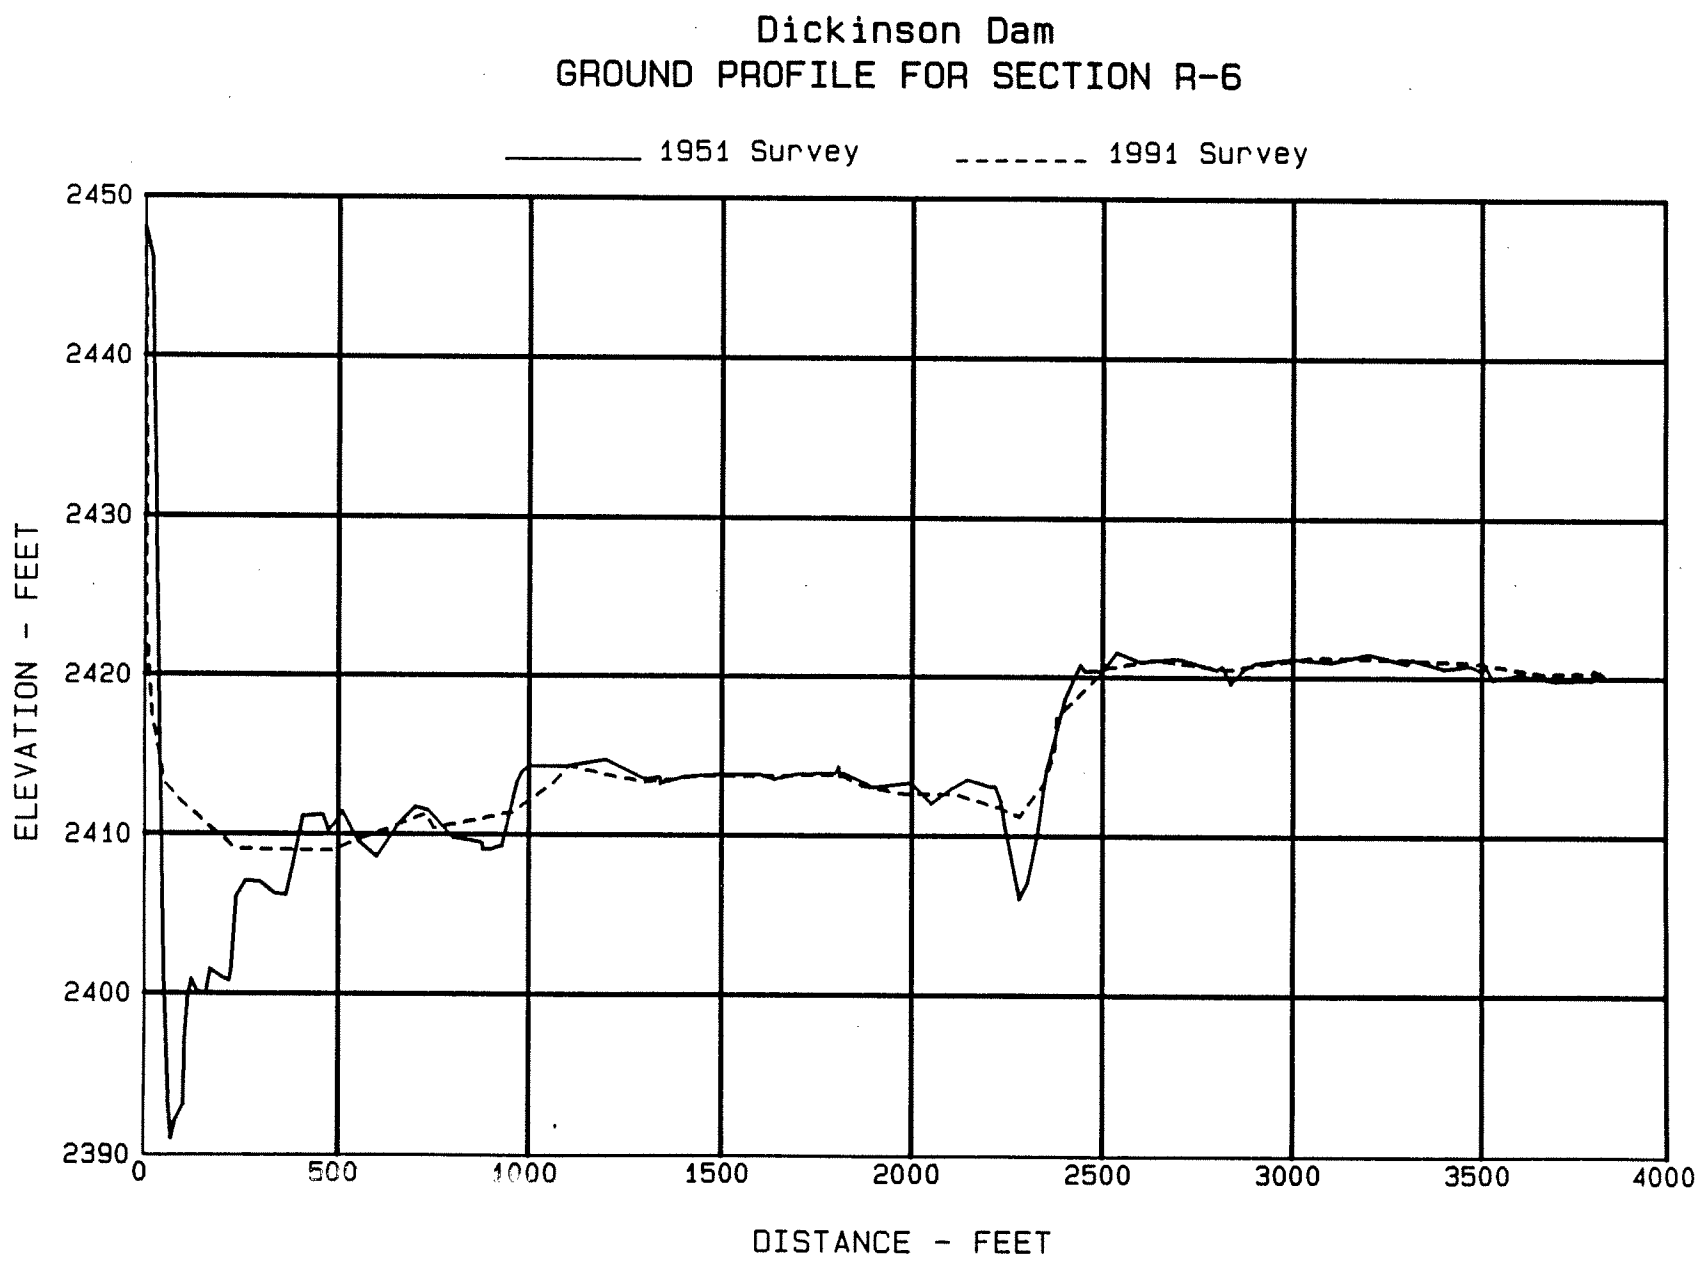
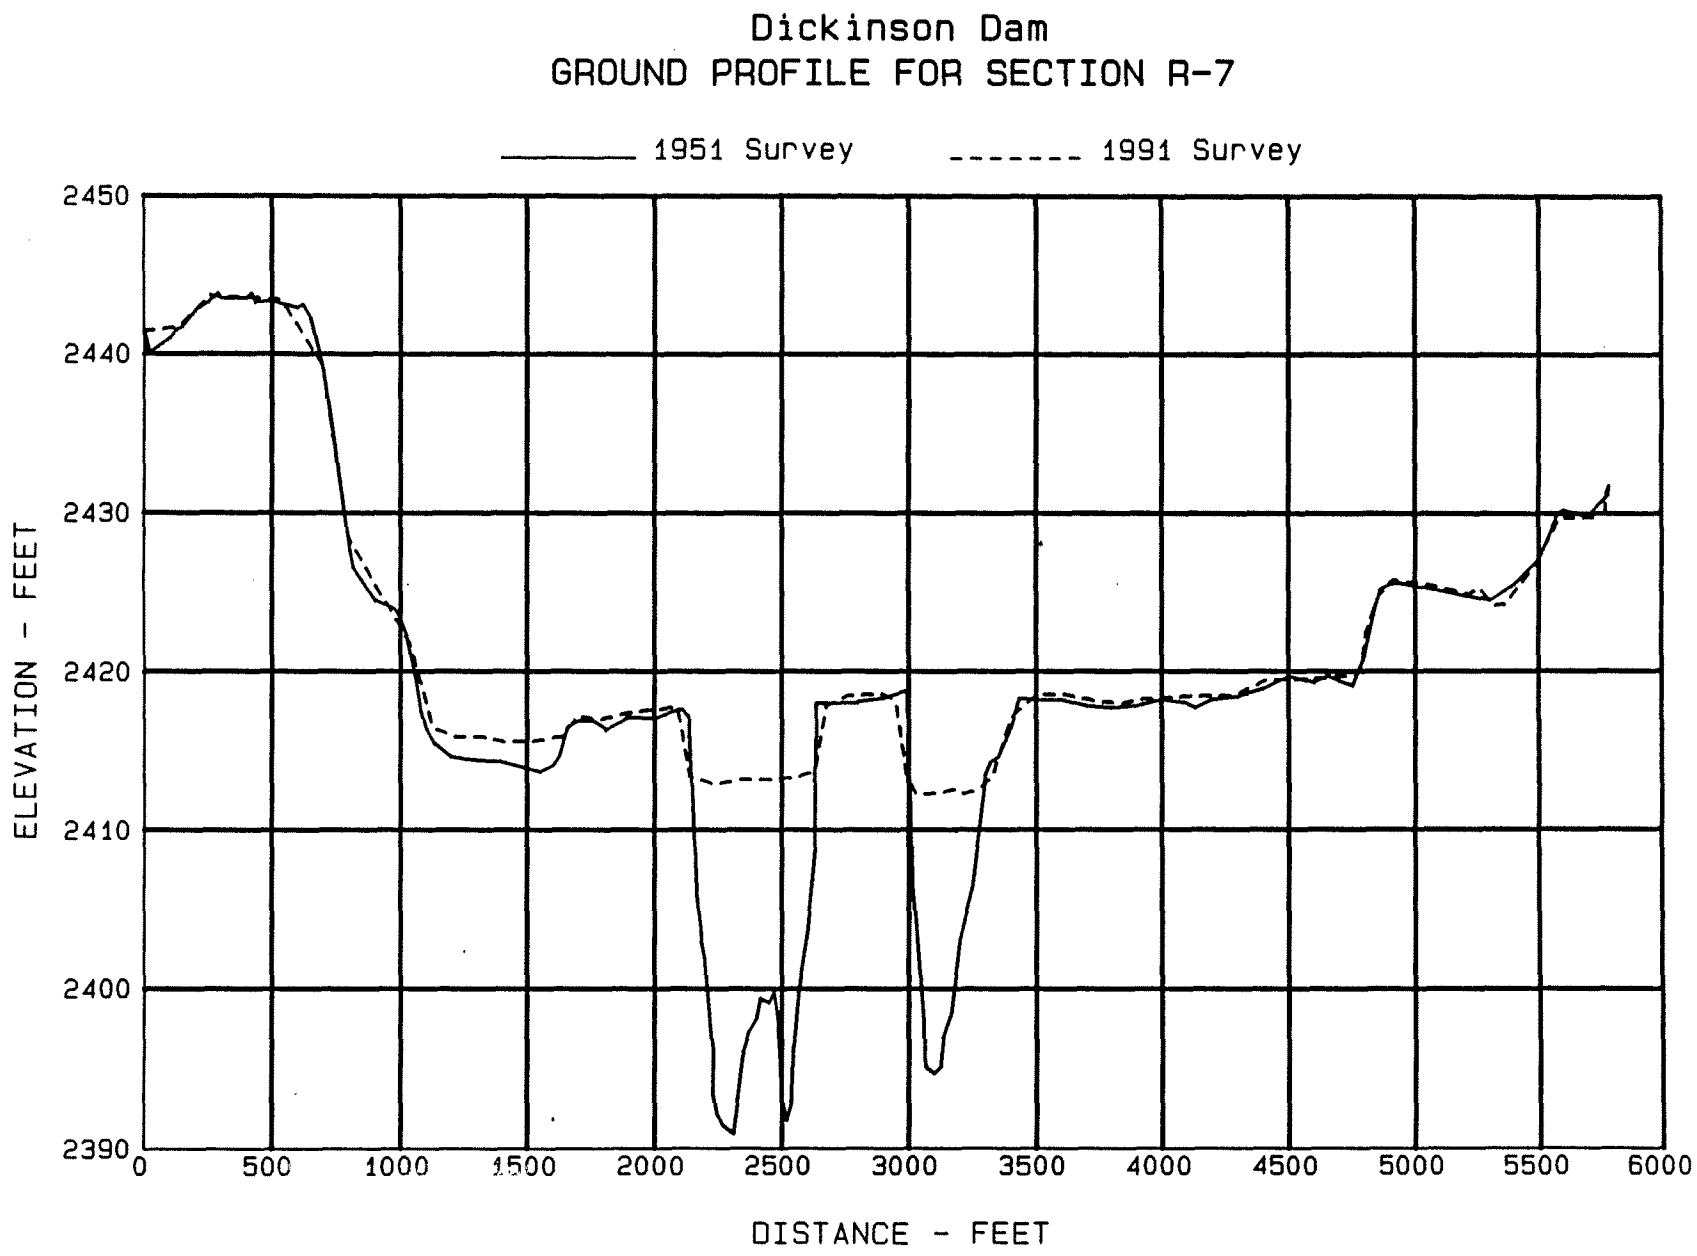
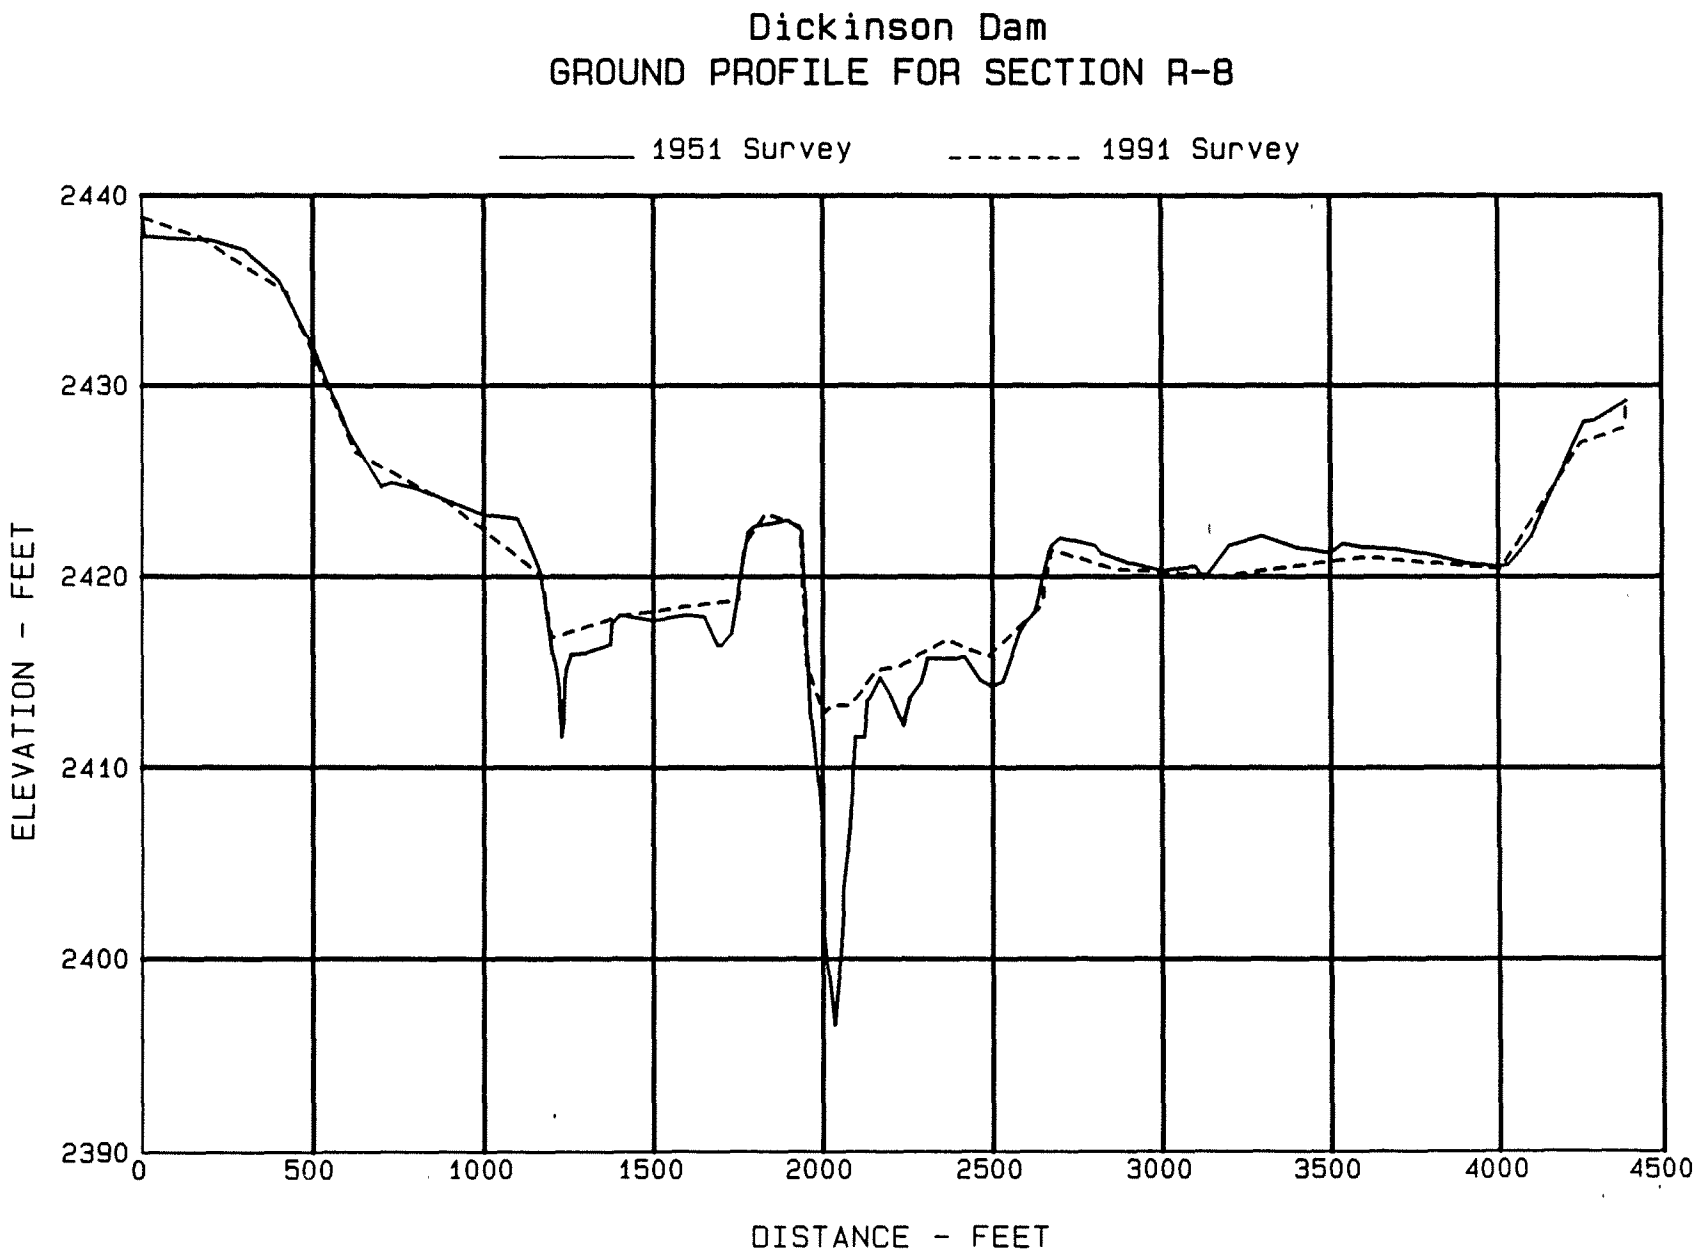
The 41 range lines originally surveyed in 1950 were resurveyed in 1991. The original and the 1991 range cross-section data are plotted together to depict the changes that have occurred and to represent the general lateral distribution of sediment within the reservoir (figs. 5 to 45). Most of the sediment deposition is located within the historic river channel.
