UNDERWATER INSPECTION OF RED BLUFF
DIVERSION DAM

FISHWAY ATTRACTION STUDY

AUGUST 13 THROUGH 17, 2001

Subject: **UNDERWATER INSPECTION OF RED BLUFF DIVERSION DAM
STILLING BASIN -- AUGUST 13 THROUGH 17, 2001
FISHWAY ATTRACTION STUDY**

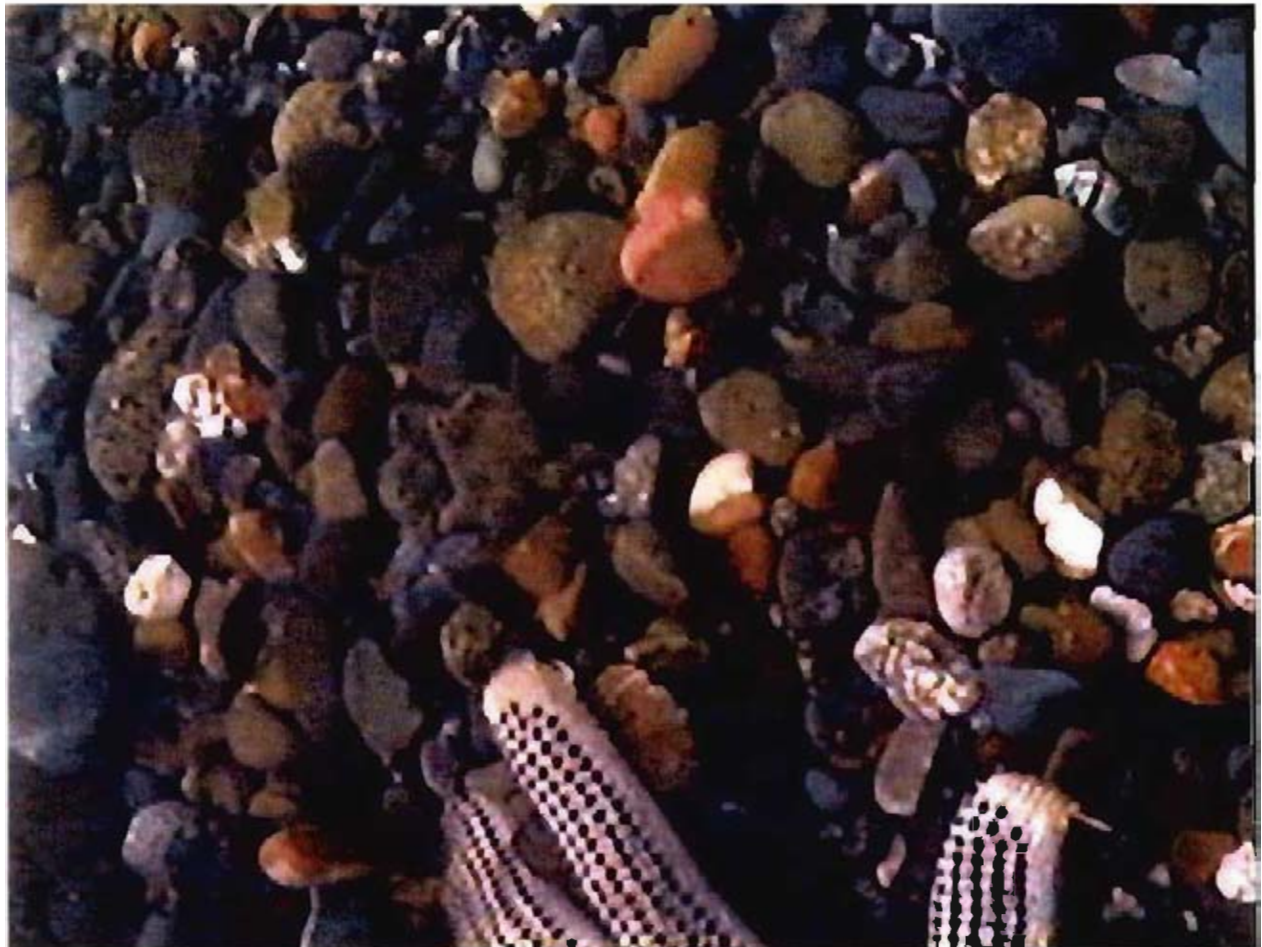
Photo 4

Severely Undercut Rebar (SU) on top of endsill downstream of Gate 2. The ruler shows 3 to 4 inches of undercutting. Loose fine and coarse gravel covers much of the endsill.

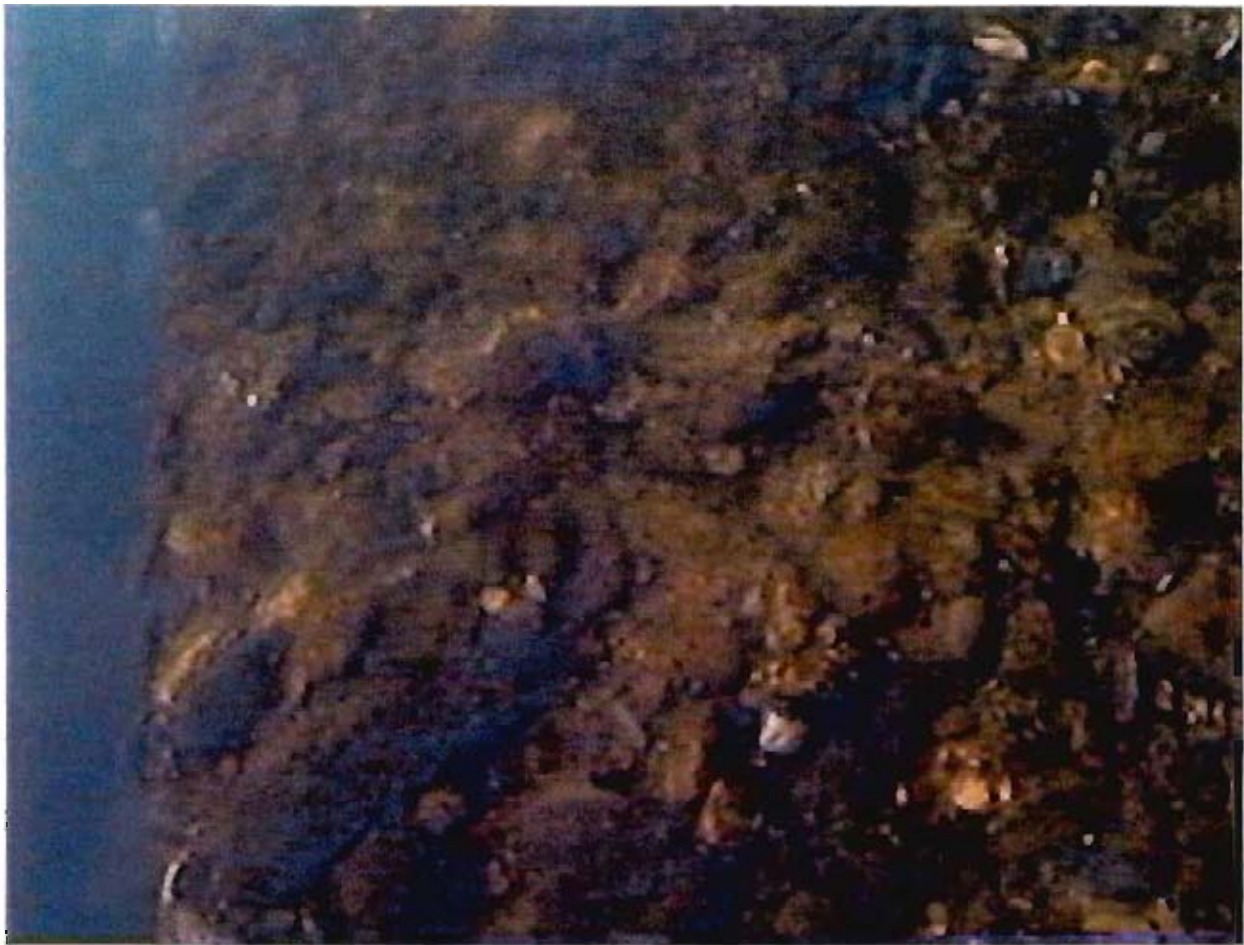
Severely Undercut Rebar (SU) and loose gravel and cobbles on top of endsill downstream of Gate 9.
