Hydraulic Laboratory Technical Memorandum PAP-1145

Buffalo Bill Power Plant Tailrace Barrier Fence

As-Built Sonar Inspection

Pick-Sloan Missouri Basin Program

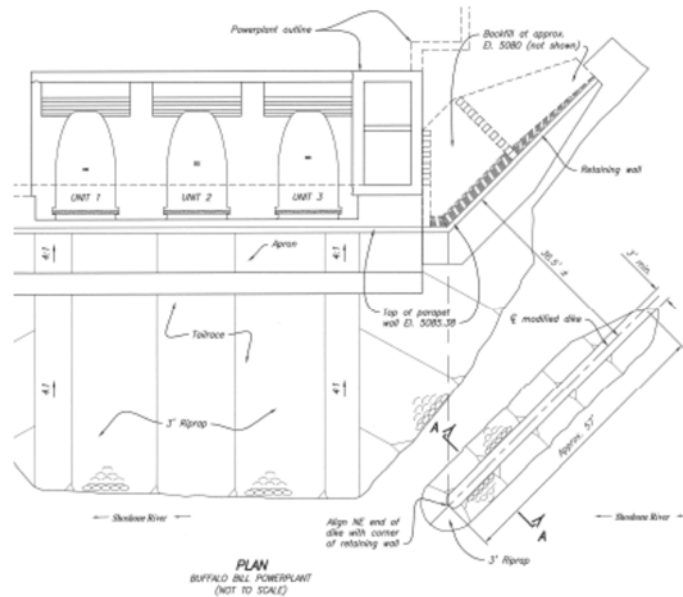
Figure 11. Plan view drawing of the Buffalo Bill Power Plant and tailrace protection dike.

The tailrace protection dike is meant to prevent mobilized river bed material from entering the tailrace area. The original dike had eroded over the years and was no longer functioning as designed. As a result, the dike was reconstructed to be stable during flood releases and to prevent rocks from entering the tailrace. Figure 11 is a plan view of the power plant and the tailrace protection dike. Figure 12 shows a section view of the original and re-designed tailrace protection dike.
