5.0 Summary of Results

5.1 Reach 1a

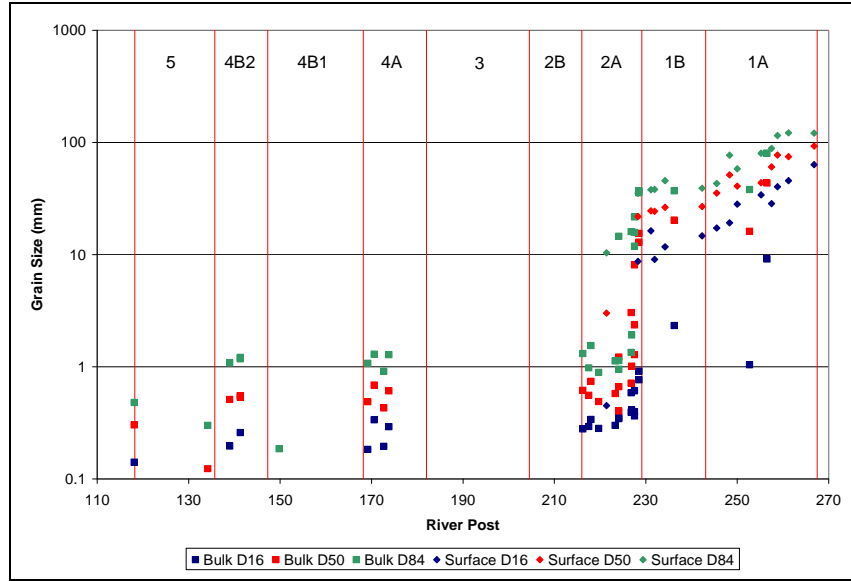
Figure 5-1.
Results of Reclamation Bed Material Sampling in Reach in 2008

Reach 1b has an average slope of approximately 0.0004, which is approximately 40 percent less than the average slope in Reach 1a. The riffles are composed of slightly smaller gravels than Reach 1a and contain significant amounts of sand. Photographs of the riffles material in the upper, middle, and lower parts of Reach 1b are found in Figures 5-11, 5-12, and 5-13, respectively. Material in the riffles gradually becomes finer, and the fraction of sand in the bed gradually increases in the downstream direction. The trend of fining bed material is also visible in the measured representative diameters of riffle material shown in Figure 5-1.

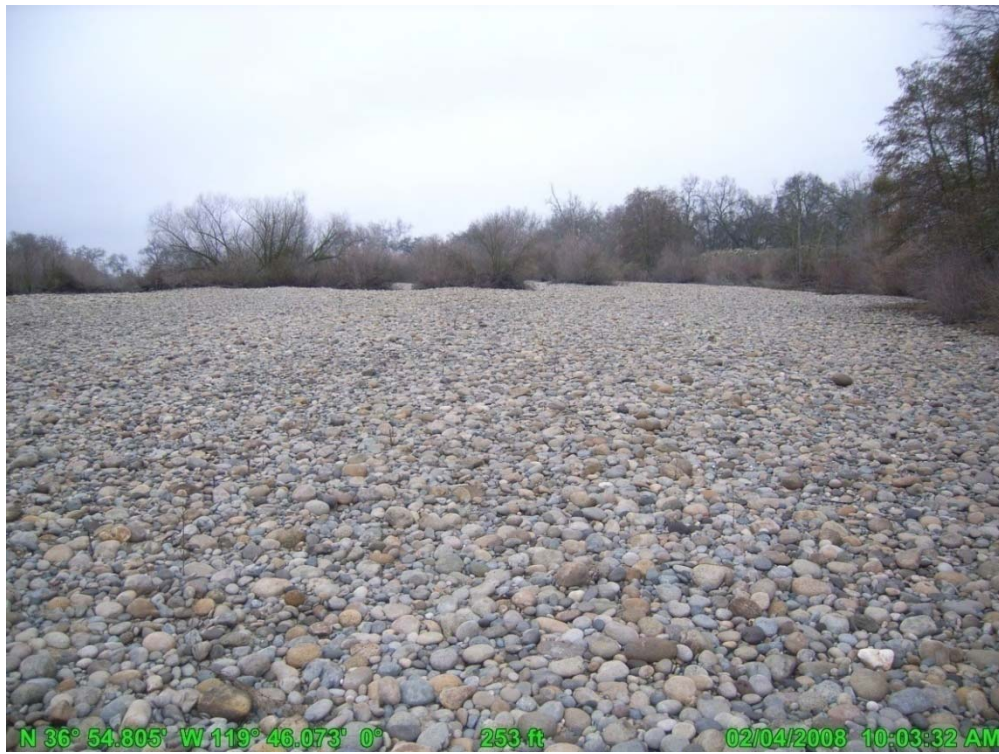
Figure 5-2.
Gravel Bar Below Rank Island in Reach 1a (RP 259)

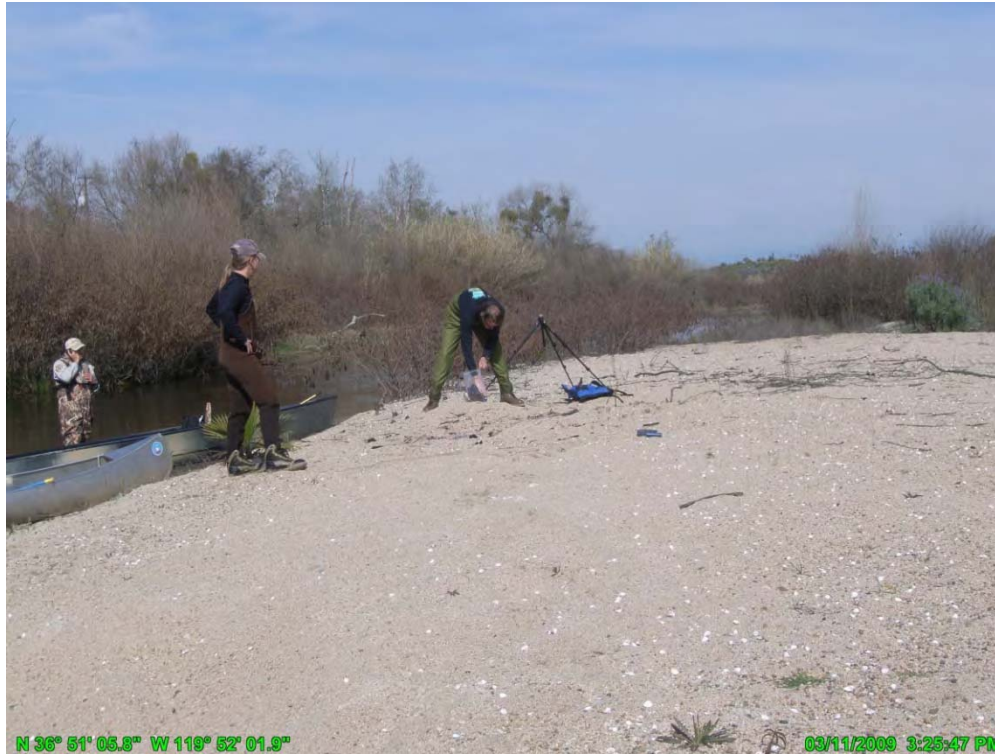
Figure 5-3.
Sand Bar in Reach 1a (RP 248)

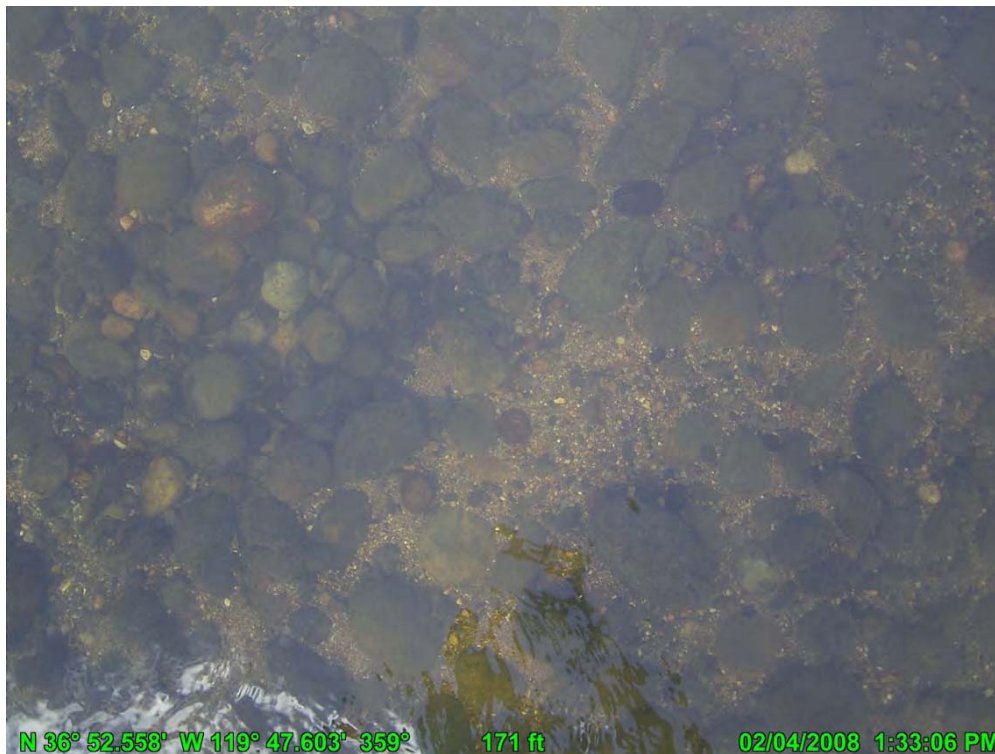
Figure 5-4.
Riffle just Downstream from Highway 41 in Reach 1a (RP 255.1)

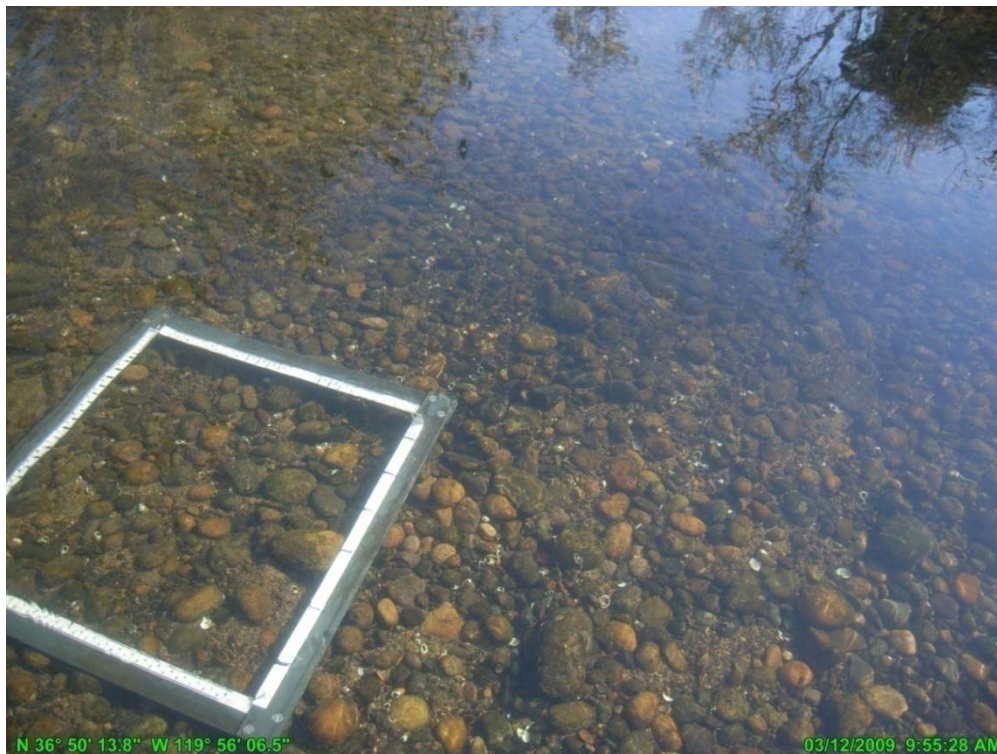
Figure 5-11.
Riffle Bed Material Between Highway 99 and Skaggs Bridge in Reach 1b

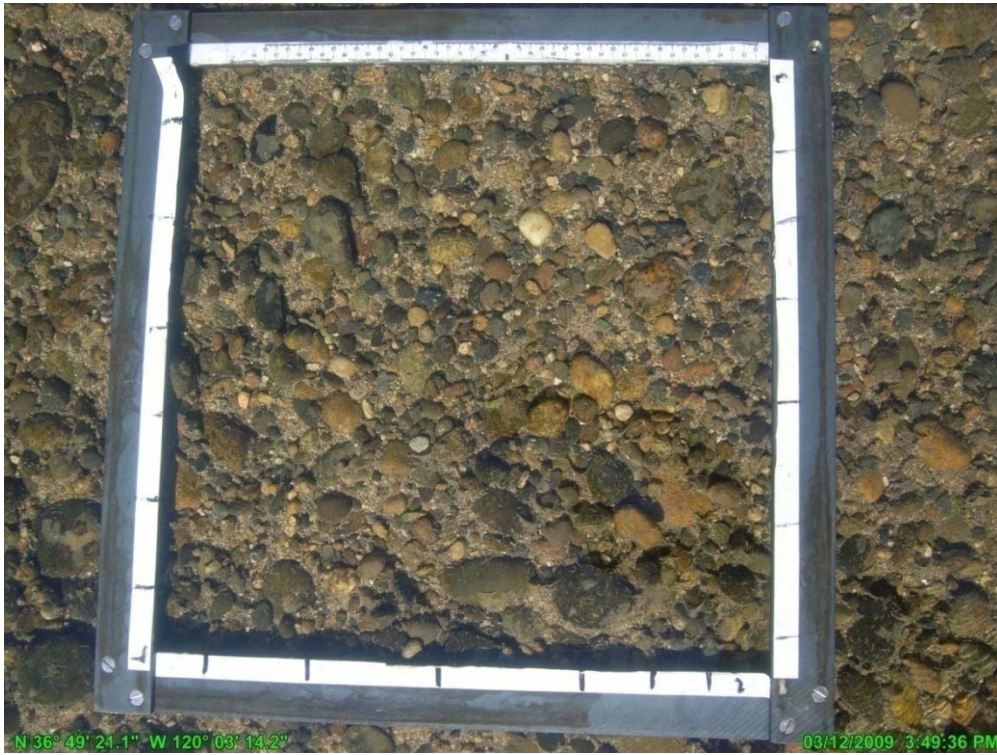
Figure 5-12.
Riffle Bed Material Upstream from SH 145 in Reach 1b

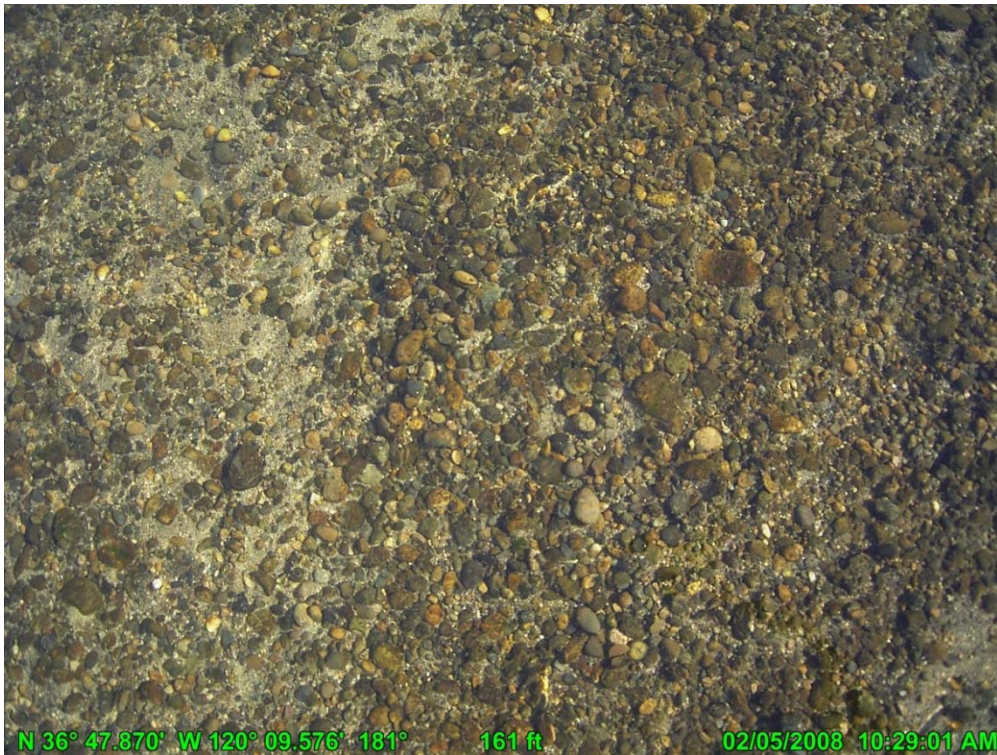
Figure 5-13.
Riffle Bed Material at Gravelly Ford

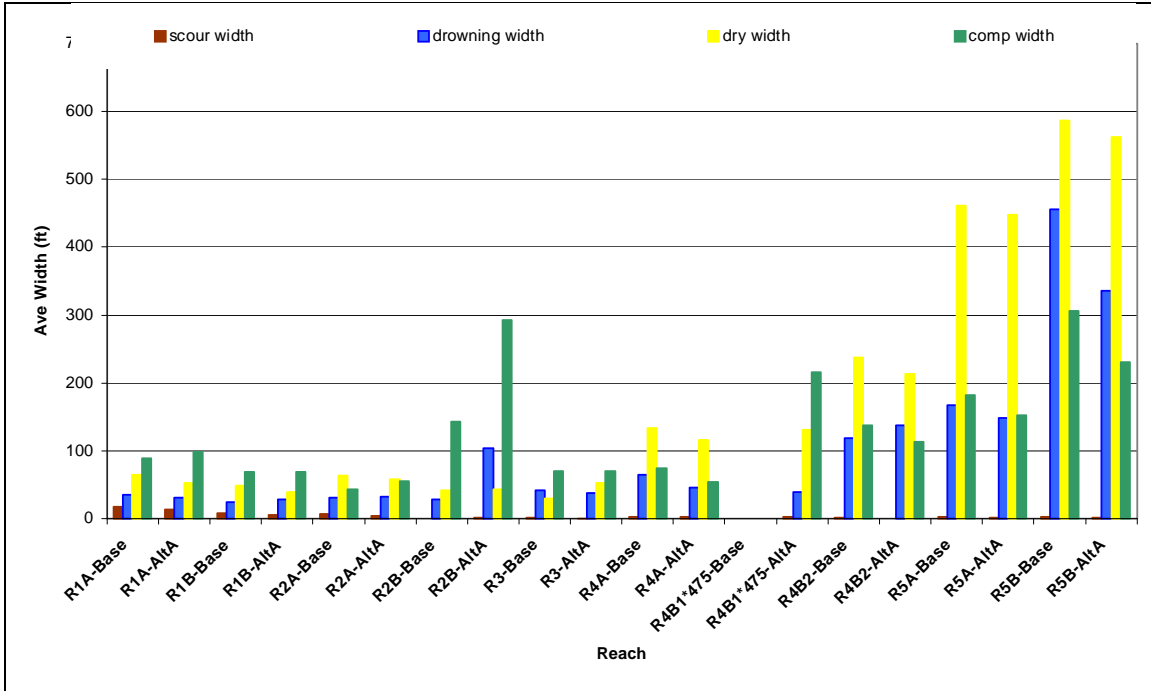
Key: Scour = mortality by scour; drowning = mortality by inundation; dry = mortality by desiccation, and comp = mortality by shading or competition

Figure 5-14.
Native Vegetation Mortality with Baseline and Alternative A Flows

24 Under Baseline and Project Conditions, the main causes of mortality in Reaches 1a and
25 1b is competition/shading (Figures 5-14 and 5-15). The second most common cause of
26 mortality is desiccation. However, under Project Conditions, there is slightly more
27 competition/shading and slightly less desiccation.

27 Mortality based on plant productivity is the lowest of any reach for invasive plants and
28 has the third smallest plant removal, behind only Reach 1B and Reach 1A, for native
29 plants. Shading and competition removes the most native plants while desiccation is the
30 largest cause of invasive plant mortality (Figure 5-14).

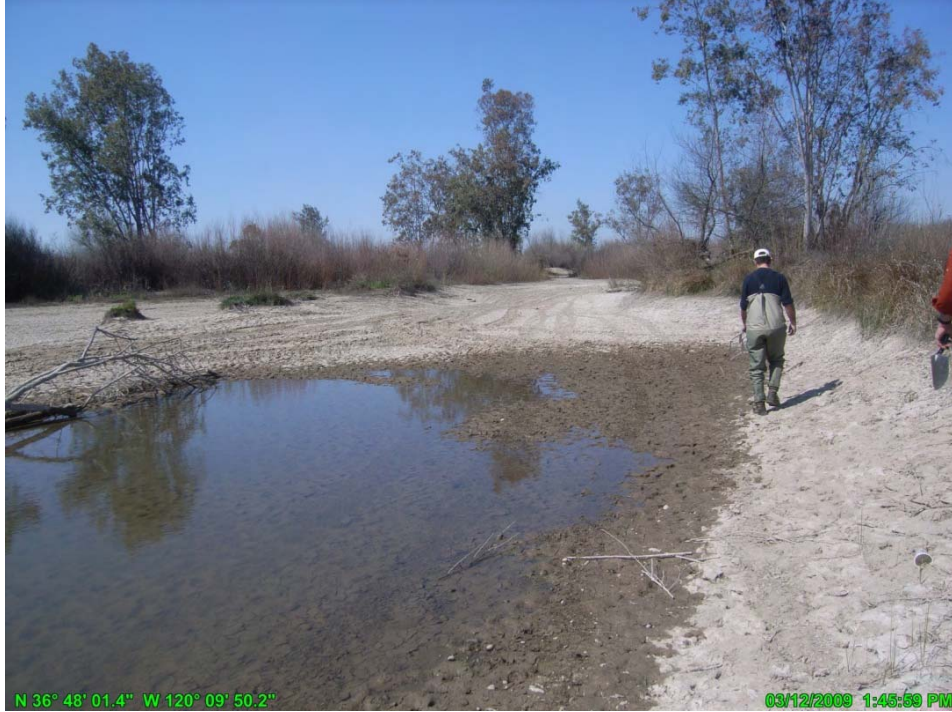
Figure 5-18.
Termination of the Wet Reach of the San Joaquin River in the Transition Between
Reach 1b and 2a, Approximately 0.25 Mile Downstream from the Gravelly Ford
Stream Gage (RP 227.1)

16 The river typically ceases to flow a few hundred feet downstream from Gravelly Ford
17 unless flood releases occur. The current water rights agreement requires a minimum flow
18 of 5 cfs at Gravelly Ford, which quickly infiltrates into the substrate. Therefore, Reach 2a
19 is dry the majority of the year and can even be dry for several years in a row. The
20 termination of the wet channel in Reach 2a is shown in Figure 5-18. The dry channel
21 downstream from Gravelly Ford is shown in Figure 5-19.

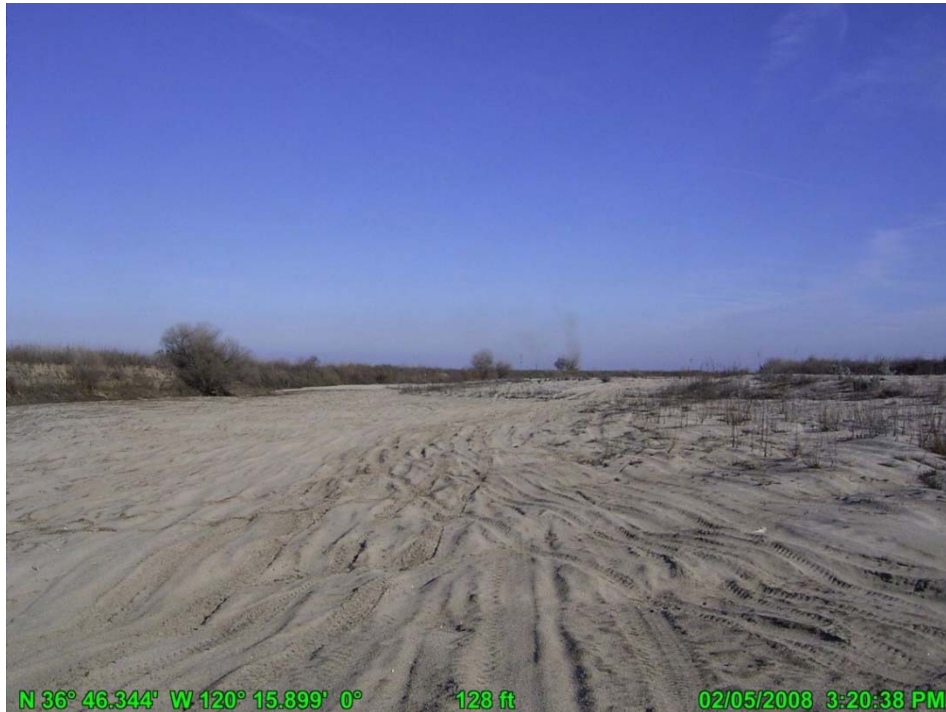
Figure 5-19.
Dry Channel in Reach 2a at RP 218

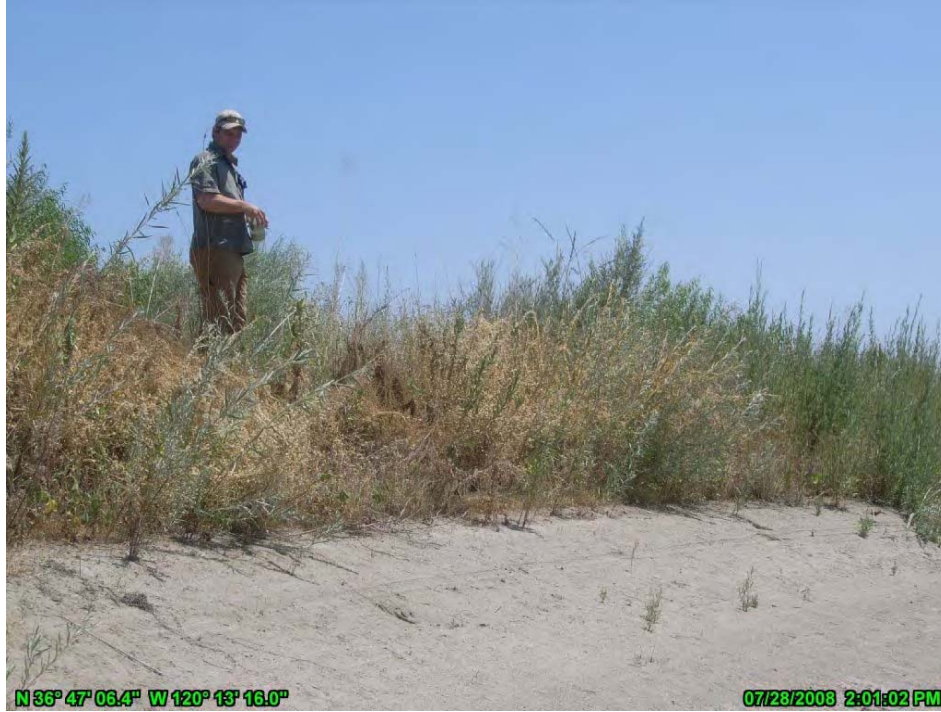
Figure 5-20.
Picture Taken from Low-Flow Channel in Reach 2a During Period of 300-cfs Releases in 2008 (RP 222)

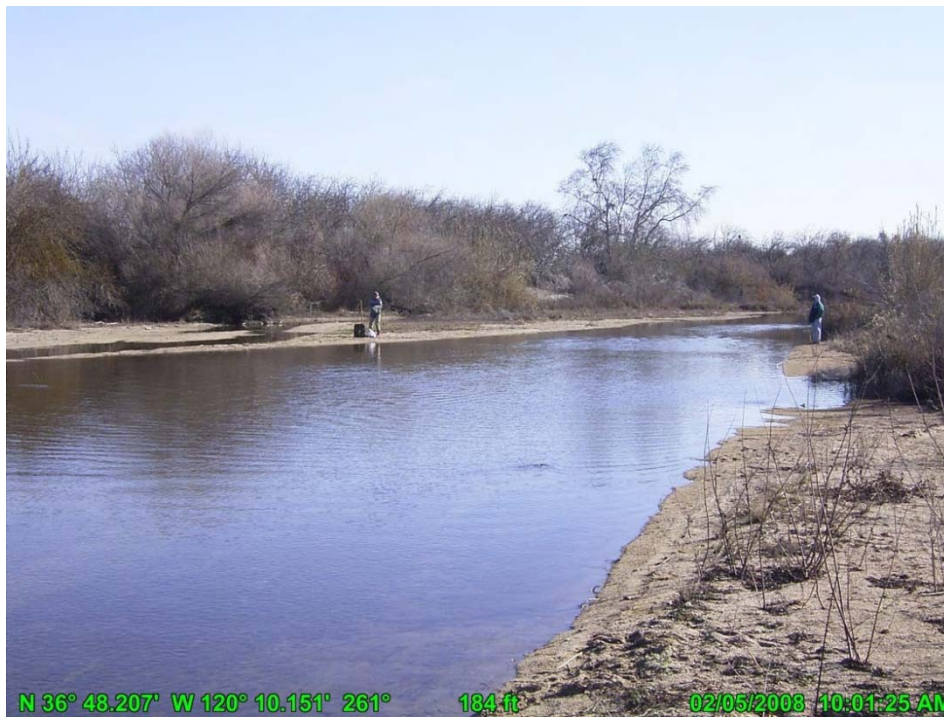
Note: Picture taken in February 2008.

Figure 5-21.
Wet Channel in Reach 2a at RP 226.9, Approximately 0.7 Mile Downstream from Gravelly Ford

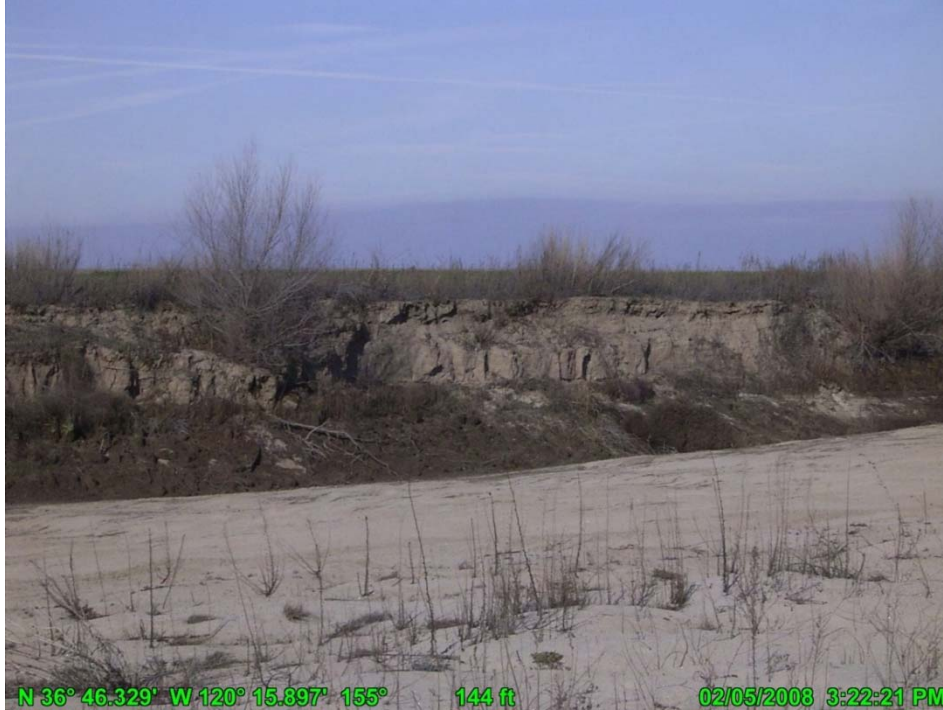
Figure 5-22.
Typical Bank Composed of Fines Along the Outside of a Bend in Reach 2a

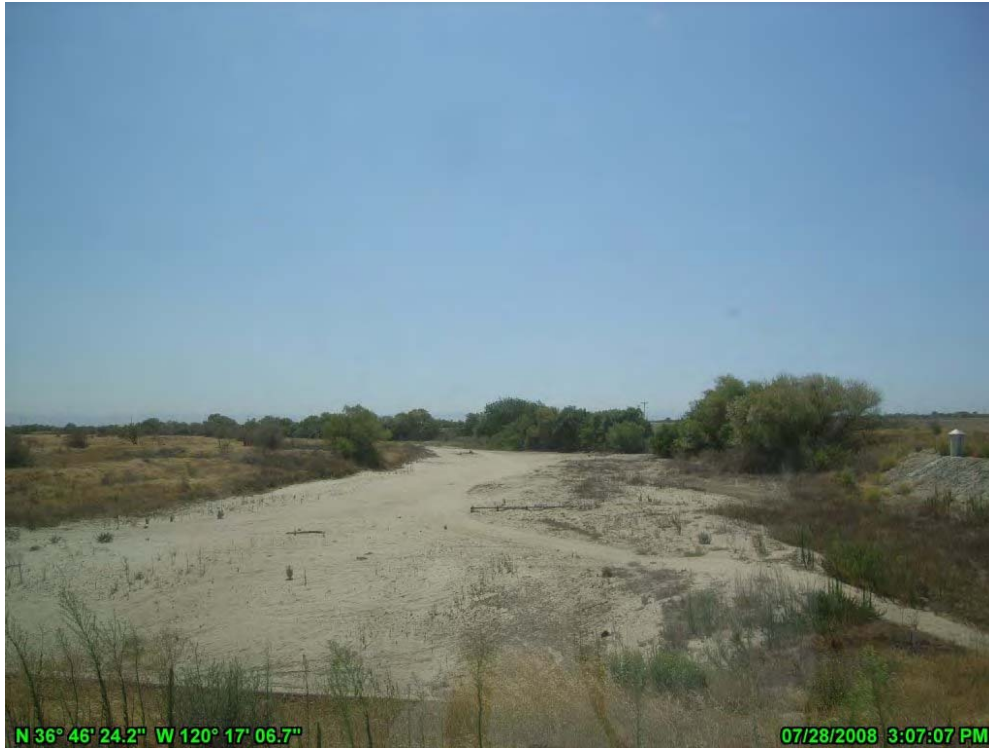
Figure 5-23.
Looking Downstream from Chowchilla Bifurcation Structure at
Upstream End of Reach 2b

7 Reach 2b extends from just downstream from the Chowchilla Bifurcation Structure
8 downstream to Mendota Pool. The slope decreases to 0.00022 or about 1 foot per mile,
9 which is almost a factor of 2 less than in Reach 2a. The median bed material diameter is
10 approximately 0.65 mm (MEI 2002a). Currently, water operations only allow a maximum
11 flow of approximately 1,300 cfs in this reach with all excess flow diverted into the
12 Chowchilla Bypass. No tributaries are present in Reach 2b, and therefore this reach is
13 also dry the majority of the time. Reach 2b is confined by levees its entire length, and the
14 distance between the levees ranges from approximately 500 feet to 300 feet. Figure 5-23
15 shows a photograph of the reach looking downstream from the Chowchilla Bifurcation
16 Structure.

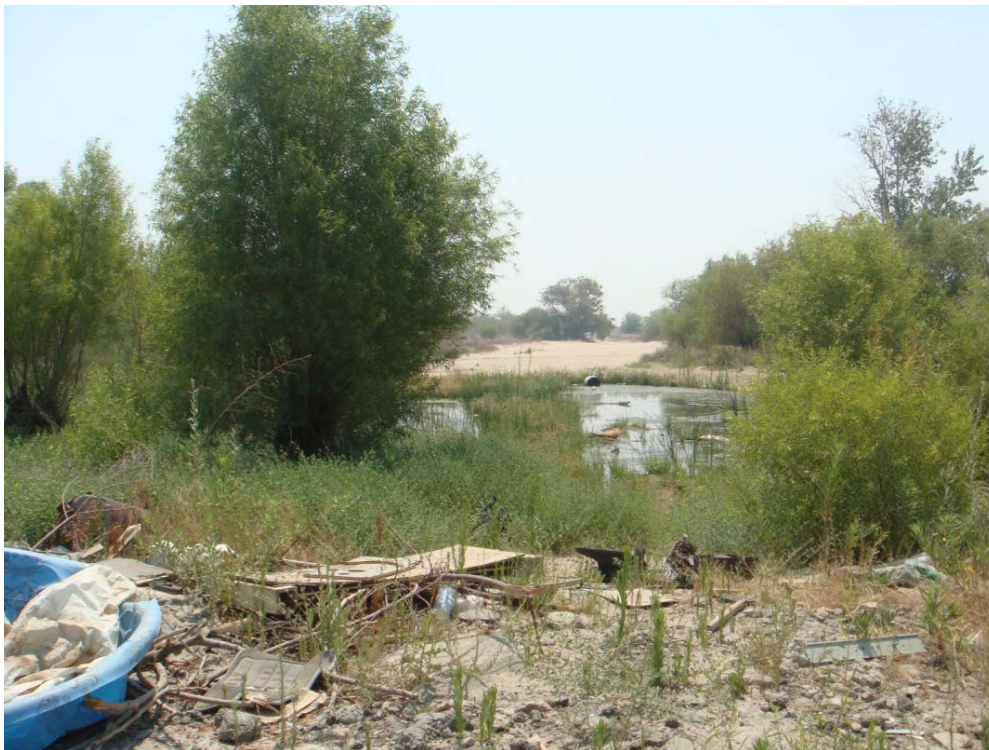
Figure 5-24.
Looking Upstream from San Mateo Crossing (RP 211.9)

17 The backwater of Mendota Pool extends upstream to approximately San Mateo Crossing
18 at RP 211.9. Photographs looking upstream and downstream from San Mateo Crossing
19 are shown in Figure 5-24 and Figure 5-25. The photograph looking upstream shows the
20 extent of the backwater pool from Mendota Dam. The channel upstream from the pool is
21 much less vegetated due to the lack of water. The photograph looking downstream
22 illustrates the dense vegetation present in the channel due to the backwater from Mendota
23 Pool.

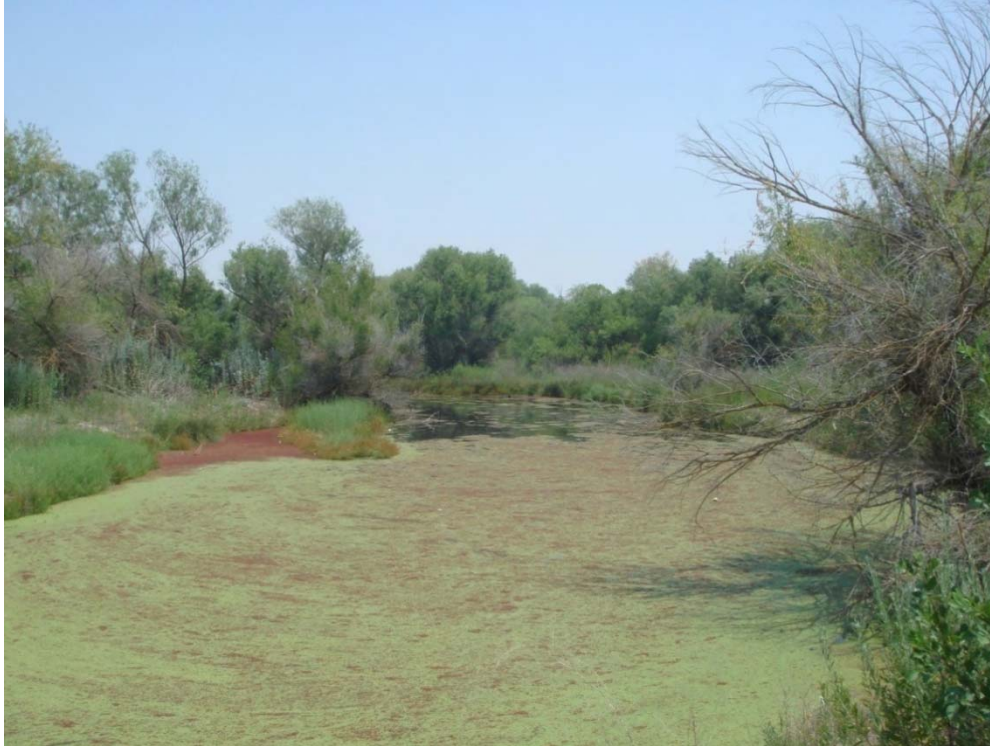
Figure 5-25.
Looking Downstream from San Mateo Crossing (RP 211.9)

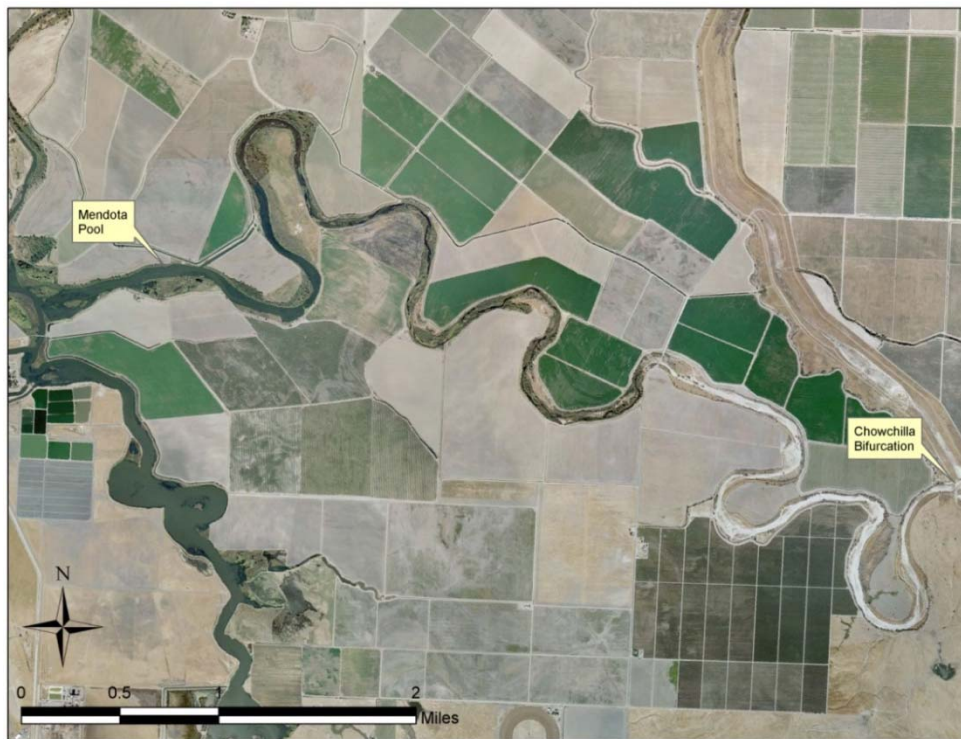
Figure 5-26.
Overview of Reach 2b, Showing Large-Amplitude Meanders

1 There are large-amplitude meander bends in this reach (Figure 5-26). These bends have
2 been relatively stable in the recent past but little flow has been conveyed in the channel to
3 promote lateral channel migration.

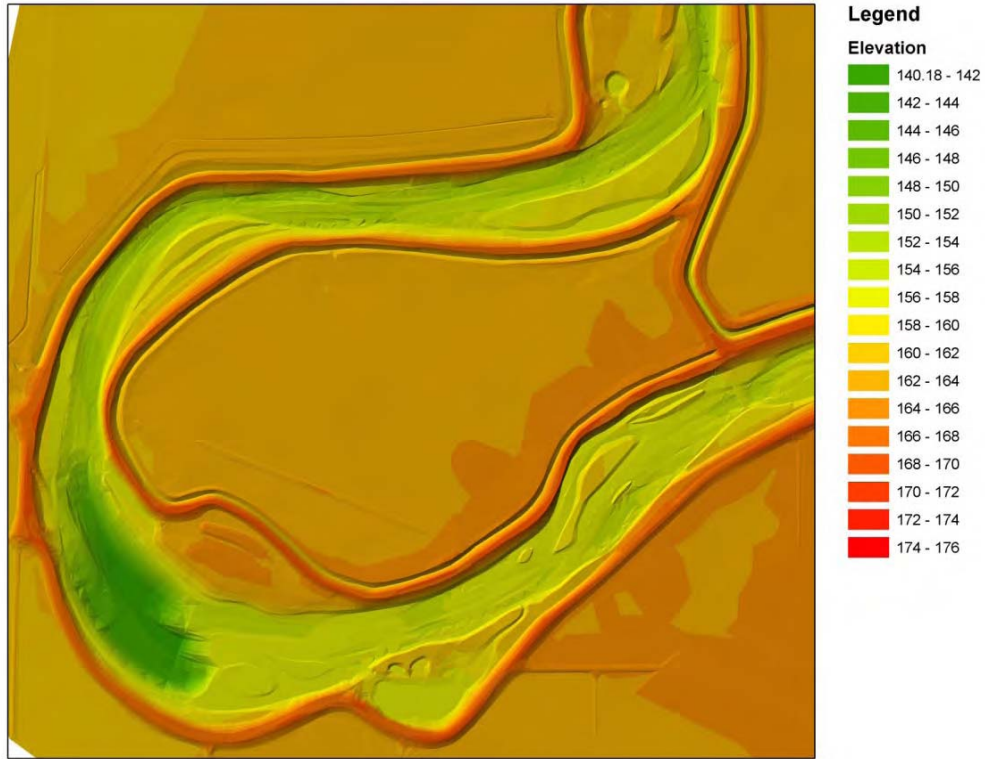
Figure 5-27.
Detailed Topographic Map of Bend in Reach 2b

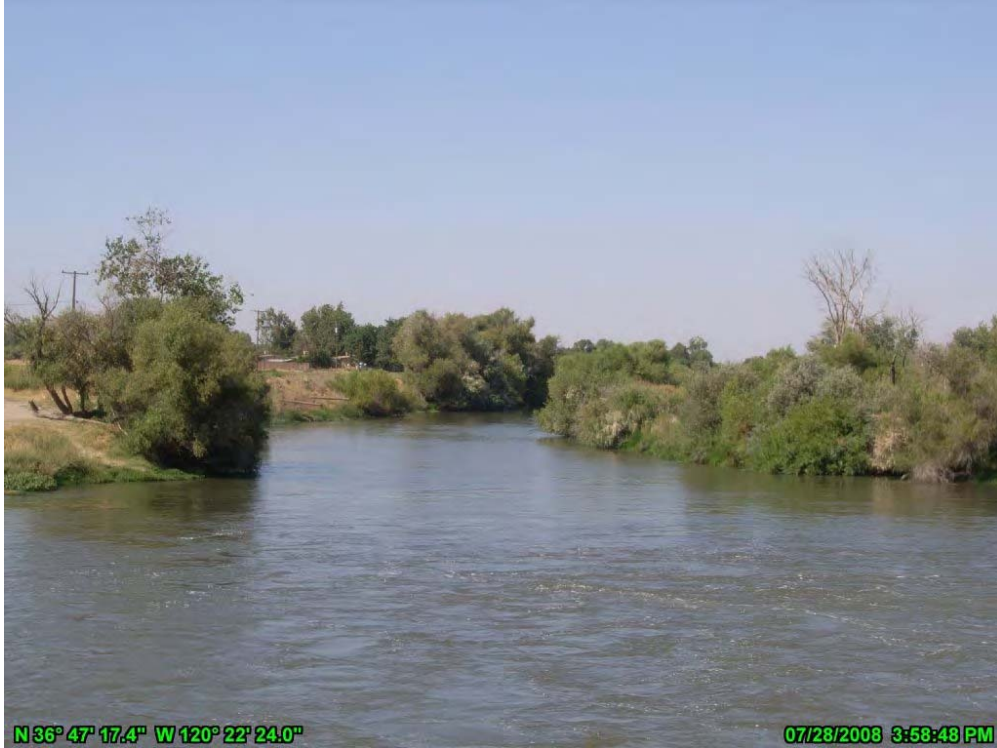
Figure 5-29.
Looking Downstream at Reach 3 from Mendota Dam

6 The increase in flow magnitude under Project Conditions may increase the channel
7 migration and bank erosion rates, but the increase is expected to be minimal and may not
8 be detectable. Because the banks in Reach 3 are densely vegetated (Figure 5-29 and
9 Figure 5-30), the flows under Project Conditions are not anticipated to scour the
10 vegetation from the banks and cause bank erosion. Pre-dam channel migration rates were
11 small in this reach (McBain and Trush 2002). The peak flows under Project Conditions
12 are still much less than the peak flows under pre-dam conditions, and therefore, the rate
13 of channel migration should be small. McBain and Trush (2002) also determined that
14 potential future flows under Project Conditions will likely not be sufficient to erode the
15 well established vegetation and they estimated that channel migration does not occur until
16 the flow exceeds 12,000 cfs.

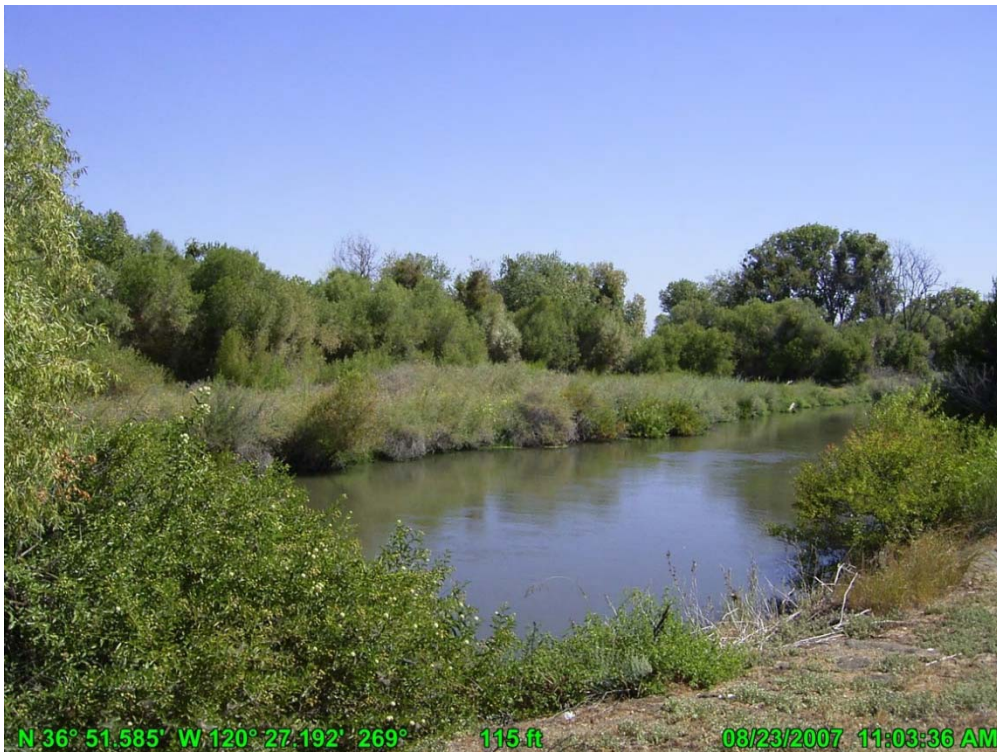
Figure 5-30.
Looking Upstream at Reach 3 near Firebaugh

1 No flow was present in Reach 2b when this photograph was acquired. Figure 5-30 is a
 2 photograph taken from the levee at Firebaugh looking upstream. Figure 5-31 is a
 3 photograph looking downstream from Sack Dam. Some seepage was evident through
 4 Sack Dam at the time of the photograph, but little flow usually enters the river
 5 downstream from Sack Dam, except during flood flows.

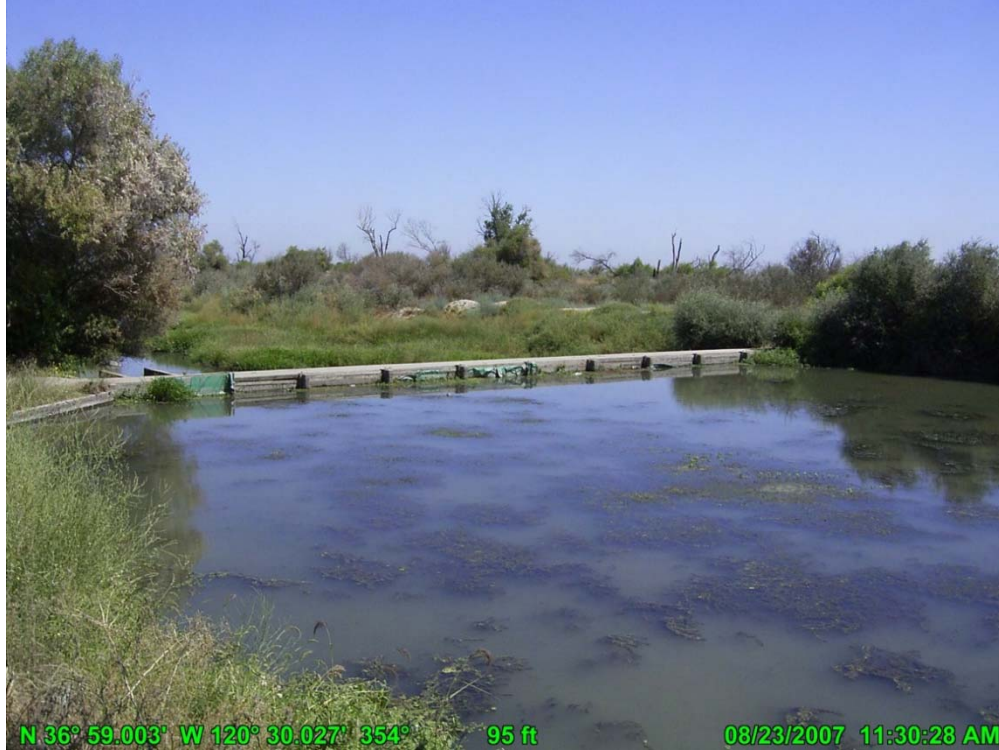
Figure 5-31.
Looking Downstream at Sack Dam

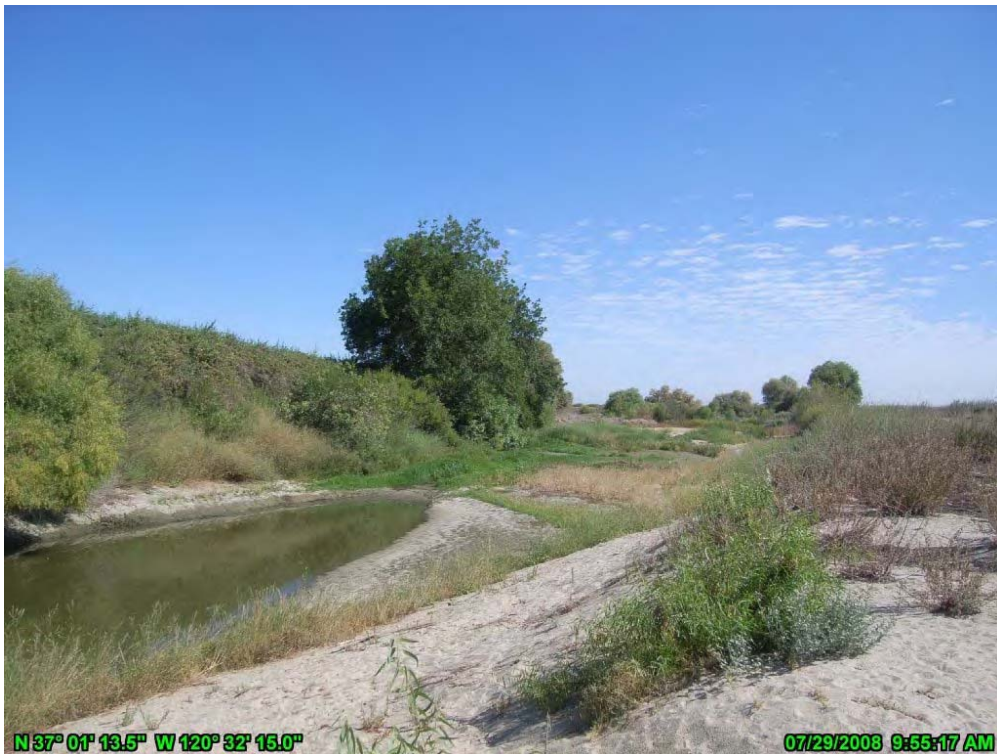
Figure 5-34.
Photograph Showing Pool Supplied by Seepage from Canal Flows or Irrigation Returns (RP 177.1)

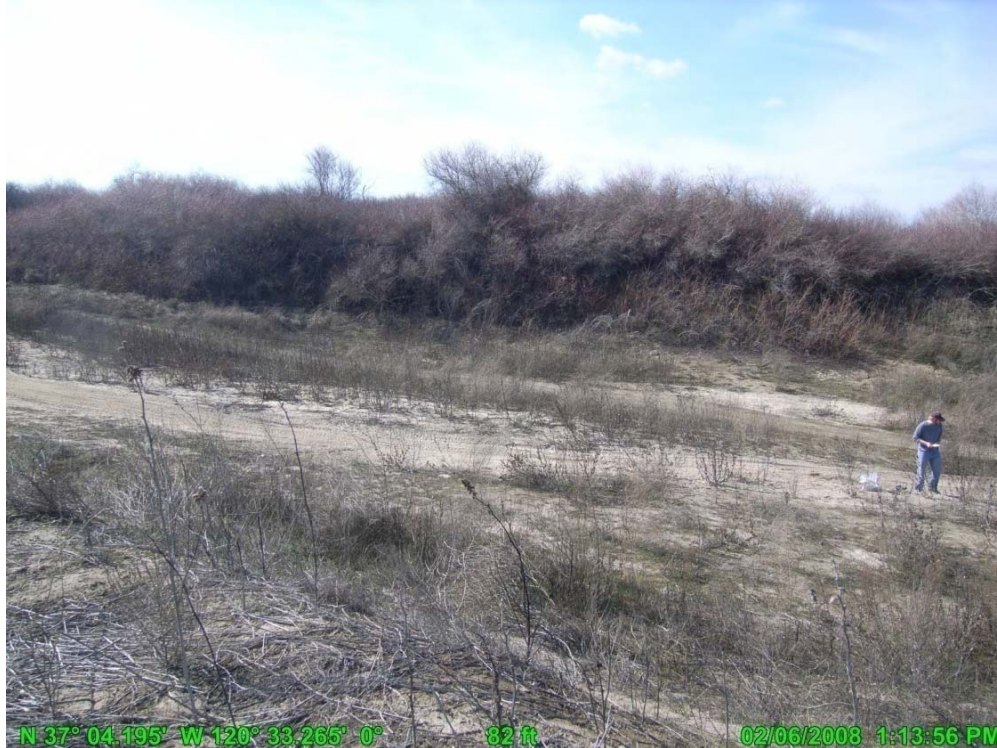
Figure 5-35.
Dry Section of Reach 4a (RP 172.7)

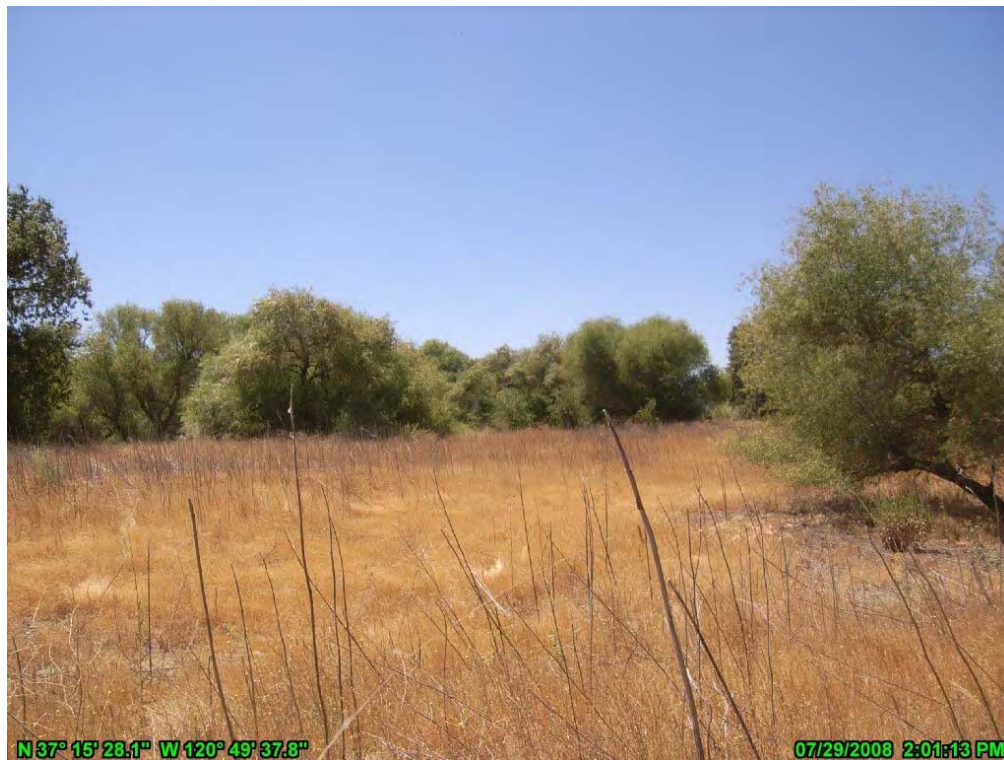
Figure 5-40.
Photograph of Reach 4b2 Looking Downstream near RP 141.2

12 The channel is heavily vegetated and is generally lined by dense woody vegetation or
13 brush (Figure 5-39 and Figure 5-40). Higher floodplain surfaces, however, are generally
14 only covered by grasses (Figure 5-41). Meander rates are low, as described in Reach 4a.
15 Figure 5-42 shows other vegetation types within Reach 4b2.

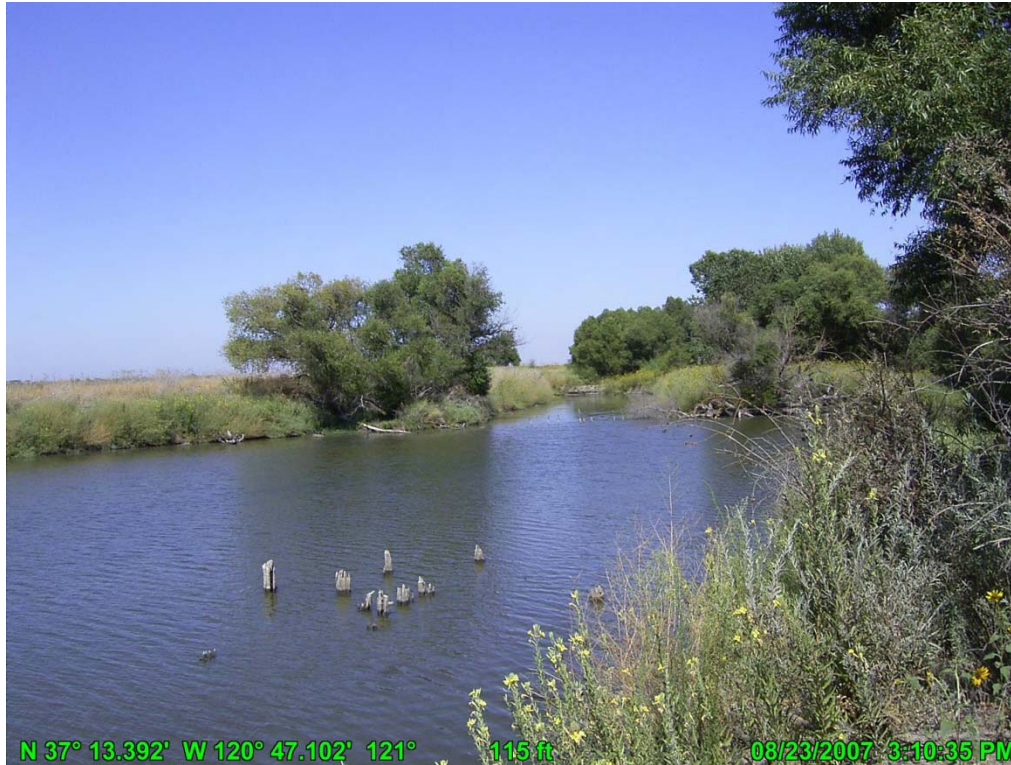
Figure 5-41.
Floodplain Terrace in Reach 4b2 at RP 138.8

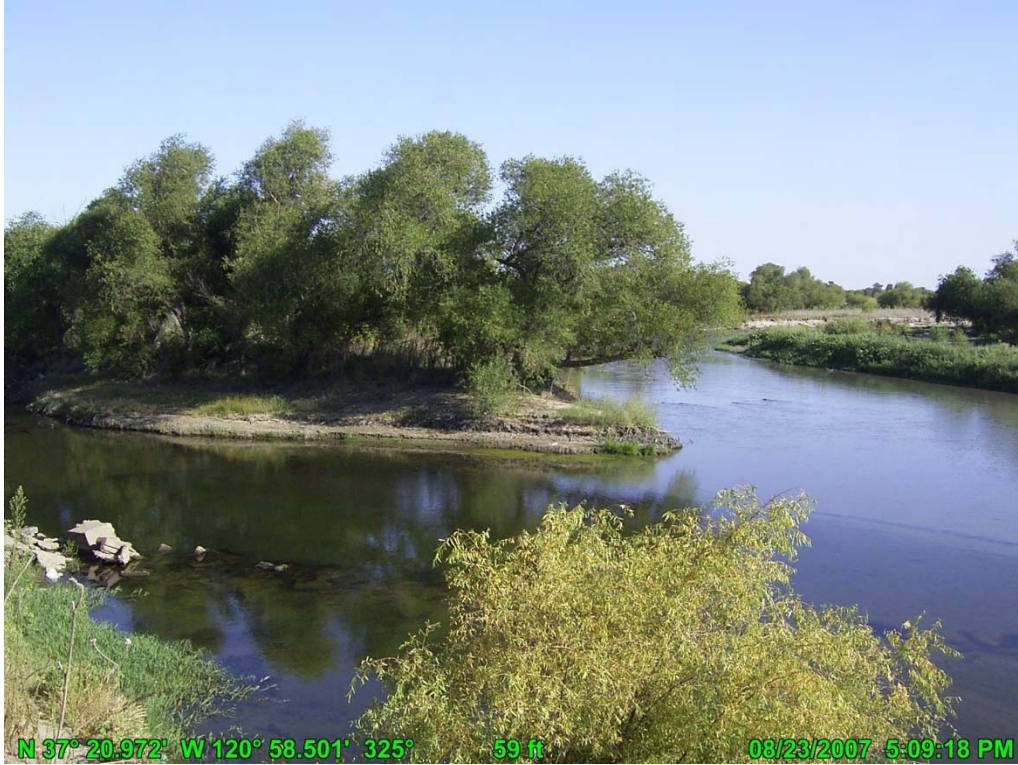
Figure 5-44.
Confluence of San Joaquin and Merced Rivers

11 The historic channel morphology appears to be similar between Reaches 4 and 5
12 (McBain and Trush 2002) with few minor differences (i.e., flows may access the
13 floodplain less in Reach 4b2). MEI (2002b) estimated the capacity of this reach to be
14 over 20,000 cfs. The slope is 0.0002, and the median bed material size is 0.52 mm. The
15 river is generally much wider as it receives larger flows with the return of the water from
16 the Eastside Bypass. A photograph taken at RP 134.1 approximately 1.5 miles
17 downstream from the return of the Eastside Bypass is shown in Figure 5-43. The
18 confluence with the Merced River is shown in Figure 5-44.

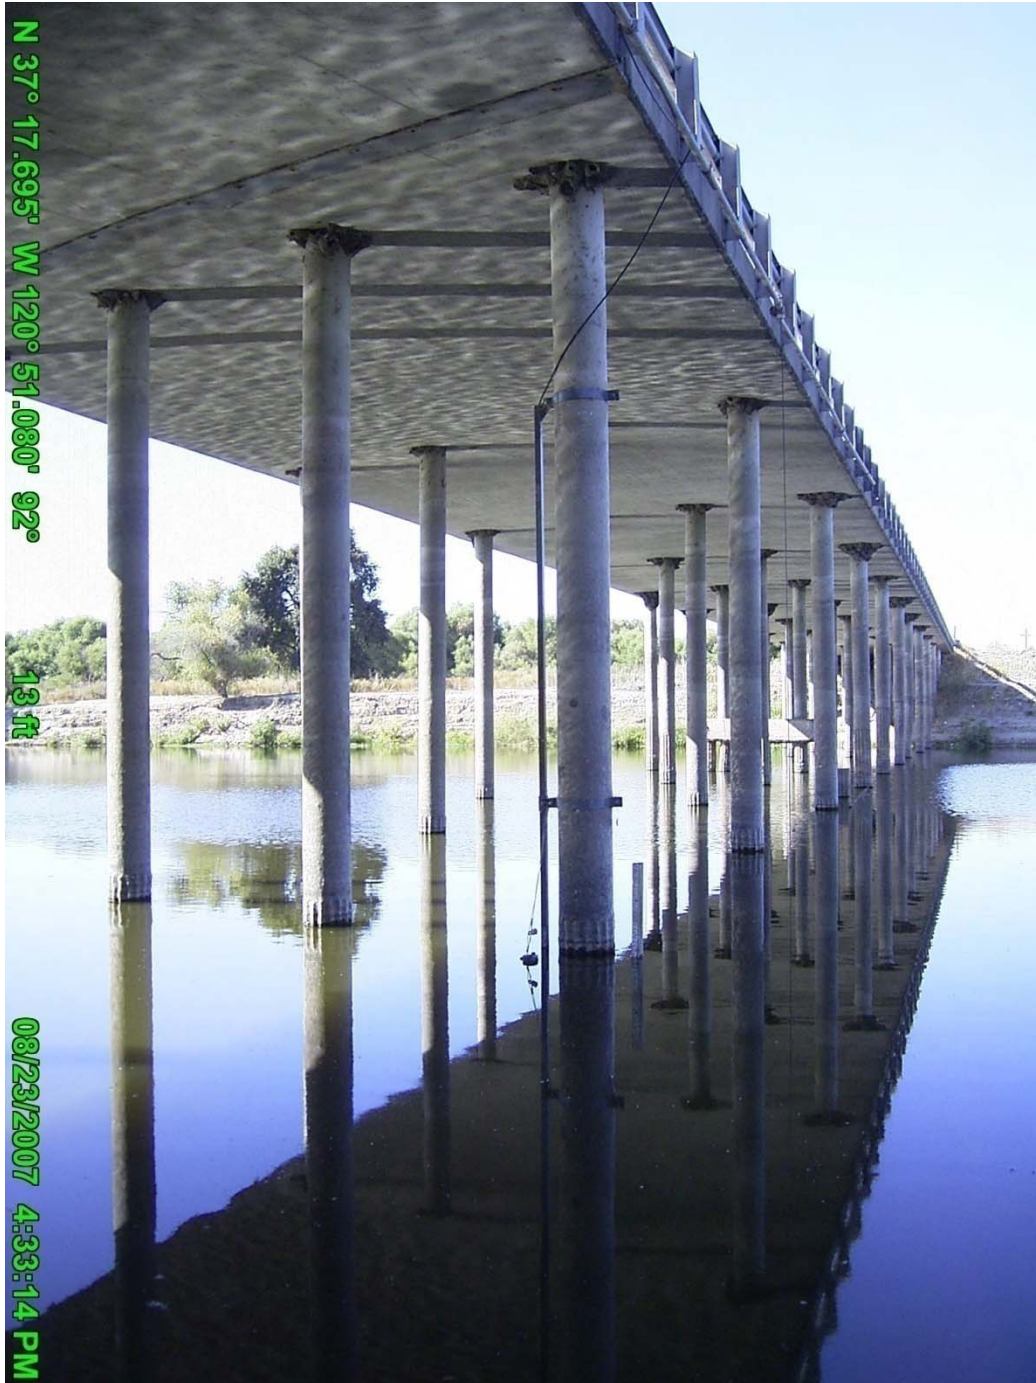
Note:
Degradation is Evident from the Bridge Pier Exposure (Dated 8-23-2007).

Figure 5-45.
Photograph of SH 165 Bridge (RP 132.8)

19 Erosion in this reach is suspected to have taken place as evidenced by the exposure of the
20 bridge piers at SH 165 at RP 132.8. Figure 5-45 illustrates the erosion and was taken in
21 August 2007. By August 2008, the bridge piers were reinforced with steel piers
22 (Figure 5-46). The erosion is most likely driven by the return of relatively sediment-free

1 water from the bypass system. McBain and Trush (2002) determined no change between
2 1972 and 1997 based upon the survey data at the SR 165 bridge. However, the
3 photographs taken in 2007 and 2008 seem to indicate that erosion is now occurring at the
4 SR 165 Bridge. McBain and Trush (2002) also found that a cross section in the upper
5 portion of Reach 5 had degraded 8.5 feet from 1914 to 1998. Based on these findings,
6 erosion may be progressing downstream beginning at the return of the Eastside Bypass.
