5.0 Summary of Results

5.1 Reach 1a

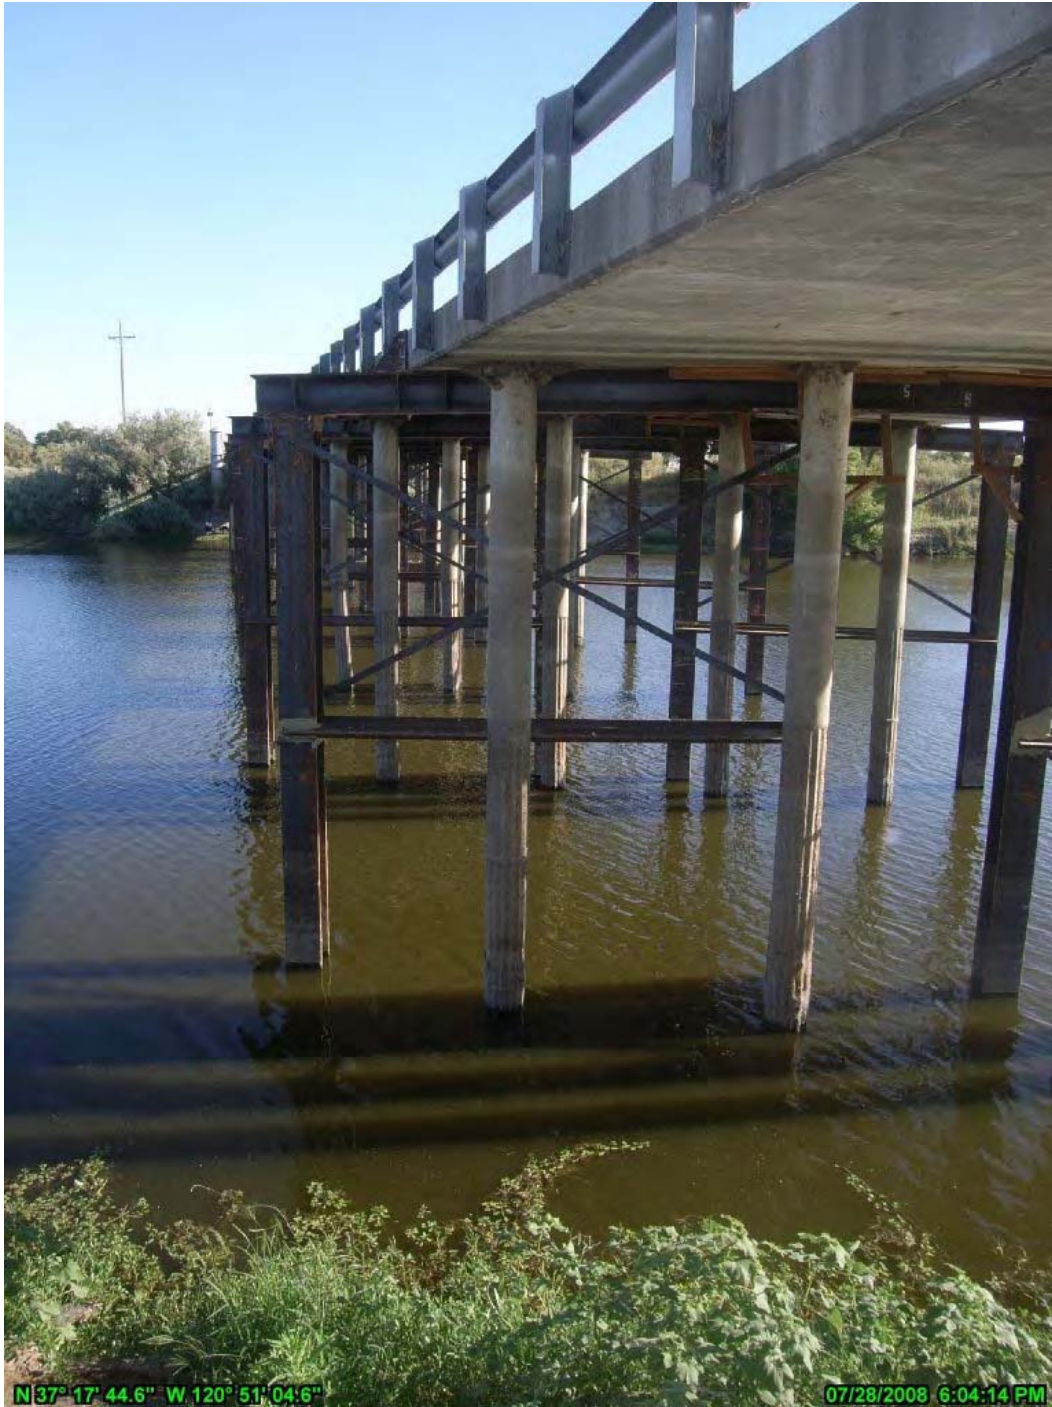
Note:

Degradation is Evident from the Bridge Pier Exposure. Photograph is Taken in 2008 Showing the Structural Reinforcement of the Bridge Piers.

19 Erosion in this reach is suspected to have taken place as evidenced by the exposure of the
20 bridge piers at SH 165 at RP 132.8. Figure 5-45 illustrates the erosion and was taken in
21 August 2007. By August 2008, the bridge piers were reinforced with steel piers
22 (Figure 5-46). The erosion is most likely driven by the return of relatively sediment-free

1 water from the bypass system. McBain and Trush (2002) determined no change between
2 1972 and 1997 based upon the survey data at the SR 165 bridge. However, the
3 photographs taken in 2007 and 2008 seem to indicate that erosion is now occurring at the
4 SR 165 Bridge. McBain and Trush (2002) also found that a cross section in the upper
5 portion of Reach 5 had degraded 8.5 feet from 1914 to 1998. Based on these findings,
6 erosion may be progressing downstream beginning at the return of the Eastside Bypass.

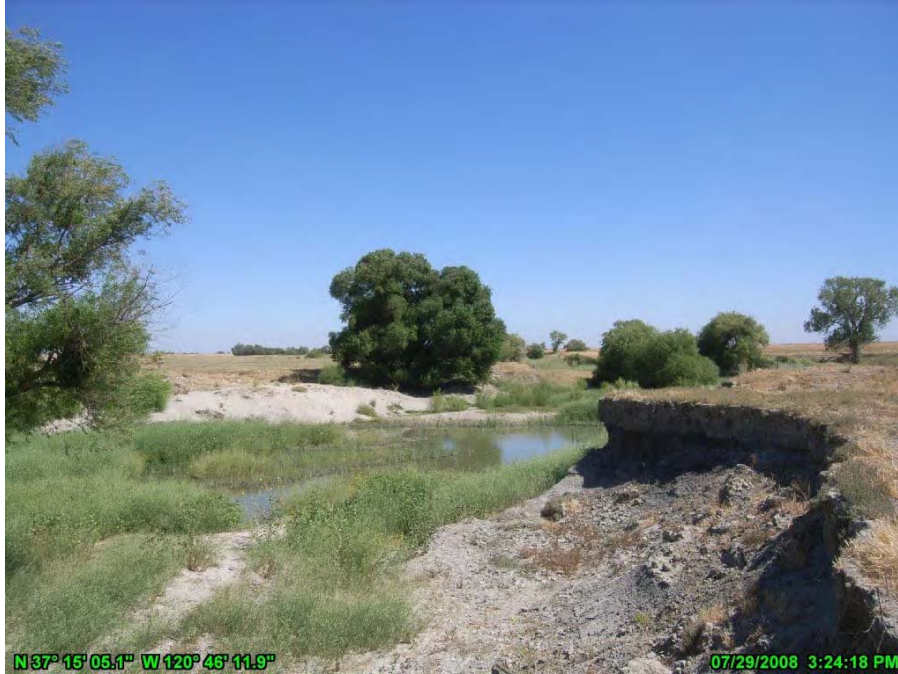
Figure 5-48.
Looking Upstream at Eastside Bypass, Approximately 4 miles Upstream from the
Confluence with the San Joaquin River, Downstream from the Confluence with
Bear Creek

17 The bed elevation of the lower Eastside Bypass has lowered over time, particularly below
18 the confluence with Bear Creek (Figures 5-48 and 5-49). The base-level control for the
19 lower Eastside Bypass is the upstream portion of Reach 5, and Reach 5 appears to have
20 also experienced degradation in the recent past (Section 5.9.1). Therefore, both the lack
21 of sediment supply to the Eastside Bypass and the lowering of the base-level control in
22 Reach 5 would contribute to additional bed degradation in the lower Eastside Bypass.

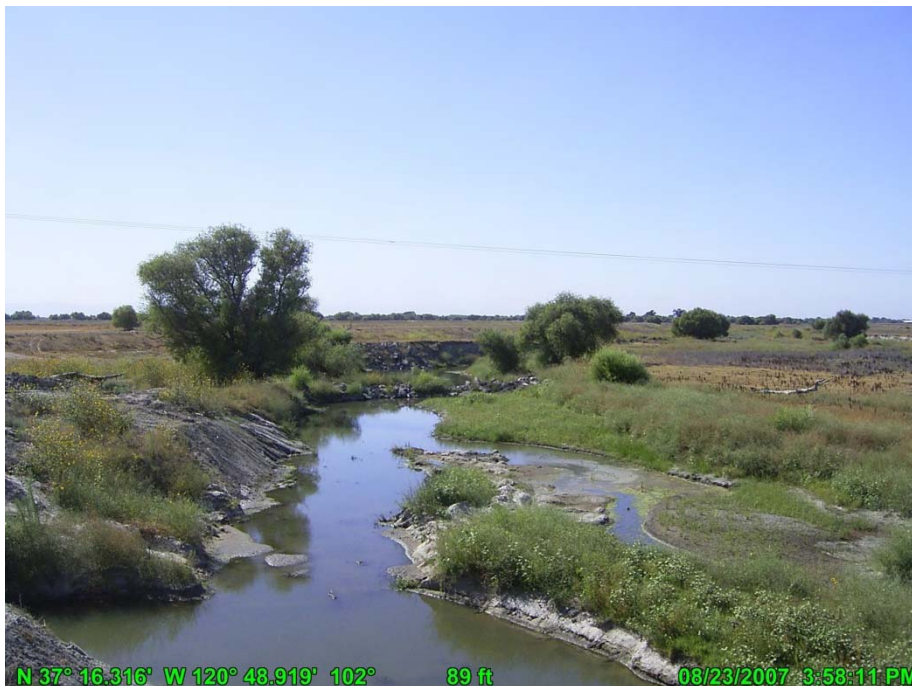
Figure 5-49.
Picture looking Downstream on Bear Creek. After Confluence of Eastside Bypass
and Bear Creek, Approximately 1 Mile Upstream from Confluence with
San Joaquin River

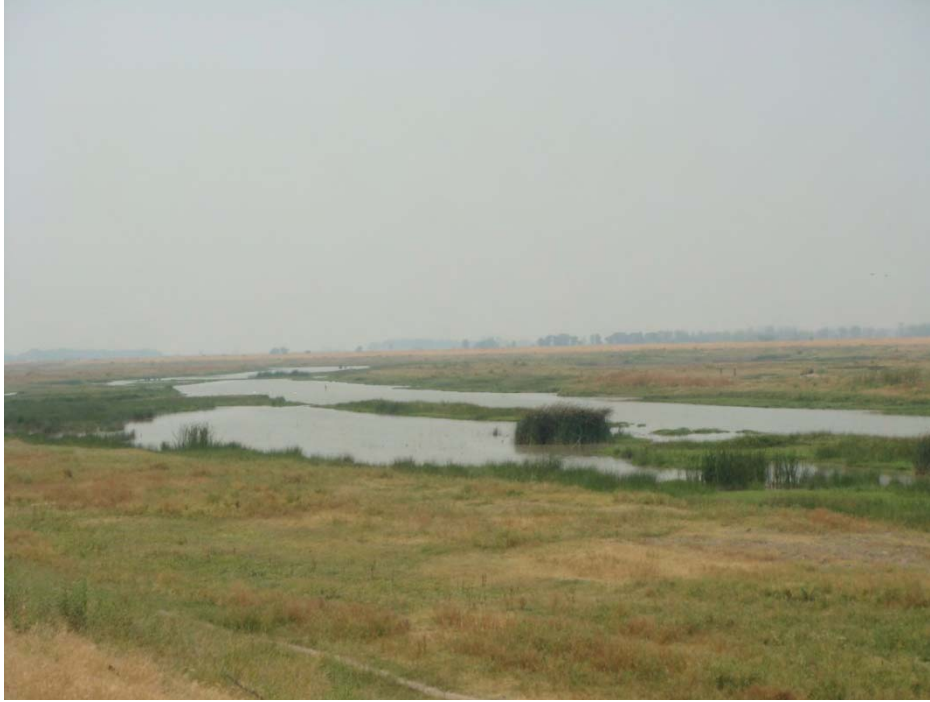
Figure 5-50.
Looking Downstream from El Nido Stream Gage. Approximately 2.5 Miles
Downstream from Sand Slough Control Structure

23 The bypass system is mostly covered by grasses and is devoid of woody vegetation (see
24 Figures 5-50, 5-51, and 5-52). The combination of a lack of base flow and possibly the
25 soil conditions prevent establishment of woody species. More vegetation is present within
26 the incised lower Eastside Bypass (Figure 5-53). This may be due to more base flow in
27 the lower Eastside Bypass resulting from flow contributions from Bear Creek and other
28 smaller tributaries. The incised channel in the lower Eastside Bypass is developing a
29 floodplain within the incised channel. The process in the lower Eastside Bypass below
30 Bear Creek confluence is similar to the conceptual channel development model of Simon
31 (1989), where a disturbance introduces channel incision, followed by channel widening,
32 followed by a development of alluvial channel and floodplain.

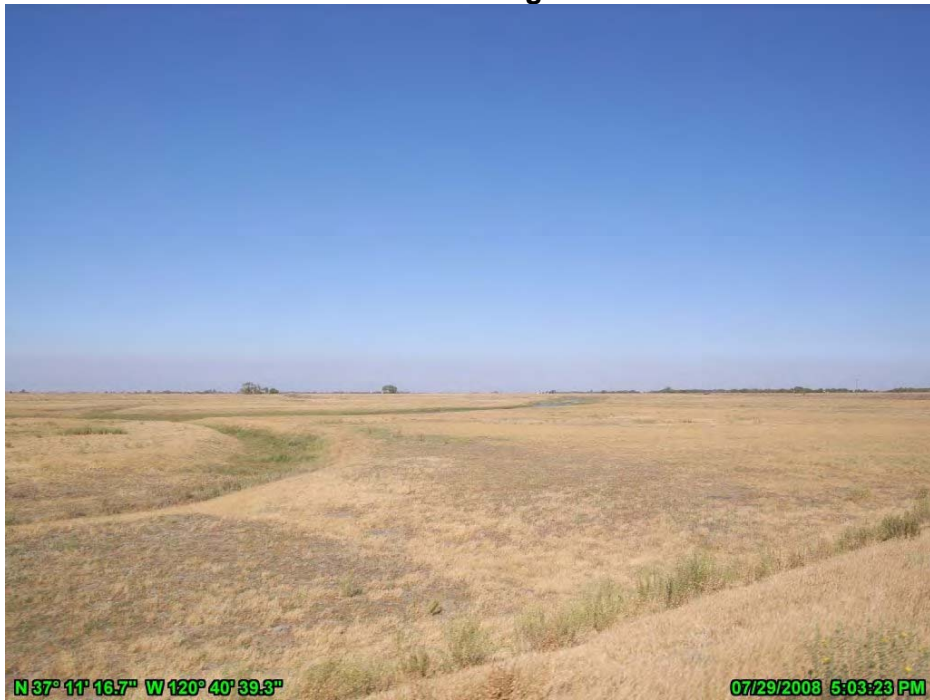
Figure 5-51.
Looking Upstream at Eastside Bypass. Approximately 1 Mile Upstream from the
Mariposa Control Structure

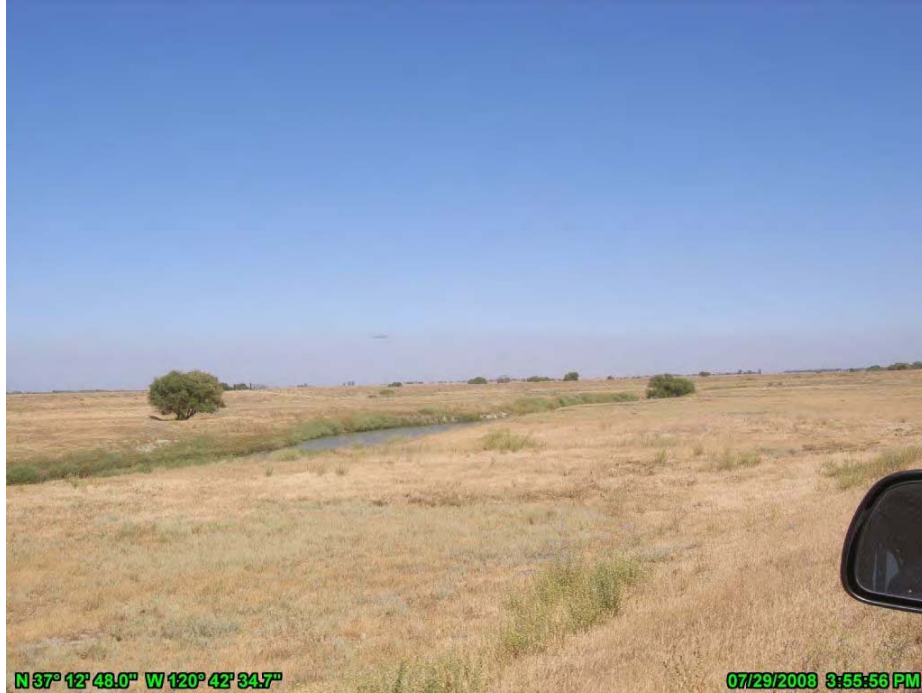
Figure 5-52.
Looking Upstream at Eastside Bypass. Approximately 8 Miles Upstream from the Confluence with the San Joaquin River, 1.5 Miles Downstream from Mariposa Bypass Channel

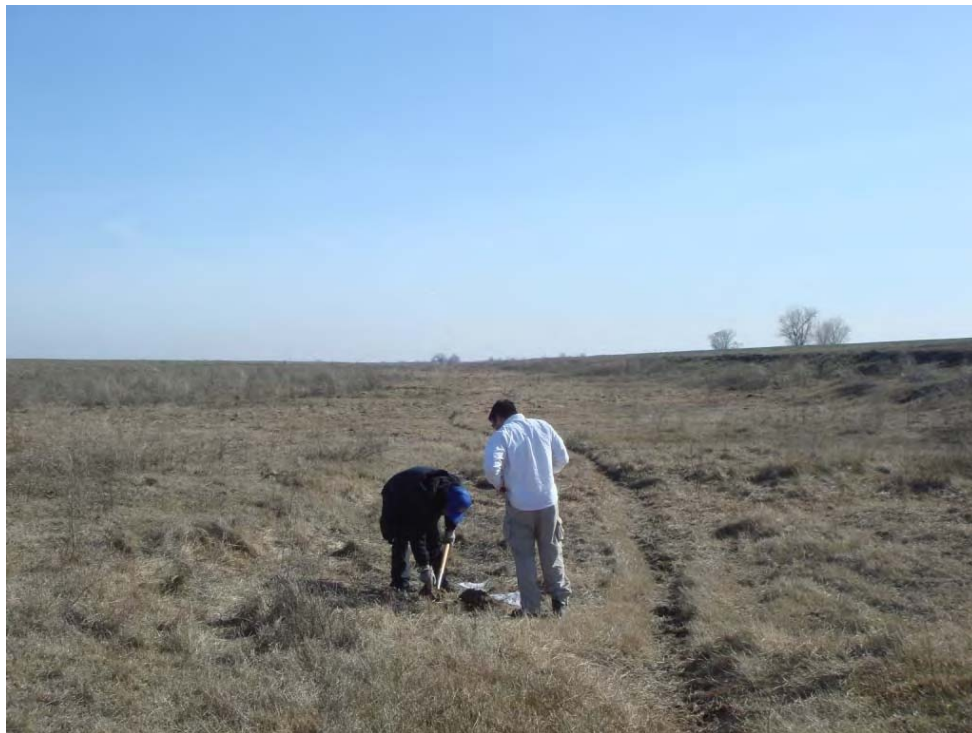
Figure 5-55.
Looking Upstream in Mariposa Bypass

3 The Mariposa Bypass is similar in bed material and vegetation to the upper Eastside
4 Bypass (Figures 5-54, 5-55, 5-56, and 5-57). The width is constant at 700 feet, and the
5 slope is 0.00019, which is similar to the slope of Reaches 3, 4, and 5. A gated control
6 structure is located at the upstream end of the reach, and a concrete grade control is
7 located at the downstream end before it enters the San Joaquin River. Scour pools are
8 present downstream from structures that are about 14 to 16 feet deep, based upon the
9 1998 survey of the U.S. Army corps of Engineers. There is also an approximately 8-foot
10 drop in average bed elevation across the downstream grade control. Overall degradation
11 in Mariposa Bypass is limited due to the grade control at its downstream end.

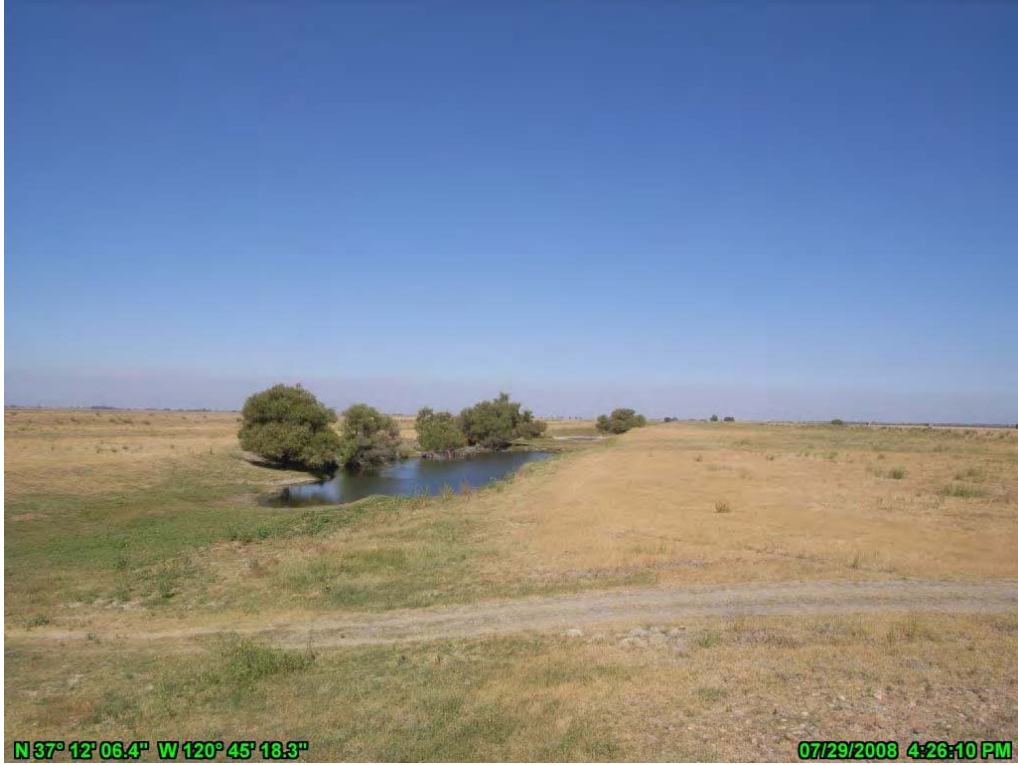
Figure 5-56.
Looking Upstream from Downstream Grade Control on Mariposa Bypass

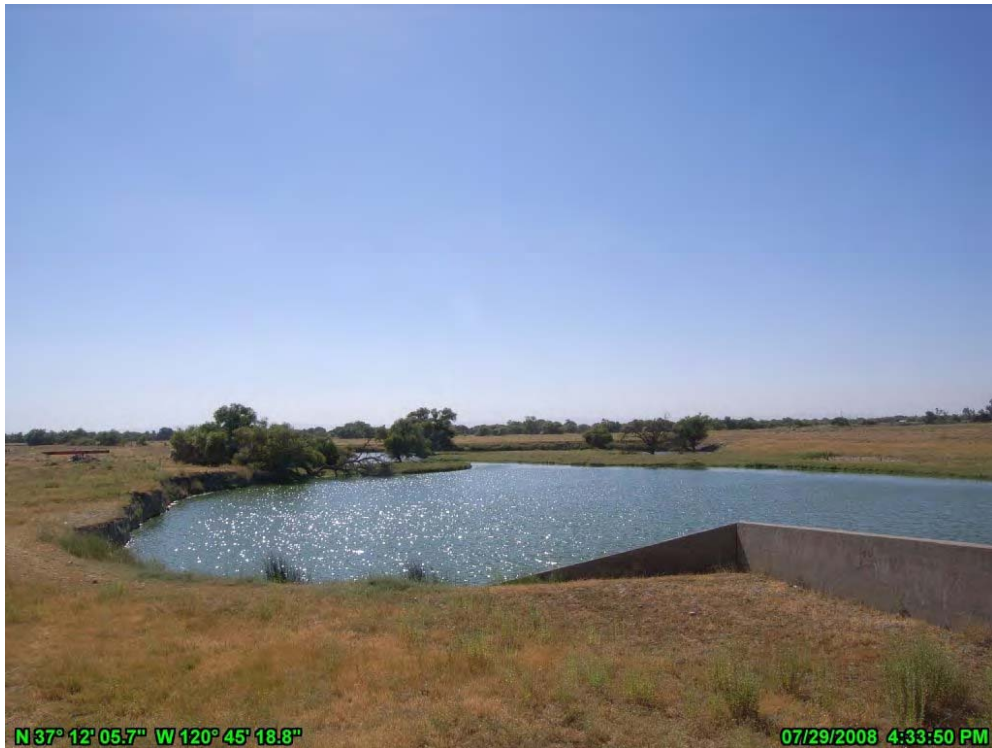
Figure 5-57.
Looking Downstream from Downstream Grade Control on Mariposa Bypass
