Hydraulic Laboratory Report HL-2018-04

St. Mary Diversion Dam, Rock Ramp & Fish Screen Model Study

August 2018

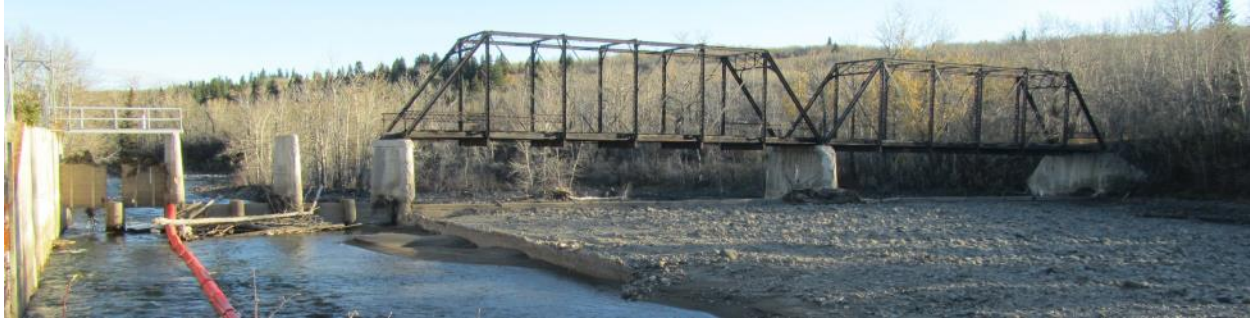
Figure 3. Existing St. Mary Dam Diversion weir, sluiceway and abandoned bridge during low flow fall season (the view is from the upstream left bank).

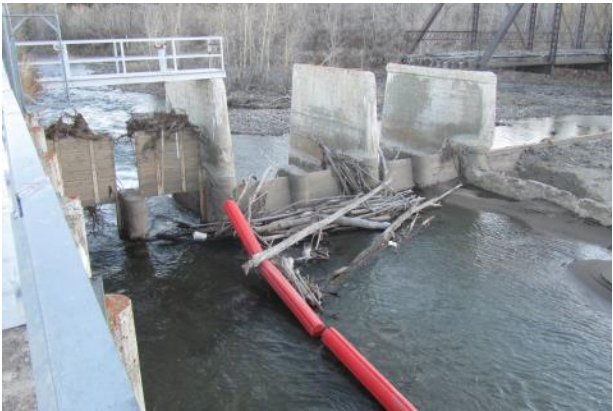
Figure 4. St. Mary Diversion sluiceway gates (the view is from the upstream left bank, standing on top of the headworks structure).

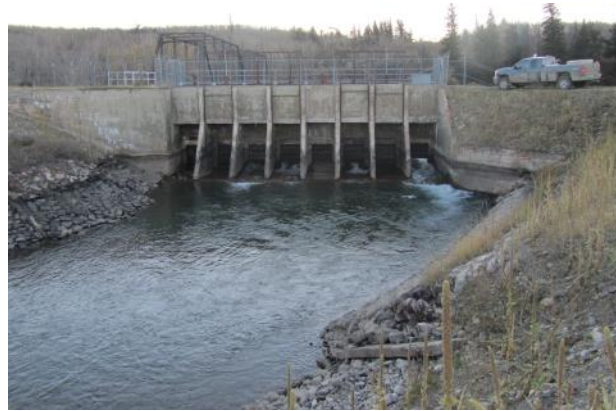
Figure 5. St. Mary Diversion headworks structure (the view is from downstream of the headworks, with flow towards the reader).

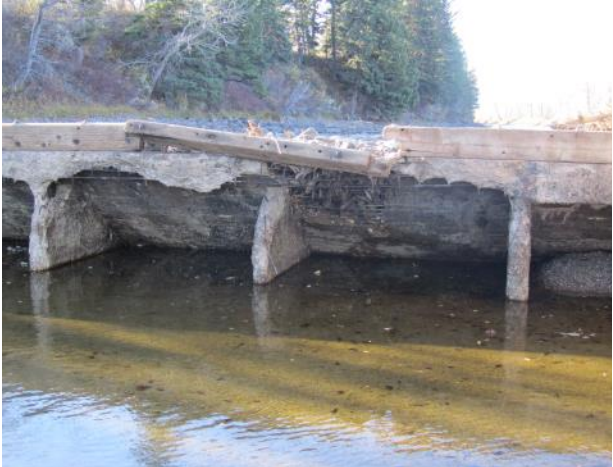
Figure 6. St. Mary Diversion weir concrete failure and exposed rebar.

Recent examinations of the 100-year old diversion dam, headworks, and canal revealed substantial freeze-thaw damage to exposed concrete surfaces. Concrete core samples taken from the piers on the dam and sluiceway indicated the condition of the concrete is very poor where exposure to ice and frequent freeze-thaw cycles have degraded the strength (Mefford 2003). Based on available inspection data and visits to the structure, the weir (Figure 6), abutments (Figure 7), piers (Figure 8), sluiceways (Figure 9) and diversion headworks will likely all require demolition and replacement in the near future. Each year, continued modifications and repairs to the facility are made which greatly reduce the risk of catastrophic failure of the structures until replacement is possible.

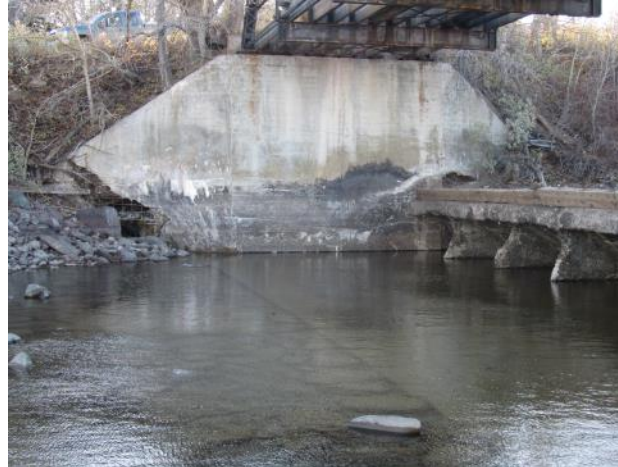
Figure 7. St. Mary Diversion right abutment damage and exposed rebar.

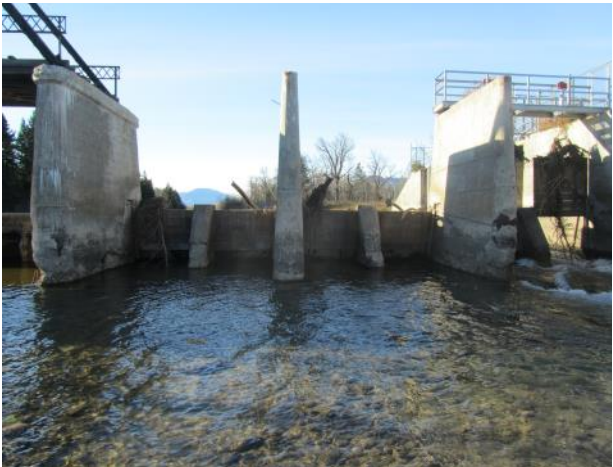
Figure 8. Concrete degradation on the downstream end of piers surrounding sluice bays.

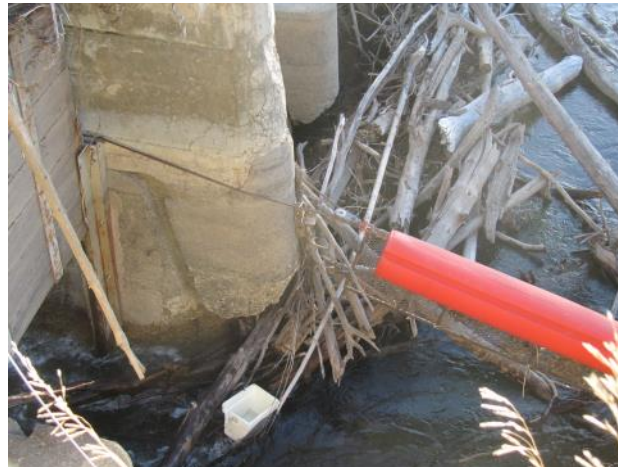
Figure 9. Concrete degradation on the upstream sluice bay pier noses.

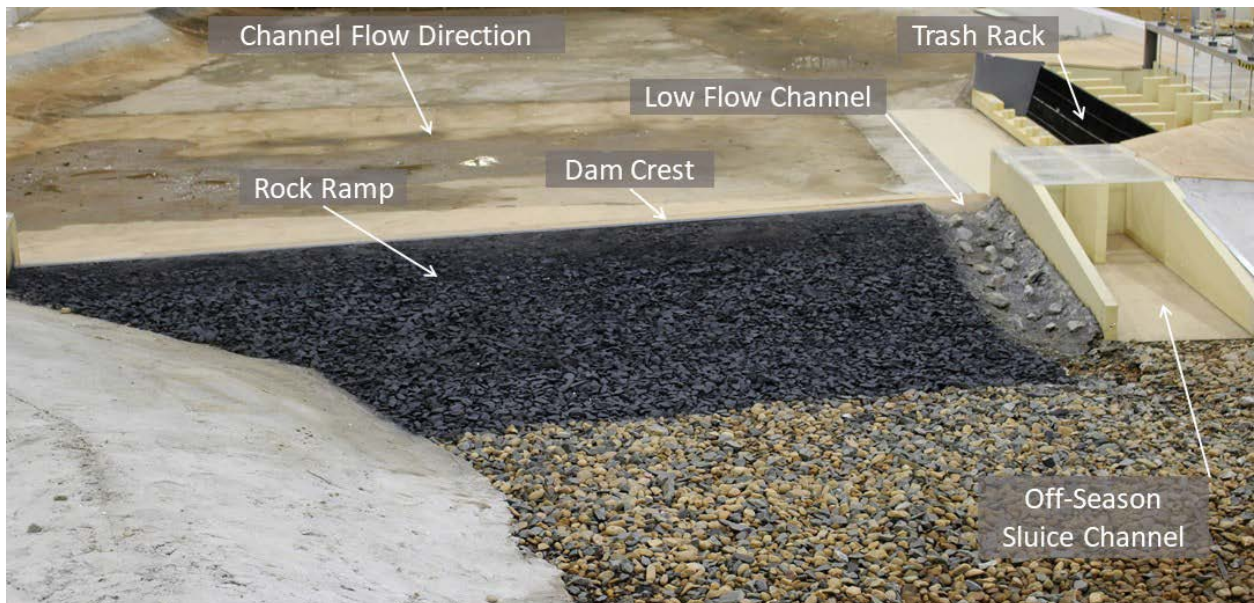
Figure 21. Rock ramp, low flow channel, off-season sluice, dam crest and trashrack (the view is from the downstream middle of river channel).

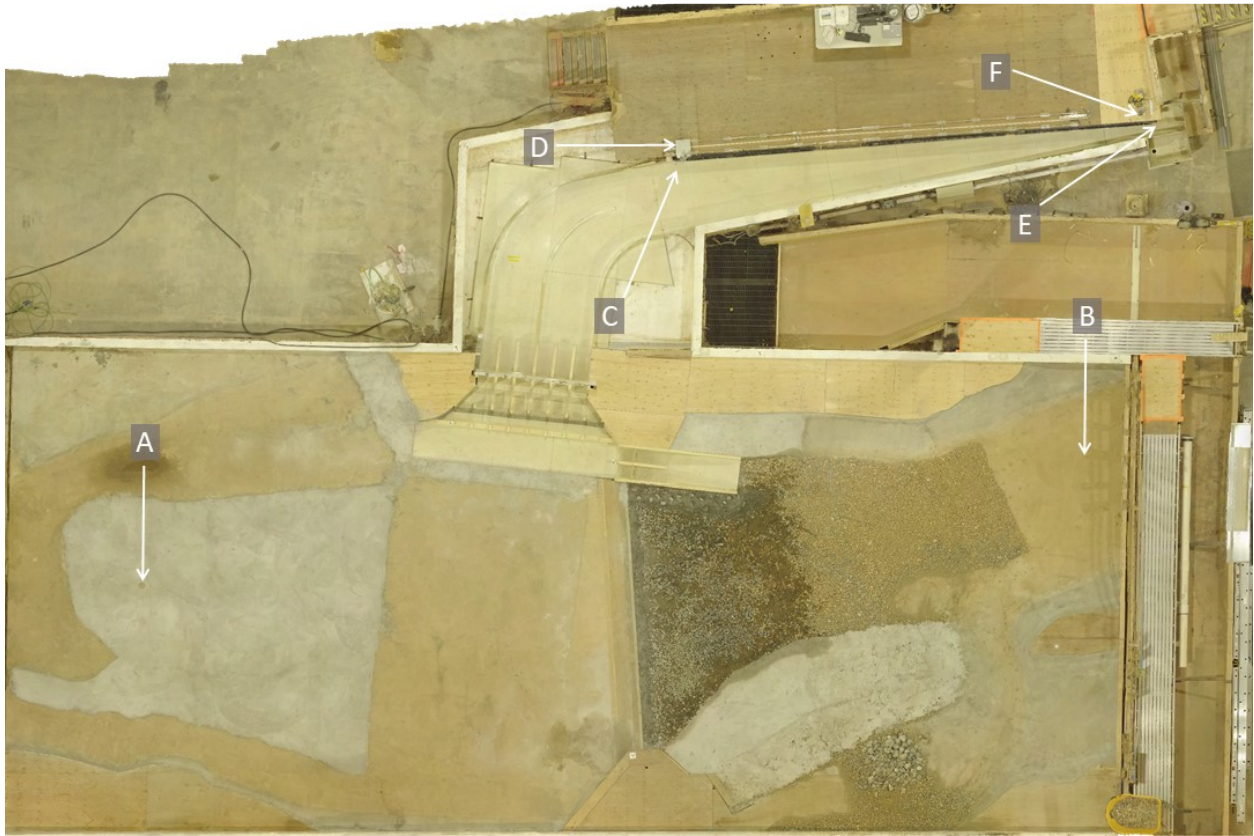
Figure 24. Location of head measurements taken in the St. Mary Diversion Dam model.

Piezometer taps and stilling wells were equipped with ultrasonic level sensors (Massa Pulstar Plus 150 kHz), with an accuracy of $\pm 0.1\%$ of the target range (24 inches) and a measurement resolution of 0.01 inches. Point gauges accurate to 0.001-ft were also attached to each stilling well providing redundancy and a method to calibrate the electronic sensors if necessary. Figure 24 shows the 6 locations where water surface data were collected in the model: A) upstream river channel, B) downstream river channel, C) screen #1 upstream side (where fish will be), D) screen #1 downstream of the fish screen (non-fish side), E) screen #30 upstream side, just upstream of the entrance to the bypass channel (where fish will be), and F) screen #30 downstream side, just upstream of the canal check control structure (non-fish side). The target water surface elevation in the diversion channel upstream of the fish screen (Location C) was controlled by adjusting a slide gate located downstream of the screen in the same location as the check gates in the prototype. It was also necessary to ensure that the water surface elevation at location F remained above 4471.0 which is the normal water surface elevation of the canal.

Gate operations for both 600 and 850 ft³/sec diversion rates were investigated. To gain the best velocity uniformity over the fish screen it is recommended that symmetrical gate operation be used with at least 4 gates open for the 600 ft³/sec diversion and all 6 gates open for the 850 ft³/sec. Table 3 and Figure 32 provide the gate openings and headworks loss information for a canal diversion of 600 ft³/sec (600 ft³/sec + 40 ft³/sec bypass total flow through headworks). Table 4 and Figure 33 provide the gate openings and headworks loss information for a canal diversion of 850 ft³/sec (850 ft³/sec + 40 ft³/sec bypass total flow through headworks). As the flows in the St. Mary River increase, gate openings decrease which increases the total head loss across the headworks for both canal diversion rates. Total head loss across the headworks was measured in the model by taking the difference between the upstream river water surface elevation (Location A in Figure 24) and the water surface elevation in the fish screen section on the fish side of screen number 1 (Location C in Figure 24).

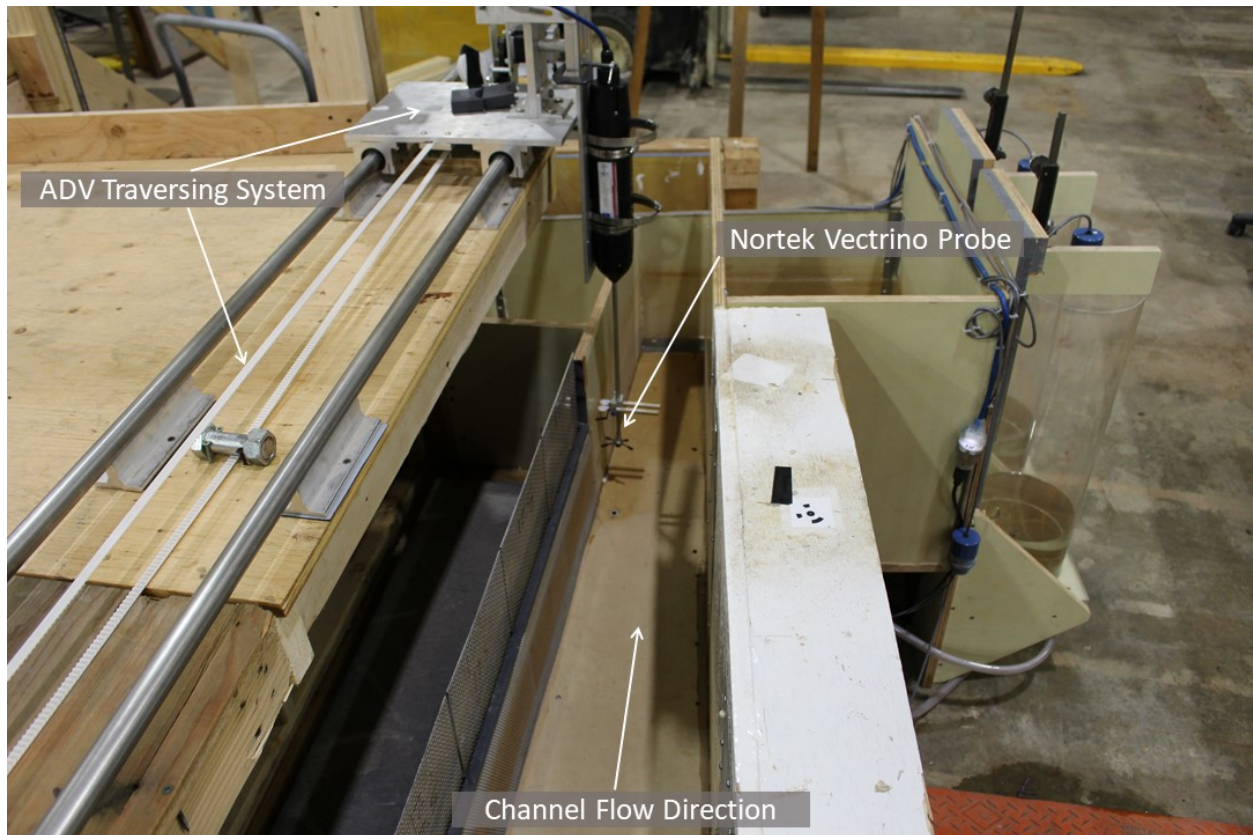
Figure 25. Nortek Vectrino+ 3D velocimeter mounted in the model at 0.50 depth centered at the end of screen number 30.

Three-dimensional velocity data were collected at the fish screen using a Nortek Vectrino+ side looking 3-D velocimeter (Figure 25) with an accuracy of $\pm 0.5\%$ of measured value. The approach (perpendicular to the screen) and sweeping velocities (parallel to the screen) were measured 1.375 inches in front of the screen face in the model (1.375-ft prototype), which was as close to the screen as the instrumentation would allow. Screen measurements during field verification tests of fish screens are recommended to occur at a prototype distance of 3-in (0.25-in. model) (Mefford 2009), but this was not possible due to model scale and instrument limitations relating to interference with boundaries and acoustic reflections off the screen and baffles. Velocity patterns and distributions in the model will be similar in direction and location to those in the prototype, but will not provide the scaled velocity magnitudes that would be obtained when measuring 0.25-in (3-in prototype) from the screen face. For this reason, all velocity measurements presented in this report are used solely to identify uniformity of approach velocity. All velocity measurements in this report are referred to in prototype units unless noted otherwise.

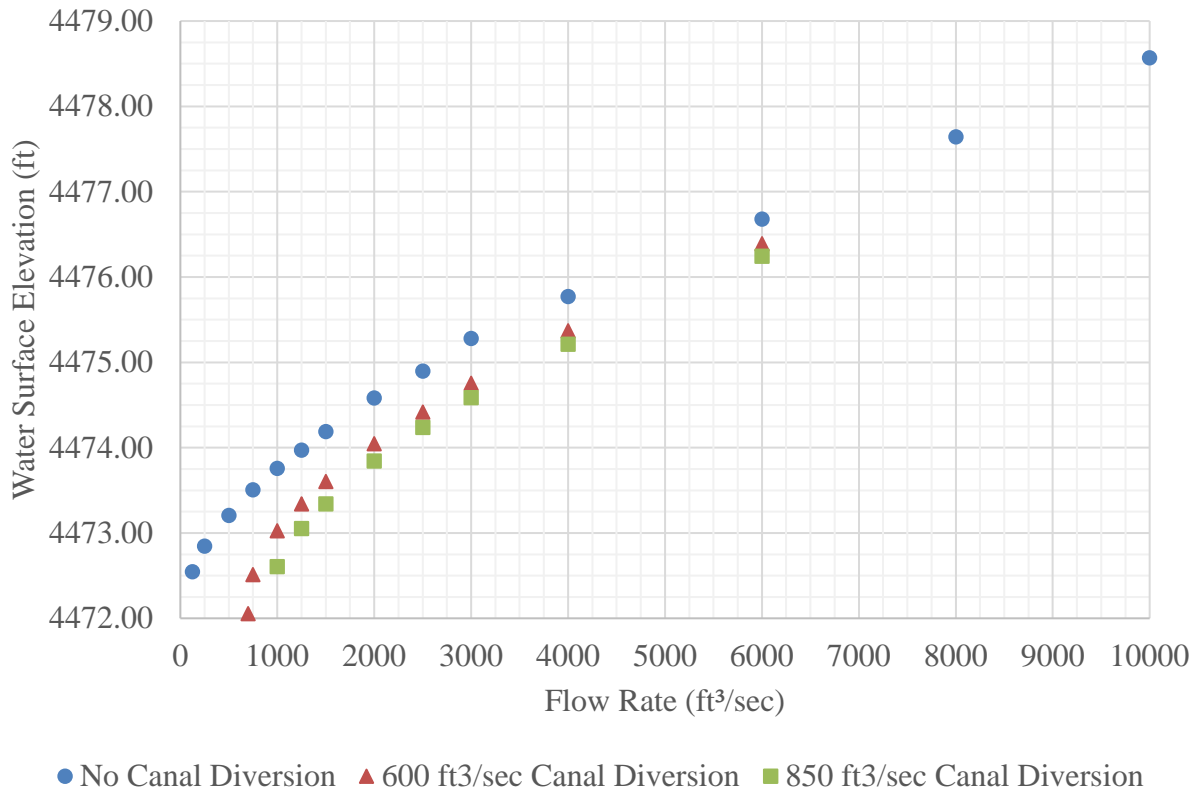
Figure 26. Rating Curves for the St. Mary Diversion Dam with No Diversion, 650 ft³/sec and 850 ft³/sec passing down the canal diversion (additional details in Appendix B).

The model study was conducted with a range of river flow rates from 125 ft³/sec up to 10,000 ft³/sec, the 100-year flood based on an analysis of mean daily flow rates (Cheng 2011), and with diversion canal flow rates of 0, 600 and 850 ft³/sec. Rating curves were developed for the dam structure with no diversion flow and with diversion canal flow rates of 600 and 850 ft³/sec. When the diversion canal was operating, the fish bypass was set to the expected normal bypass flow rate of around 40 ft³/sec. Figure 26 provides a plot of four rating curves for the St. Mary Diversion Dam including no diversion, 600 ft³/sec and 850 ft³/sec passing down the diversion. Appendix B provides both tabulated and plotted rating curves for each tested condition.

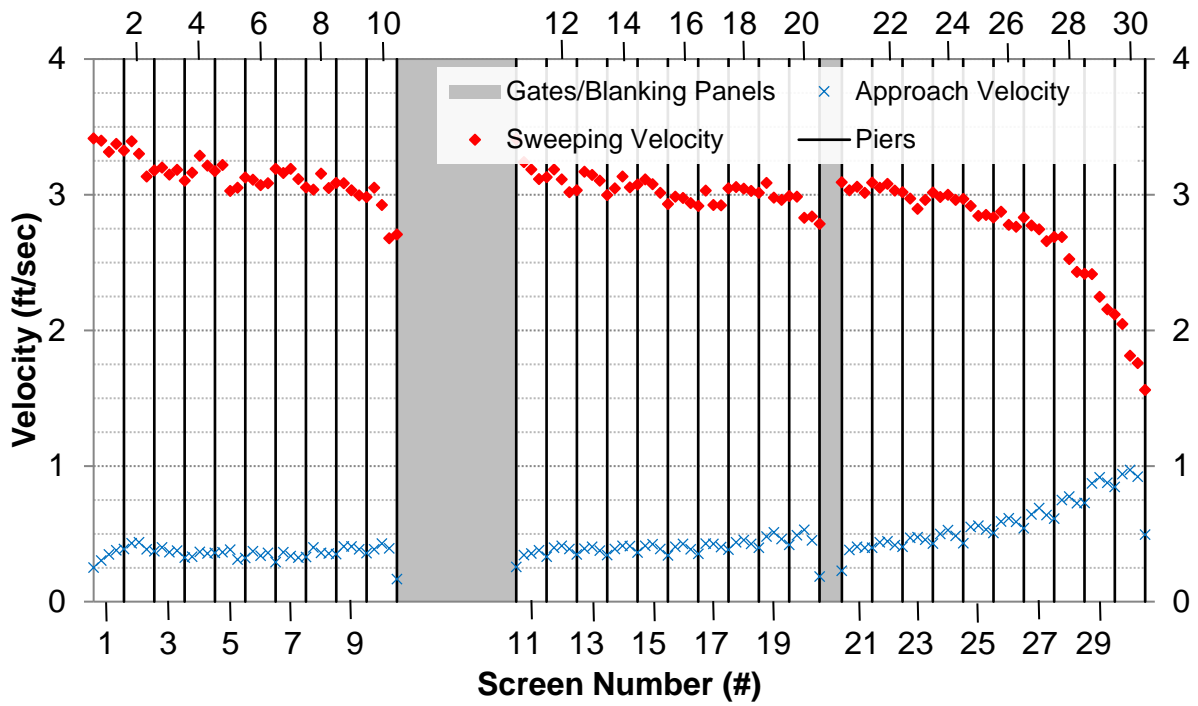
Figure 27. Approach and sweeping velocities at 600 ft³/sec diversion with baffle 100% open.

Figure 27 and Figure 28 provide the measured sweeping and approach velocities for 600 ft³/sec diversion with and without baffles, respectively. Figure 29 and Figure 30 provide the measured sweeping and approach velocities for 850 ft³/sec diversion with and without baffles, respectively. The x-axis on each plot represents the screen location with screen 1 (closest to the headworks) on the left side and screen 30 (closest to the fish bypass) on the right side, the numerical numbering of screens increases in the direction of flow (left to right). Vertical black lines representing the support piers between each screen are shown but not labeled. Blanking panels are included between gates 20 and 21 (grayed area), where a movable cleaning system will rest when not in operation. The blanking panel between screens 10 and 11 (grayed area) includes a gate structure, which will allow equipment to pass between the upstream and downstream side of the screen.

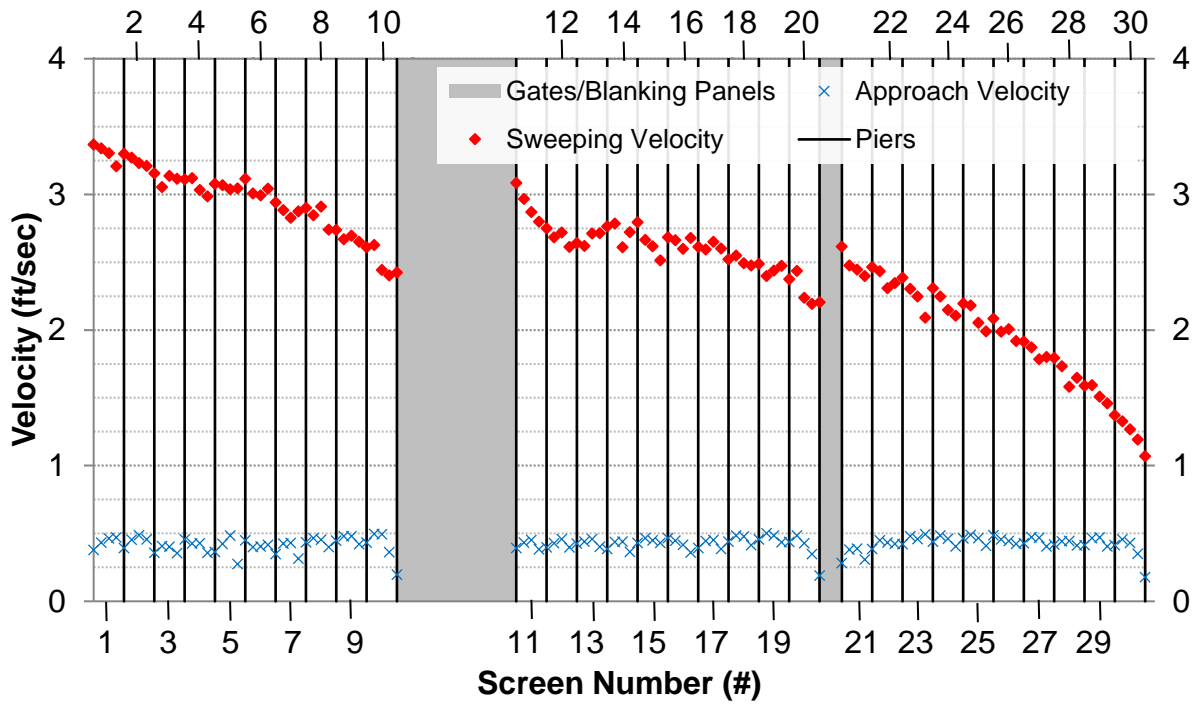
Figure 28. Approach and sweeping velocities at 600 ft³/sec diversion with baffles installed (25% screens 1-10, 20% screens 11-20, and 17.5% screens 21-30).

Baffling downstream of the fish screen at each flow condition was required to uniformly distribute approach velocities across the screen. Numerous screen baffle configurations were tested in the laboratory to best meet approach velocity uniformity requirements ($\pm 10\%$ of average measured approach velocity). Baffles set at 25% open area for screens 1-10, 20% open area for screens 11-20 and 17.5% open area for screens 21-30 were found to maintain approach velocities that were within $\pm 10\%$ of the average measured approached velocity for both the 600 ft³/sec and 850 ft³/sec diversion rates. Velocity uniformity requirements were not met for a few screens near the blanking panels and gate sections. The locations where screens did not meet criteria were minimal and were always present regardless of the baffle configuration. This only becomes a concern when diverting 850 ft³/sec, because this is the only condition where velocities might exceed the 0.8 ft/sec design requirement.

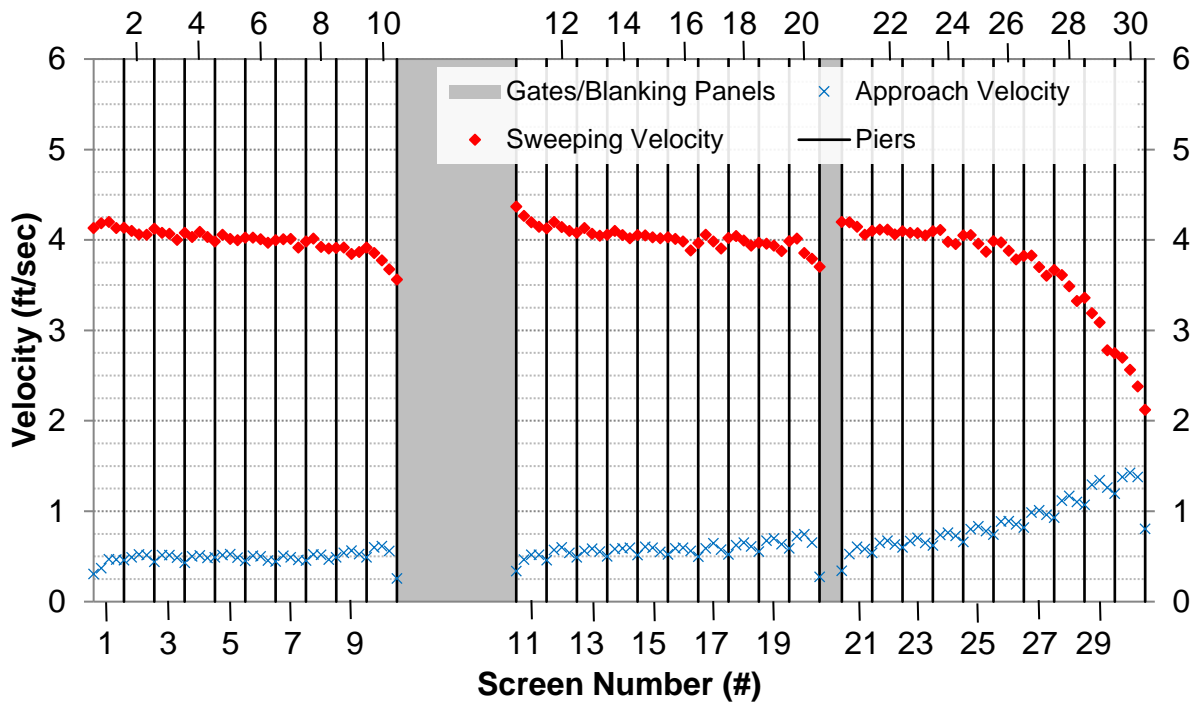
Figure 29. Approach and sweeping velocities at 850 ft³/sec diversion with baffle 100% open.

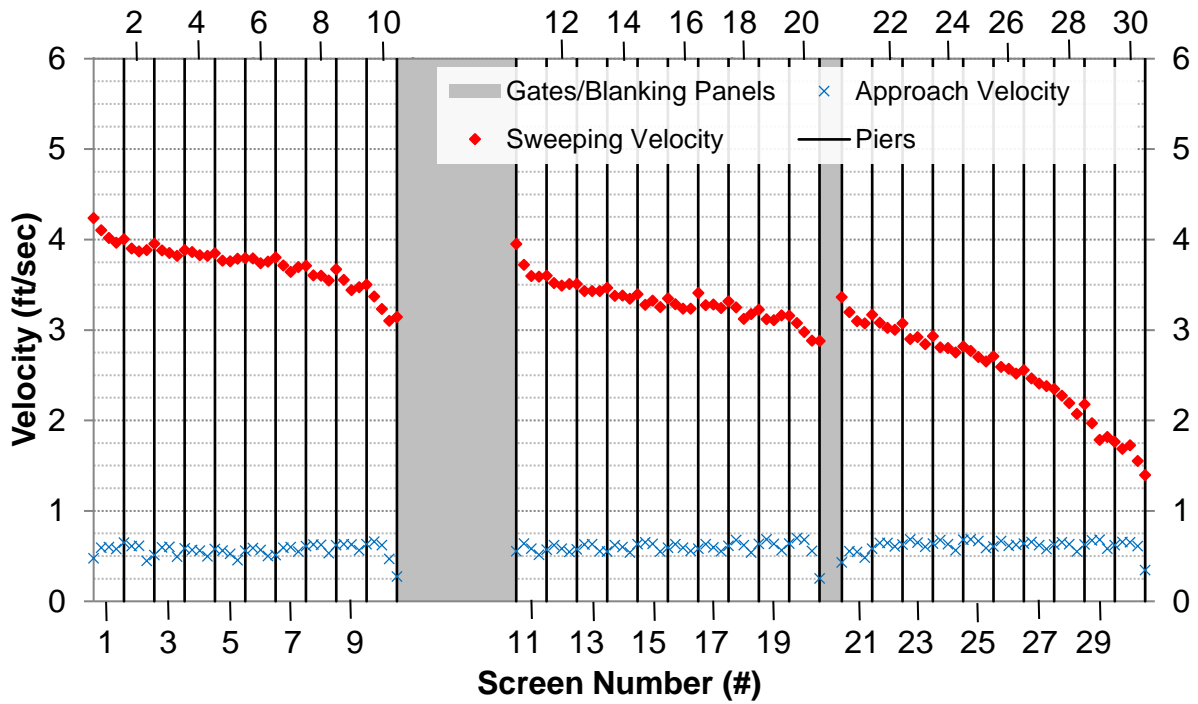
Figure 30. Approach and sweeping velocities at 850 ft³/sec diversion with baffles installed (25% screens 1-10, 20% screens 11-20, and 17.5% screens 21-30).

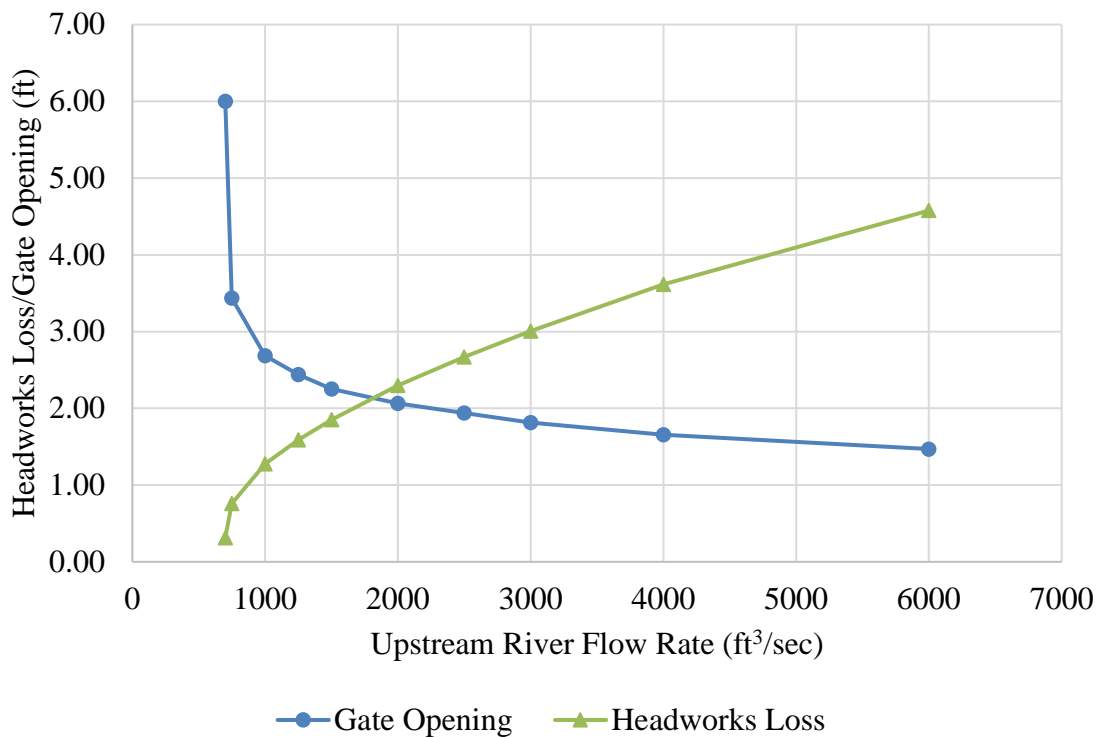
Figure 32. Gate Opening and Headworks Loss for 600 ft³/sec diversion.

Upstream River Flow (ft ³ /sec)	Gates Open (#)	Gate Opening (ft)	Headworks Loss (ft)
700	1,2,3,4,5,6	6.00	0.32
750	1,2,5,6	3.44	0.76
1000	1,2,5,6	2.69	1.28
1250	1,2,5,6	2.44	1.59
1500	1,2,5,6	2.25	1.85
2000	1,2,5,6	2.06	2.30
2500	1,2,5,6	1.94	2.67
3000	1,2,5,6	1.81	3.01
4000	1,2,5,6	1.66	3.62
6000	1,2,5,6	1.47	4.58

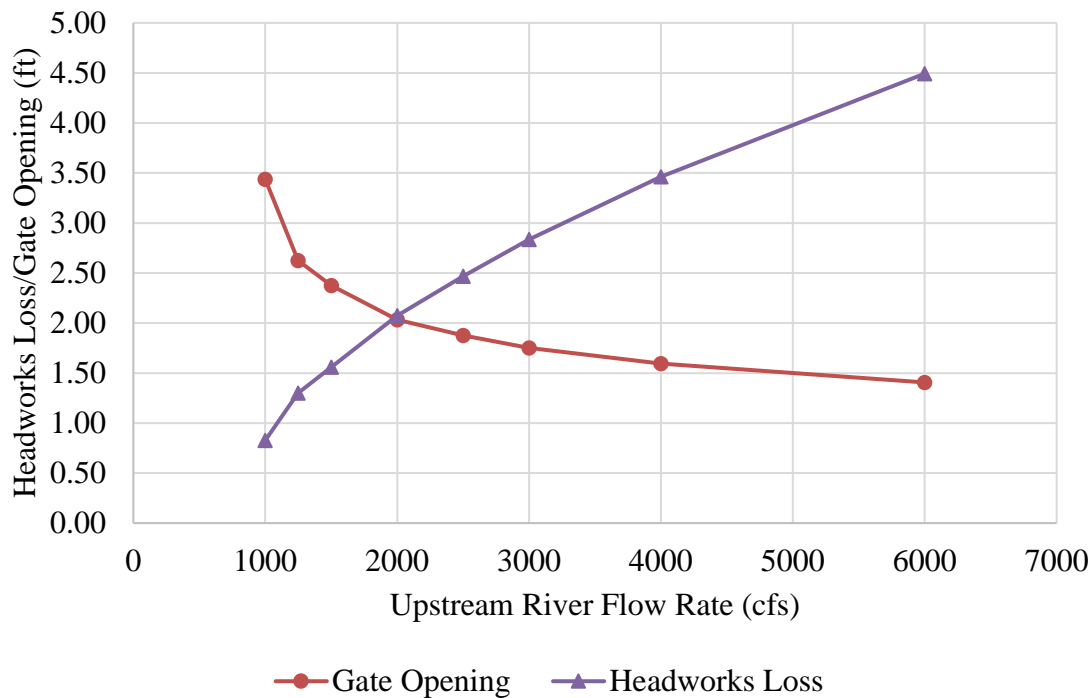
Figure 33. Gate opening and headworks loss for 850 ft³/sec diversion.

Upstream River Flow (ft ³ /sec)	Gates Open (#)	Gate Opening (ft)	Headworks Loss (ft)
1000	1,2,3,4,5,6	3.44	0.83
1250	1,2,3,4,5,6	2.63	1.30
1500	1,2,3,4,5,6	2.38	1.56
2000	1,2,3,4,5,6	2.03	2.07
2500	1,2,3,4,5,6	1.88	2.47
3000	1,2,3,4,5,6	1.75	2.84
4000	1,2,3,4,5,6	1.59	3.46
6000	1,2,3,4,5,6	1.41	4.49

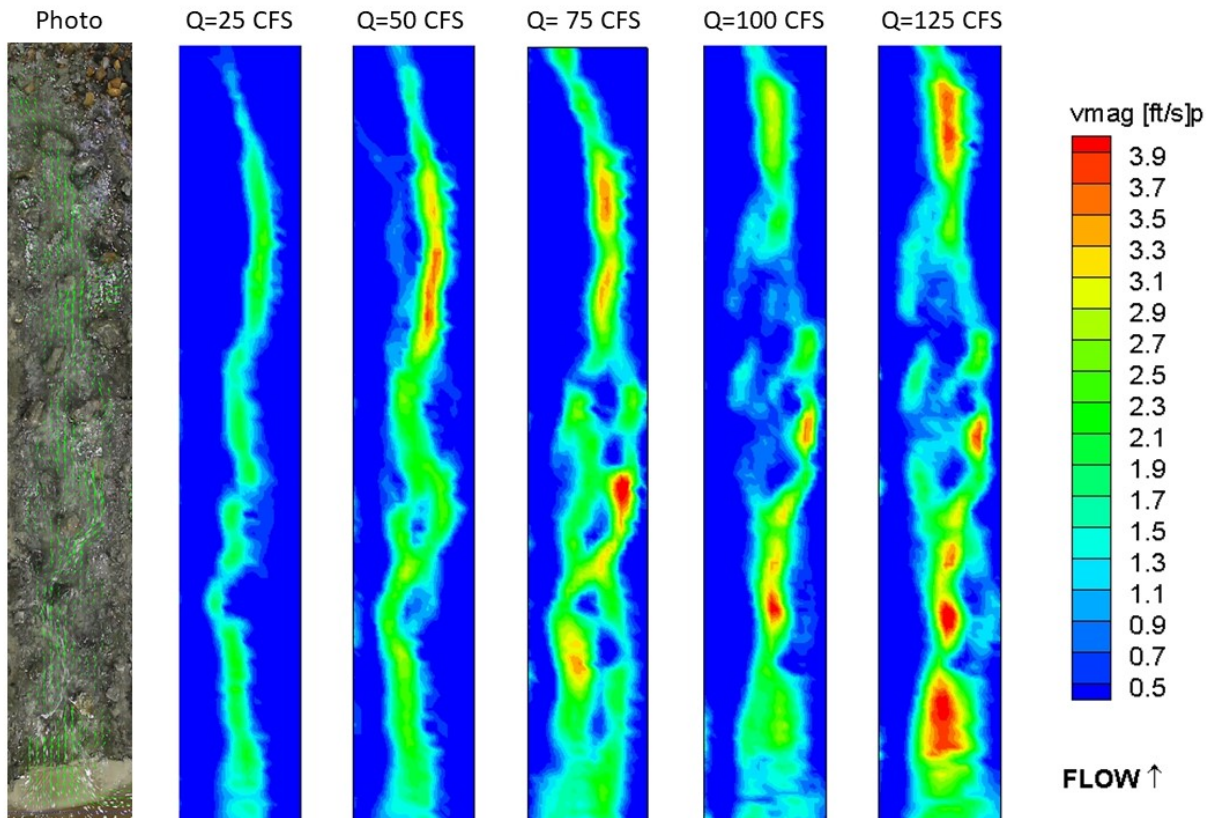
Figure 34. Surface velocities for the low-flow channel at discharges ranging from 25-125 ft³/sec (CFS) (flow from bottom to top).

Depth and velocities in both the low-flow channel and rock ramp were measured to ensure that passage requirements were satisfied. Table 5 provides a summary of the average depth and calculated cross-sectional velocity in the low-flow channel for discharges of 25, 50, 75, 100 and 125 ft³/sec down the low-flow channel. Depths were measured using a graduated staff with 1/32-in resolution. The cross-section average velocity was calculated from the area of the low-flow channel at the corresponding depth in the channel. Figure 34 provides contours of the surface velocities down the low-flow channel of the rock ramp for each tested flow rate. Surface velocities were measured using a technique called Large-Scale Particle Image Velocimetry (LSPIV). Short video clips of particles moving down the rock ramp were recorded and post-processed. Particles were tracked from one frame to another and the relative distance moved over the frame rate is converted into surface velocity. Individual frame by frame results are averaged over a specified duration of time (10 seconds of video) to provide an average of the surface velocities. Surface velocities are typically larger than the average cross-sectional velocity. Due to minimal depth (less than 2.5-in in the model) and high turbulence down the rock ramp, no other methods were successful at measuring the velocities in the low-flow channel.

Flow Rate (ft ³ /sec)	Minimum Depth (ft)	Maximum Depth (ft)	Average Depth (ft)	Cross-Section Average Velocity (ft/sec)	Maximum Velocity from LSPIV (ft/sec)
25	0.5	1	0.75	2.27	2.58
50	0.75	1.25	1	3.64	3.80
75	1	1.75	1.375	3.90	4.27
100	1.25	2.25	1.75	4.04	4.07
125	1.5	2.5	2	4.55	4.43

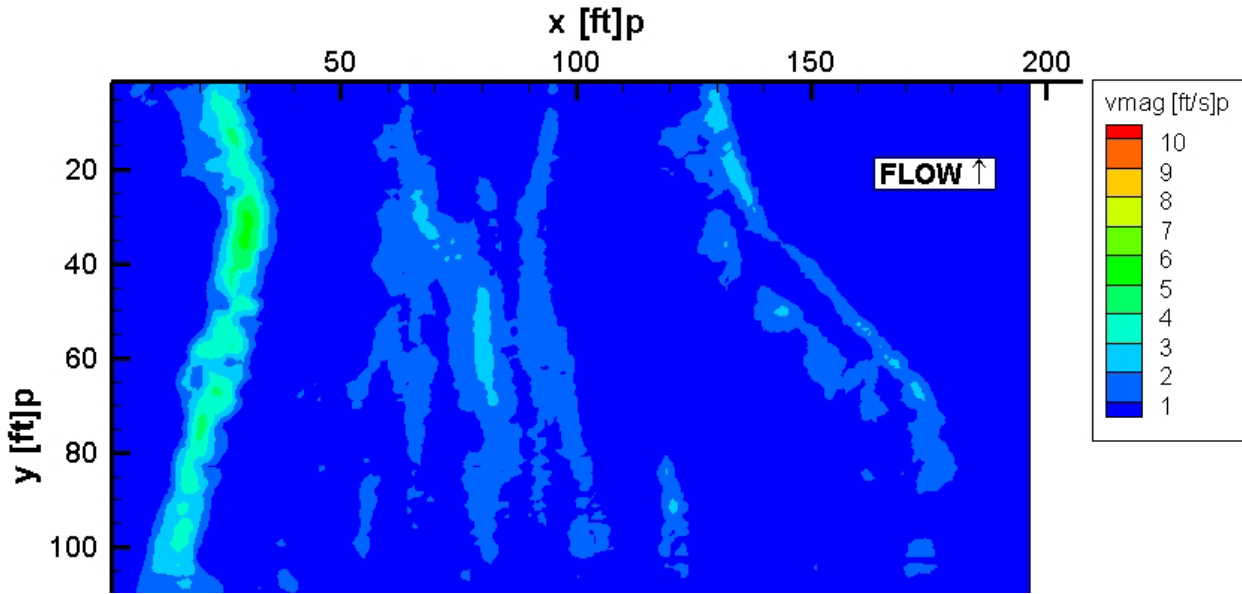
Figure 35. Velocity contours for a flow of 360 ft³/sec over the rock ramp with 640 ft³/sec being diverted through the headworks.

Flow Rate (ft ³ /sec)	Maximum Velocity from LSPIV (ft/sec)
360	5.40
610	6.53
860	7.55
1360	9.01
1860	10.78
2360	9.15
3360	9.52
5360	14.93

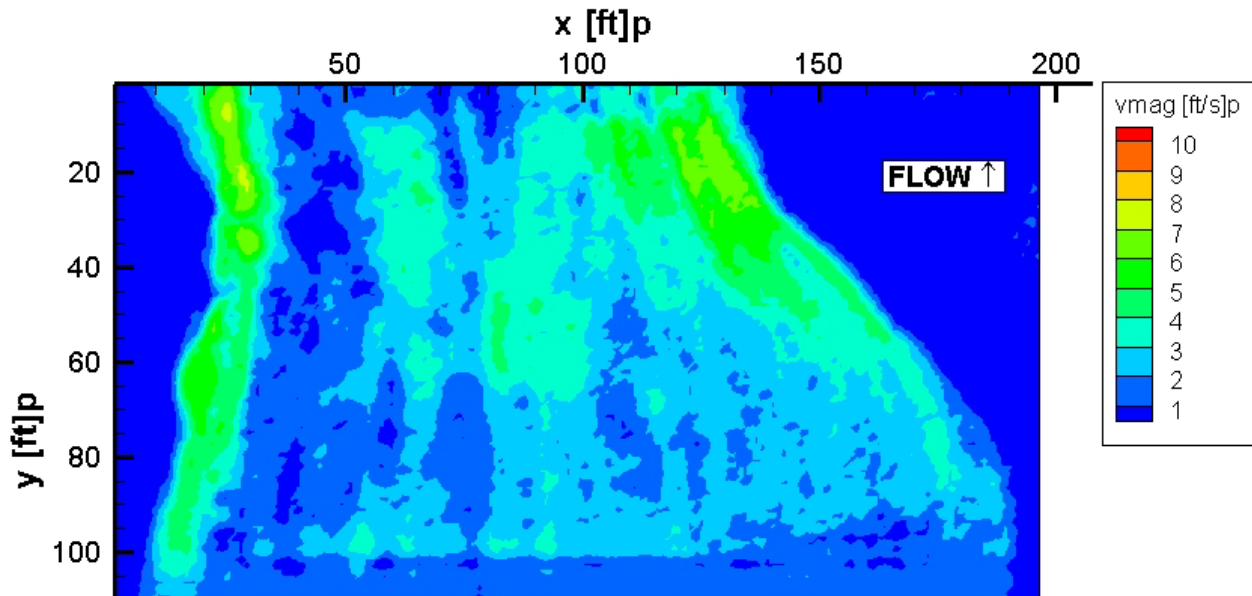
Figure 37. Velocity contours for a flow of 860 ft³/sec over the rock ramp with 640 ft³/sec being diverted through the headworks.

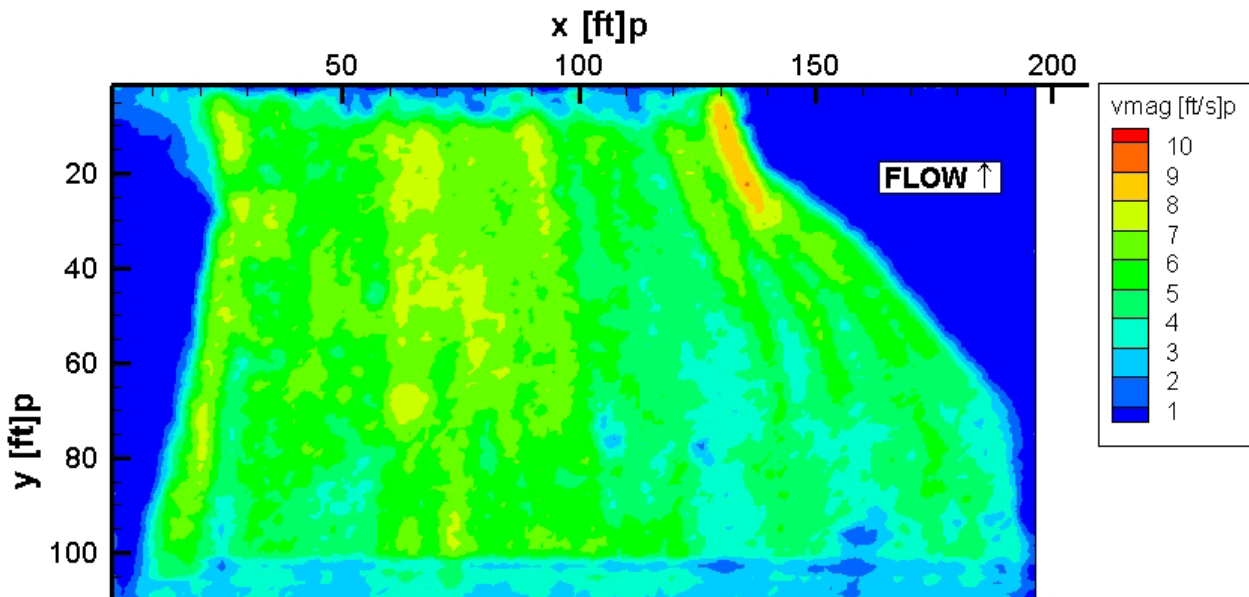
Figure 40. Velocity contours for a flow of 2360 ft³/sec over the rock ramp with 640 ft³/sec being diverted through the headworks.

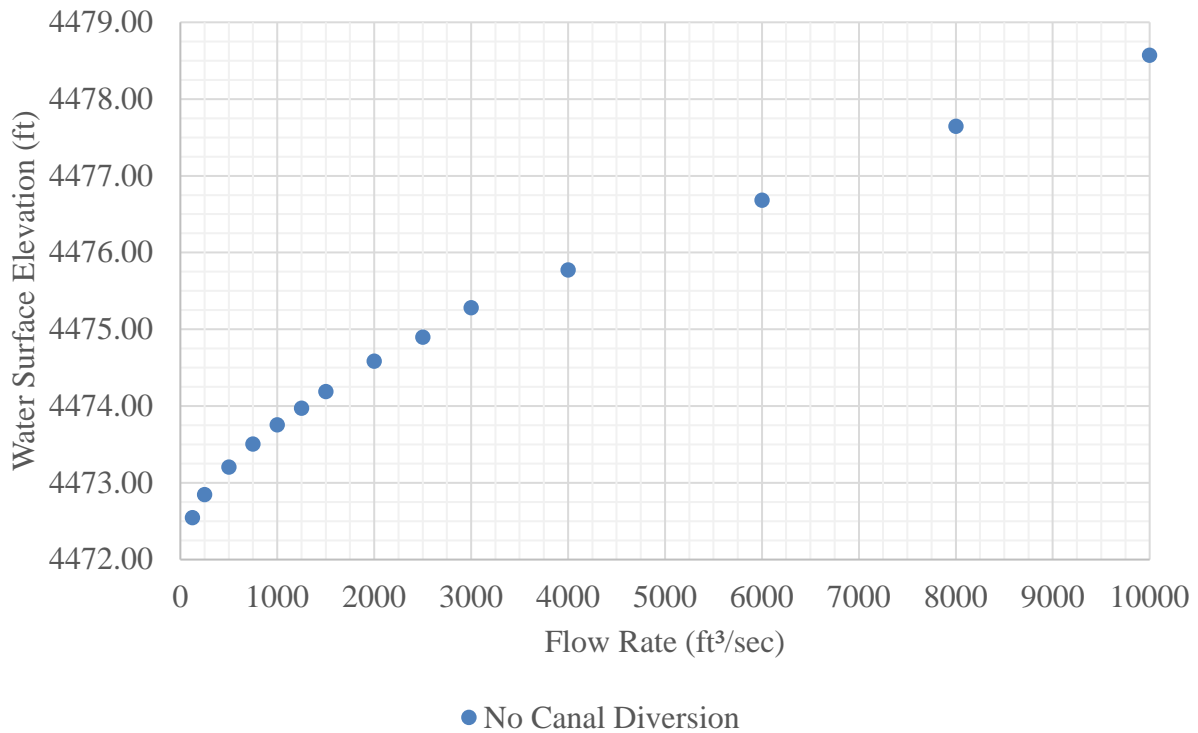
Figure 44. Dam rating curve with no diversion flow.

Rating curves were developed for the dam structure with no diversion flow and with diversion canal flow rates of 600 and 850 ft³/sec. Diversion flow rate refers to the amount of water being delivered to the downstream canal. For each rating curve where the diversion canal was operating, the fish bypass was operated at 40 ft³/sec. Total diversion flows from the river (through the trashrack and headworks gates) for each case would equal the diversion flow rate plus the bypass flow. This appendix includes tabulated and plotted rating curves for no diversion (Table 9 & Figure 44), 600 ft³/sec (Table 10 & Figure 45) and 850 ft³/sec (Table 11 & Figure 46).

Upstream River Flow Rate (ft ³ /sec)	Upstream River Water Surface Elevation (ft)	Rock Ramp Flow Rate (ft ³ /sec)	Diversion Flow Rate (ft ³ /sec)	Fish Bypass Flow Rate (ft ³ /sec)
125	4472.54	125	0	0
250	4472.84	250	0	0
500	4473.20	500	0	0
750	4473.50	750	0	0
1000	4473.76	1000	0	0
1250	4473.97	1250	0	0
1500	4474.19	1500	0	0
2000	4474.58	2000	0	0
2500	4474.90	2500	0	0
3000	4475.28	3000	0	0
4000	4475.77	4000	0	0
6000	4476.68	6000	0	0
8000	4477.64	8000	0	0
10000	4478.57	10000	0	0

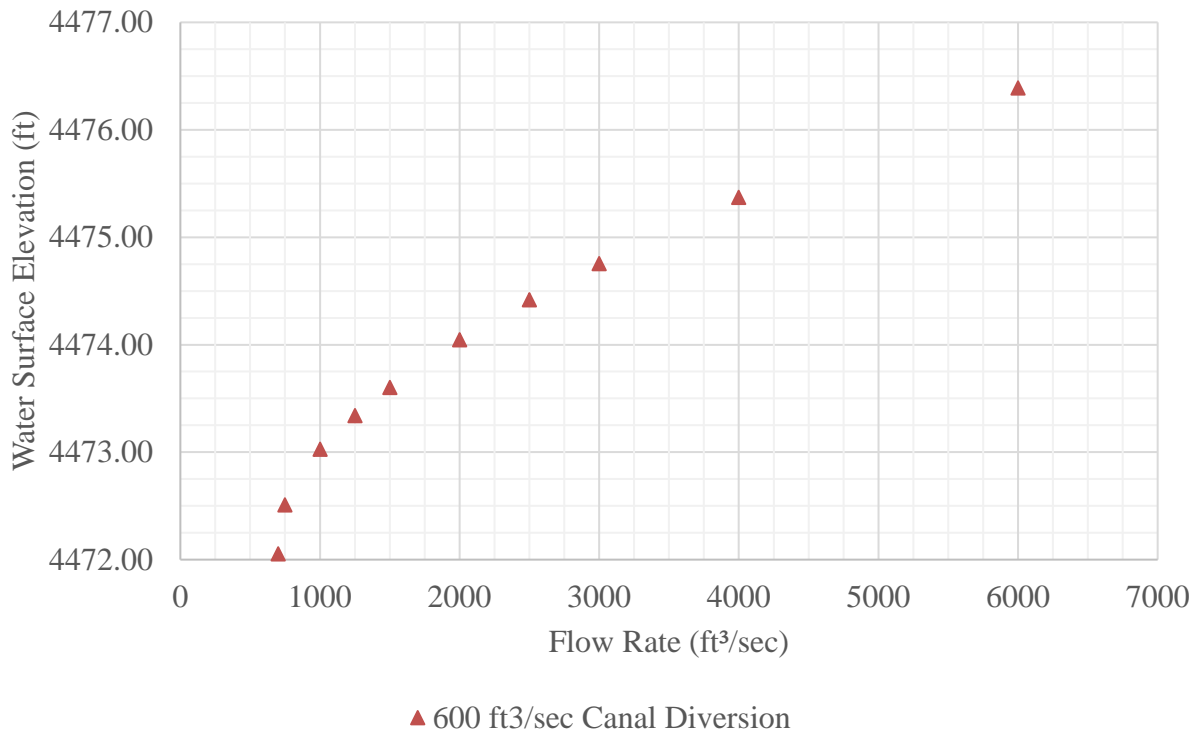
Figure 45. Rating curve for diversion flow rate of 650 ft³/sec.

Upstream River Flow Rate (ft ³ /sec)	Upstream River Water Surface Elevation (ft)	Rock Ramp Flow Rate (ft ³ /sec)	Diversion Flow Rate (ft ³ /sec)	Fish Bypass Flow Rate (ft ³ /sec)
700	4472.06	60	600	40
750	4472.51	110	600	40
1000	4473.03	360	600	40
1250	4473.34	610	600	40
1500	4473.60	860	600	40
2000	4474.05	1360	600	40
2500	4474.42	1860	600	40
3000	4474.76	2360	600	40
4000	4475.37	3360	600	40
6000	4476.39	5360	600	40
