UNITED STATES
DEPARTMENT OF THE INTERIOR
BUREAU OF RECLAMATION

HYDRAULIC MODEL STUDIES FOR THE REDESIGN
OF POWER CANAL DIVERSION DAM--
SALT RIVER PROJECT, ARIZONA

Hydraulic Laboratory Report No. Hyd.-218

NOVEMBER 29, 1948

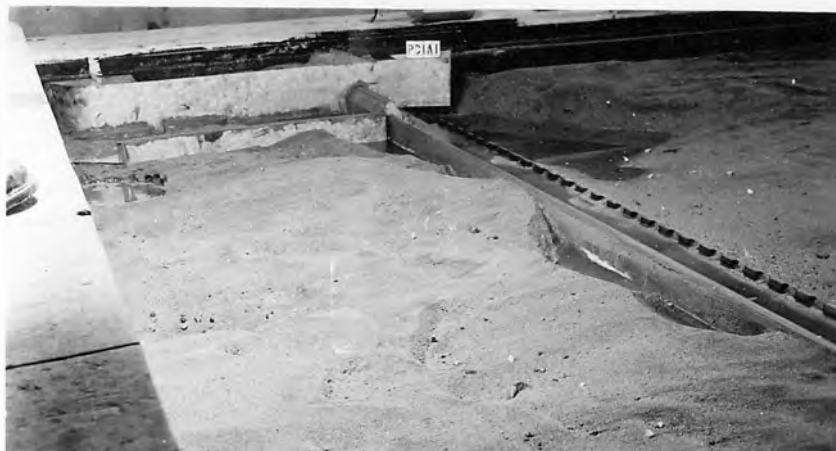
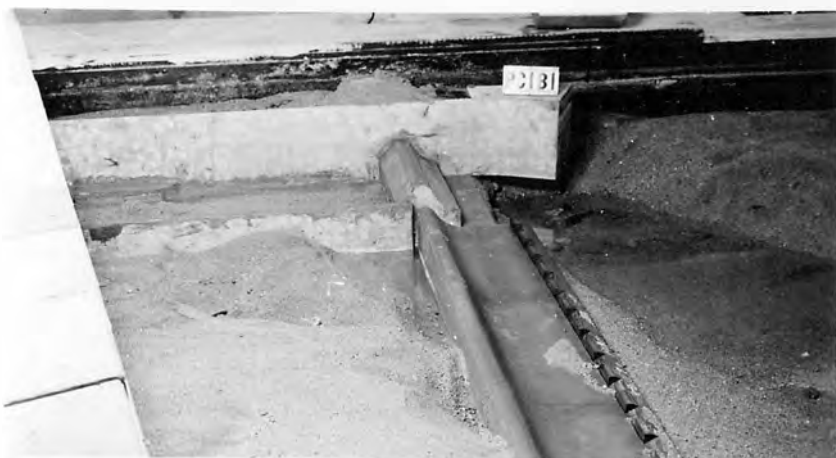
PITS ADJACENT TO UPSTREAM FACE OF DAM NEAR THE LEFT END.

PITS AT LEFT END OF SPILLWAY AND ADJACENT TO THE INTAKE WORKS.

PITS WHICH WERE CONTINUALLY BEING DUG AND FILLED
THE UPSTREAM FACE OF SPILLWAY DURING A DISCHARGE
130,000 SECOND-FOOT WITHOUT RIPRAP IN PLACE.

An interesting and rather startling incident, impossible to observe on the prototype because of the turbid condition of the flood water, was witnessed in the 1:24 model. The river above the dam carries a heavy bed load, and during a flood bars form across the dam completely covering it for short intervals. In the clear water of the model it could be seen that holes were scoured to a depth of 12 feet along the upstream face of the spillway crest. The velocity of approach was high due to the shallow channel, and as the water passed over the crest an eddy formed below the upstream edge. This eddy picked up bed material near the upstream face of the dam and carried it downstream. The pocket increased in size until the intensity of the eddy was decreased, and it could no longer pick up material. The hole then gradually filled again from material being moved along by the stream, but while a particular hole was filling, another would be forming elsewhere. As a hole became filled, the cycle would be repeated. Examination of portions of the original dam remaining in place disclosed scour to a depth sufficient to confirm the observations in the model. Based on these facts, there is reason to believe that one of the major factors of the 1916 failure was piping under the dam due to the reduction of percolation length by the formation of the holes upstream. Only one section of the dam, the "lost section," was moved any distance from its original position. Assuming that the major cause was piping, that one section was undermined and literally skidded downstream where it came to rest tilted upstream. In the original 1937 redesign, the riverbed was heavily riprapped upstream from the dam to stabilize it against a recurrence of this failure. Immediately after completion of the original reconstruction of the prototype, a flood of approximately 68,000 second-feet passed over the dam in January 1937. This flood was equal to or greater in magnitude than the one which had caused the 1916 failure. Subsequent examination of the riprapping immediately upstream of the dam face showed no disturbance. what does?

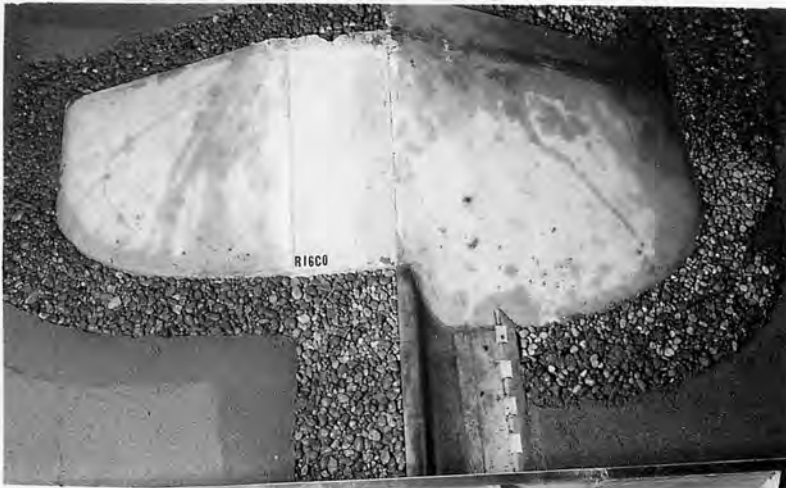
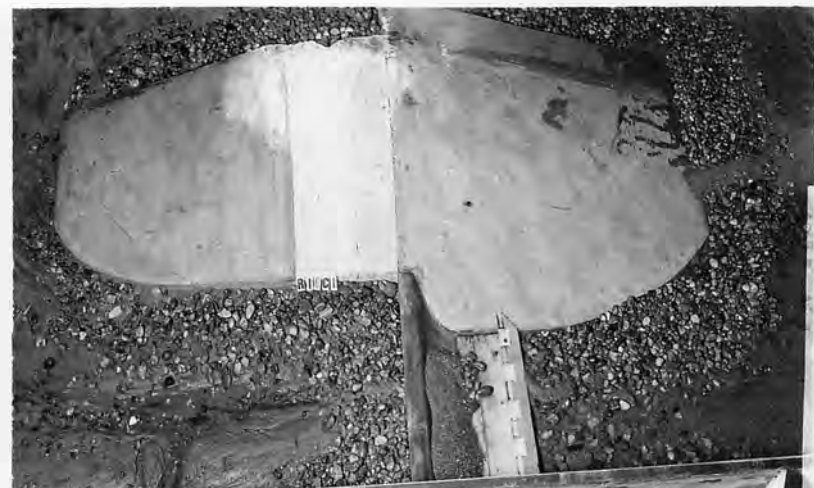
A. RIVER BED BEFORE RUN.

B. RIVER BED AFTER RUN.

ORIGINAL DESIGN.

C. RIVER BED BEFORE RUN.

D. RIVER BED AFTER RUN.

ORIGINAL DESIGN WITH UPSTREAM SECTION OF ABUTMENT MOVED 25 FEET UPSTREAM.

EFFECT OF LENGTHENING UPSTREAM SECTION OF RIGHT ABUTMENT
DISCHARGE 150,000 SECOND-FEET - MINIMUM ESTIMATED TAILWATER.

The intermediate wall in the model was removed, giving an arrangement representing the right abutment according to the original design and about 60 feet of the adjacent prototype crest. Tests 14 to 28 were made to study the flow conditions in the vicinity of the right abutment to determine necessary alterations to prevent serious erosion. The minimum estimated tailwater curve was used. Severe scour occurred downstream (Test 14) from the end of the apron and along the cutoff wall of the original abutment with a discharge of 150,000 second-feet (Figure 9-A and B). Visual tests indicated that improvement might be obtained by extending the upstream portion of the abutment. It was extended upstream in increments of 10, 10, and 5 feet (Figure 10). No appreciable change resulted after the first extension. The second, however, gave more acceptable conditions, while the third proved entirely satisfactory (Figure 9-C and D).

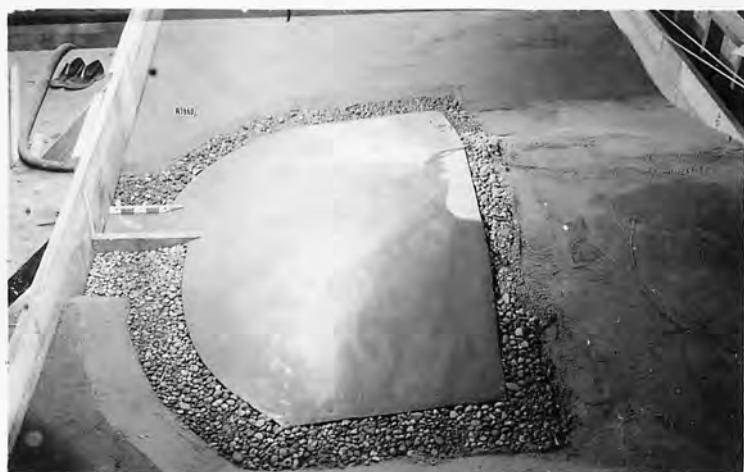
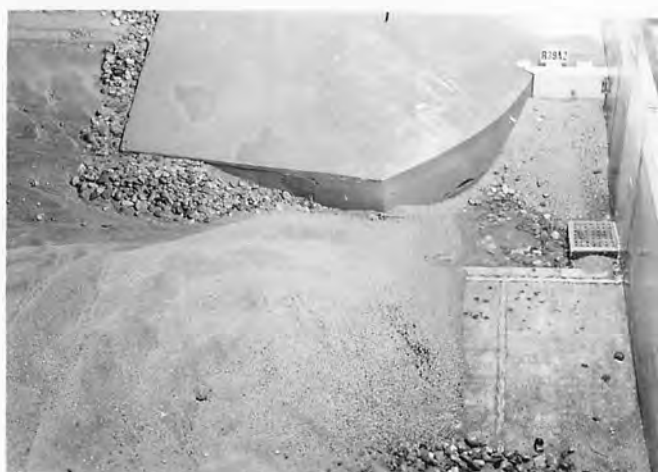
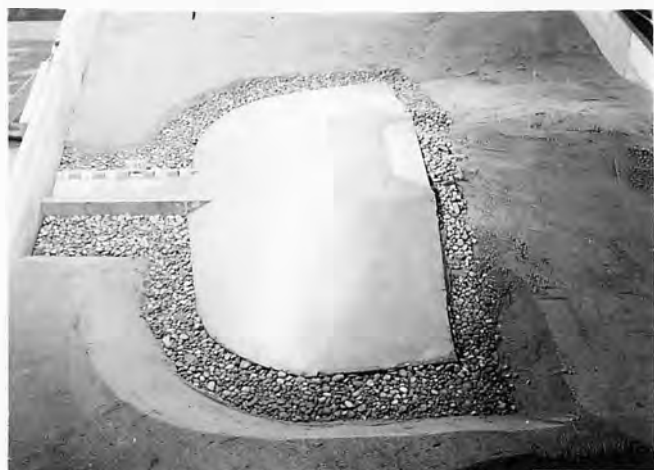
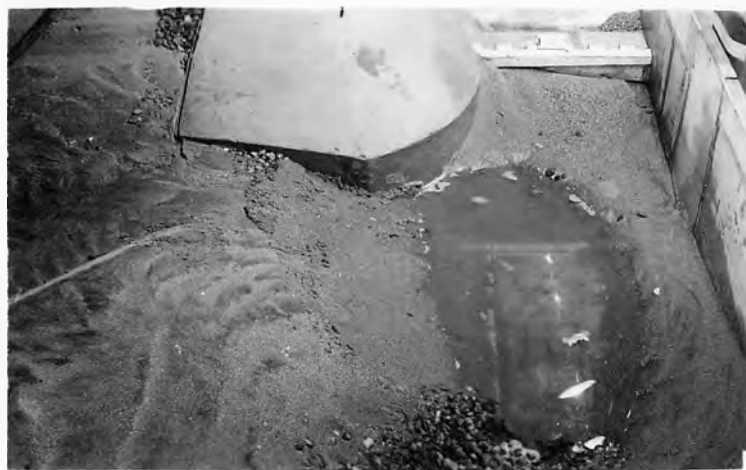
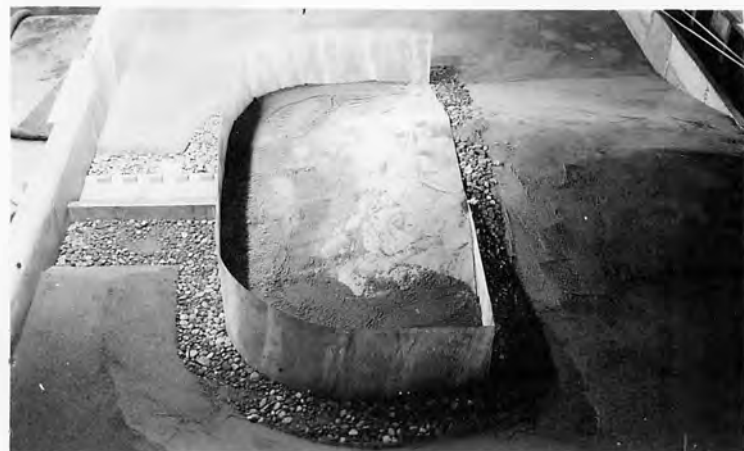
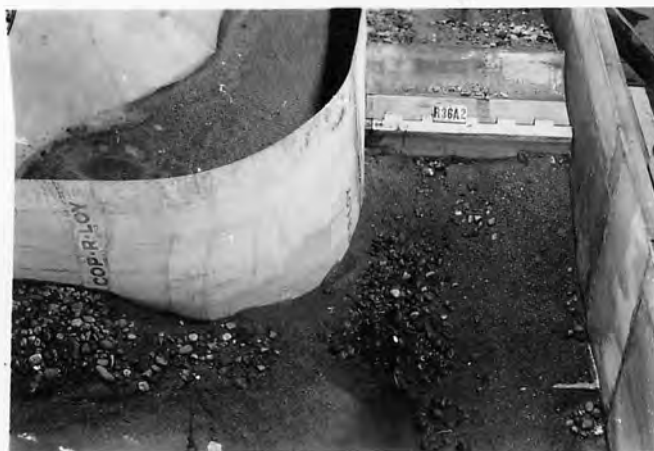
A. RIVER BED BEFORE RUN.

B. RIVER BED AFTER RUN.

STREAMWARD SIDE OF ABUTMENT ON 3:1 SLOPE.

C. RIVER BED BEFORE RUN.

D. RIVER BED AFTER RUN.

STREAMWARD SIDE OF ABUTMENT ON 1 1/2:1 SLOPE.

E. RIVER BED BEFORE RUN.

F. RIVER BED AFTER RUN.

STREAMWARD SIDE OF ABUTMENT VERTICAL

downstream edge of the abutment was extended level at elevation 2173 (Figure 11), but prolonged operation produced severe erosion. The streamward side of the downstream abutment section was made vertical by removing the portion of the 2:1 paved slope below the crest (Figure 11), but this gave no improvement in scour conditions. Several minor alterations to the apron, including variable length sections in this vicinity gave slight improvement. However, the shallow sand bed below the model and the short approach to it were believed to contribute to the severe conditions, so the model was reconstructed before additional tests were conducted. This design, which had proven satisfactory with the minimum estimated tailwater was then considered inadequate when severe scour (Test 35) occurred along the downstream edge of the abutment (Figure 12-A and B).

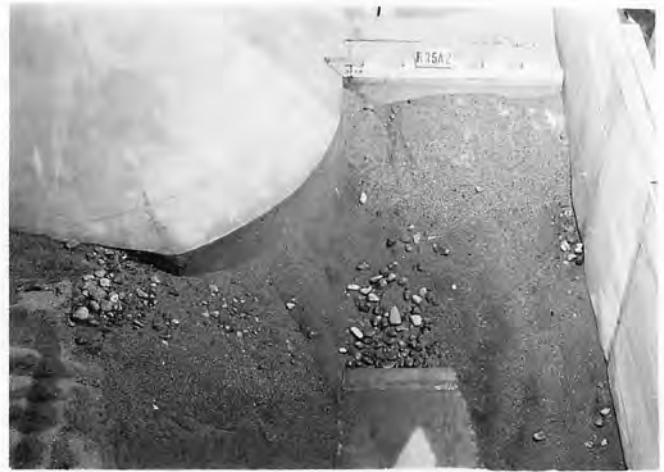
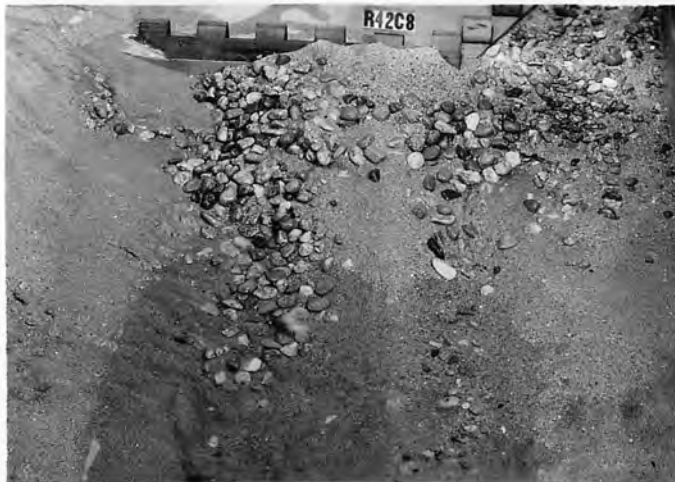
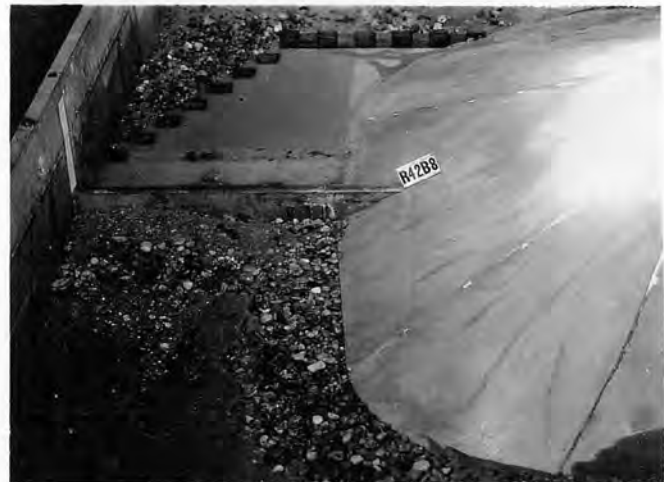
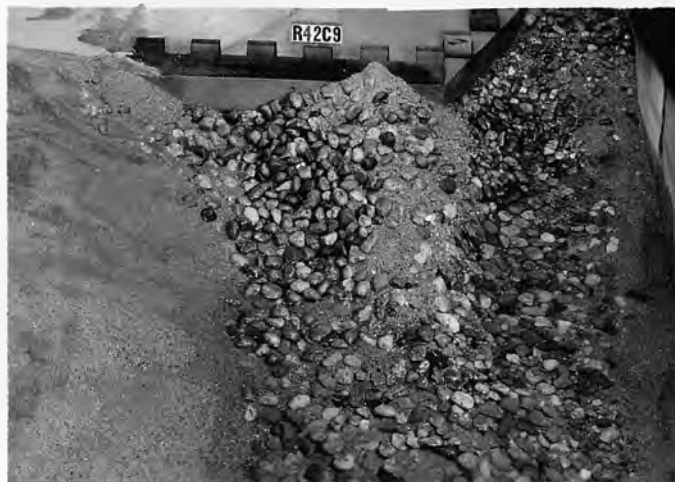
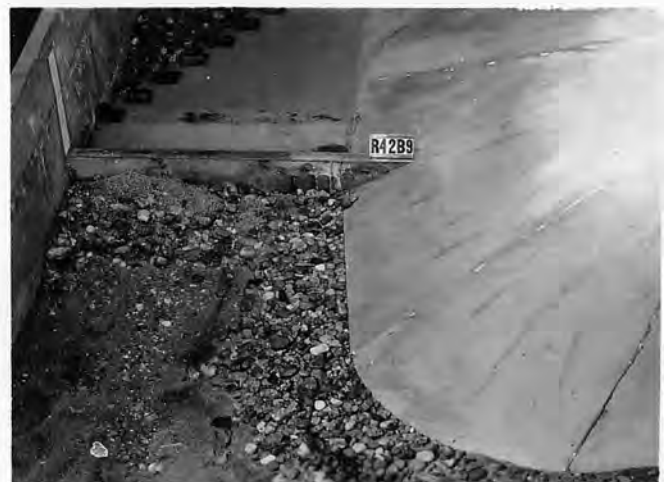
A. RIVER BED BEFORE RUN.

B. RIVER BED AFTER RUN.

SHORT APRON - TAILWATER TWO FEET BELOW MINIMUM ESTIMATED.

C. SCOUR AT END OF APRON.

D. CONDITIONS UPSTREAM.

VARIABLE LENGTH APRON - MINIMUM ESTIMATED TAILWATER.

E. SCOUR AT END OF APRON.

F. CONDITIONS UPSTREAM

VARIABLE LENGTH APRON - TAILWATER TWO FEET BELOW MINIMUM ESTIMATED.

CONDITIONS FOR RECOMMENDED ABUTMENT - WITH AND WITHOUT VARIABLE LENGTH APRON - DISCHARGE 150,000 SECOND- FEET.

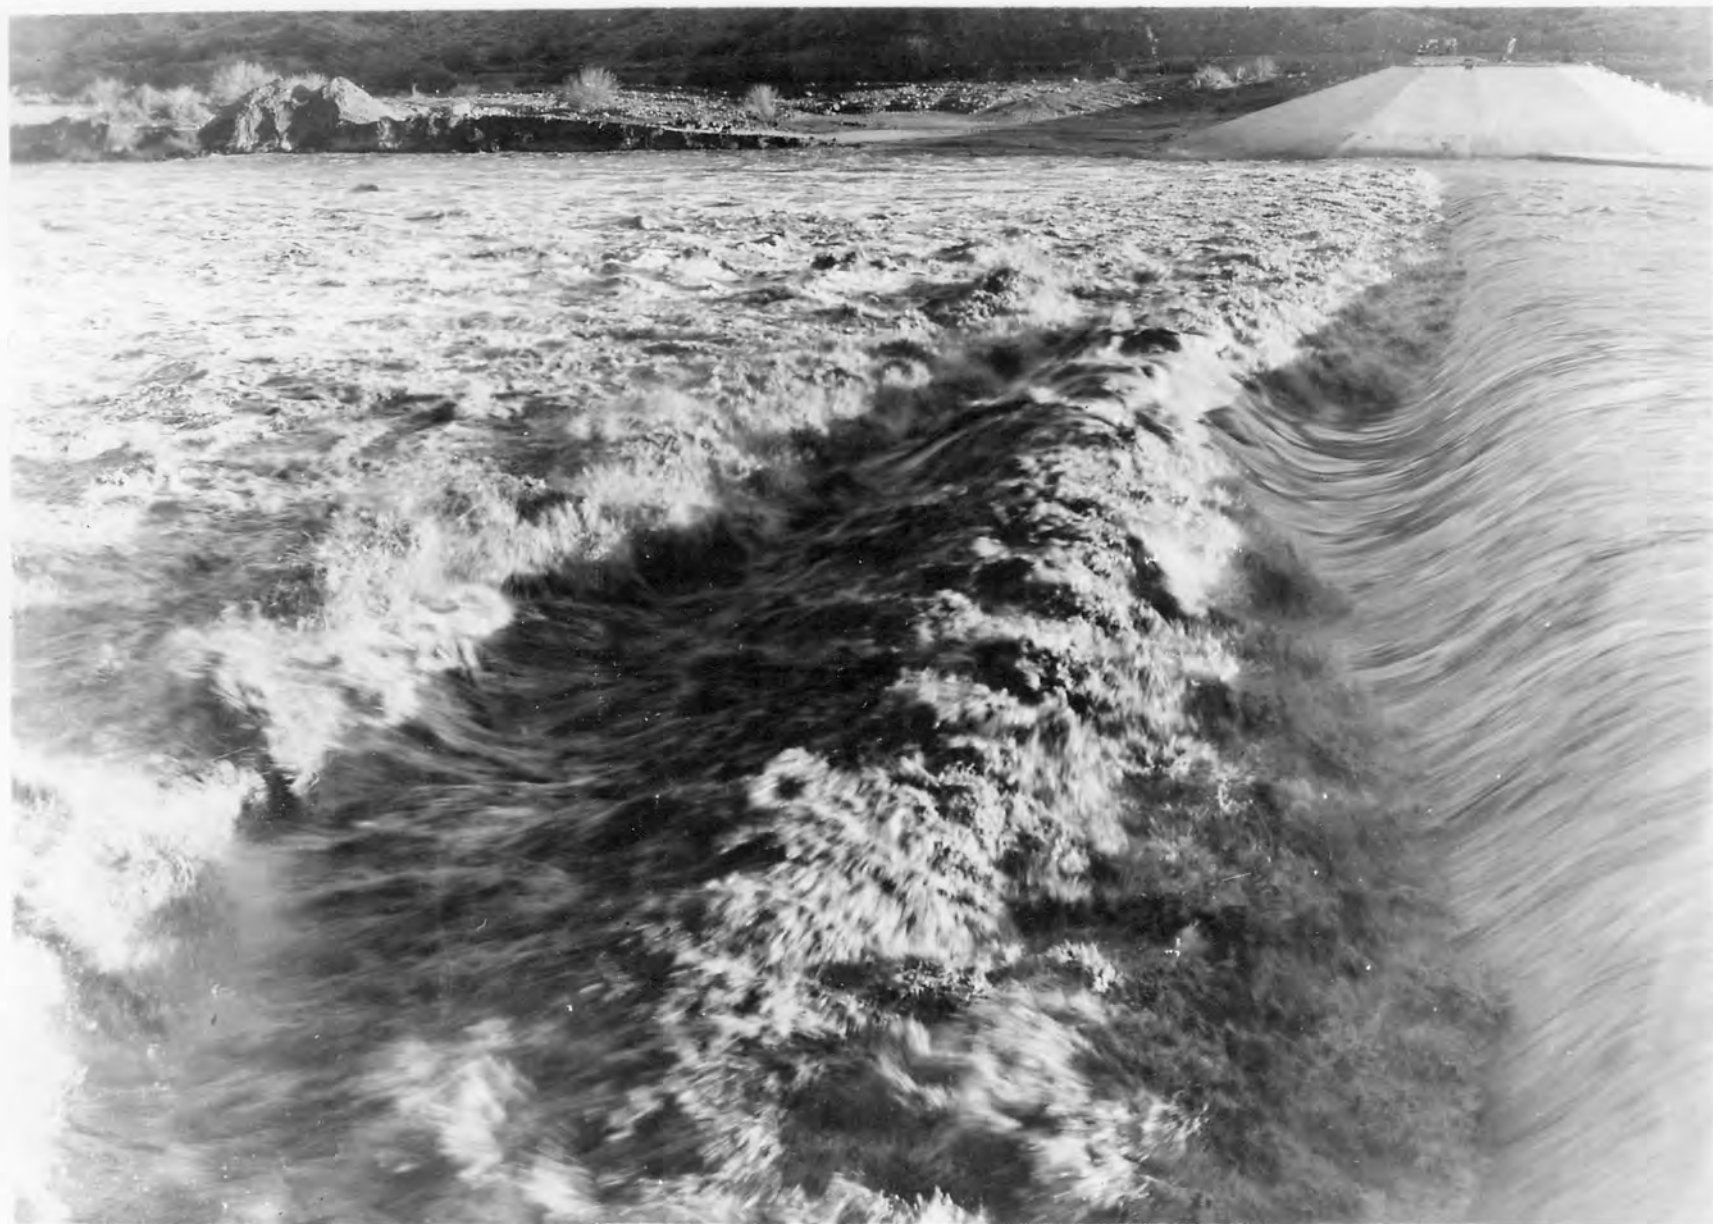
VIEW OF PROTOTYPE FROM LEFT BANK SHOWING CONCENTRATION OF FLOW
NEAR LEFT END OF SPILLWAY FOR A DISCHARGE OF 38,000 SECOND-FOOT.

On February 7 and 8, 1937, a few days after completion of the reconstruction of the prototype, a flood with a peak capacity of 68,000 second-feet passed over the dam. The meandering of the river upstream caused the flood to be concentrated near the intake structure (Figure 15), thus distorting the relation between tailwater and headwater to such extent that the riprap protection downstream from the apron in this area was washed away. With the possibility of larger floods, these conditions were critical. A laboratory reinvestigation was necessary. A model was built to a scale of 1:48 to represent the entire spillway and the approach and tailwater conditions (Figure 16). This model was also constructed and studied in the Colorado Agricultural Experiment Station at Fort Collins, Colorado. As additional area was then available

In the preliminary tests the flow upstream from the dam was concentrated to approximate the prototype conditions shown on the photographs taken during the flood (Figure 15). The concentration of flow near the intake structure could not be maintained in the model with the riverbed built of fine sand. The sand upstream from the model spillway crest was replaced by a coarse gravel. Tests indicated inadequate scour protection for the left end of the dam with discharges above 60,000 second-feet and the tailwater 2 feet below the minimum estimated. Because of the close agreement up to 40,000 second-feet between the tailwater in the field during the first part of the 1937 flood and the arbitrary curve used for testing the 1:24 model, that curve was used for these investigations.

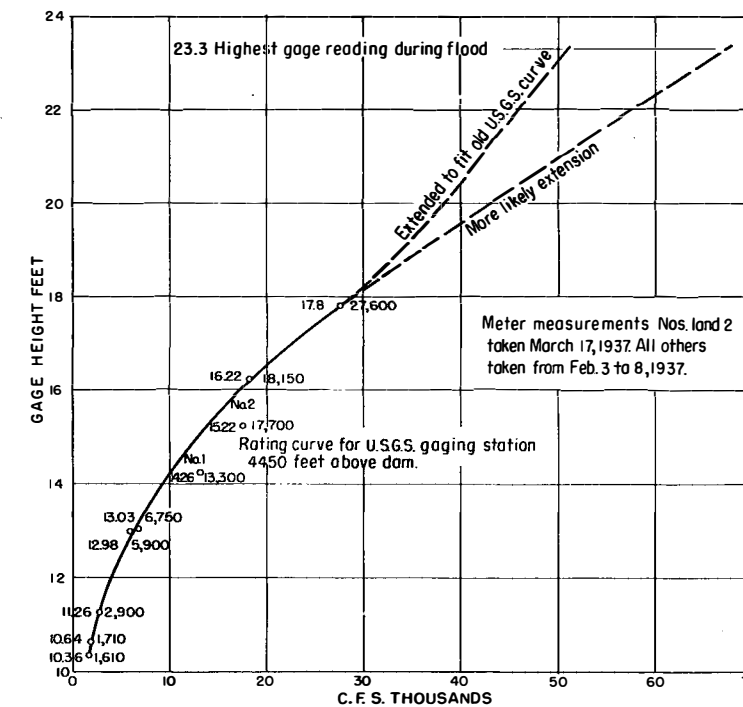
POWER CANAL DIVERSION DAM FLOOD LEVELS FEB. 7 AND 8, 1937

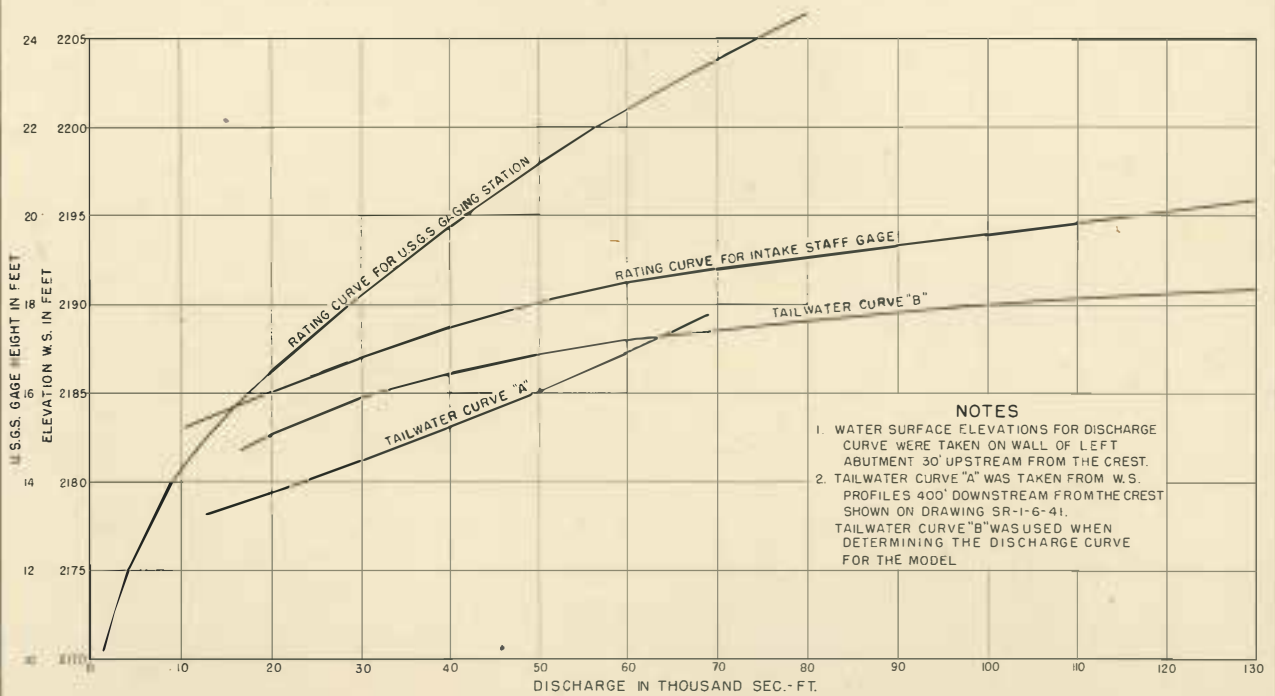
LONGITUDINAL SECTION OF DAM
SHOWING W.S. AT CREST

- NOTES**
1. WATER SURFACE ELEVATIONS FOR DISCHARGE CURVE WERE TAKEN ON WALL OF LEFT ABUTMENT 30' UPSTREAM FROM THE CREST.
 2. TAILWATER CURVE "A" WAS TAKEN FROM W.S. PROFILES 400' DOWNSTREAM FROM THE CREST SHOWN ON DRAWING SR-1-6-41. TAILWATER CURVE "B" WAS USED WHEN DETERMINING THE DISCHARGE CURVE FOR THE MODEL.

POWER CANAL DIVERSION DAM
HYDRAULIC MODEL STUDIES
MODEL SCALE 1:48
SUMMARY OF FLOW DATA

was checked to determine if a more likely extension of the rating curve (Figure 18) were correct. Two staff gages were installed in the model, one 30 feet (prototype) upstream from the crest axis on the left intake wall, and the other on the 2:1 slope of the right abutment at the axis of the dam. Prototype flows of 17,500, 25,750, 42,800, and 51,000 second-feet for which field data have been obtained were used for the test. The staff gages were observed for each flow, and the depth on the crest was obtained over the entire length of the dam. For the first two flows the surface on the wall of the intake section checked the prototype elevations, while those at the right abutment were too low. These lower elevations were attributed to a relatively smooth and differently arranged streambed below the model dam. The tailwater was raised until the proper elevation was obtained at the abutment. It was necessary to raise the tailwater to elevation 2182 for a discharge of 17,500 and elevation 2184 for 25,750 second-feet. The staff reading at the intake was not affected by the increase in tailwater depth, so this method was used for subsequent runs for which prototype data were available. When an attempt was made to check the water surfaces for 42,800 and 51,000 second-feet, an unreasonably deep tailwater was required to give the proper reading on the intake staff gage, and the water surface at the right abutment was considerably above the recorded prototype elevation when the intake gage read correctly. This condition was corrected by maintaining the desired water surface elevation at the right abutment with the tailwater regulating device, while increasing the flow until the desired reading was obtained on the intake staff gage. A discharge of 50,000 second-feet was required to obtain water surface elevations comparable to the prototype for the estimated 42,800 second-feet, while 67,300 second-feet were necessary to give the proper elevation for the estimated 51,000 second-feet. From these studies it was concluded that the maximum discharge for the flood of February 7 and 8 was nearer the 68,000 second-feet obtained by a smooth extension of the rating curve (Figure 18) than the 51,000 second-feet obtained by extension to fit the old United States Geological Survey rating curve. Discharges of 100,000 and 130,000 second-feet were also studied. The absence of prototype data for these discharges made it impossible to extend the rating curve accurately. However, the prototype curve should not vary much from the approximate extension obtained on the model. The water surfaces across the dam for the various flows were plotted, and a new rating curve for the staff gage on the intake wall obtained. A new rating curve for the United States Geological Survey station, including discharges up to the peak flood, was also prepared from these data (Figure 19). TW

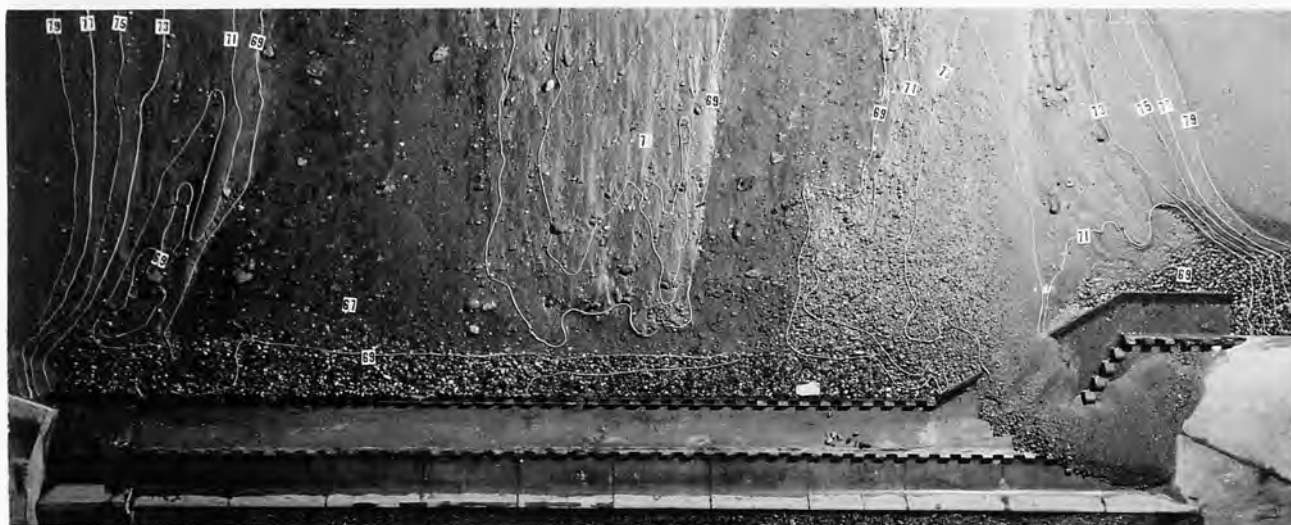
A. RIVER BED UPSTREAM RUN.

B. RIVER BED AFTER CONSTANT CONDITIONS WERE OBTAINED WITH A FLOW OF 30,000 SECOND-FEET.

C. RIVER BED AFTER DISCHARGE OF 60,000 SECOND-FEET FOR AN ADDITIONAL PERIOD OF 50 MINUTES.

ACCUMULATIVE SCOUR FOR VARIOUS DISCHARGES WITH TAILWATER FOUR FEET BELOW MINIMUM ESTIMATED - SLOPING APRON EXTENSION OF 25 FEET. RECOMMENDED DESIGN EXCEPT DOWNSTREAM FROM INTAKE SECTION.

tested for 150,000 second-feet. Some increase in erosion was obtained at this flow but no critical change occurred. The design was considered satisfactory. The model was then operated at various discharges to investigate the conditions throughout the flood range. Very desirable results were obtained adjacent to all parts of the structure except the intake section. The riprap downstream from the apron in this region washed downstream at 60,000 second-feet, and the conditions became more severe as the flow was increased to 150,000 second-feet when a large area of the model floor, elevation 2151, was exposed (Figures 22 and 23).

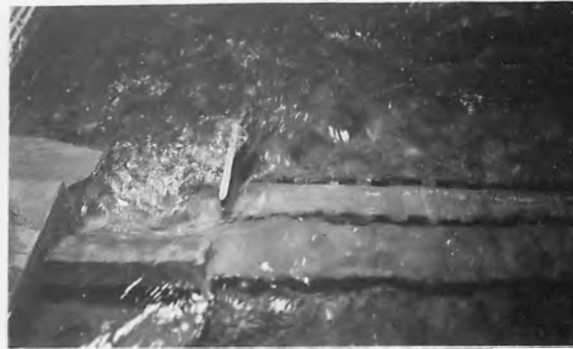
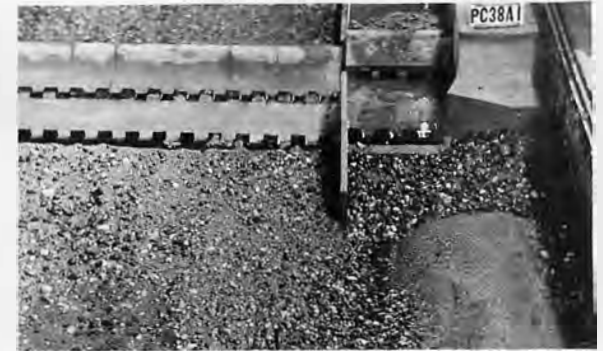
A. River bed before run

B. Discharge 150,000 second-feet

C. Bed after one-hour run

REHBOCK SILL

COMPARISON OF INTERMEDIATE TRAINING WALL WITH
DIFFERENT TYPE OF SILL DOWNSTREAM FROM THE INTAKE SECTION

The fact that this increase was at the downstream end indicated that the wall could not be shortened, especially at the base. The water surface on the intake side seldom reached to within 2 feet of the top, and the wall was lowered for the next test. With the downstream limit determined, attention was transferred to the upstream end. The walls previously tested were constructed partly on the existing prototype apron. As this complicated the construction, the wall was cut vertical at the junction of the new and old construction and the upstream end given the shape of a parabolic pier nose (Test 38). The top of the wall was cut on a slope making it similar to the design obtained by model studies for the training walls on the Marshall Ford Dam (Figure 24). The wall was overtopped slightly at 150,000 second-feet, but this arrangement gave good results with the Rehbock sill in place. The necessity of this sill was clearly shown when it was replaced by the trapezoidal shape and the conditions became more severe below the intake section (Figure 25).

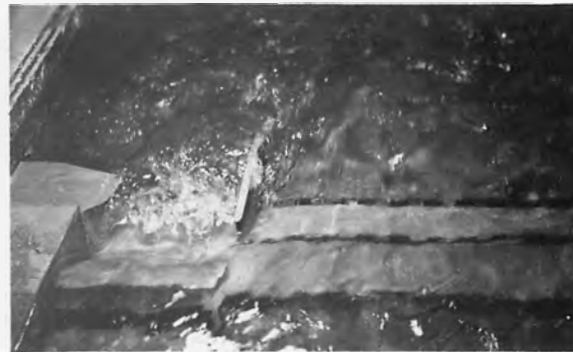
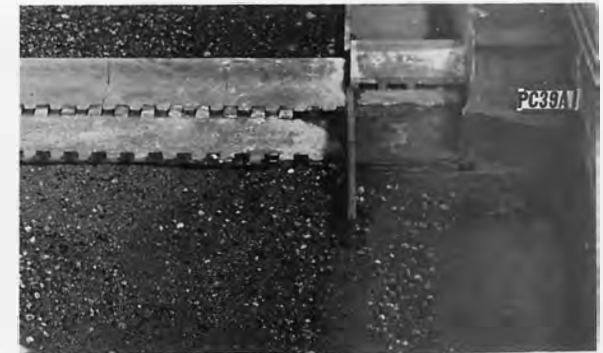
A. River bed before run

B. Discharge 150,000 second-feet

C. Bed after one hour run

TRIANGULAR SILL
