HYDRAULIC MODEL STUDIES RELATING TO
THE REDESIGN OF THE SPILLWAY AND
POWERHOUSE FOR THE DAVIS DAM

Hydraulic Laboratory Report Hyd. 232

Bureau of Reclamation
Denver, Colo.

July 15, 1947

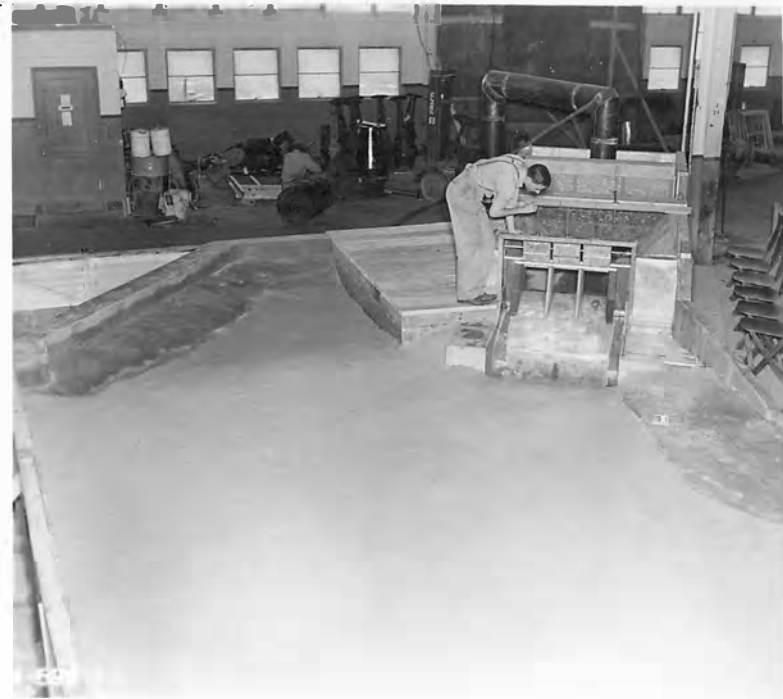
Discharge-----200,000 second-feet

Tailwater-----533 (Present Elevation)

Length of Test----6 hrs. 55 min.

Appearance of Model Bed
before Test No. 1

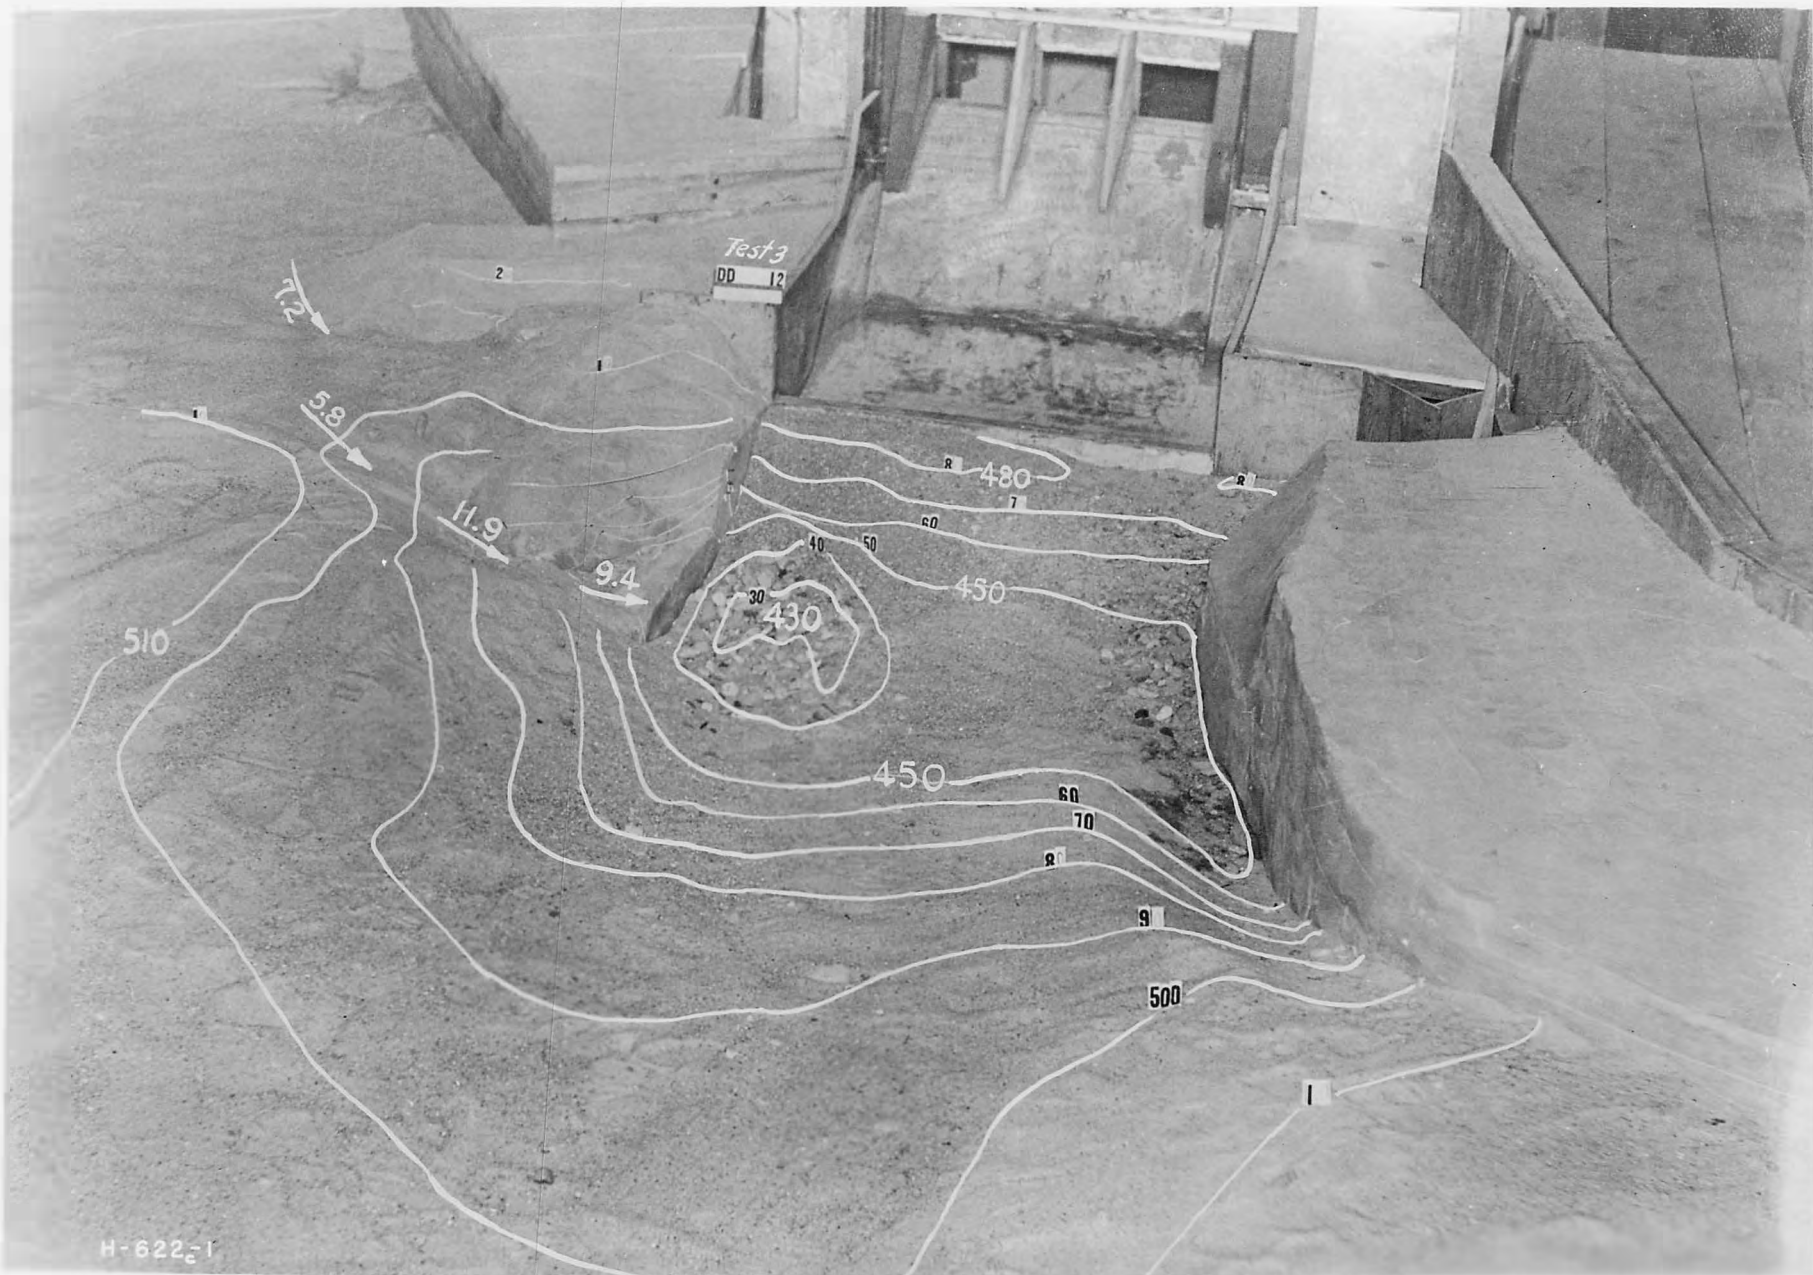
Test No. 3

This test differed from Test No. 1 in that the sand area between right training wall and powerhouse was molded in non-erodible concrete using rock contours obtained from field data. Also at this time the maximum discharge for design purposes was reduced from 300,000 to 175,000 second-feet.

Results of erosion test are shown below. Rocks in the bottom of the erosion hole are remnants of dikes used in an attempt to reduce the eddy action in a previous test.

Discharge - 175,000 sec.-ft.
Tailwater - Present - El. 532.75
Time of Test - 8 hrs.

powerhouse reproduced in nonerodible concrete. Tests then showed that the erosion at the bucket lip, and in the powerhouse tailrace was reduced since the eddy was reduced in size and intensity. For ultimate tailwater conditions, however, the eddy persisted and tended to undermine the rock projection.

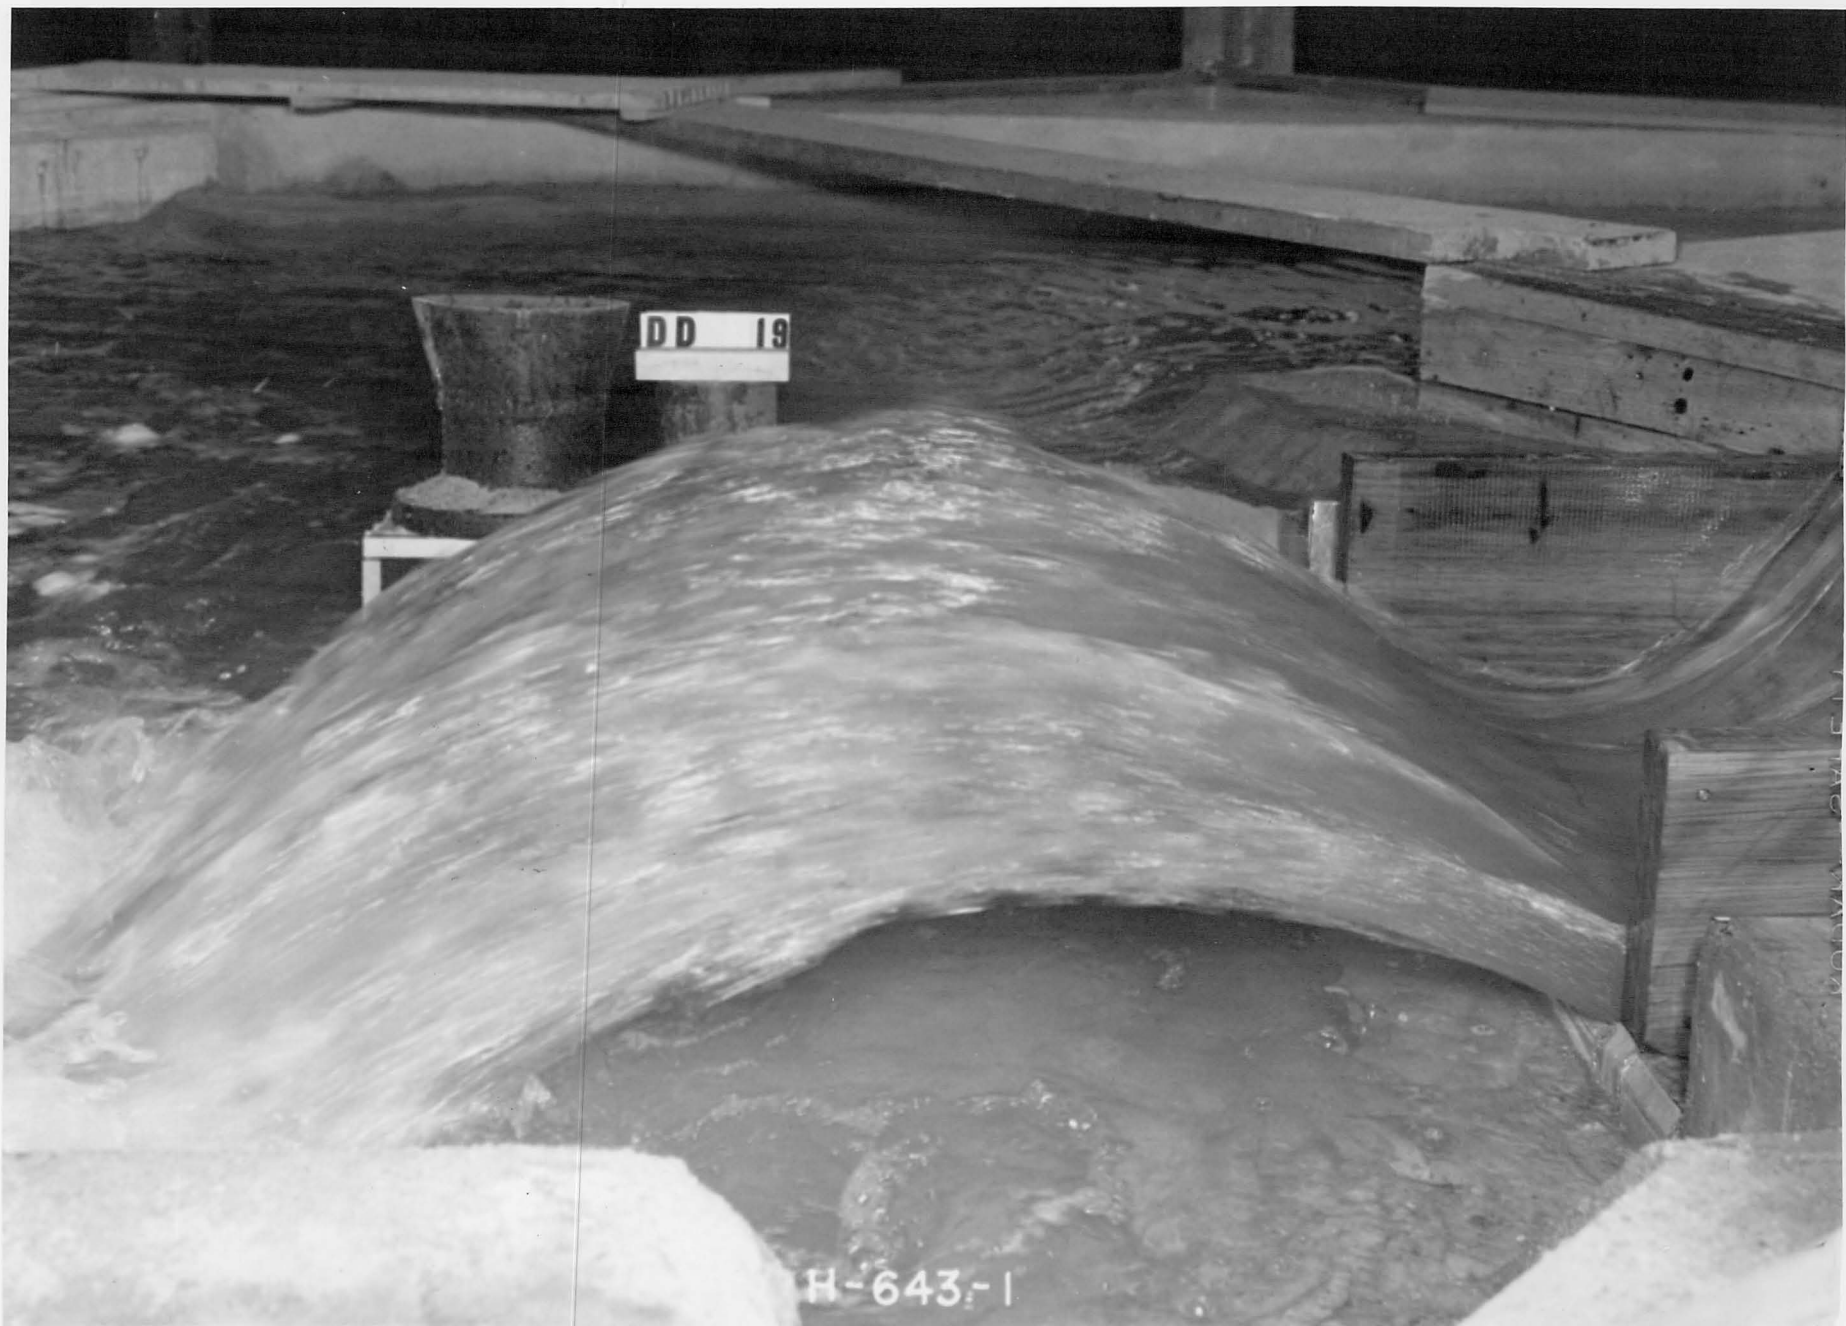
Test No. 5

Photographs on the two following pages show the operation of this bucket, first in general, then in detail. The third photograph shows the results of erosion test 5. The cofferdam along the line of the right training wall was installed in the model since it appeared to reduce the eddy in the lead water area.

Discharge-175,000 sec.-ft.
 Tailwater-Ultimate-El. 515.75
 Time of Test-2 hrs.

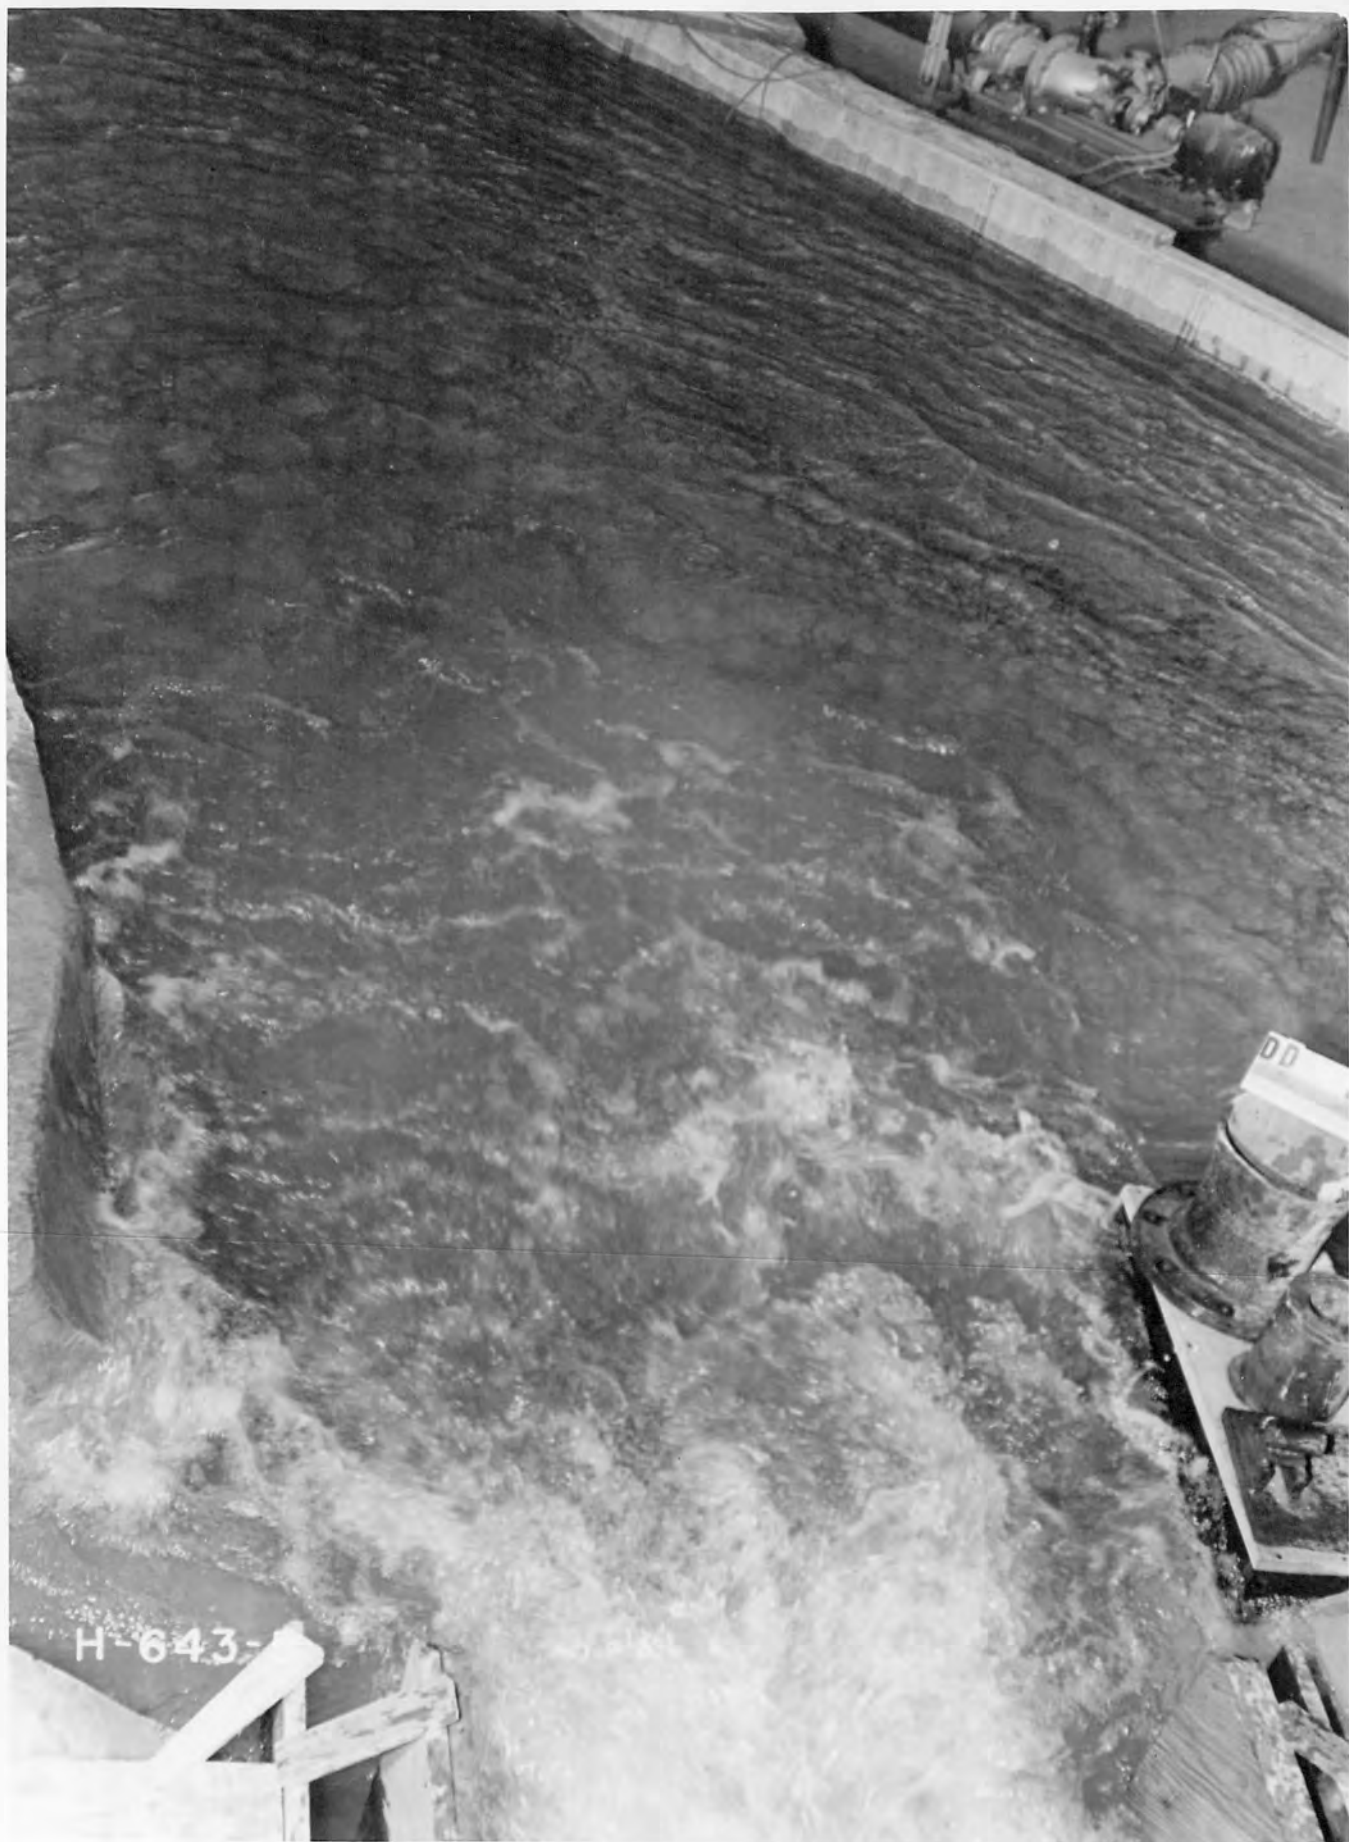
Test No. 6

Discharge - 175,000 sec.-ft.

Tailwater - Ultimate - El. 515.75

Time of Test - 2 hrs.

With this low bucket the roller action occurred for all discharges and tailwater conditions. The submerged action reduced the surface velocities in the eddy on the right side but some erosion was still evident and the cofferdam was undermined. Photographs on the following 2 pages show first, the action on and below the bucket and second, the results of erosion Test No. 6.

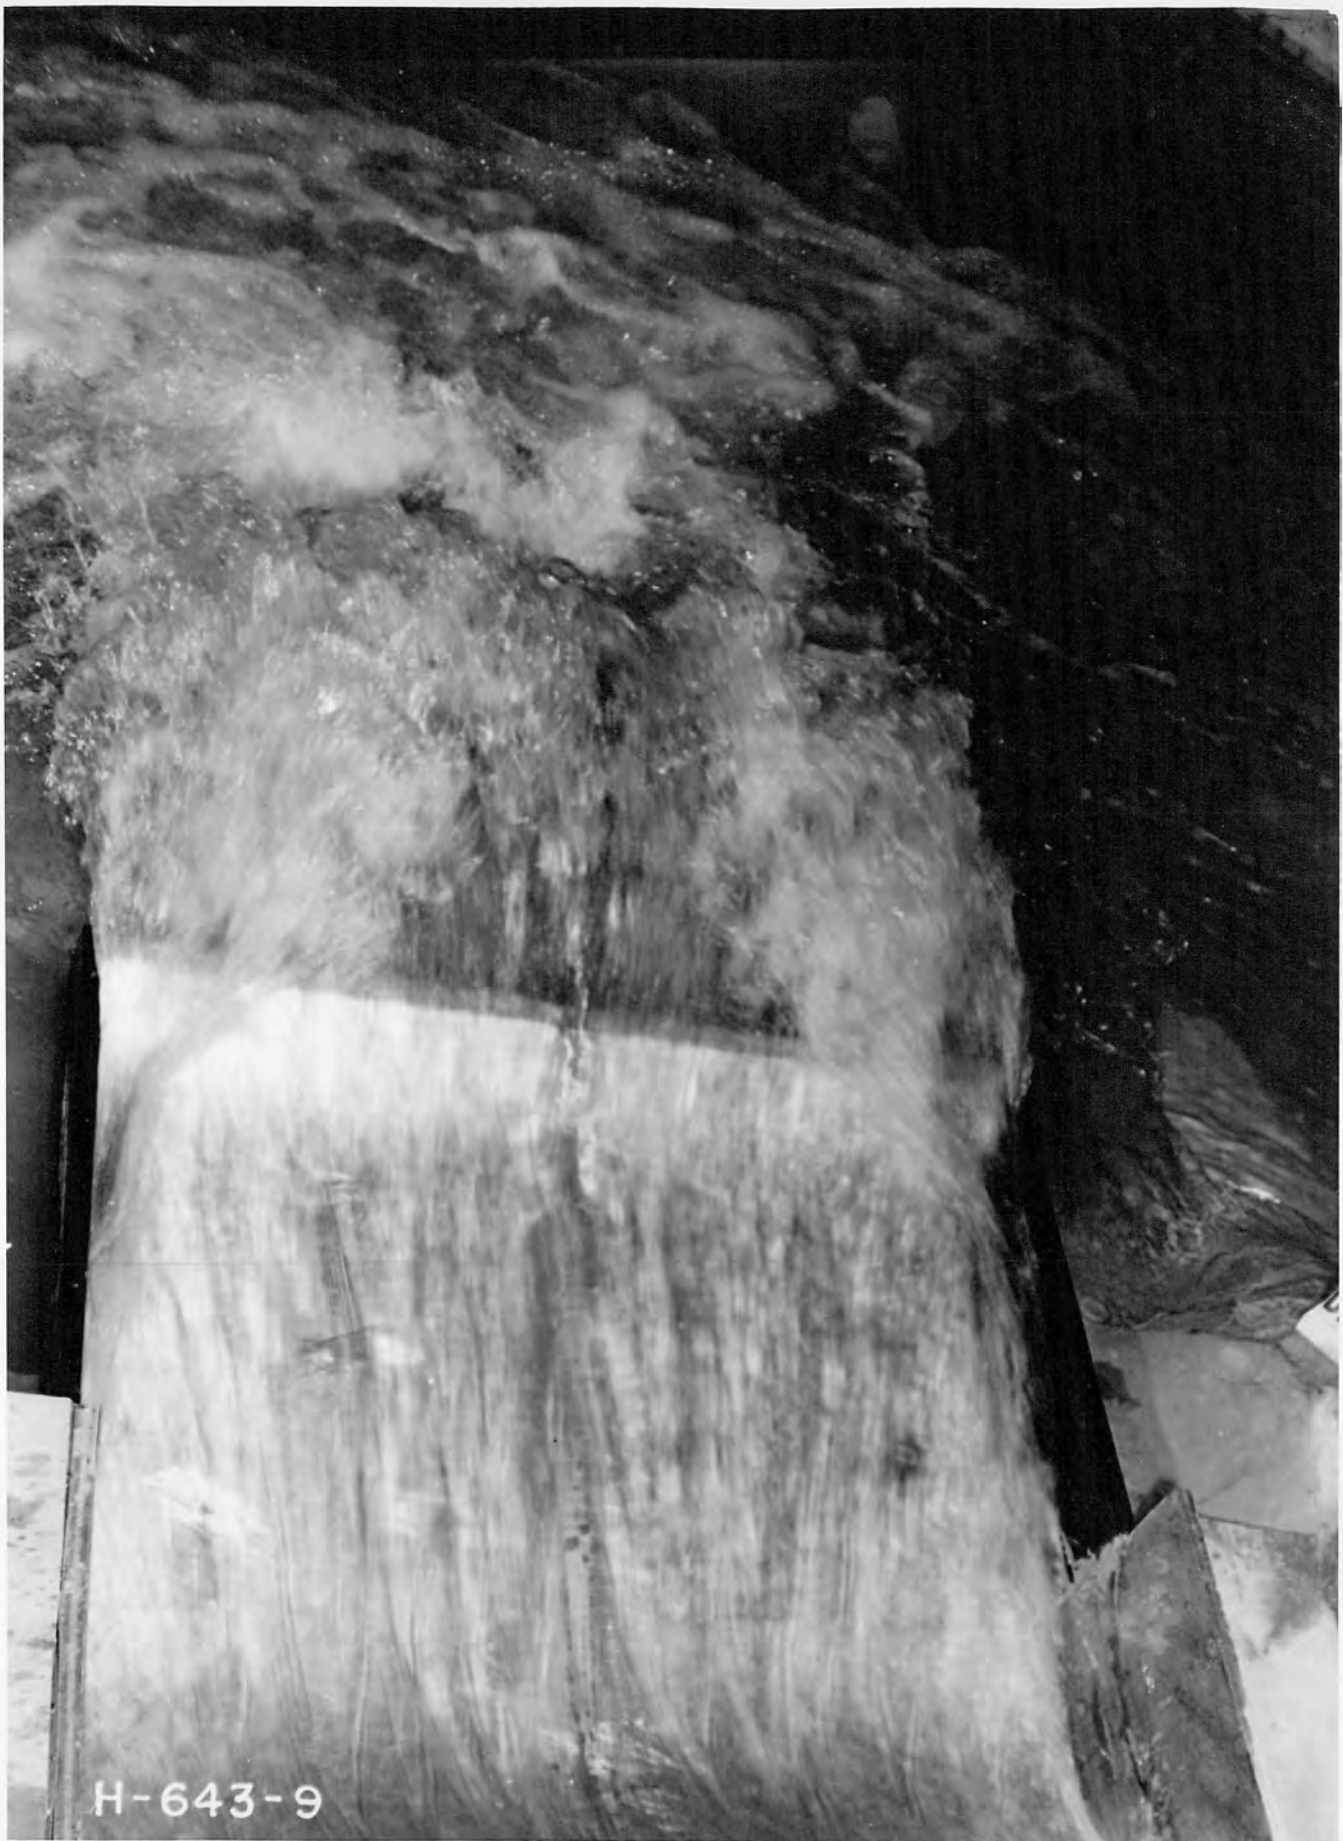
Test No. 8

The photograph on the opposite page shows the jet being "thrown" clear of the rock projection. The jet was not "thrown" far enough, however, to prevent the eddy from attaining a velocity of 16.2 ft. per second, prototype, and causing excessive erosion as shown in the second photograph.

Discharge - 175,000 sec. ft.
Tailwater - Ultimate - El. 515.7
Time of Test - 6hrs. 30min.

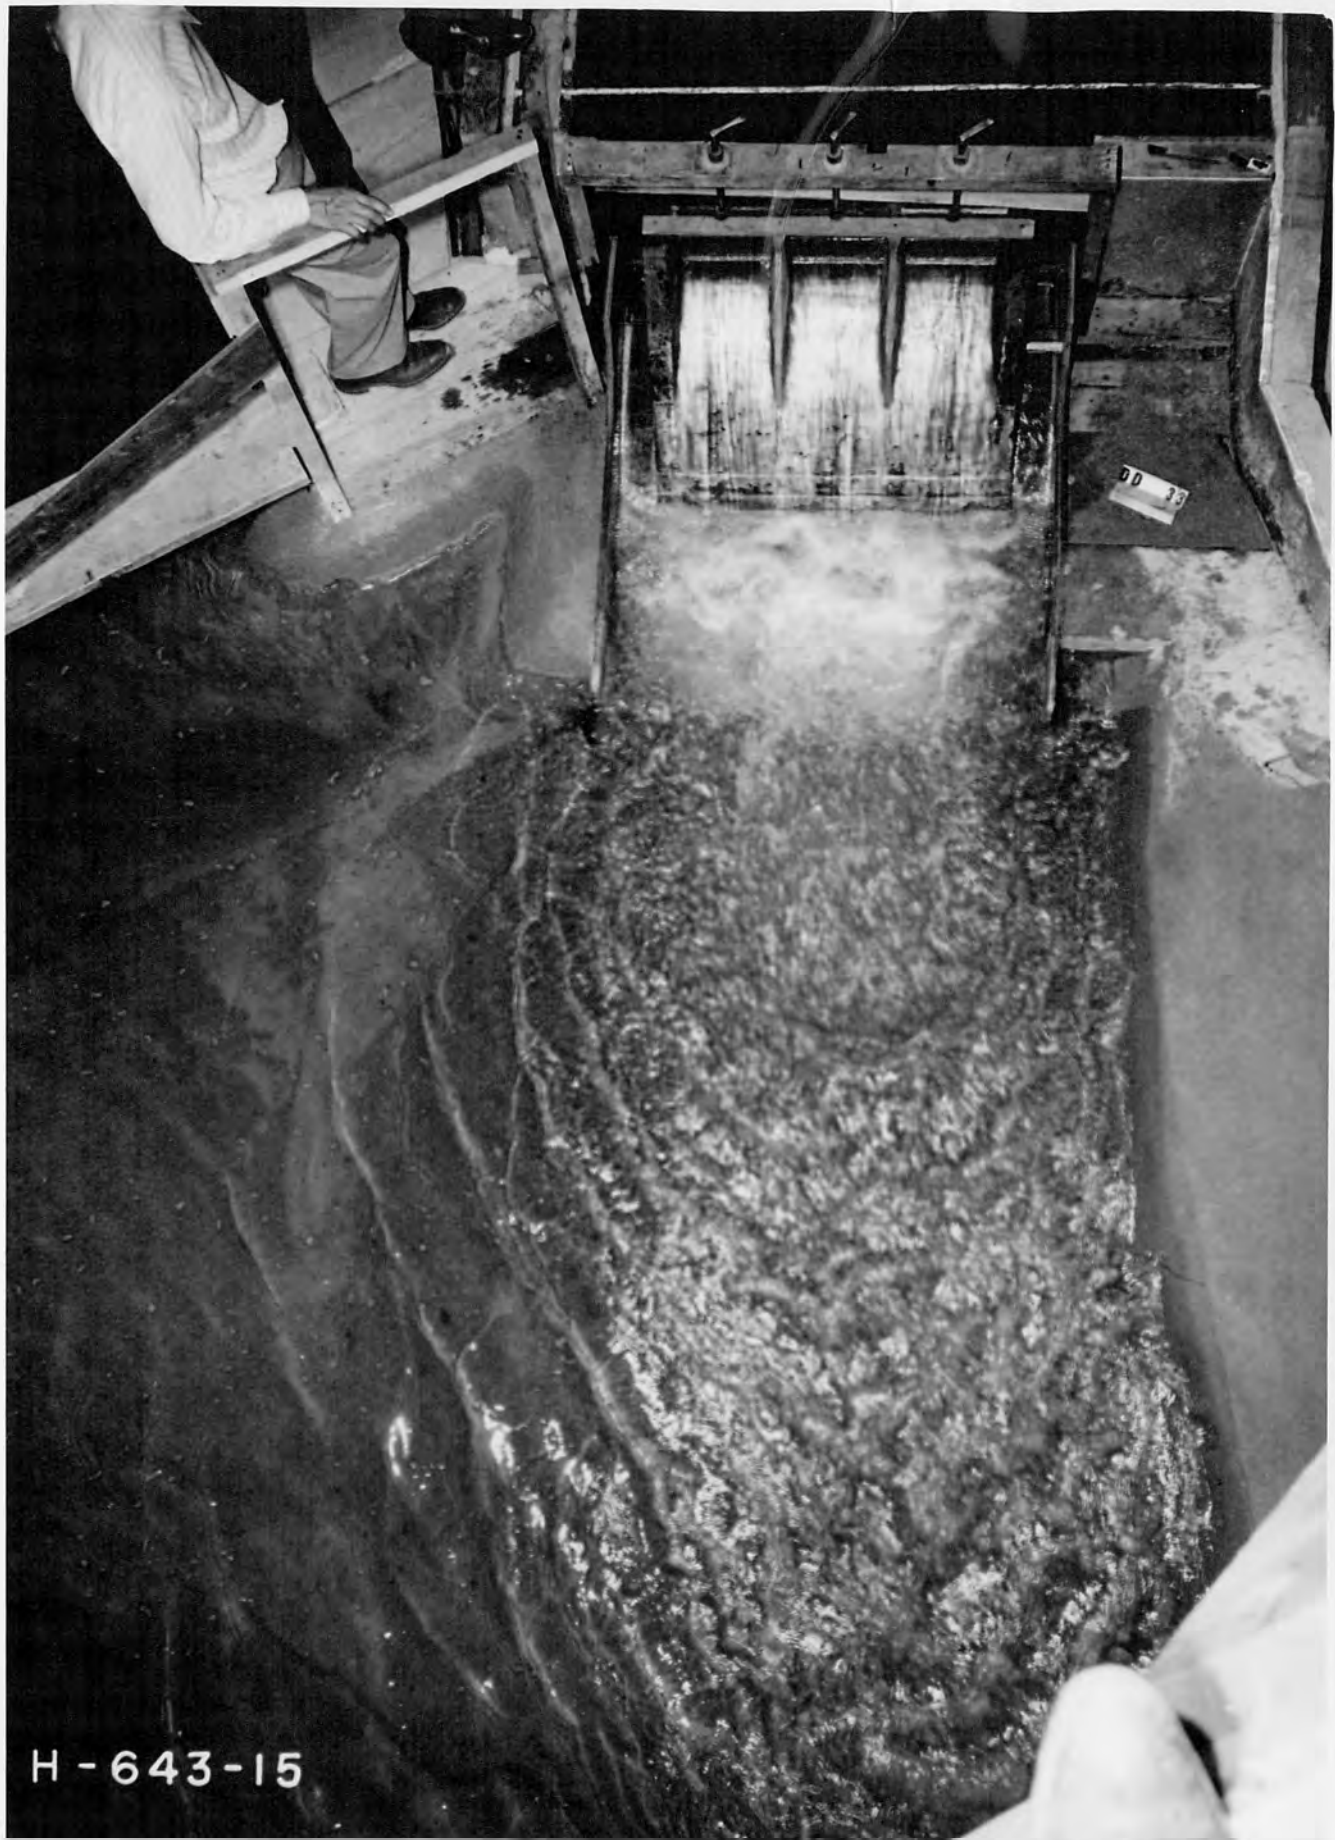
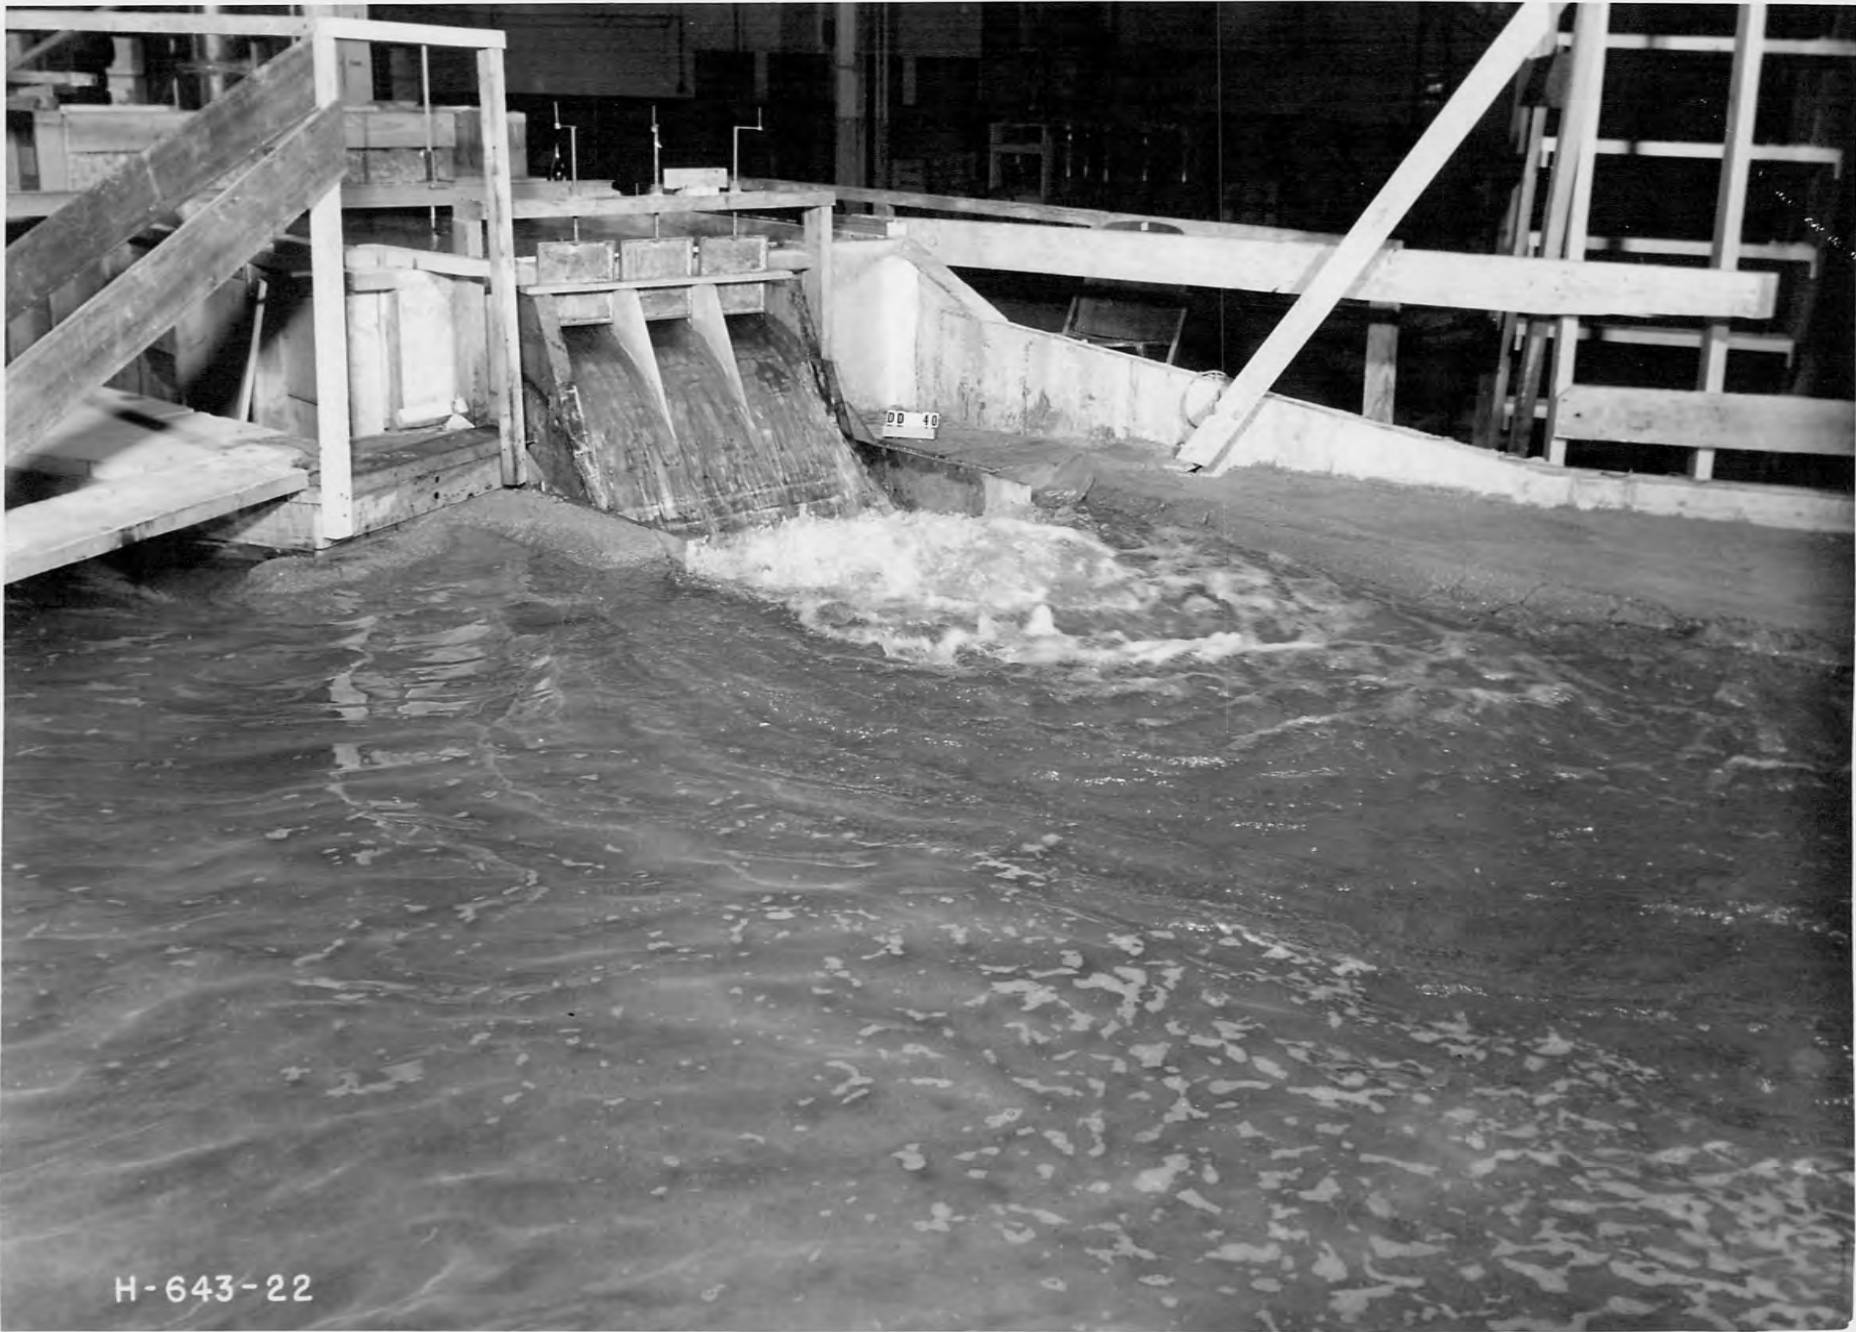
Test No. 9

With the bed molded in stabilized sand at elevation 515, similar to that shown in the first photograph for Test 10, the discharge was gradually increased to 50,000 second-feet. The tailwater was set for present conditions, elevation 524. The resulting flow, shown in the following photograph, was entirely satisfactory and practically no erosion occurred after a one hour run. Because the flow did not sweep out of the bucket the eddy at the right training wall was hardly noticeable.

For 100,000 second-feet and tailwater elevation 528 flow and erosion conditions were similar. For 150,000 second-feet and tailwater elevation 531, shown in the second photograph, flow jumped clear of the bucket and some erosion occurred. Each discharge was tested for one hour and the bed was not remolded between runs. Erosion and eddy conditions were more severe, however for ultimate tailwater conditions shown in Test 10.
