HYDRAULIC MODEL STUDIES RELATING TO
THE REDESIGN OF THE SPILLWAY AND
POWERHOUSE FOR THE DAVIS DAM

Hydraulic Laboratory Report Hyd. 232

Bureau of Reclamation
Denver, Colo.

July 15, 1947

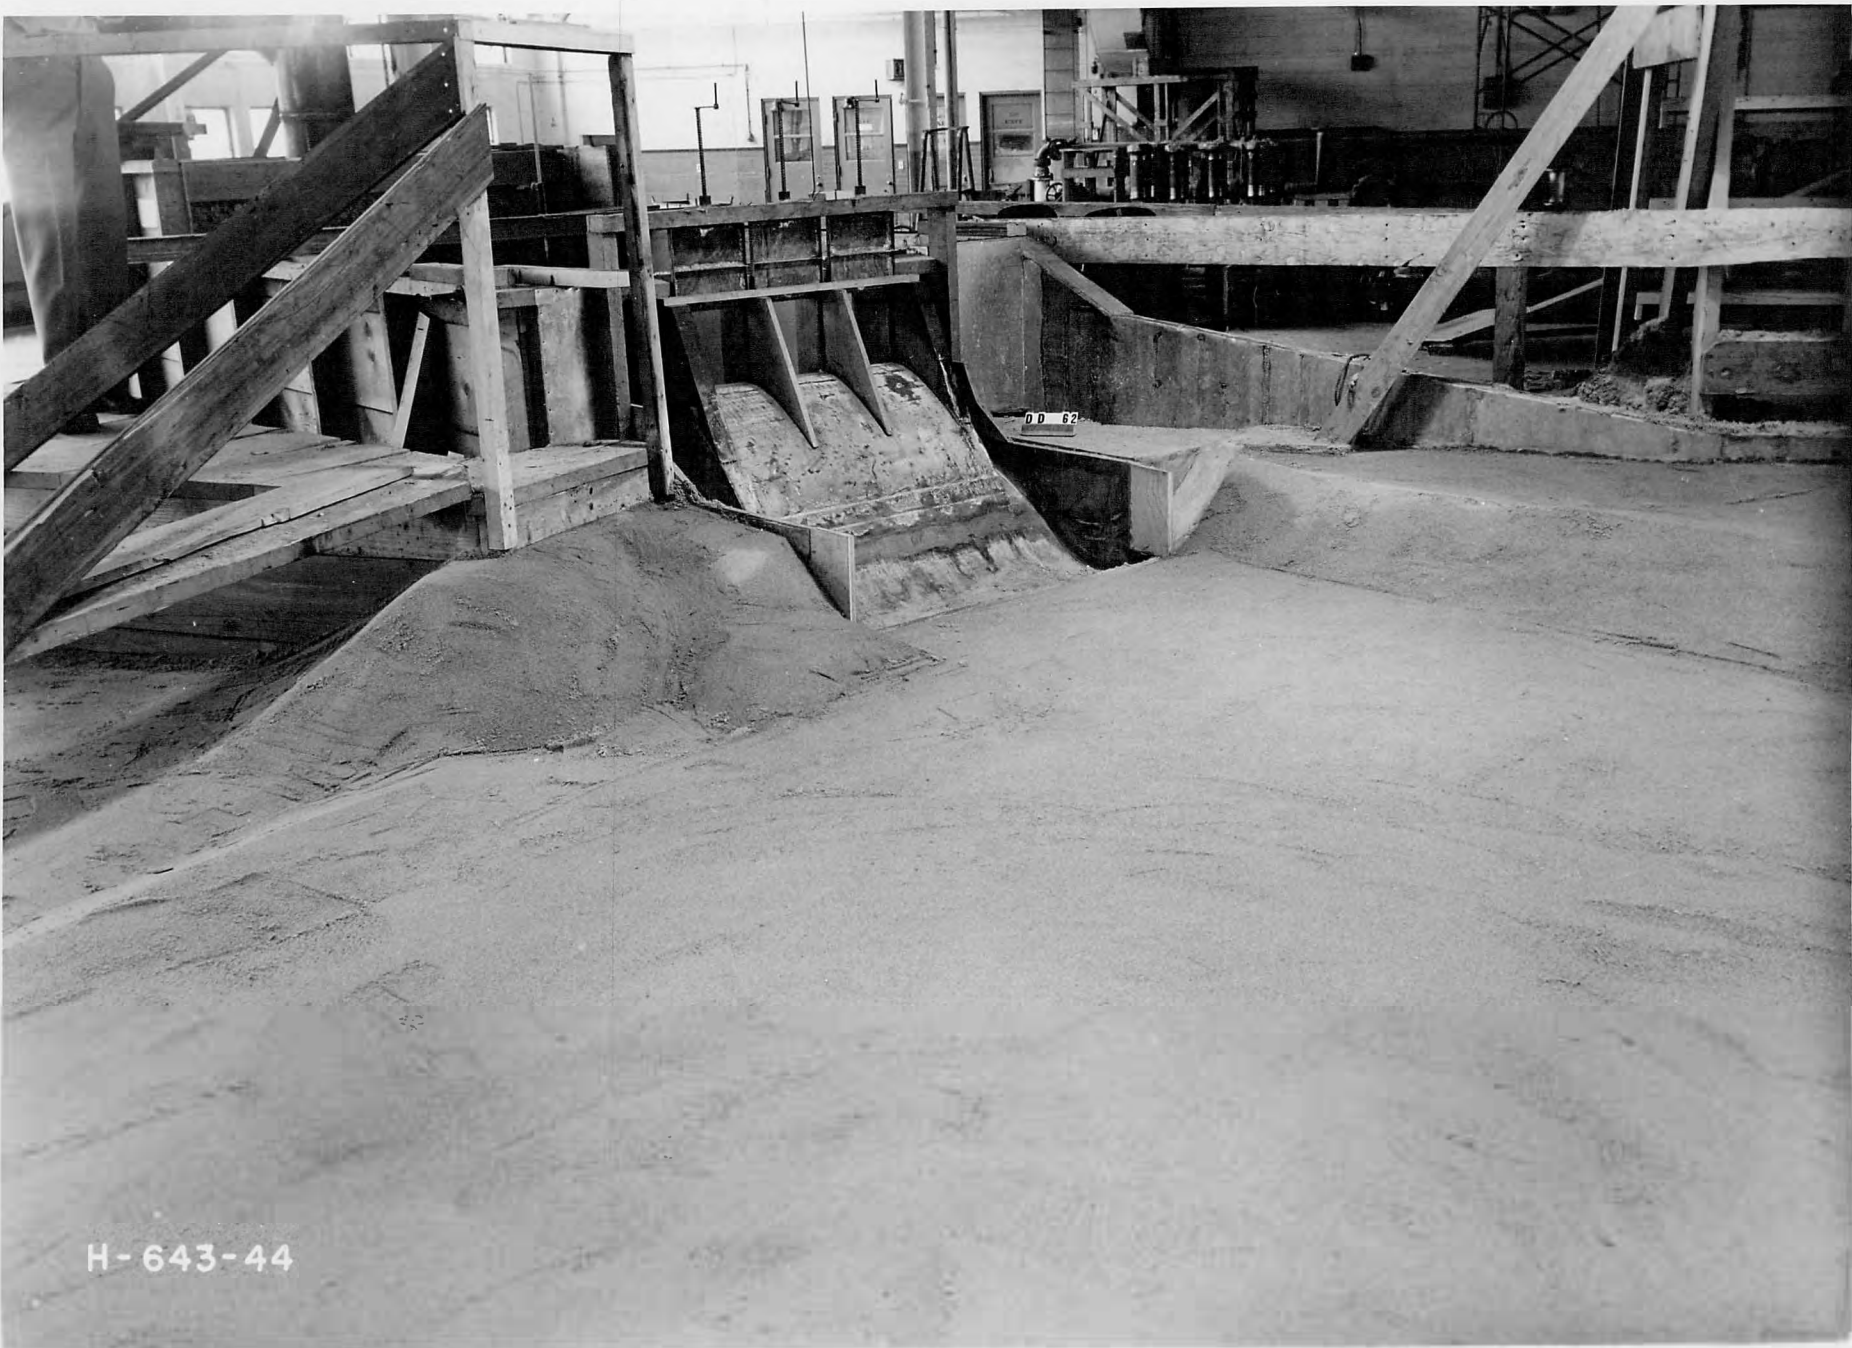
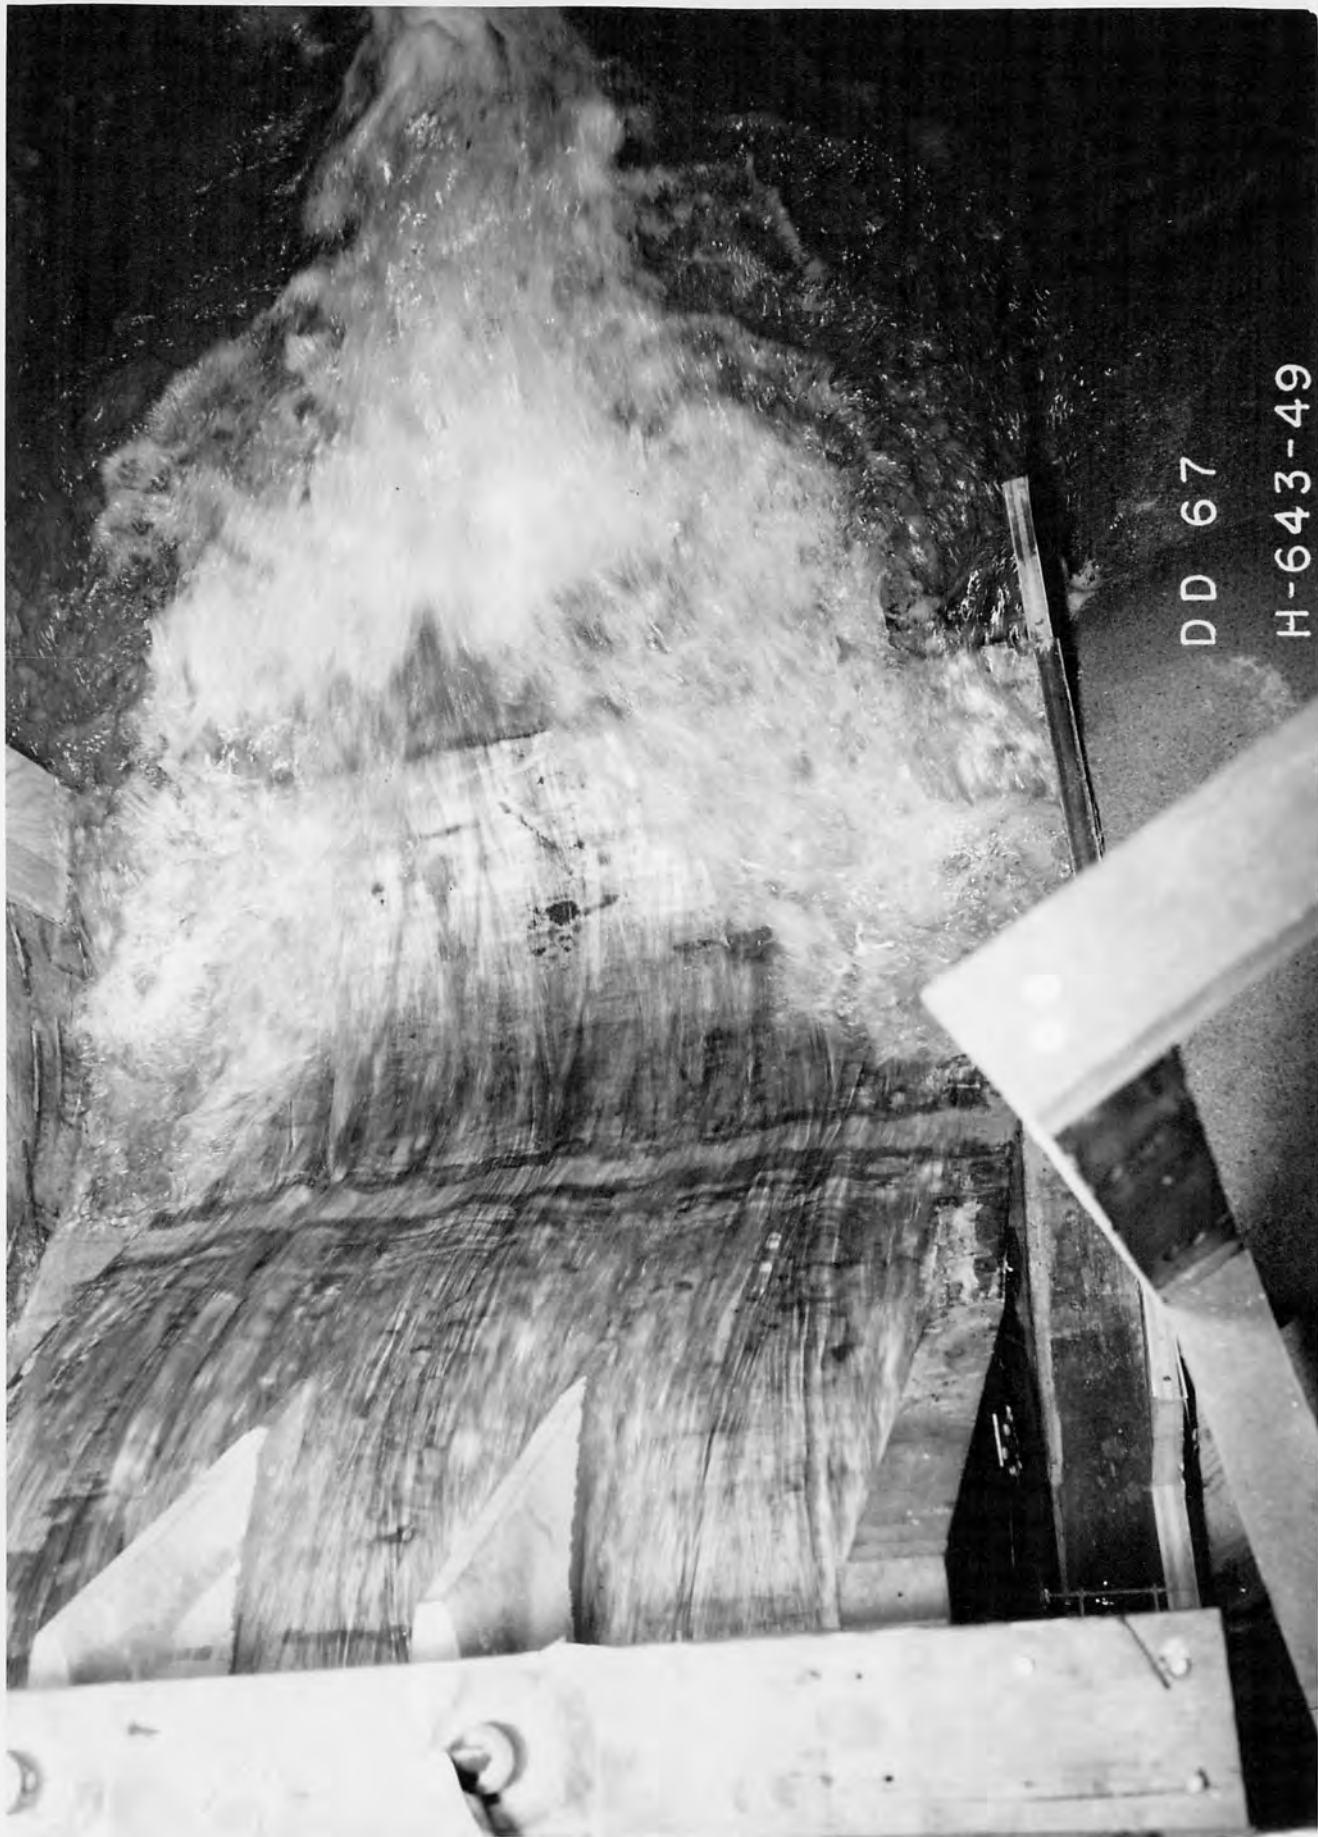
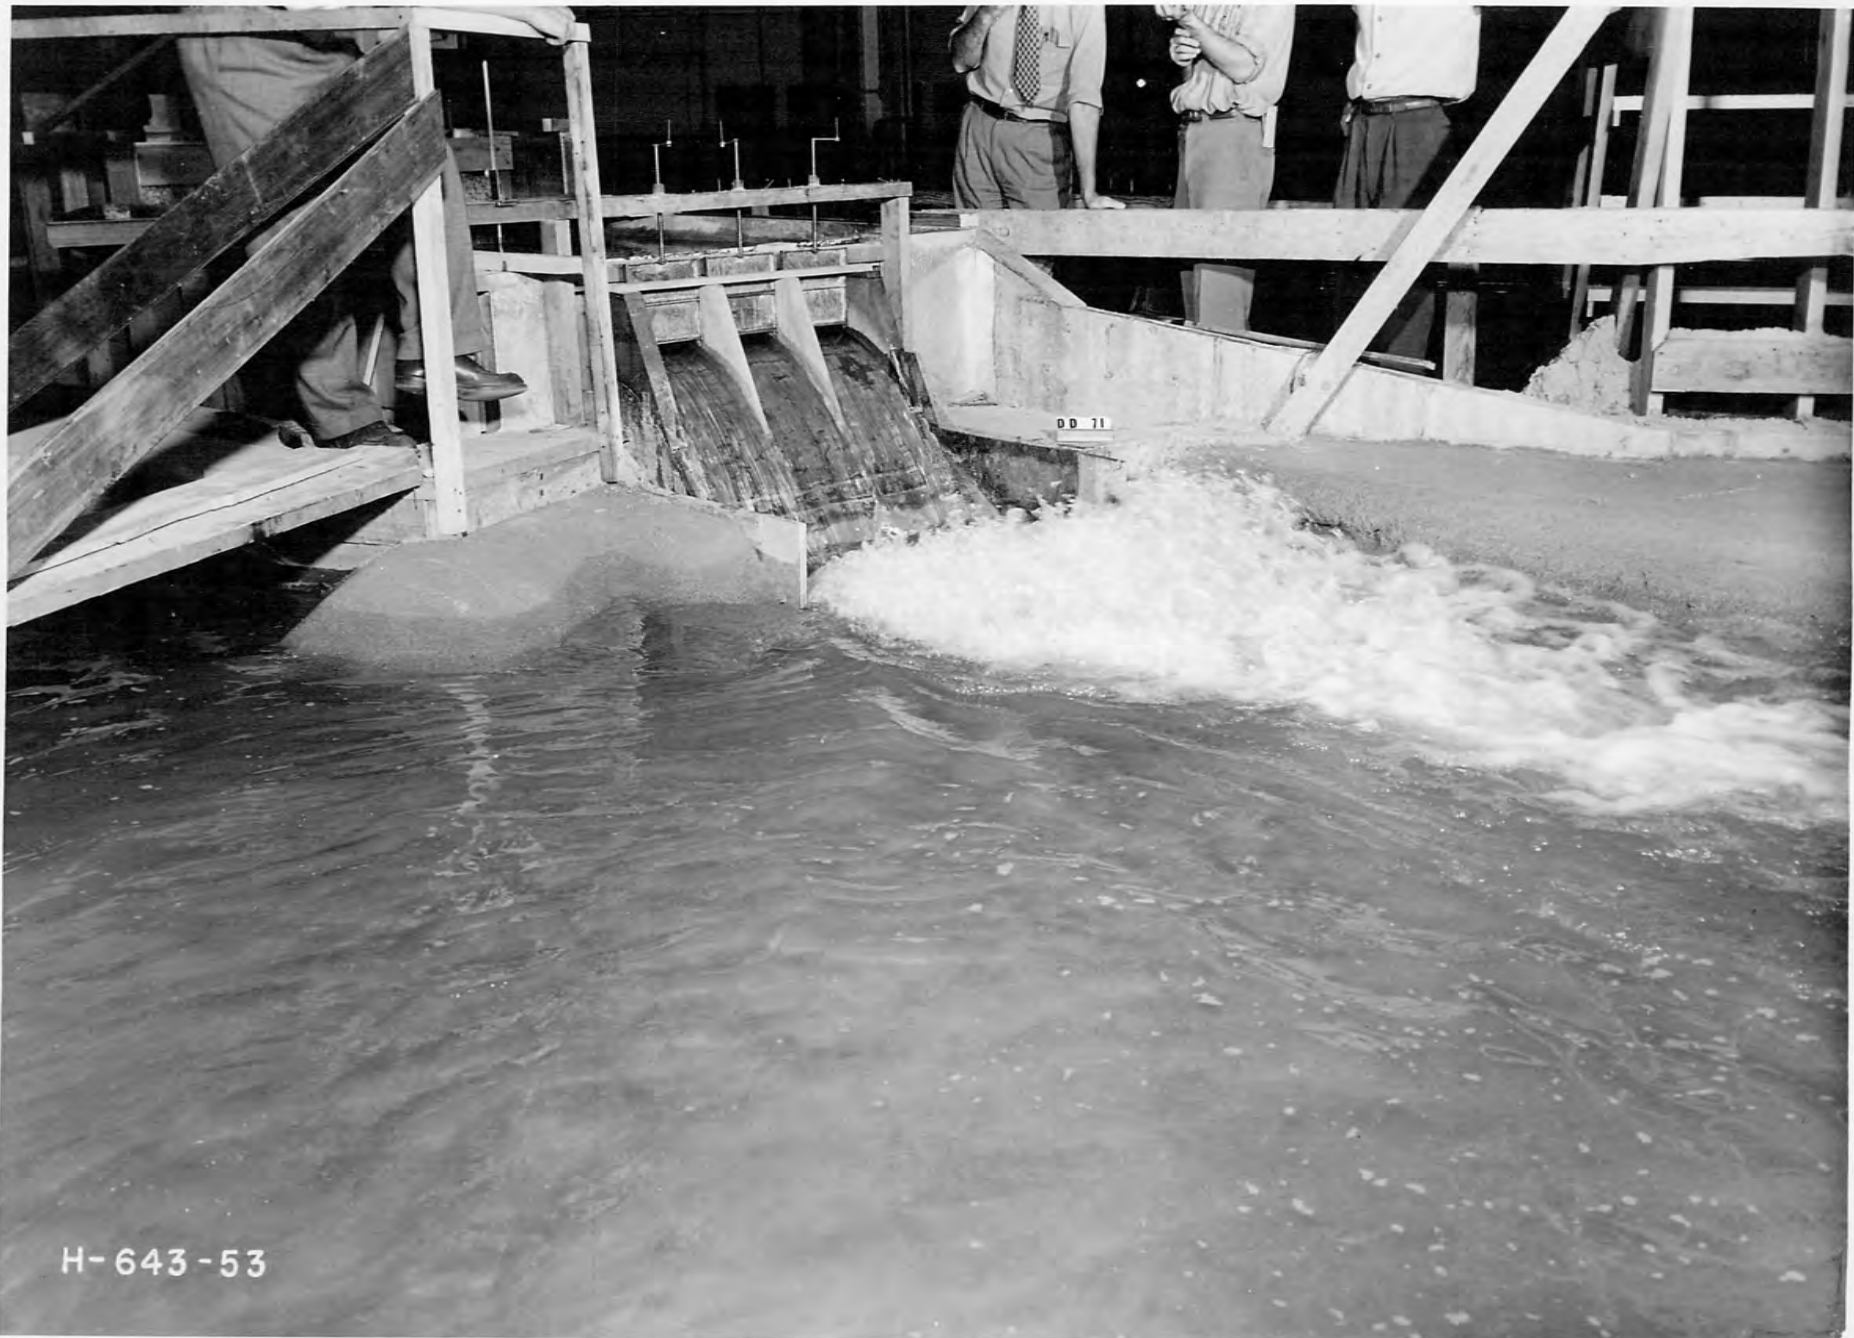
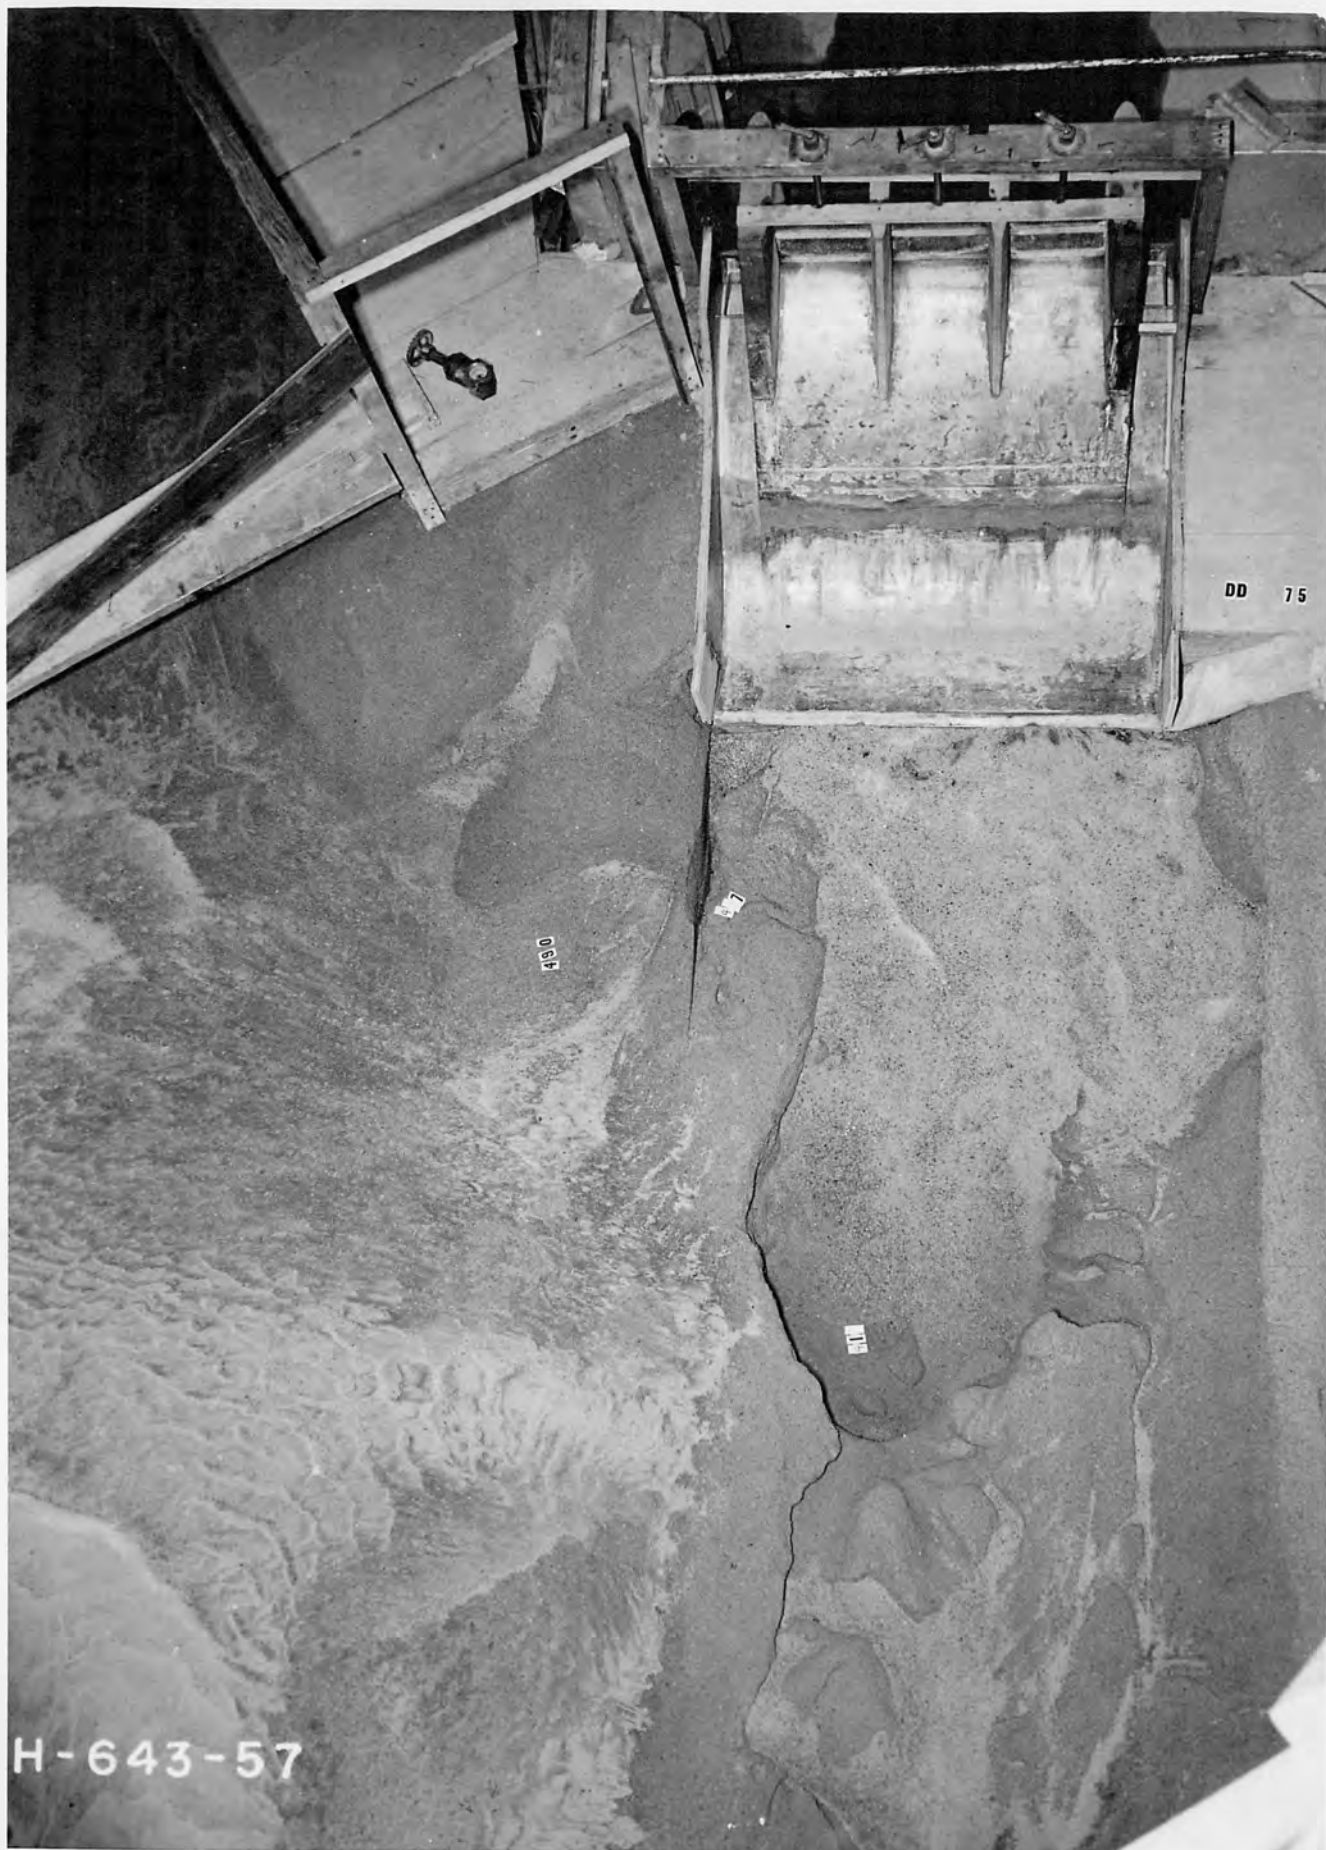
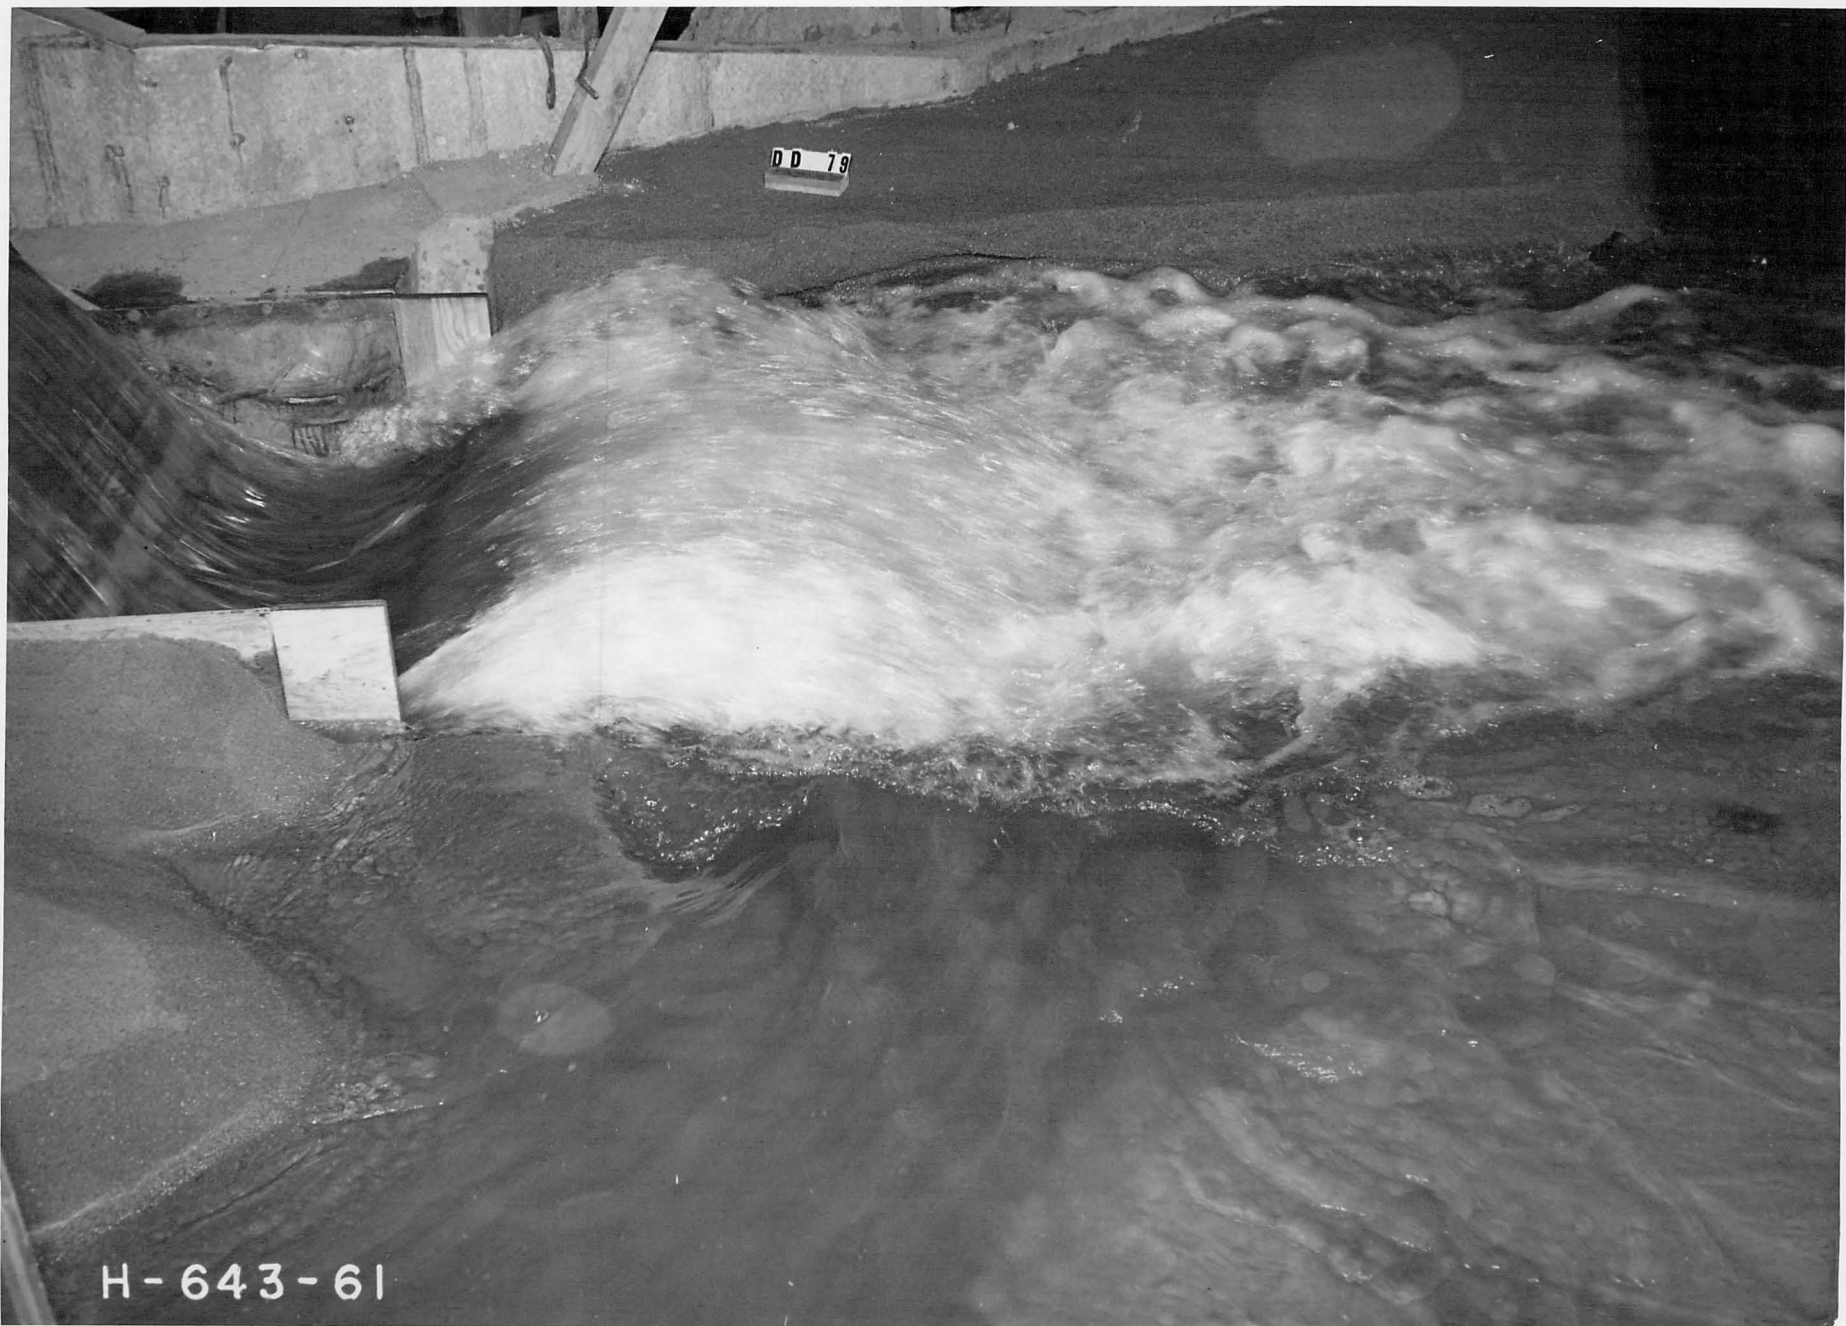
Test No. 10

The bed was remolded after Test 9 in stabilized sand at elevation 515 as shown in the following photograph, (DD62). For 50,000 second-feet and ultimate tailwater elevation 506 an eddy formed in the bucket as shown in the second photograph, (DD66). For no apparent reason another eddy formed in the bucket for short periods of time as shown in the third photograph, (DD67). At the end of a one hour run the river bed was eroded as shown in the next photograph, (DD70).

Without remolding the bed a discharge of 100,000 second-feet was run for one hour with ultimate tailwater at elevation 511.5 as shown in photograph DD71. The ground roller covered up erosion close to the bucket that had occurred during the 50,000 second-foot run as shown in photograph DD75.

For 175,000 second-feet with ultimate tailwater elevation 516 the operation was as shown in photograph DD79. The velocity of the eddy in the foreground was estimated to be about 15 feet per second and caused very little erosion of the rock outcropping. The erosion after a one hour run at 175,000 second-feet, plus the effects of the 50,000 and 100,000 second-foot runs, is shown in photographs DD80 and DD81. The greatest erosion occurred below the rock projection on the right side and in the hill along the left bank.
