HYDRAULIC MODEL STUDIES OF
ARBUCKLE DAM OUTLET WORKS
ARBUCKLE PROJECT, OKLAHOMA

Report No. Hyd-528

Hydraulics Branch
DIVISION OF RESEARCH

August 7, 1964

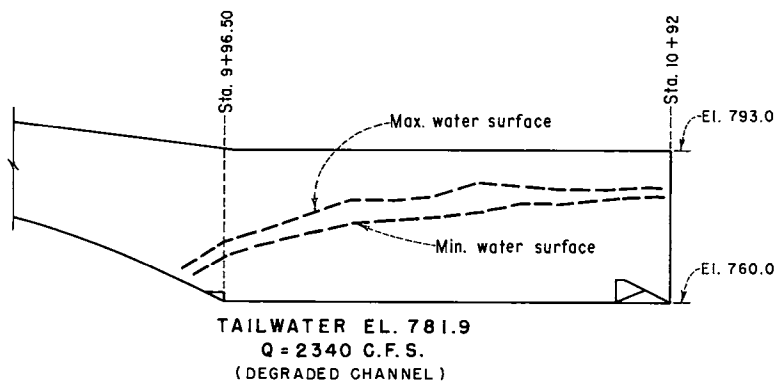
HYD-528

ARBUCKLE DAM OUTLET WORKS
1:18 SCALE MODEL
STILLING BASIN WATER SURFACE PROFILES

Water surface profiles. --Water surface profiles, measured for discharges of 2,340 and 2,665 cfs with both initial and degraded channel conditions are shown in Figure 12. The profiles show the maximum and minimum water surface, indicating the amount of surging in the basin. These profiles, when compared to Figure 11, show similarity with the pressure profiles, indicating essentially hydrostatic pressure distribution on the wall.
