Middle Rio Grande River Maintenance Plan Part 1 Report

Middle Rio Grande Project, NM
Upper Colorado Region

U.S. Department of the Interior
Bureau of Reclamation
Albuquerque Area Office, Albuquerque, New Mexico
Technical Service Center, Denver, Colorado

May 31, 2007

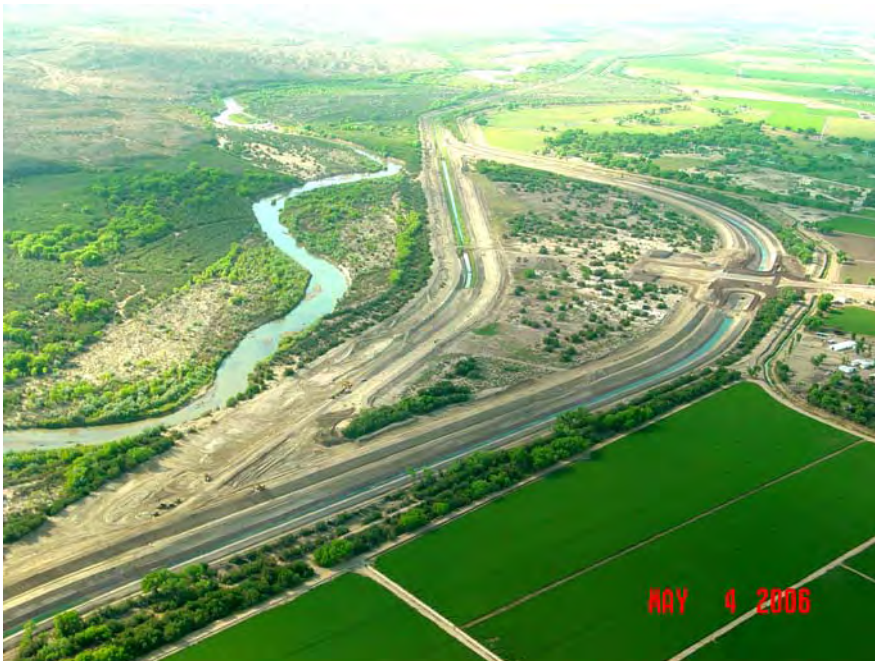
Recent river maintenance projects have been designed to address habitat needs as well as erosion problems. Levee setback, a method in which the levee is relocated away from the point of erosion in the channel, was used at the Santa Fe River Confluence and the San Acacia River Mile 113 and 114 priority sites (Figure 2). This technique improves habitat by increasing the area of the floodplain and providing greater latitude for fluvial processes.

Figure 2. Levee setback at river mile 113/114

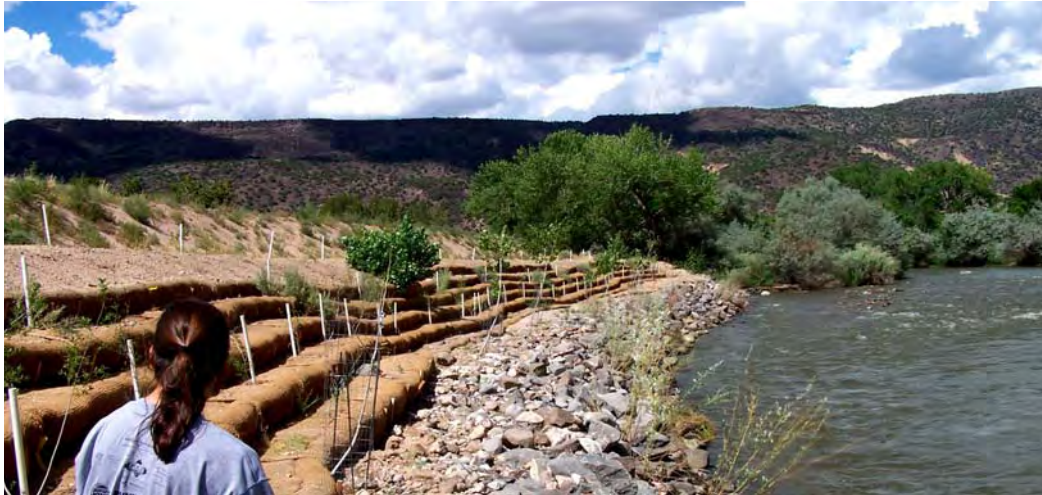
The Santa Ana and La Canova priority site projects (Figure 3) included a bio-engineered bankline consisting of a rock toe and several layers of coir fabric-encapsulated soil planted with native vegetation. The native vegetation provides wildlife habitat and increases soil stability as the plants mature. At Santa Ana, the rock toe of the bio-engineered bankline was sized to be mobile at very high flows, allowing the channel dimensions to naturally adjust to the hydrology.

Figure 3. Bioengineered bankline at La Canova
