Geomorphic background for Glen Canyon Slough

Glen Canyon Dam Adaptive Management Program
Technical Working Group Meeting
October 29, 2024

Paul Grams
U.S. Geological Survey
Southwest Biological Science Center
Grand Canyon Monitoring and Research Center

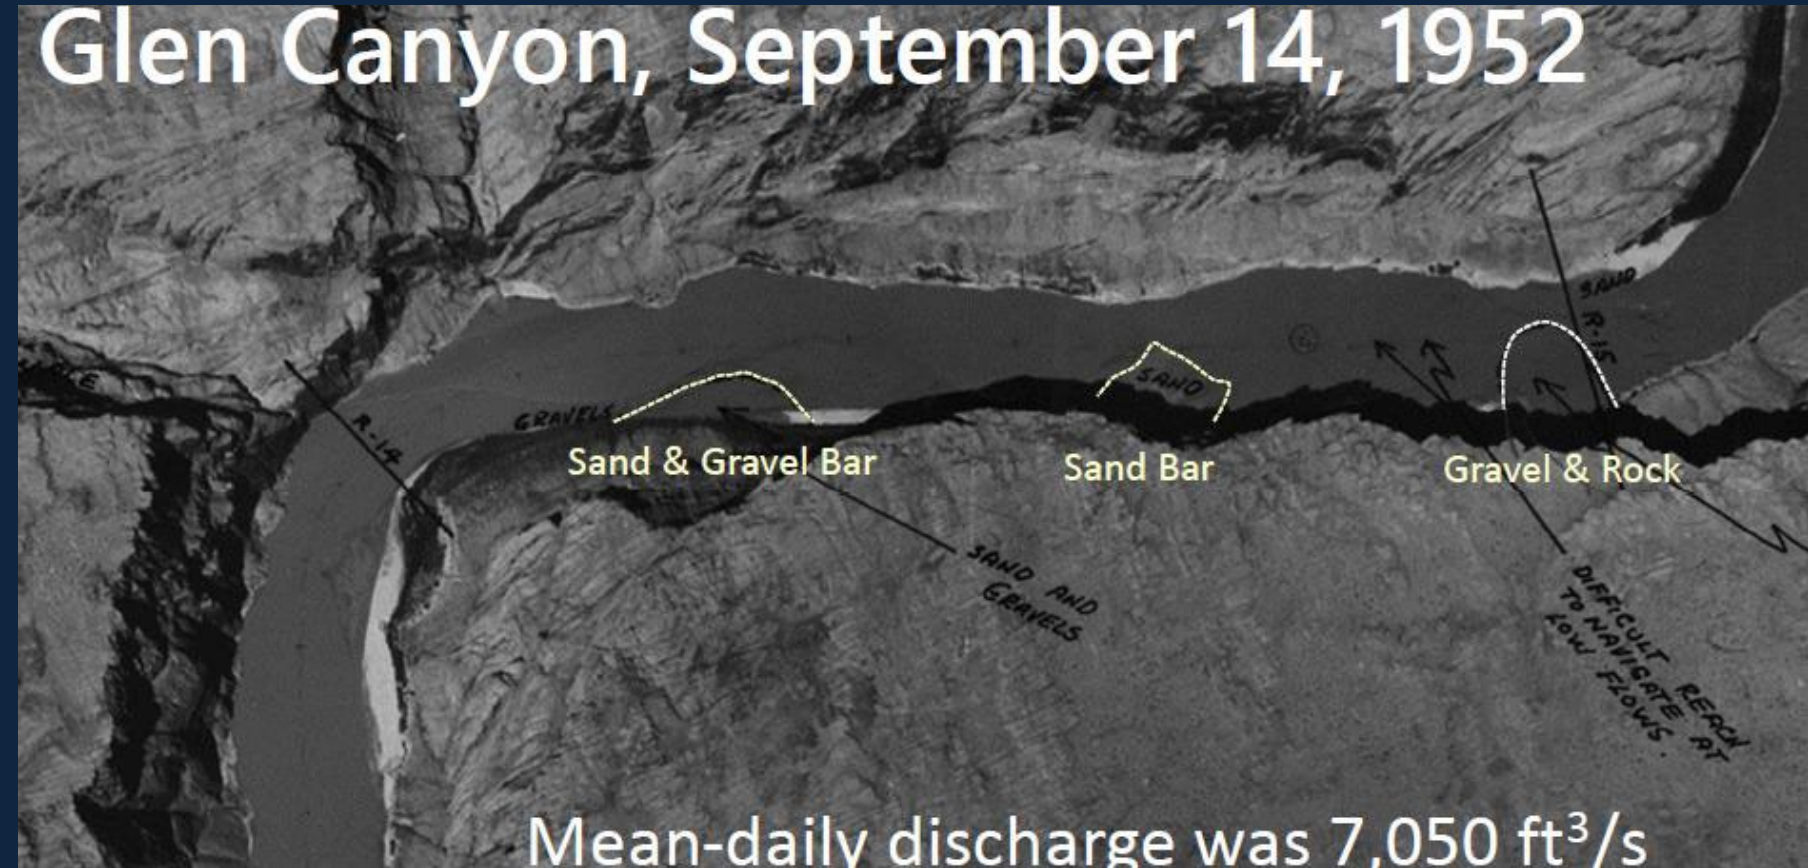
1952

- Photo at 7,050 cfs shows water, sand, and gravel.
- Shadows limit view of river left bank.
- Here and throughout Glen Canyon, annual snowmelt floods scoured the channel and mobilized sand and gravel bars.

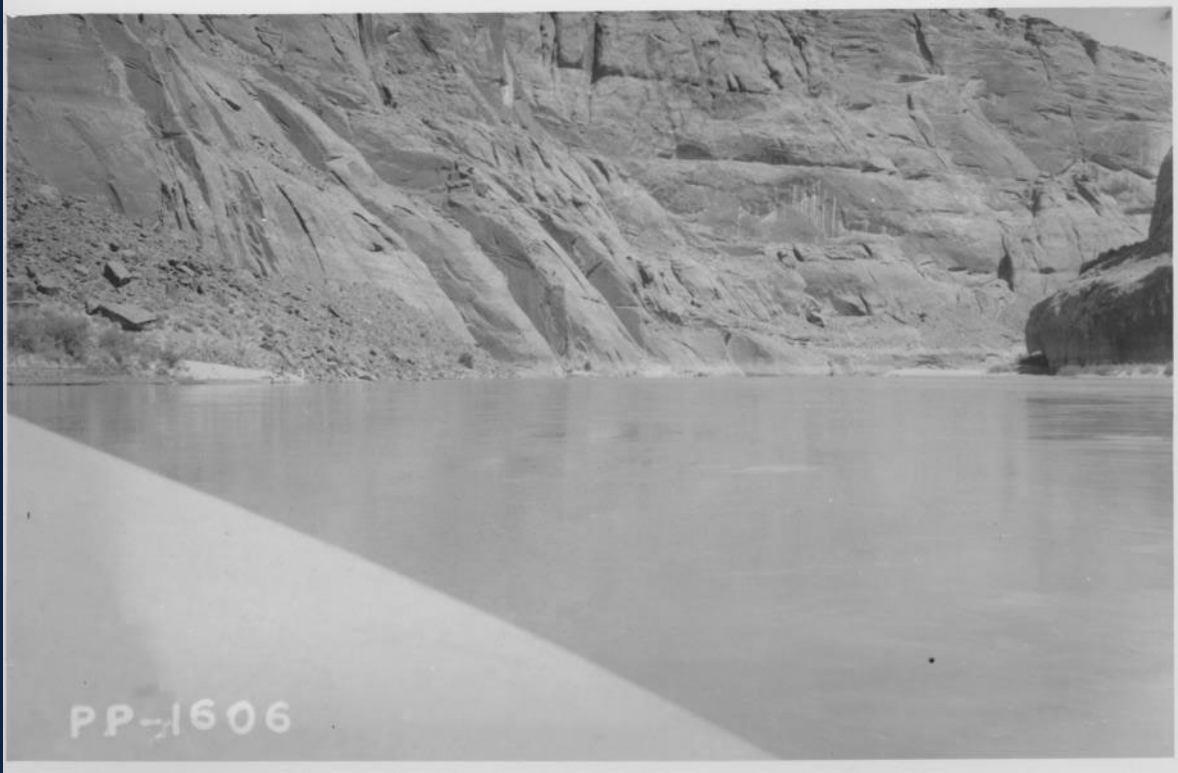
July 23, 1956: Looking downstream toward river Section R-15.

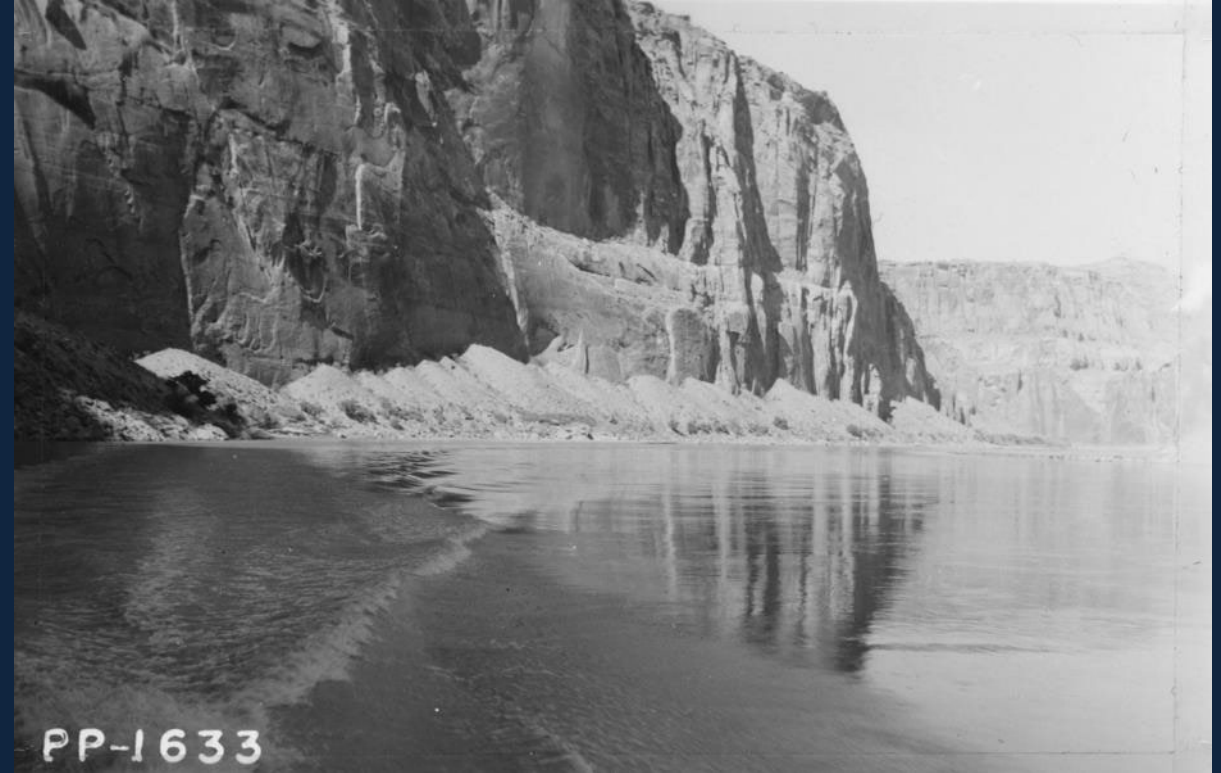
July 27, 1956: Looking downstream toward river Section R-15.

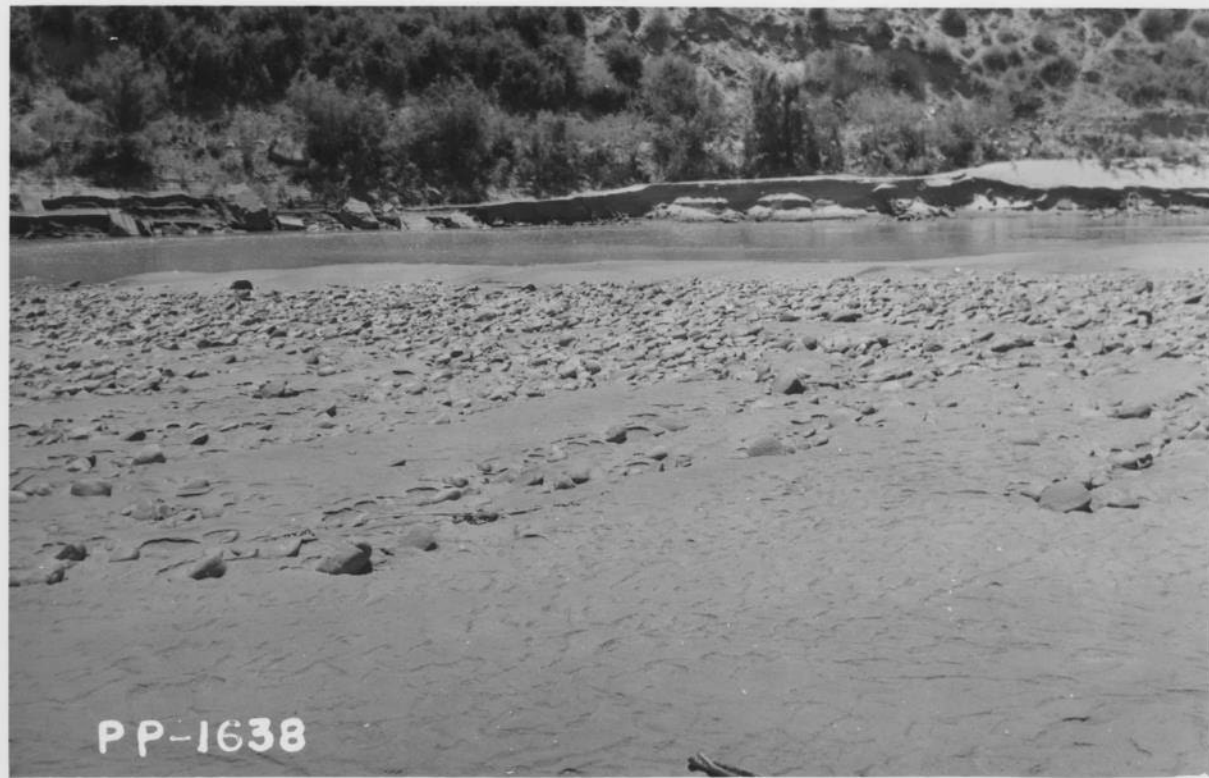
July 27, 1956: Looking at left bank from gravel and cobble bar at river section R-15 (This has not been relocated in the field, but could be looking directly at the present slough).

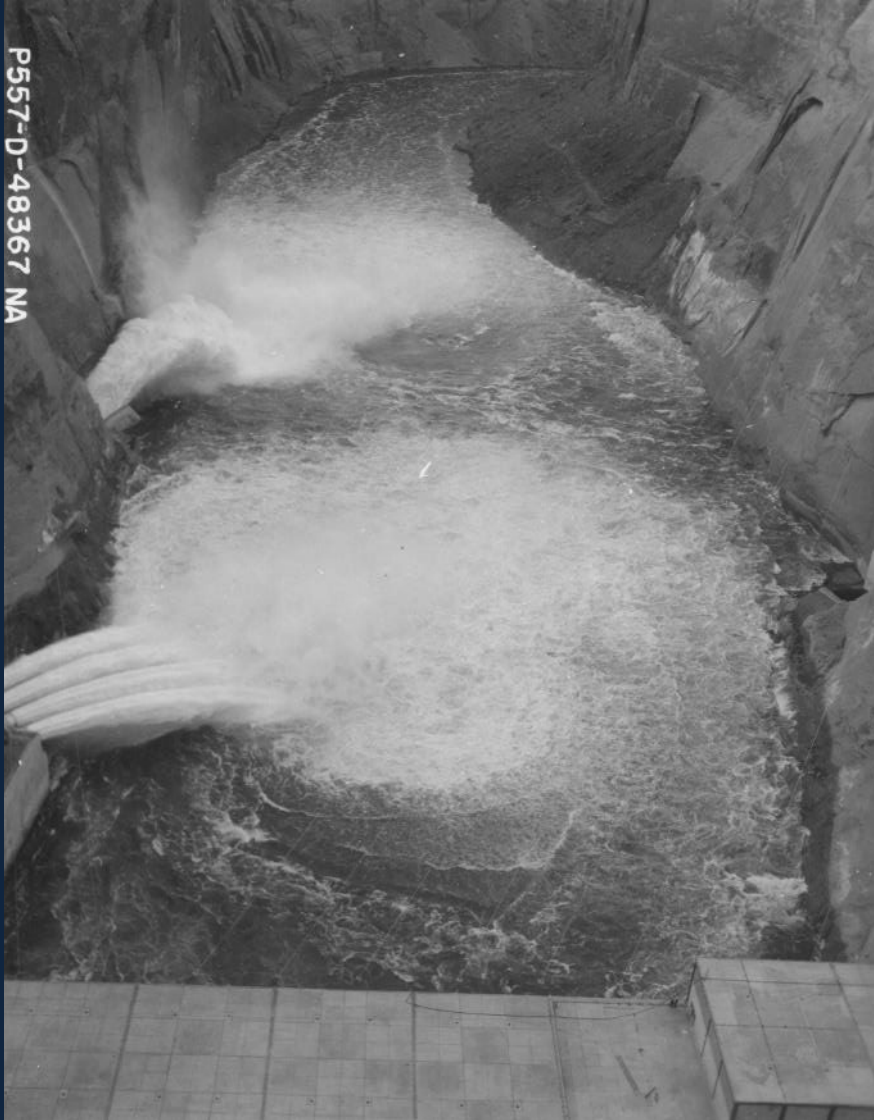
May 4, 1965: 52,000 cfs

- Beginning in February 1965, a series of progressively larger flow pulses were released from the dam, using the outlet works, river diversion tunnels (before they were closed off), and the partially completed powerplant.
- Largest pulse was 60,000 cfs in June 1965

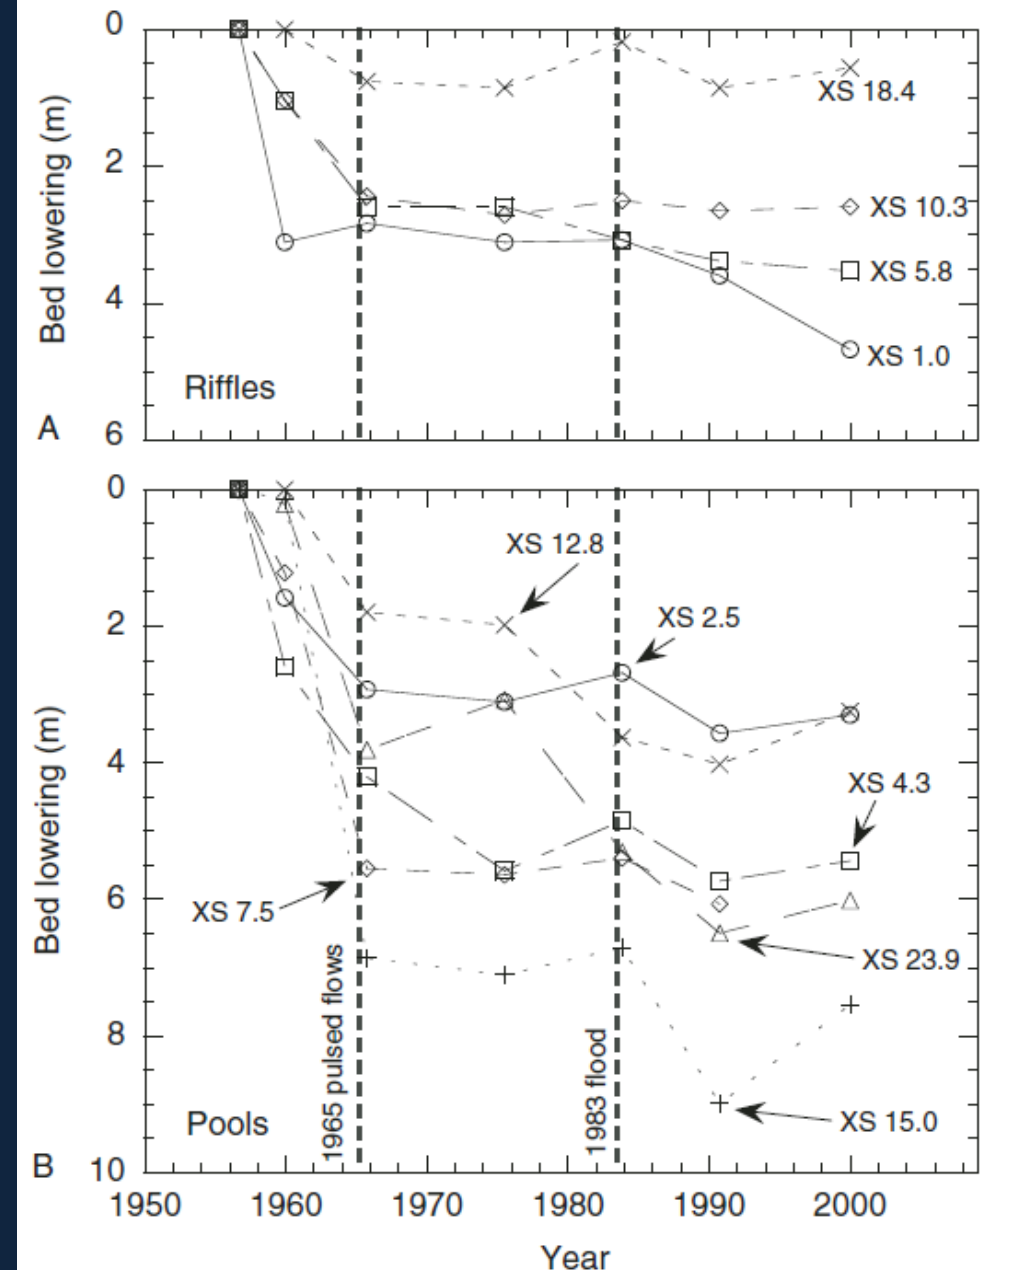
- Scour occurred throughout the entire reach between the dam and Lees Ferry
- Scour occurred in both pools and riffles
- The slough is adjacent to the gravel bar riffle at 5.8 km downstream from dam (RM - 12)

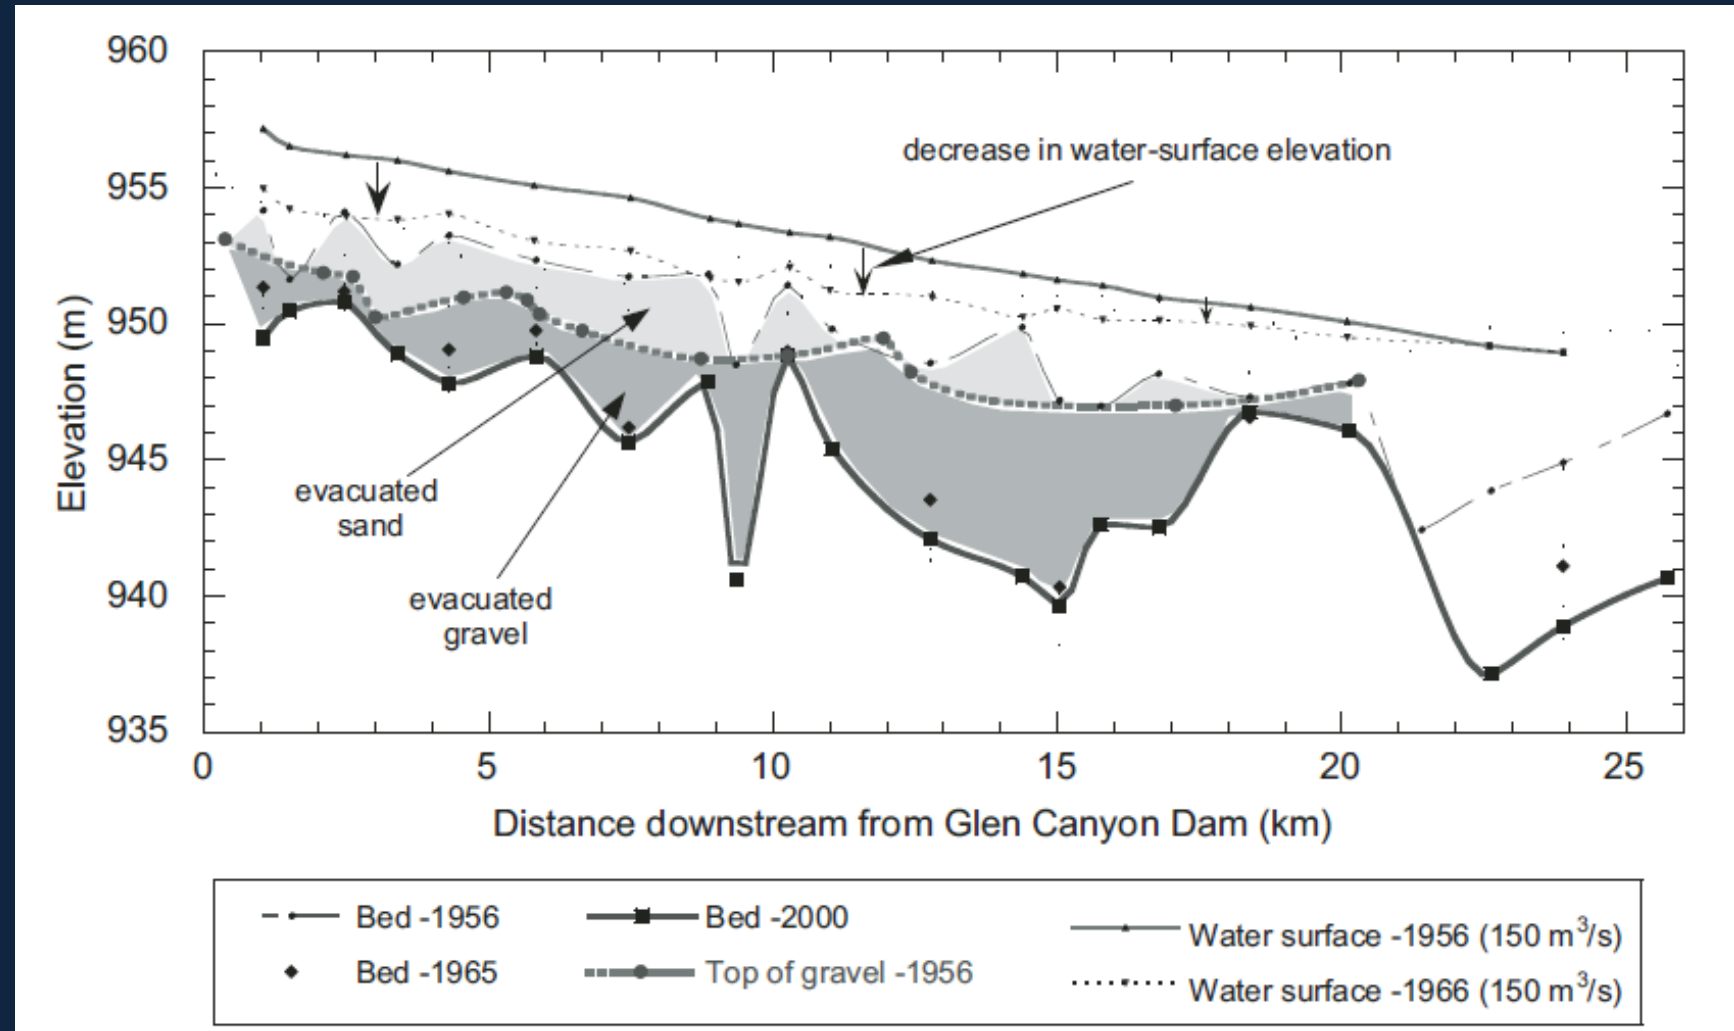
- More than 10 million cubic meters of sand and gravel evacuated from reach
- This bed scour lowered the water surface for a given discharge by up to 7 feet
- At the slough, the water surface lowered by ~6 feet for discharges from 5000 to 30,000 cfs
- That resulted in the “abandonment” of the gravel bar and formerly active side channel next to the gravel bar

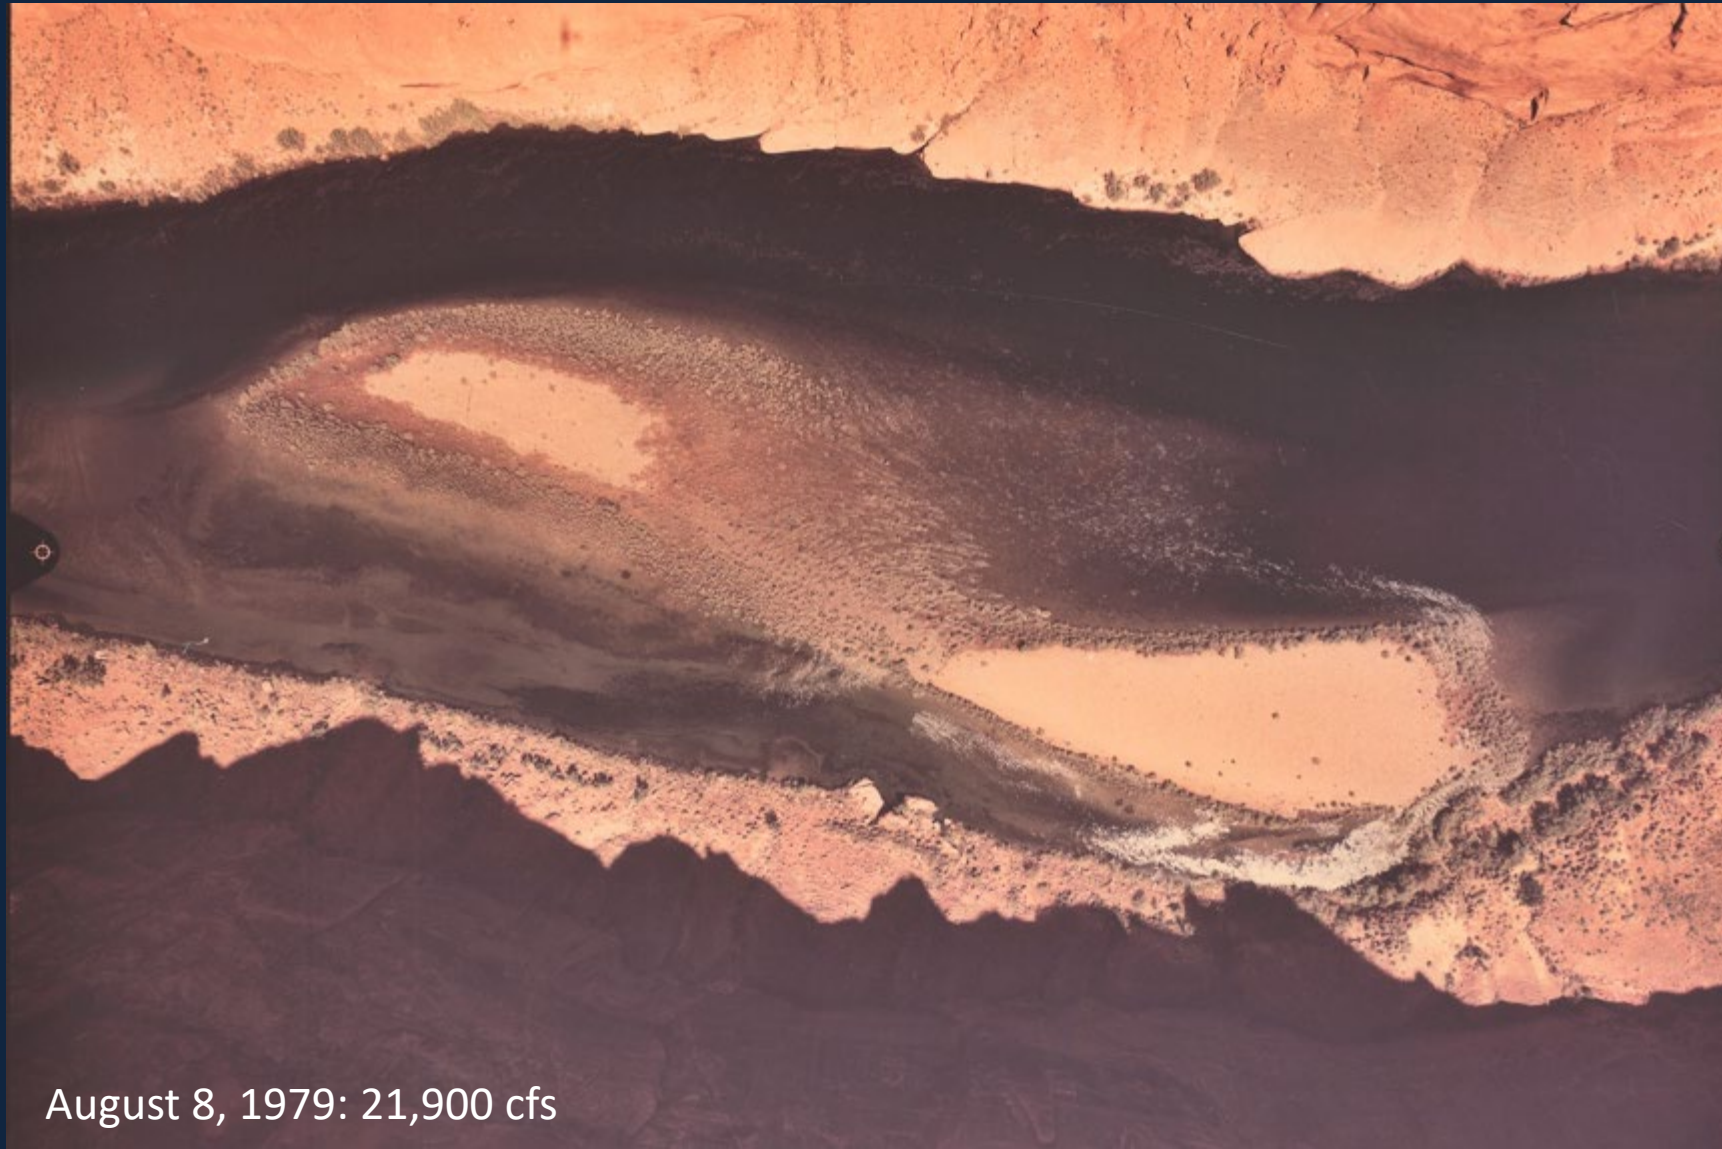
August 8, 1979: 21,900 cfs

- Daily fluctuations between 12,000-26,000 cfs
- Little vegetation visible due to frequent scouring. both cobble and sand visible.
- Flow through back channel and across center.

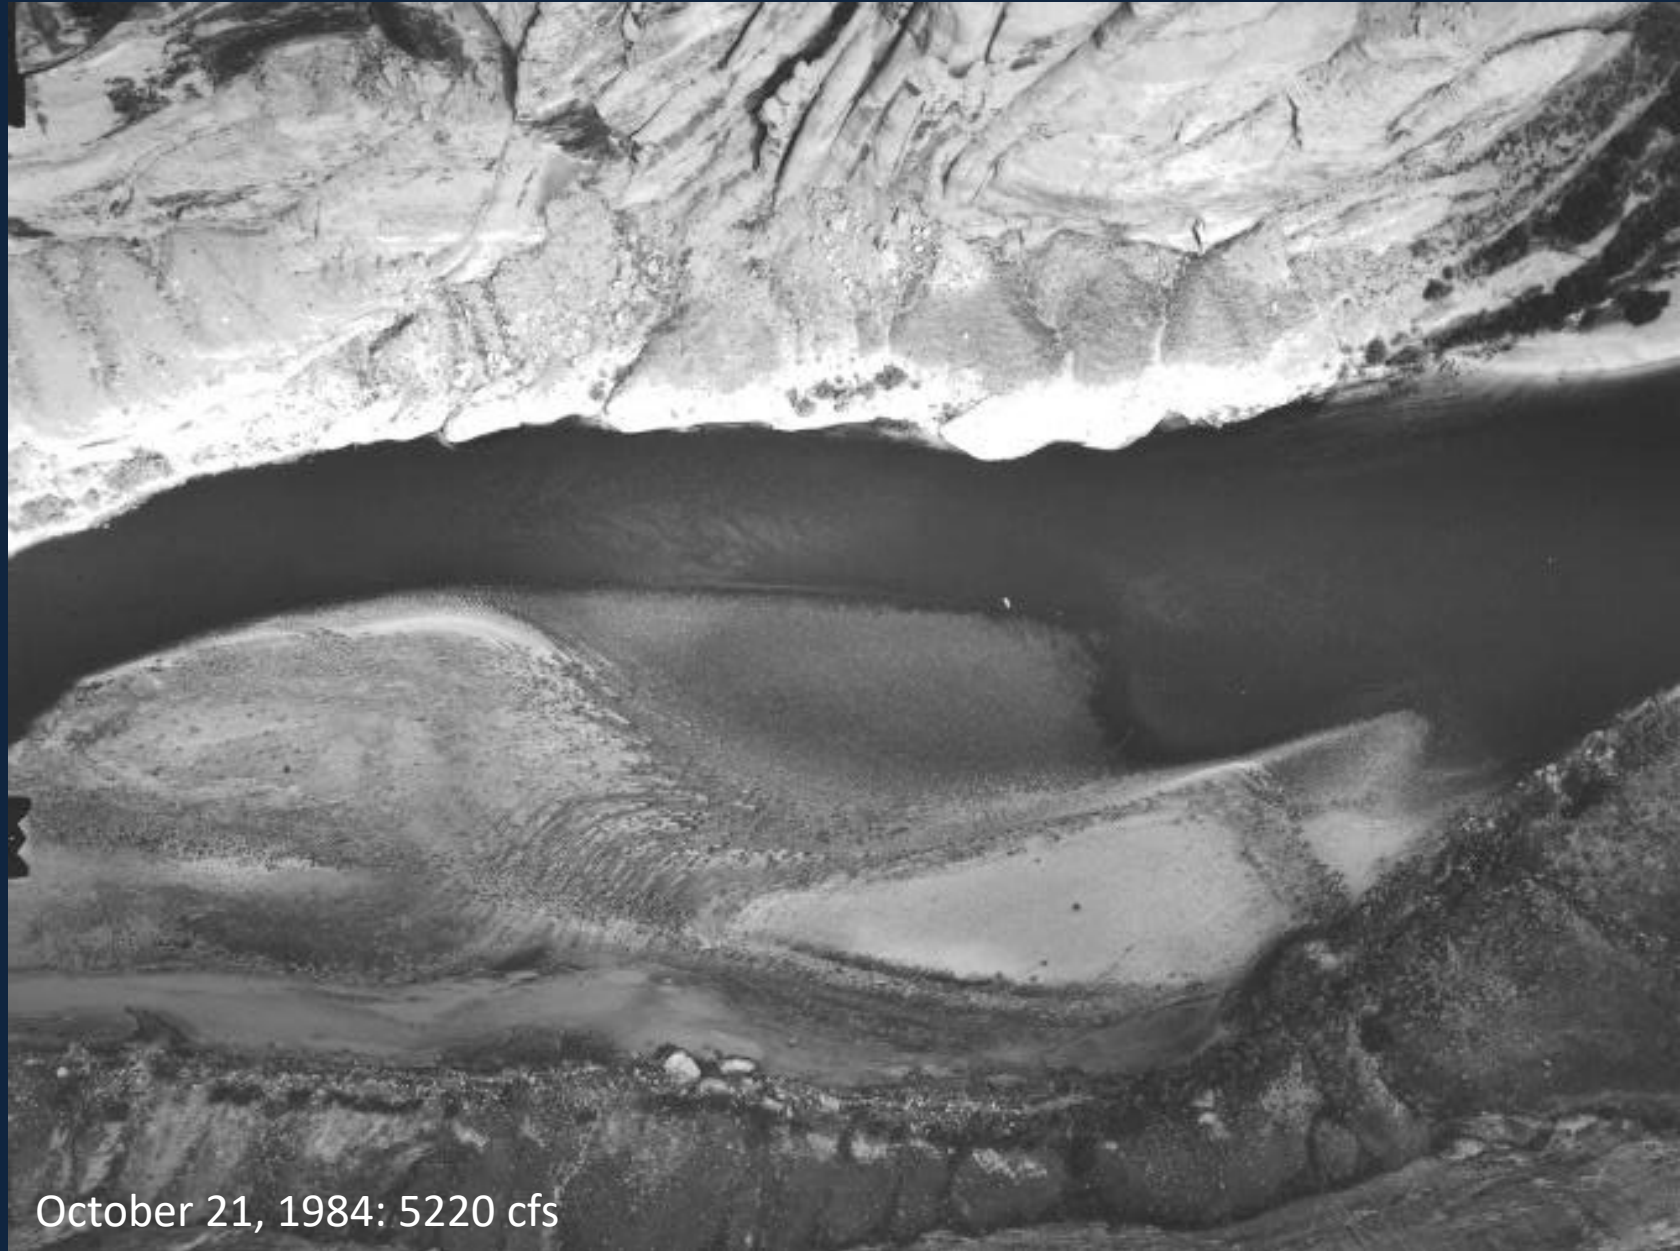
October 21, 1984: 5220 cfs

- This photo is after the 1983 and 1984 spillway floods.
- Daily fluctuations were still very high so daily overtopped
- The 1983 and 1984 high flows scoured vegetation and deposited fresh sand and gravel

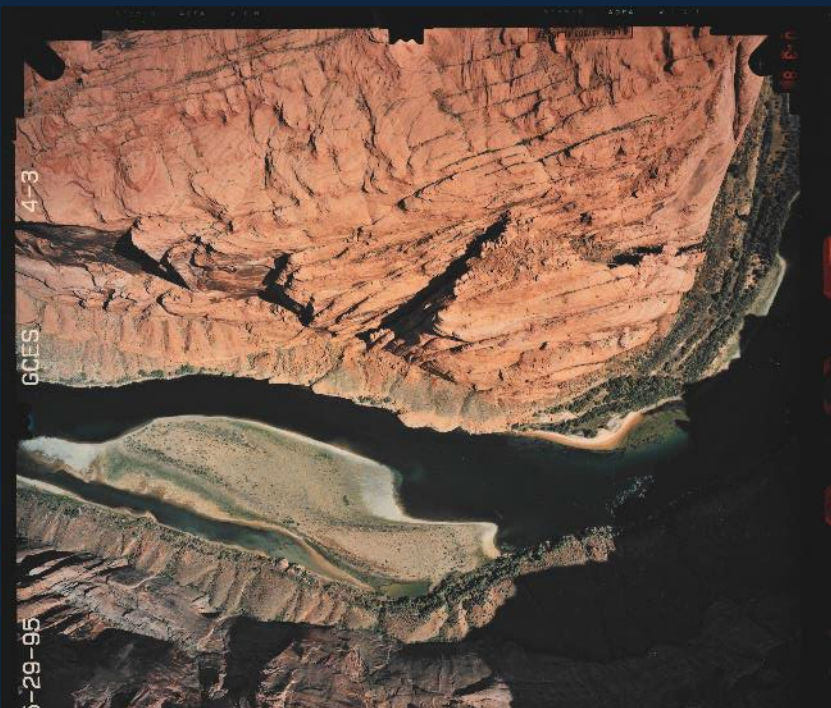
May 29, 1995
(~8000 cfs)

- Starting to look like the modern “slough”

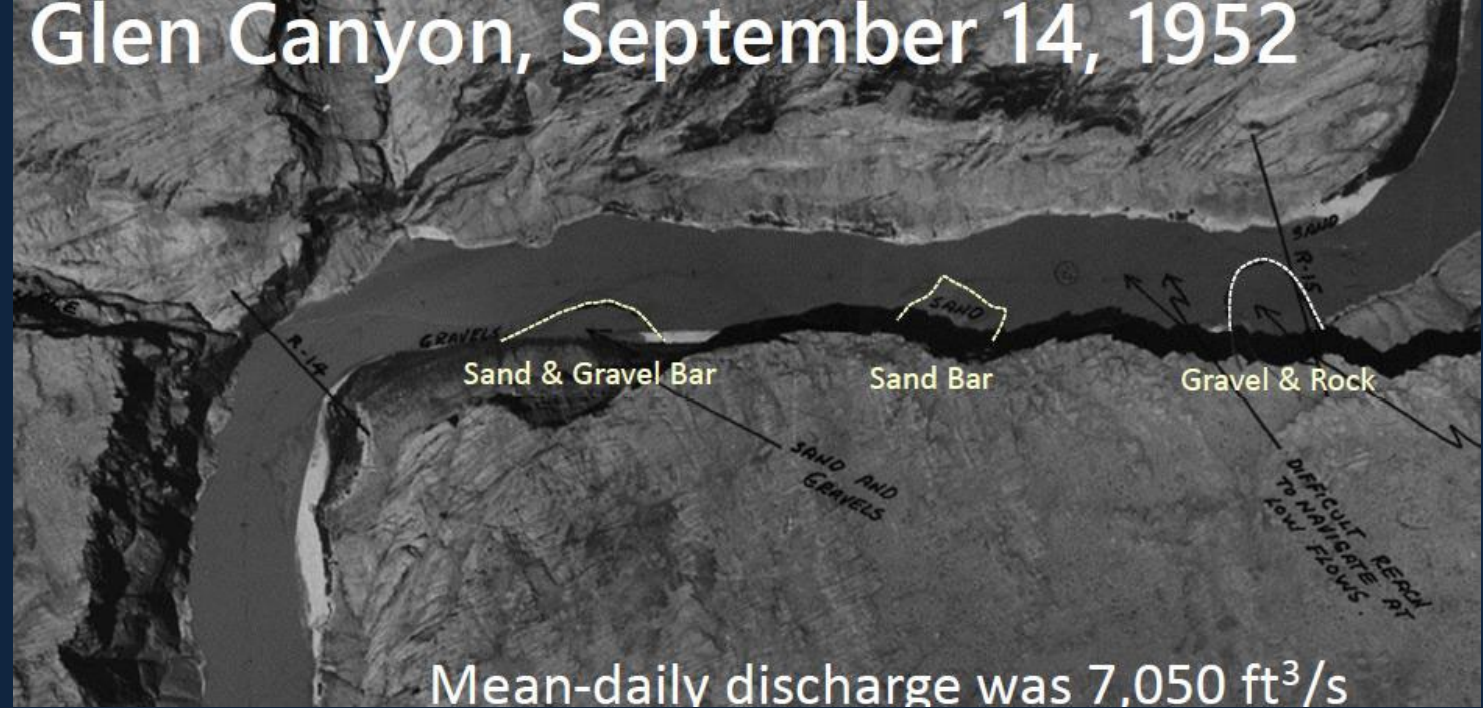
Glen Canyon, September 14, 1952

- No cobble above water at 7,050 cfs
- No vegetated wetland present
- Sand and gravel bar, reworked by annual snowmelt flood

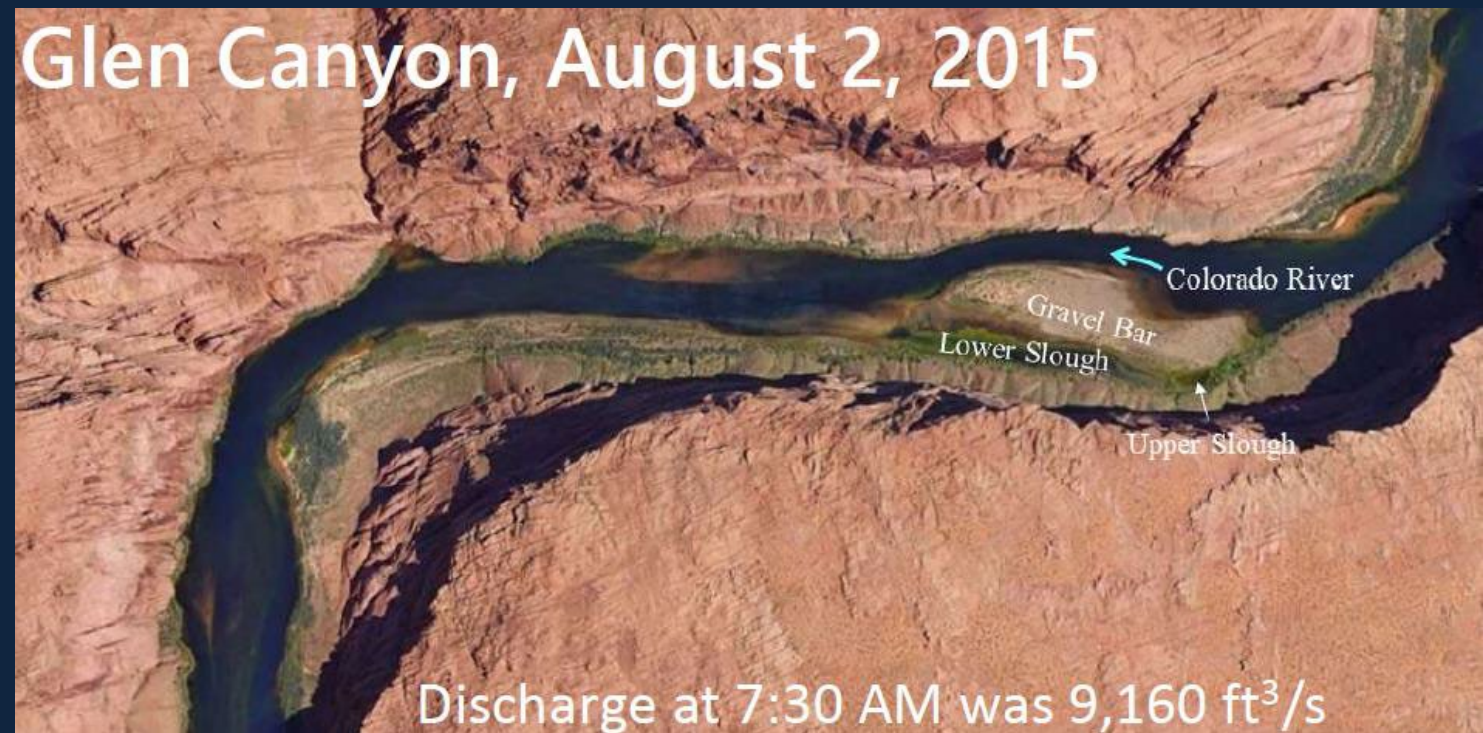
Glen Canyon, August 2, 2015

- “abandoned” gravel/cobble bar with vegetation
- Ponded, vegetated area present because bar is not overtopped by annual floods
