Yolo Bypass Salmonid Habitat Restoration and Fish Passage

Appendix F

Complete Last Day Wet (LDW) Results

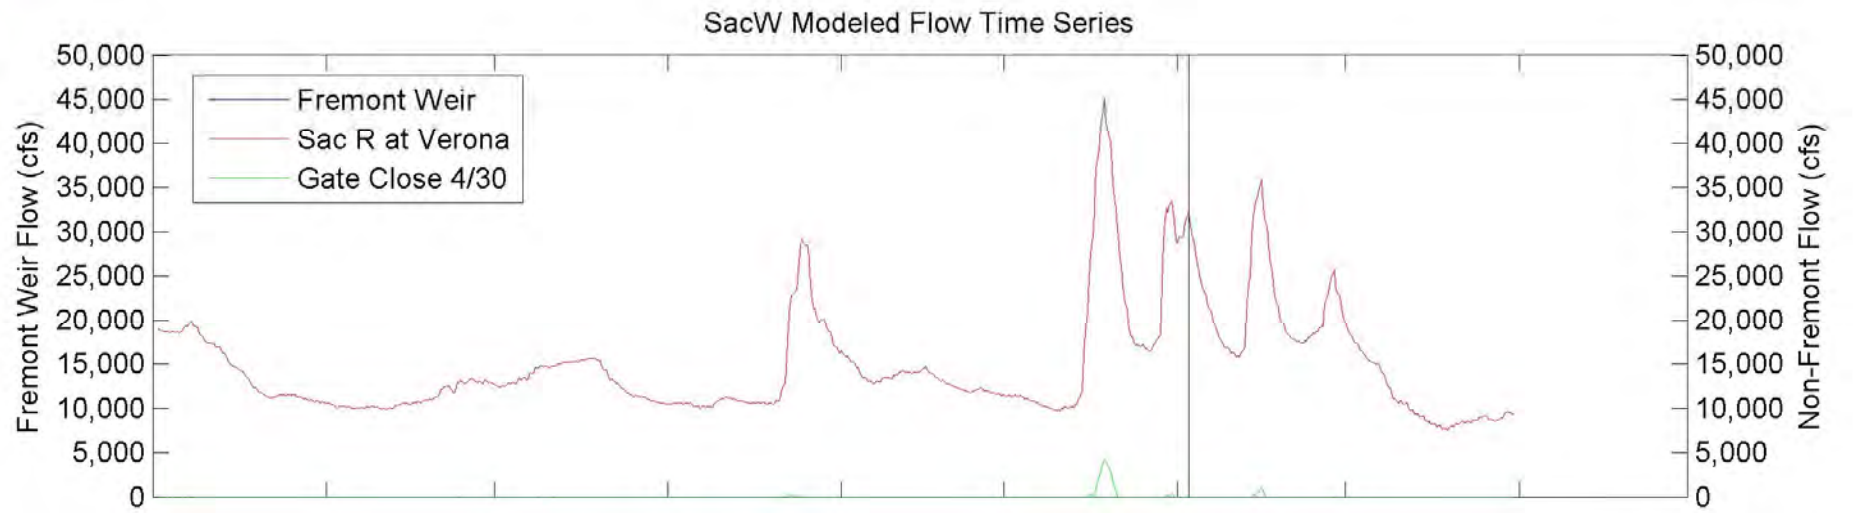
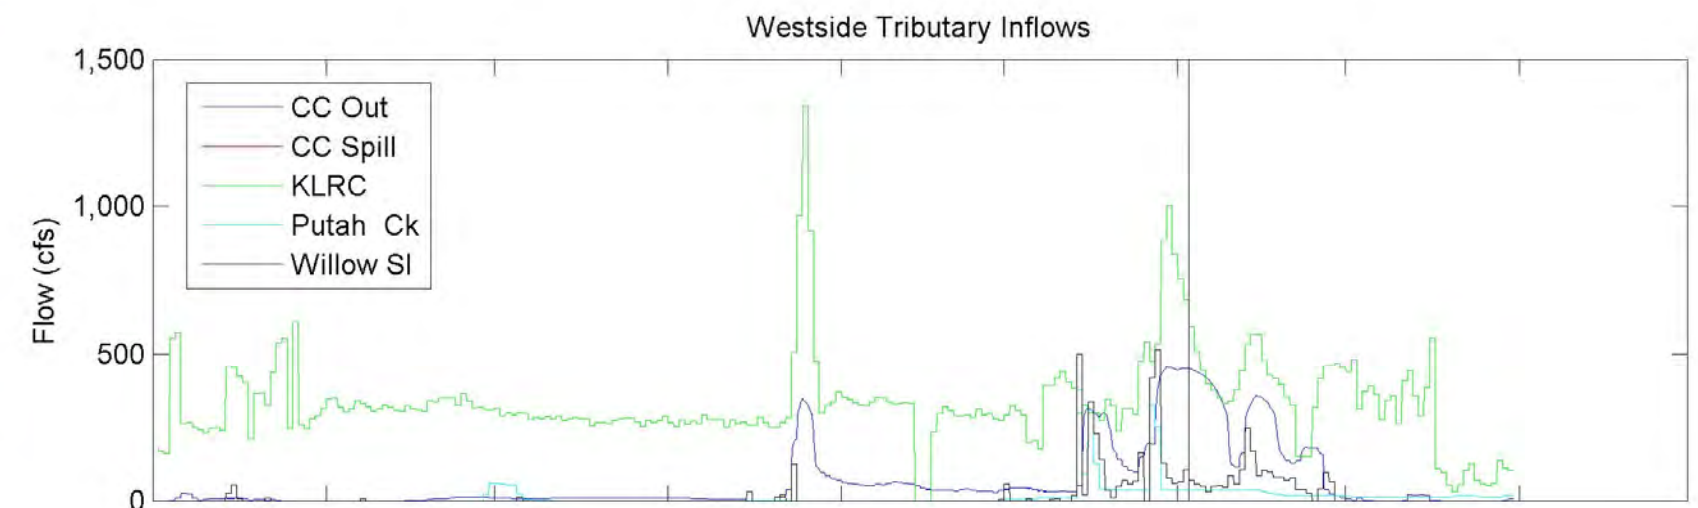
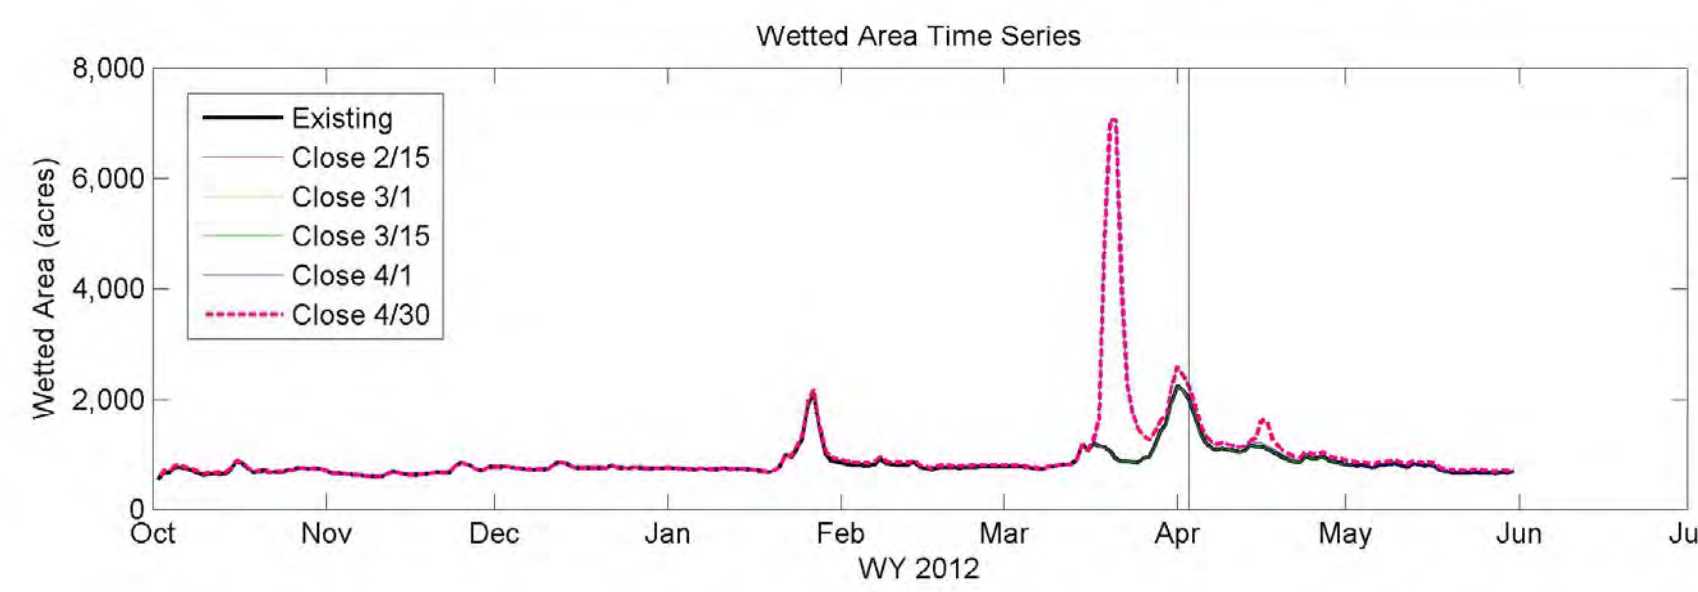
Figure E64

Notes: TUFLOW model results showing 2D inundation patterns (at specified time stamp) for existing and 4/30 gate closure (left panes), Yolo Bypass inflows (upper right panes), and wetted area for all five gate closures (lower right pane). The vertical bar in the right panes corresponds to the time stamp below the left panes, whereby the blue hatching represents 4/30 gate closure conditions as overlain by the grey hatching representing existing conditions.

Wetted Area Comparison for WY 2012 for SacW
