Labor-Saving Debris and Fish Screens

By Tony L. Wahl¹, Robert K. Weir², John K. Cerise³, Brian Sauer⁴, Jack Wergin⁵

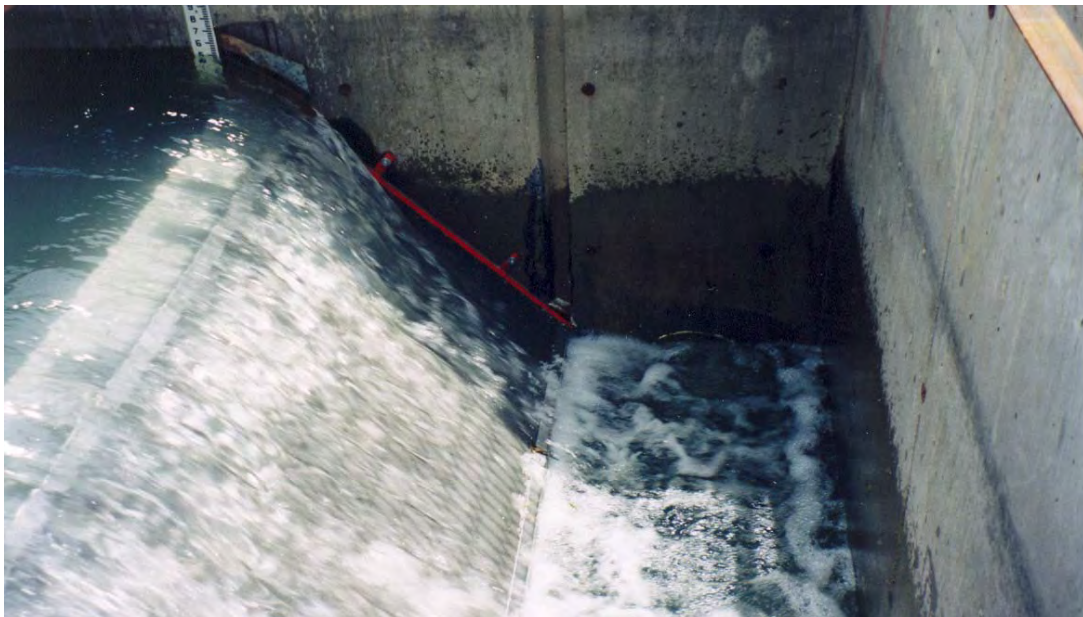
Figure 2. — Coanda-effect screen installed on the Boise Project. Clean water drops through the screen section into a conveyance channel beneath the screen. A staff gage and sheet-metal flow deflector are visible at the upstream corner of the screen.

The screen shown in Figure 2 was installed on the Boise Project to provide removal of fine debris at a drop structure and flow metering box serving both flood and sprinkler-irrigated farms. The Coanda-effect screen was installed during the spring of 2003. The new stainless steel screen is 3 ft long and 8 ft wide, with 0.5 mm slots. This screen is cleaned a couple of times per week. The project made two minor modifications after the screen was installed. First, they added small flow deflectors near the top edge of the accelerator plate because debris was collecting where the screen met the sidewall of the concrete box. The deflectors successfully keep the edges of the screen clean. Second, the project added a staff gage upstream from the weir to allow them to make a rough estimate of the flow being delivered to the screen. This measurement only approximates the flow actually delivered to farmers on this lateral, since a small amount of overflow passes off of the screen into a bypass pipe that leads back to the canal. Downstream from the screen, piped farm deliveries are measured with paddle-wheel-type insertion flow meters, and since the screen was installed, the project has had little problem with the meters. This screen was installed as a demonstration project through a 50% cost share between the irrigation district and Reclamation's Science & Technology program.

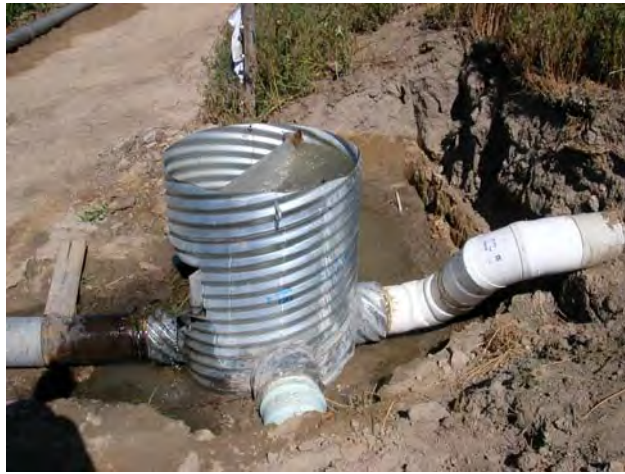
Figure 3. — Coanda-effect screen structure built with corrugated metal pipe. Raw water enters from the right. Clean water is discharged through the center and left-hand pipes, while debris exits onto the ground through the slot in the left side of the structure.

As part of recent modernization efforts, the Pioneer Irrigation District has been converting from flood to sprinkler irrigation systems. To facilitate this conversion, the district has added several Coanda-effect screen devices. Those shown in Figures 3-5 are incorporated into low-pressure piped delivery systems. In each case, the pipe is interrupted by a well that contains a Coanda-effect screen. Flow enters the well and builds up to flow over a weir and across the screen. The screened flow is collected beneath the screen and exits the well into a discharge pipe. The debris passes over the screen and is discharged out of the side of the structure. These devices consume a few feet of head, which has not been a problem for this district, but might be an issue on other projects.

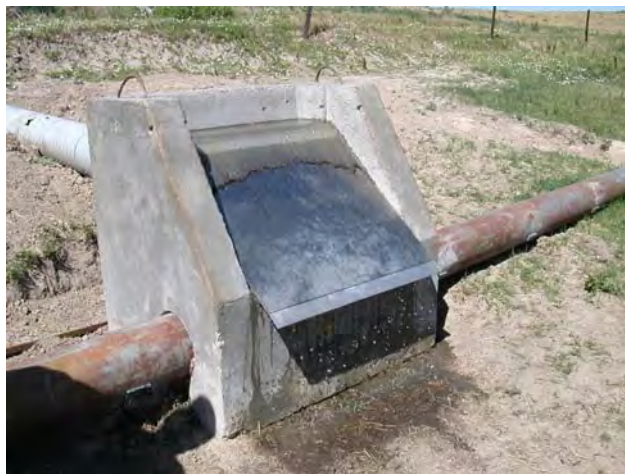
Figure 4. — Coanda-effect screen structure feeding two irrigation pipelines. Raw water enters the back of the structure through the white, PVC pipe. Screened water exits to the right and left. Overflow and debris are discharged onto the ground at the front of the screen.

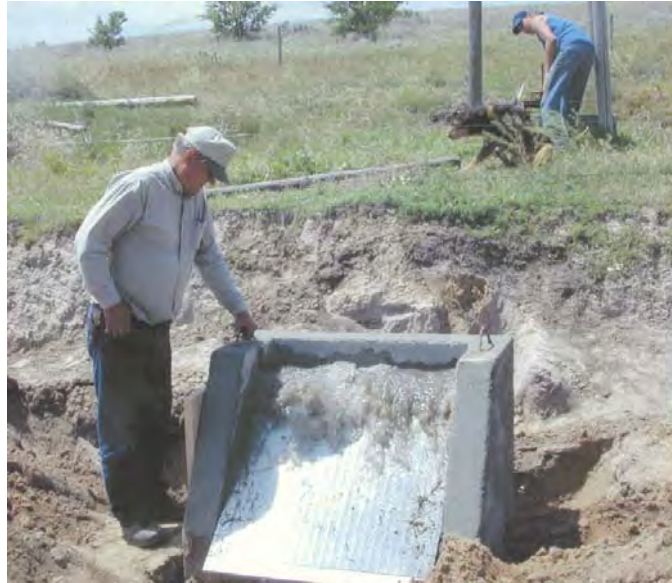
Figure 5. — Coanda-effect screen structure similar to that shown in Fig. 4, operating at a relatively high flow rate. All flow still passes through the screen before reaching the toe.

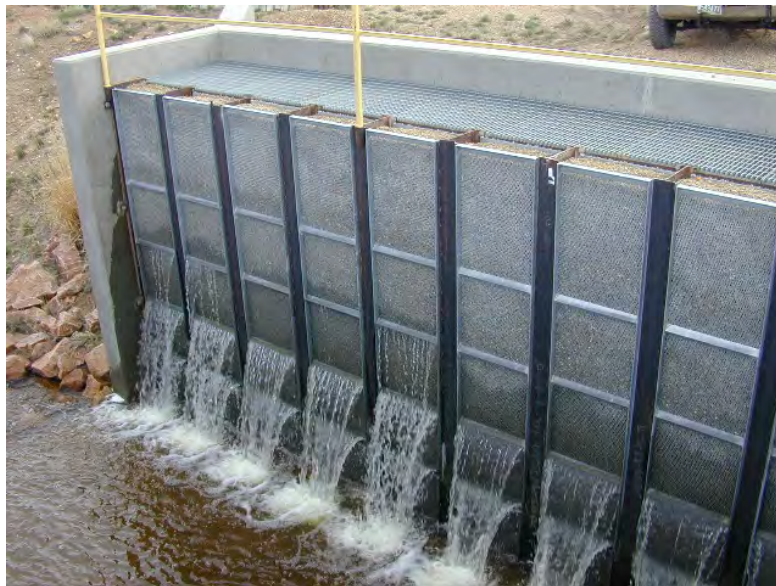
Figure 6. — Sand filter at Lake John. This structure presented some exciting maintenance challenges.

For many years the Colorado Division of Wildlife has tried to limit the entry of carp and sucker eggs and larvae into Lake John in an effort to preserve and maintain a sport fishery there. In the 1990's they constructed a sand filter device (Fig. 6) like those often used in water treatment applications, but maintenance of the filter was a serious problem, with backwashing and reconditioning of the filter required on a frequent basis. Cleaning involved lowering a burning cherry bomb held in the jaws of a wrench into the structure, where its detonation disturbed the accumulated fine sediments.

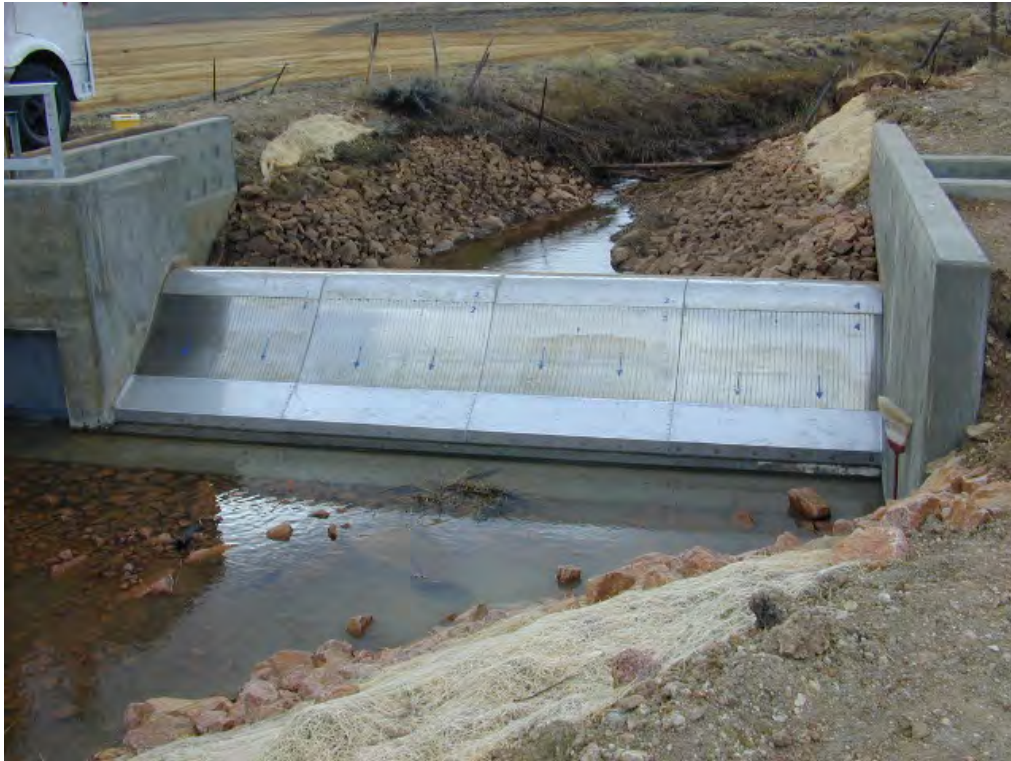
Figure 7. — Coanda-effect screen structure at Lake John, constructed in 2001. This structure replaced that shown in Fig. 6.

In July of 2001 the Division replaced the sand filter structure with 4 panels of tilted-wire Coanda screens on the irrigation ditch diversion to Lake John. Each panel measured 5 ft wide by 47 inches long. The wire slot opening was 0.5 mm (0.019”), small enough to exclude the undesirable fish and larvae. The design discharge was approximately 30 ft³/s. To date the screens have easily accepted the full design flow, but the outlet channel capacity beneath the screens has been somewhat less, preventing screen operations at the full design flow. Despite this problem, the screens themselves have worked well and have significantly reduced the maintenance problems associated with this site. Plans are currently under way to install similar screens on the supply to adjacent lakes.

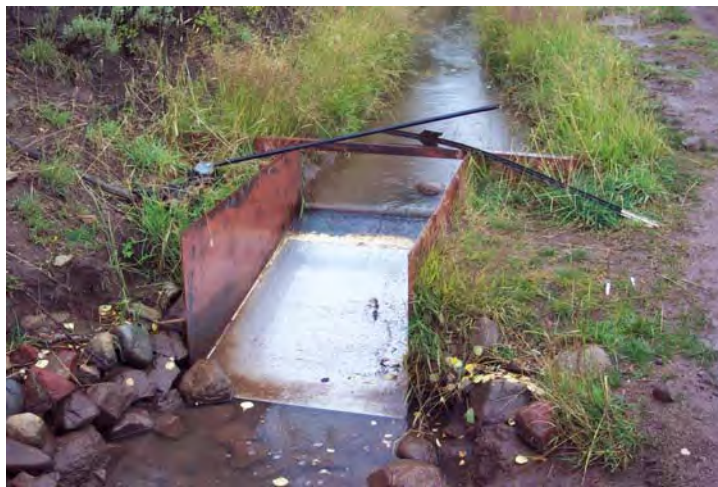
Figure 11. — A small Coanda-effect screen provides water to a sprinkler irrigation system near Carbondale, Colorado.

Several small Coanda-effect screen structures have been installed in the past 2 to 3 years in western Colorado, primarily on projects converting from flood irrigation to sprinkler systems. The screens provide low-maintenance removal of fine debris that would potentially plug sprinkler nozzles. The screens are installed in modular turnout boxes that are installed into existing irrigation ditches (Figs. 11 and 12). Because head is limited, screens are often installed on slopes of about 10° to 15°. Typical sizes are about 2 to 3 ft wide and 3 ft long, with design diversion capacities less than 10 ft³/s. Screens typically have a 0.5 mm slot width. Most of these screens have worked very well and new installations continue to be made. The few problems have occurred at sites where there was very little head drop available, so tailwater submerged most of the screen and reduced the velocity across the screen surface, which allowed some clogging to occur.

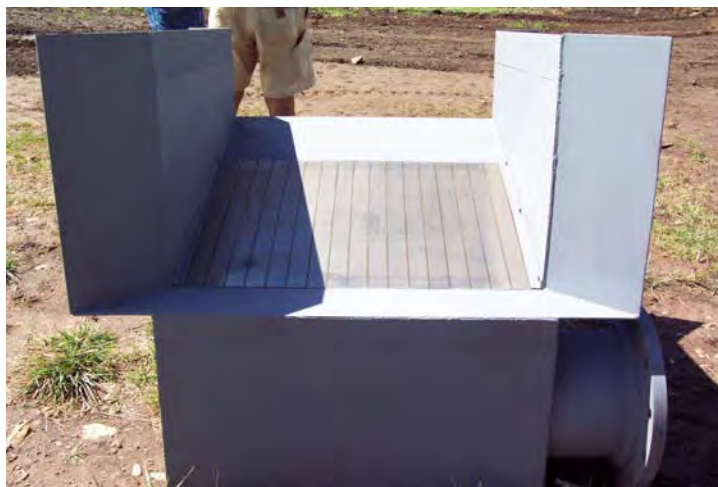
Figure 12. — Modular Coanda-effect screen structure. Flow is toward the reader. Screened flow exits to the right through the flanged pipe connection.

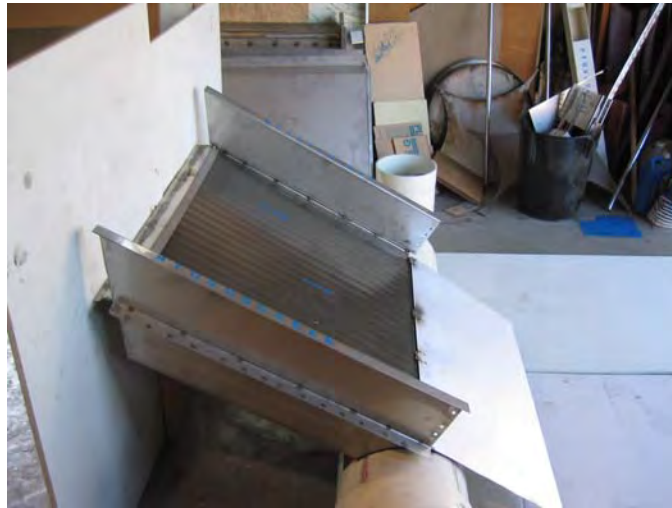
Figure 13. — Coanda-effect screen structure in the shop, configured to discharge directly into a PVC pipe.

At canal check structures, a unique screen structure has been developed that is easily incorporated into an existing check. Fig. 13 shows the structure, which contains a wedge-wire screen and an underlying stainless steel chute attached to a PVC pipe. The flow passes through the screen and down the chute into the PVC pipe. The deep vault beneath the screen shown in Fig. 12 has been eliminated. Note the flap at the bottom of the screen in Fig. 13. When one wishes to stop the diversion, check boards are removed to eliminate flow over the screen and the flap is raised to prevent flow entering the screen from the downstream channel. Figs. 14 and 15 show plan and elevation views of a typical installation.

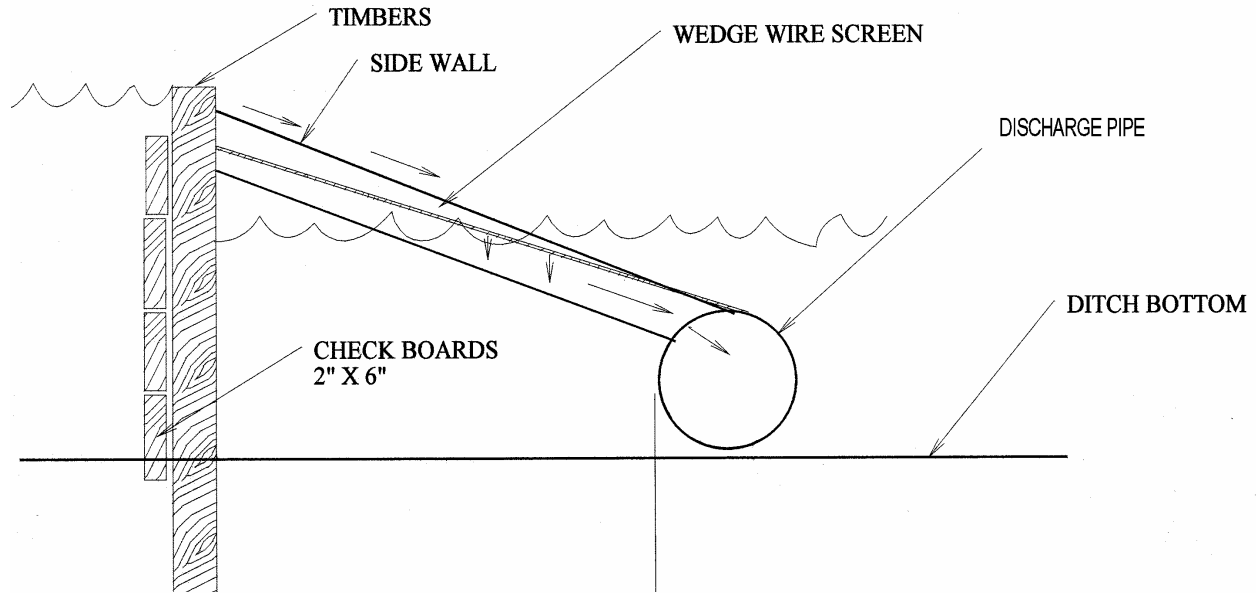
Figure 15. — Elevation view of Coanda-effect screen installation at a stoplog check.
