BUREAU OF RECLAMATION
Technical Service Center
Denver, Colorado

TRAVEL REPORT

Code : 86-68560 Date: August 30, 2006
To : Manager, Hydraulic Investigations and Laboratory Group
From : Tony L. Wahl
Subject : Travel to Lugert-Altus Irrigation District, Altus, Oklahoma

1. Travel period: July 3-9, 2006
2. Places or offices visited: Oklahoma City Field Office and Lugert-Altus Irrigation District
3. Purpose of trip: Collect discharge data to verify calibrations of recently installed flow measurement structures on the Lugert-Altus Irrigation District.

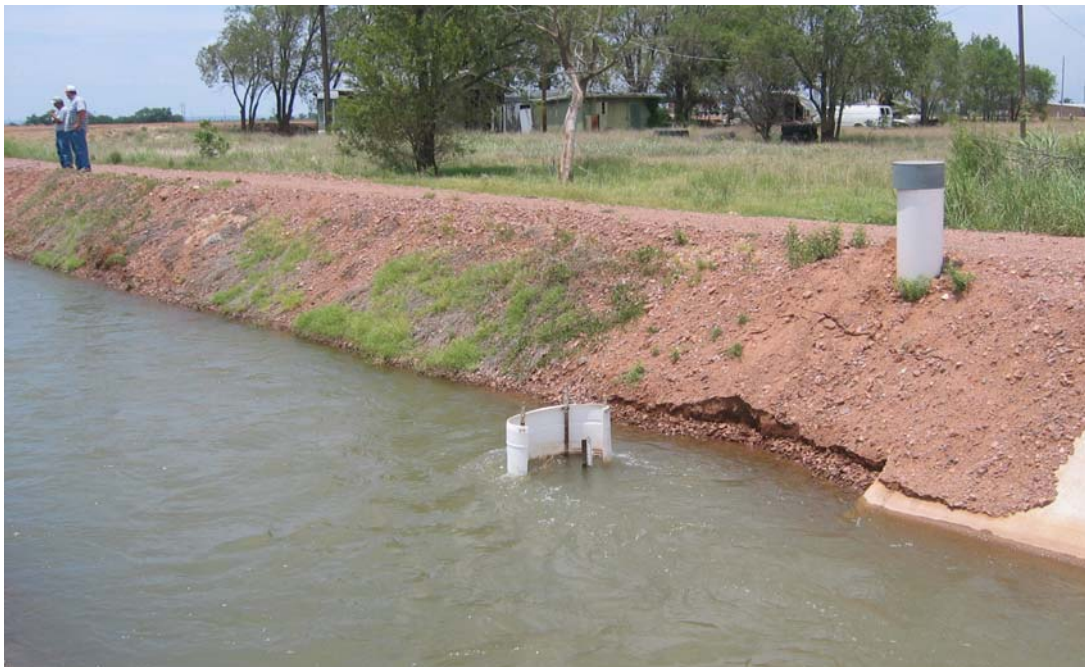
The measurements made at the two flumes on the Ozark Canal differed significantly from the theoretical ratings. In both cases, issues related to the staff gages may have contributed to this. When we arrived at the flume at the head of the Ozark lateral the staff gage used to measure the flow was located in an eddy below a trash deflector shown in figure 1. Initially the staff gage indicated a head of about 1.30 ft. While we were making the StreamPro measurements, district personnel removed the trash deflector. This improved the situation slightly, but the turbulence created by the stake that the staff gage was attached to (which was perpendicular to the flow direction) still made it difficult to accurately determine the water level. I estimated the level to be 1.35 ft, and subsequent measurements made with a folding rule in the approach section of the flume confirmed this measurement. Unfortunately, under the flow conditions on the day of our visit, we were not able to make careful and accurate survey measurements of both the crest elevation and the water level in the stilling well. Without an accurate measurement of the upstream head, we cannot confidently state that the StreamPro measurements justify adjusting the rating for the structure. The installation of an accurate staff gage and water level sensor might show that the StreamPro measurements are consistent with the real rating of the structure. However, for the remainder of this operating season (until the staff gage installation is changed), the district should adjust the flows measured at this site by increasing them 8.7 percent. We may wish to again verify the calibration of this flume (with a good staff gage installation in place) during the summer of 2007.

Figure 1. — Staff gage for flume at head of Ozark lateral.

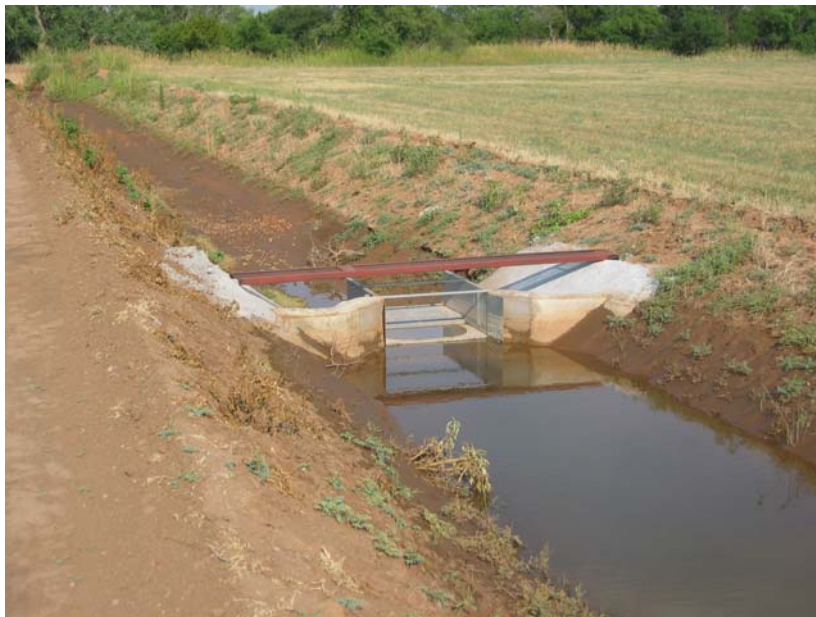
On the evening of July 6 Ben Claggett and I visited the wasteway at the tail end of the Ozark Canal. We collected some supplemental survey data here to complement information gathered on a previous trip by Bob Einhellig. The district had recently installed a $10 \text{ ft}^3/\text{s}$ capacity EZ-Flow flume manufactured by the Nu-Way Flume Co. (fig. 2). This flume had already experienced flow beyond its capacity (as expected), but will provide the district with some measurements of spills this summer. We will provide a design for a larger-capacity replacement flume that the district can construct during this off-season.

Figure 2. — EZ-Flow flume installed in Ozark wasteway for temporary use in the summer of 2006.

6. Action correspondence initiated or required: Provide adjusted flume and weir ratings to Lugert-Altus Irrigation District, and complete flow measurement structure designs for the W10.6, West Canal Wasteway, and Ozark Wasteway sites.

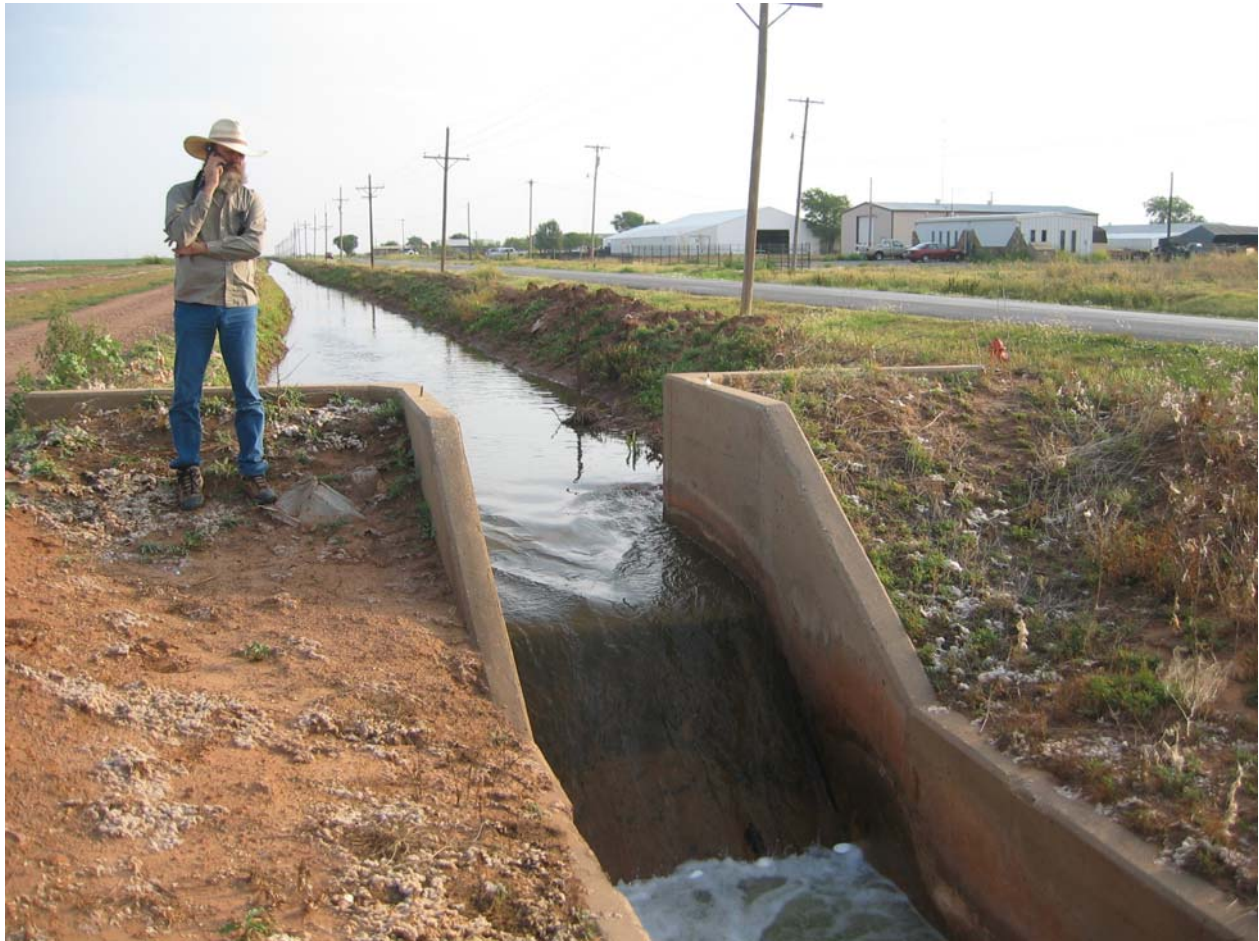
On Friday morning Tom Buchanan, Ben Claggett, and I visited the A9.9 lateral near the cotton gin and measured dimensions of an existing drop structure that the district would like to use for flow measurement (fig. 3). A design utilizing a small sill and ramp with some entrance

Figure 3. — Drop structure in A9.9 lateral near cotton gin.

transitions will be developed and provided to the district.

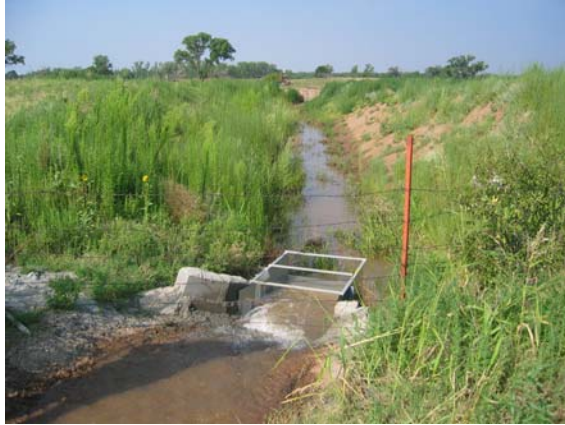
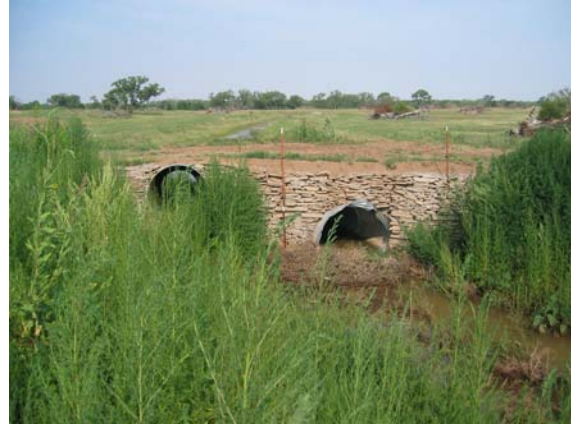
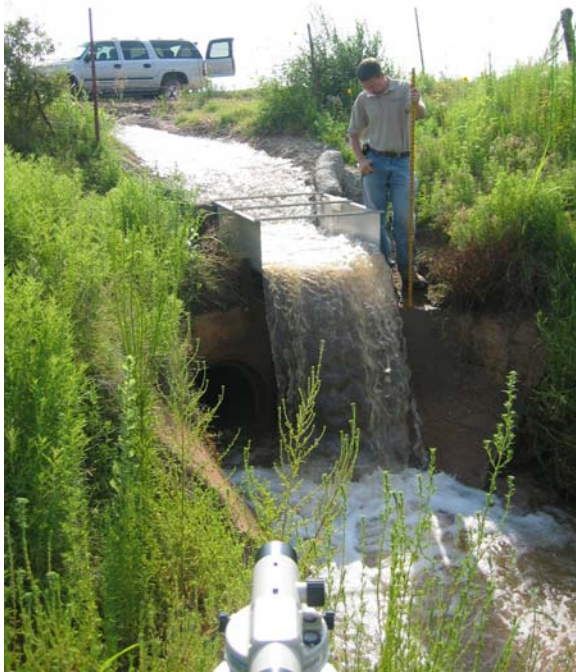
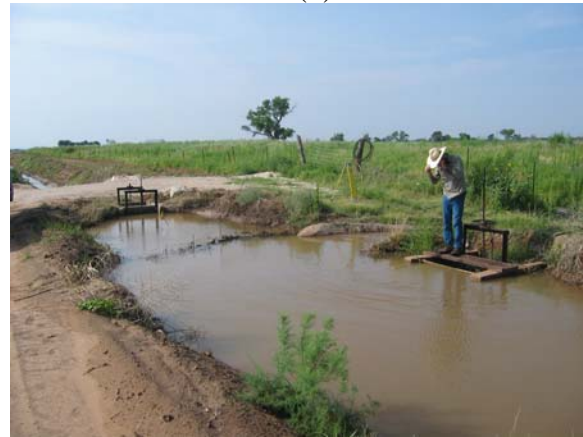
We also visited the West Canal wasteway on Friday morning. This site has undergone significant changes since my last visit. The district has added a new culvert in the wasteway that dramatically reduces the tailwater at the desired measurement site. They also added a 10 ft³/s EZ-Flow flume to measure a portion of the wasteway flows (flow enters the wasteway through a gated overflow and also through an uncontrolled overflow section; the flume measures only the uncontrolled overflow). We collected survey data that will be used to develop a permanent flume design that will be able to measure all of the wasteway flow.

Figure 4. — Photos of the West Canal wasteway site showing (a) excavated channel, (b) new culvert [rightmost culvert], (c) EZ-Flow flume, and (d) the control structures at the end of the West Canal. Gated spill flows discharge through the concrete culvert pipe beneath the flume in (c).

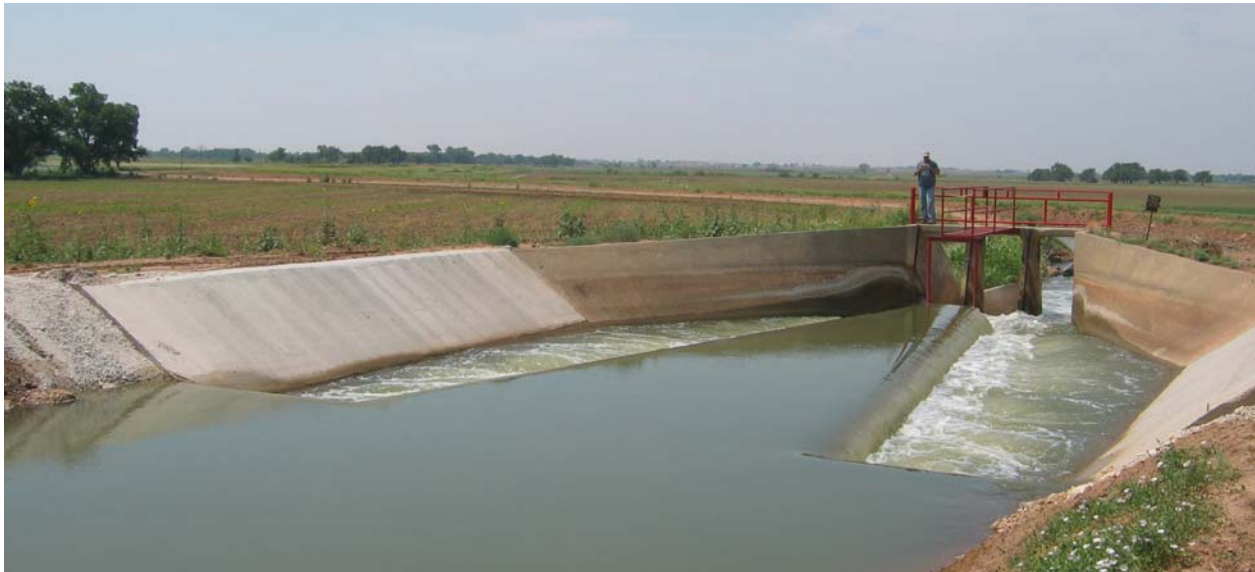
additional weirs this winter. We visited three additional potential long-crested weir sites. At the Altus 19.0 check-drop, an attempt had been made initially to develop a simple design utilizing an L-shaped layout that would funnel most of the flow through one half of a two-bay check structure. This proved to be infeasible because it would cause submergence of the downstream side of the long-crested weir. A better approach appears to be a design like that used on the three weirs that have already been built. This design is a duckbill layout that places the weir far enough upstream that the flow can pass through both bays of the original check structure. An example is shown in fig. 5.

Figure 5. Long-crested weir check structure.
