Technical Report No. SRH-2010-12

Bighorn Lake-Yellowtail Dam 2007 Sedimentation Survey

**Pick-Sloan Missouri Basin Program, Montana
Fort Smith, Montana**

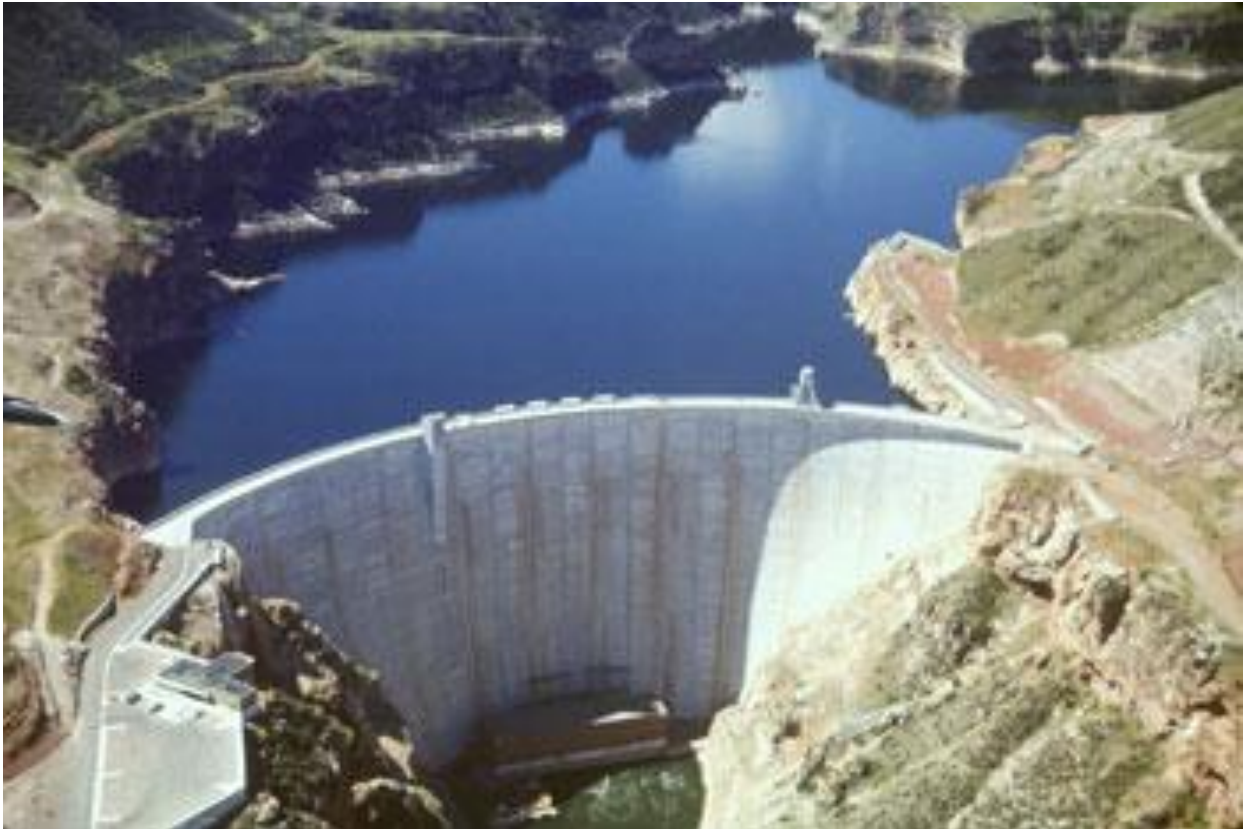
Figure 2 - Downstream Face of Yellowtail Dam.

Yellowtail Dam is a concrete thin-arch dam that was constructed between 1961 and 1966 (Figure 2). The dam's dimensions are:

Hydraulic height ¹	494 feet	Dam crest elevation	3,660.0 feet ²
Structural height	525 feet	Parapet crest elevation	3,664.0
Crest length	1,480.0 feet

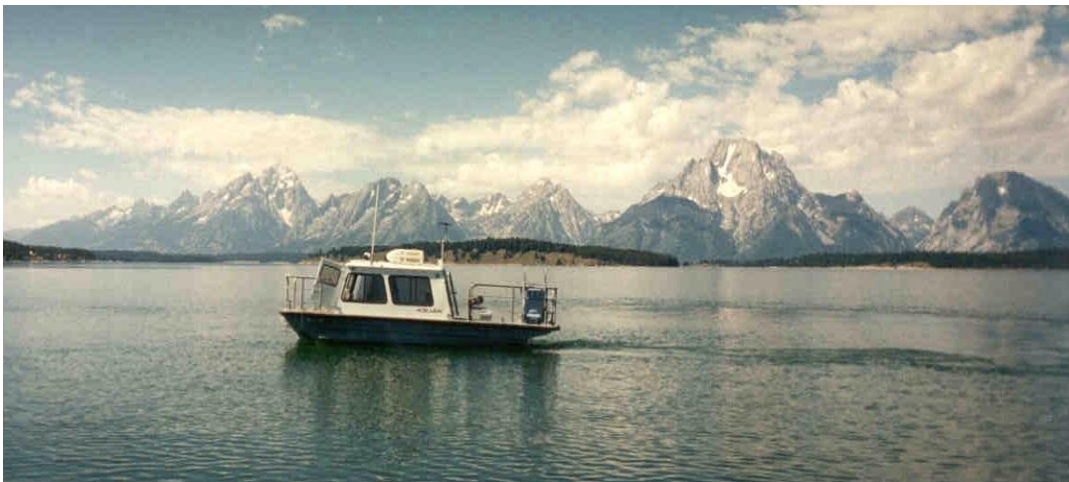
Figure 4 - Survey Vessel With Mounted Instrumentation on Jackson Lake in Wyoming.

The hydrographic survey equipment was mounted in the cabin of a 24-foot trihull aluminum vessel equipped with twin in-board motors (Figure 4). The hydrographic system included a GPS receiver with a built-in radio, depth sounders, a helmsman display for navigation, a computer, and hydrographic system software for collecting the underwater data. An on-board generator supplied power to all the equipment. The shore equipment that provided DGPS included a second GPS receiver with an external radio. The GPS receiver and antenna were mounted on a survey tripod over a known datum point and a 12-volt battery provided power for the shore unit. The majority of the bathymetric survey was conducted with DGPS provided by a leased commercial service.

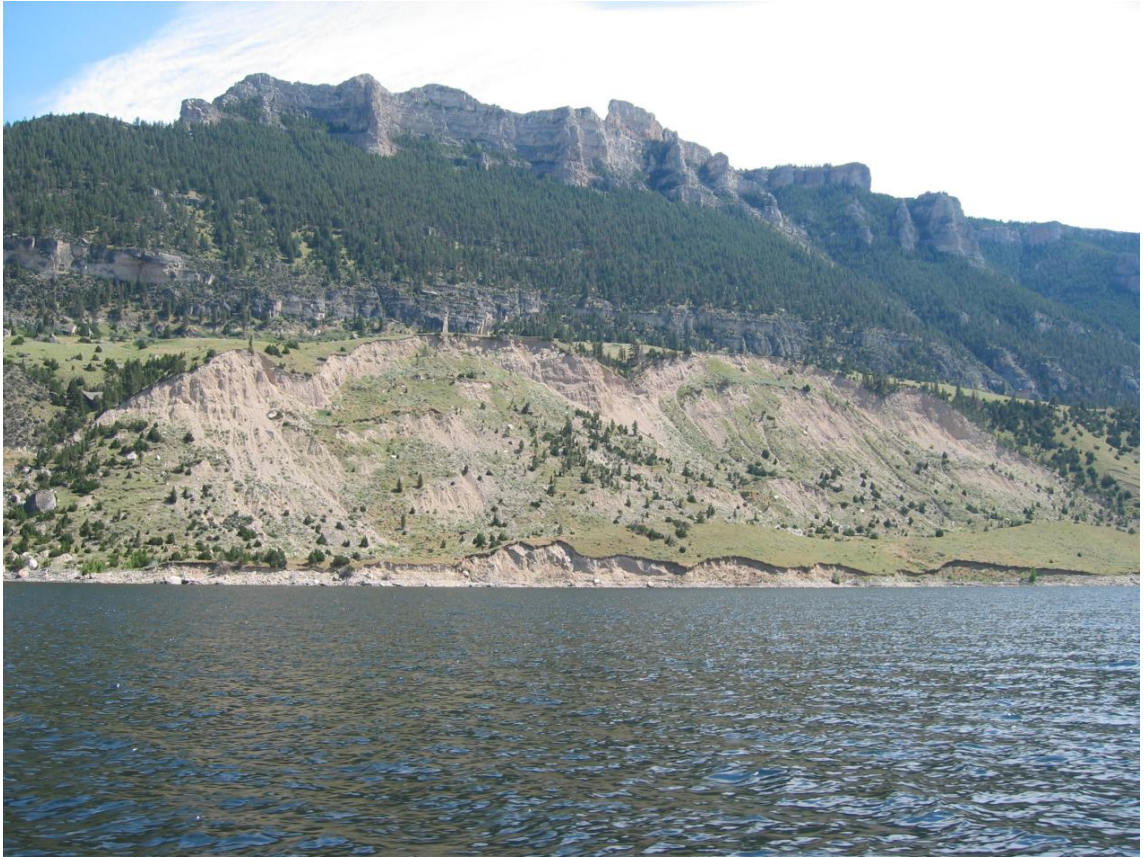
Figure 26 - Bighorn Lake Landslide Area Upstream of Range Line 3A.

The range line plot comparisons illustrate some interesting results when comparing the original, 1982, 2000 and 2007 surveys. The plots indicate minimal to no change at range line 2 and 2A since the 1982 survey. From the multibeam bottom images a high point or rock slide was located upstream of range line 3A and about 1.7 miles upstream of range line 3, Figures 26 through 28. The slide created a 20-foot high point, measured in 2007, that hindered the density currents from carrying the bottom depositing sediments downstream towards the dam. Changes measured at range line 3 indicate that some sediment has crept over the barrier and deposited downstream with the toe of the deposit about 3,500 feet downstream of range line 3.
