**Technical Report No. ENV-2021-019**

# **Blue Mesa Reservoir 2019 Sedimentation Survey**

**Colorado River Storage Project, Colorado  
Upper Colorado Basin Region**

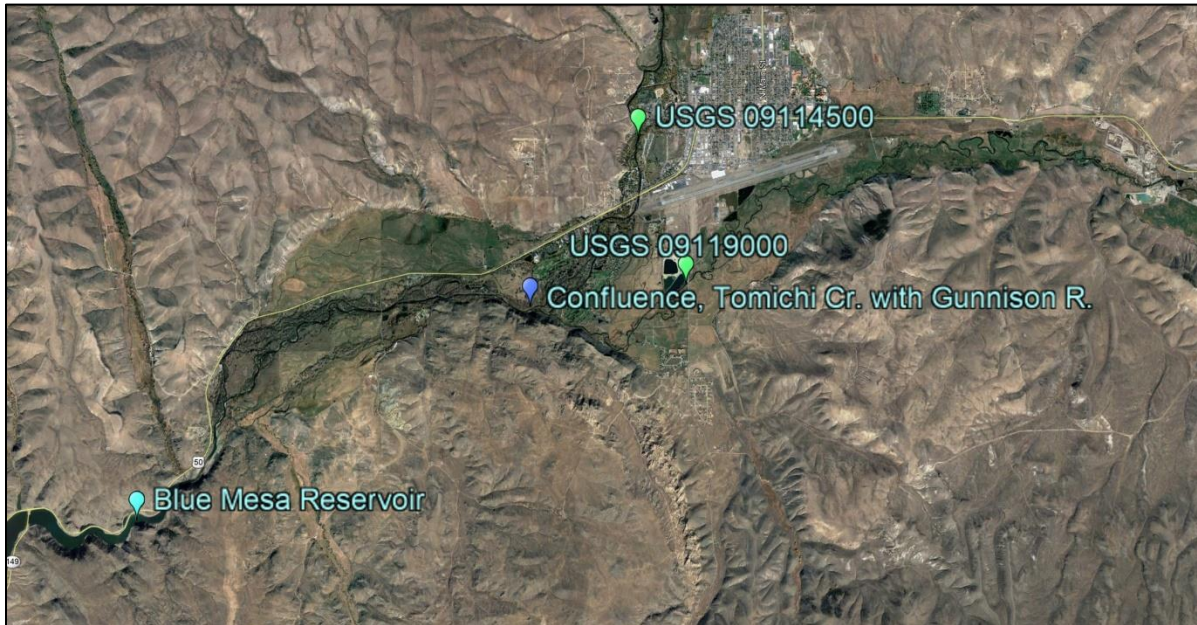
Figure 3. Map of USGS gages relative to the confluence of Tomichi Cr. with the Gunnison R. and Blue Mesa Reservoir. Flow direction is from east to west. Only the upstream-most portion of Blue Mesa Reservoir is shown in this image.

Reservoir inflows are primarily from the Gunnison River and Tomichi Creek. Tomichi Creek joins the Gunnison River downstream of the town of Gunnison and the USGS stream gage 09114500 (Gunnison R. nr. Gunnison, Colorado). Tomichi creek is gaged by USGS 09119000 (Tomichi Cr. at Gunnison, Colorado). The confluence of Tomichi Creek and the Gunnison River is approximately 4.5 miles upstream of the reservoir head (Figure 3). USGS stream gage records are available for the sites shown in Figure 3 and presented in Table 1, which represent 60 percent of the total contributing drainage area.

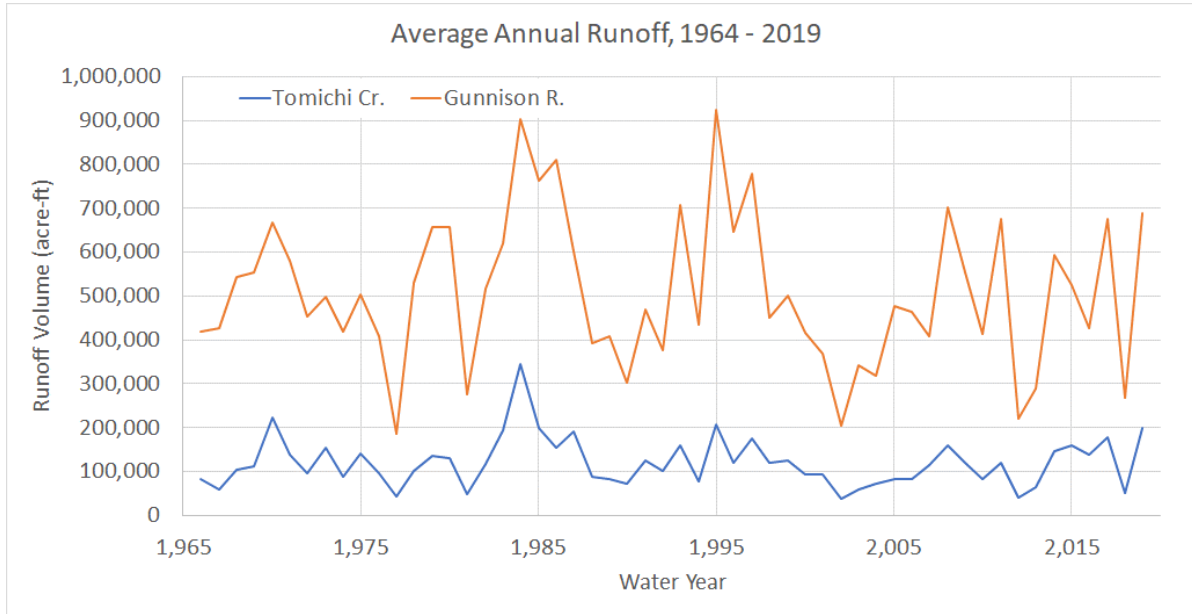
Figure 4. Plot of mean annual runoff from the Gunnison River and Tomichi Creek into Blue Mesa Reservoir. These streams account for 60% of the drainage area and 67% of runoff. The remaining contribution is from ungaged streams in the drainage.

Based on USGS data presented in Table 1, the mean annual runoff to Blue Mesa Reservoir from Tomichi Creek and the Gunnison River is 628,139 acre-feet. This runoff is from both rainfall and snowmelt. The mean annual stream flow to the reservoir is 704 ft<sup>3</sup>/s from the Gunnison River and 168 ft<sup>3</sup>/s from Tomichi Creek. The ratio of reservoir storage capacity to the mean annual runoff from these two streams is 67 percent. The remaining inflow comes from ungaged streams in the drainage. A plot of mean annual runoff to Blue Mesa Reservoir since 1966 is shown in Figure 4. Annual peak stream flow for the Gunnison River and Tomichi Creek are shown in Figure 5 and Figure 6.

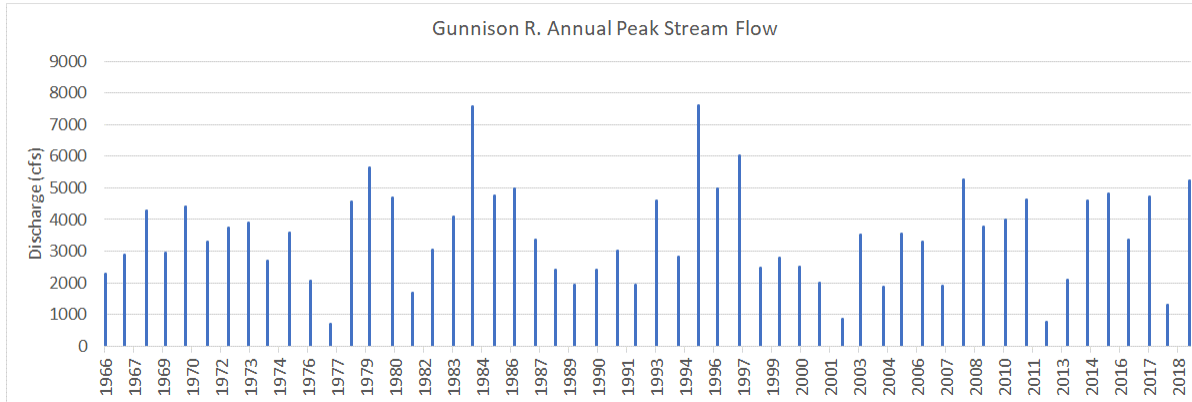
Figure 5. Annual peak stream flow for the Gunnison River (USGS #09114500).

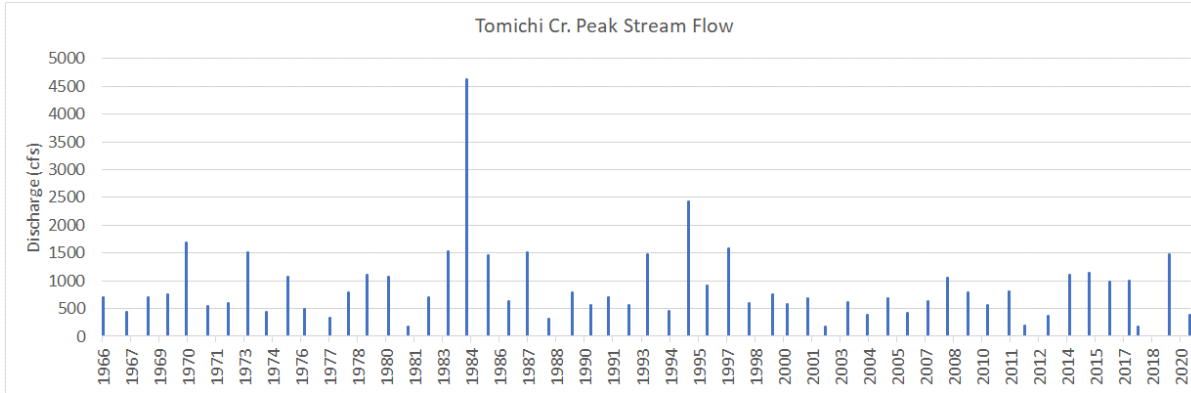
Figure 6. Annual peak stream flow for Tomichi Cr. (USGS #09119000)

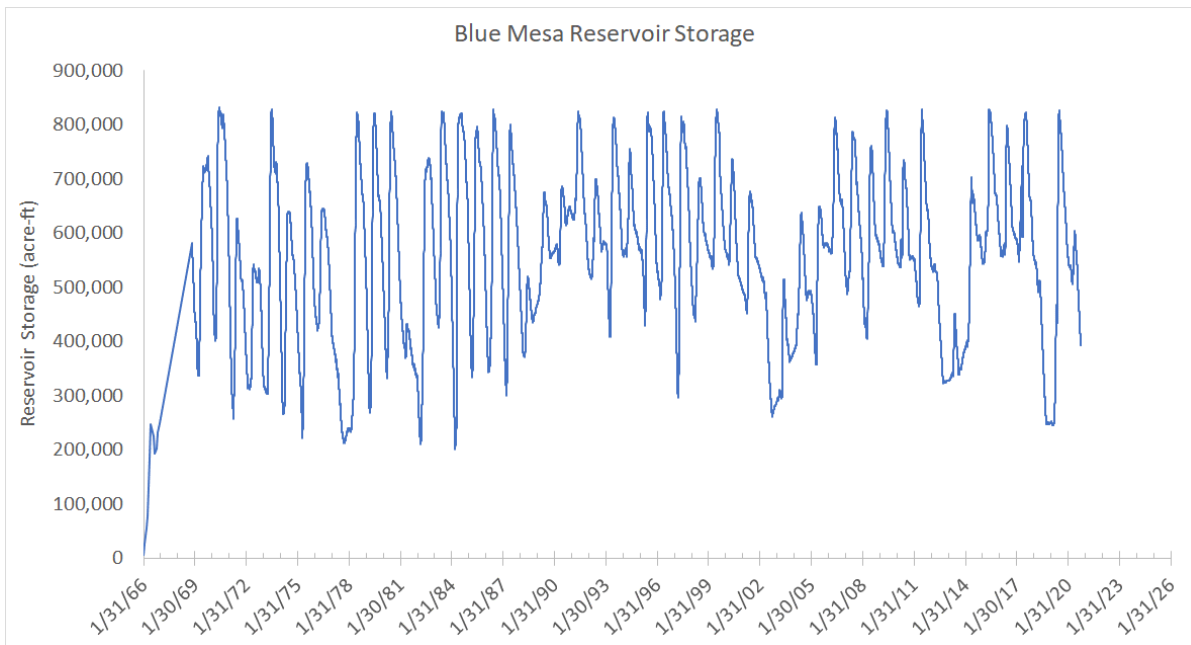
Figure 7. Historic Blue Mesa Reservoir storage volume. Data web source: [https://www.usbr.gov/uc/water/hydrodata/reservoir\\_data/site\\_map.html](https://www.usbr.gov/uc/water/hydrodata/reservoir_data/site_map.html)

Blue Mesa Dam is a zoned, earth and rock fill embankment dam with a volume of 3,093,000 yd<sup>3</sup> (Reclamation 1981). The dam has a structural height of 390 feet with a crest length of 785 feet. The reservoir had an original length of about 18 miles long at full pool with 2 major tributaries. Construction of this dam began in 1962 and was completed in 1966, when filling began. The historic reservoir storage is presented in Figure 7. Annually, reservoir storage typically fluctuates about 350,000 to 500,000 acre-feet.

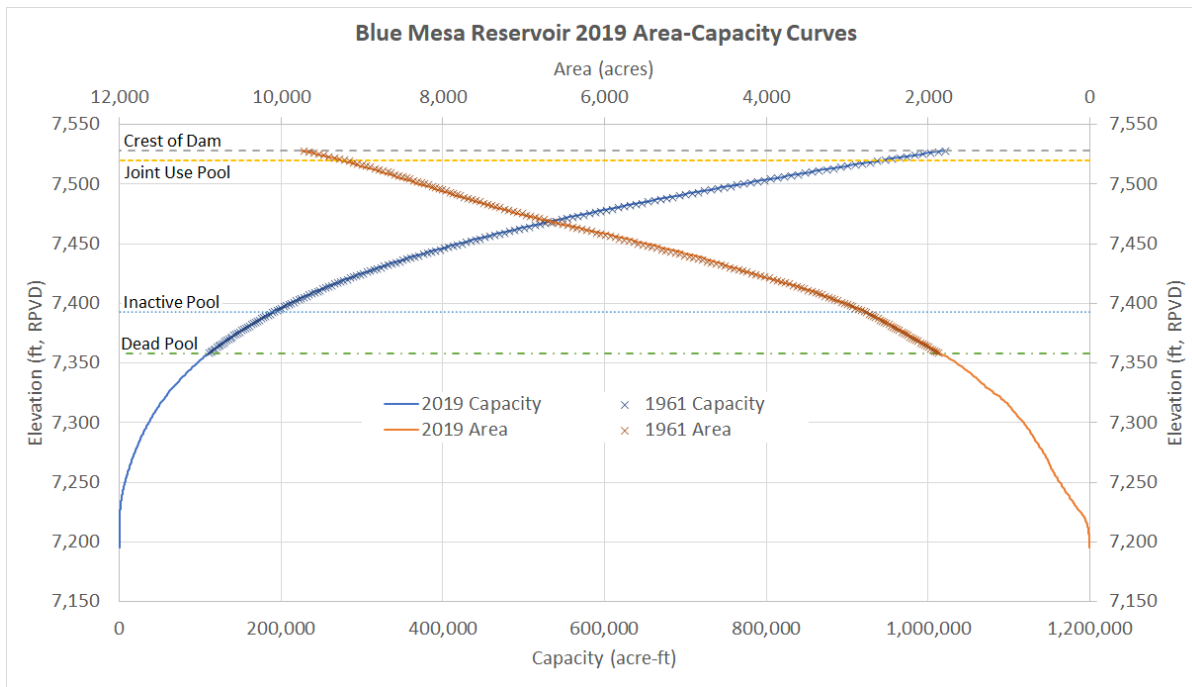
Figure 12. Plot of Blue Mesa Reservoir surface area (orange) and storage capacity (blue) versus elevation (RPVD). Key elevations are also included in the plot. The 1961 values are only available above the dead pool elevation.

Tables of reservoir surface area and storage capacity were produced for the full range of reservoir elevations ([Blue Mesa Area and Capacity Tables 2019](#)). Plots of the 2019 area and capacity curves are presented in Figure 12. The surface map used to obtain the area and capacity is shown in Figure 13. For the 2019 survey, area and capacity curves are based on the bathymetric (below-water) survey up to approximately 7,490 feet elevation (RPVD), while curves above this elevation are based on 2019 airborne LiDAR. At the top of the joint use pool (elevation 7519.4 feet, RPVD), the reservoir has a surface area of 9,219 acres and a storage capacity of 938,141 acre-feet. The 1961 area and capacity values are also plotted in Figure 12. These data are shown in Table 2.

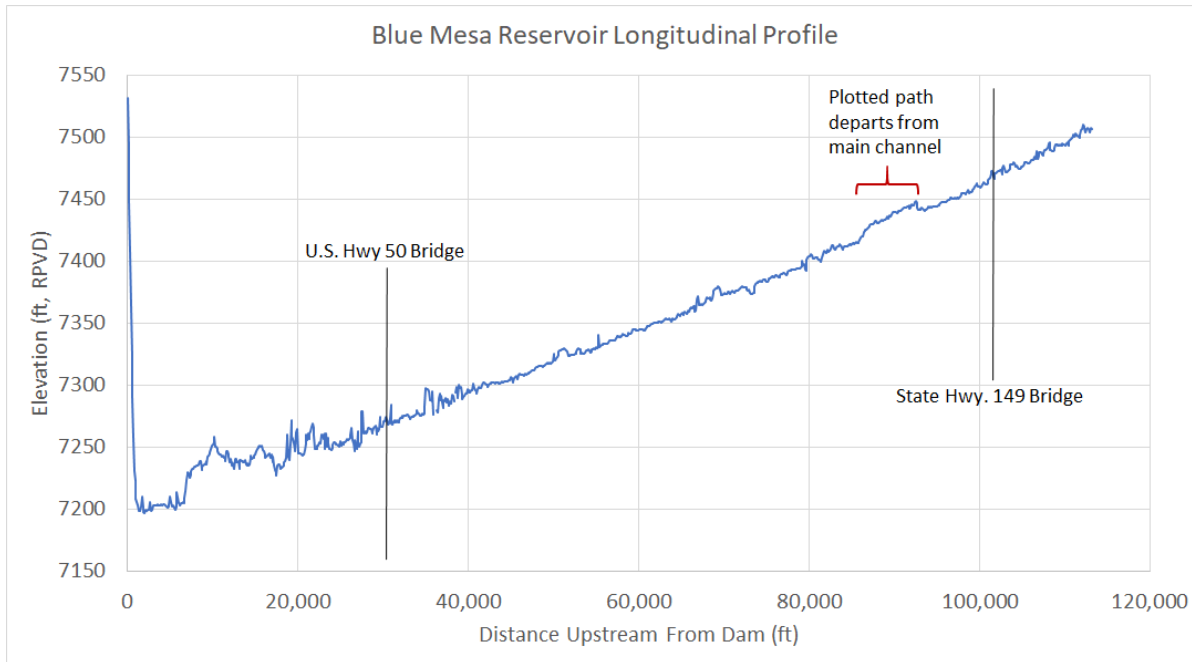
Figure 15. Longitudinal profile of Blue Mesa Reservoir bottom from the dam to the upstream end of the bathymetric survey in the upper reservoir. The red bracket indicates the location where the profile leaves the main channel (sta. 93,100 ft) and rejoins it further downstream (sta. 86,100 ft).

A longitudinal profile of the 2019 reservoir bottom surface was developed in GIS along the alignment presented in Figure 14. The longitudinal profile (Figure 15) shows no evidence of a delta face or formation. This is consistent with the lack of significant sedimentation as indicated by the difference between the original and 2019 reservoir capacity values.

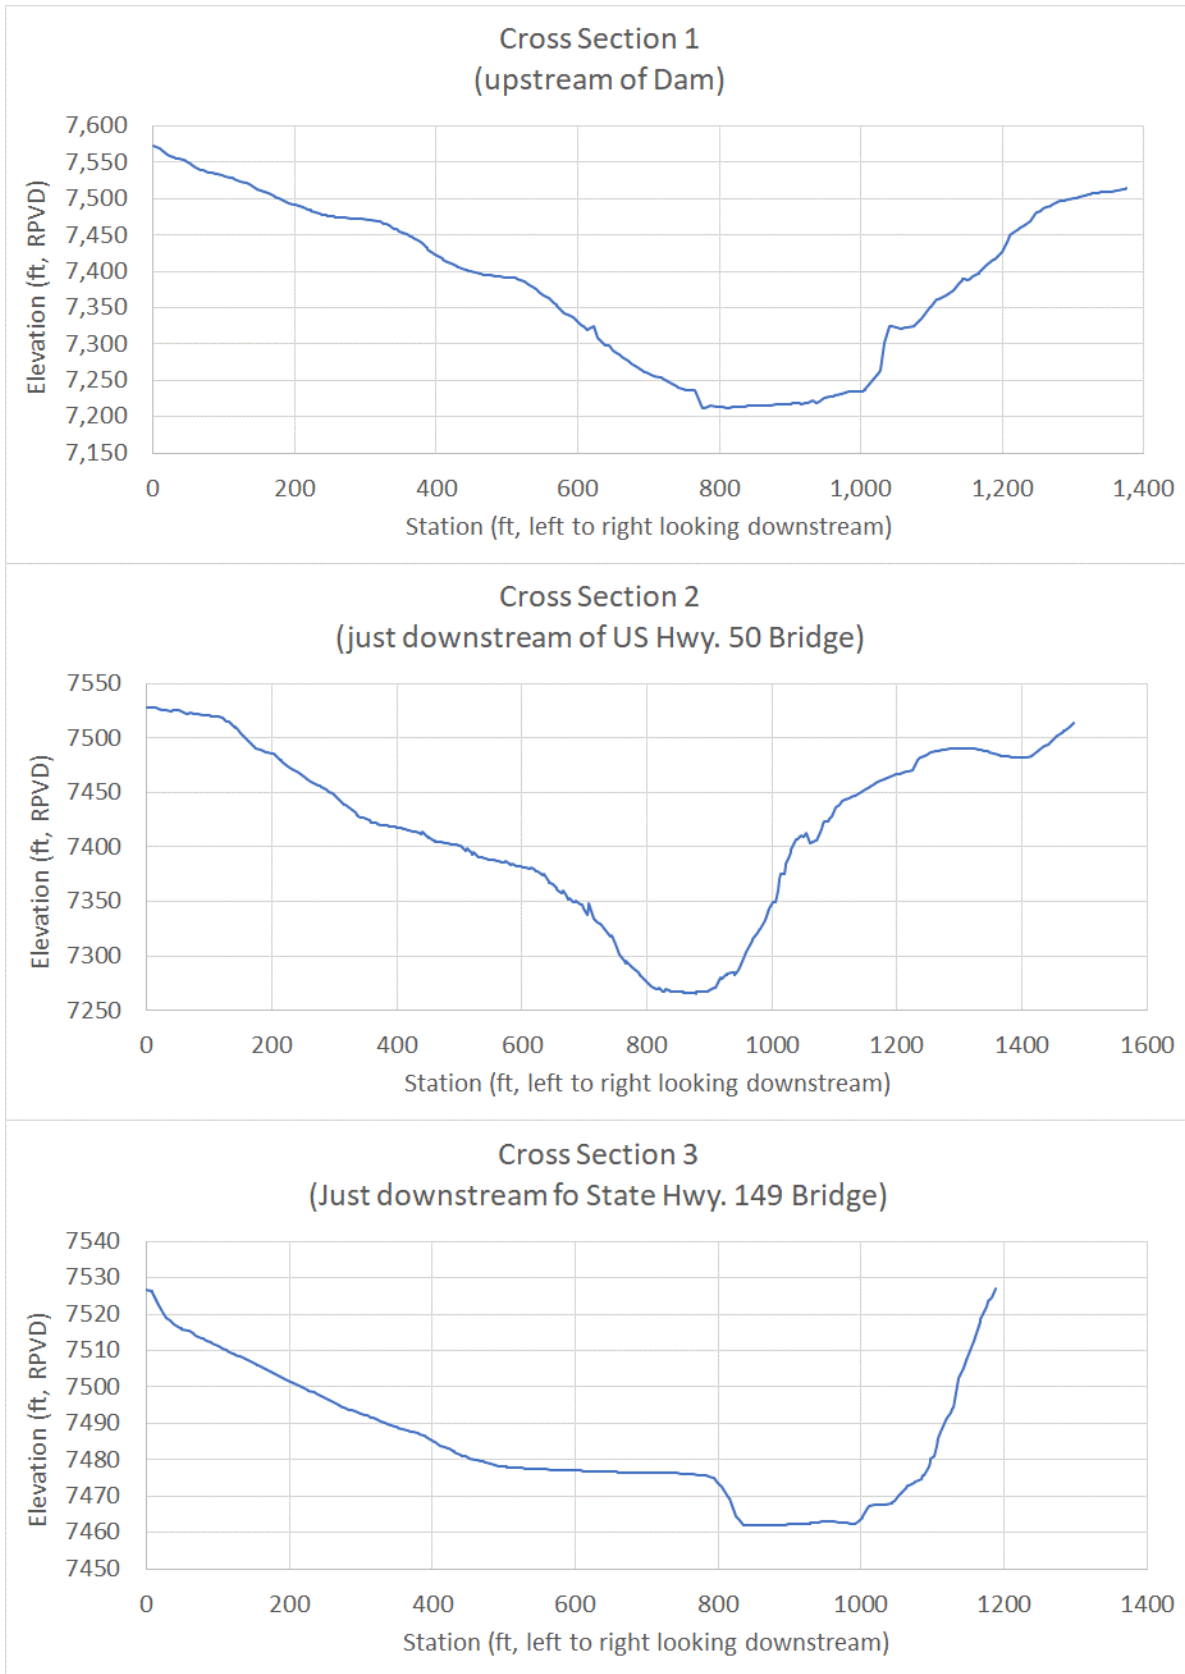
Figure 16. Cross section plots at locations shown in Figure 14.

Reservoir cross section at three select locations are shown in Figure 16. The lack of historical reservoir cross section data prevents comparison to previous reservoir bed elevations. These cross sections were created in Arc GIS and will allow comparisons in future surveys.

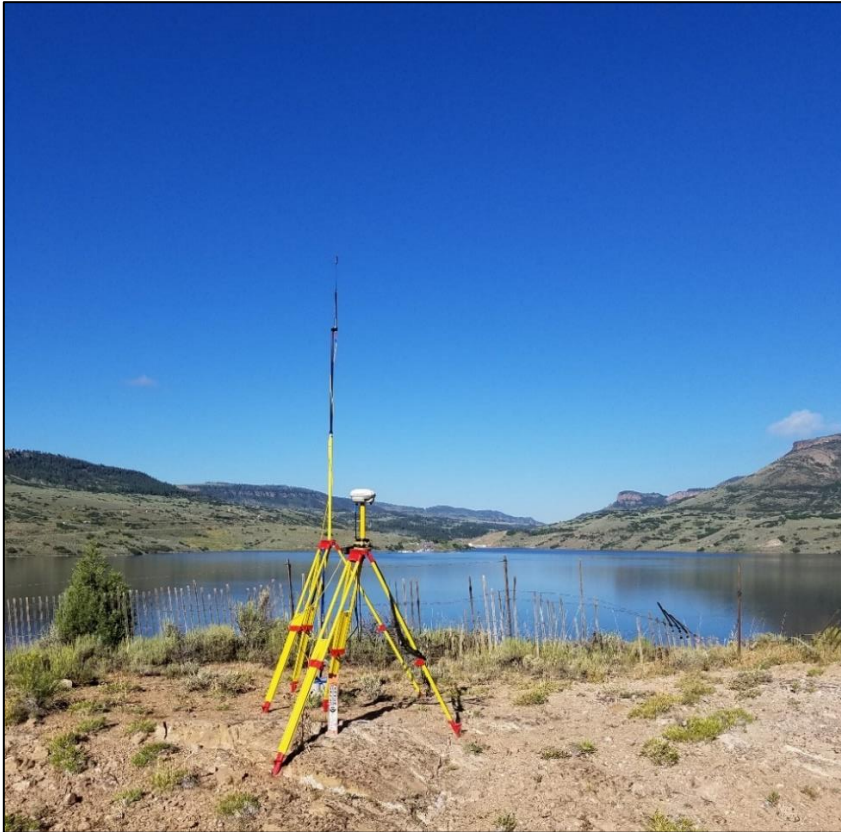
Figure A-2. The RTK-GPS base station set-up used during the Blue Mesa Reservoir survey (NGS bench mark designation S424 near Sapinero, Colorado is shown).

RTK GPS survey instruments were used to continuously measure the survey boat position and measure other ground control points. The GPS base station and receiver was set up on a tripod over three points overlooking the reservoir (Figure 10 and Figure 11). The coordinates of two of these points utilized published values by the NGS (verified with OPUS ([www.ngs.noaa.gov/OPUS/](http://www.ngs.noaa.gov/OPUS/))) following the survey. A third base location was set over a temporary benchmark and its coordinates were computed using OPUS. The data using the temporary benchmark were shifted to match the OPUS solution. Throughout the survey various benchmarks were surveyed while the base station was occupying other bench marks to insure the coordinates for each base station and other NGS bench marks were tied together. This insures accuracy and consistency. During the survey, position corrections were transmitted from the GPS base station to the GPS rover receiver on the survey vessel using an external GPS radio and UHF antenna (Figure A-2). The base station was powered by a 12-volt battery.
