ELEPHANT BUTTE RESERVOIR

1999 RESERVOIR SURVEY

U.S. Department of the Interior
Bureau of Reclamation

**Sedimentation and River Hydraulics Group
Water Resources Services
Technical Service Center
Denver, Colorado**

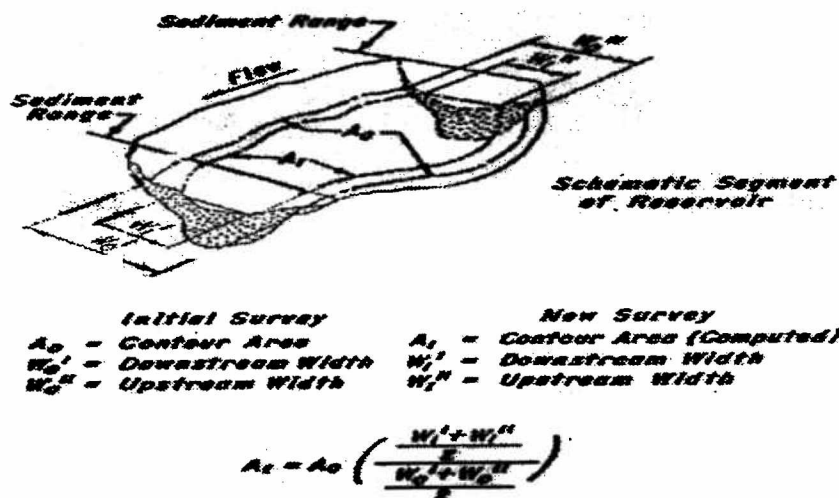
Figure 102 - Width adjustment method for revising contour areas

A comparison of the simultaneous plots of original range profiles against the resurveyed range profiles indicates the lateral distribution of the sediment at the measured points. Where these plots indicate changes have occurred on the side slopes of the reservoir, an engineering judgment decision was required to determine whether the change is due to survey inaccuracies or due to actual deposition or erosion. As noted previously the original range line data was scaled from the original 10-foot contour maps.

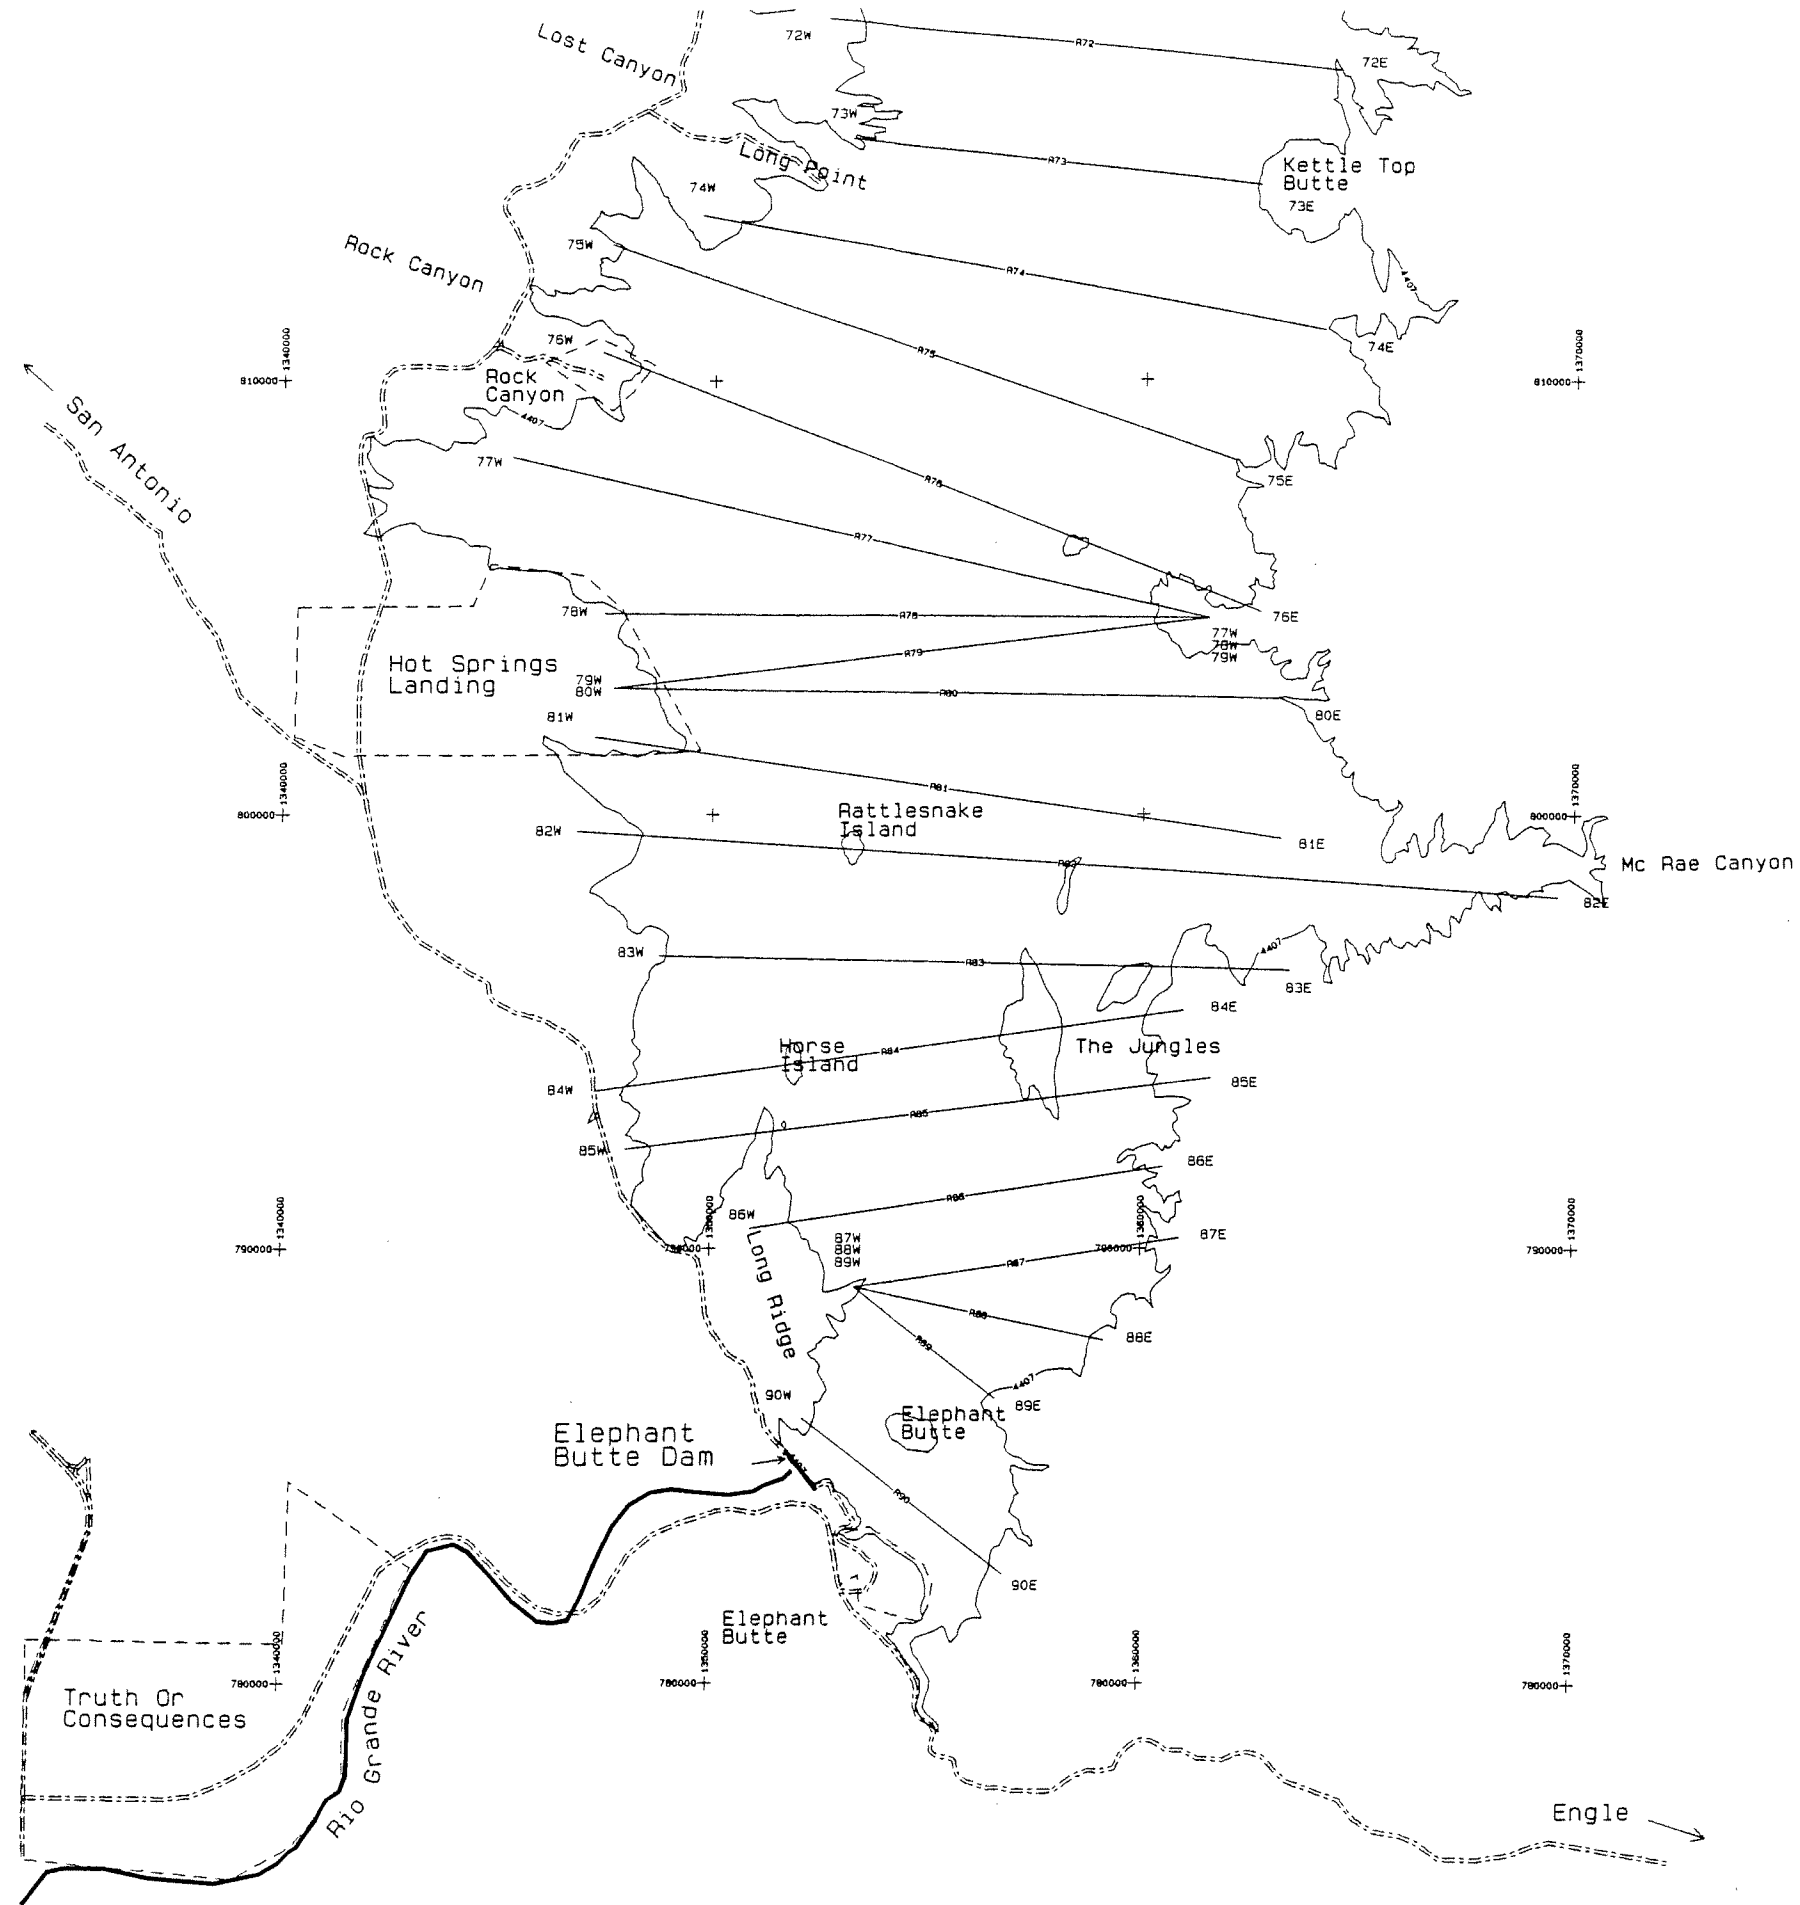
Figure 3 - Elephant Butte Reservoir sedimentation range lines

Vertical datum based on original project datum established by U.S. Bureau of Reclamation which is 43.3 feet less than the National Geodetic Datum of 1929.
 Horizontal datum based on New Mexico's State Plane Coordinate System, Central Zone (NAD83).

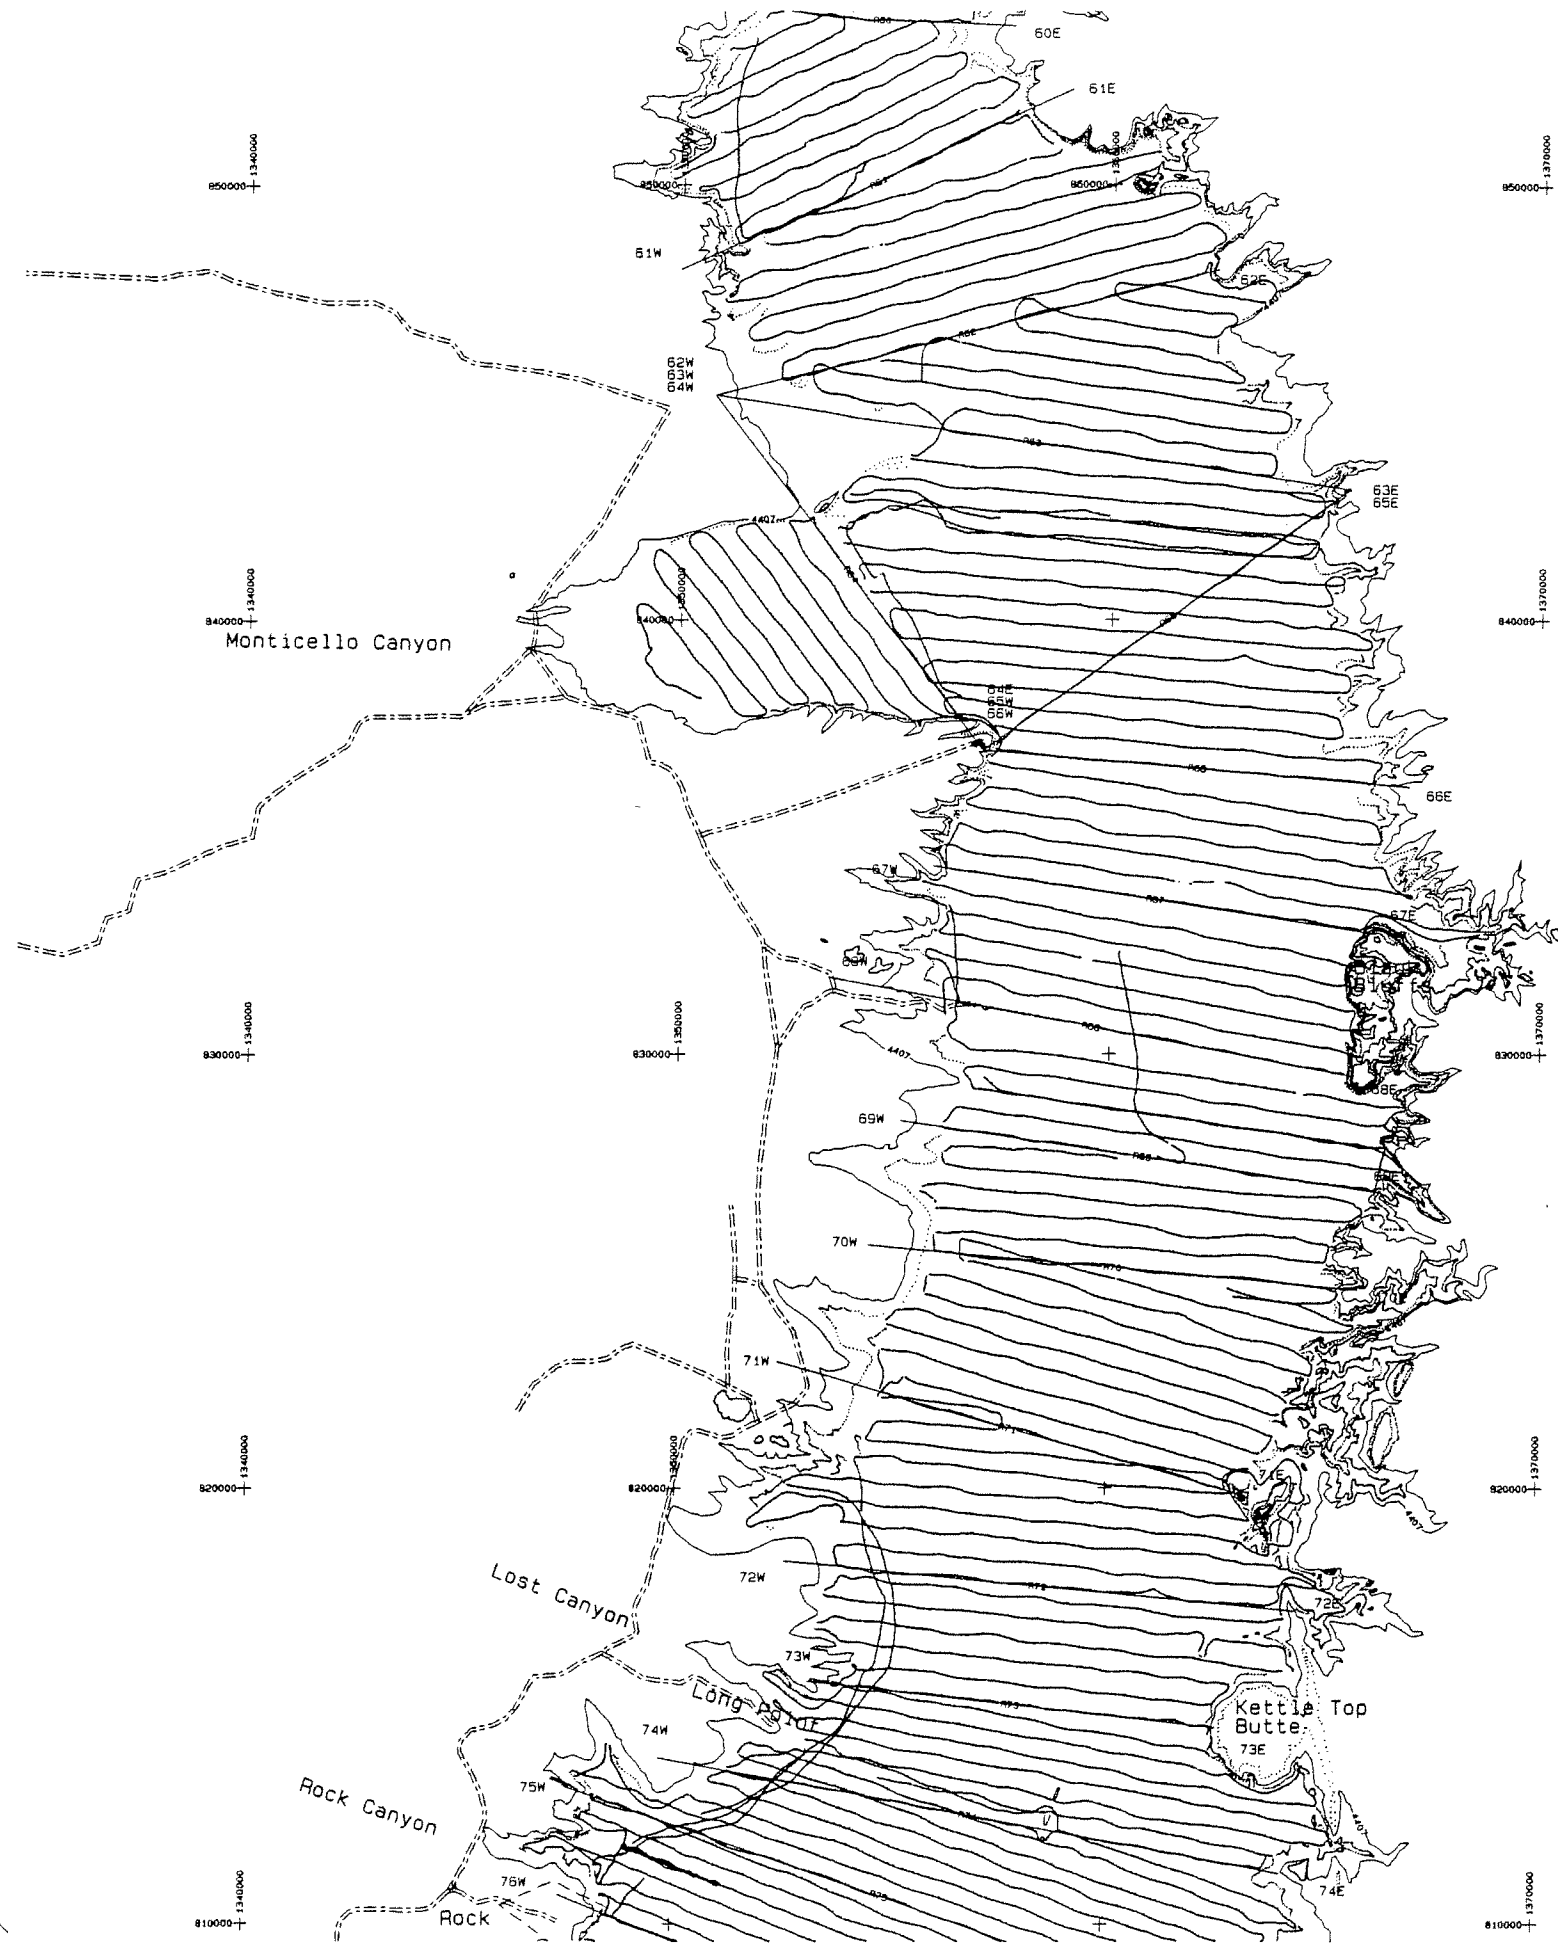
Figure 10 - Elephant Butte Reservoir underwater surveyed data

Vertical datum based on original project datum established by U.S. Bureau of Reclamation which is 43.3 feet less than the National Geodetic Datum of 1929.

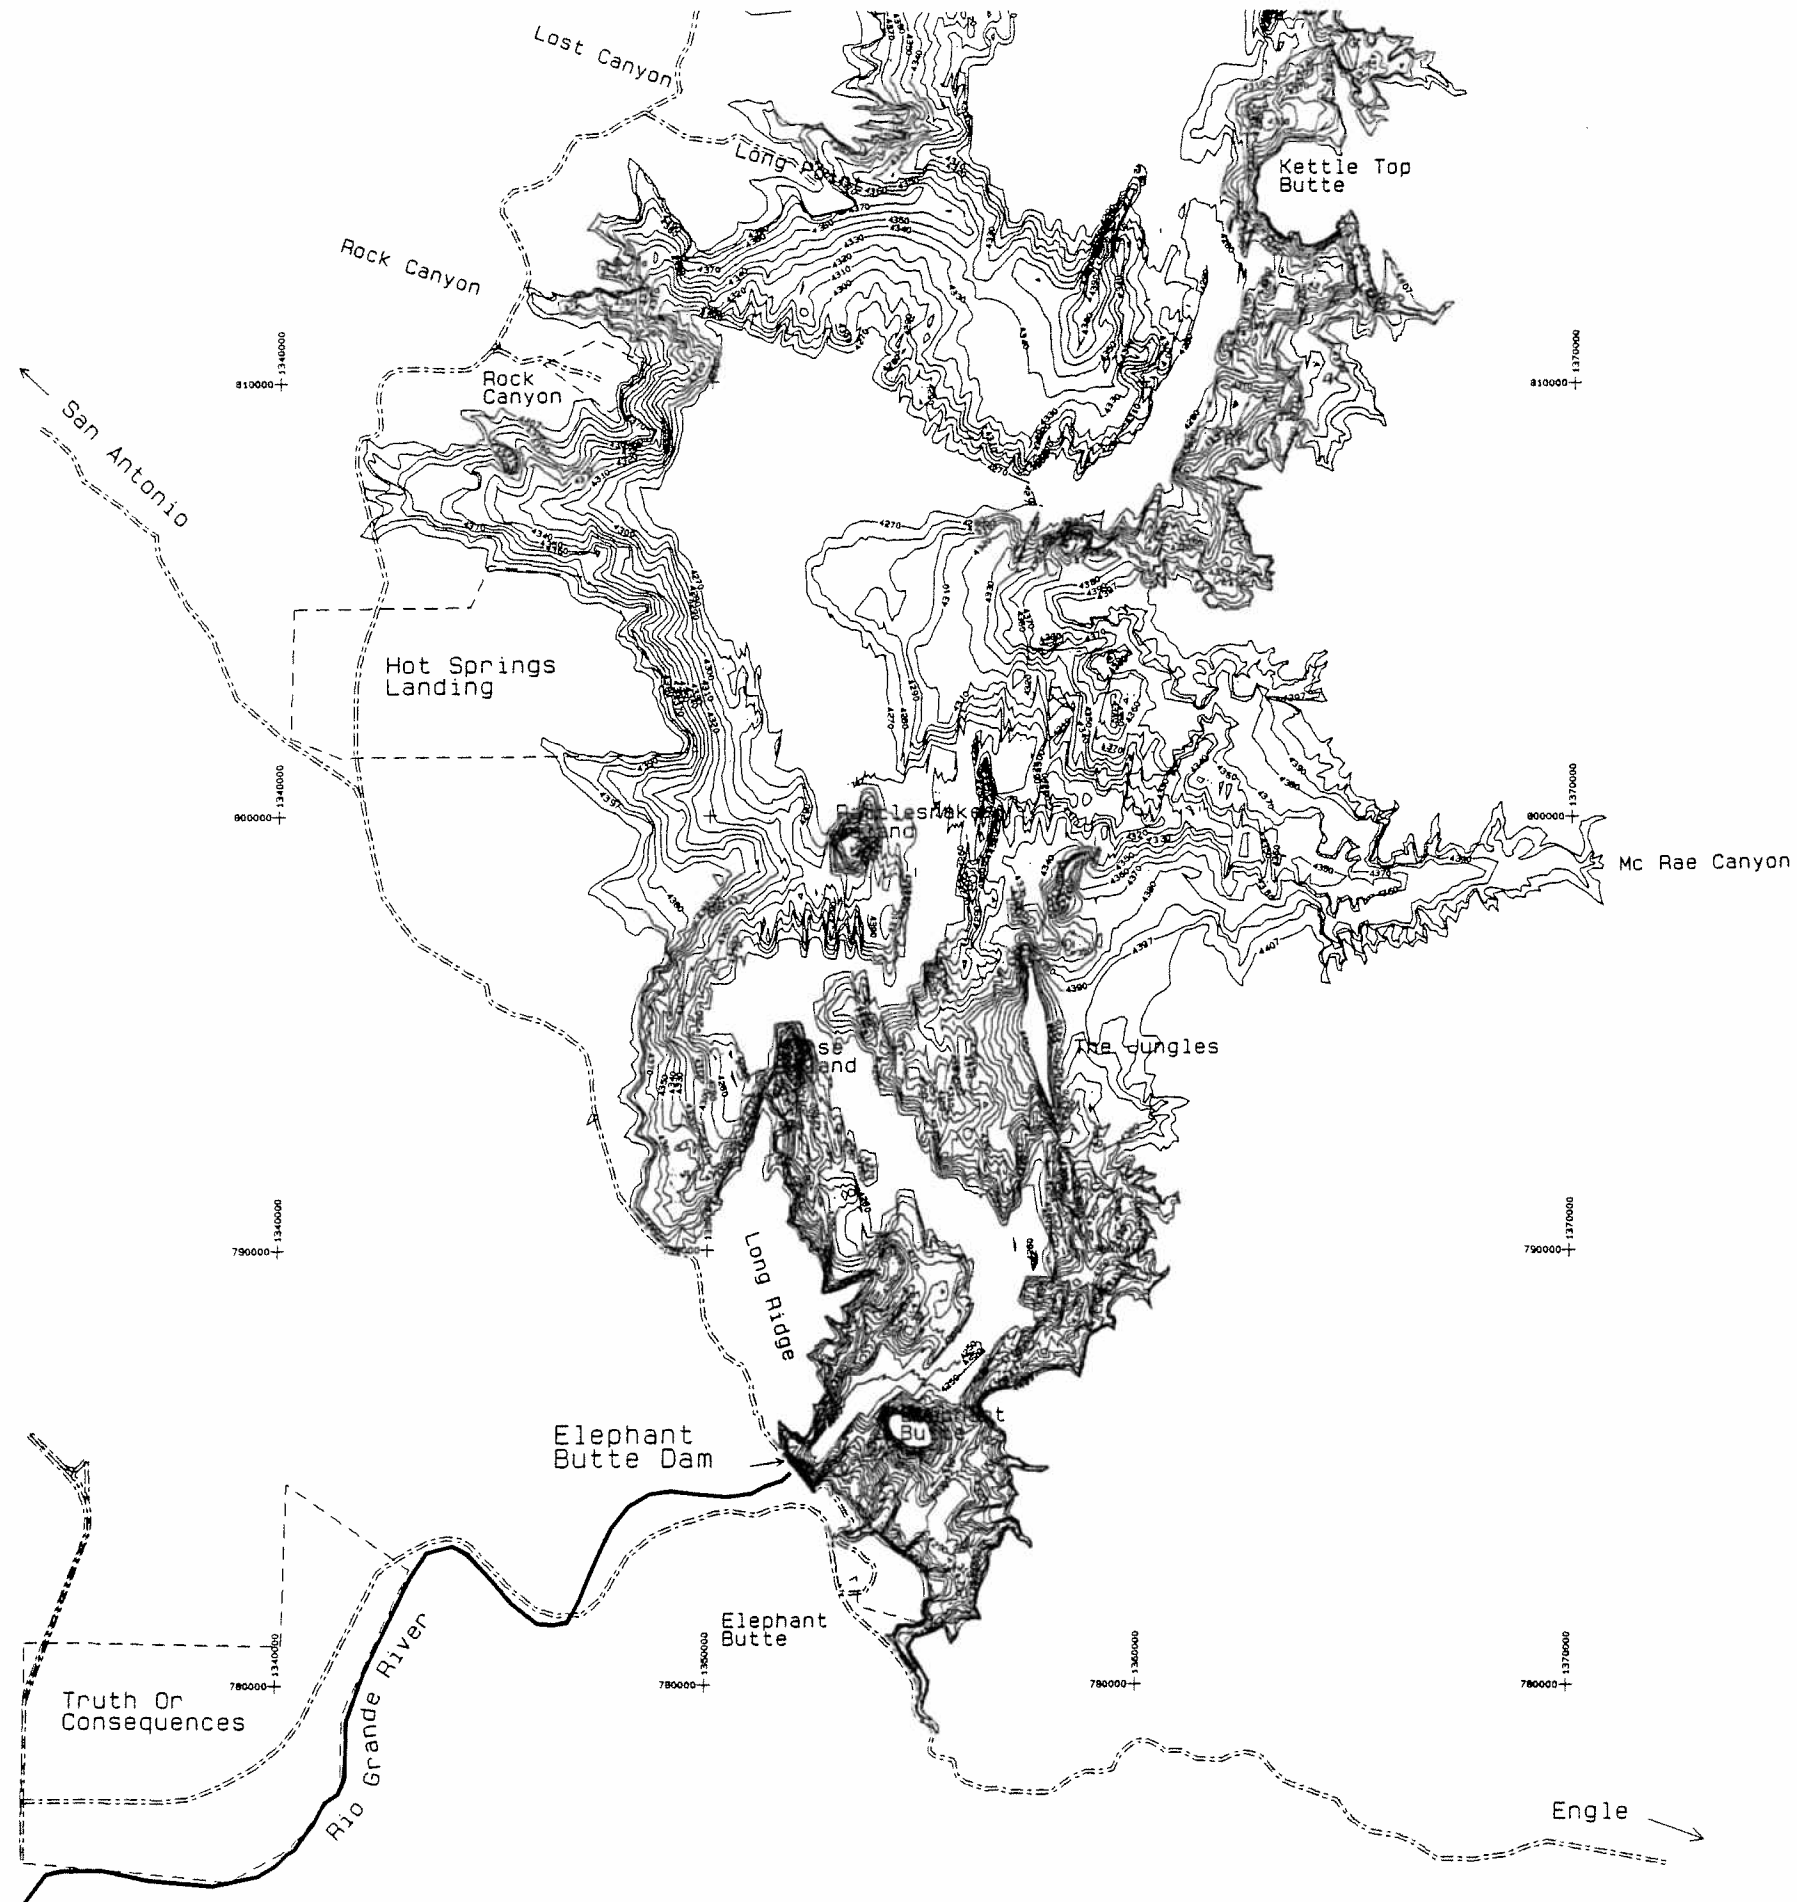
Figure 13 - Elephant Butte Reservoir topographic map, No. 24-D-1863

Vertical datum based on original project datum established by U.S. Bureau of Reclamation which is 43.3 feet less than the National Geodetic Datum of 1929.

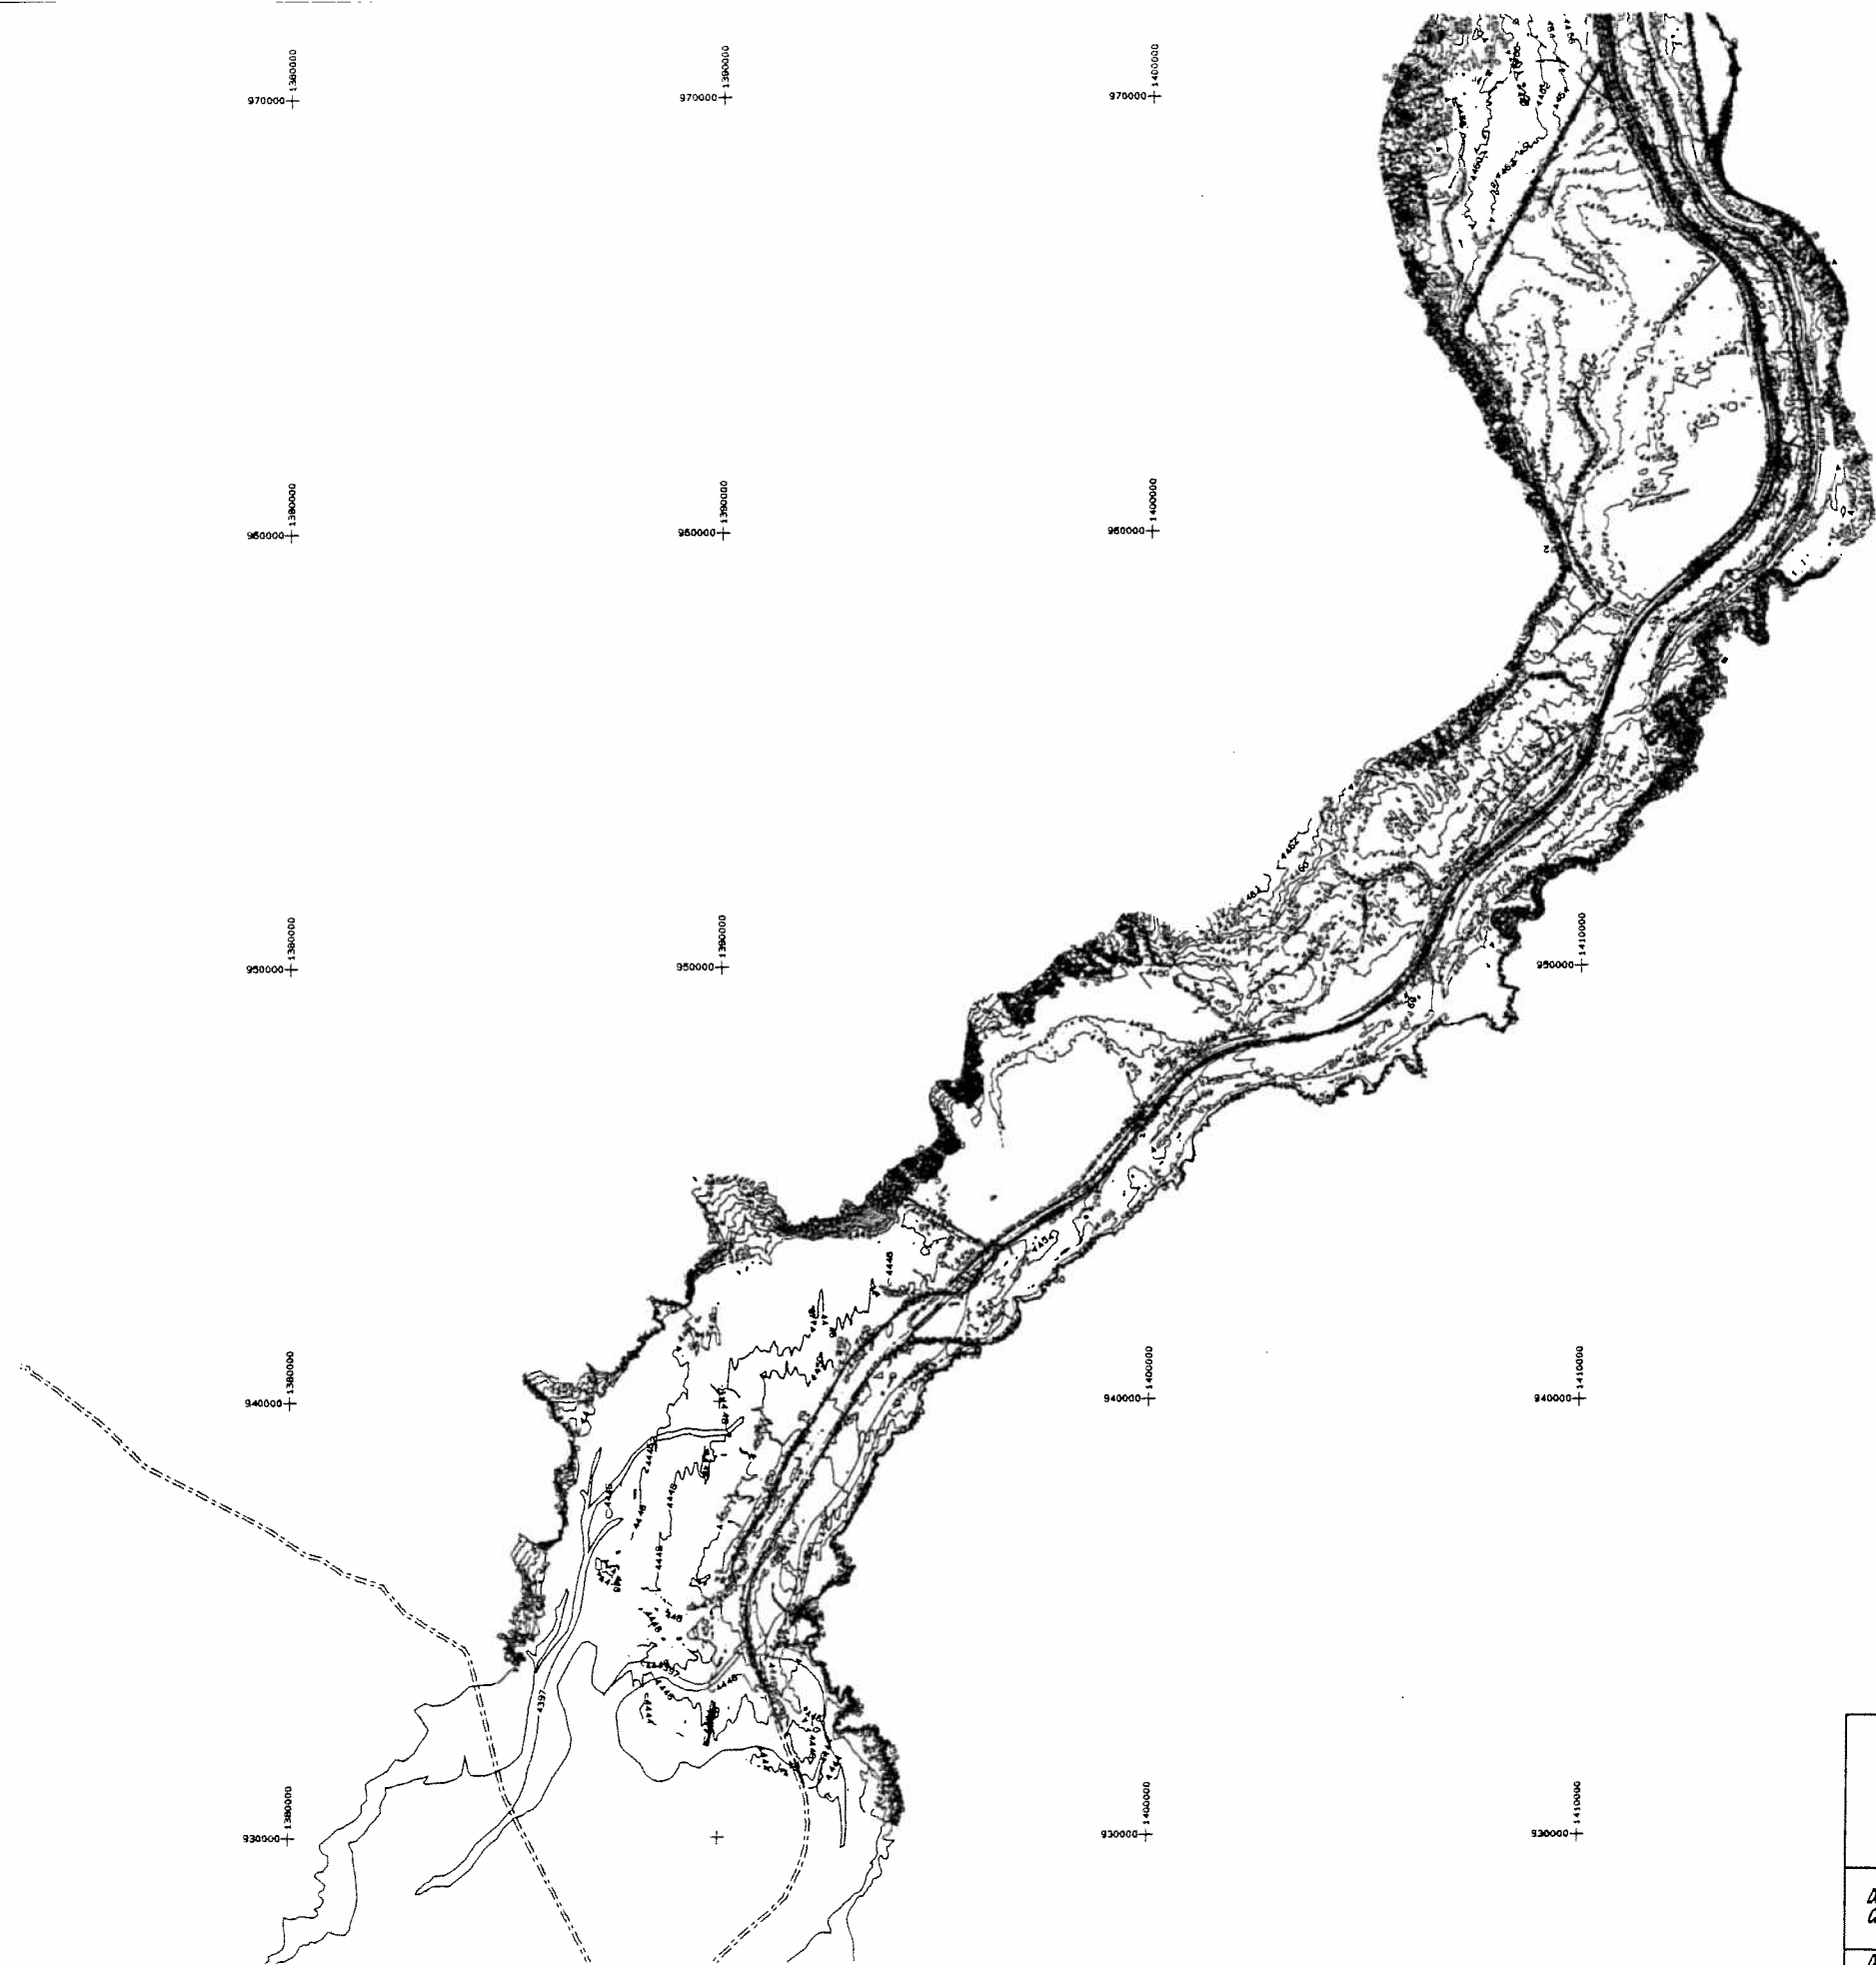
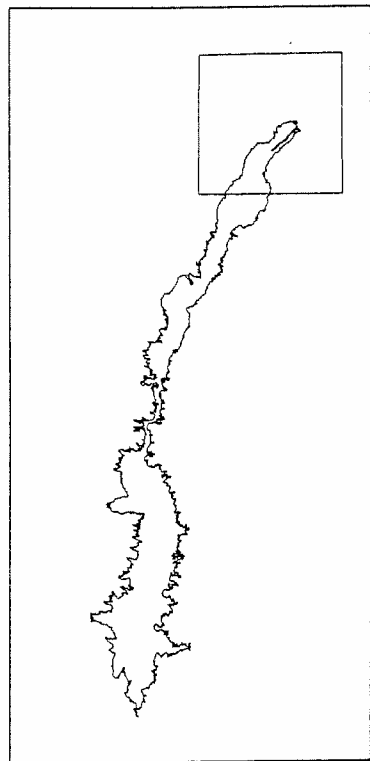
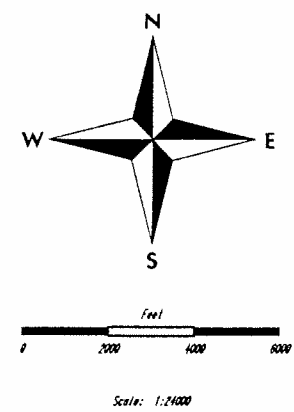
Figure 16- Elephant Butte Reservoir topographic map, No. 24-D-1866

Detailed topography developed by 1997 aerial collection with vertical Datum of 1929.

Vertical datum based on original project datum established by U.S. Bureau of Reclamation which is 43.3 feet less than the National Geodetic Datum of 1929.

Horizontal datum based on New Mexico's State Plane Coordinate System, Central Zone (NAD83).

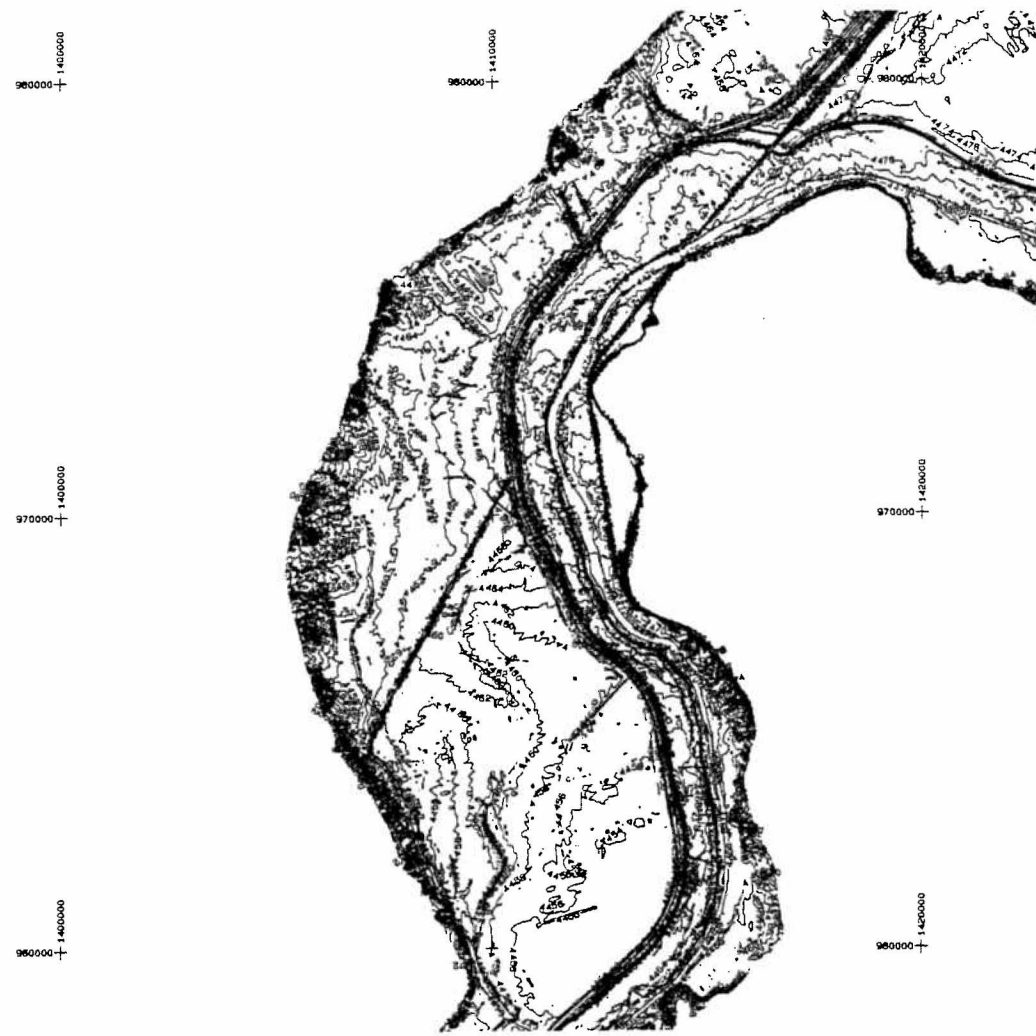
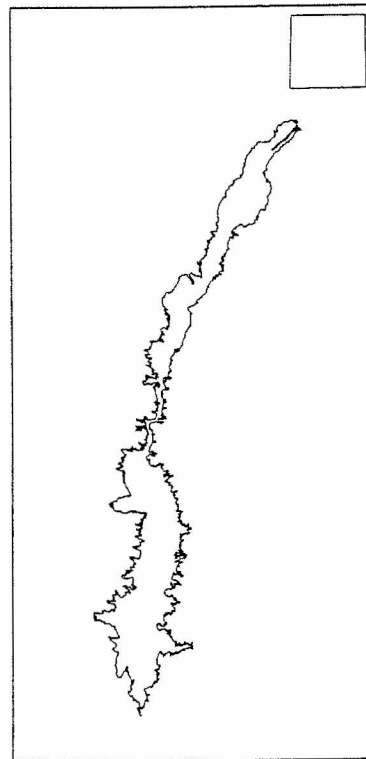
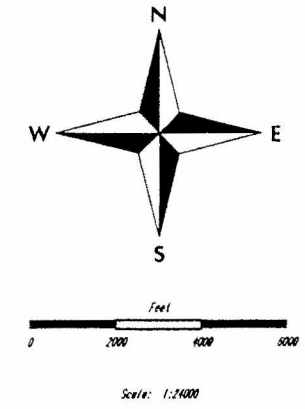
Figure 17 - Elephant Butte Reservoir topographic map, No. 24-D-1867

Detailed topography developed by 1997 aerial collection with vertical Datum of 1929.

Vertical datum based on original project datum established by U.S. Bureau of Reclamation which is 43.3 feet less than the National Geodetic Datum of 1929.

Horizontal datum based on New Mexico's State Plane Coordinate System, Central Zone (NAD83).

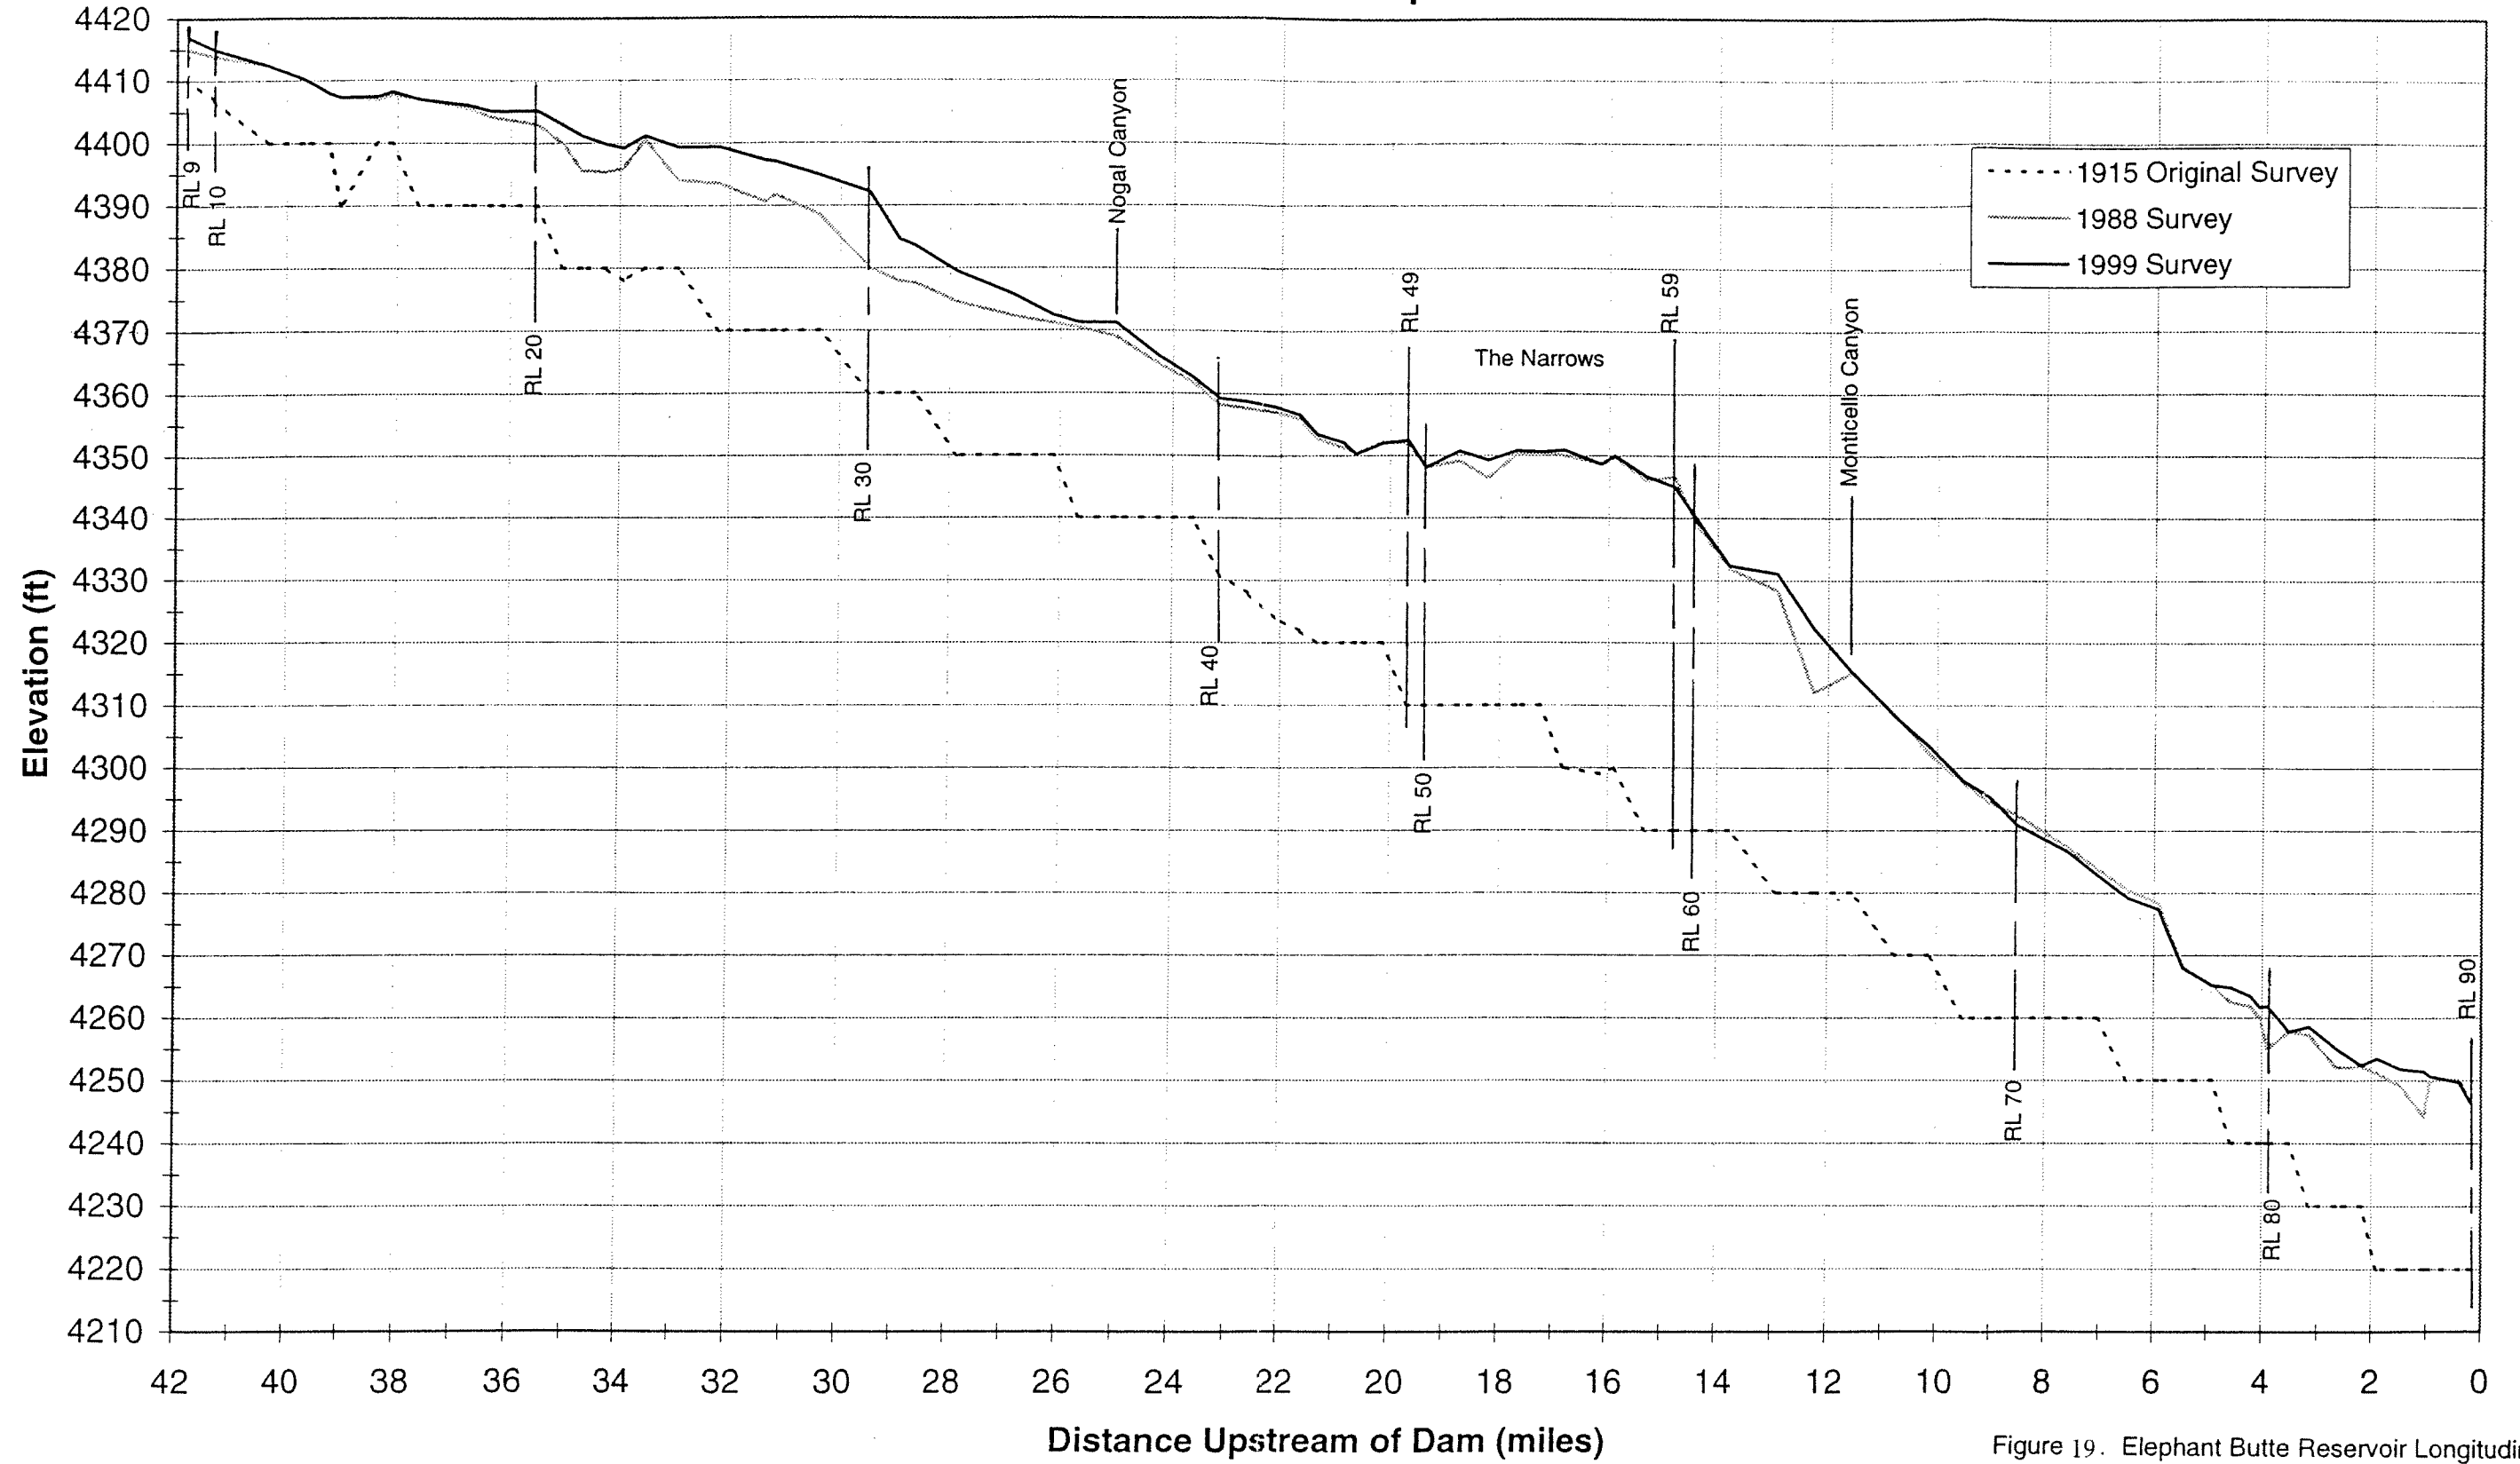
Figure 19. Elephant Butte Reservoir Longitudinal Profiles

Elephant Butte Reservoir Longitudinal Profiles 1915, 1988, 1999 Comparison

To illustrate the sediment distribution throughout the reservoir a longitudinal profile was plotted for the original, 1988 and 1999 reservoir conditions (figure 19). The difference between the original thalweg and the 1988 and 1999 thalweg represents the sediment encroachment into the reservoir since the dam closed in 1915. The plot illustrates the greatest depths of longitudinal sediment deposits occurring between 14 to 16 miles above the dam. The deposit pattern in this region was probably influenced by the "Narrows" area located between 15 and 20 miles above the dam. When the reservoir is full, the narrows divides the reservoir into 2 large water bodies. The narrows has an average width of 0.36 miles compared to an average width of 1.39 miles for the overall reservoir. A major factor influencing the longitudinal pattern of the reservoir is the operational water surface. During 1950 through 1968 there was a severe drought in the region where the reservoir was held at a much lower stage allowing the sediment inflow to be deposited in the lower reaches of the reservoir. The plot of the 1988 and 1999 thalweg illustrates where the majority of sediments have deposited over the last 11 years, which is in the upper reservoir area above mile 26. Since the 1988 survey the reservoir has fluctuated between reservoir elevation 4380.3 and 4406.7. The sediment delta buildup since 1988 starts around elevation 4380.

The Elephant Butte Reservoir original and 1999 area and capacity values are illustrated on figures 19 and 103 and the results are listed on tables 2 and 3. These presentations illustrate the capacity difference that has occurred during the 84.3 years of reservoir operations. This study found that as of April 1999, at reservoir water surface elevation (feet) 4,407.0, the surface area was 35,984 acres with a total capacity of 2,023,358 acre-feet. Since the reservoir's initial filling in 1915, 611,442 acre-feet of sediment have accumulated in Elephant Butte Reservoir. Since the last reservoir survey in 1988, 41,652 acre-feet of sediment have been trapped. The average annual rate of sediment accumulation since 1915 is 7,253 acre-feet and since 1988 it is 3,719 acre-feet.

The 1999 survey measured a capacity of 1,225,489 acre-feet at elevation 4,380 or a sediment accumulation since 1988 of 15,675 acre-feet. The 1999 survey measured 62 percent of accumulated sediment since 1988 above elevation 4,380. As noted previously, since 1988 the reservoir has been at elevation 4380 or higher which has not allowed the accumulated sediment to be flushed from the upper reservoir area to the lower reservoir areas as illustrated on figure 19.
