ELEPHANT BUTTE RESERVOIR

1999 RESERVOIR SURVEY

U.S. Department of the Interior
Bureau of Reclamation

**Sedimentation and River Hydraulics Group
Water Resources Services
Technical Service Center
Denver, Colorado**

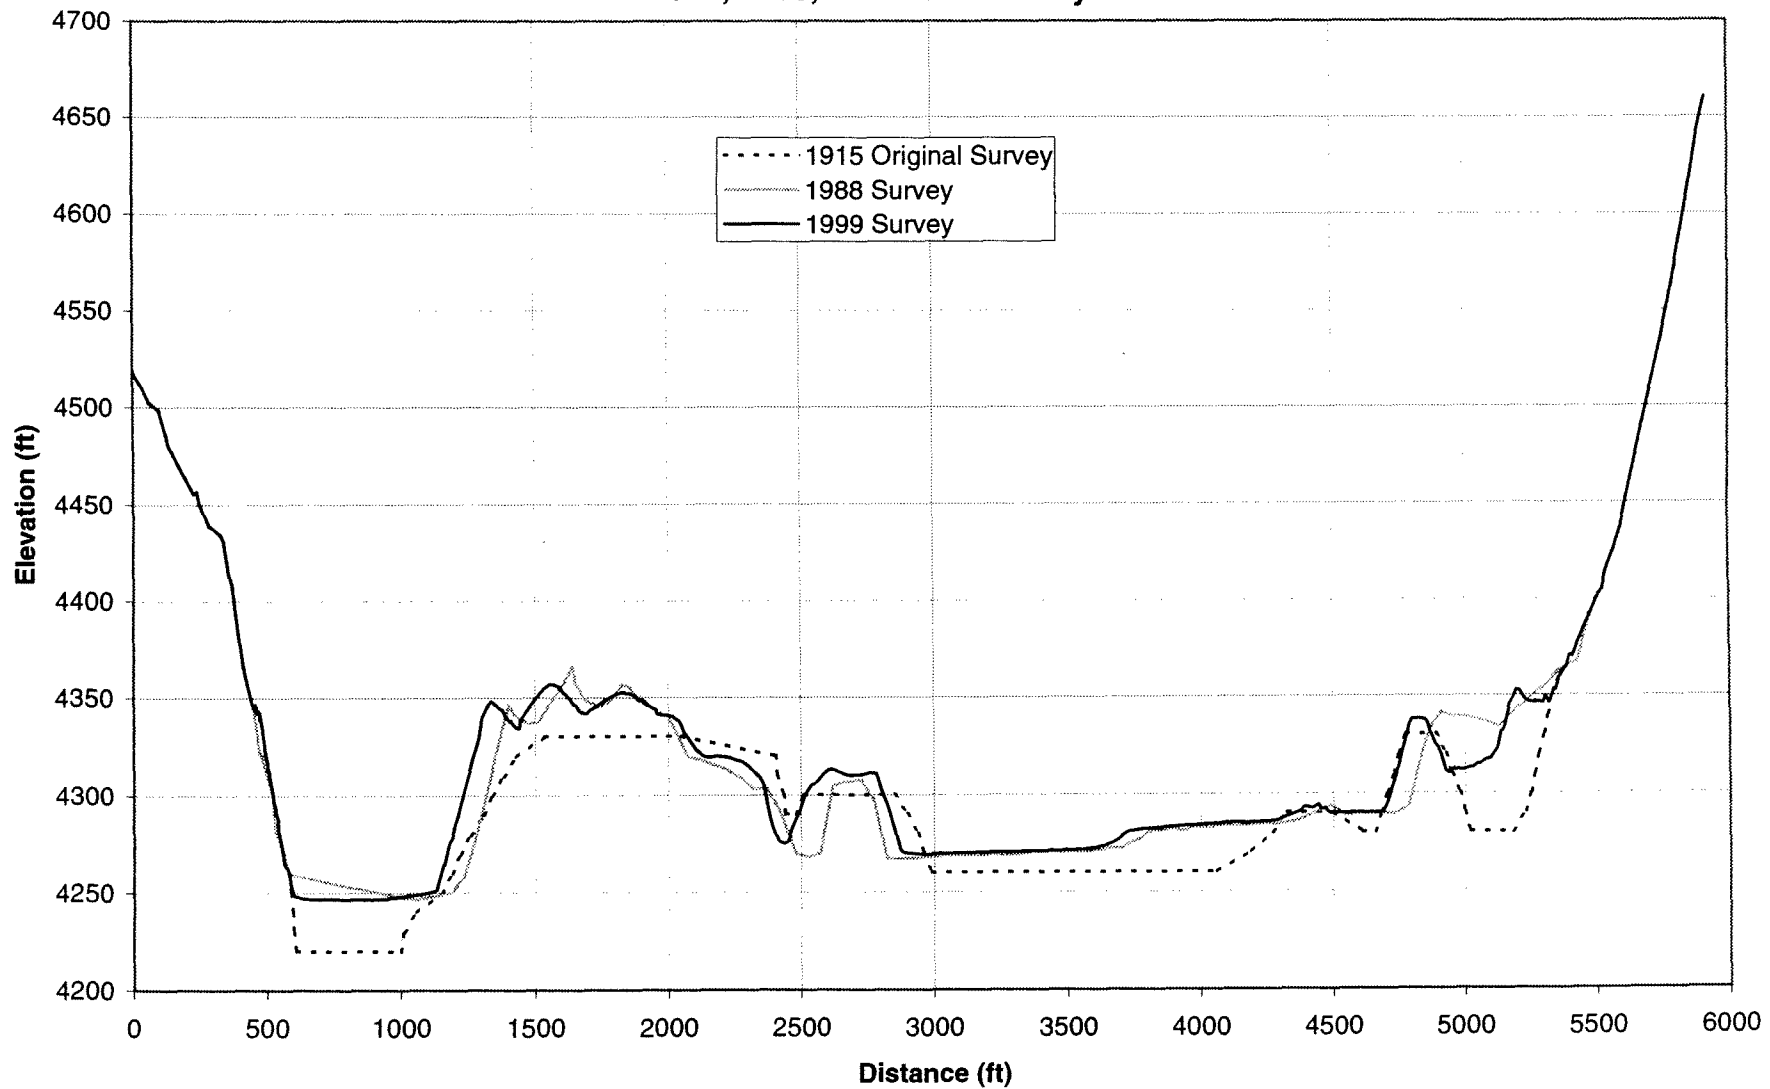
Elephant Butte Sediment Range Profile: Rangeline 90 1915, 1988, and 1999 Surveys

Figure 20. - Sedimentation range profiles for 1915, 1988, and 1999, range 90.

Ground profiles of the 82 reservoir sedimentation ranges are shown on figures 20 through 101. These profiles illustrate the general lateral distribution of sediments in the reservoir. Plots are from left to right looking upstream to be consistent with previous survey reports. The plots illustrate the survey results from the original, 1988, and 1999 surveys. The original and other profiles do not fully agree in the lateral direction for all ranges mainly due to the fact the original profiles were

A comparison of the simultaneous plots of original range profiles against the resurveyed range profiles indicates the lateral distribution of the sediment at the measured points. Where these plots indicate changes have occurred on the side slopes of the reservoir, an engineering judgment decision was required to determine whether the change is due to survey inaccuracies or due to actual deposition or erosion. As noted previously the original range line data was scaled from the original 10-foot contour maps.

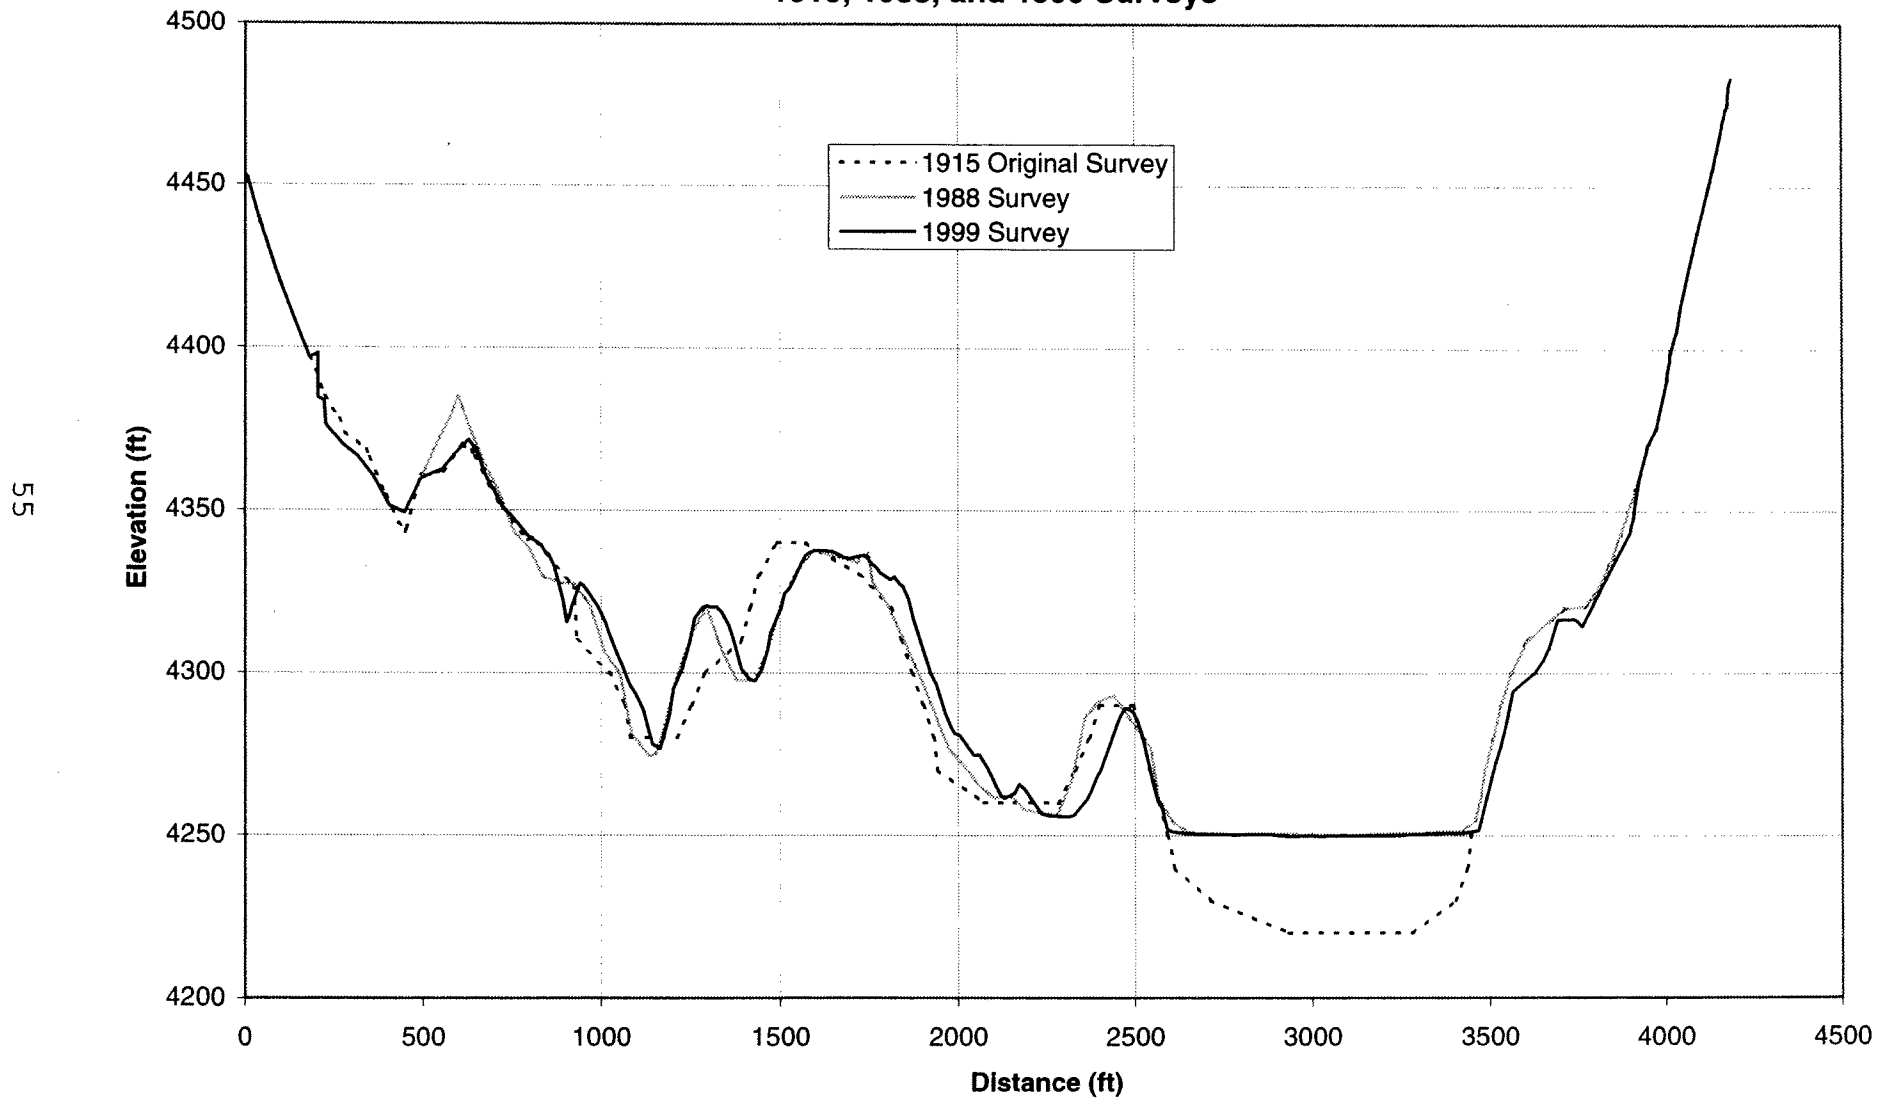
Figure 21. - Sedimentation range profiles for 1915, 1988, and 199, range 89.

Elephant Butte Sediment Range Profile: Rangeline 89 1915, 1988, and 1999 Surveys

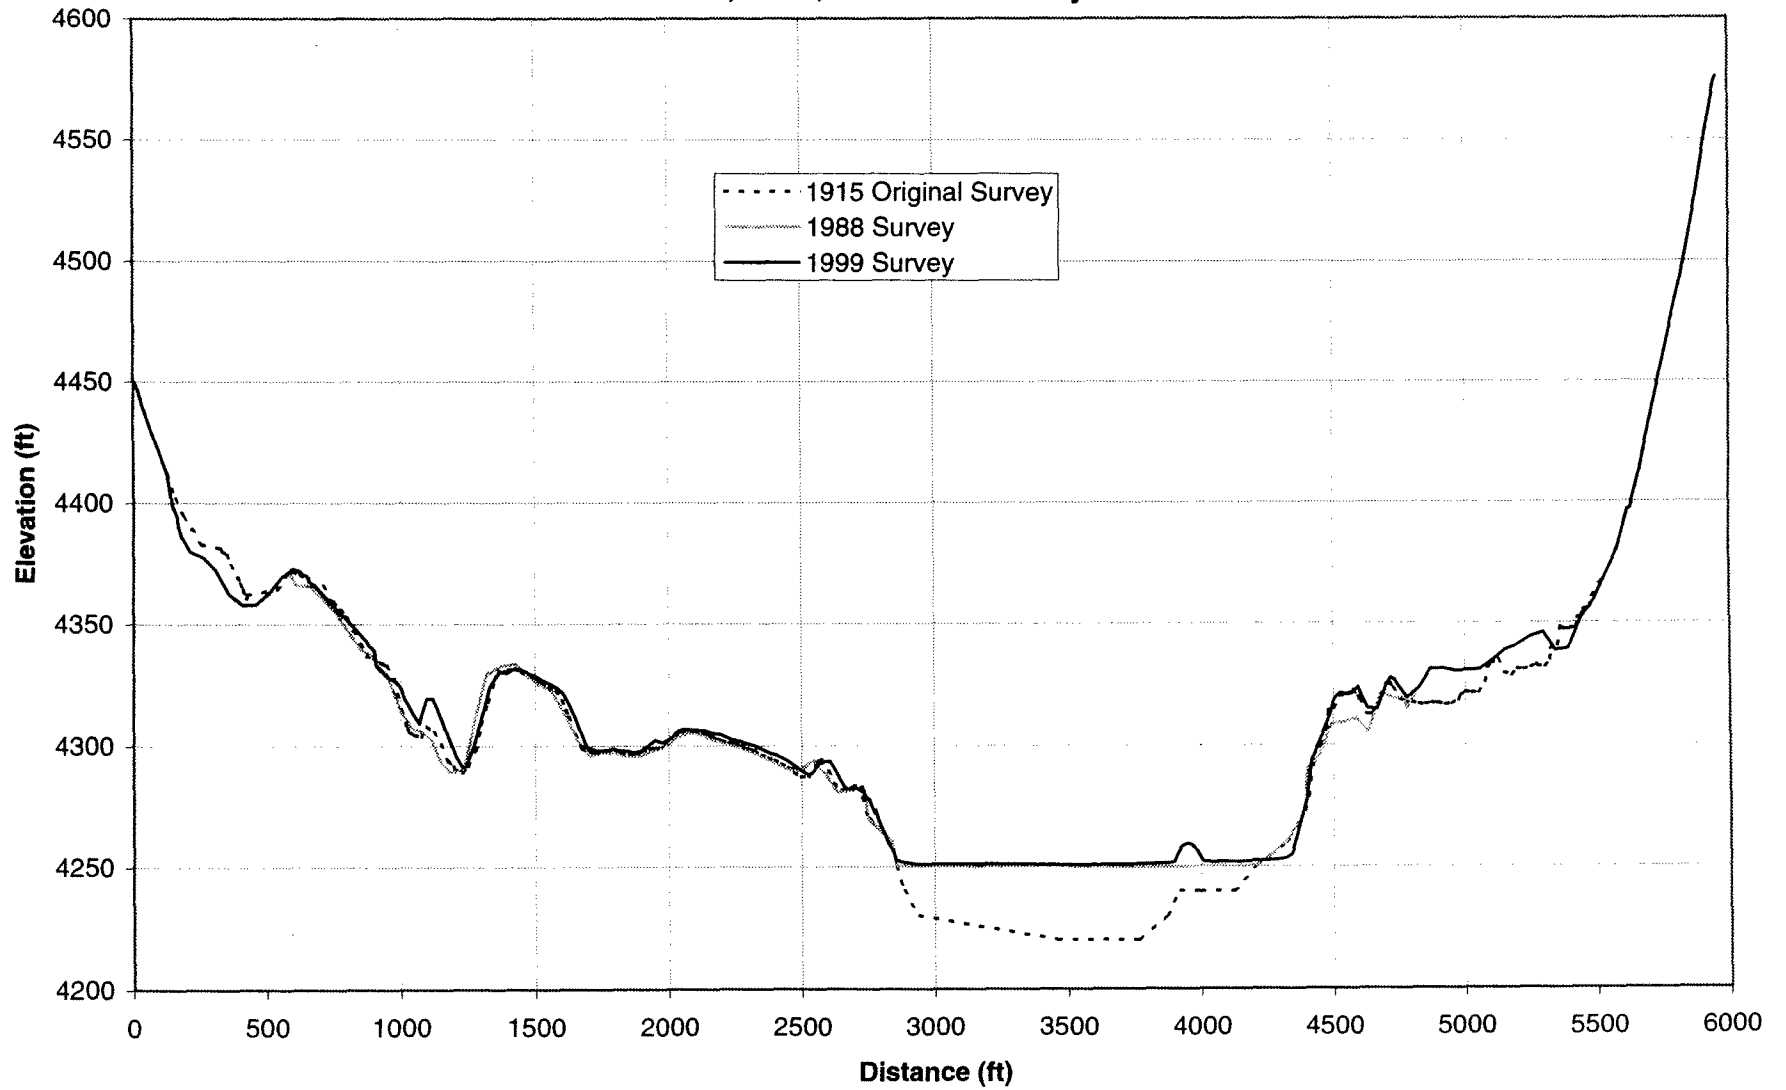
**Elephant Butte Sediment Range Profile: Rangeline 88
1915, 1988, and 1999 Surveys**

Figure 22. - Sedimentation range profiles for 1915, 1988, and 1999, range 88.

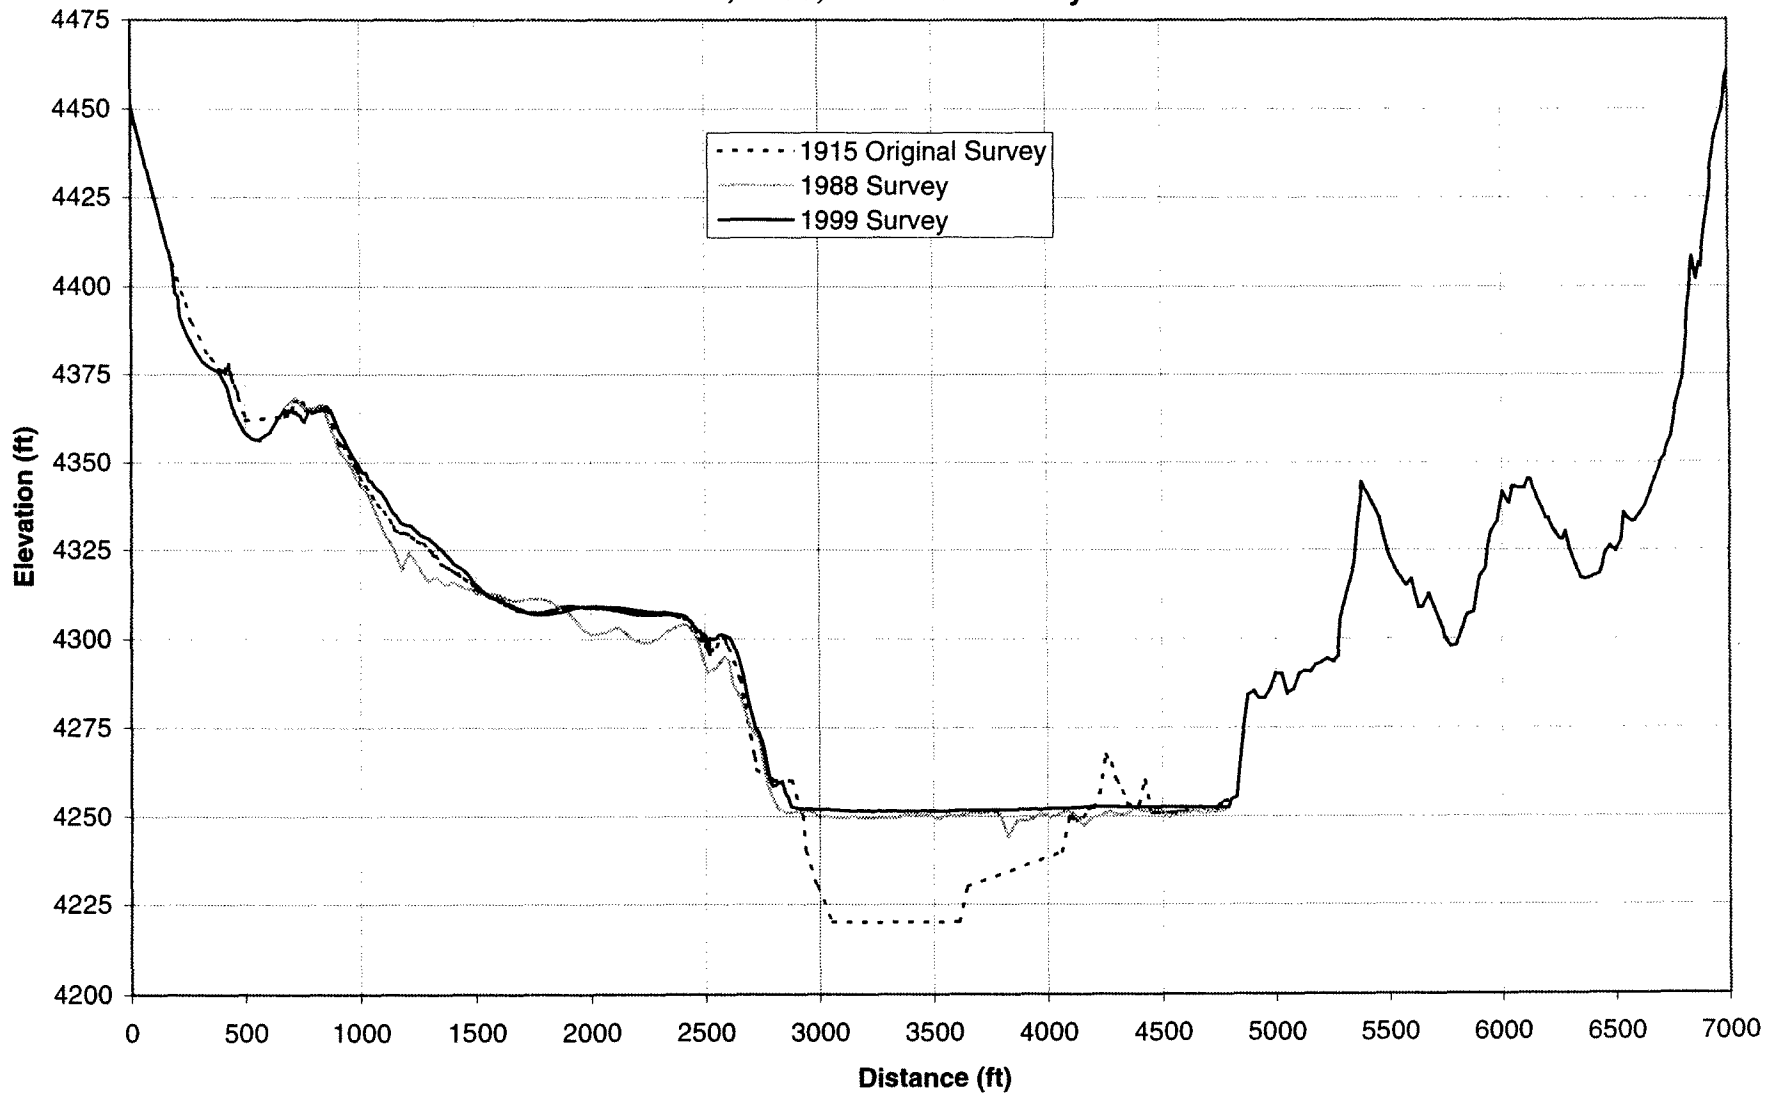
Elephant Butte Sediment Range Profile: Rangeline 87 1915, 1988, and 1999 Surveys

Figure 23. - Sedimentation range profiles for 1915, 1988, and 1999, range 87.

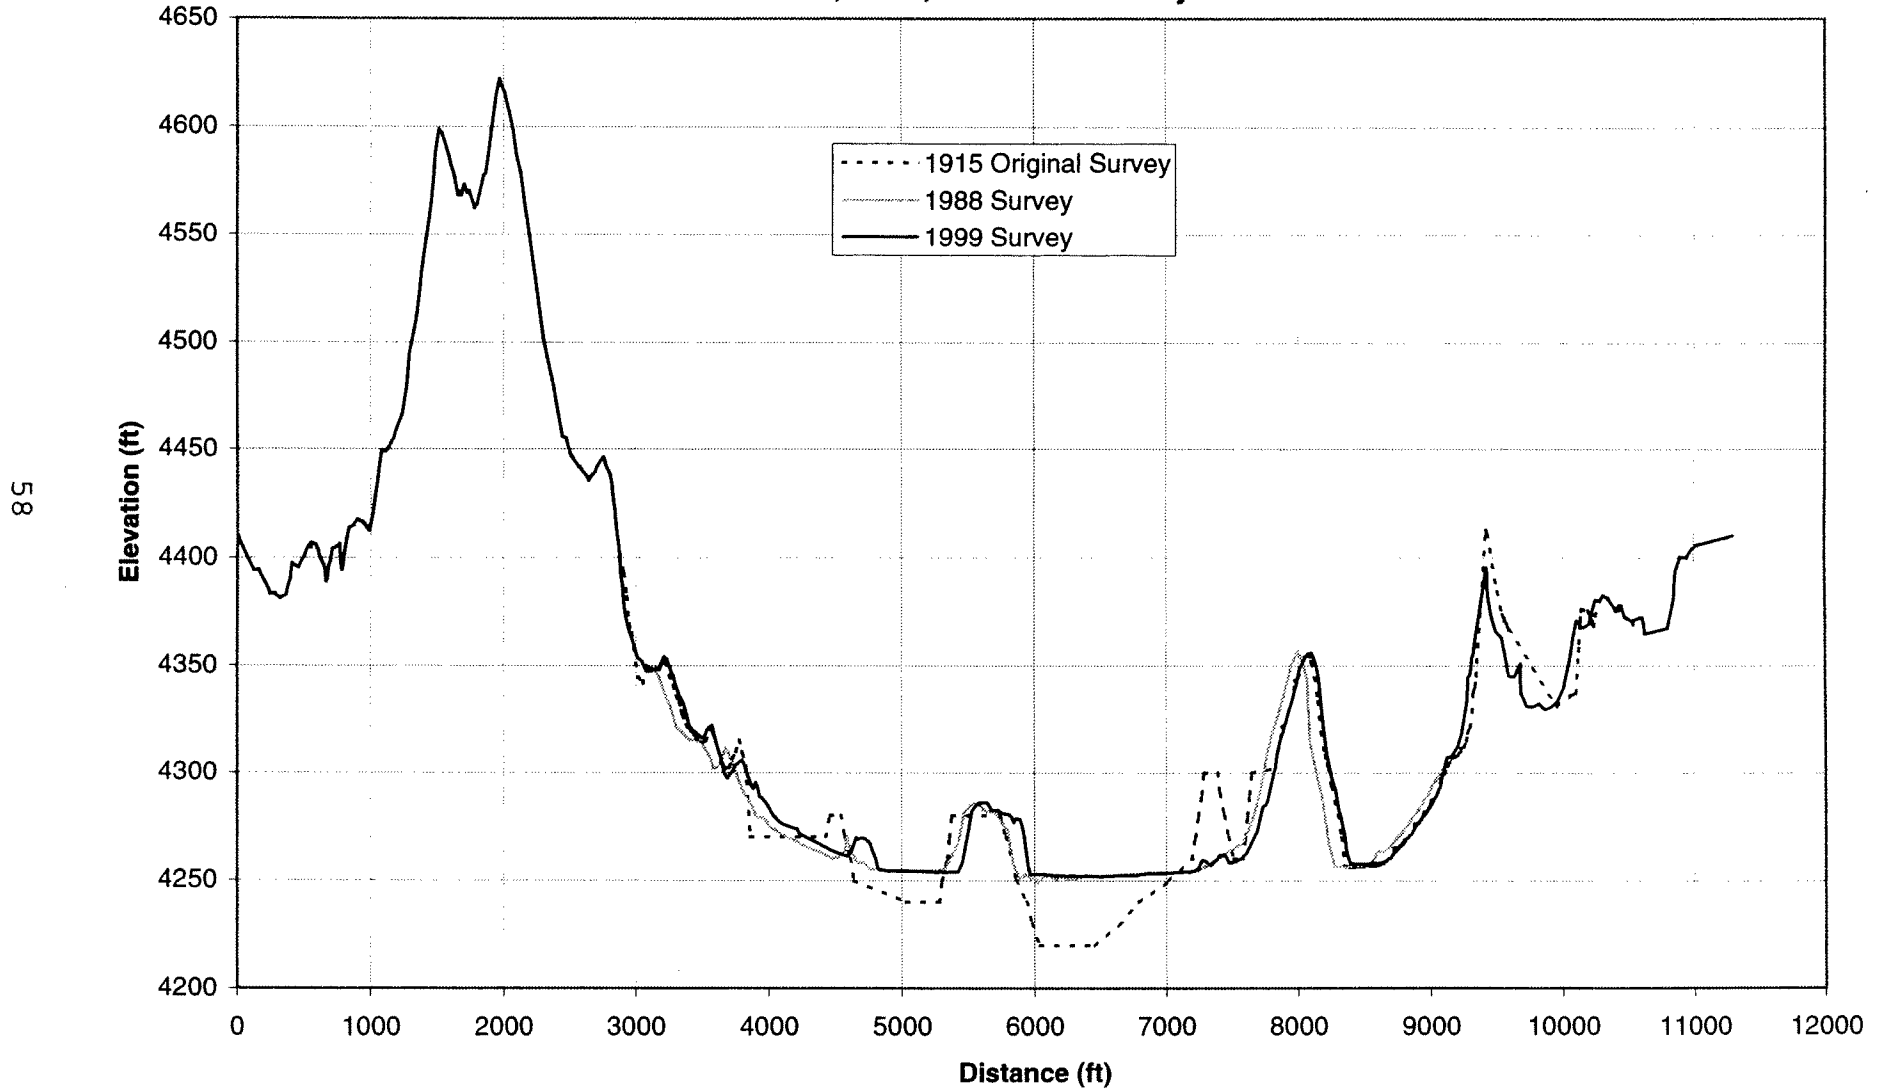
Figure 24. - Sedimentation range profiles for 1915, 1988, and 1999, range 86.

**Elephant Butte Sediment Range Profile: Rangeline 86
1915, 1988, and 1999 Surveys**

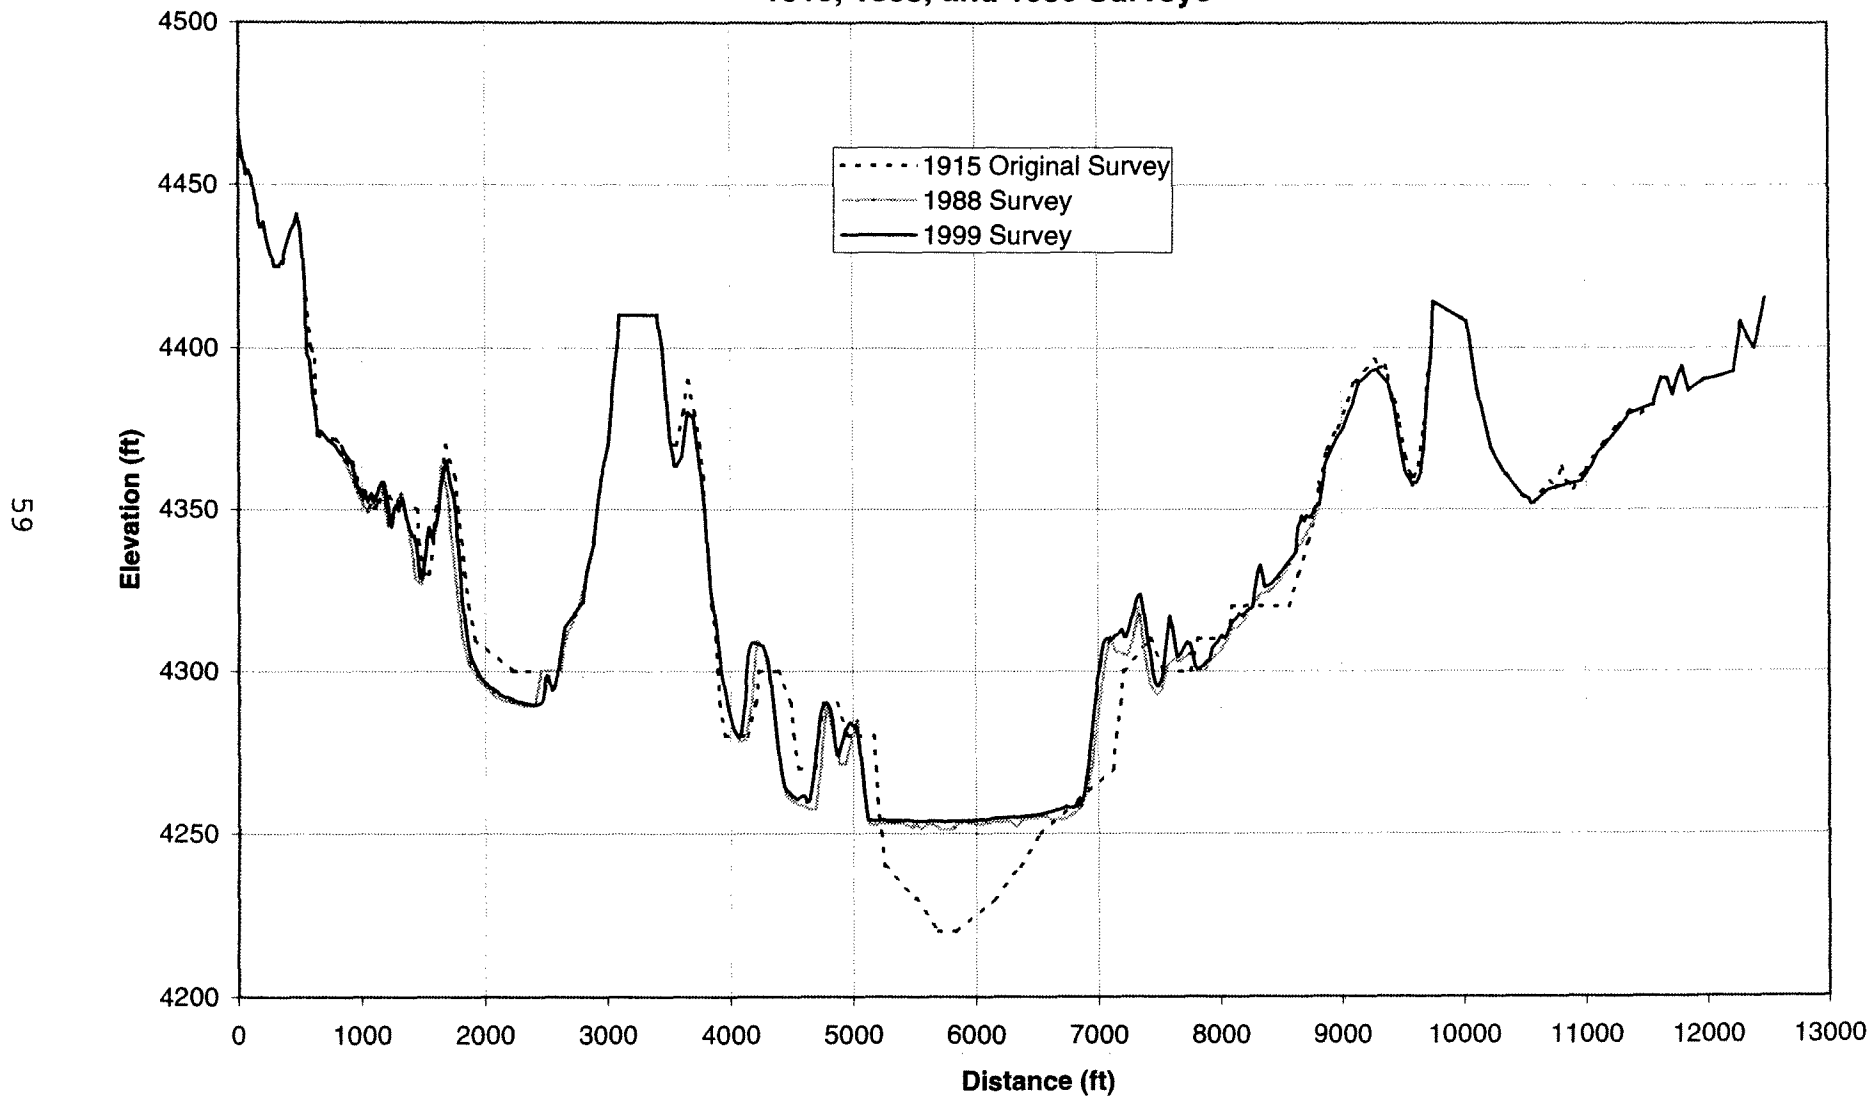
Elephant Butte Sediment Range Profile: Rangeline 85 1915, 1988, and 1999 Surveys

Figure 25. - Sedimentation range profiles for 1915, 1988, and 1999, range 85.

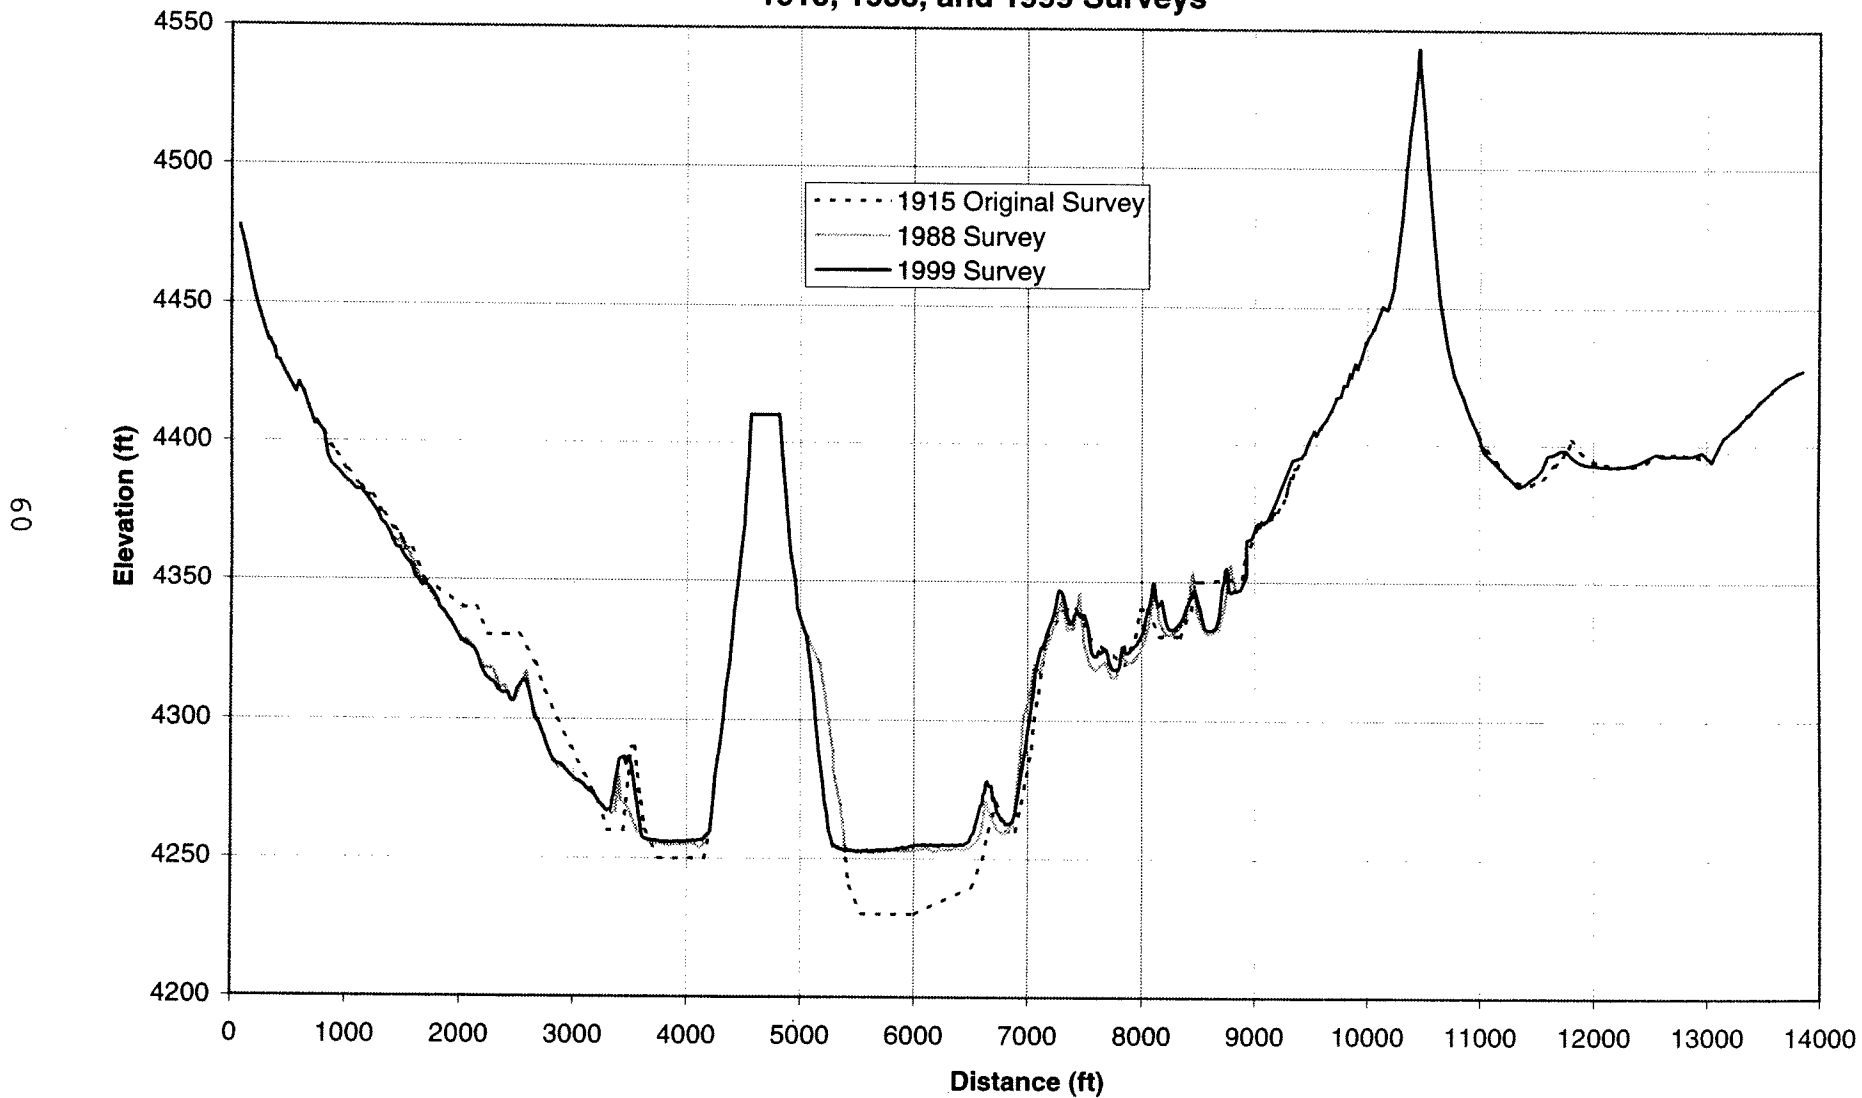
Elephant Butte Sediment Range Profile: Rangeline 84 1915, 1988, and 1999 Surveys

Figure 26. - Sedimentation range profiles for 1915, 1988, and 1999, range 84.

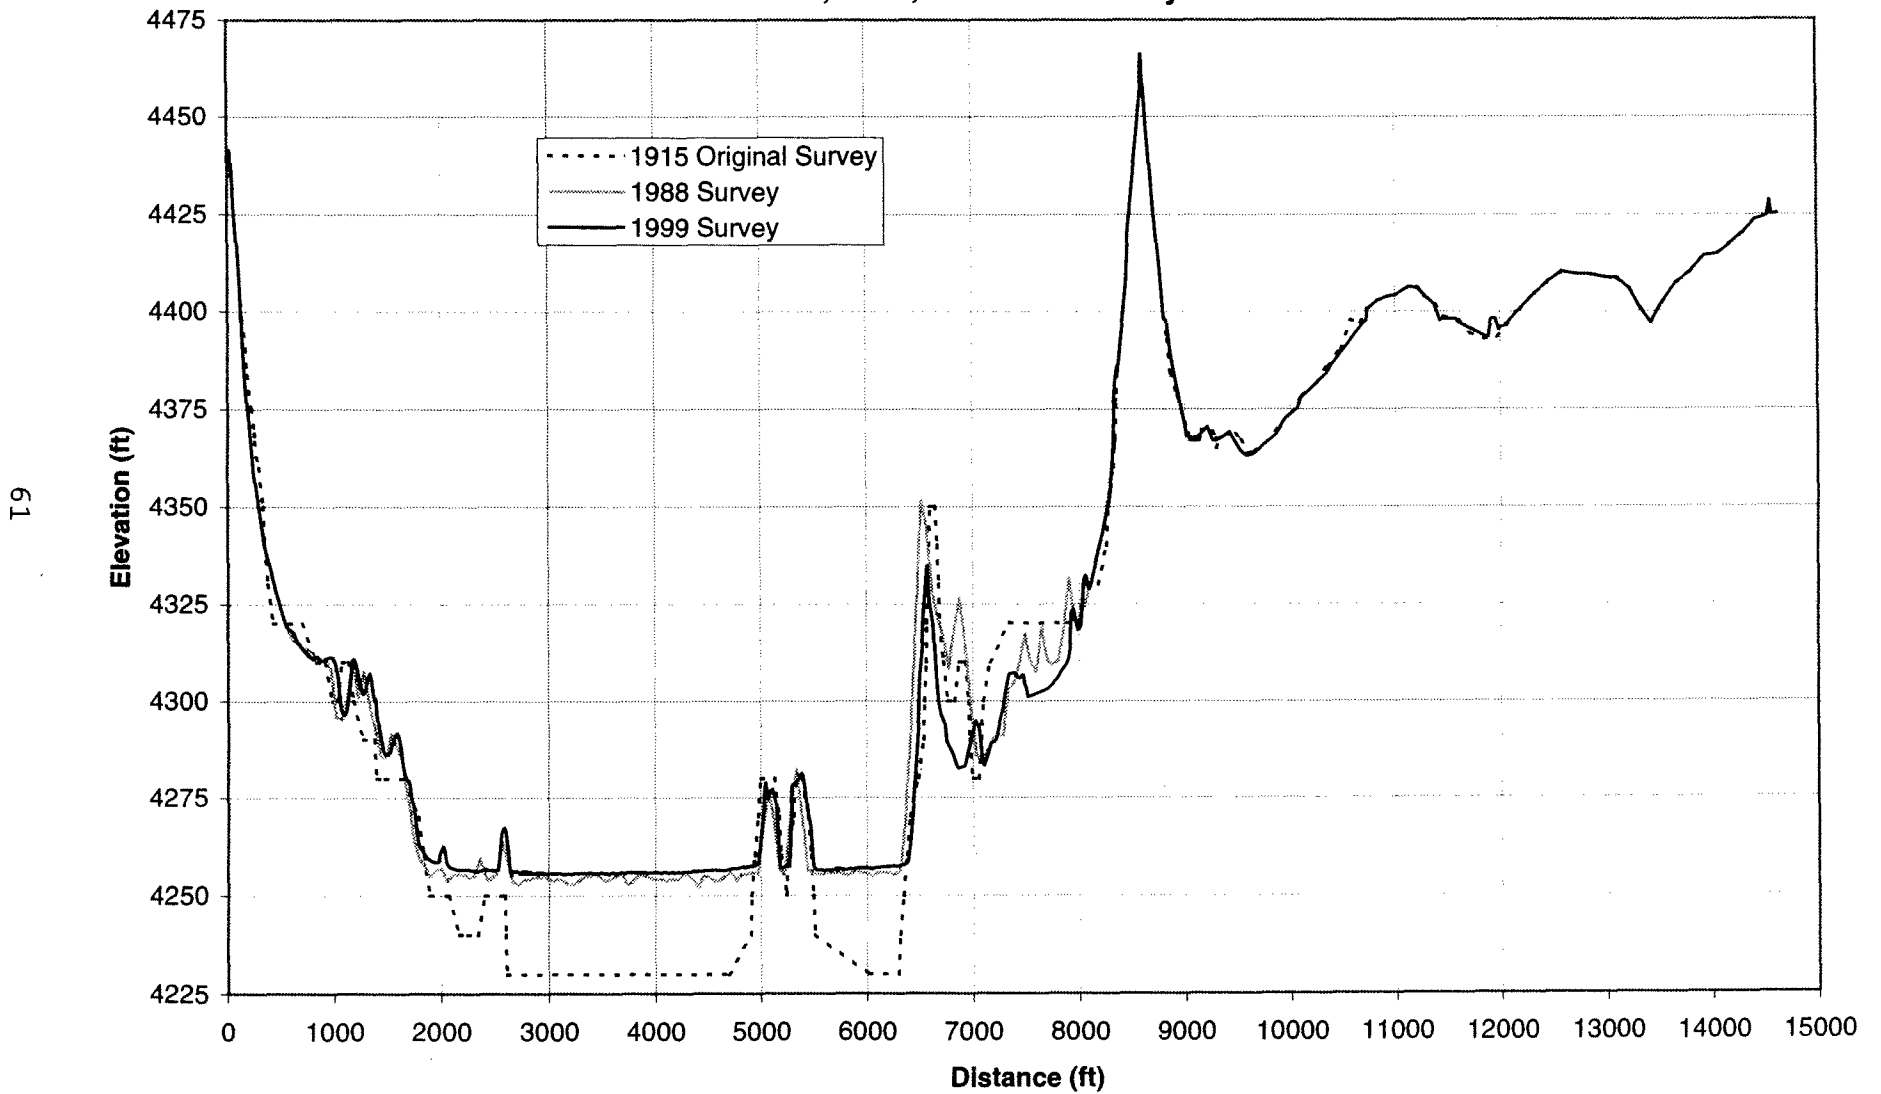
**Elephant Butte Sediment Range Profile: Rangeline 83
1915, 1988, and 1999 Surveys**

Figure 27. - Sedimentation range profiles for 1915, 1988, and 1999, range 83.

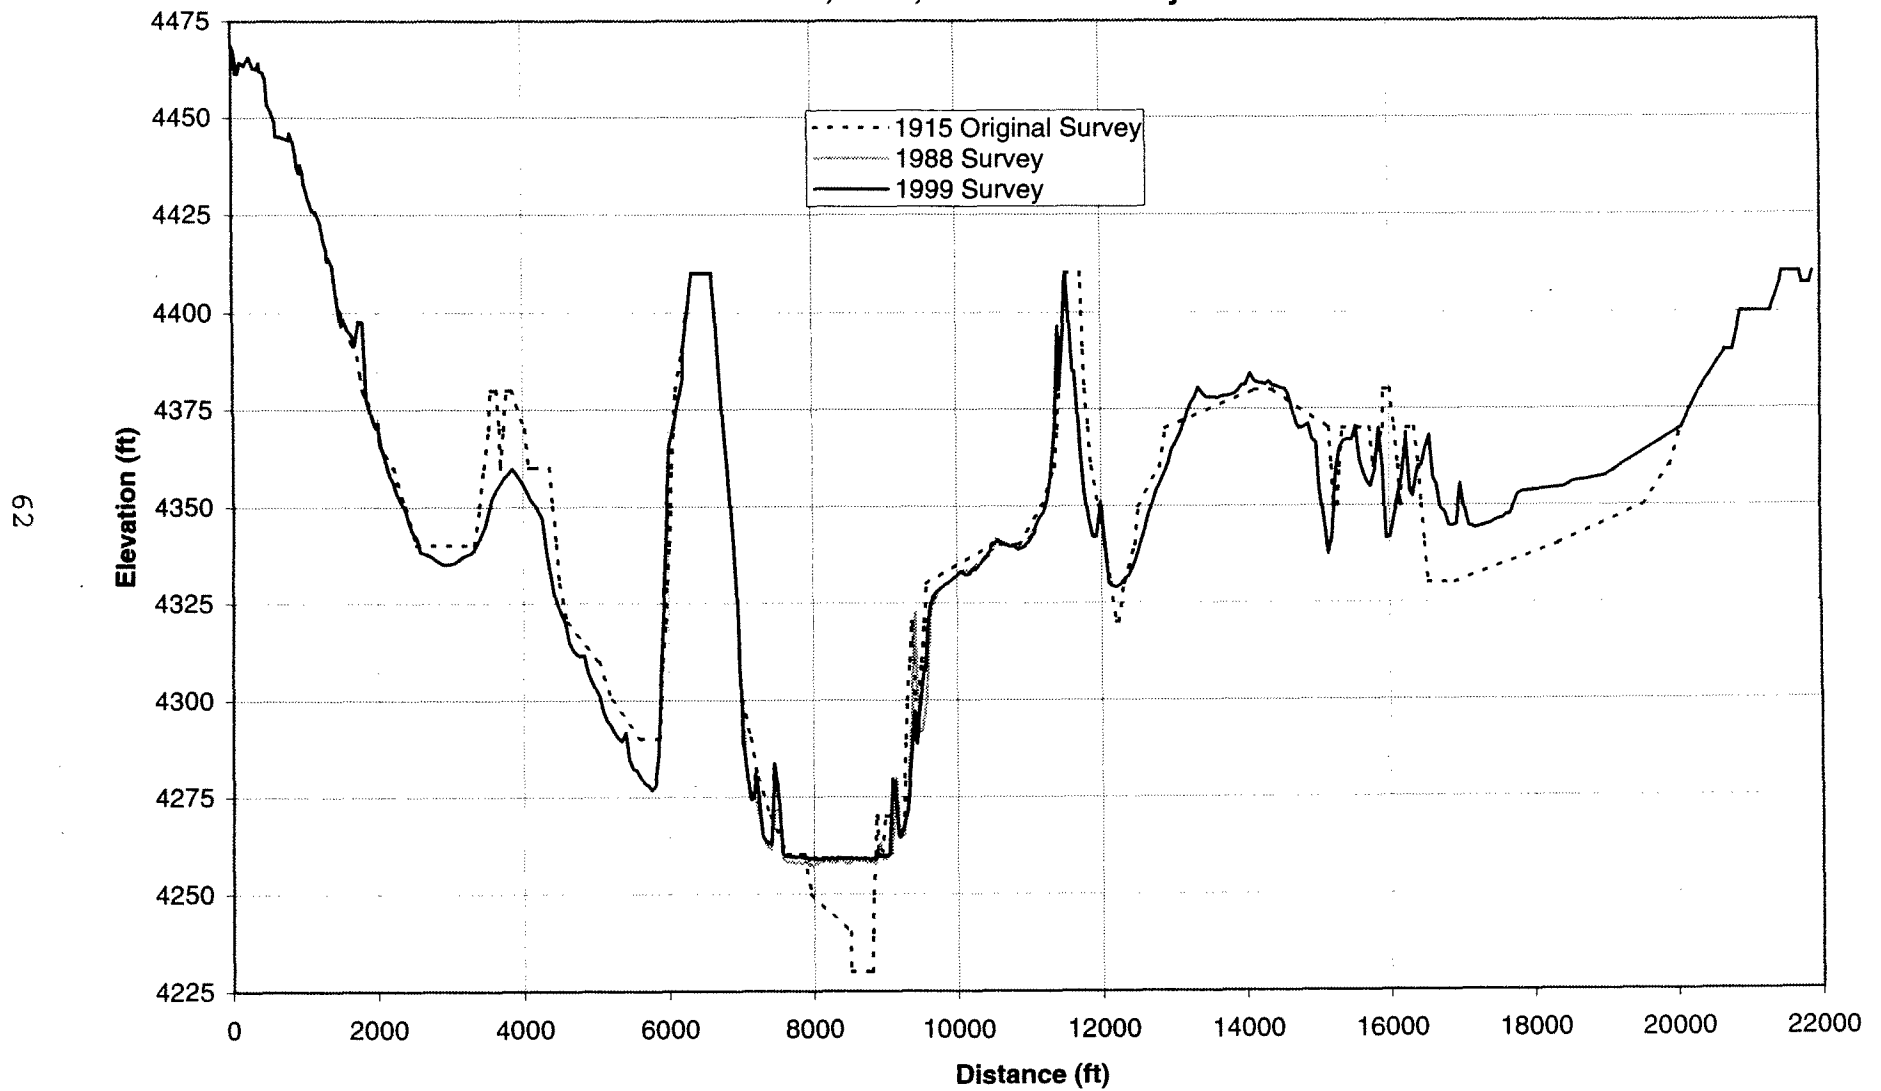
Elephant Butte Sediment Range Profile: Rangeline 82 1915, 1988, and 1999 Surveys

Figure 28. - Sedimentation range profiles for 1915, 1988, and 1999, range 82.

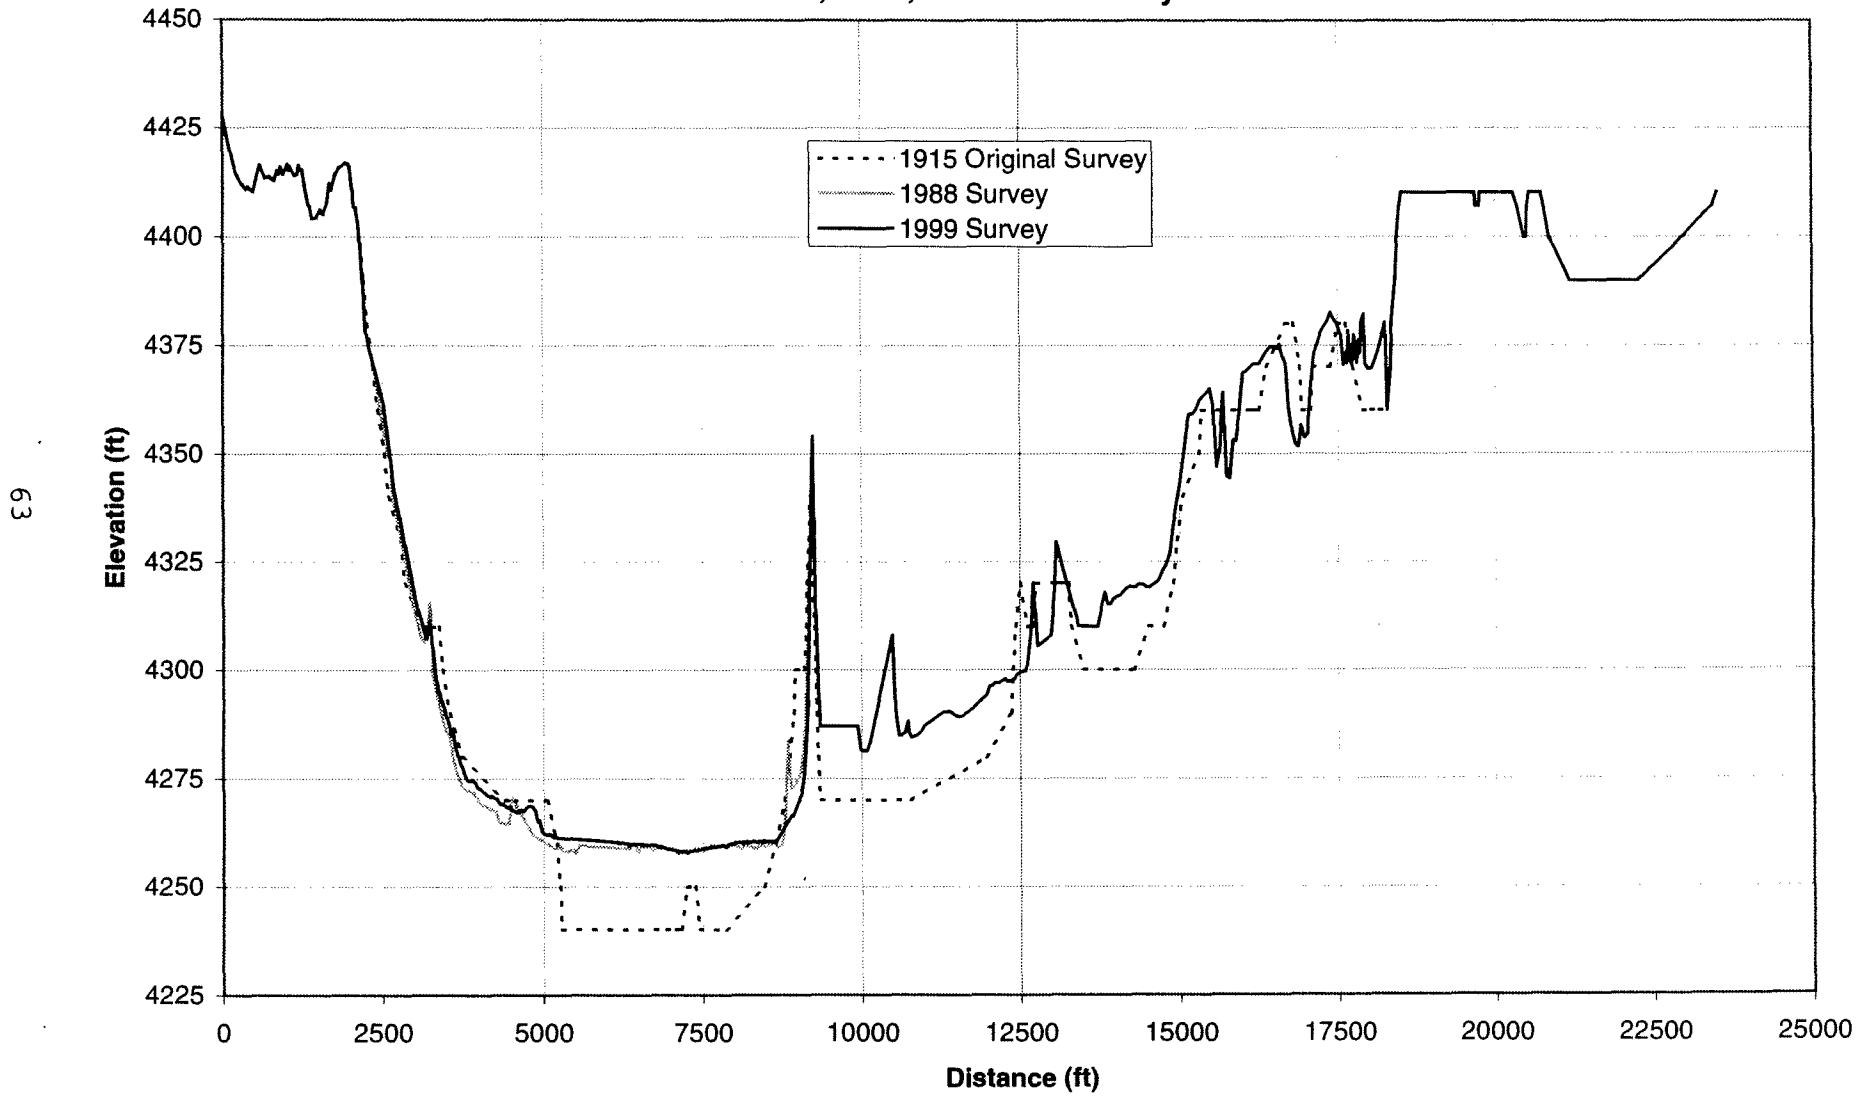
**Elephant Butte Sediment Range Profile: Rangeline 81
1915, 1988, and 1999 Surveys**

Figure 29. - Sedimentation range profiles for 1915, 1988, and 1999, range 81.

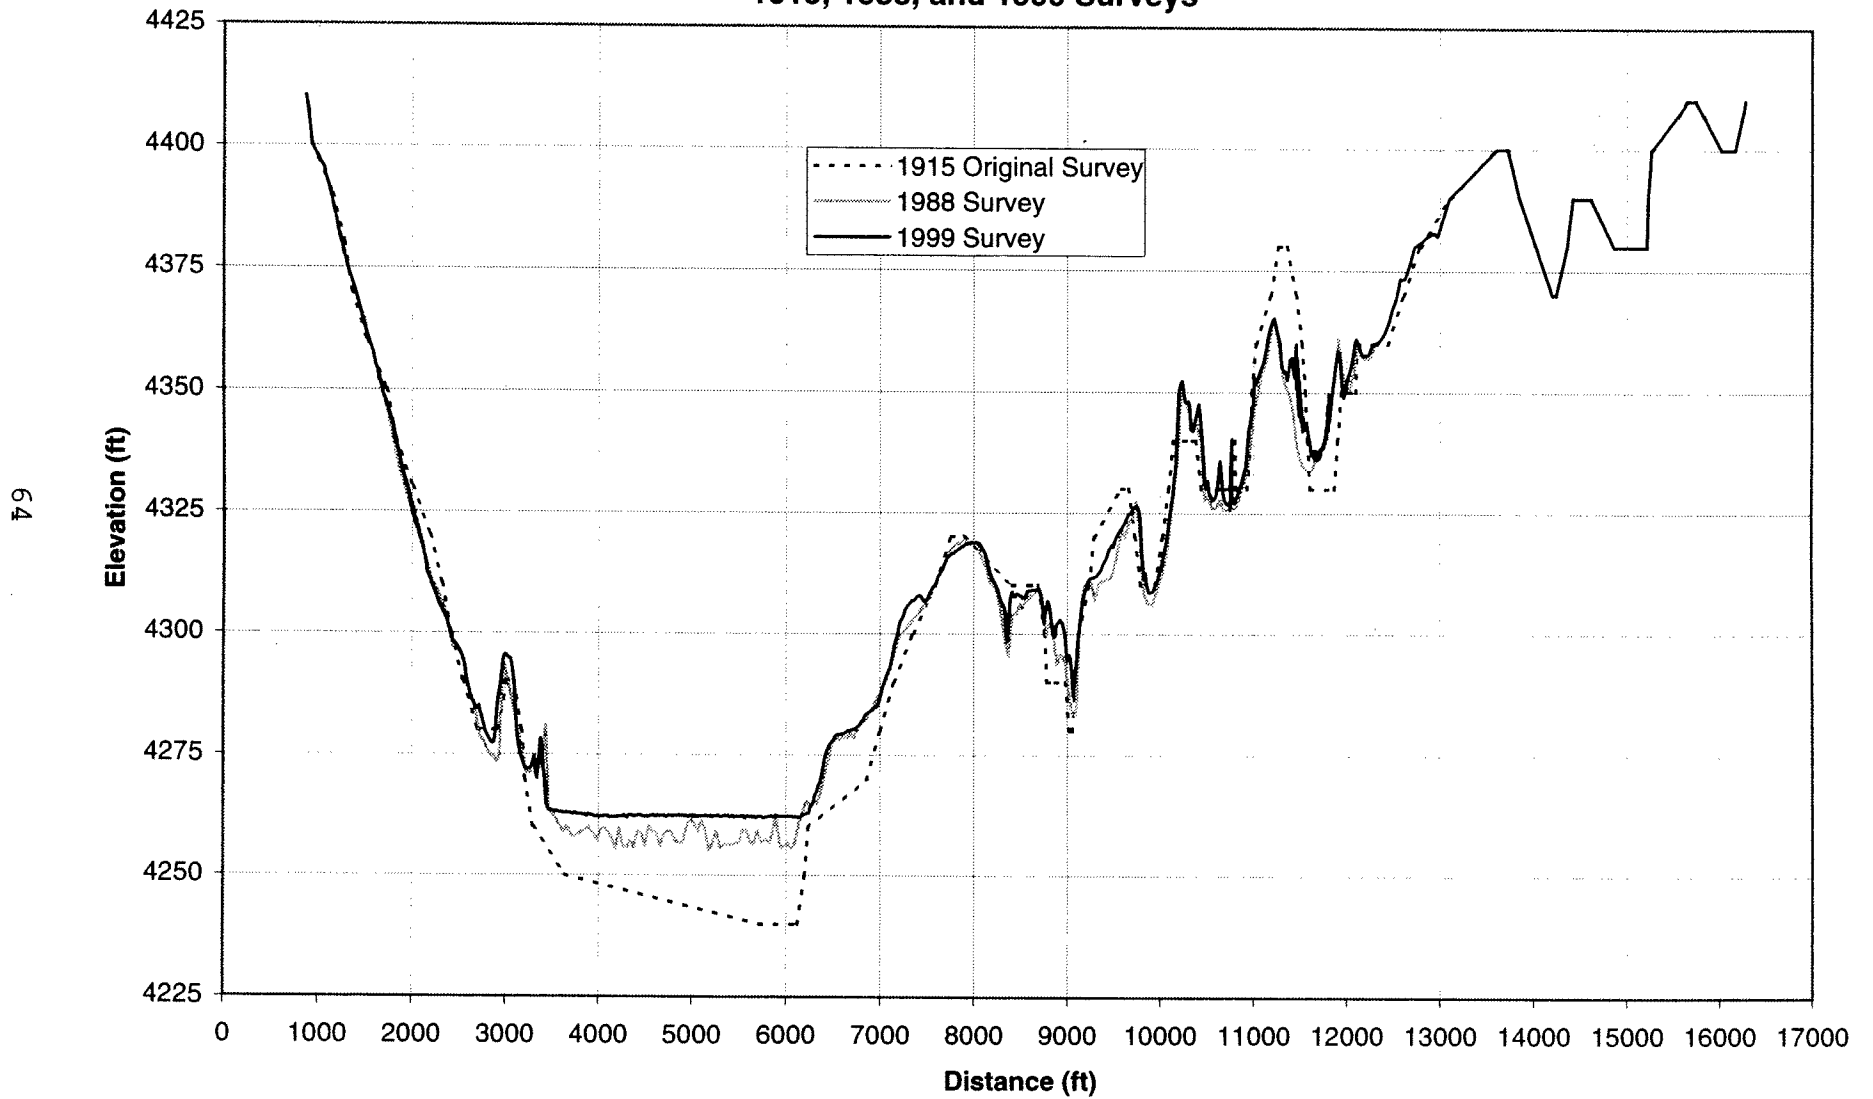
**Elephant Butte Sediment Range Profile: Rangeline 80
1915, 1988, and 1999 Surveys**

Figure 30. - Sedimentation range profiles for 1915, 1988, and 1999, range 80.
