ELEPHANT BUTTE RESERVOIR

1999 RESERVOIR SURVEY

U.S. Department of the Interior
Bureau of Reclamation

**Sedimentation and River Hydraulics Group
Water Resources Services
Technical Service Center
Denver, Colorado**

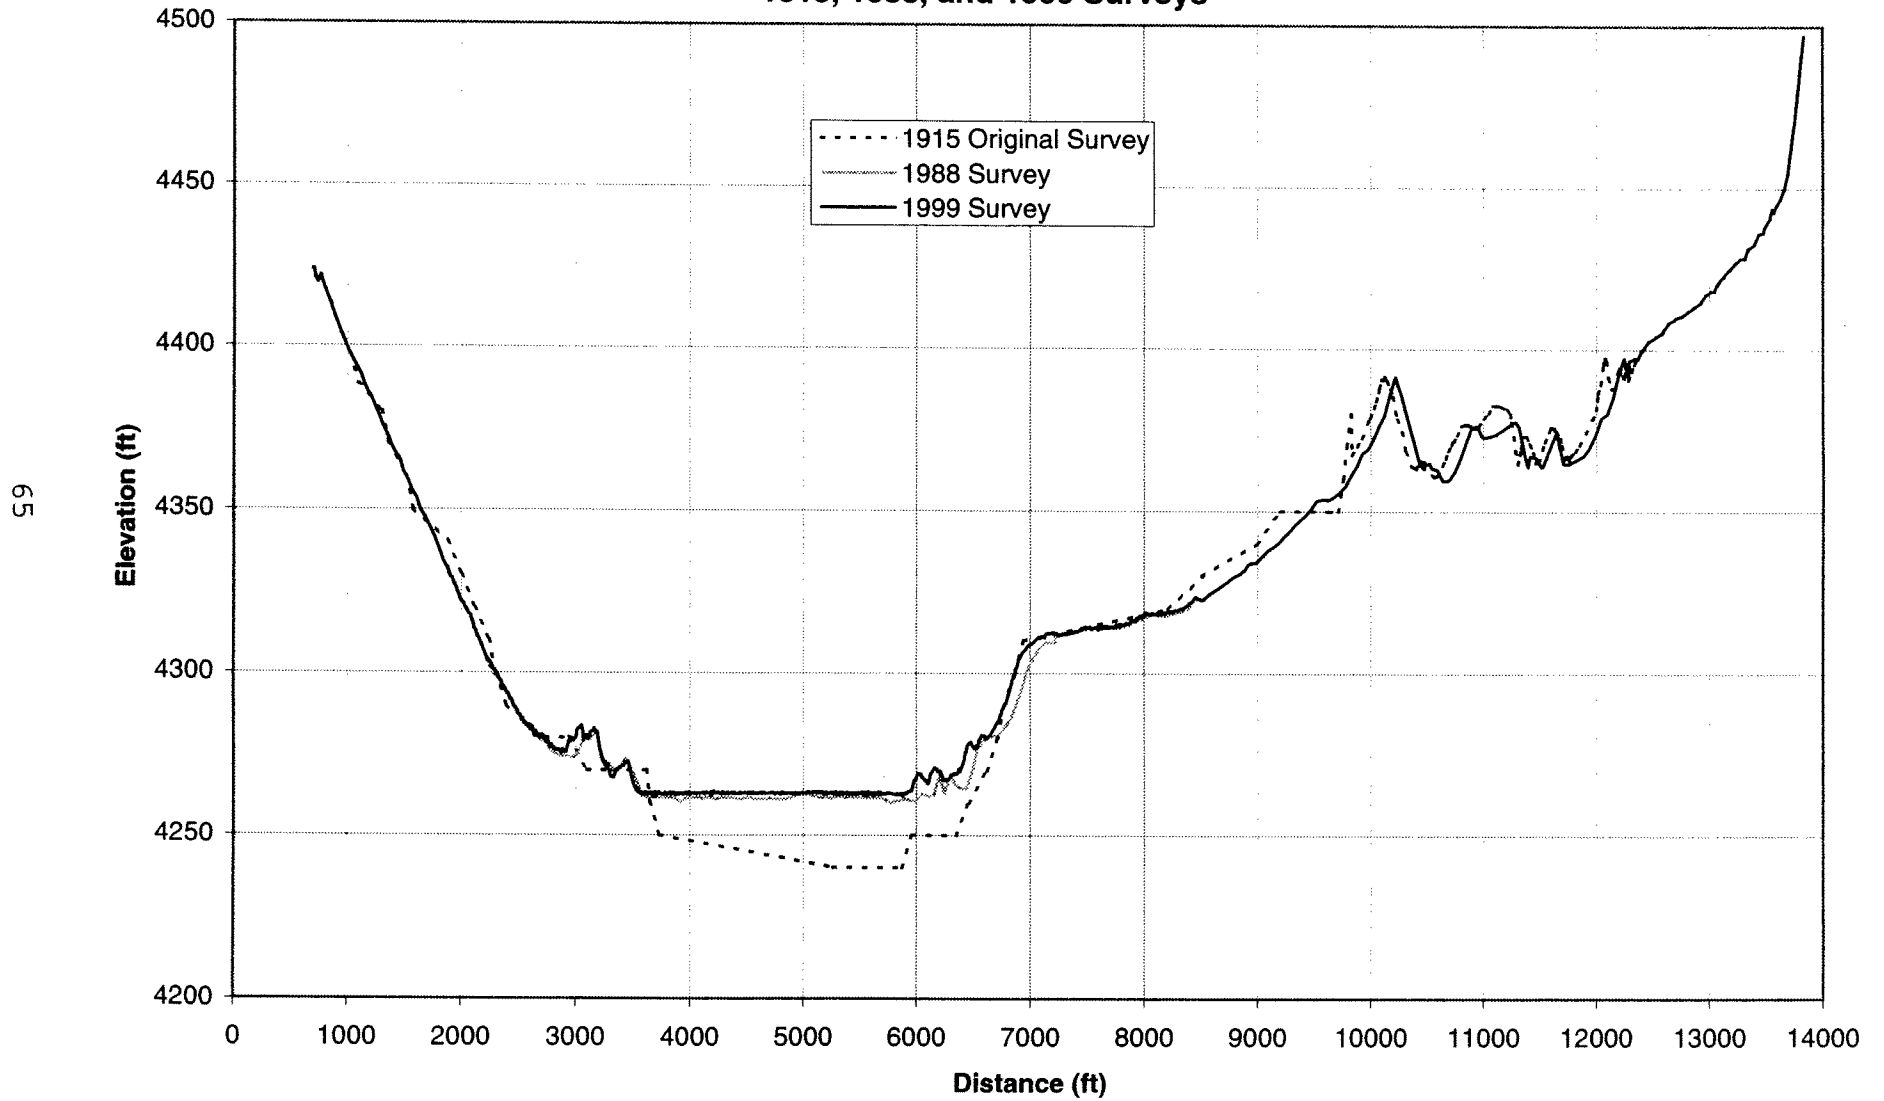
**Elephant Butte Sediment Range Profile: Rangeline 79
1915, 1988, and 1999 Surveys**

Figure 31. - Sedimentation range profiles for 1915, 1988, and 1999, range 79.

Ground profiles of the 82 reservoir sedimentation ranges are shown on figures 20 through 101. These profiles illustrate the general lateral distribution of sediments in the reservoir. Plots are from left to right looking upstream to be consistent with previous survey reports. The plots illustrate the survey results from the original, 1988, and 1999 surveys. The original and other profiles do not fully agree in the lateral direction for all ranges mainly due to the fact the original profiles were

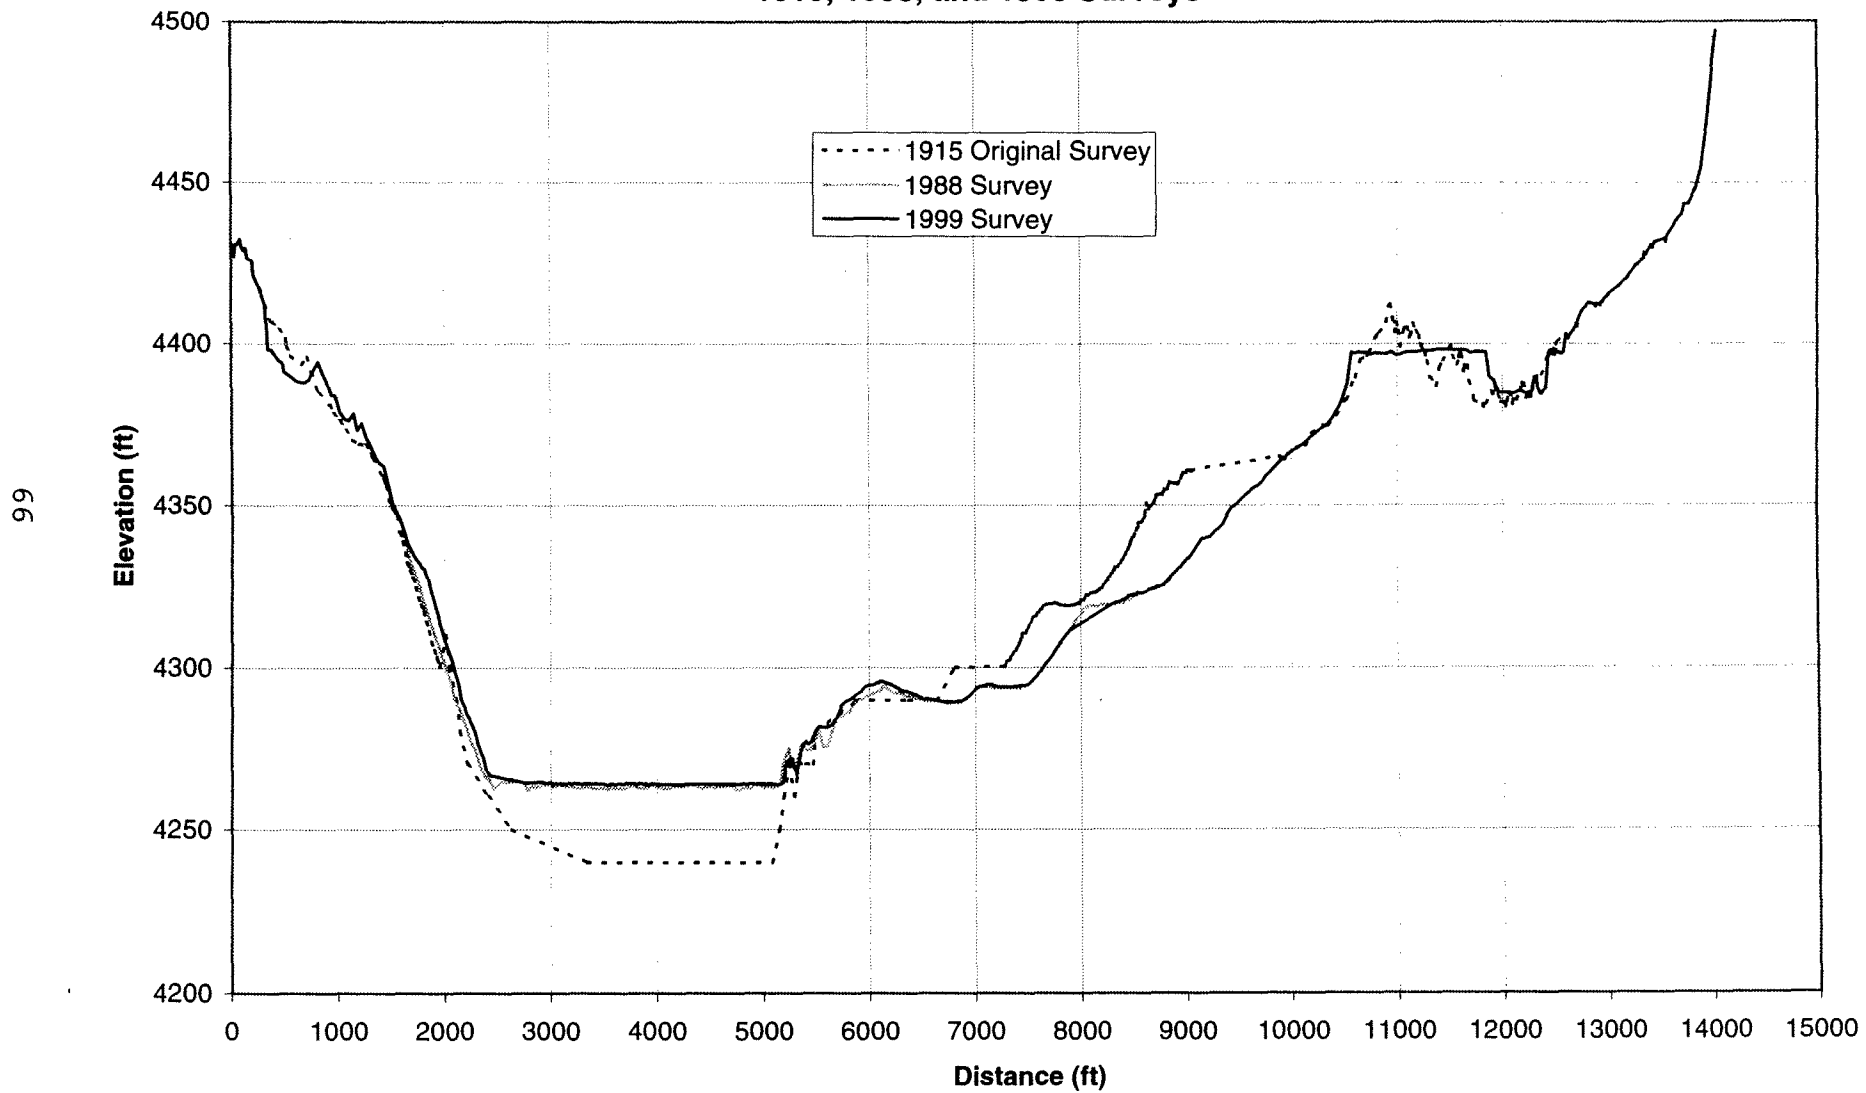
Elephant Butte Sediment Range Profile: Rangeline 78 1915, 1988, and 1999 Surveys

Figure 32. - Sedimentation range profiles for 1915, 1988, and 1999, range 78.

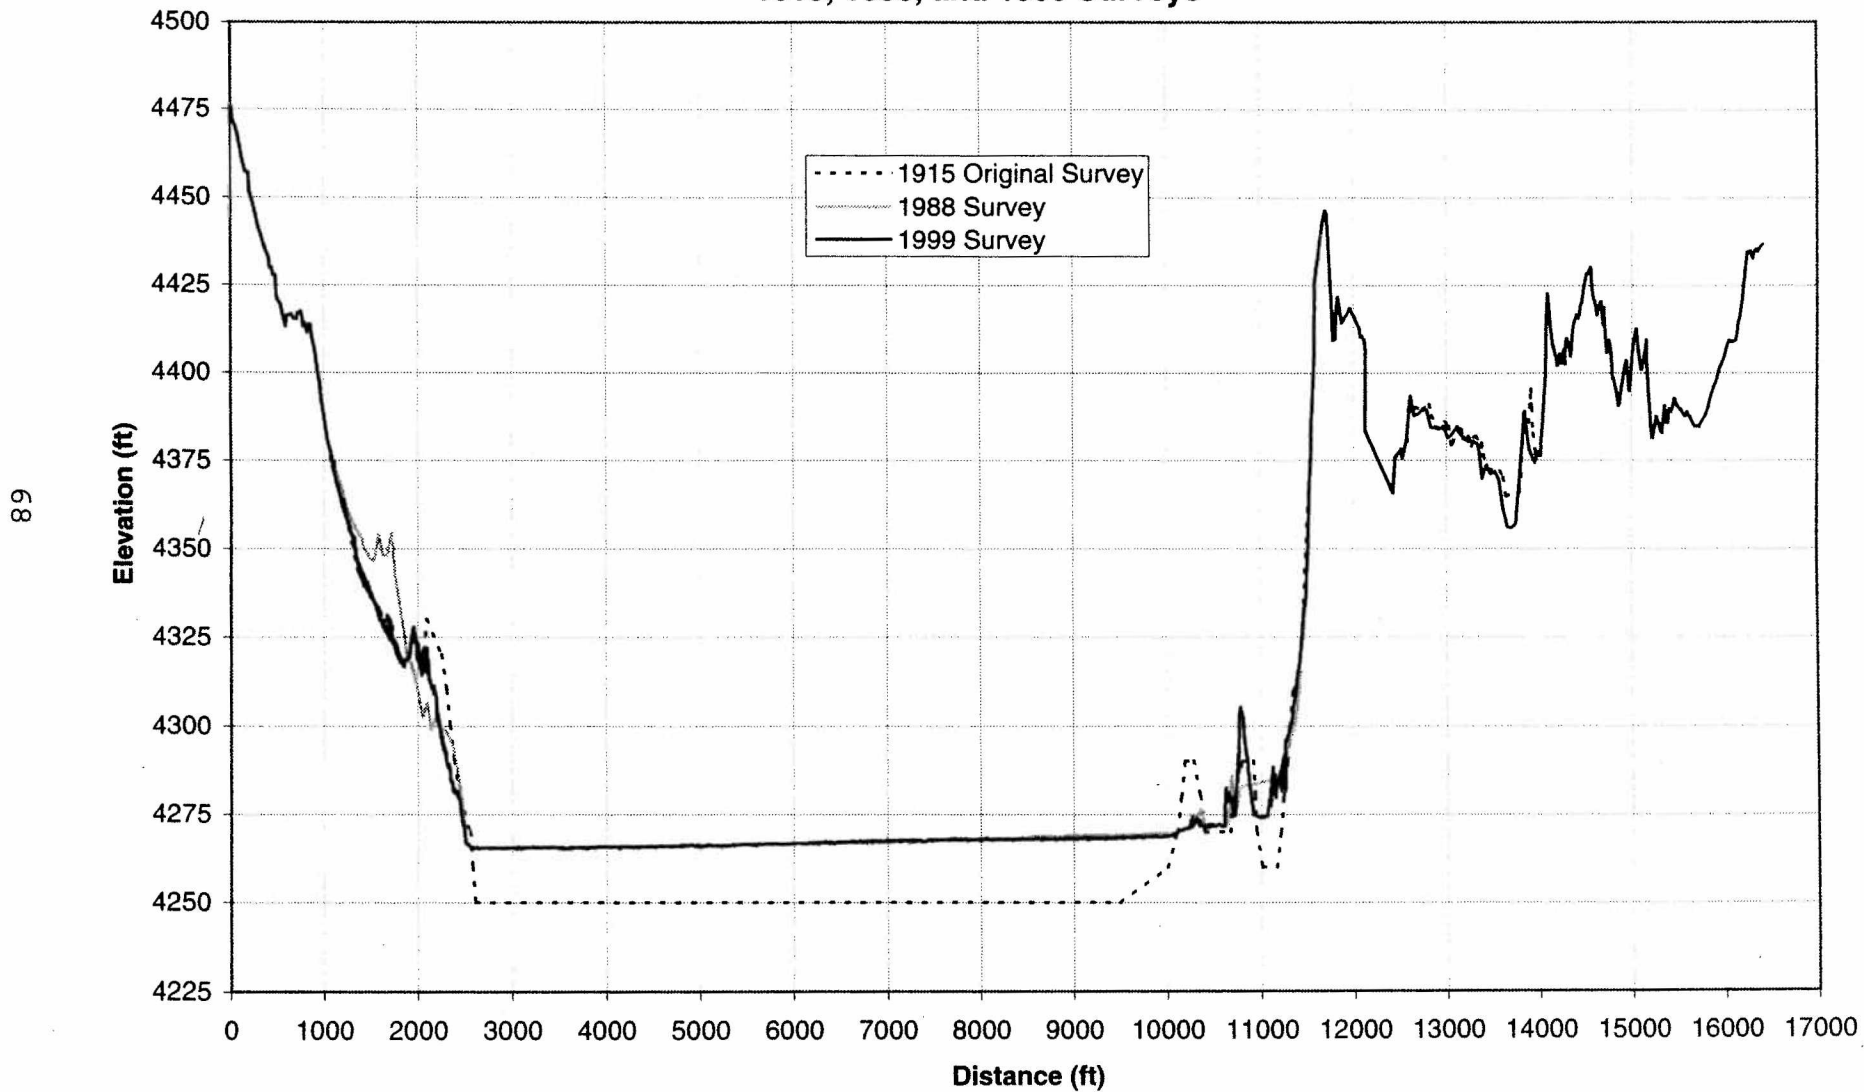
Elephant Butte Sediment Range Profile: Rangeline 76 1915, 1988, and 1999 Surveys

Figure 34. - Sedimentation range profiles for 1915, 1988, and 1999, range 76.

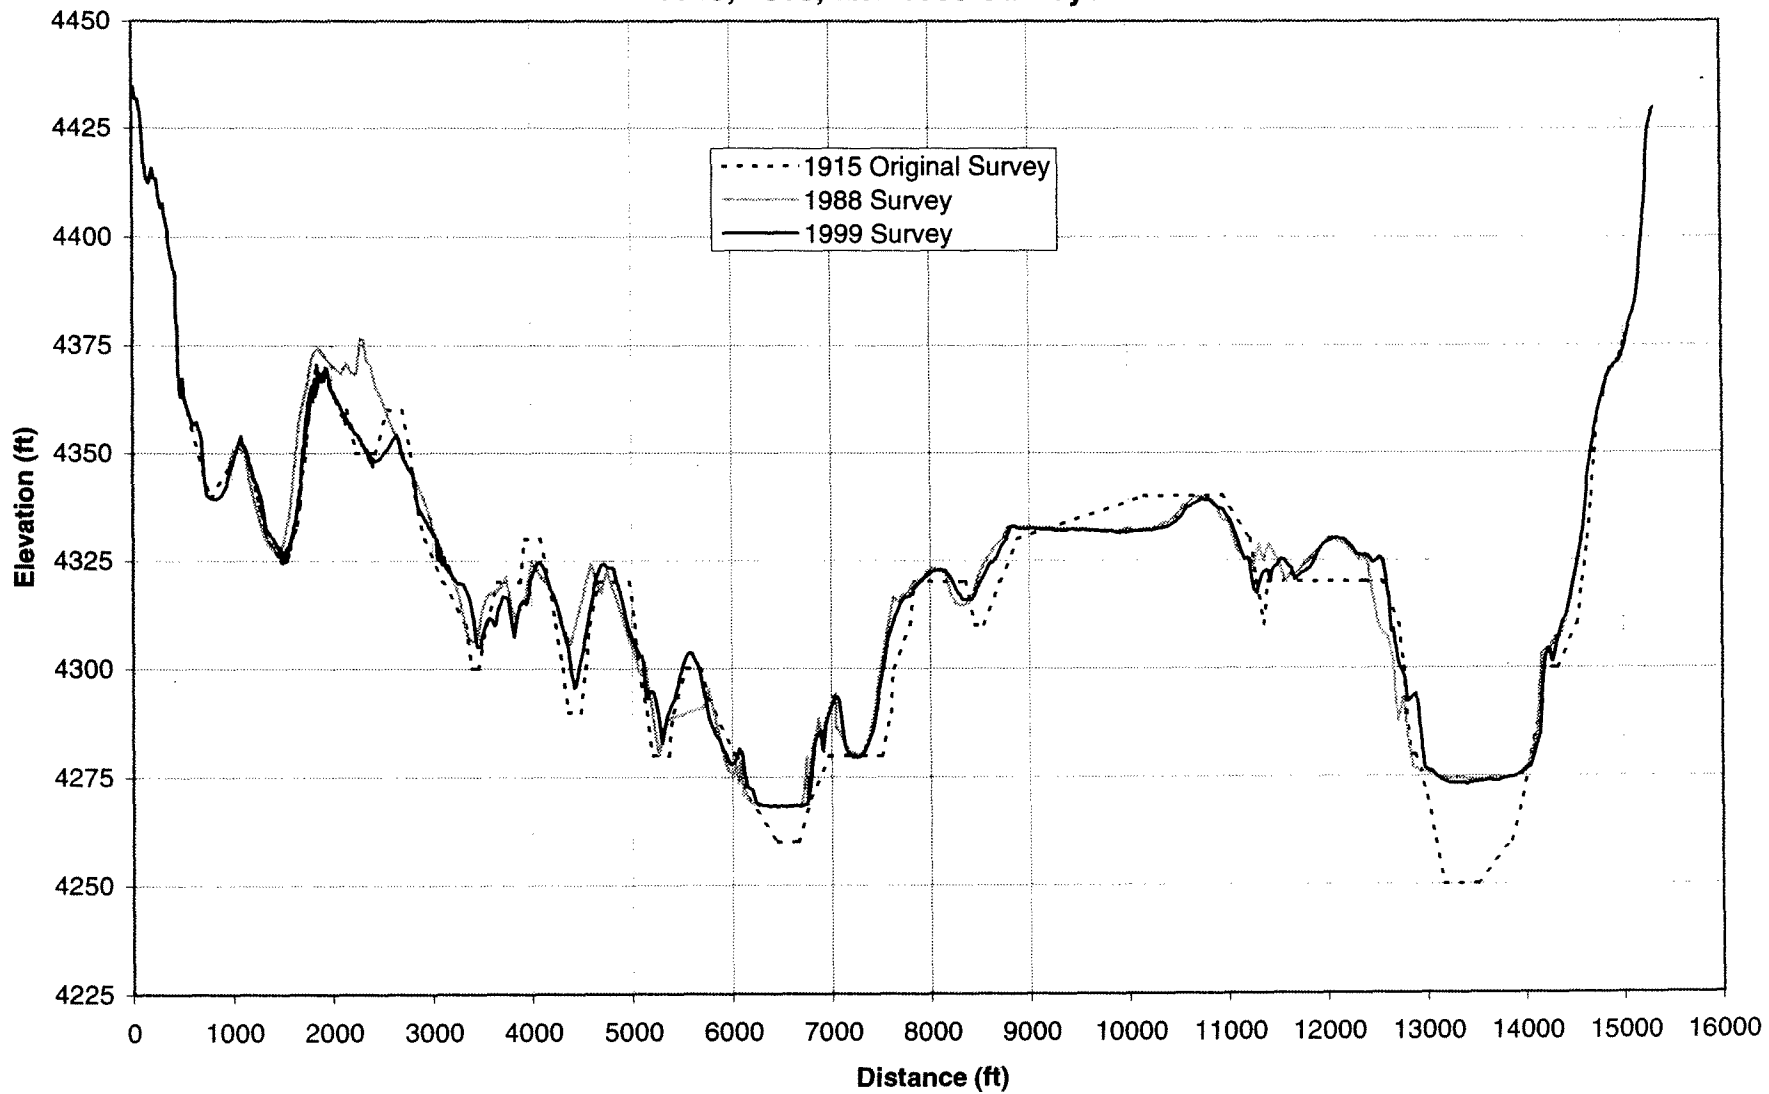
**Elephant Butte Sediment Range Profile: Rangeline 75
1915, 1988, and 1999 Surveys**

Figure 35. - Sedimentation range profiles for 1915, 1988, and 1999, range 75.

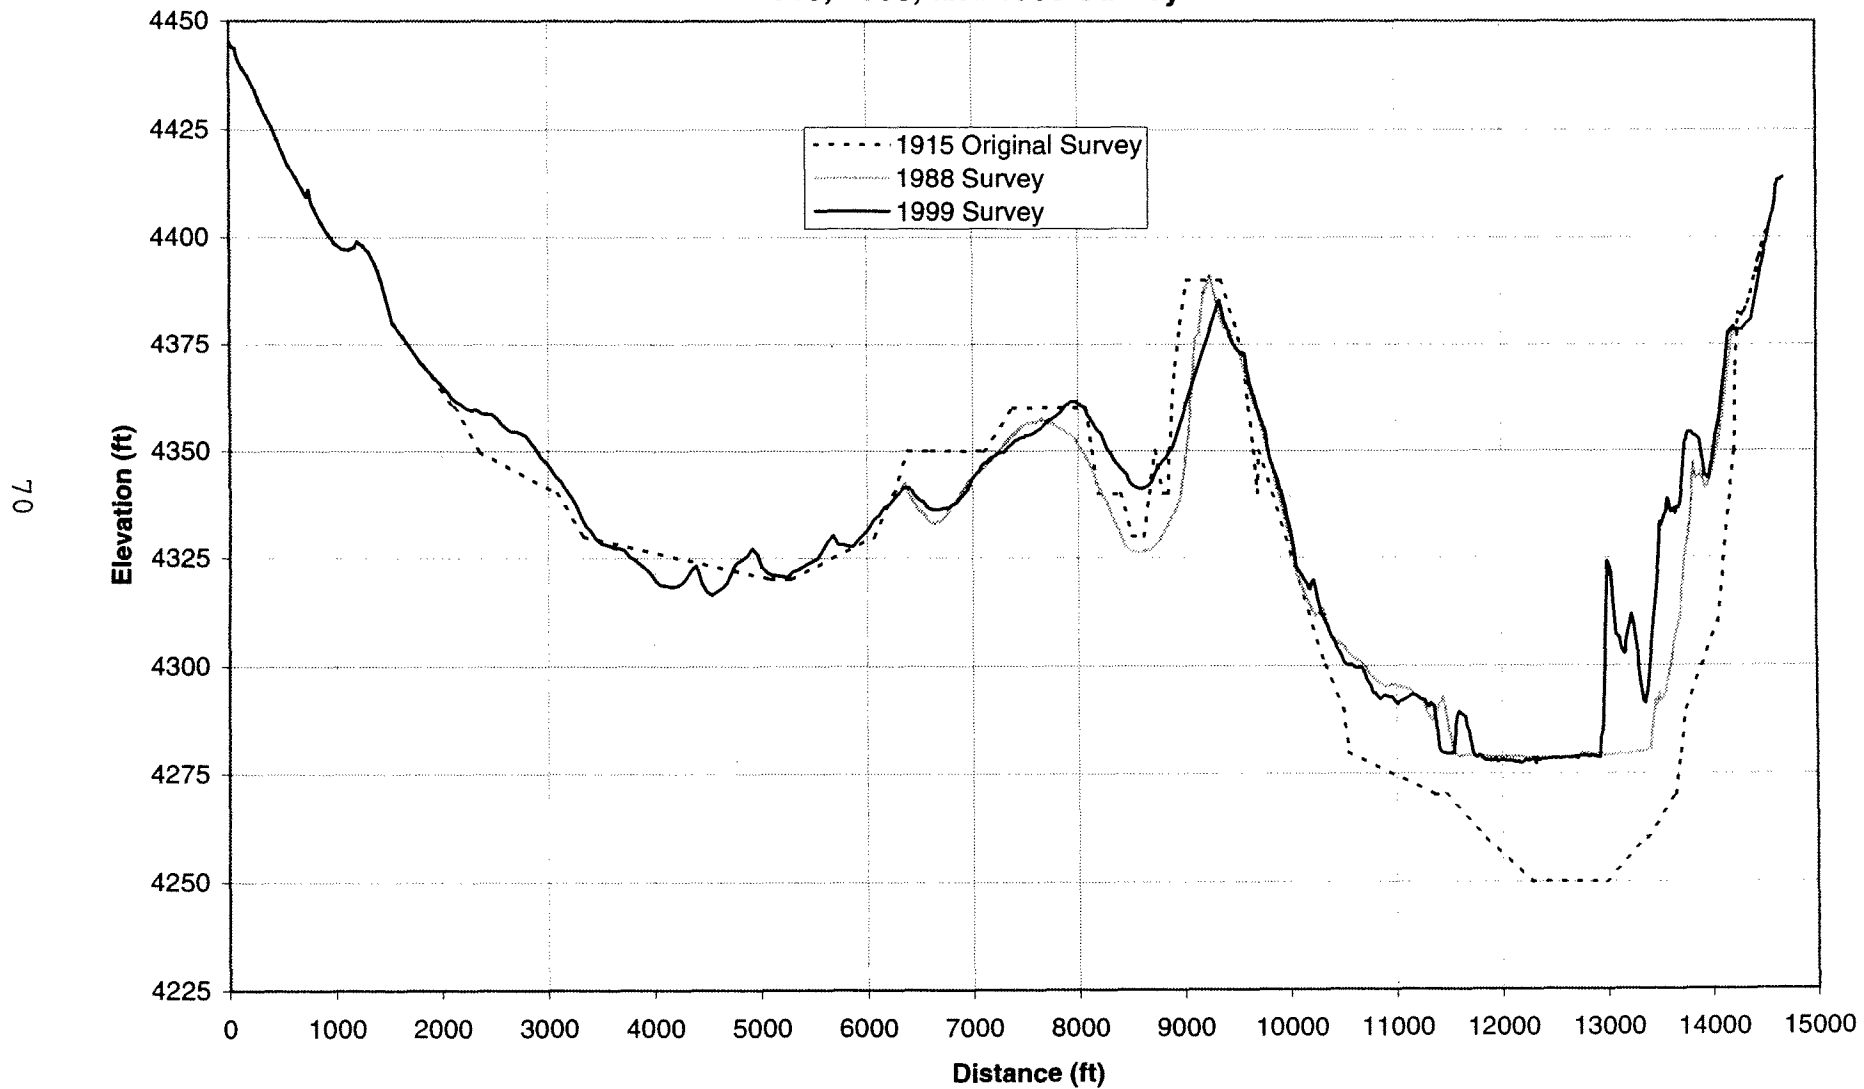
**Elephant Butte Sediment Range Profile: Rangeline 74
1915, 1988, and 1999 Surveys**

Figure 36. - Sedimentation range profiles for 1915, 1988, and 1999, range 74.

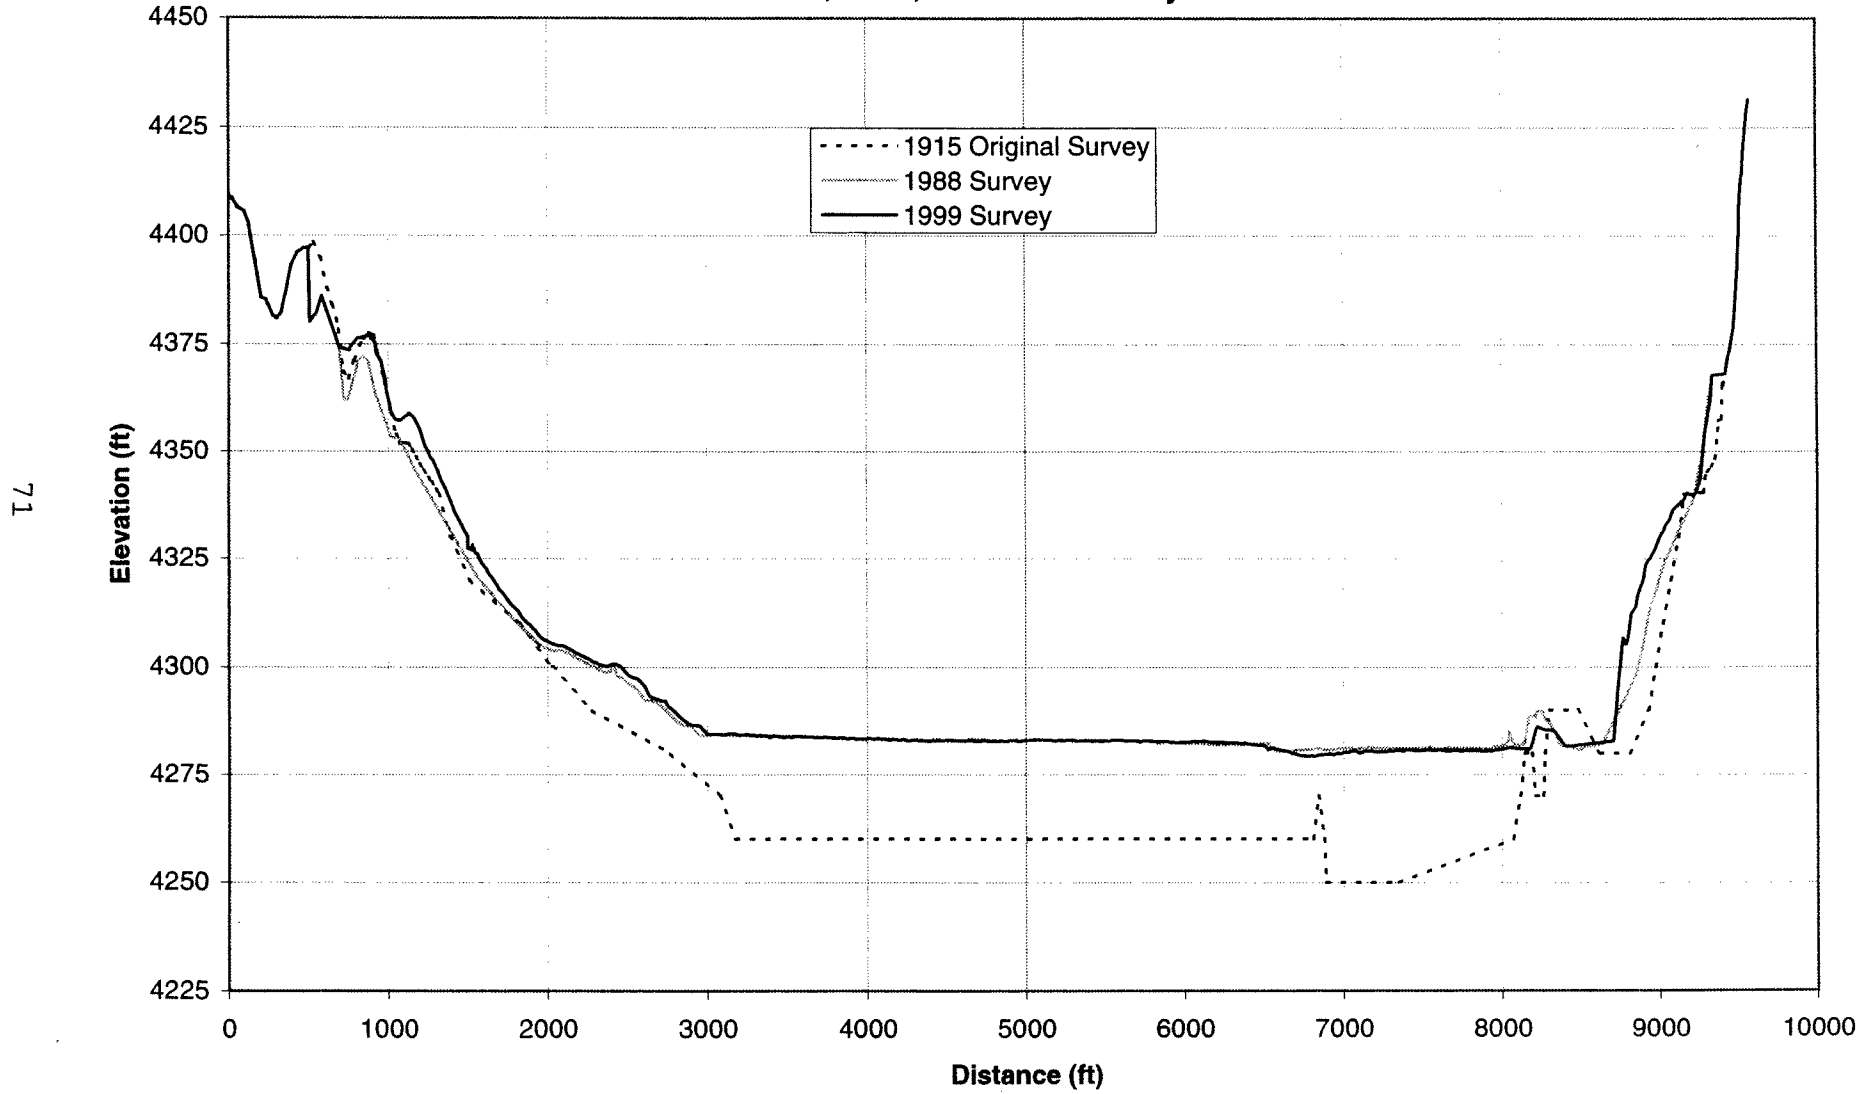
Elephant Butte Sediment Range Profile: Rangeline 73 1915, 1988, and 1999 Surveys

Figure 37. - Sedimentation range profiles for 1915, 1988, and 1999, range 73.

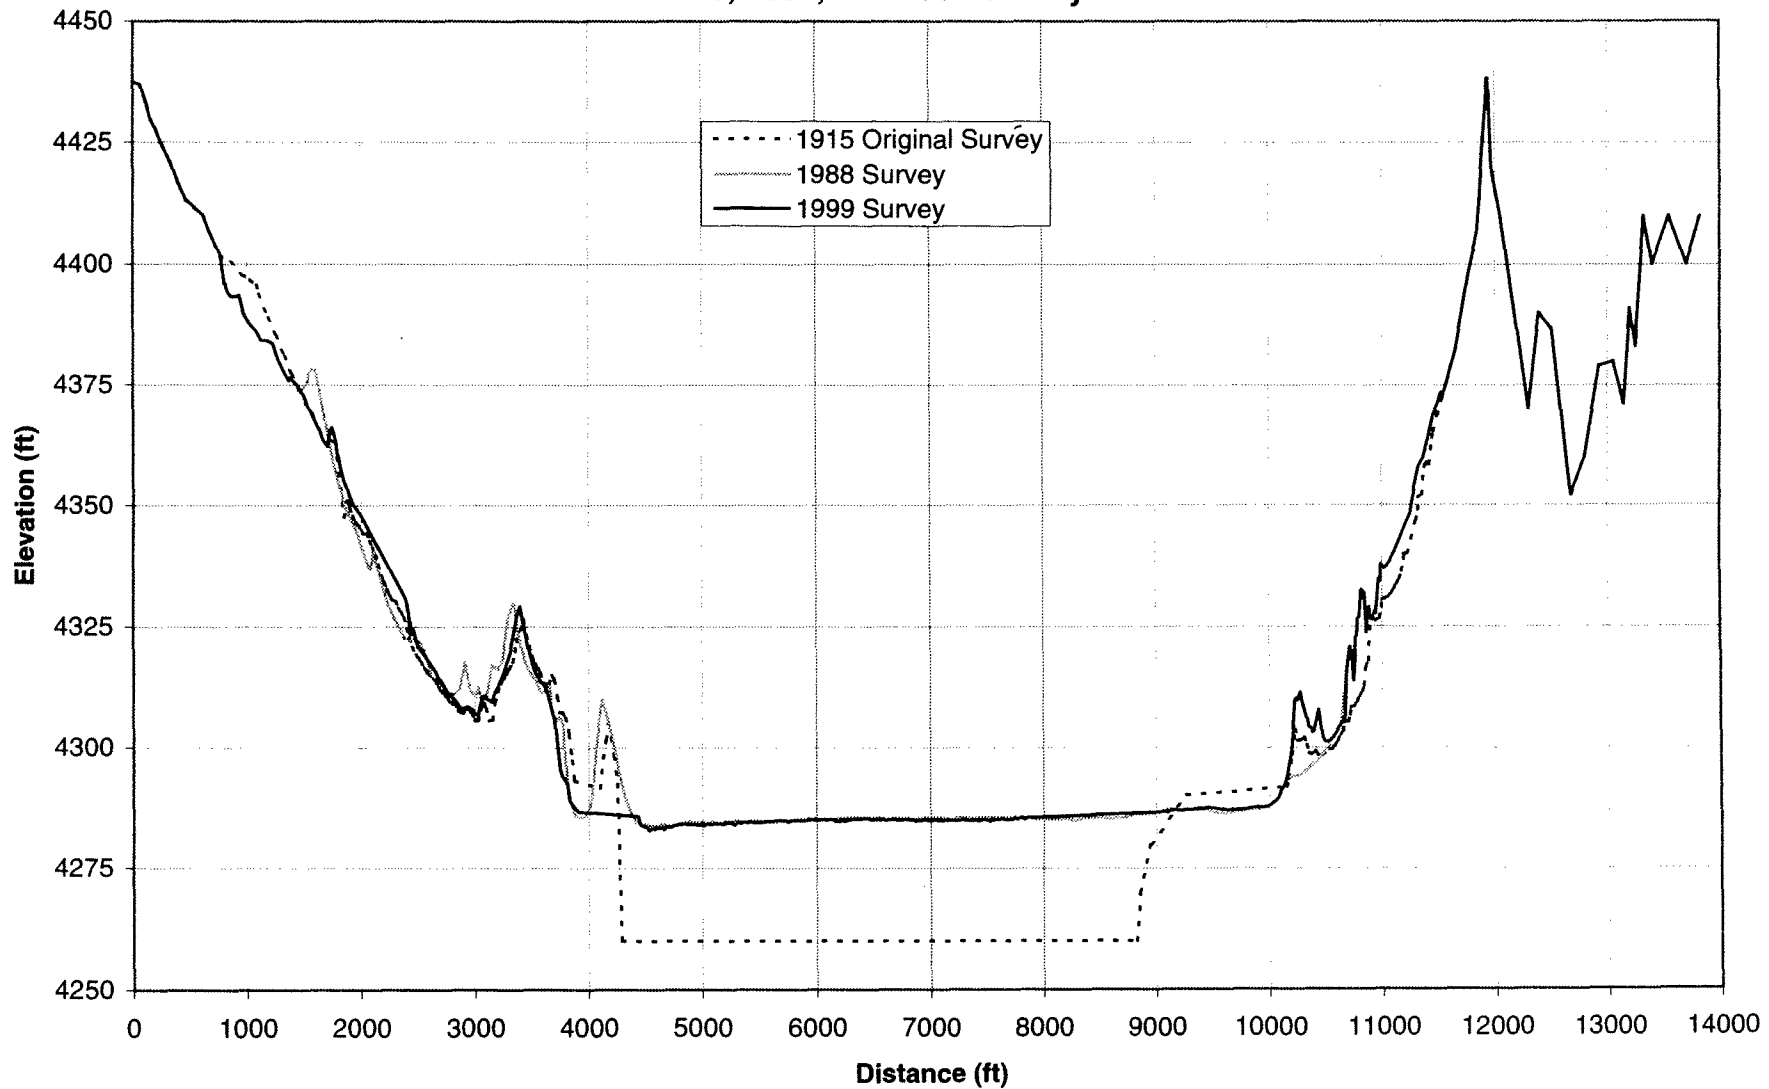
**Elephant Butte Sediment Range Profile: Rangeline 72
1915, 1988, and 1999 Surveys**

Figure 38. - Sedimentation range profiles for 1915, 1988, and 1999, range 72.

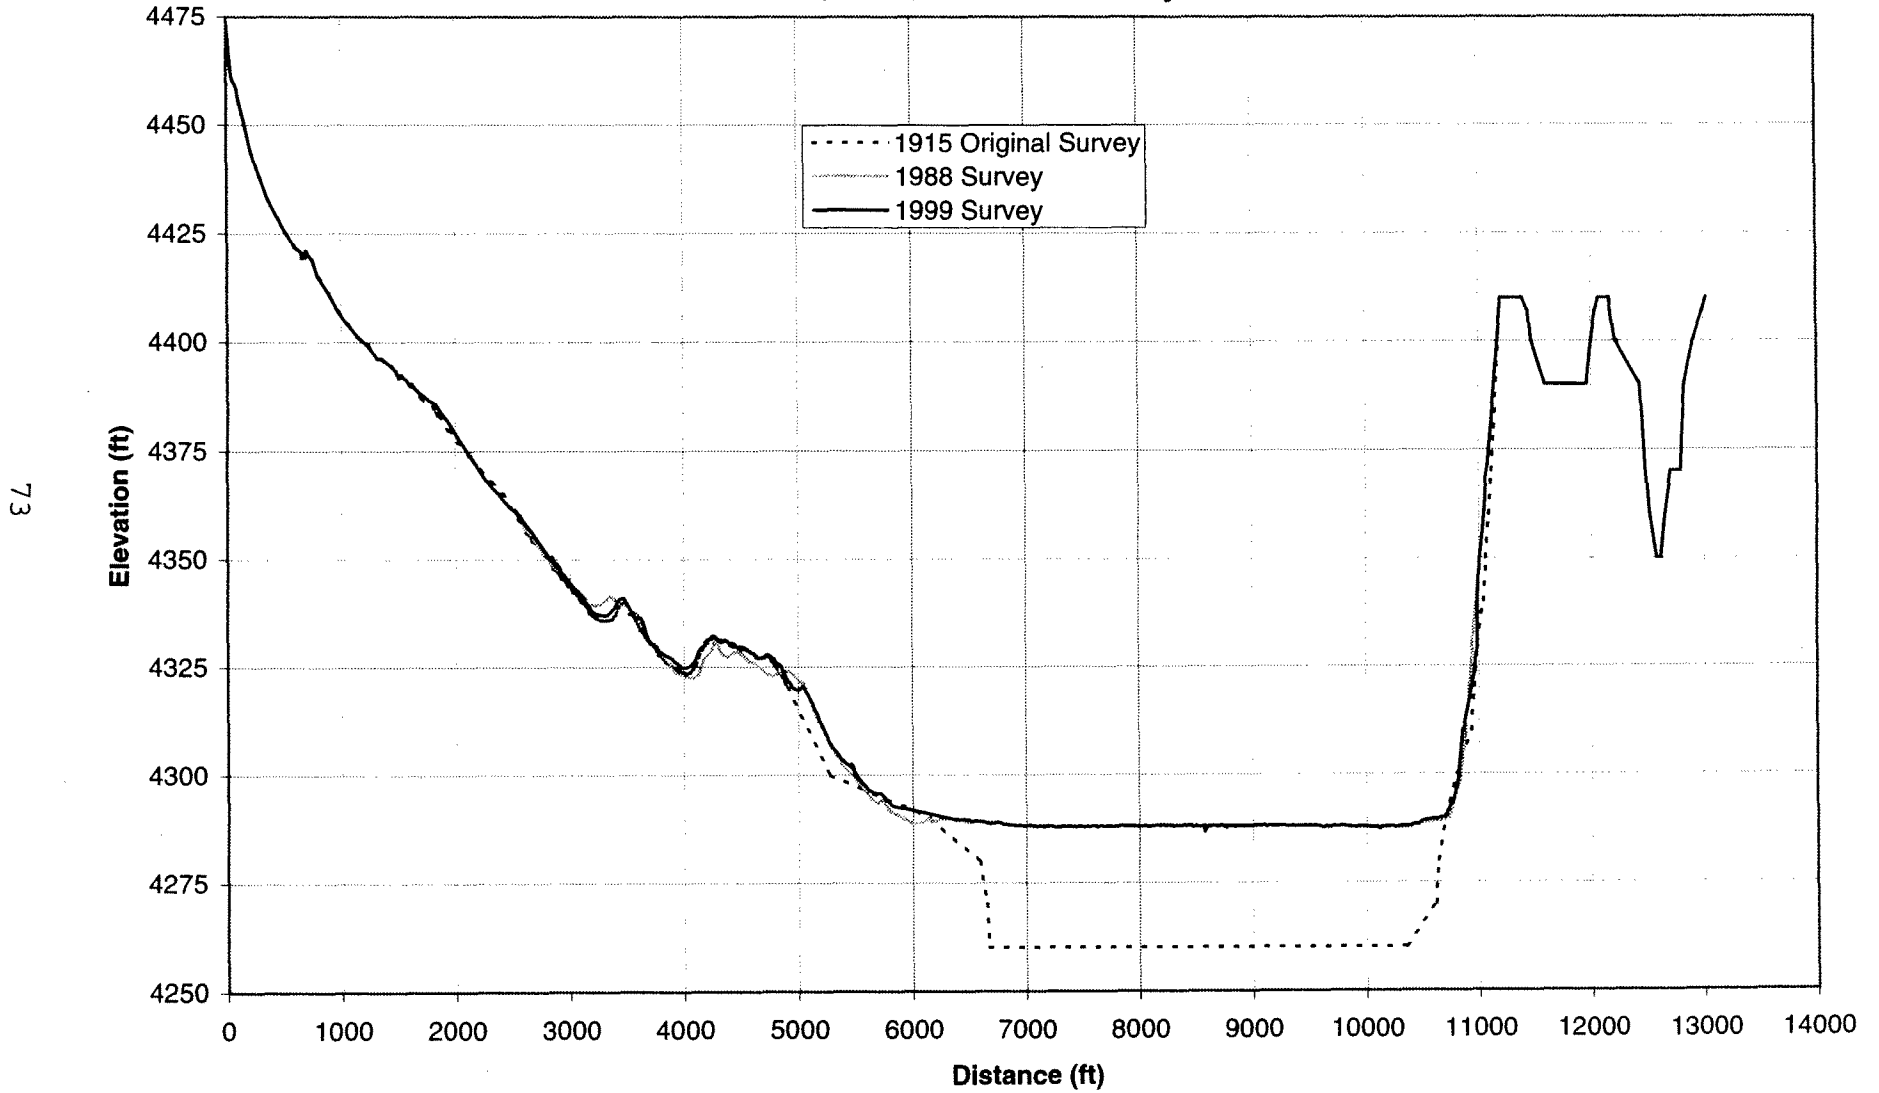
**Elephant Butte Sediment Range Profile: Rangeline 71
1915, 1988, and 1999 Surveys**

Figure 39. - Sedimentation range profiles for 1915, 1988, and 1999, range 71.

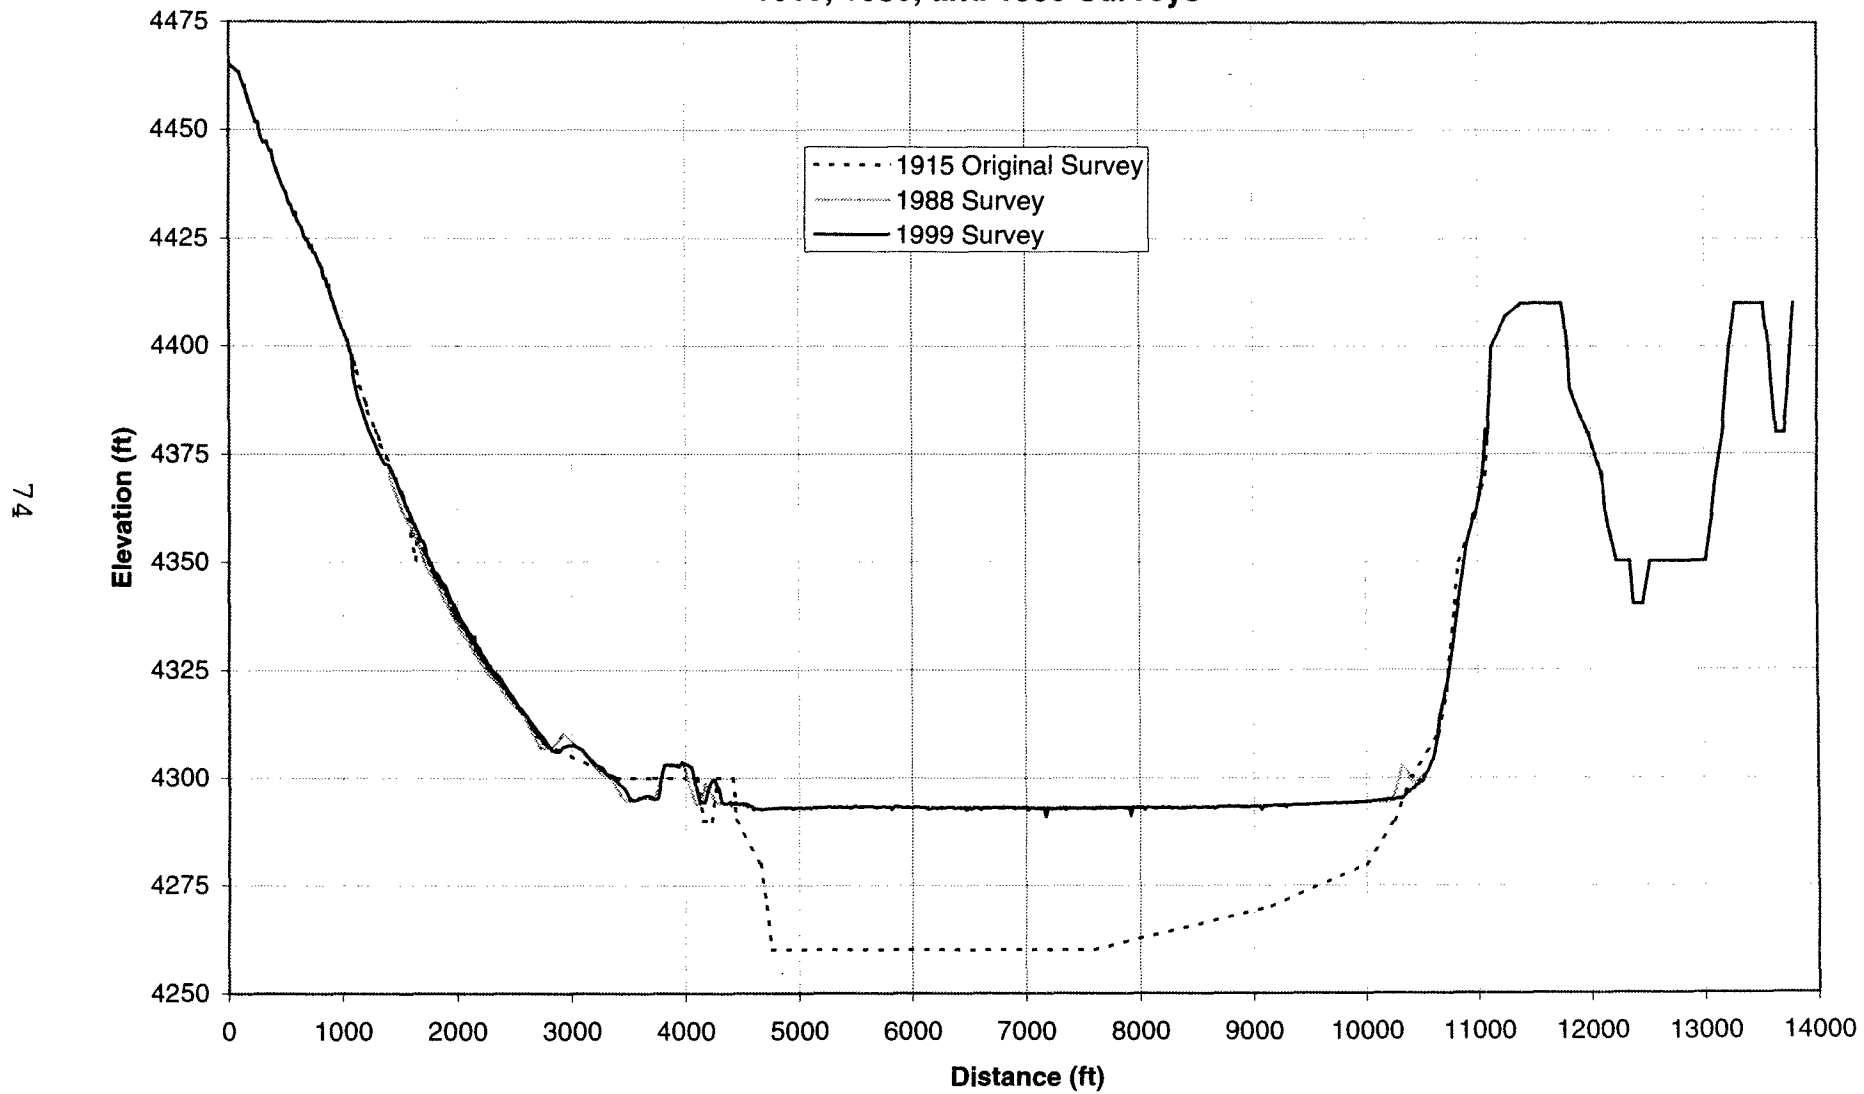
Elephant Butte Sediment Range Profile: Rangeline 70 1915, 1988, and 1999 Surveys

Figure 40. - Sedimentation range profiles for 1915, 1988, and 1999, range 70.

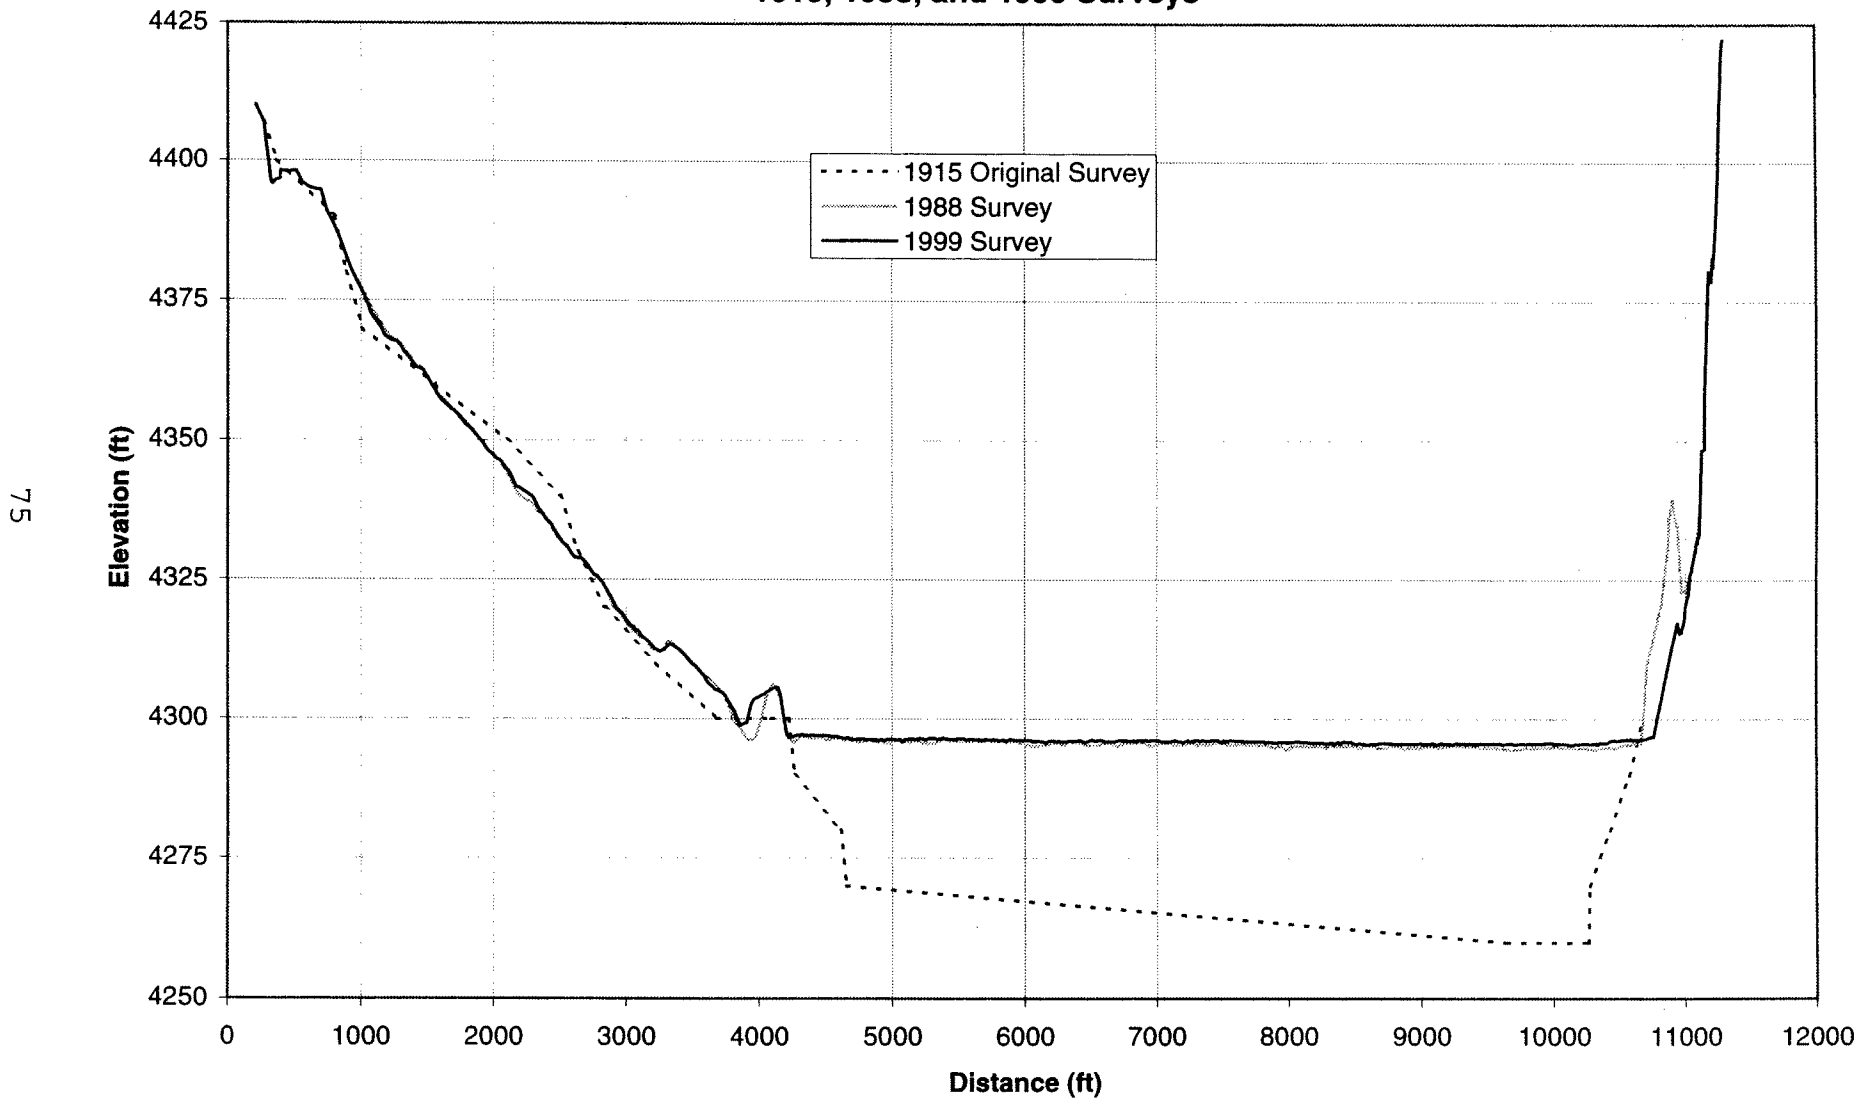
Elephant Butte Sediment Range Profile: Rangeline 69 1915, 1988, and 1999 Surveys

Figure 41. - Sedimentation range profiles for 1915, 1988, and 1999, range 69.

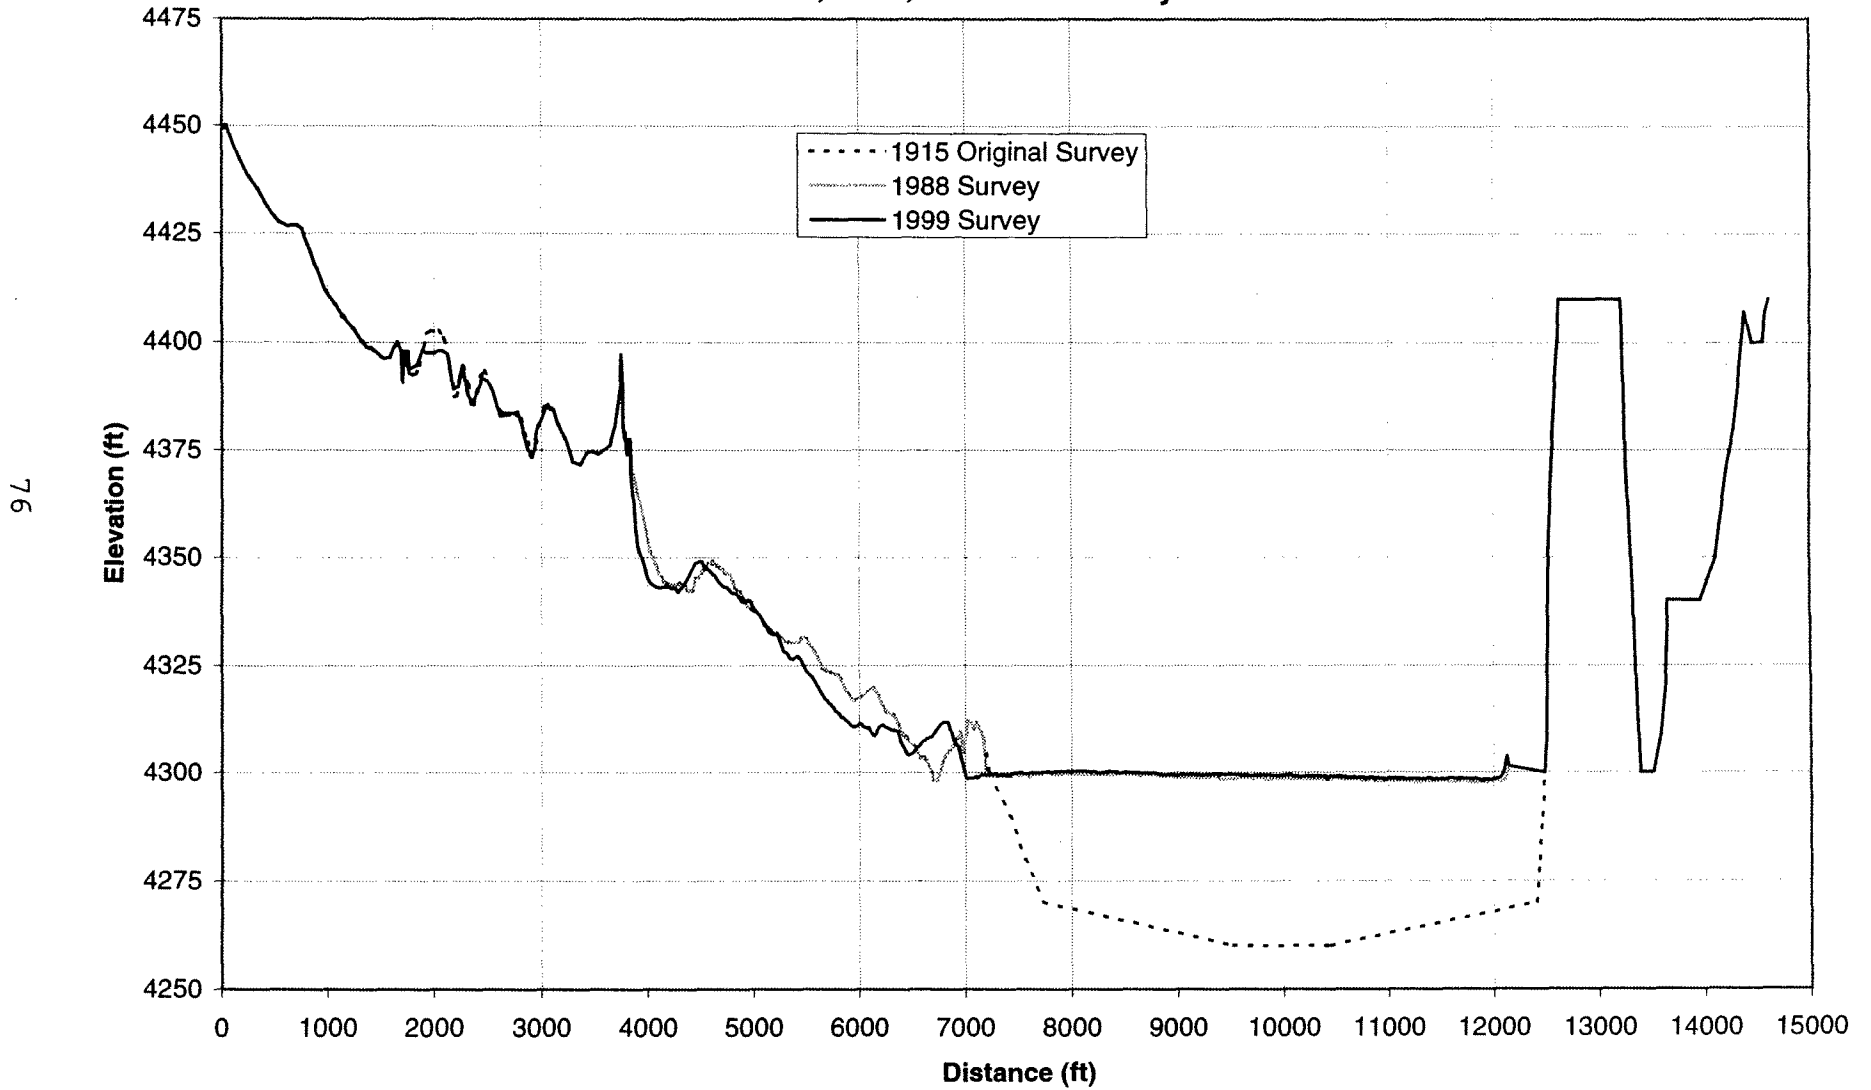
Elephant Butte Sediment Range Profile: Rangeline 68 1915, 1988, and 1999 Surveys

Figure 42. - Sedimentation range profiles for 1915, 1988, and 1999, range 68.
